Borehole Geophysical Investigation of a Formerly Used Defense Site, Machiasport, Maine, 2003–2006

By Carole D. Johnson, Remo A. Mondazzi, and Peter K. Joesten

Scientific Investigations Report 2009–5120

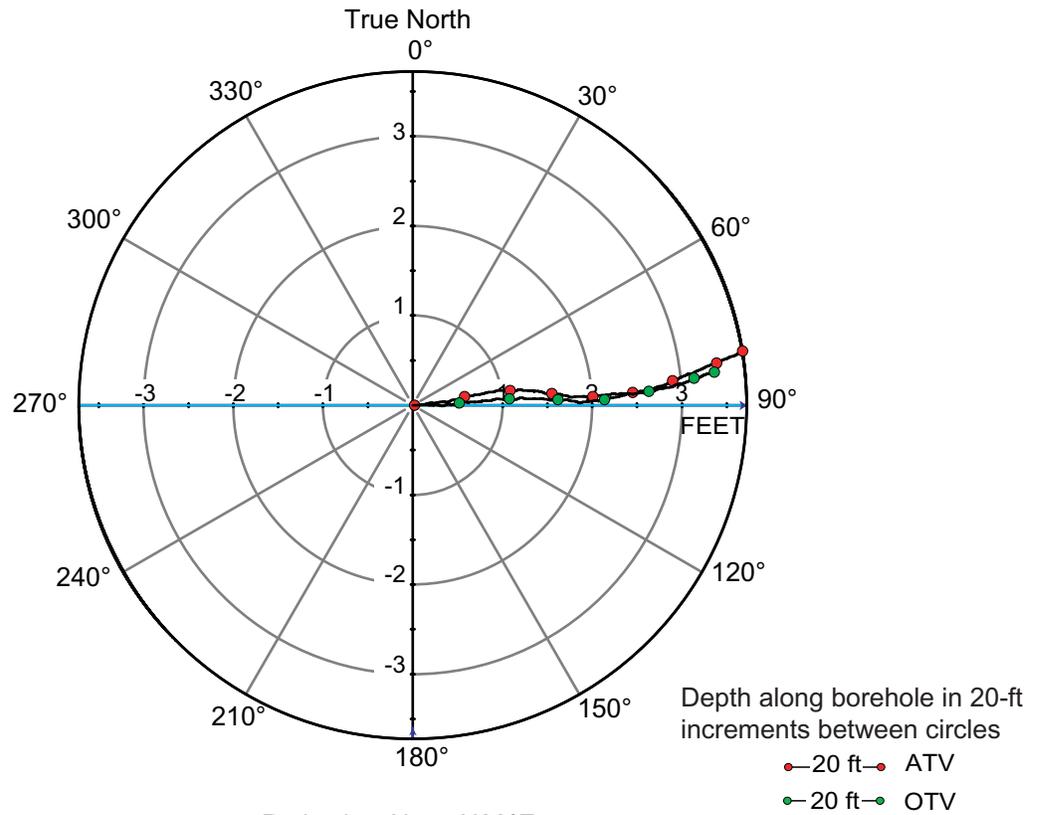
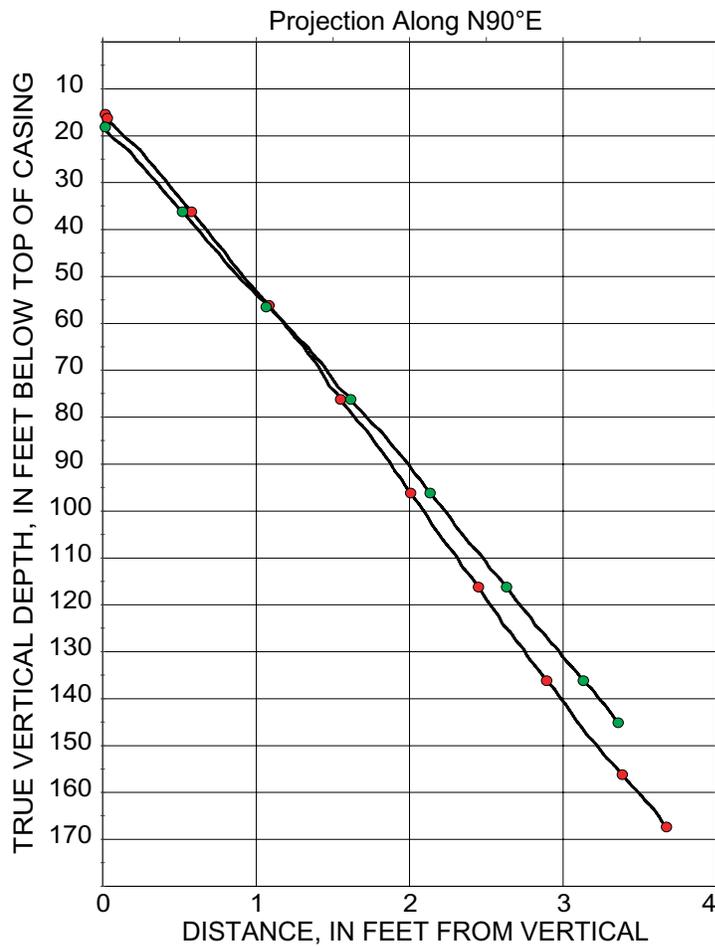
Figure 5C-1. Borehole deviation logs for borehole MW-16, near Machiasport, Maine. Blue line on radial plot (top) is line of projection for vertical plot (bottom).
[ft, foot; ATV, acoustic televiewer; OTV, optical televiewer]

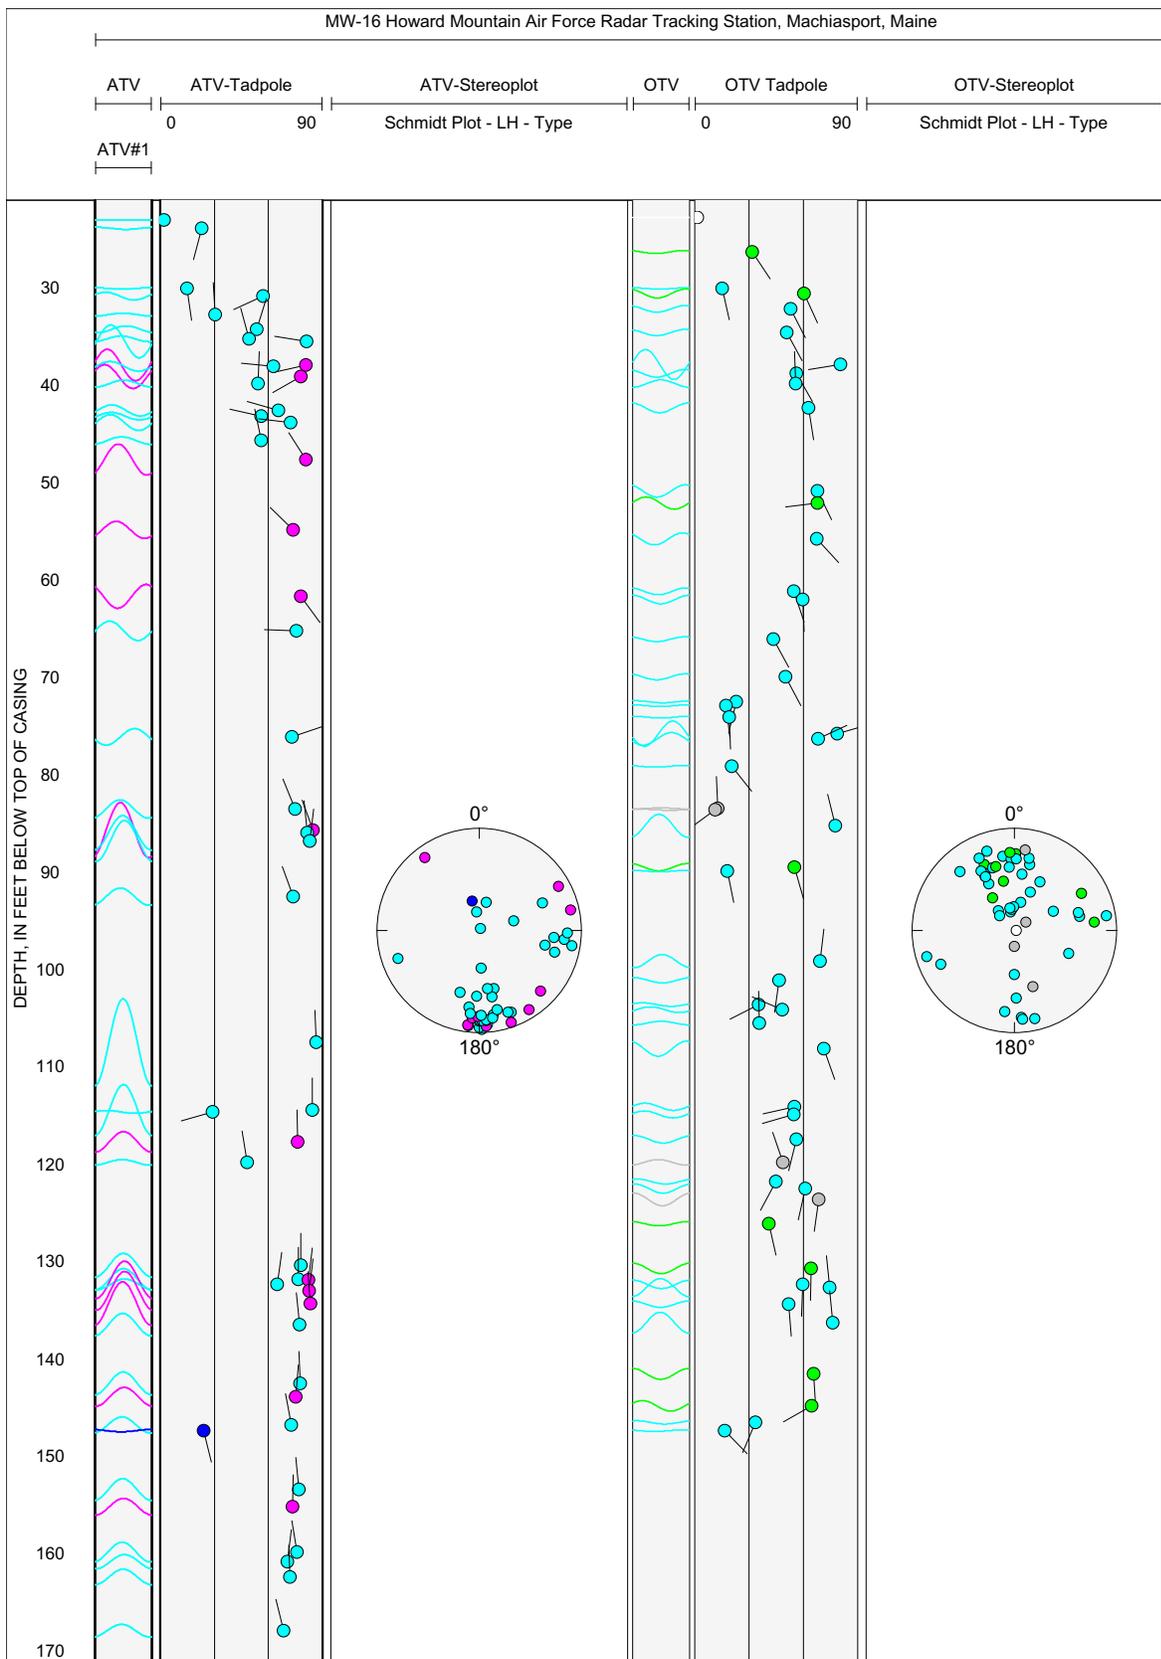
Figure 5C-2. Projection, tadpole, and stereoplots of interpretation of borehole image data for borehole MW-16, near Machiasport, Maine.

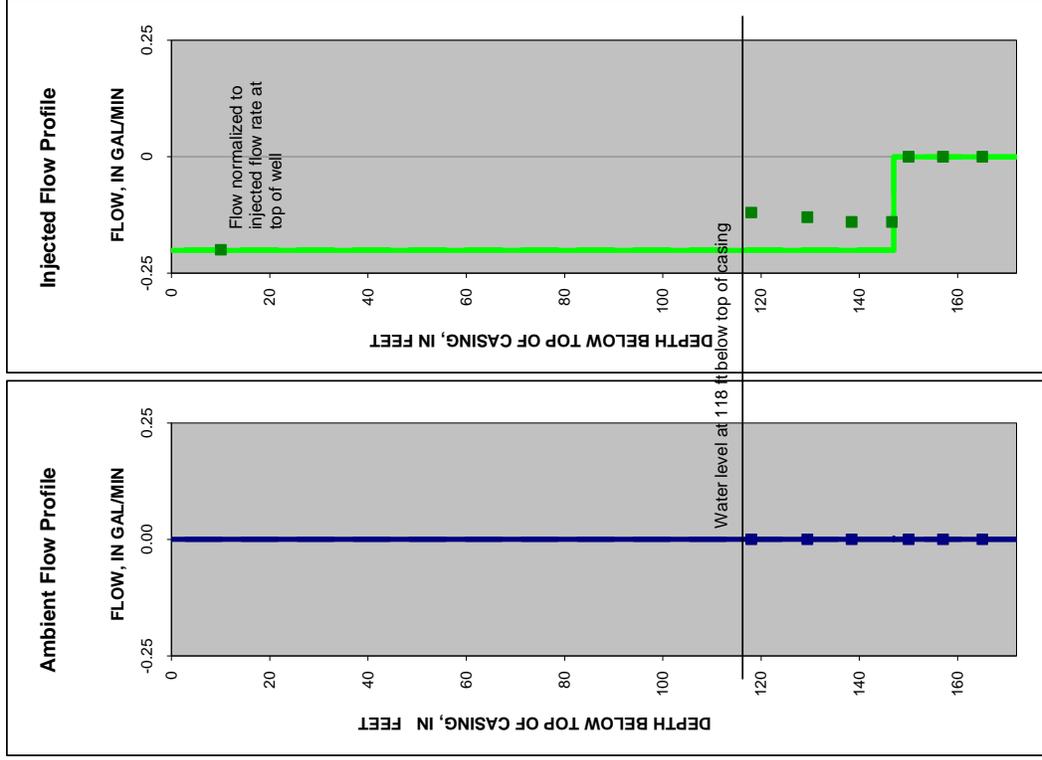
Dashed line indicates measured flow.
 Solid line indicates modeled flow.
 Points indicate measured heat-pulse flowmeter data.

Figure 5C-3. Interpretation and modeling of heat-pulse flowmeter logs for borehole MW-16, near Machiasport, Maine. [gal/min, gallon per minute; ft, feet; ft²/d, feet squared per day; positive values of flow are upward flow, negative values of flow are downward flow]

Fracture number	Depth (ft)	Ambient flow above fracture (gal/min)	Injected flow above fracture (gal/min)	Zone transmissivity (ft ² /d)	Water level (ft)	Elevation of water level (ft)	Percent transmissivity
1	147	0	-0.201	10	117.00	123.40	100

Total borehole transmissivity	10.0	(ft ² /d)
Sum of squares error	0.00000	(gal/min) ²
Root mean square error	0.00135	(gal/min)

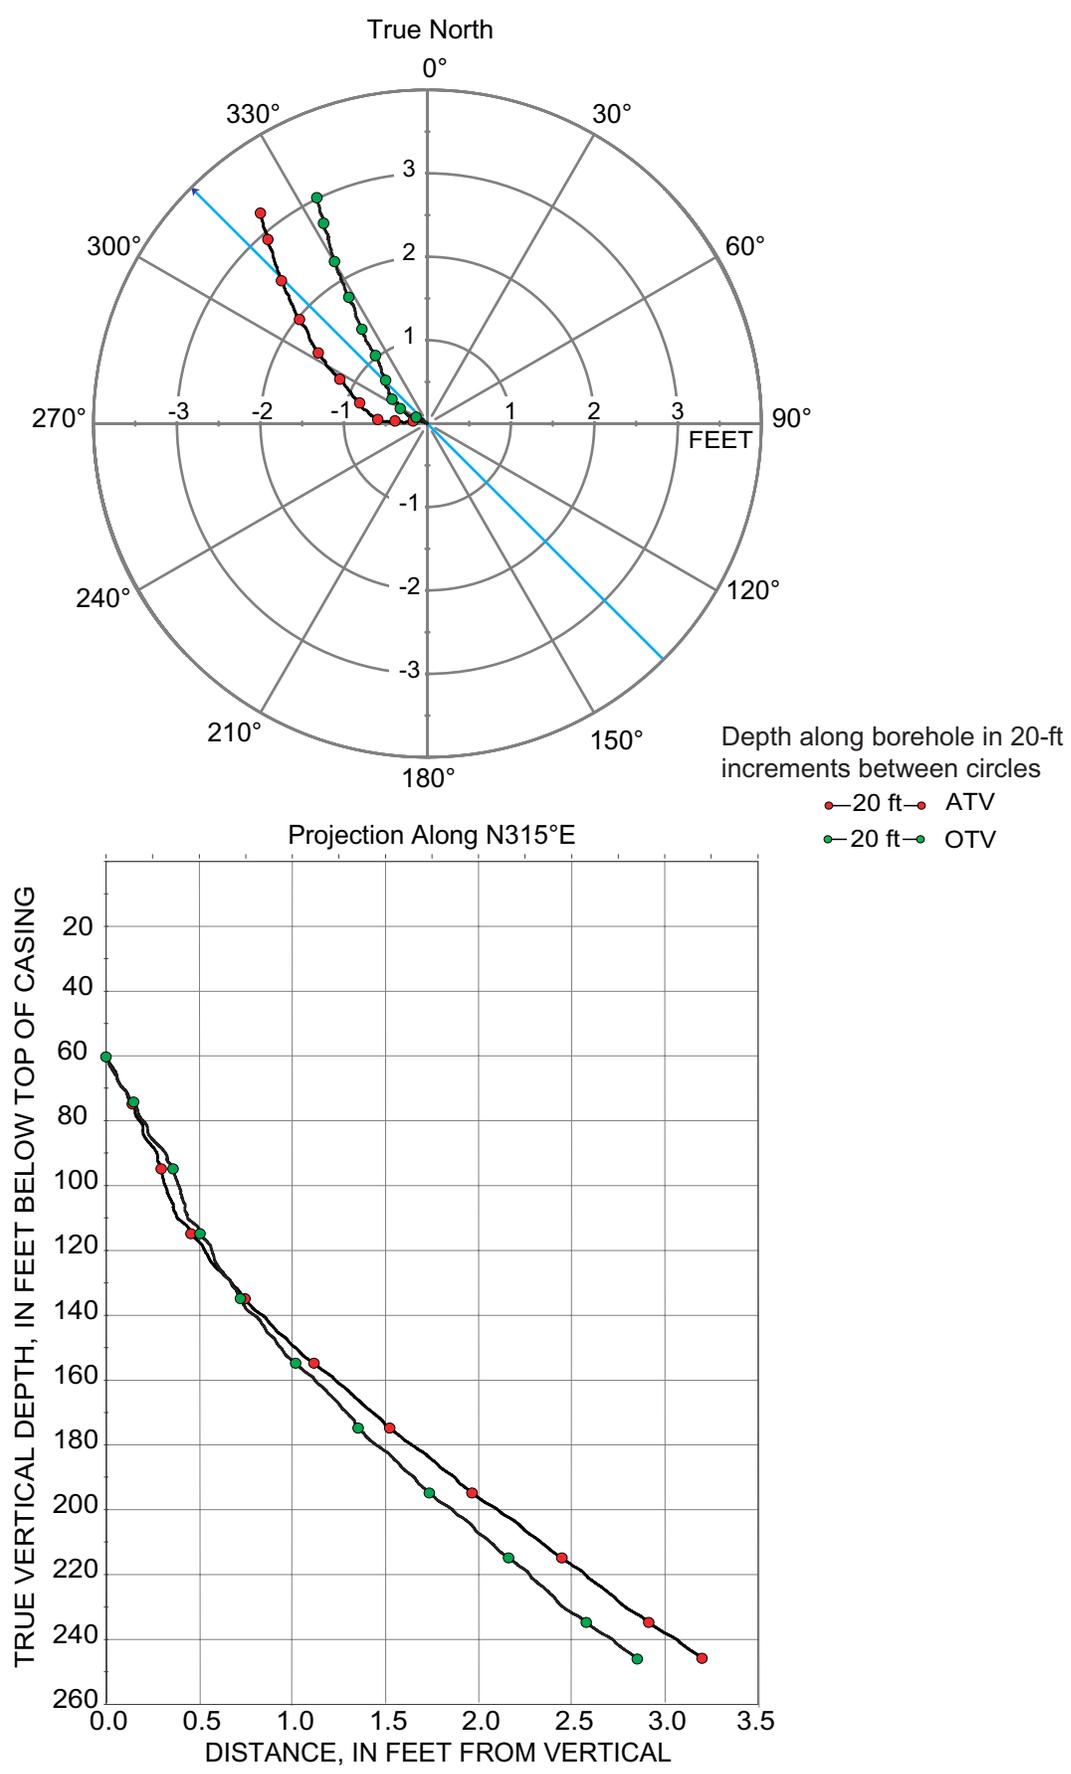
Figure 5D-1. Borehole deviation logs for borehole MW-17, near Machiasport, Maine. Blue line on radial plot (top) is line of projection for vertical plot (bottom).
 [ft, foot; ATV, acoustic televiewer; OTV, optical televiewer]

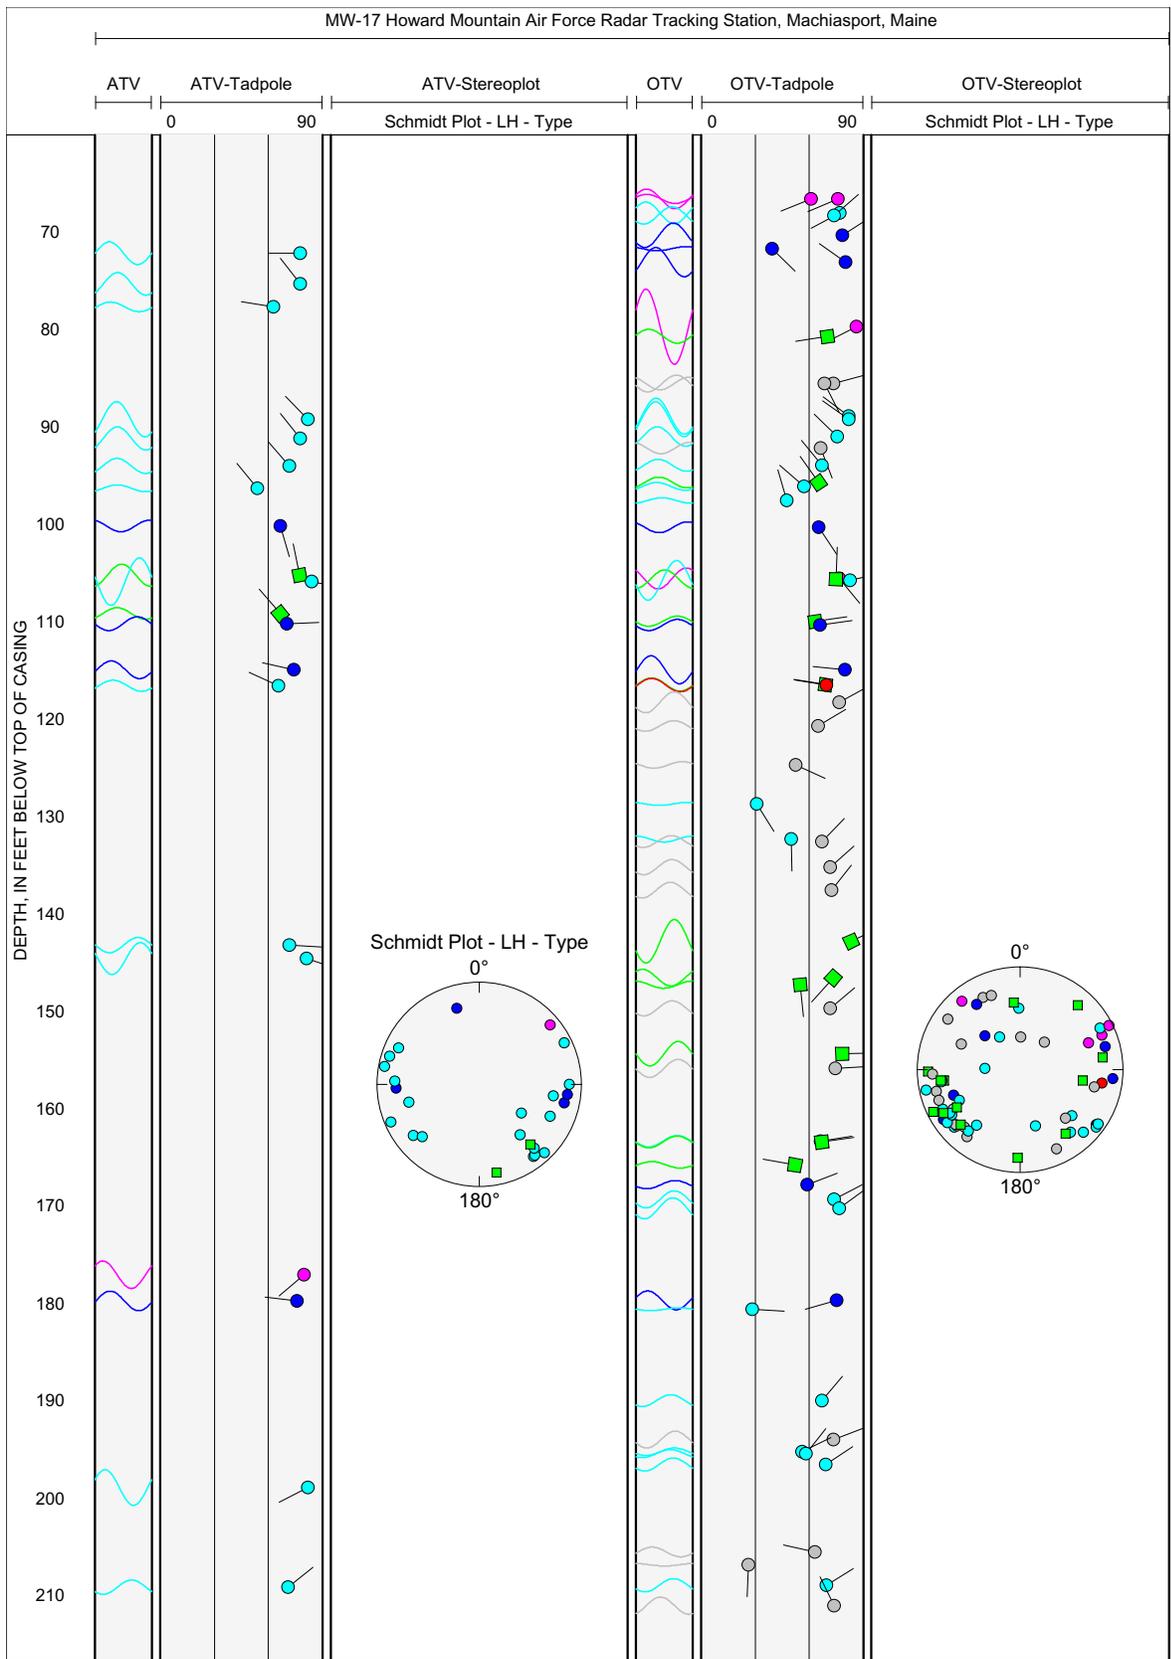
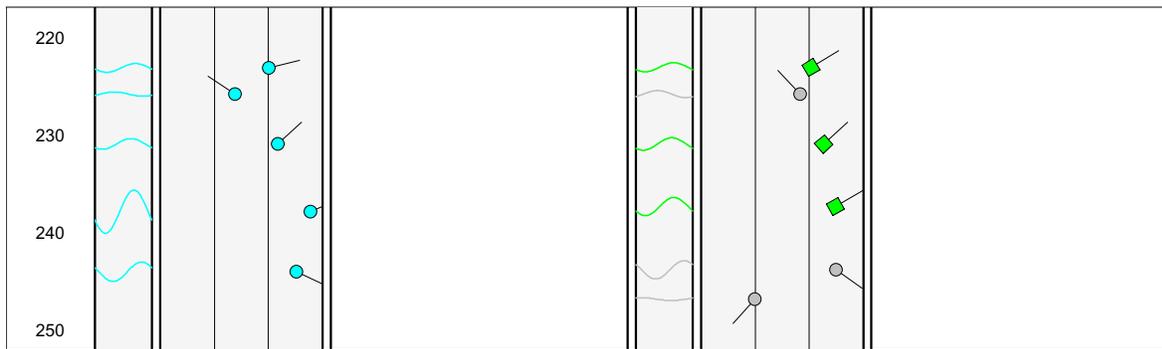
Figure 5D-2. Projection, tadpole, and stereoplots of interpretation of borehole image data for borehole MW-17, near Machiasport, Maine.

Figure 5D-2. Projection, tadpole, and stereoplots of interpretation of borehole image data for borehole MW-17, near Machiasport, Maine.—Continued

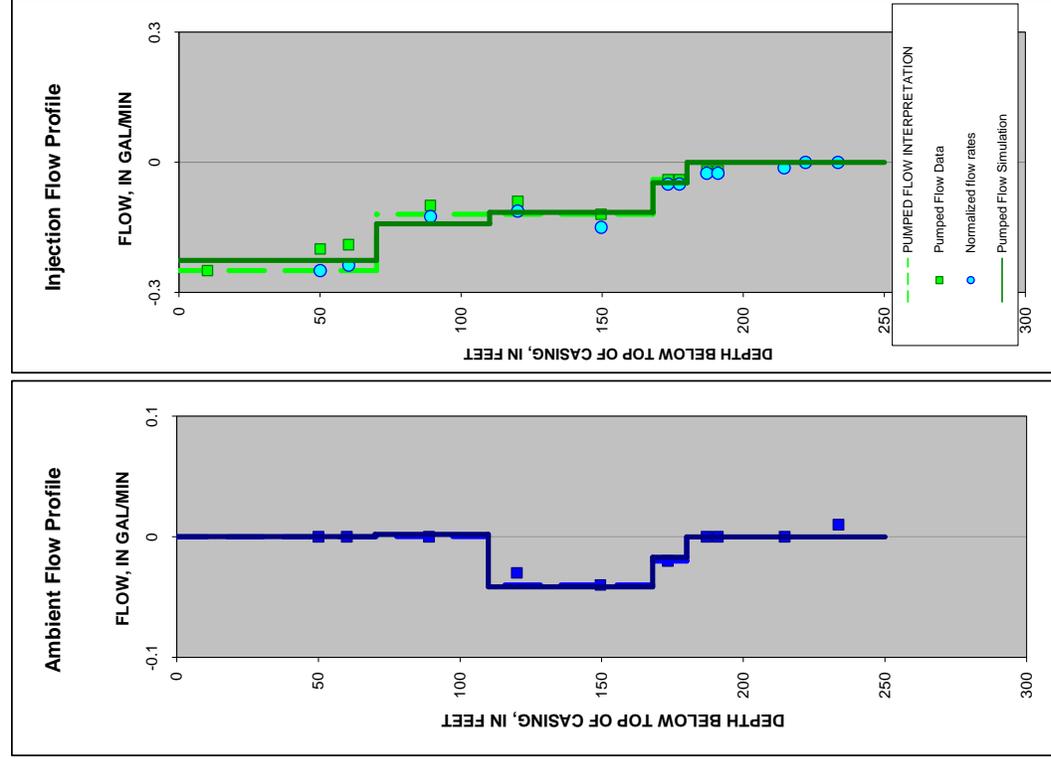
Dashed line indicates measured flow.
 Solid line indicates modeled flow.
 Points indicate measured heat-pulse flowmeter data.

Figure 5D-3. Interpretation and modeling of heat-pulse flowmeter logs for borehole MW-17, near Machiasport, Maine. [gal/min, gallon per minute; ft, feet; ft²/d, feet squared per day; positive values of flow are upward flow, negative values of flow are downward flow]

Fracture number	Depth (ft)	Ambient flow above fracture (gal/min)	Injected flow above fracture (gal/min)	Zone transmissivity (ft ² /d)	Water level (ft)	Elevation of water level (ft)	Percent transmissivity
4	70	0.000	-0.226	1.5	38.57	36.36	38
3	110	0.002	-0.142	1.25	32.57	42.36	31
2	168	-0.041	-0.115	0.75	43.57	31.36	19
1	180	-0.017	-0.047	0.5	43.57	31.36	0

Total borehole transmissivity	4.0	(ft ² /d)
Sum of squares error	0.00112	(gal/min) ²
Root mean square error	0.01676	(gal/min)

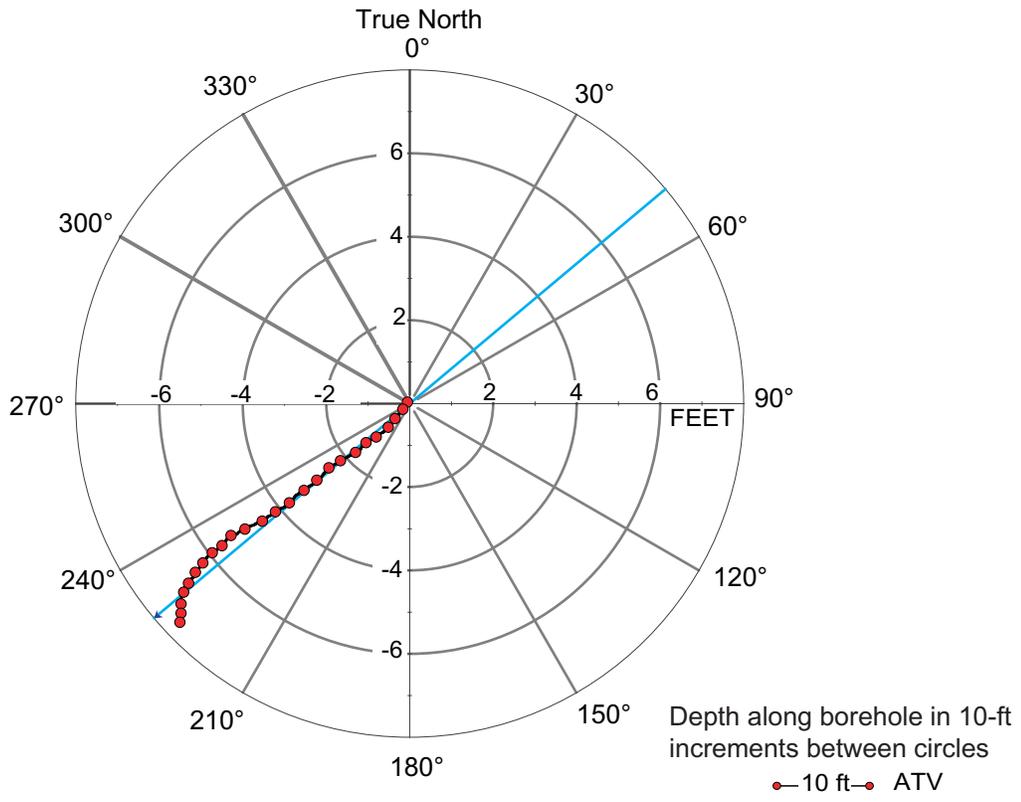
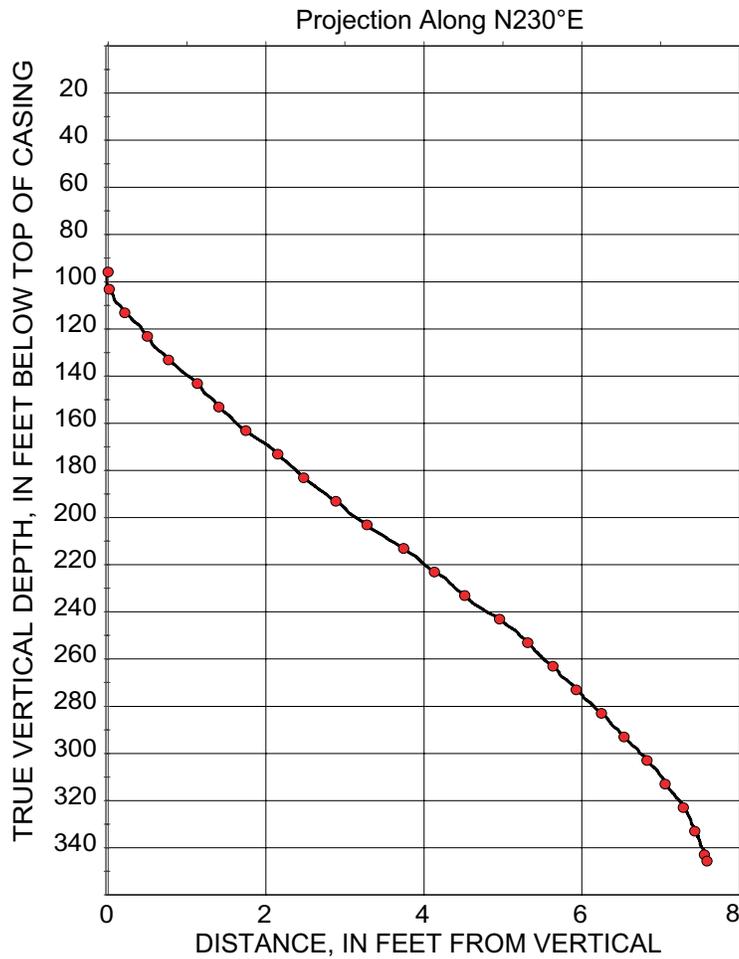
Figure 5E-1. Borehole deviation logs for borehole WY-3C, near Machiasport, Maine. Blue line on radial plot (top) is line of projection for vertical plot (bottom).
 [ft, foot; ATV, acoustic televiewer]

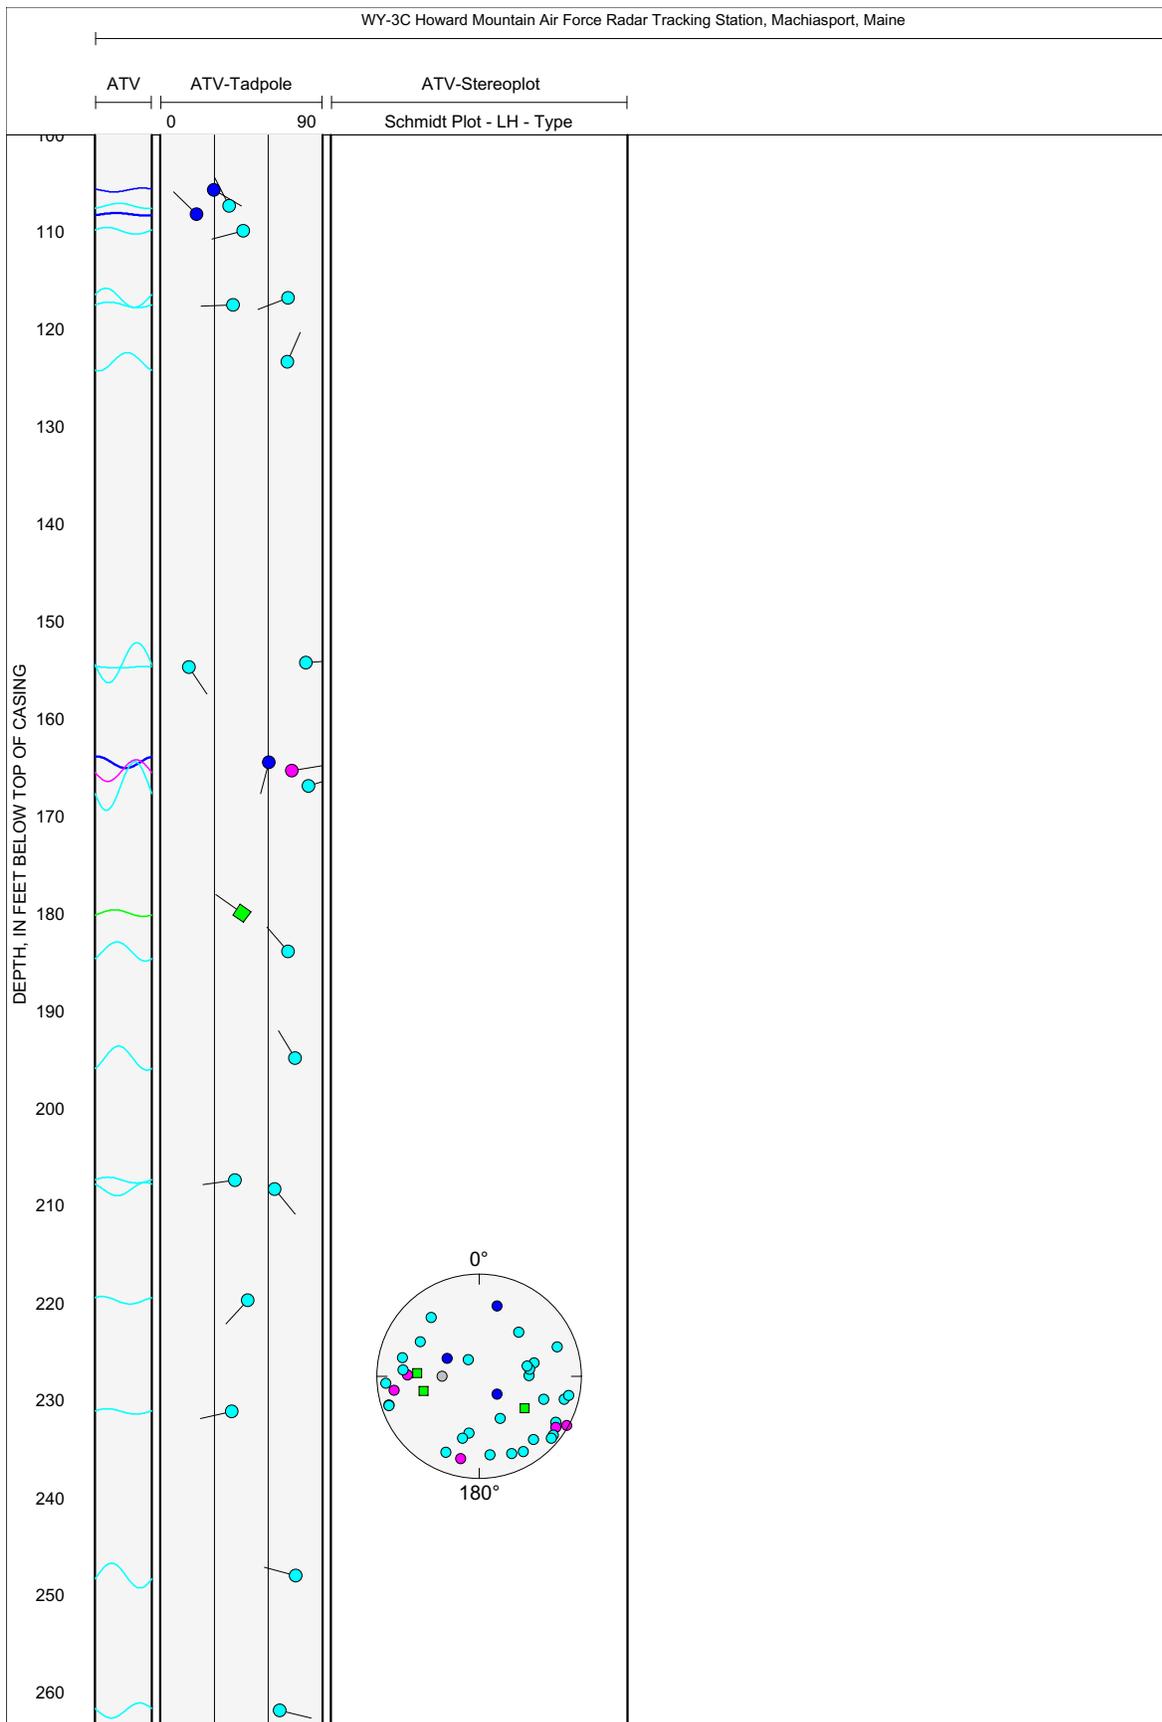
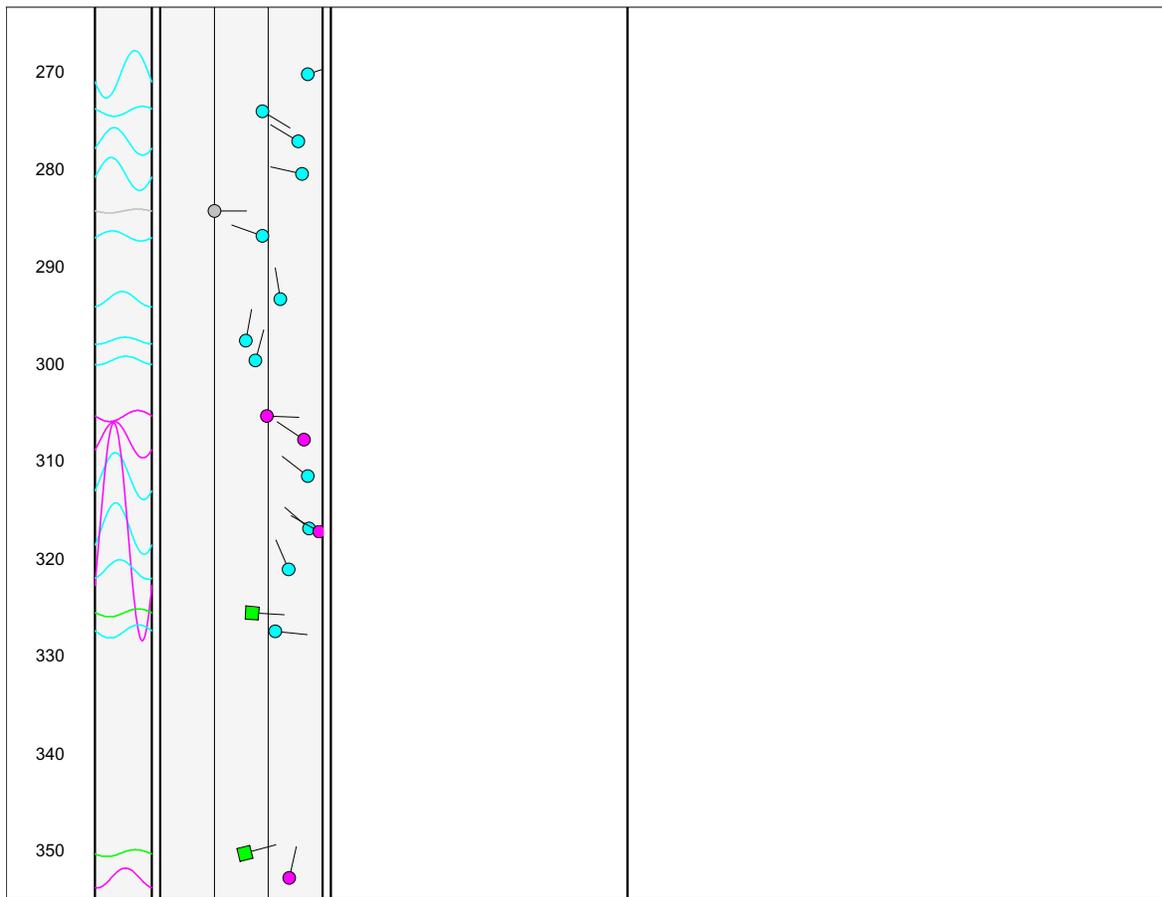
Figure 5E-2. Projection, tadpole, and stereoplots of interpretation of borehole image data for borehole WY-3C, near Machiasport, Maine.

Figure 5E-2. Projection, tadpole, and stereoplots of interpretation of borehole image data for borehole WY-3C, near Machiasport, Maine.—Continued

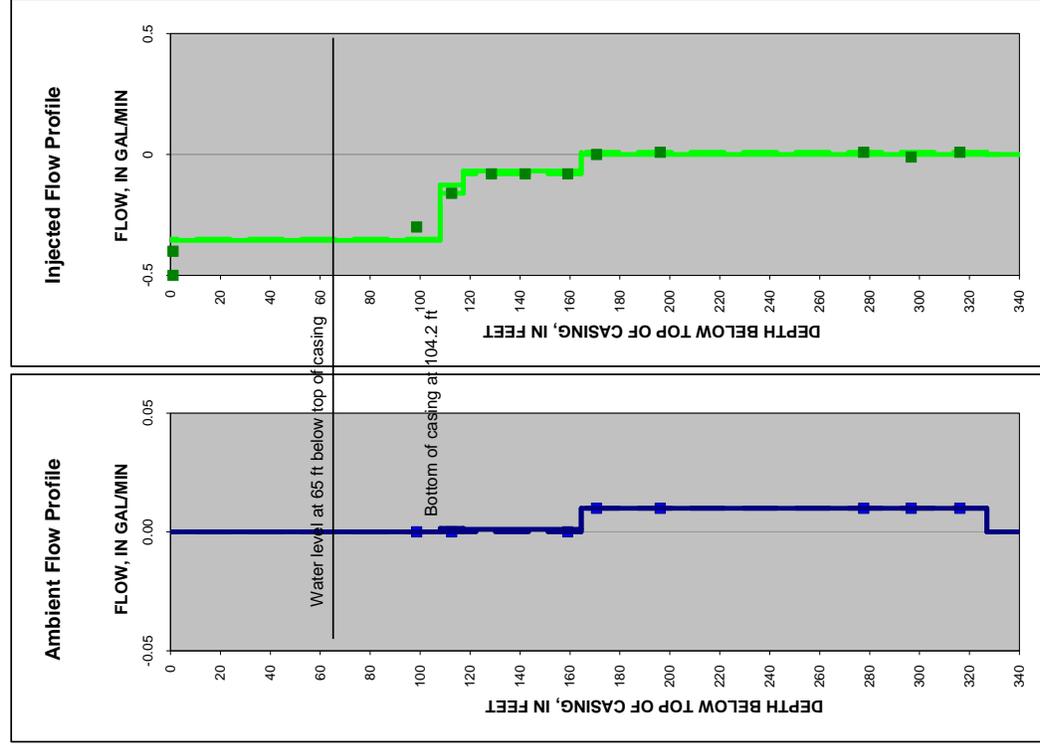
Dashed line indicates measured flow.
 Solid line indicates modeled flow.
 Points indicate measured heat-pulse flowmeter data.

Figure 5E-3. Interpretation and modeling of heat-pulse flowmeter logs for borehole WY-3C, near Machiasport, Maine. [gal/min, gallon per minute; ft, feet; ft²/d, feet squared per day; positive values of flow are upward flow, negative values of flow are downward flow]

Fracture number	Depth (ft)	Ambient flow above fracture (gal/min)	Injected flow above fracture (gal/min)	Zone transmissivity (ft ² /d)	Water level (ft)	Elevation of water level (ft)	Percent transmissivity
4	108.0	0.000	-0.355	5.28	65.48	4.32	67
3	117.4	0.002	-0.127	1.20	65.48	4.32	15
2	164.5	0.001	-0.068	1.20	66.68	3.12	15
1	327.0	0.010	0.001	0.16	57.48	12.32	2

Total borehole transmissivity	7.8	(ft ² /d)
Sum of squares error	0.00139	(gal/min) ²
Root mean square error	0.01864	(gal/min)

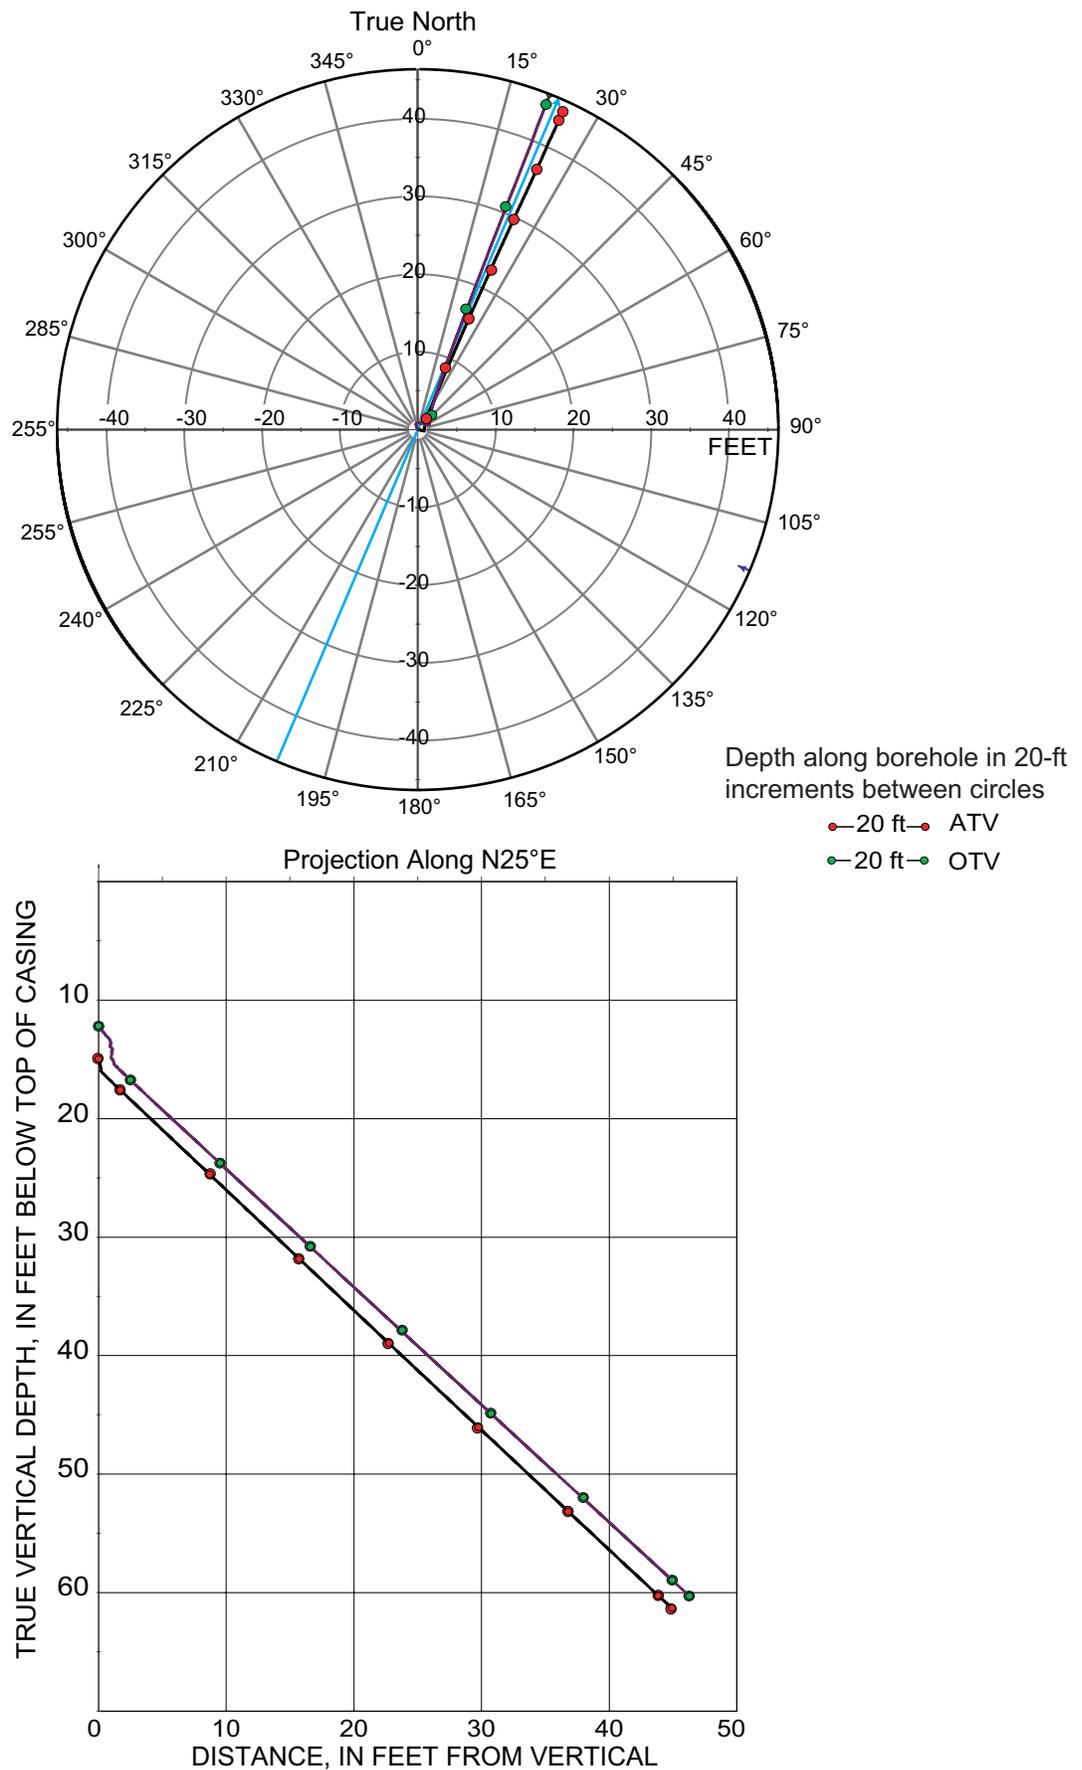
Figure 5F-1. Borehole deviation logs for borehole C-114, near Machiasport, Maine. Blue line on radial plot (top) is line of projection for vertical plot (bottom).

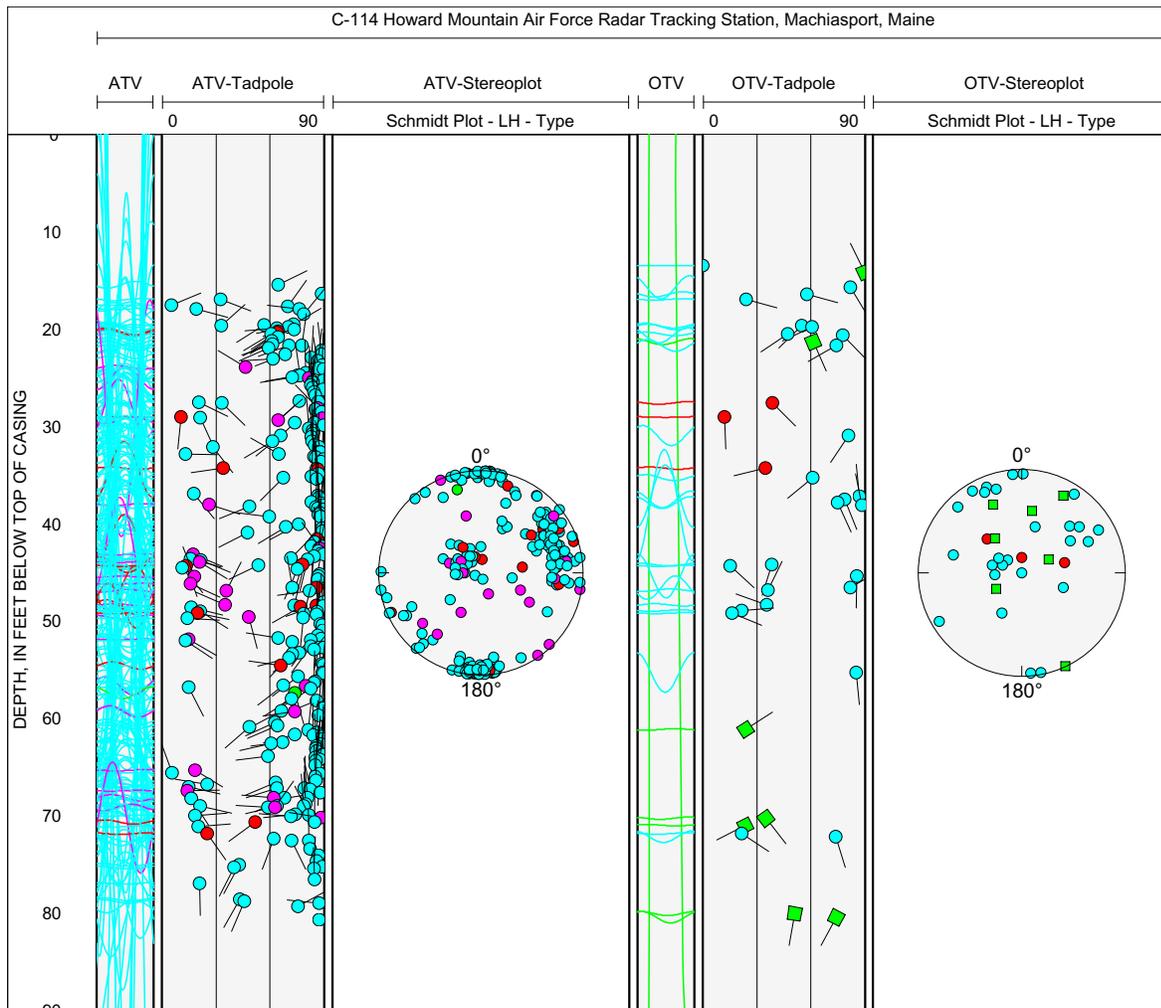
Figure 5F-2. Projection, tadpole, and stereoplots of interpretation of borehole image data for borehole C-114, near Machiasport, Maine.

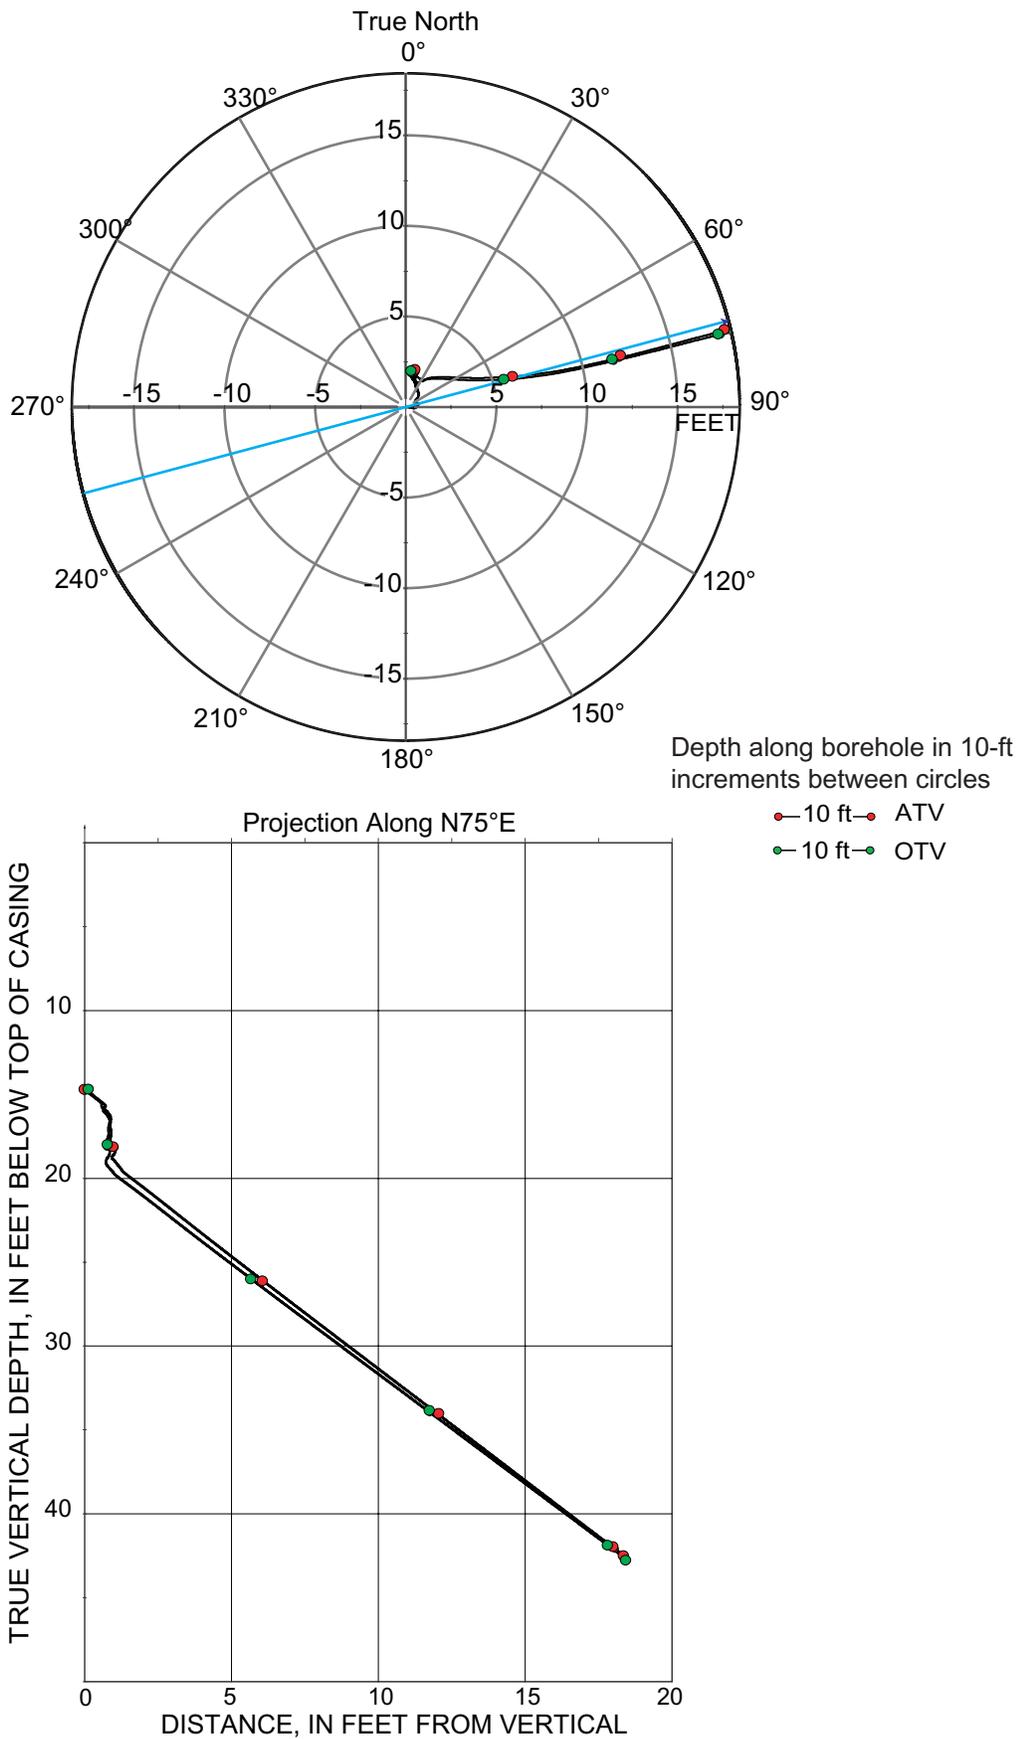
Figure 5G-1. Borehole deviation logs for borehole C-501, near Machiasport, Maine. Blue line on radial plot (top) is line of projection for vertical plot (bottom).
[ft, foot; ATV, acoustic televiewer; OTV, optical televiewer]

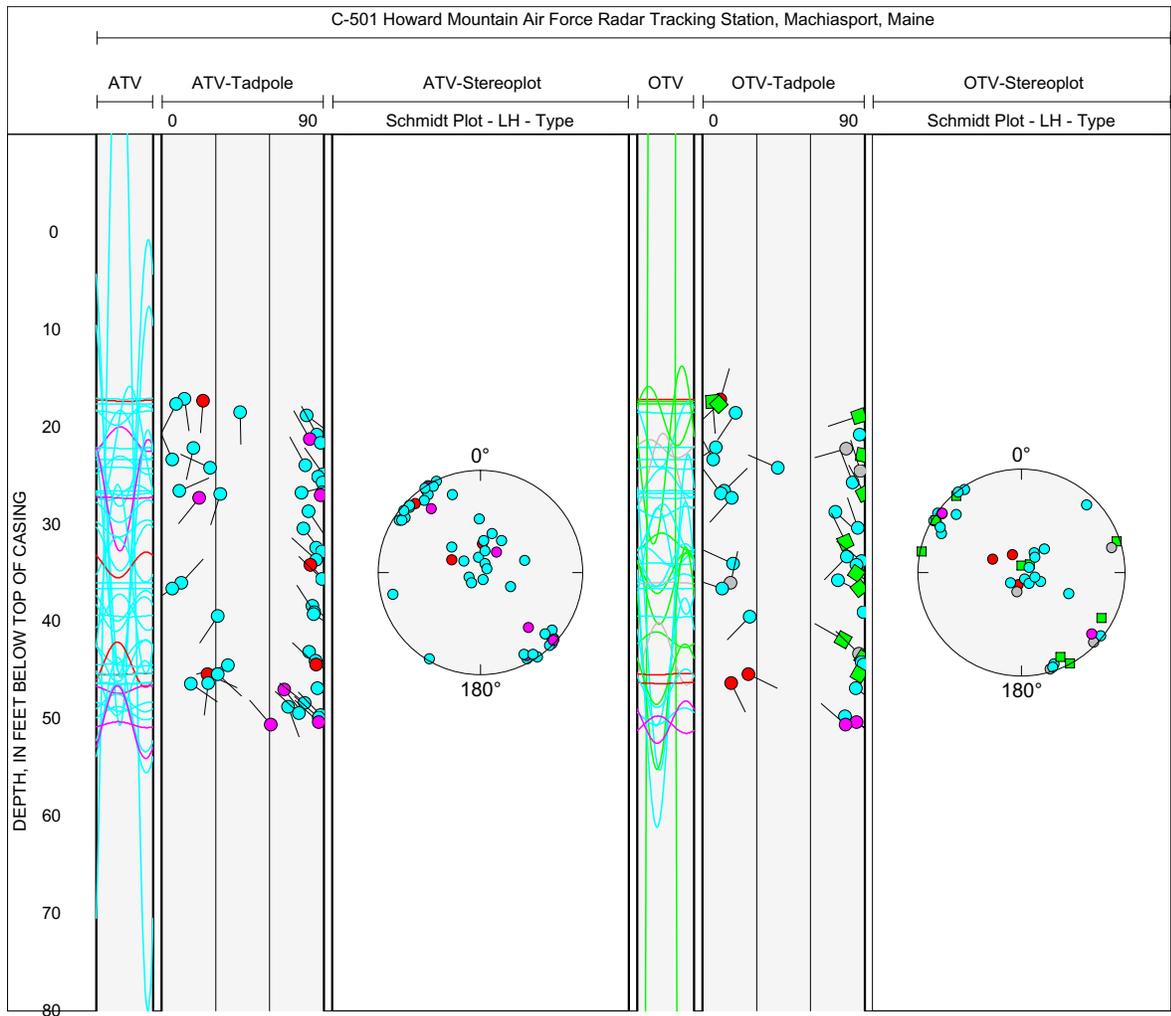
Figure 5G-2. Projection, tadpole, and stereoplots of interpretation of borehole image data for borehole C-501, near Machiasport, Maine.

Figure 5G-2. Projection, tadpole, and stereoplots of interpretation of borehole image data for borehole C-501, near Machiasport, Maine.
