Borehole Geophysical Investigation of a Formerly Used Defense Site, Machiasport, Maine, 2003–2006

By Carole D. Johnson, Remo A. Mondazzi, and Peter K. Joesten

Scientific Investigations Report 2009–5120

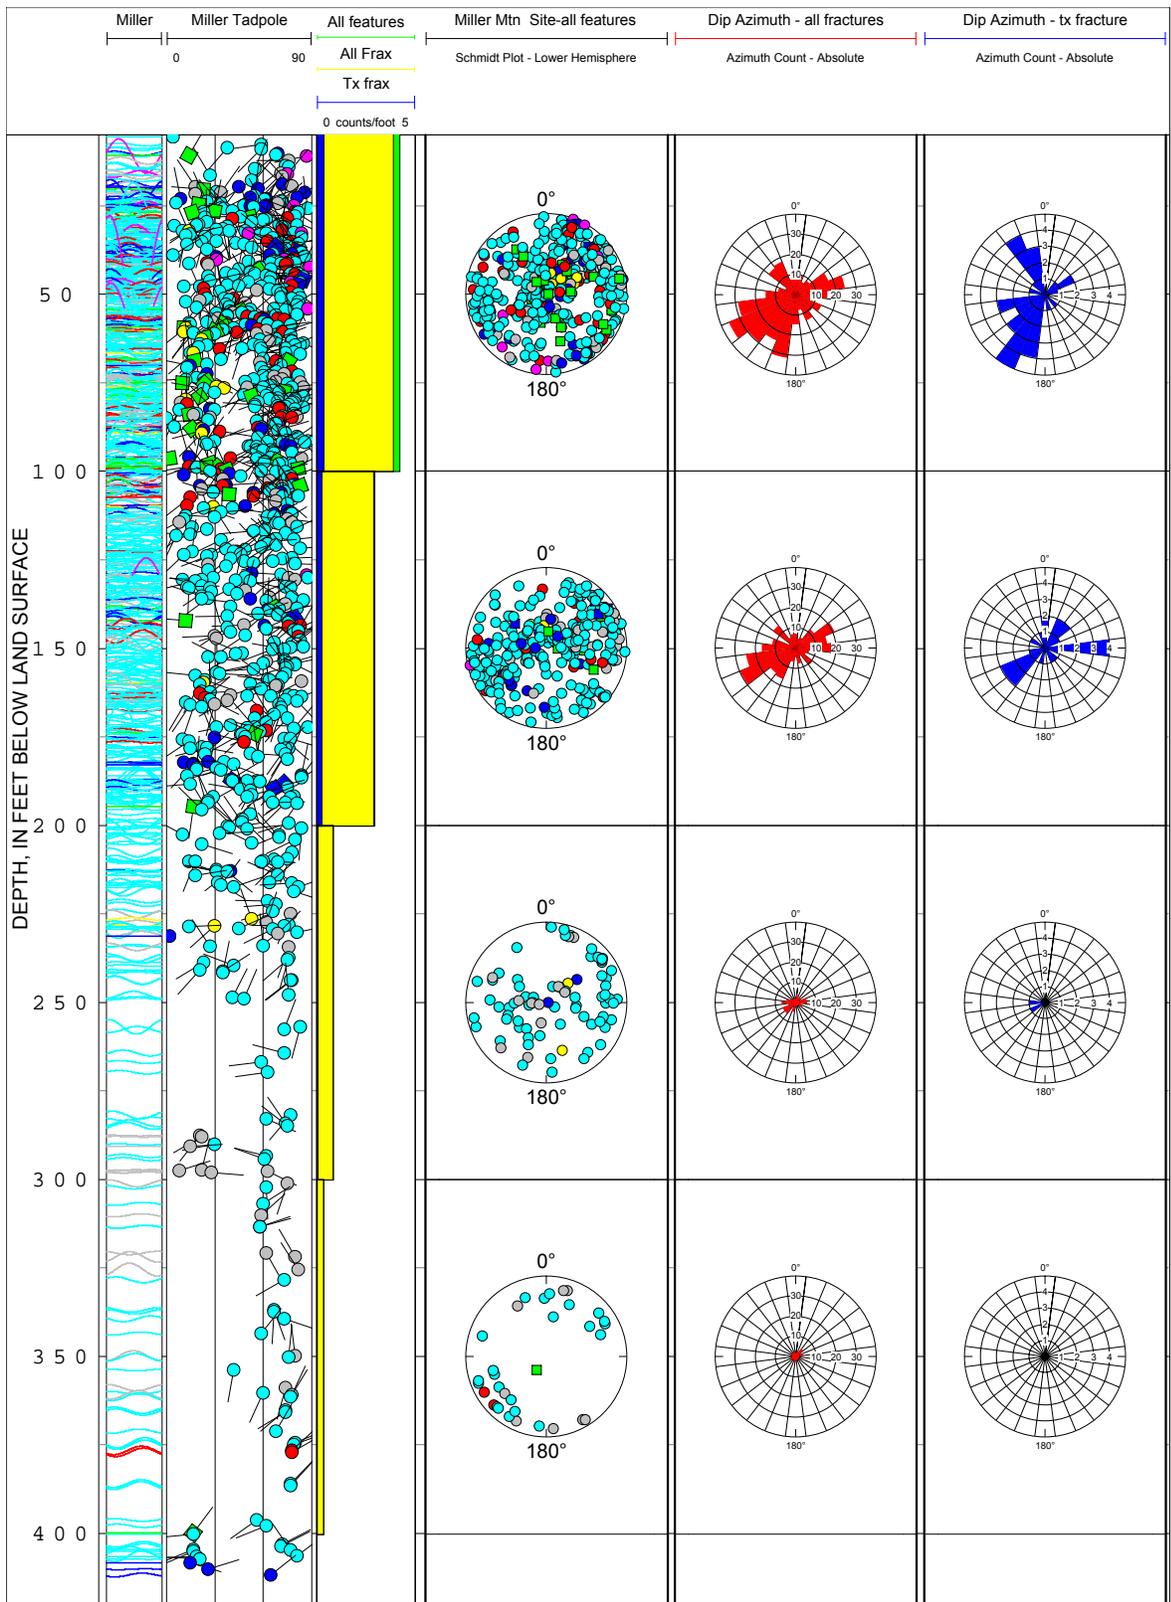
Figure 6A-2. Summary of structure interpreted from geophysical logs of boreholes on or near Miller Mountain, near Machiasport, Maine. In depth below land surface-projection and tadpole plots for all features; fracture density plots; stereoplots for all features in the entire boreholes; rose diagrams for the entire boreholes, all at 100-foot intervals.

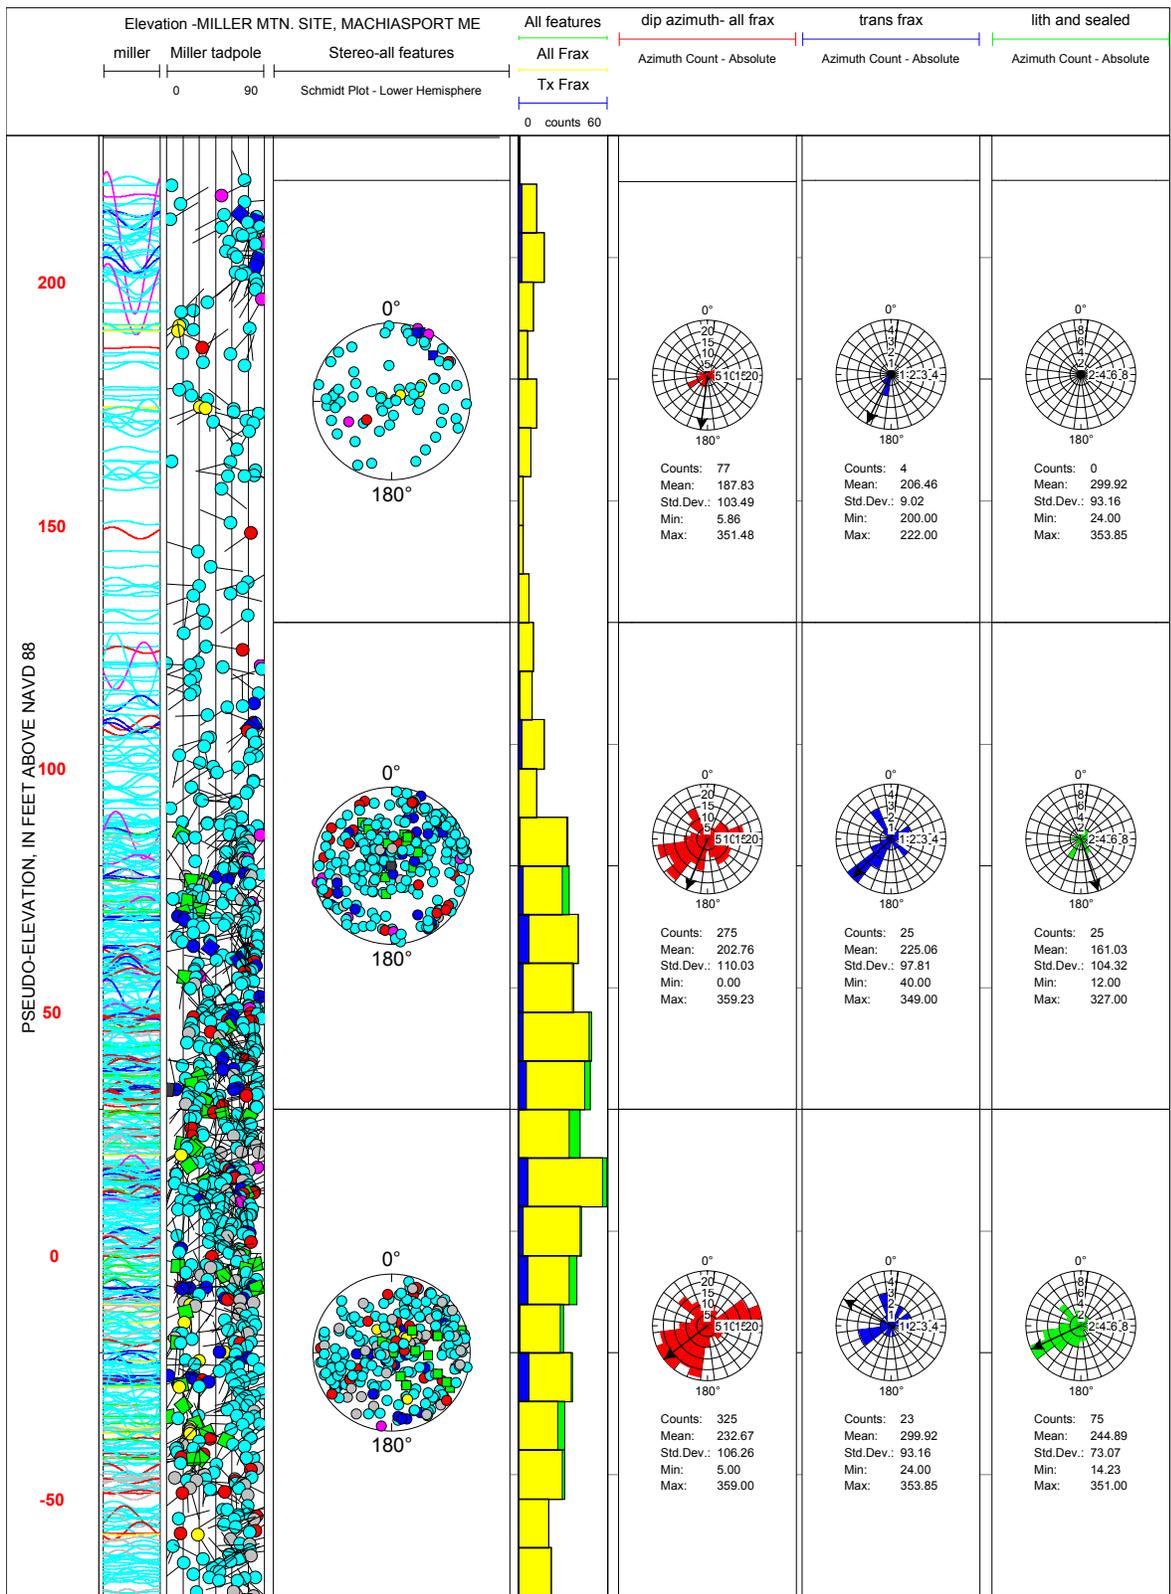
Figure 6A-3. Summary of structure interpreted from geophysical logs of boreholes on or near Miller Mountain, near Machiasport, Maine. In elevation above NAVD 88-projection and tadpole plots for all features at 100-foot intervals; fracture density plots (all fractures and transmissive fractures) at 10-foot intervals; rose diagrams of dip direction at 100-foot intervals. [Frax, fracture; Tx, transmissive; Std. Dev., standard deviation; Min, minimum; Max, maximum]

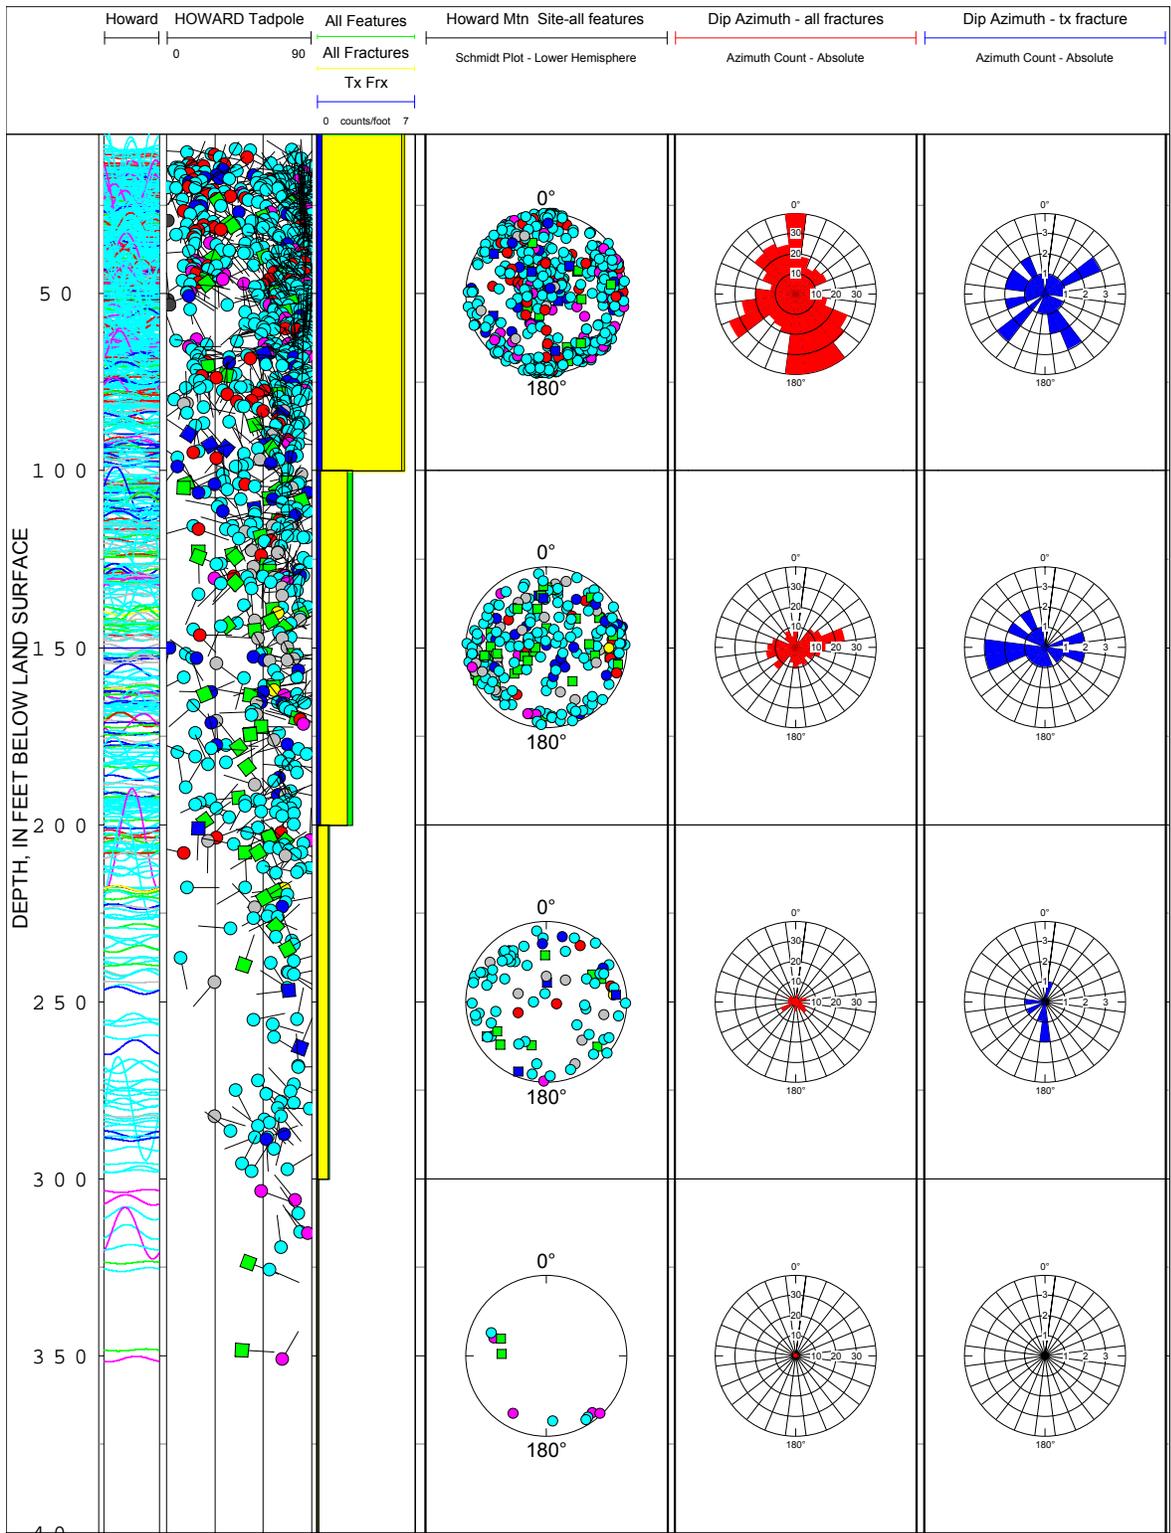
Figure 6B-1. Summary of structure interpreted from geophysical logs of boreholes near the Air Force Radar Tracking Station on Howard Mountain, near Machiasport, Maine. In depth below land surface-projection and tadpole plots for all features; fracture density plots at 10-foot intervals; stereoplots for all features in the boreholes; rose diagram of dip directions for all features in the boreholes. [Frax, fracture; Tx, transmissive; deg, degrees; Std. Dev., standard deviation]

- Figure 6B–1.** In depth below land surface-projection and tadpole plots for all features; fracture density plots at 10-foot intervals; stereoplots for all features in the boreholes; rose diagram of dip directions for all features in the boreholes.

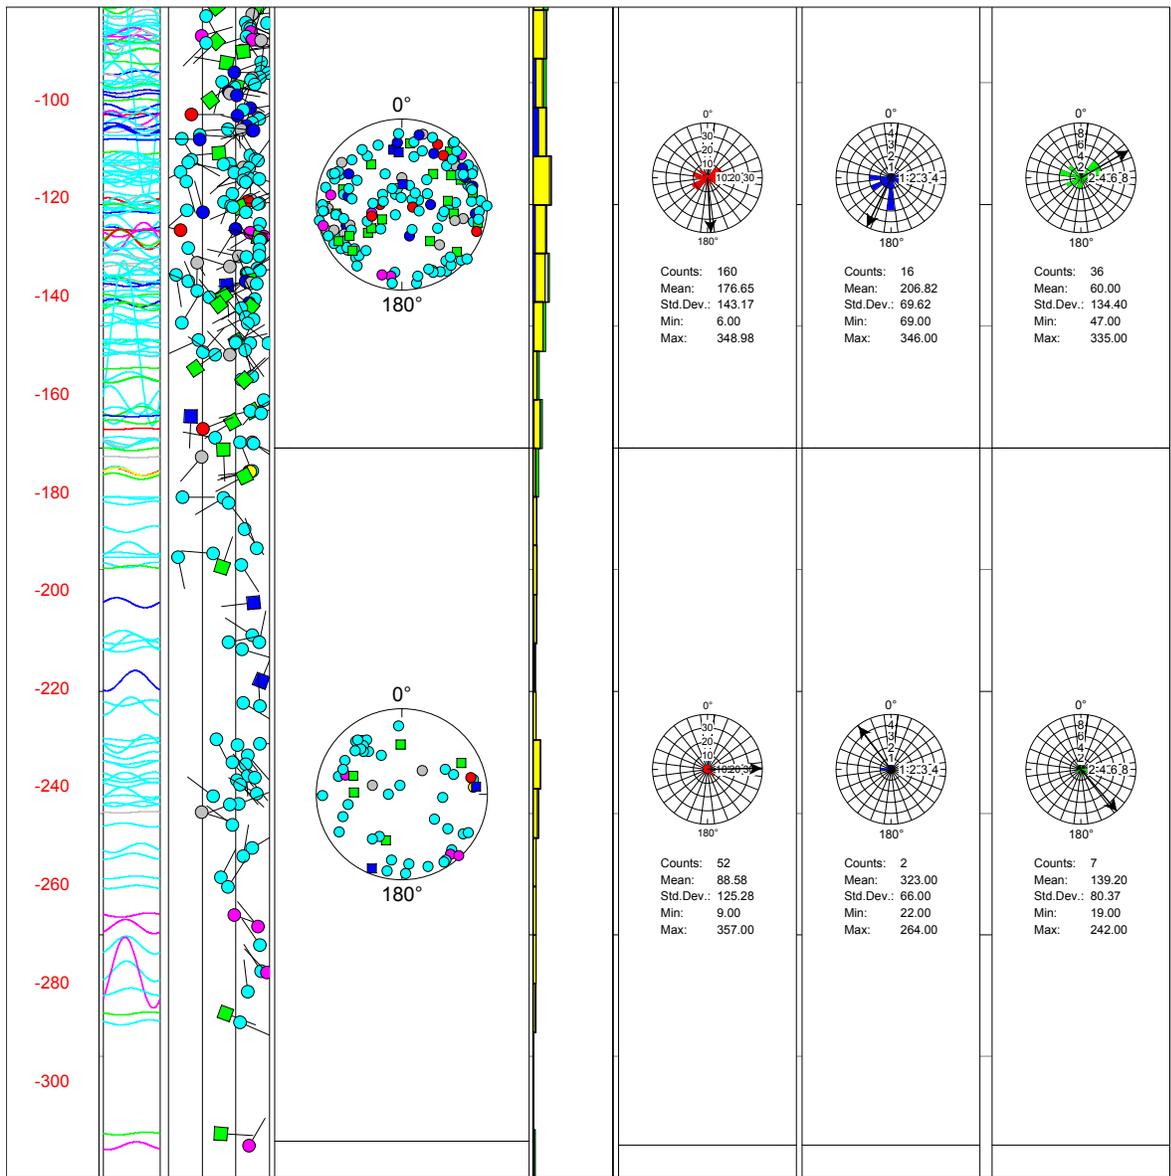
Figure 6B-3. Summary of structure interpreted from geophysical logs of boreholes near the Air Force Radar Tracking Station on Howard Mountain, near Machiasport, Maine. In elevation above NAVD 88-projection and tadpole plots for all features at 100-foot intervals; fracture density plots (all fractures and transmissive fractures) at 10-foot intervals; rose diagrams of dip direction at 100-foot intervals. [Frax, fracture; Std. Dev., standard deviation; Min, minimum; Max, maximum]

- Figure 6B–3.** In elevation above NAVD 88-projection and tadpole plots for all features at 100-foot intervals; fracture density plots (all fractures and transmissive fractures) at 10-foot intervals; rose diagrams of dip direction at 100-foot intervals.

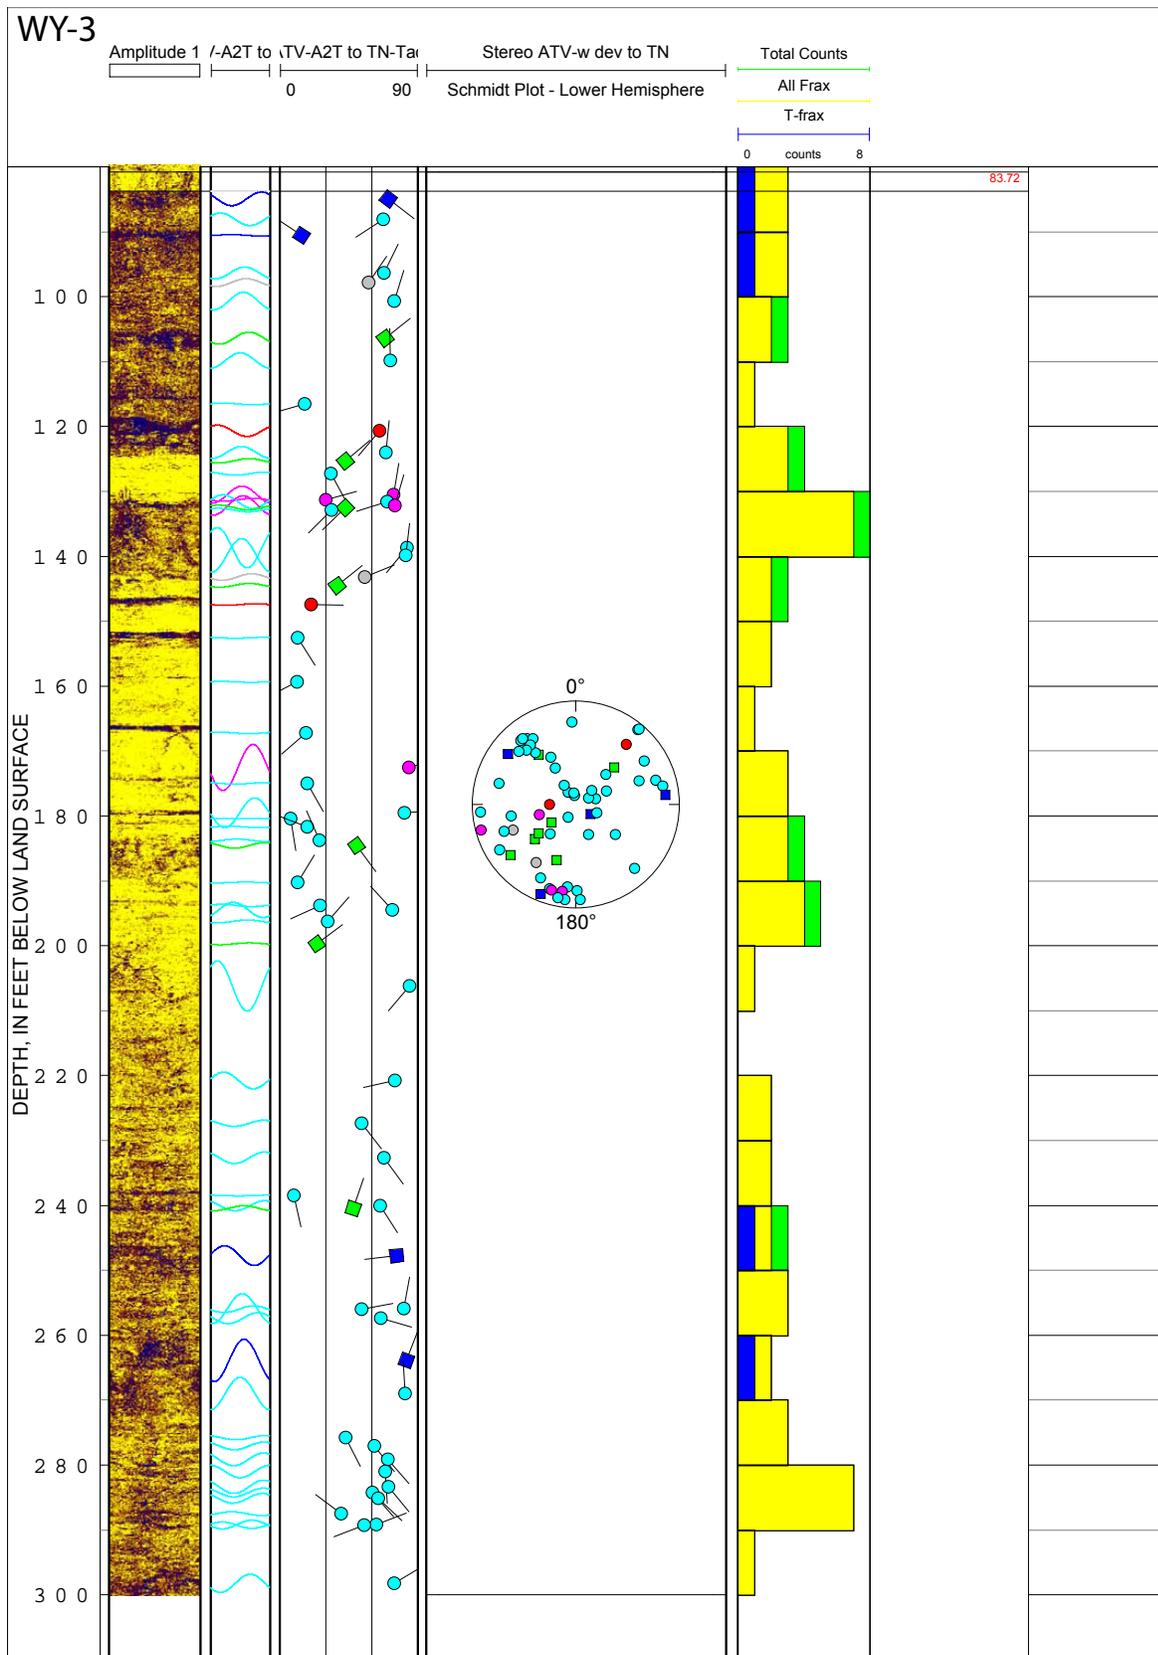
Figure 6B-3. Summary of structure interpreted from geophysical logs of boreholes near the Air Force Radar Tracking Station on Howard Mountain, near Machiasport, Maine. In elevation above NAVD 88-projection and tadpole plots for all features at 100-foot intervals; fracture density plots (all fractures and transmissive fractures) at 10-foot intervals; rose diagrams of dip direction at 100-foot intervals.—Continued [Frax, fracture; Std. Dev., standard deviation; Min, minimum; Max, maximum]

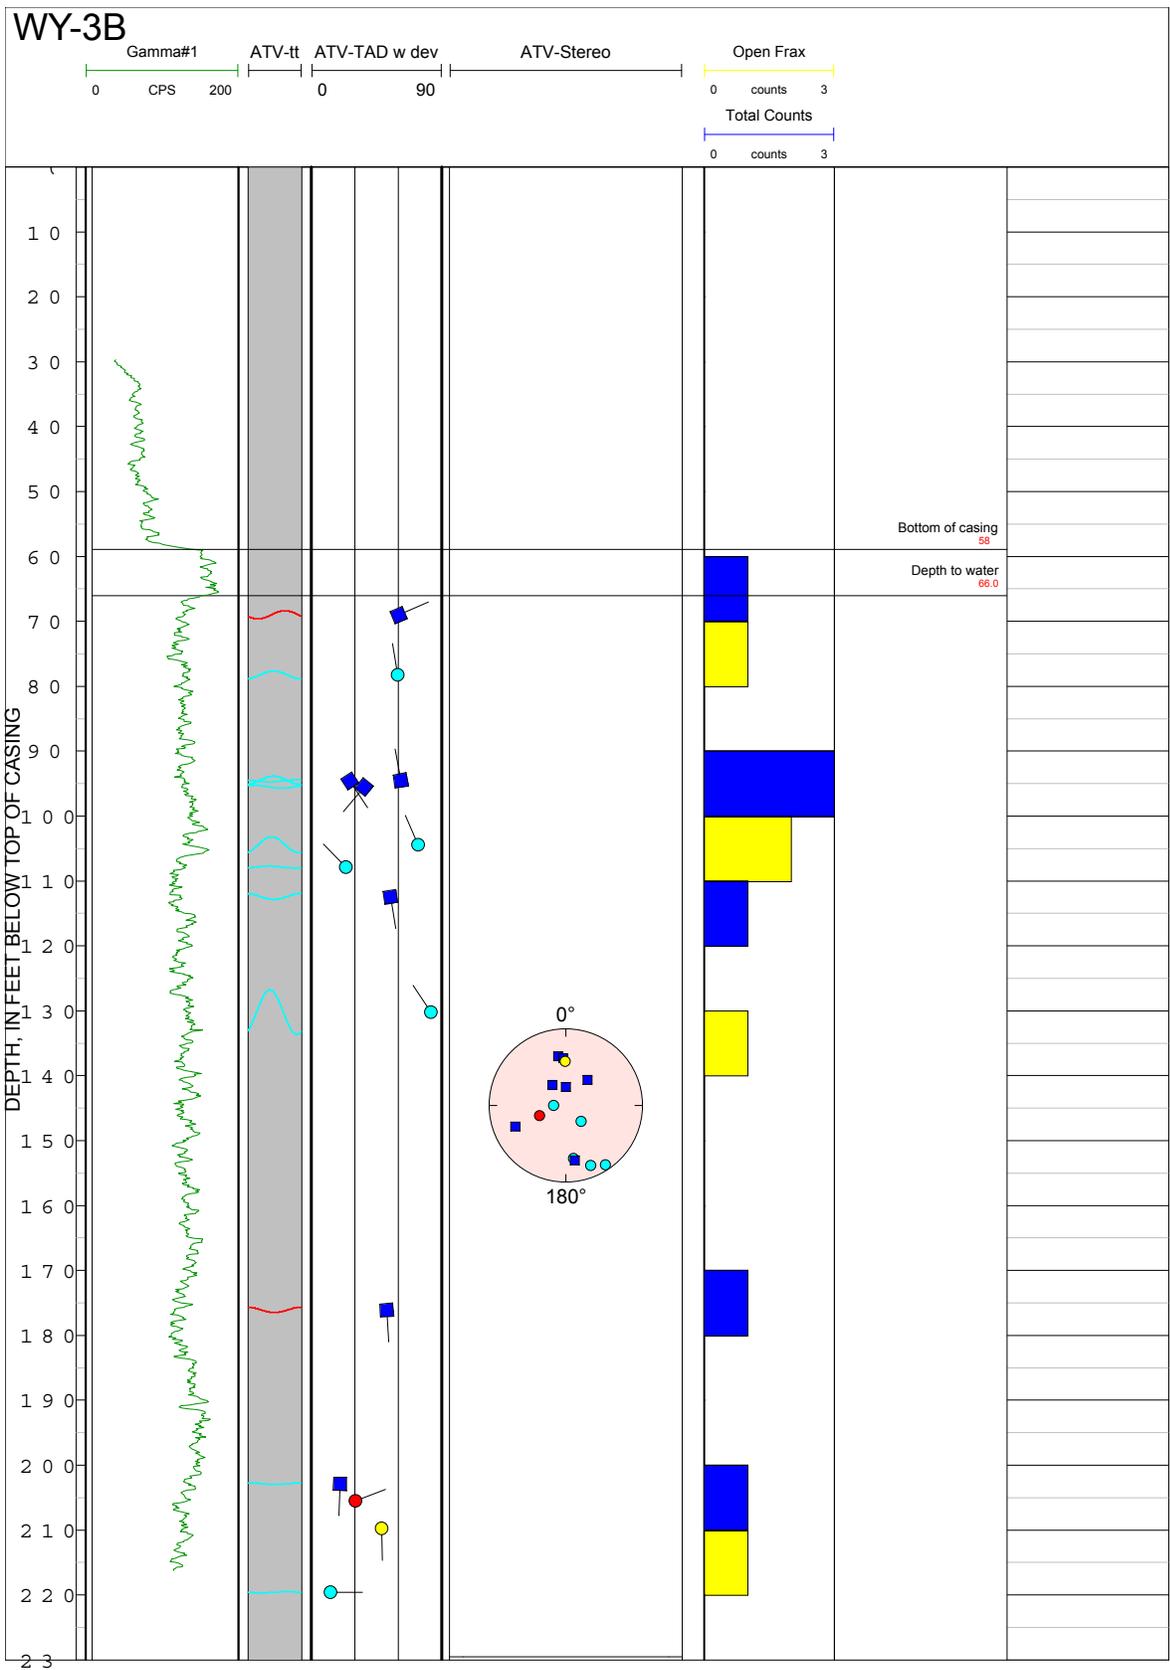
Figure 6B-4. Summary of structure interpreted from geophysical logs of boreholes near the Air Force Radar Tracking Station on Howard Mountain, near Machiasport, Maine. Fracture density plots at 10-foot intervals for boreholes WY-3, WY-3B, and WY-15, the deepest boreholes in the group. [T-frax, transmissive fracture; Tx, transmissive; TN, true north; dev, deviation]

- Figure 6B–4.** Fracture density plots at 10-foot intervals for boreholes WY-3, WY-3B, and WY-15, the deepest boreholes in the group.
- C. Summary of structure interpreted from geophysical logs of boreholes near the Transmitter Site on Howard Mountain, near Machiasport, Maine – DW-6, DW-10, MW-4, MW-5, MW-6, and MW-7**

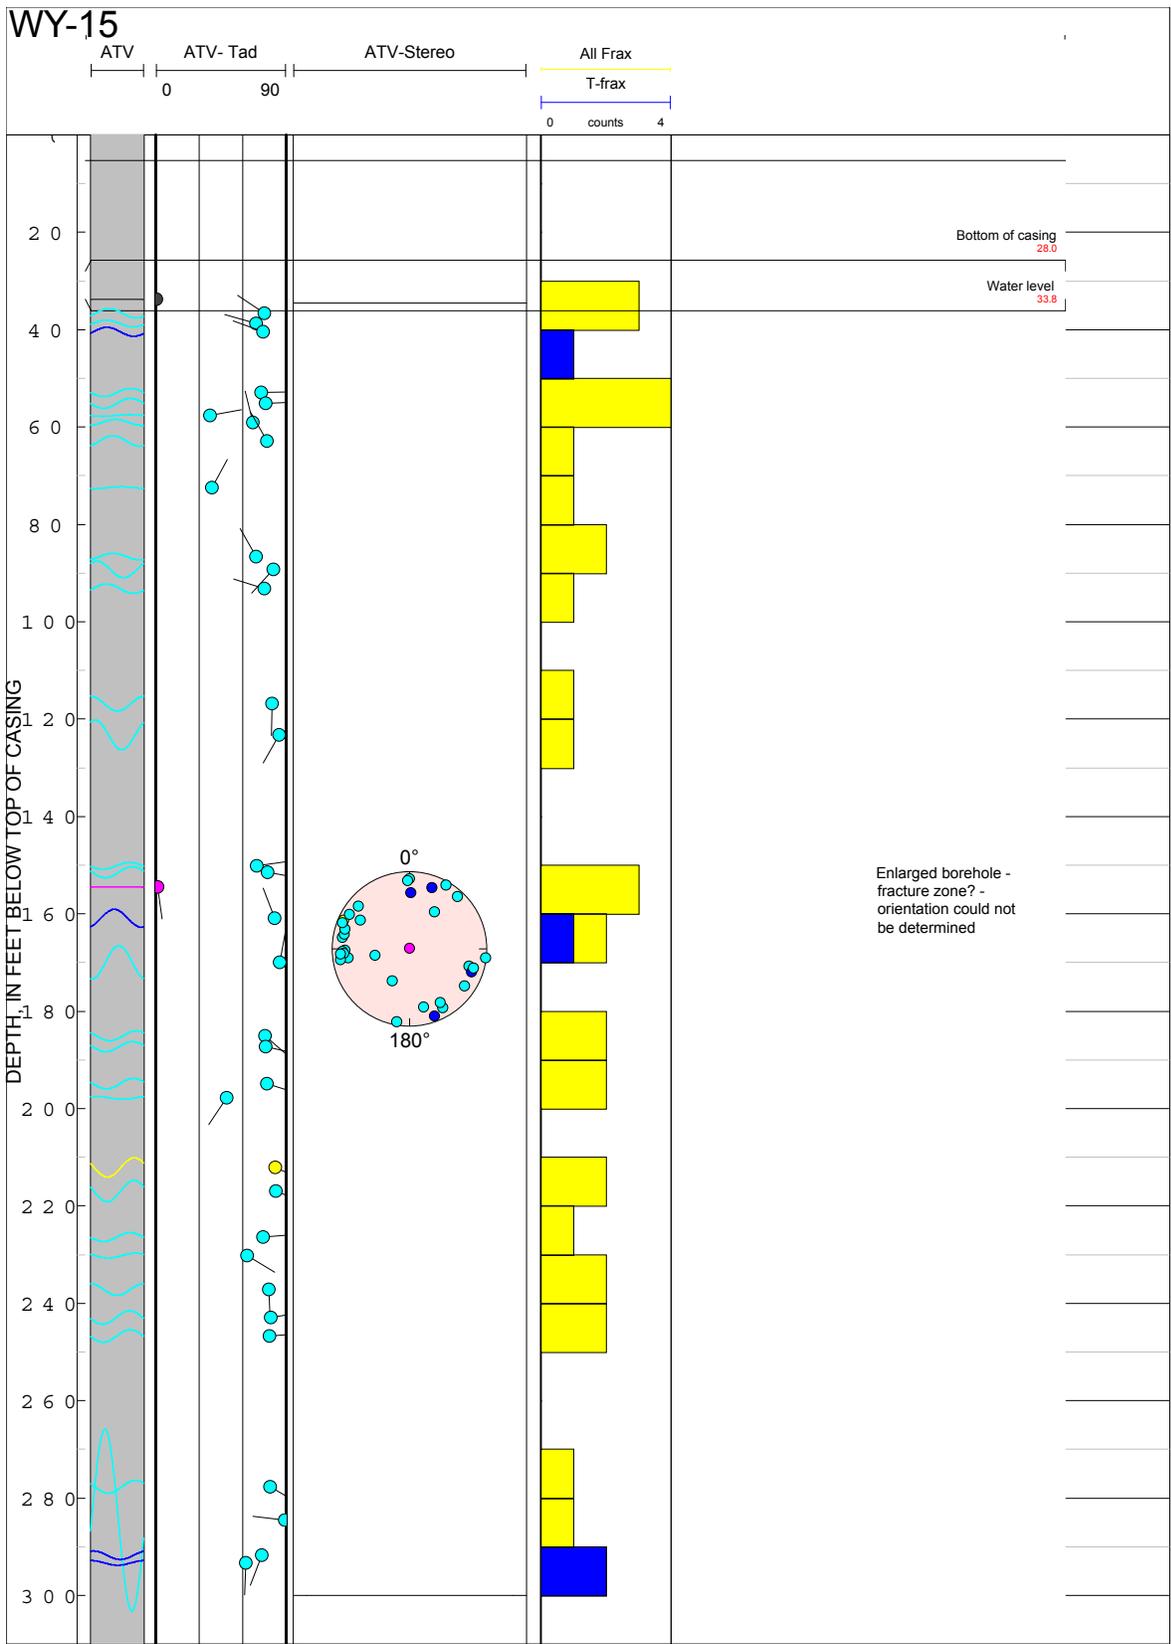
Figure 6B-4. Summary of structure interpreted from geophysical logs of boreholes near the Air Force Radar Tracking Station on Howard Mountain, near Machiasport, Maine. Fracture density plots at 10-foot intervals for boreholes WY-3, WY-3B, and WY-15, the deepest boreholes in the group.—Continued [T-frax, transmissive fracture; Tx, transmissive; TN, true north; dev, deviation]

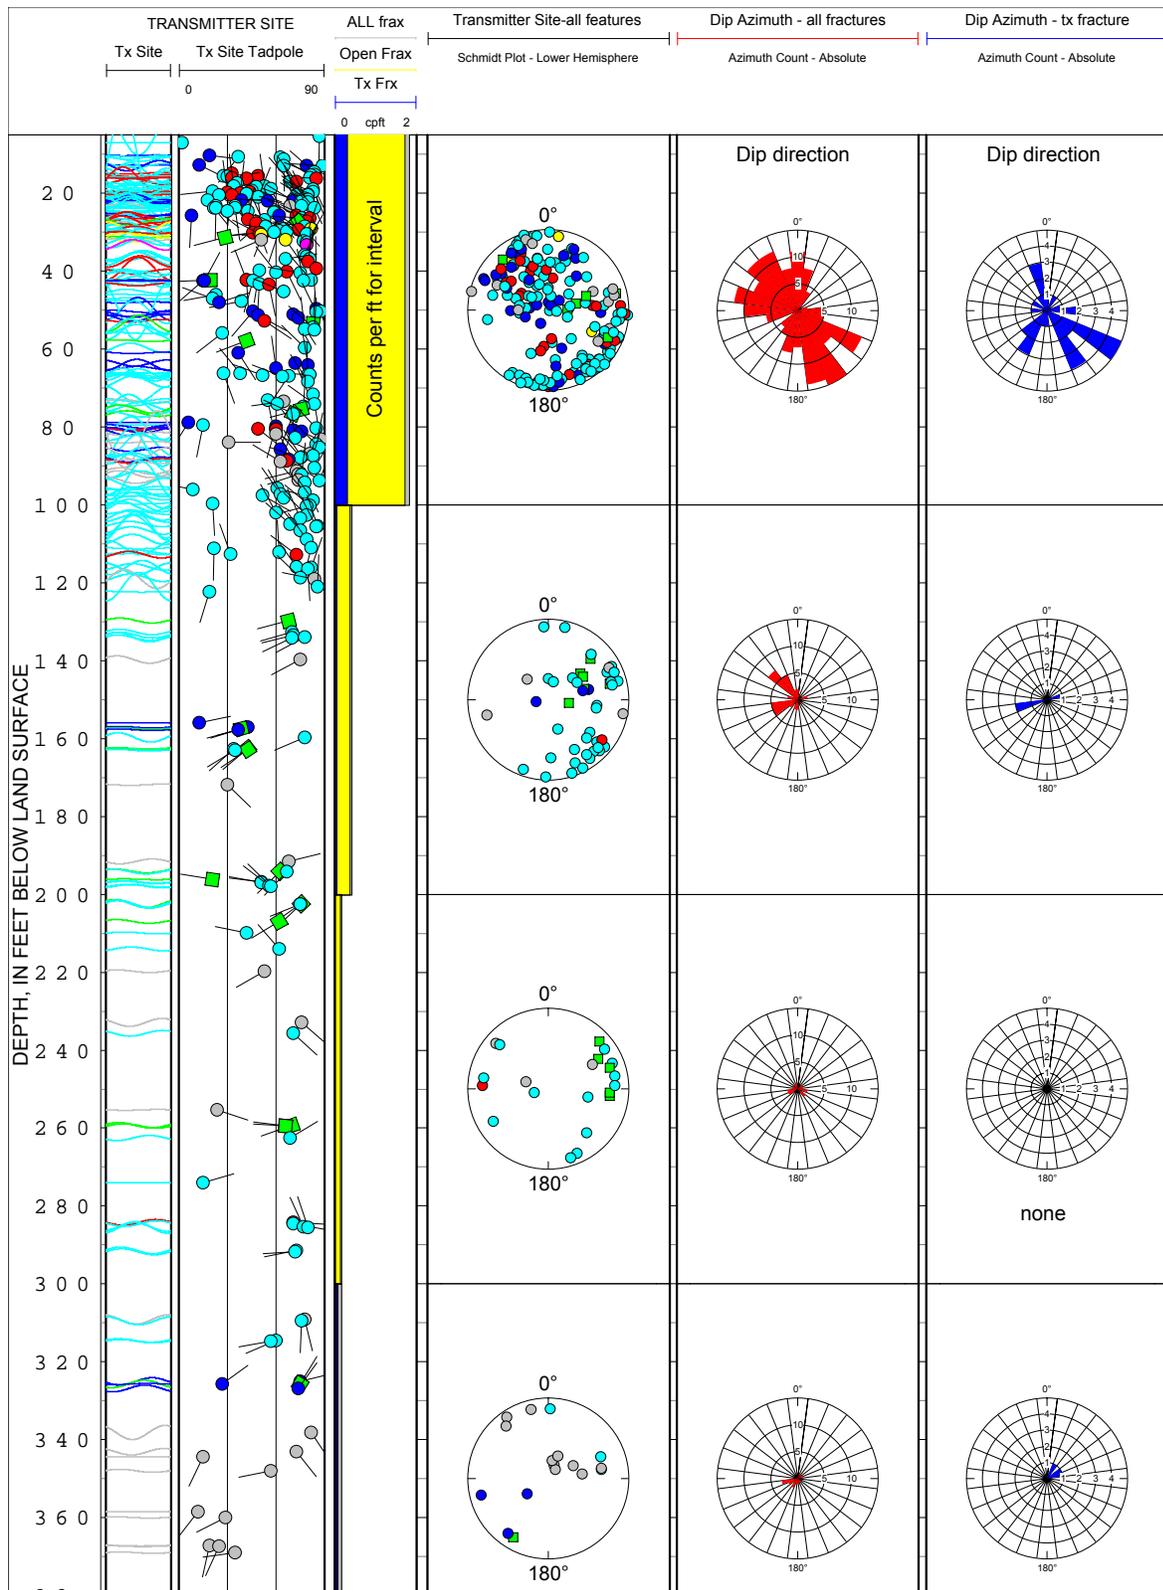
Figure 6C-1. Summary of structure interpreted from geophysical logs of boreholes near the Transmitter Site on Howard Mountain, near Machiasport, Maine. In depth below land surface-projection and tadpole plots for all features; fracture density plots at 10-foot intervals; stereoplots for all features in the boreholes; rose diagram of dip directions for all features in the boreholes. [Tx, transmissive; deg, degree; Std. Dev., standard deviation; Min, minimum; Max, maximum]

- Figure 6C–1.** In depth below land surface-projection and tadpole plots for all features; fracture density plots at 10-foot intervals; stereoplots for all features in the boreholes; rose diagram of dip directions for all features in the boreholes.

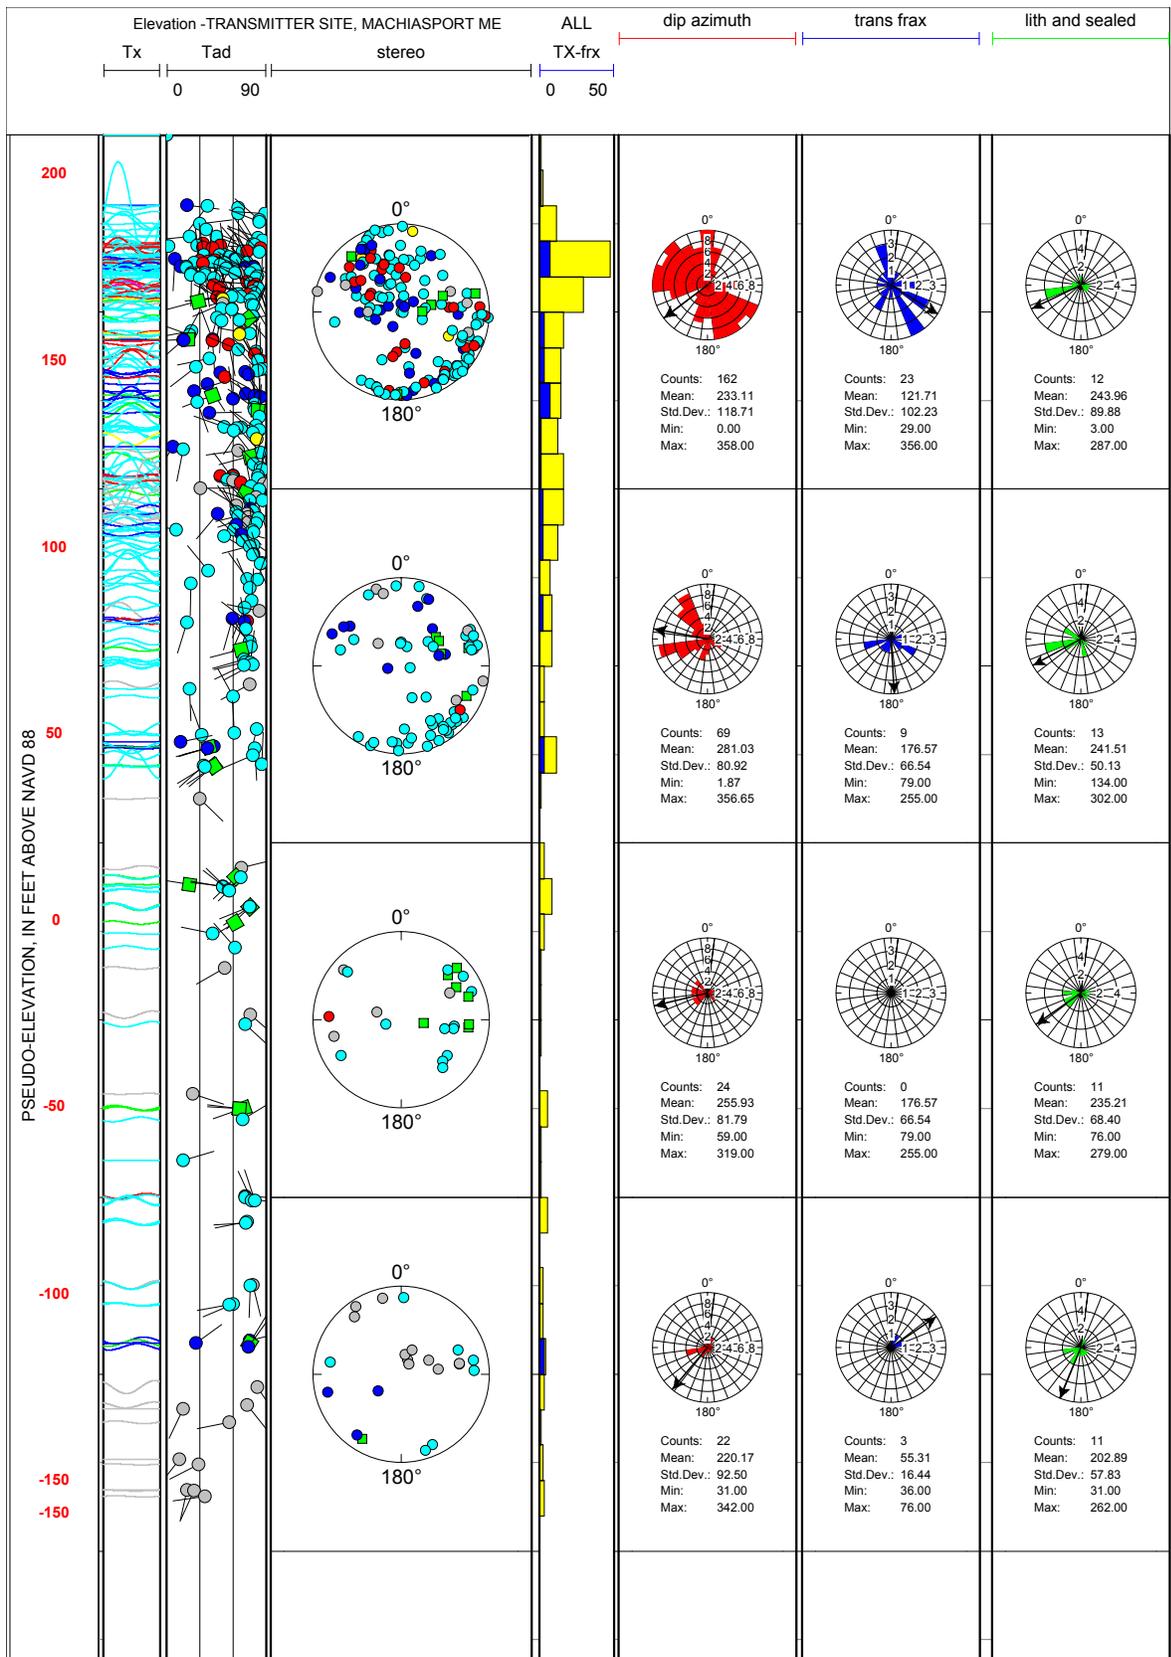
Figure 6C-2. Summary of structure interpreted from geophysical logs of boreholes near the Transmitter Site on Howard Mountain, near Machiasport, Maine. In depth below land surface-projection and tadpole plots for all features; fracture density plots; stereoplots for all features the entire boreholes; rose diagrams for the entire boreholes, all at 100-foot intervals.
 [Tx, transmissive; Frax, fracture]

- Figure 6C–2.** In depth below land surface-projection and tadpole plots for all features; fracture density plots; stereoplots for all features the entire boreholes; rose diagrams for the entire boreholes, all at 100-foot intervals.

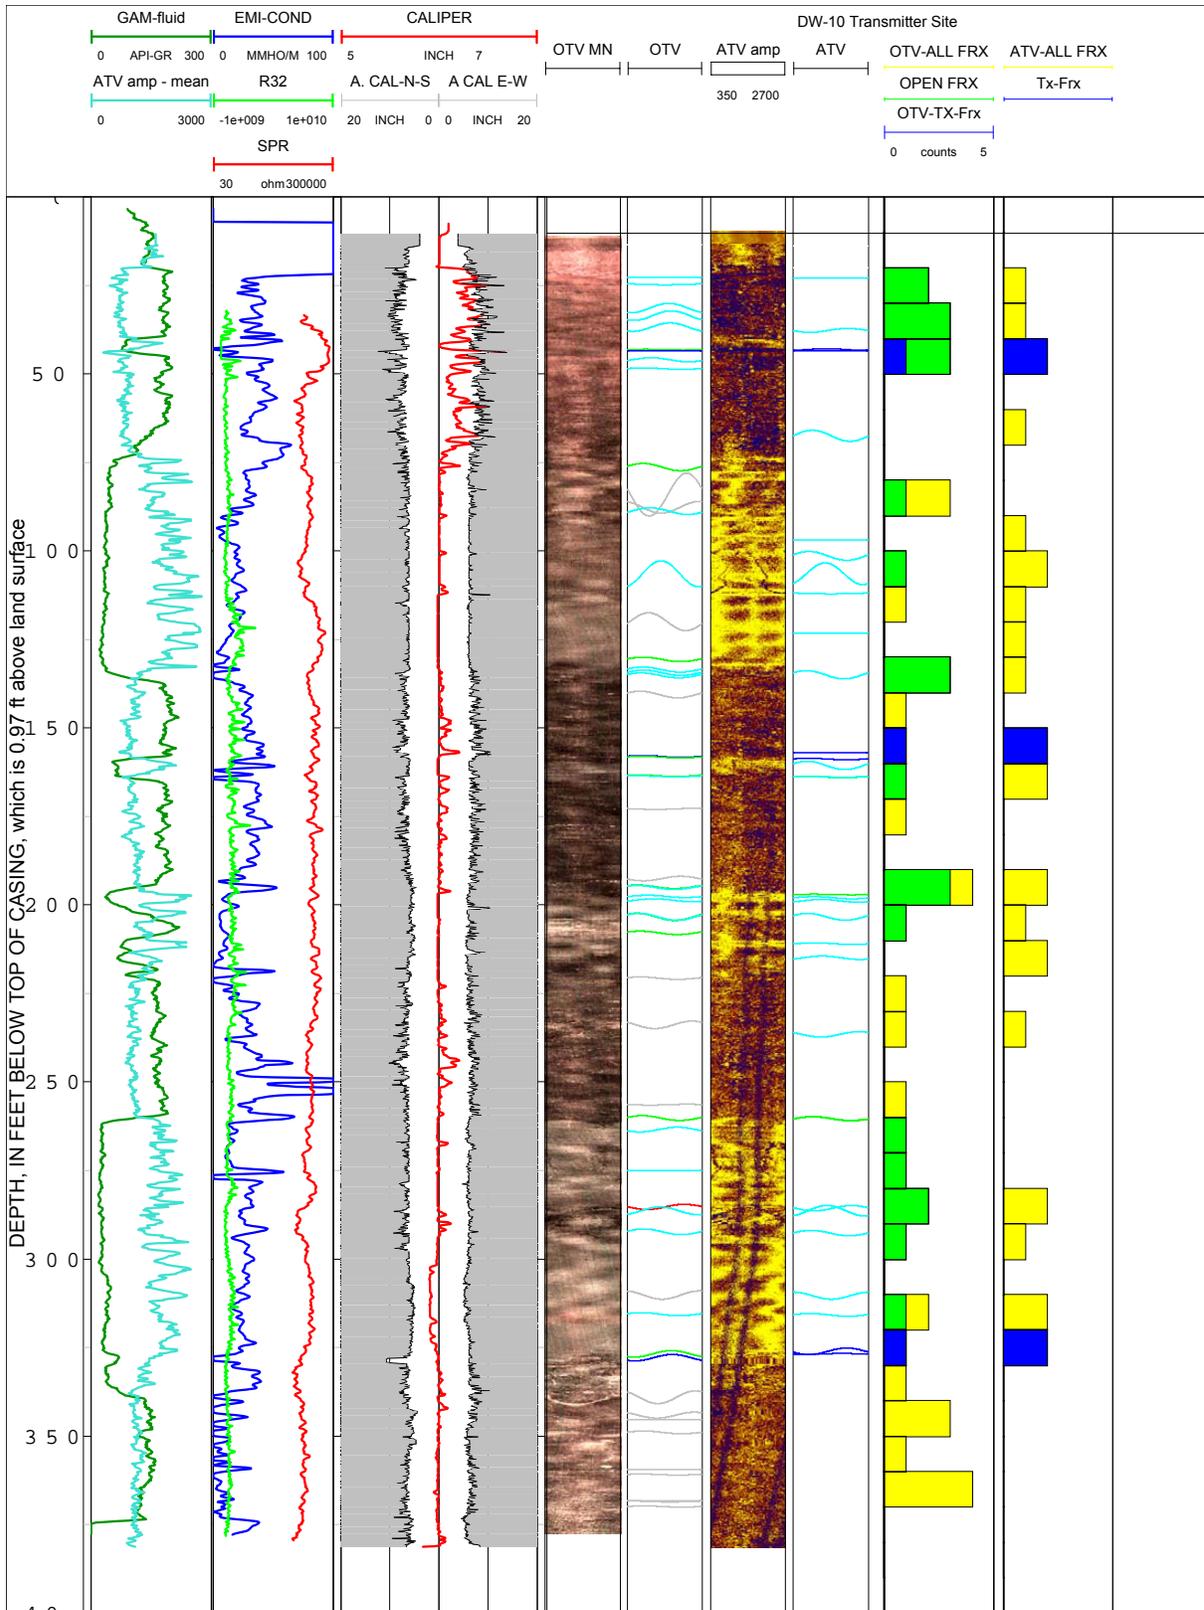
Figure 6C-3. Summary of structure interpreted from geophysical logs of boreholes near the Transmitter Site on Howard Mountain, near Machiasport, Maine. In elevation above mean sea level-projection and tadpole plots for all features at 100-foot intervals; fracture density plots (all fractures and transmissive fractures) at 10-foot intervals; rose diagrams of dip direction at 100-foot intervals. [Tx, transmissive; Tad, tadpole; trans fract, transmissive fracture; lith, lithologic feature; Std. Dev., standard deviation; Min, minimum; Max, maximum]

- Figure 6C–3.** In elevation above mean sea level-projection and tadpole plots for all features at 100-foot intervals; fracture density plots (all fractures and transmissive fractures) at 10-foot intervals; rose diagrams of dip direction at 100-foot intervals.
