Prepared in cooperation with the Puerto Rico Electric Power Authority

Dam Failure Analysis for the Lago de Matrullas Dam, Orocovis, Puerto Rico

Scientific Investigations Report 2015–5065

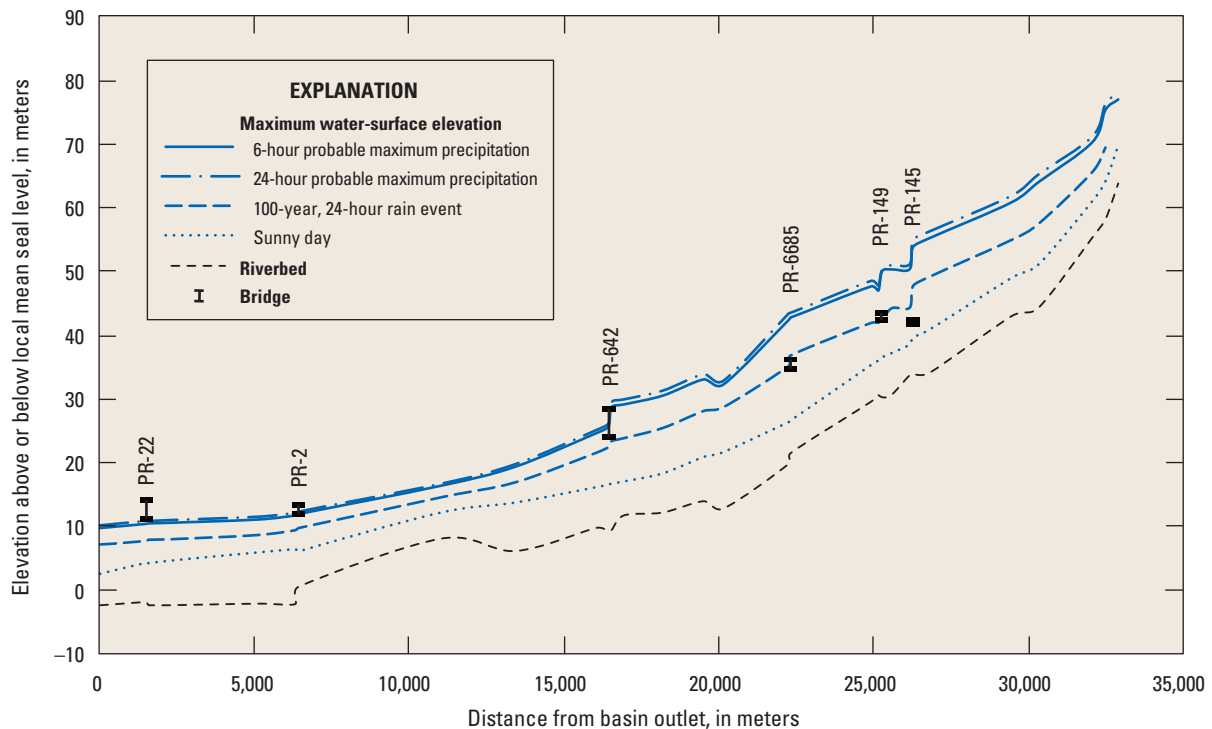
Figure 6. Maximum water-surface profile along the lower reach of the Río Grande de Manatí for the 6-hour probable maximum precipitation (PMP) for the dam failure analysis of the Lago de Matrullas Dam, Orocovis, Puerto Rico.

and 14,800.87 m³/s for the 24-hour PMP event (tables 8, 9, respectively). Near the town of Barceloneta at the PR-22 bridge, the peak discharge was 12,781.07 m³/s for the 6-hour PMP event and 14,549.13 m³/s for the 24-hour PMP event. The maximum water-surface profiles resulting from these flood events along the lower reach of the Río Grande de Manatí indicate overtopping of the PR-6685, PR-149, PR-642 and PR-145 bridges (fig. 6).

The dam failure for the 100-year-recurrence, 24-hour rainfall event (100-year flood) was initiated when the peak inflow discharge reached the dam and the reservoir pool elevation was 745.38 m. Dam failure analysis results were summarized for selected cross sections (table 10). At the toe of Lago de Matrullas Dam, the computed peak discharge produced by the dam failure was 2,103.12 m³/s. Along the Río Grande de Manatí lower reach, a peak discharge of 5,545.48 m³/s was estimated near the PR-145 bridge (about 0.6 km upstream). At the PR-22 bridge near the town of Barceloneta, the peak discharge was 4,834.68 m³/s. The maximum water-surface profile resulting from this flood event along the lower reach of the Río Grande de Manatí indicates overtopping of the PR-6685, PR-149, and PR-145 bridges (fig. 6).

Failure of the Lago de Matrullas Dam under sunny day conditions was initiated at a reservoir pool elevation of about 743.5 m. Dam failure analysis results were summarized at selected cross sections (table 11). The estimated peak discharge just downstream from the Lago de Matrullas Dam was 1,695.91 m³/s. Along the Río Grande de Manatí lower reach, the peak discharge was 1,109.09 m³/s about 0.6 km upstream of the PR-145 bridge. Estimated discharge was 387.72 m³/s near the town of Barceloneta (at the PR-22 bridge). The maximum water-surface profile along the lower reach of the Río Grande de Manatí indicates no bridge overtopping (fig. 6).

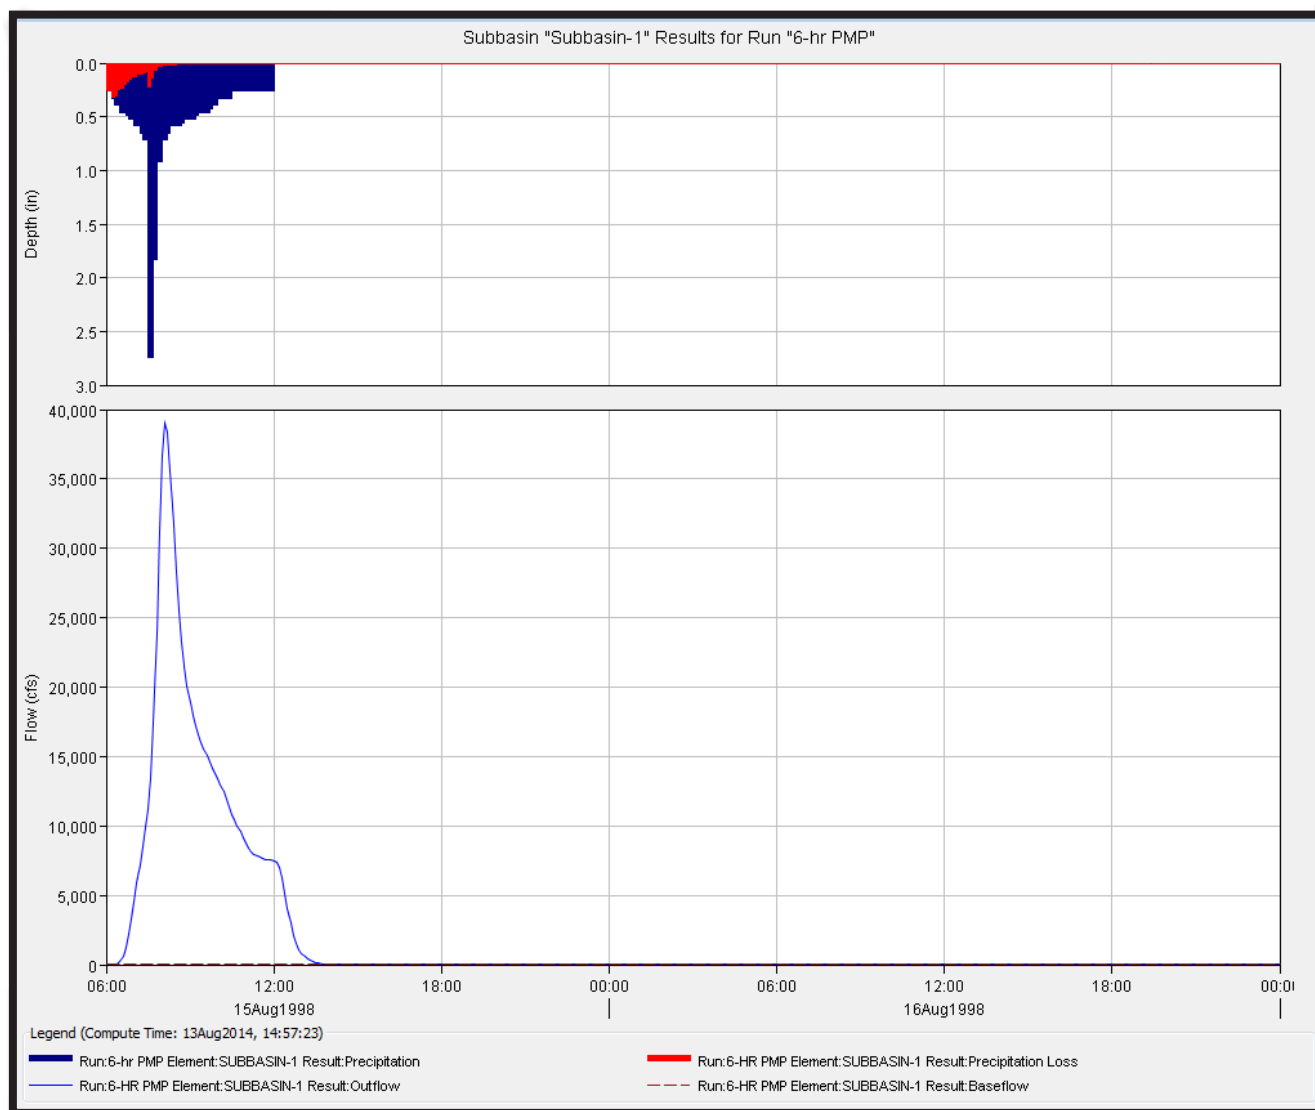
Figure 1-1. Output hydrograph screenshot for subbasin 1 from the 6-hour probable maximum precipitation (PMP) event.

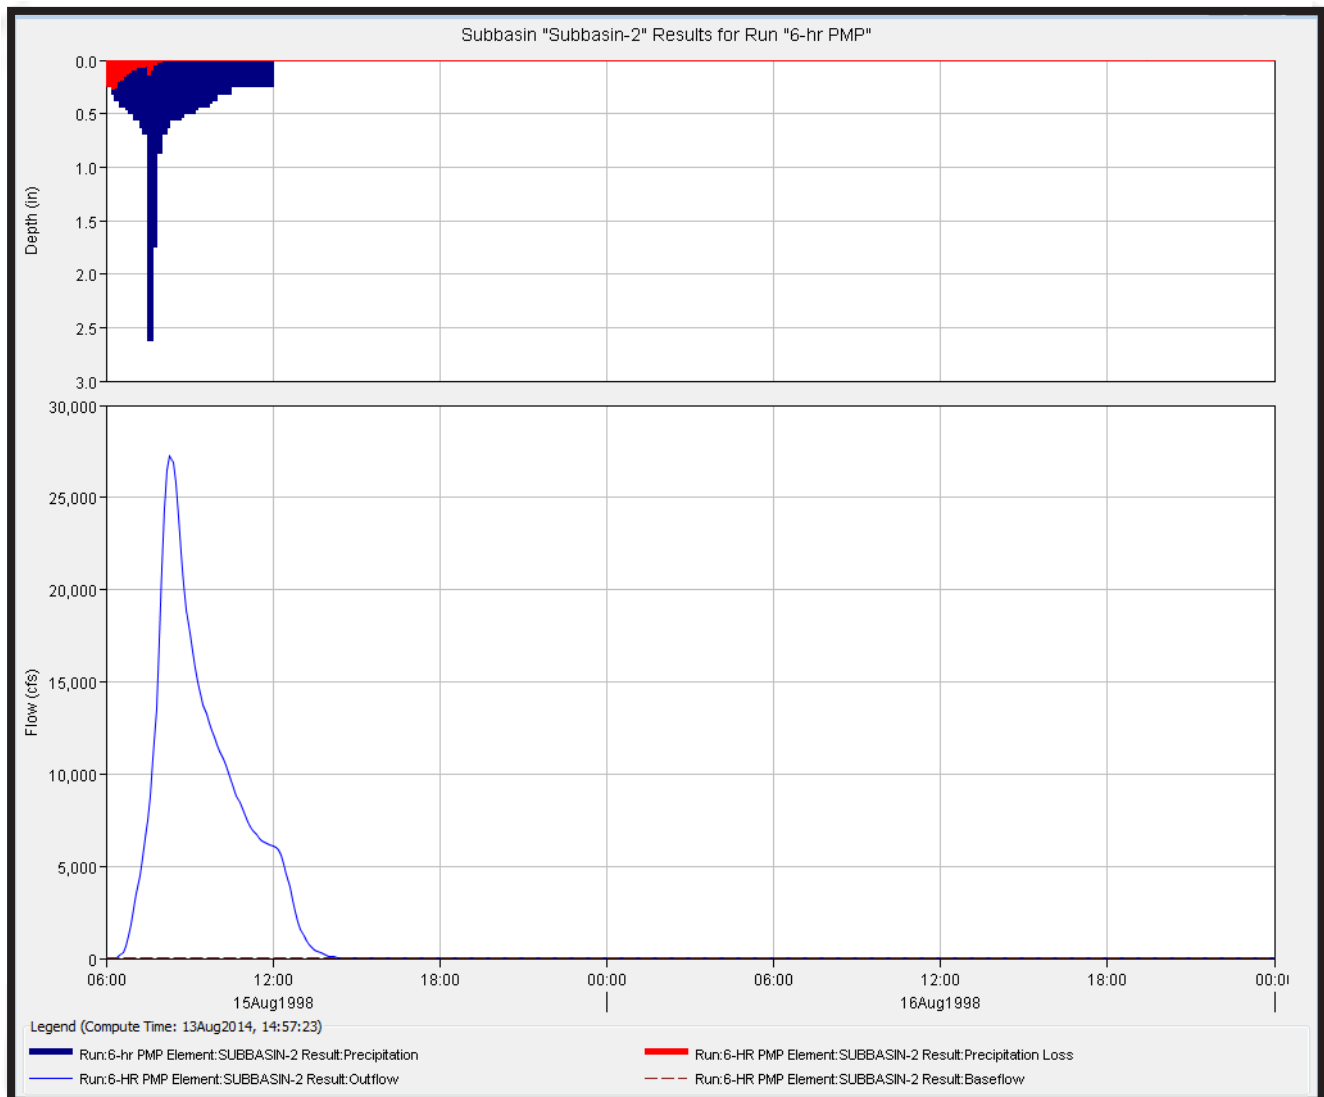
Figure 1–2. Output hydrograph screenshot for subbasin 2 from the 6-hour probable maximum precipitation (PMP) event.

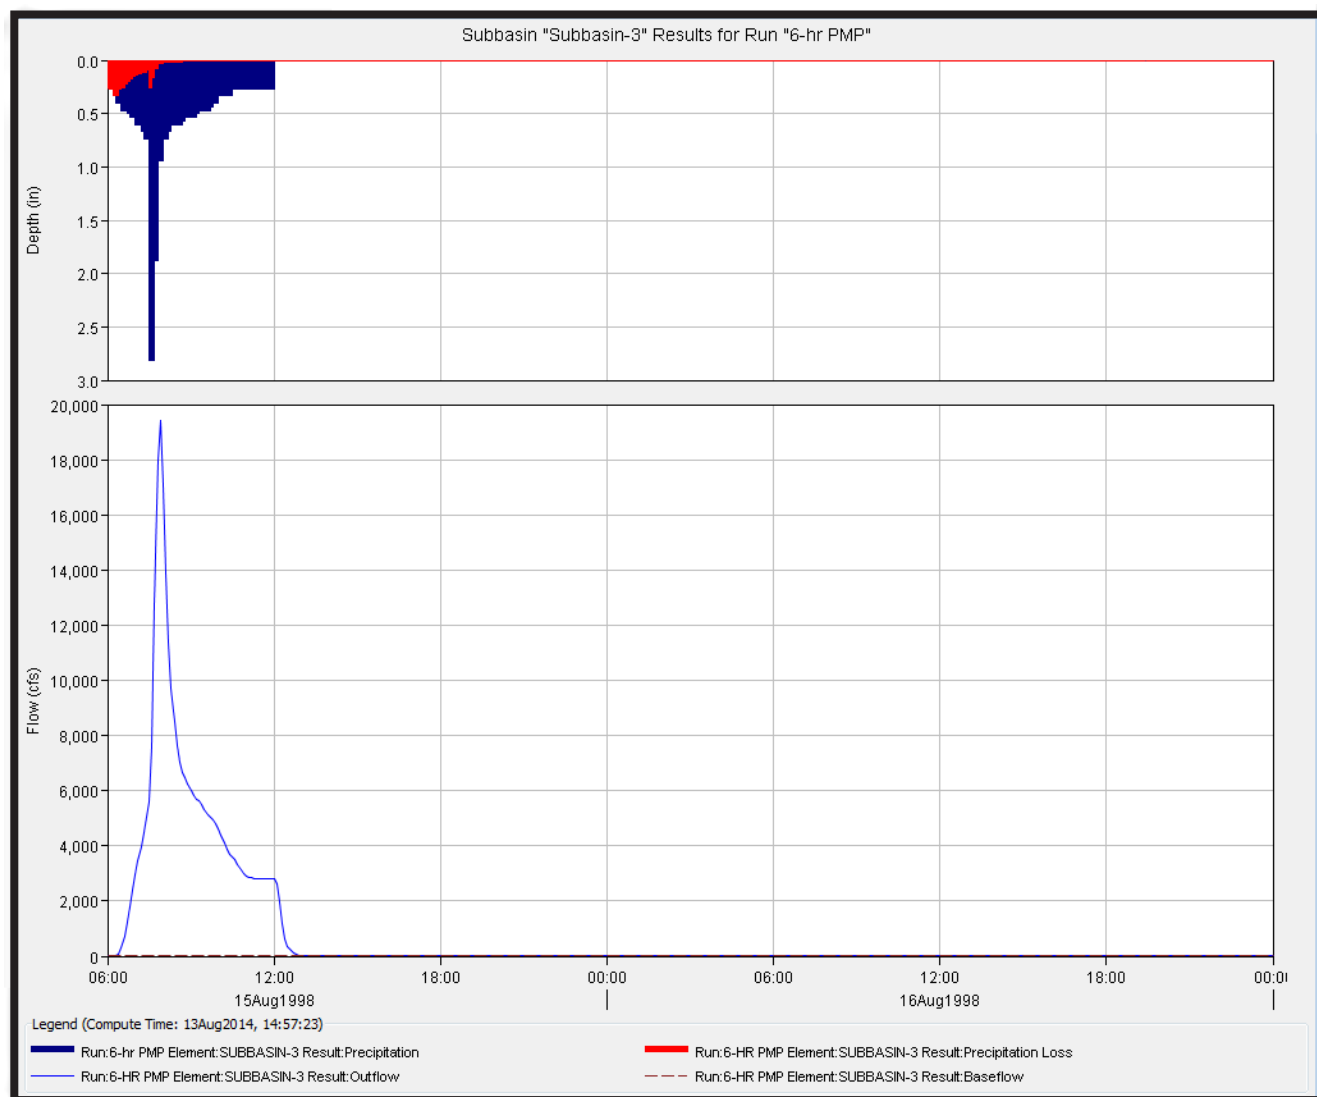
Figure 1–3. Output hydrograph screenshot for subbasin 3 from the 6-hour probable maximum precipitation (PMP) event.

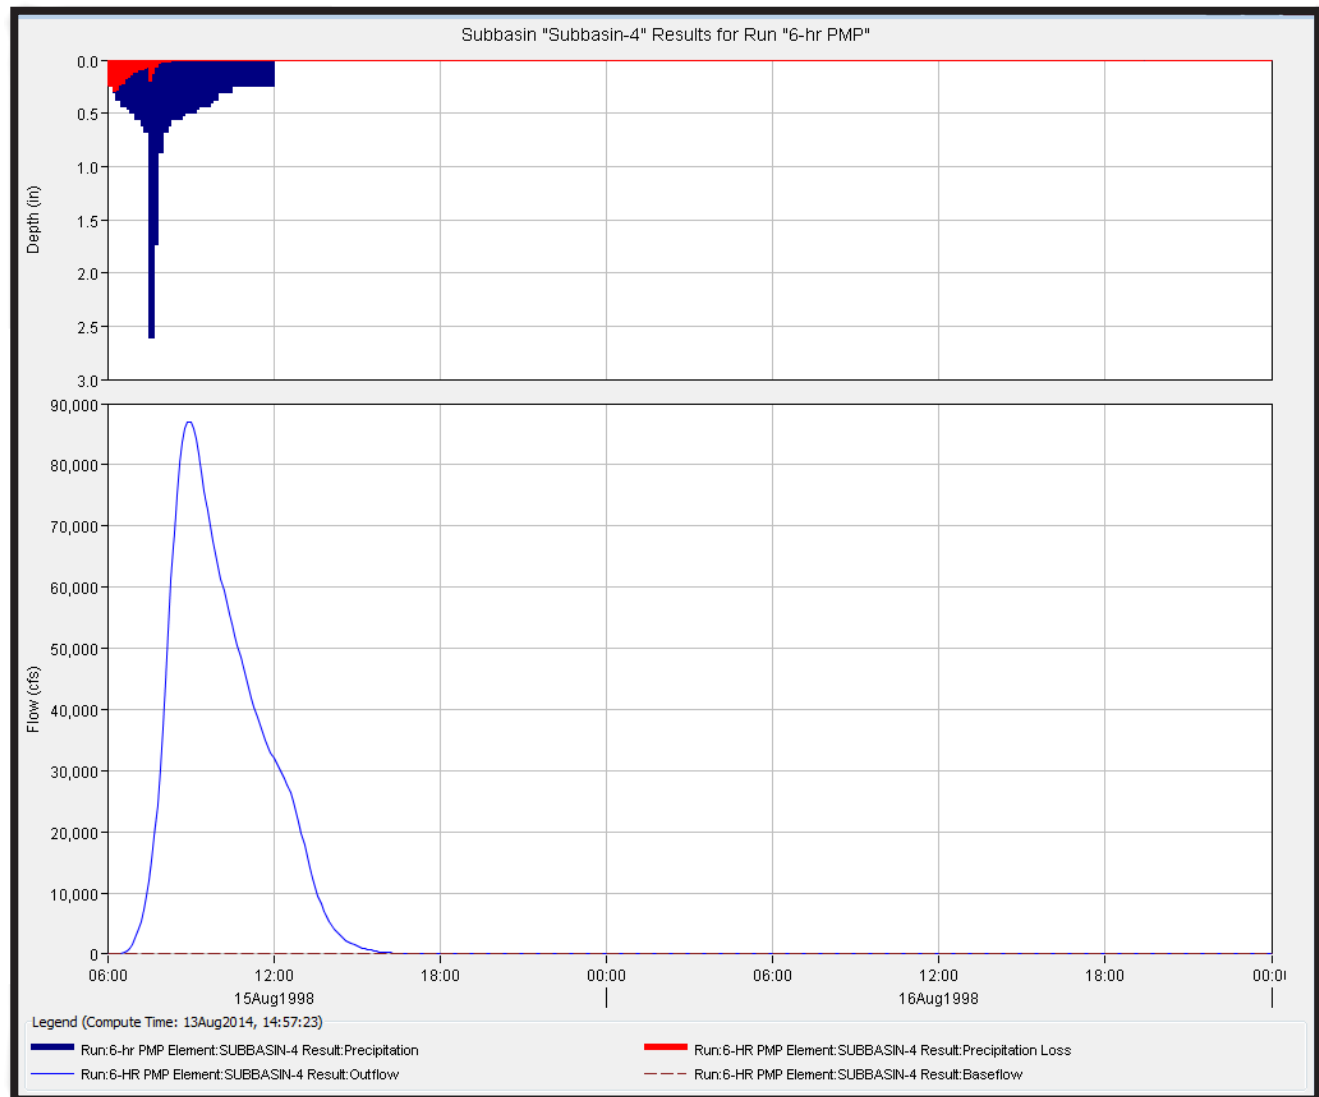
Figure 1-4. Output hydrograph screenshot for subbasin 4 from the 6-hour probable maximum precipitation (PMP) event.

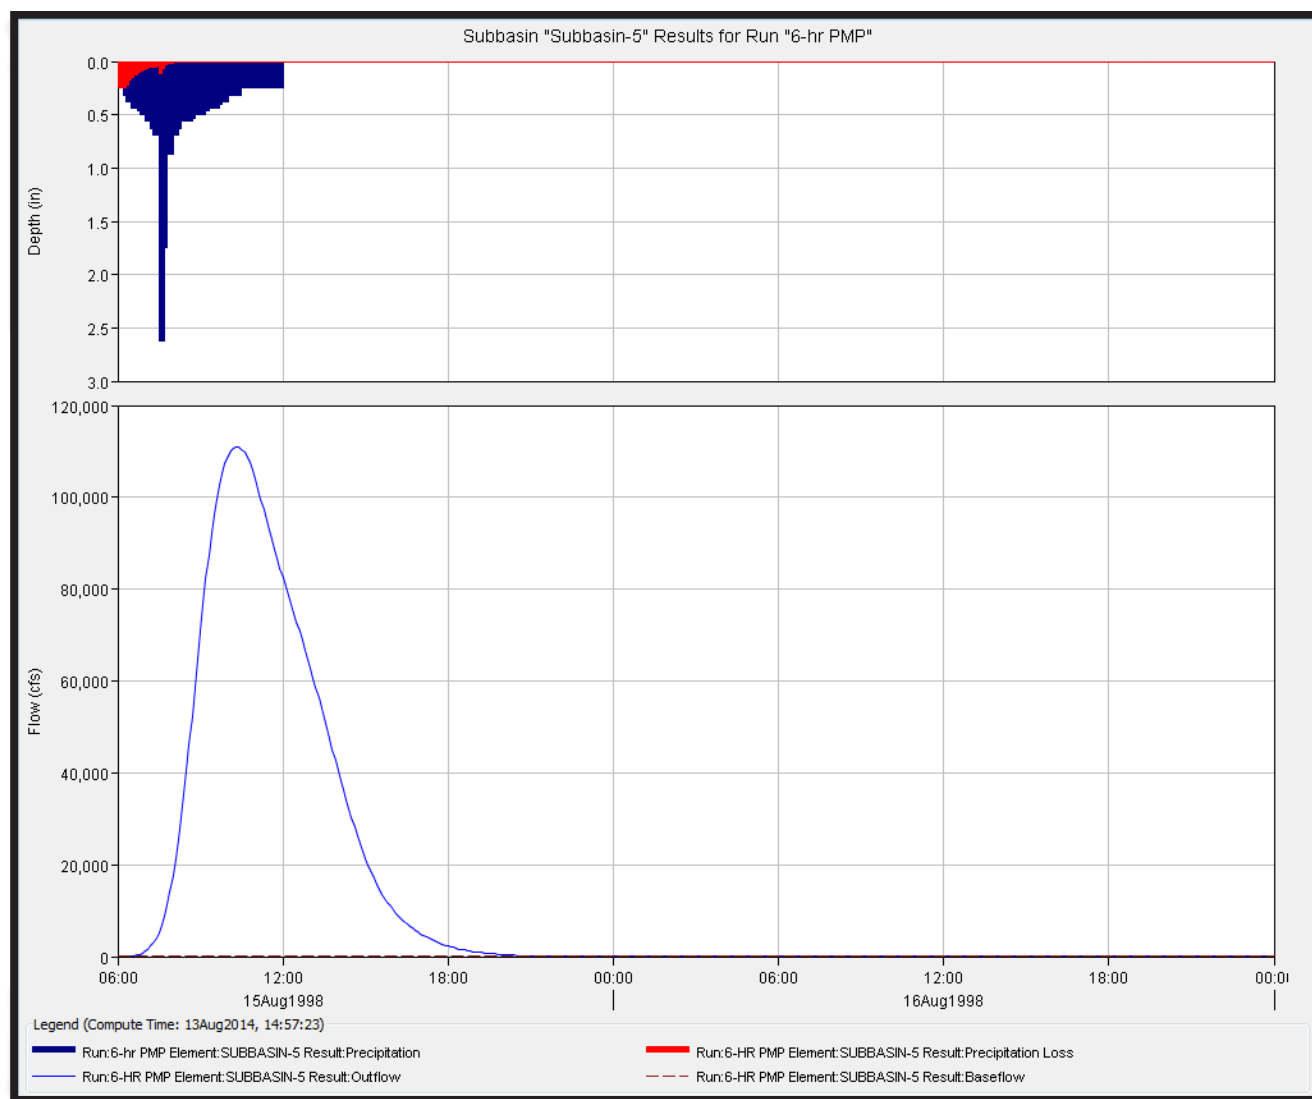
Figure 1–5. Output hydrograph screenshot for subbasin 5 from the 6-hour probable maximum precipitation (PMP) event.

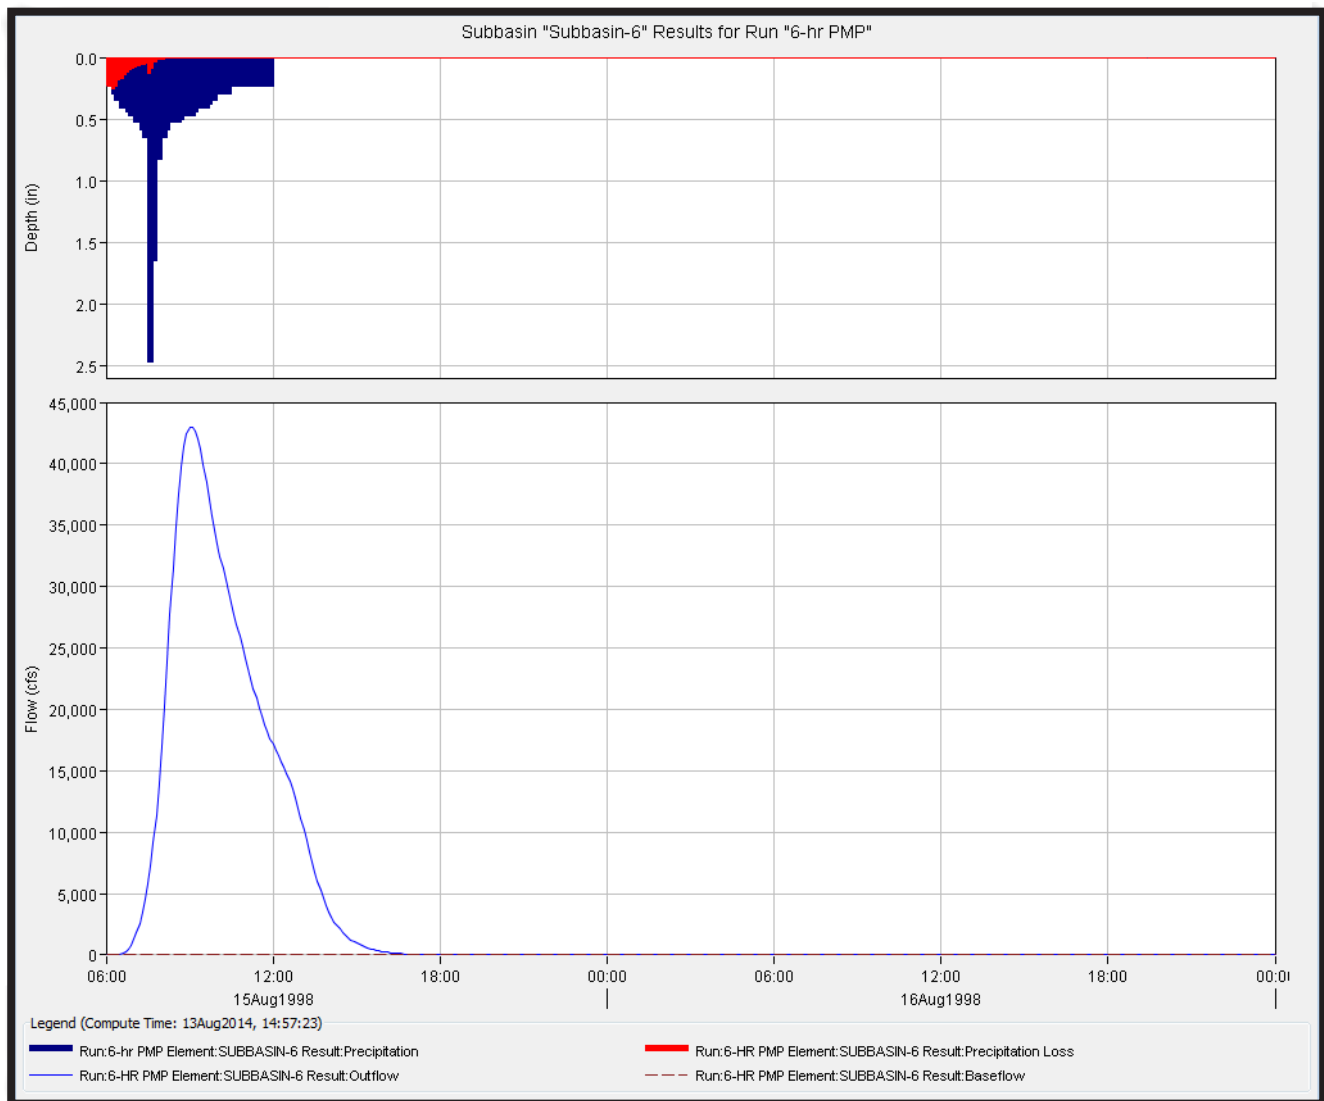
Figure 1–6. Output hydrograph screenshot for subbasin 6 from the 6-hour probable maximum precipitation (PMP) event.

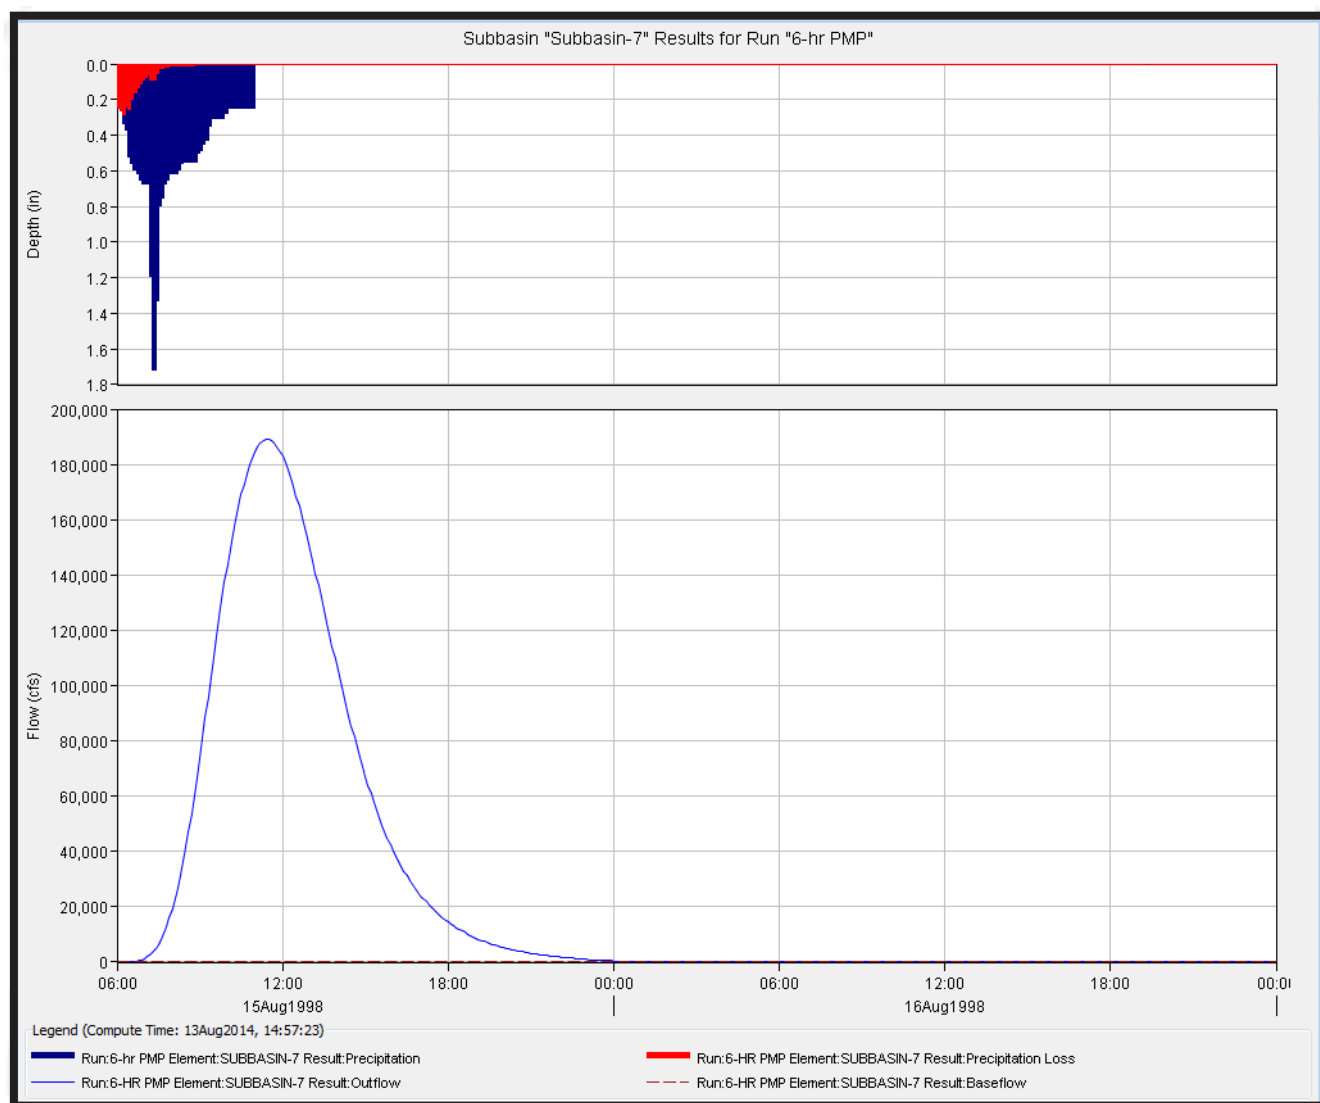
Figure 1–7. Output hydrograph screenshot for subbasin 7 from the 6-hour probable maximum precipitation (PMP) event.

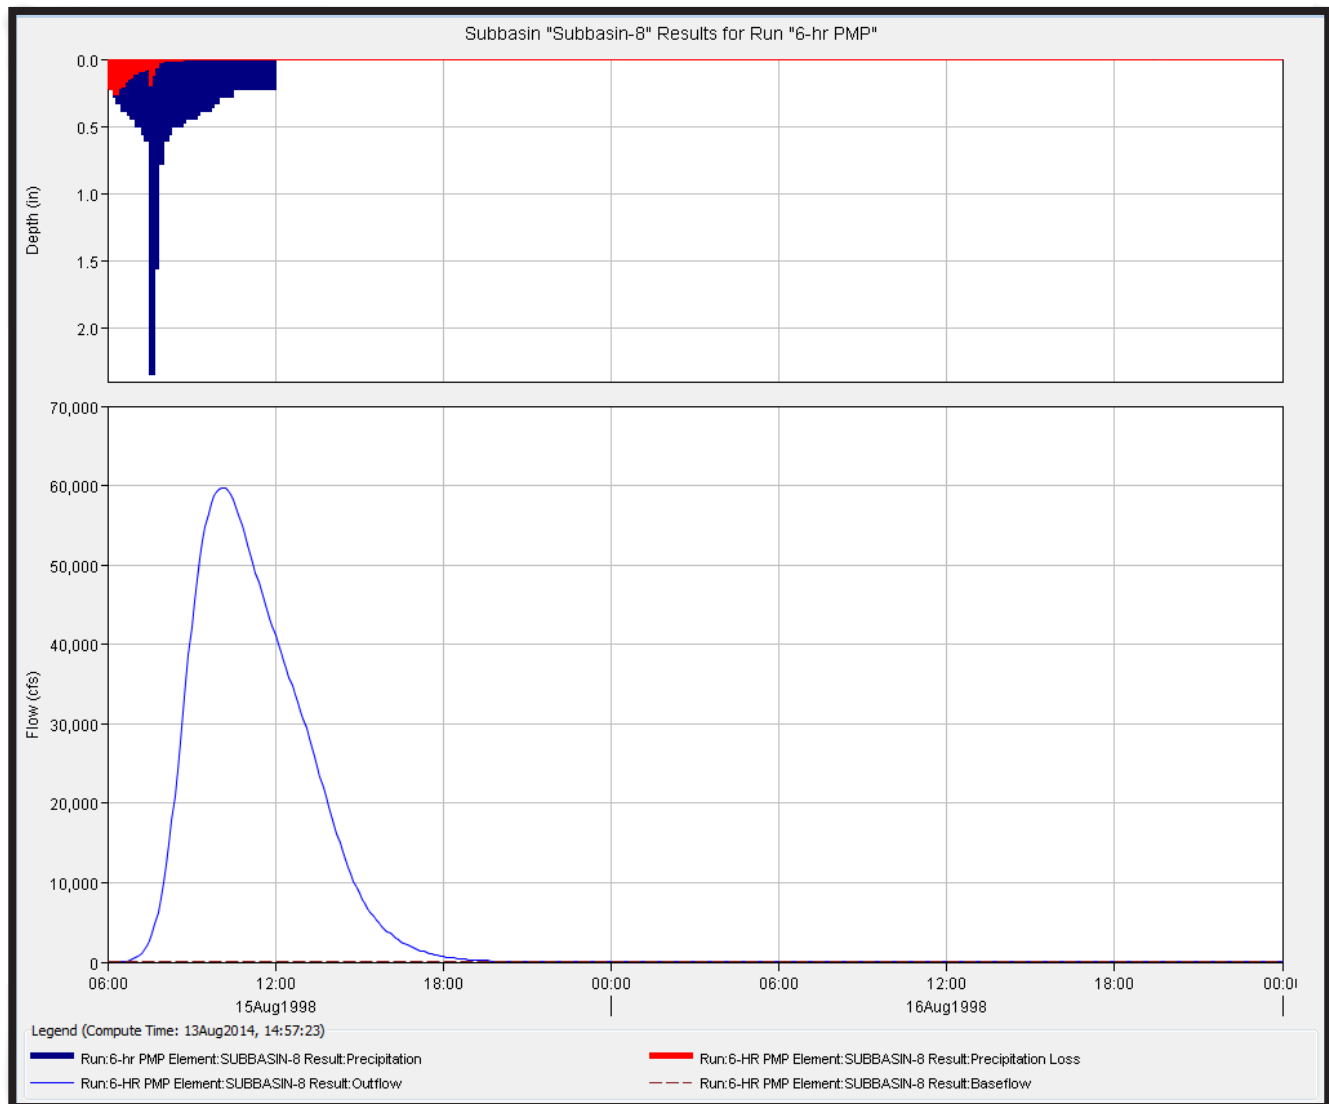
Figure 1–8. Output hydrograph screenshot for subbasin 8 from the 6-hour probable maximum precipitation (PMP) event.

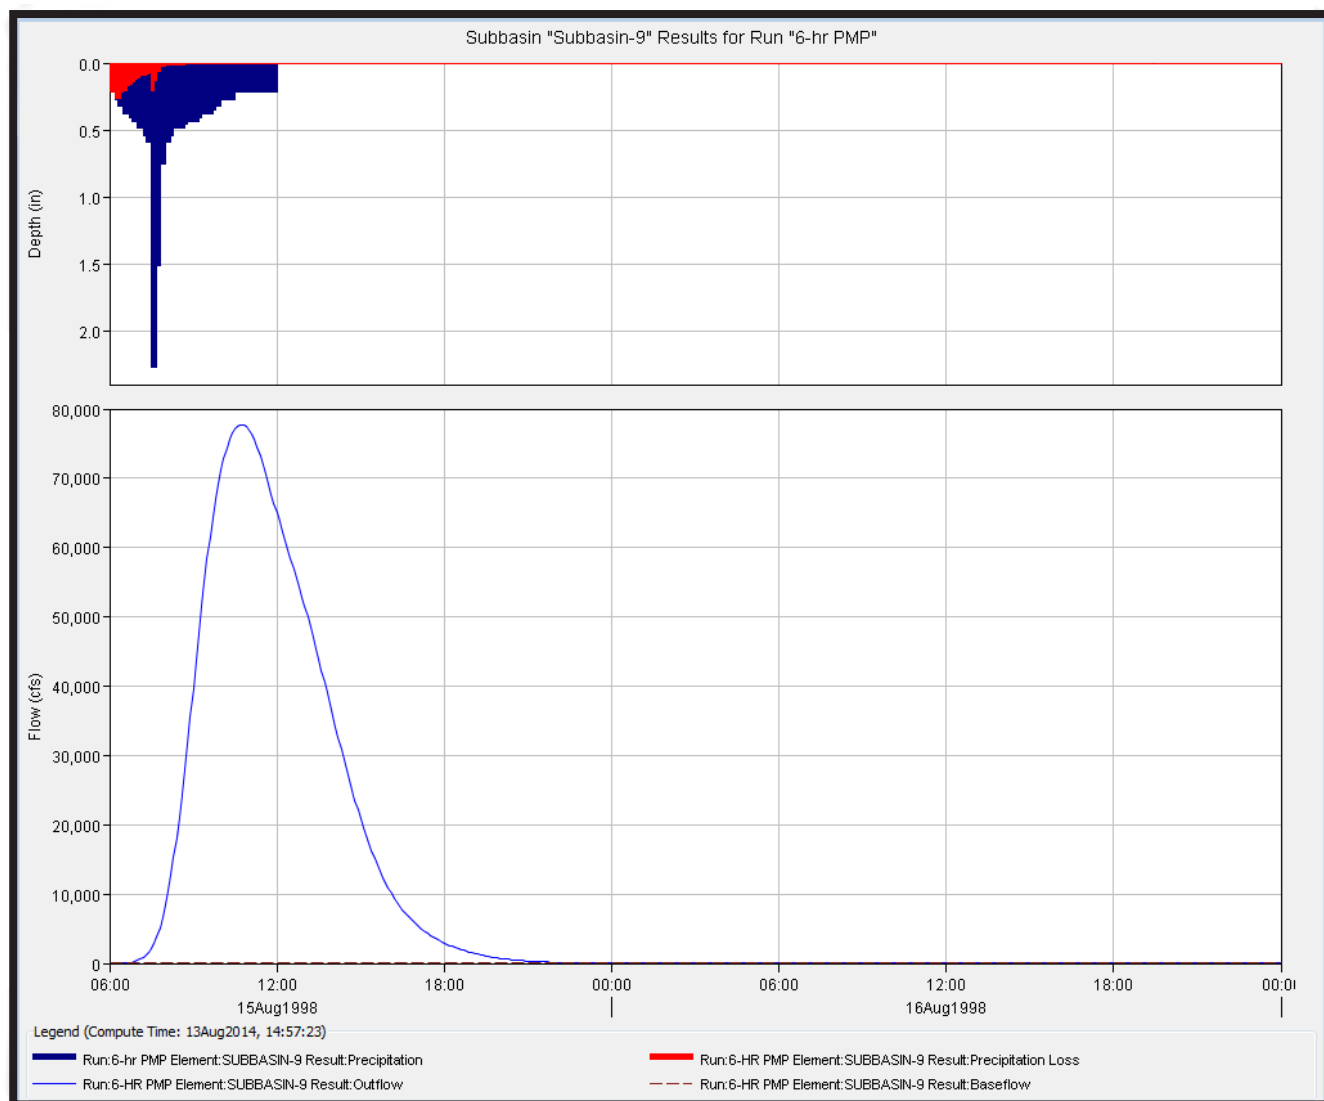
Figure 1–9. Output hydrograph screenshot for subbasin 9 from the 6-hour probable maximum precipitation (PMP) event.

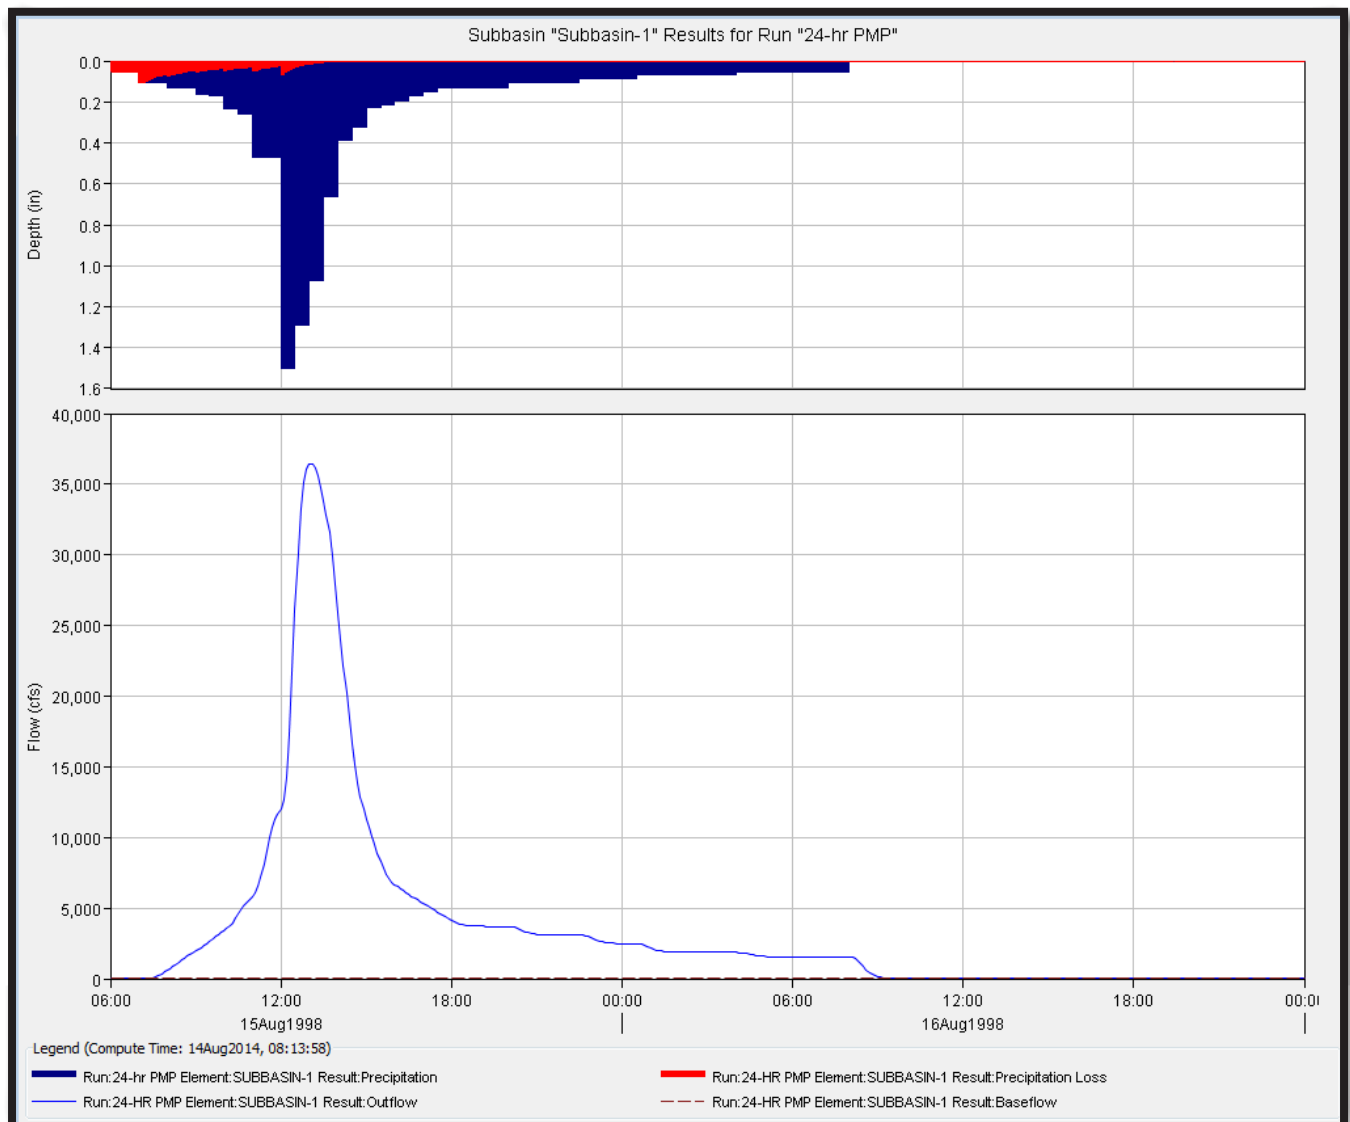
Figure 1-10. Output hydrograph screenshot for subbasin 1 from the 24-hour probable maximum precipitation (PMP) event.

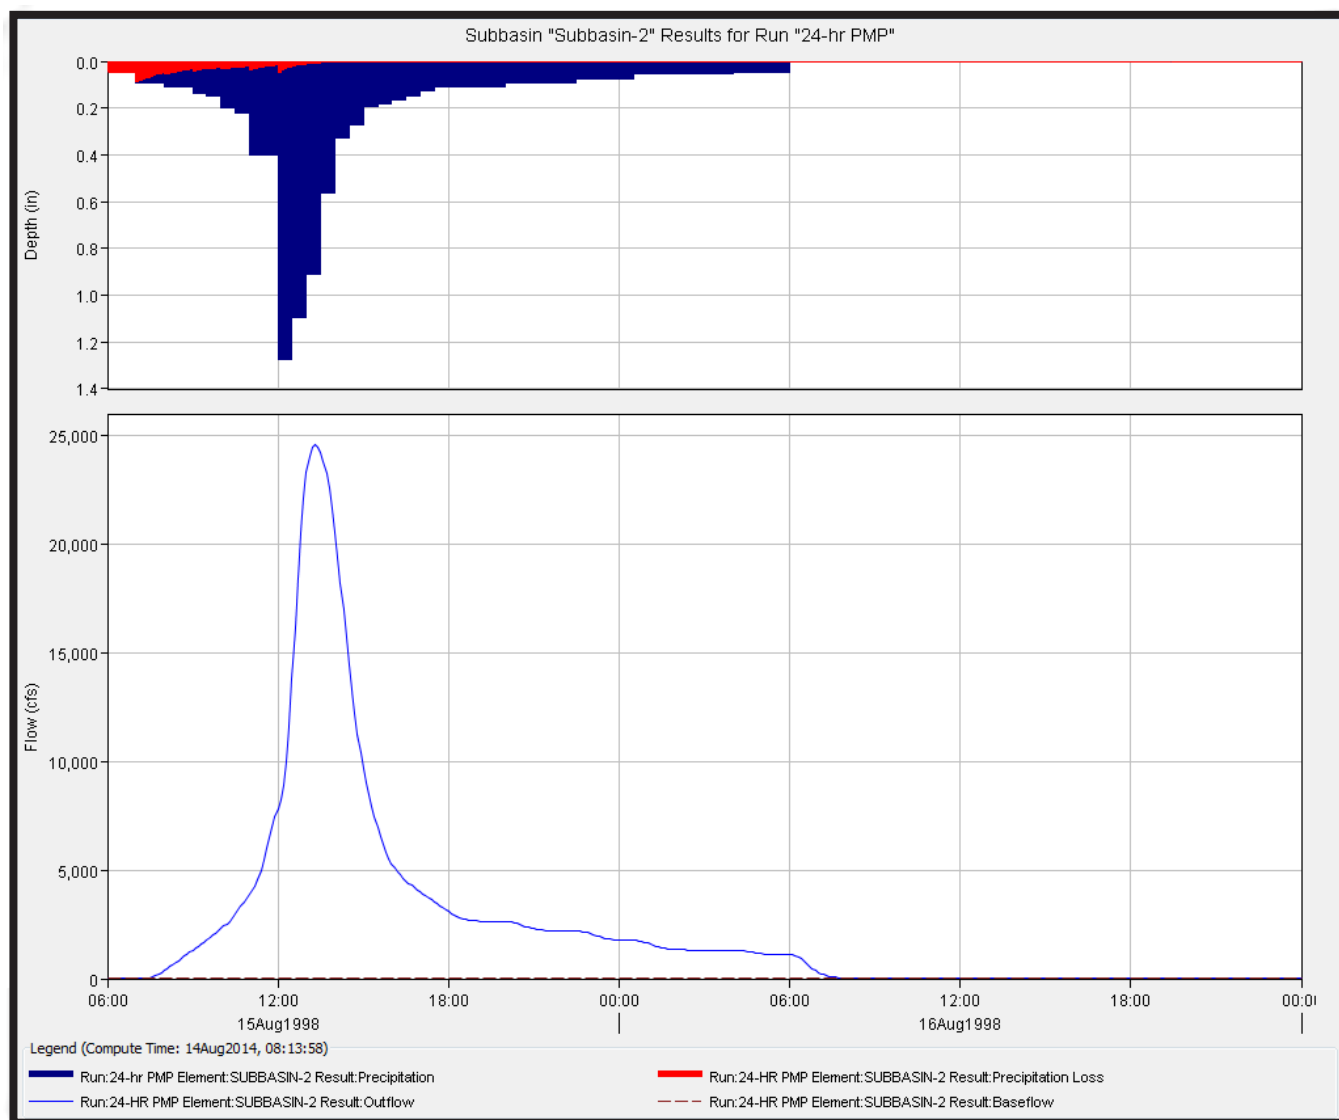
Figure 1–11. Output hydrograph screenshot for subbasin 2 from the 24-hour probable maximum precipitation (PMP) event.

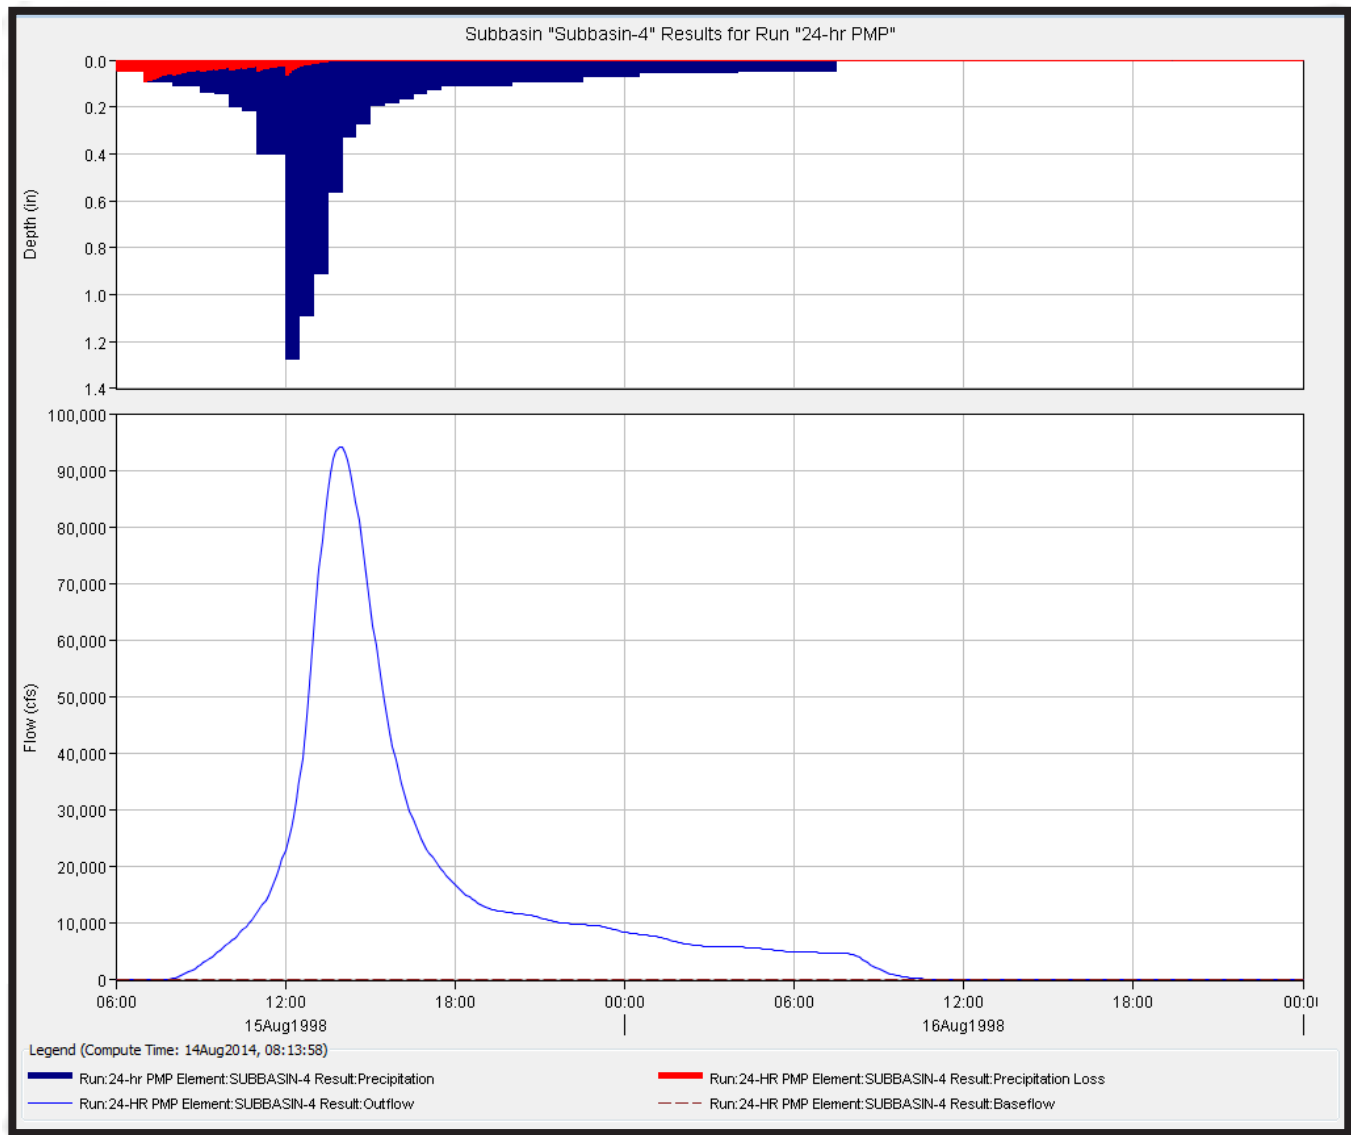
Figure 1-13. Output hydrograph screenshot for subbasin 4 from the 24-hour probable maximum precipitation (PMP) event.

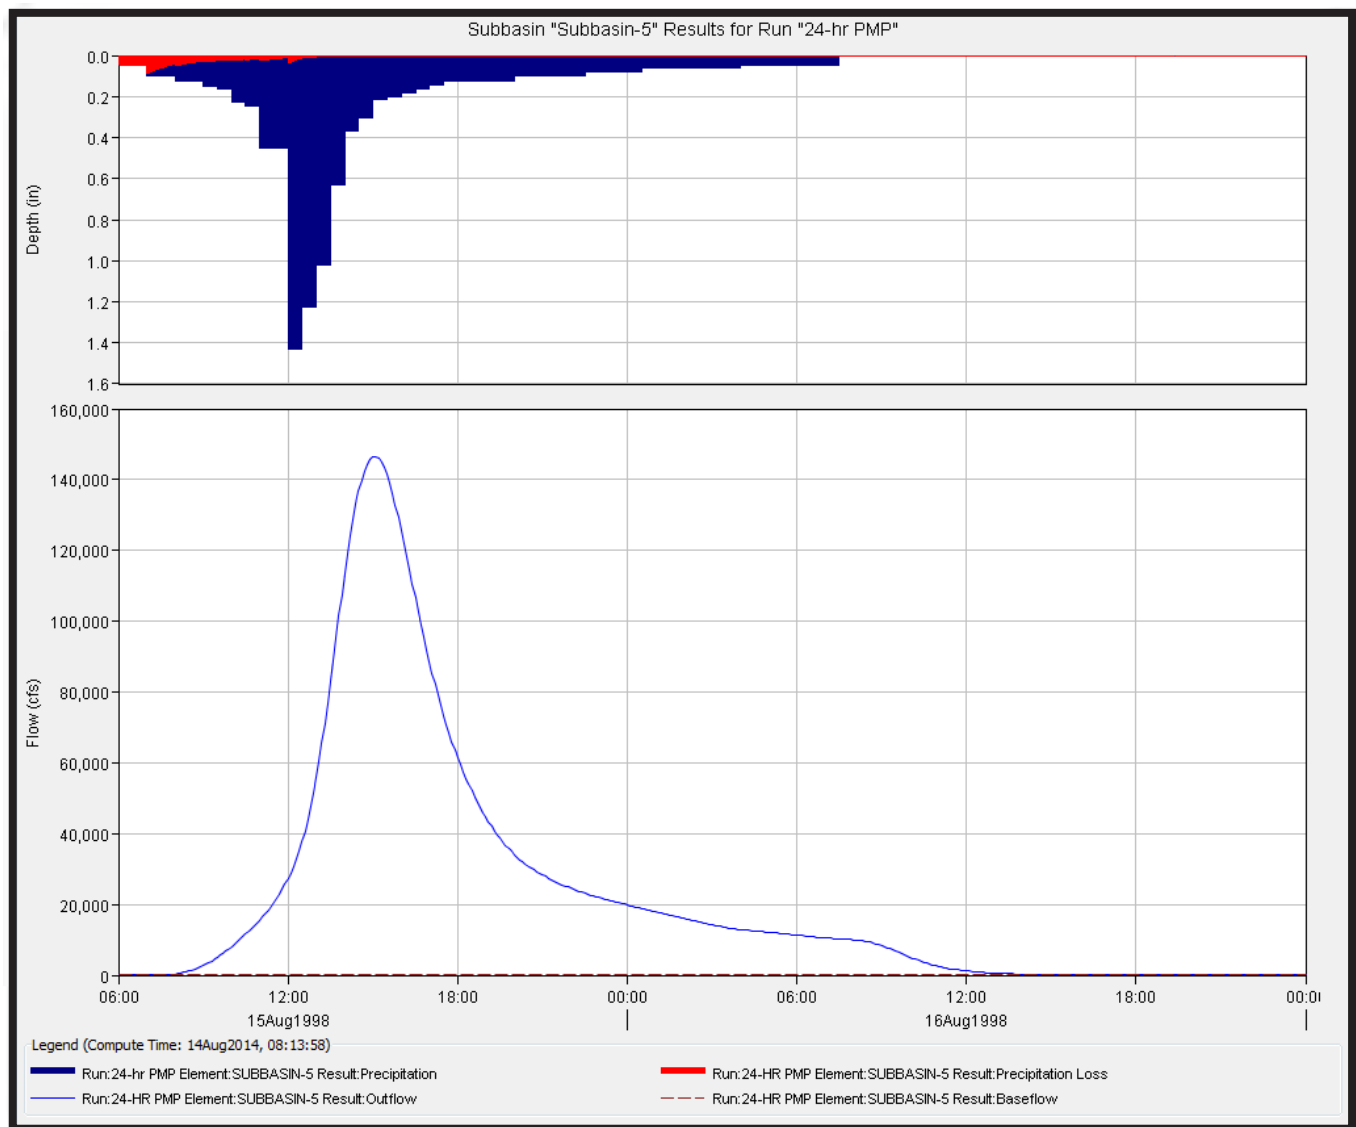
Figure 1–14. Output hydrograph screenshot for subbasin 5 from the 24-hour probable maximum precipitation (PMP) event.

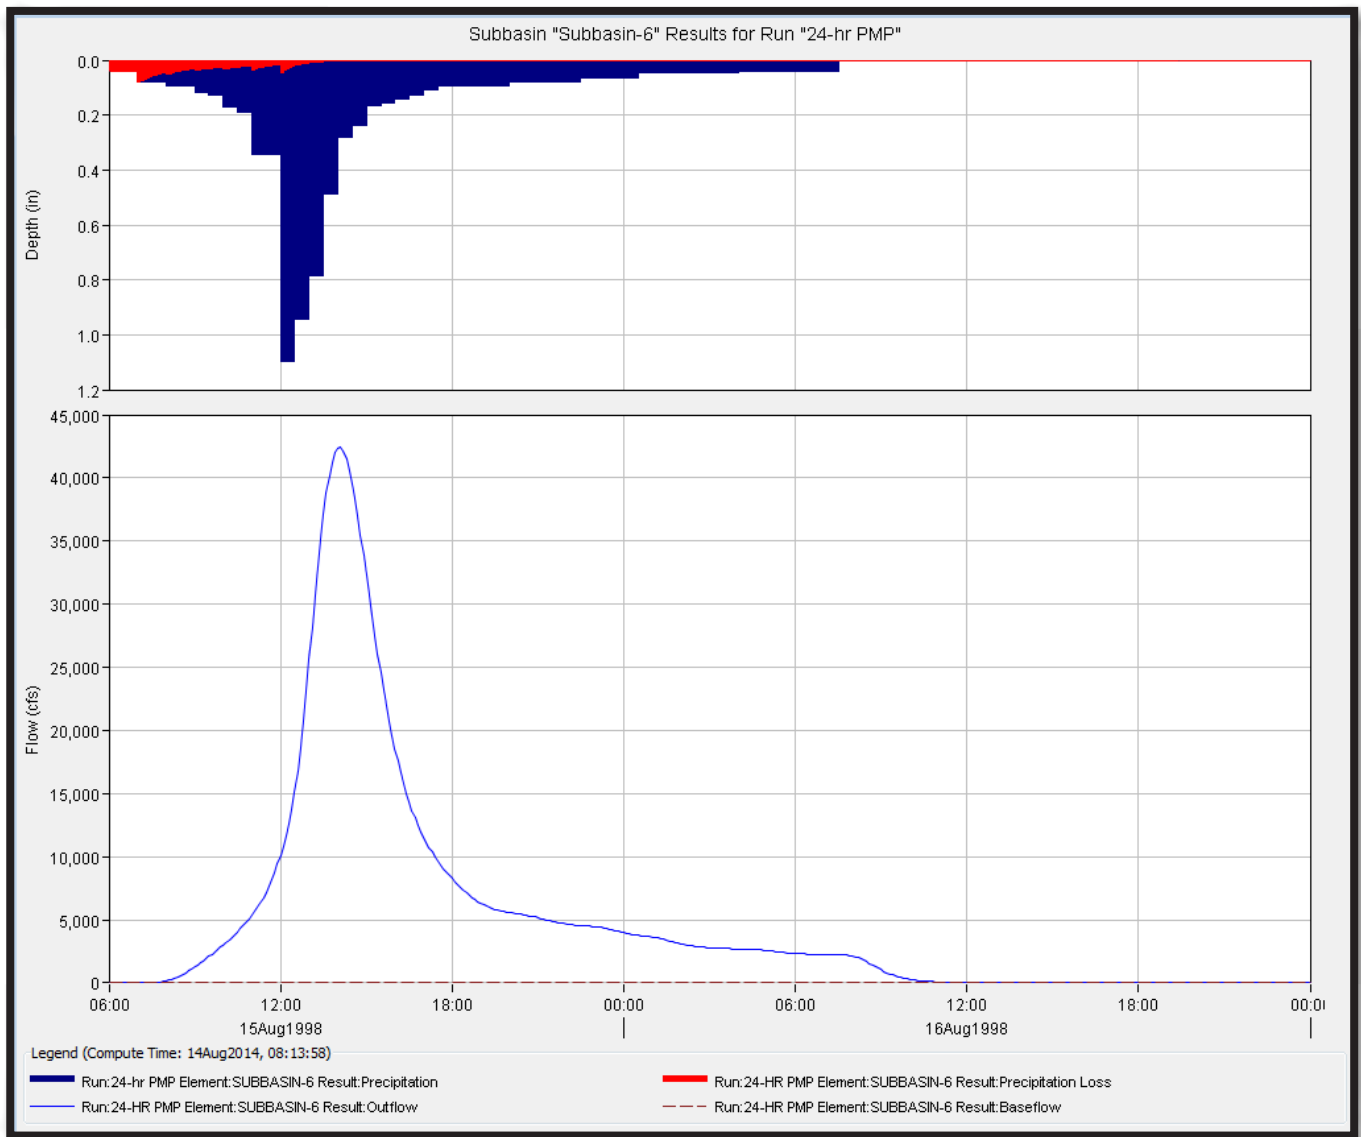
Figure 1–15. Output hydrograph screenshot for subbasin 6 from the 24-hour probable maximum precipitation (PMP) event.
