Prepared in cooperation with the Puerto Rico Electric Power Authority

Dam Failure Analysis for the Lago de Matrullas Dam, Orocovis, Puerto Rico

Scientific Investigations Report 2015–5065

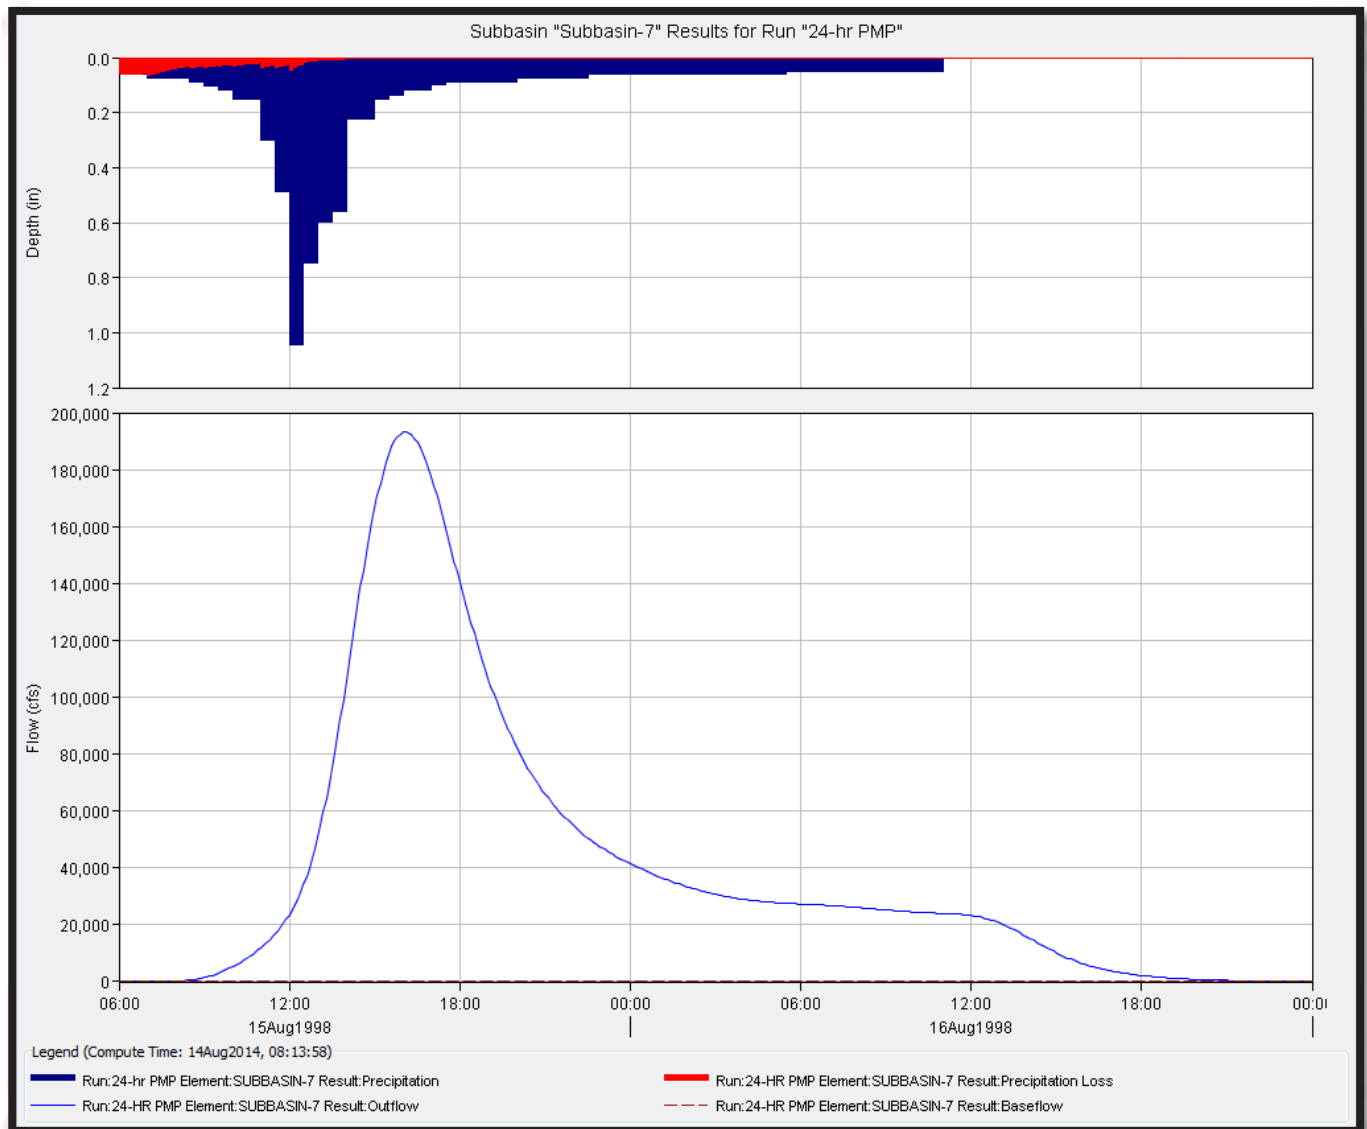
Figure 1–16. Output hydrograph screenshot for subbasin 7 from the 24-hour probable maximum precipitation (PMP) event.

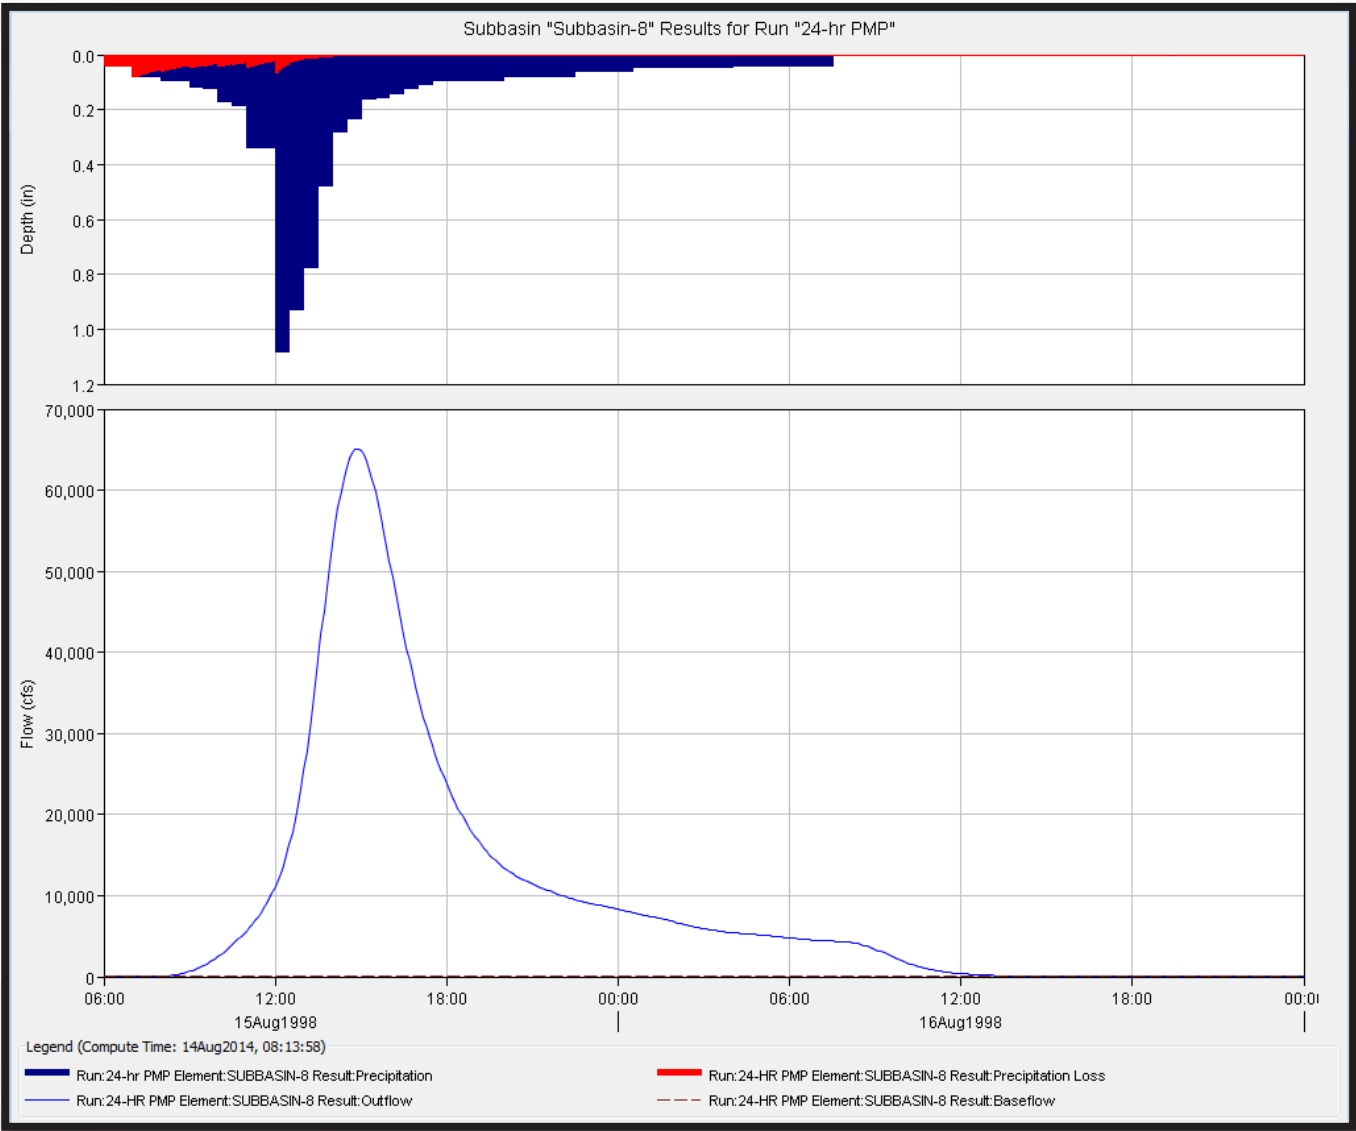
Figure 1–17. Output hydrograph screenshot for subbasin 8 from the 24-hour probable maximum precipitation (PMP) event.

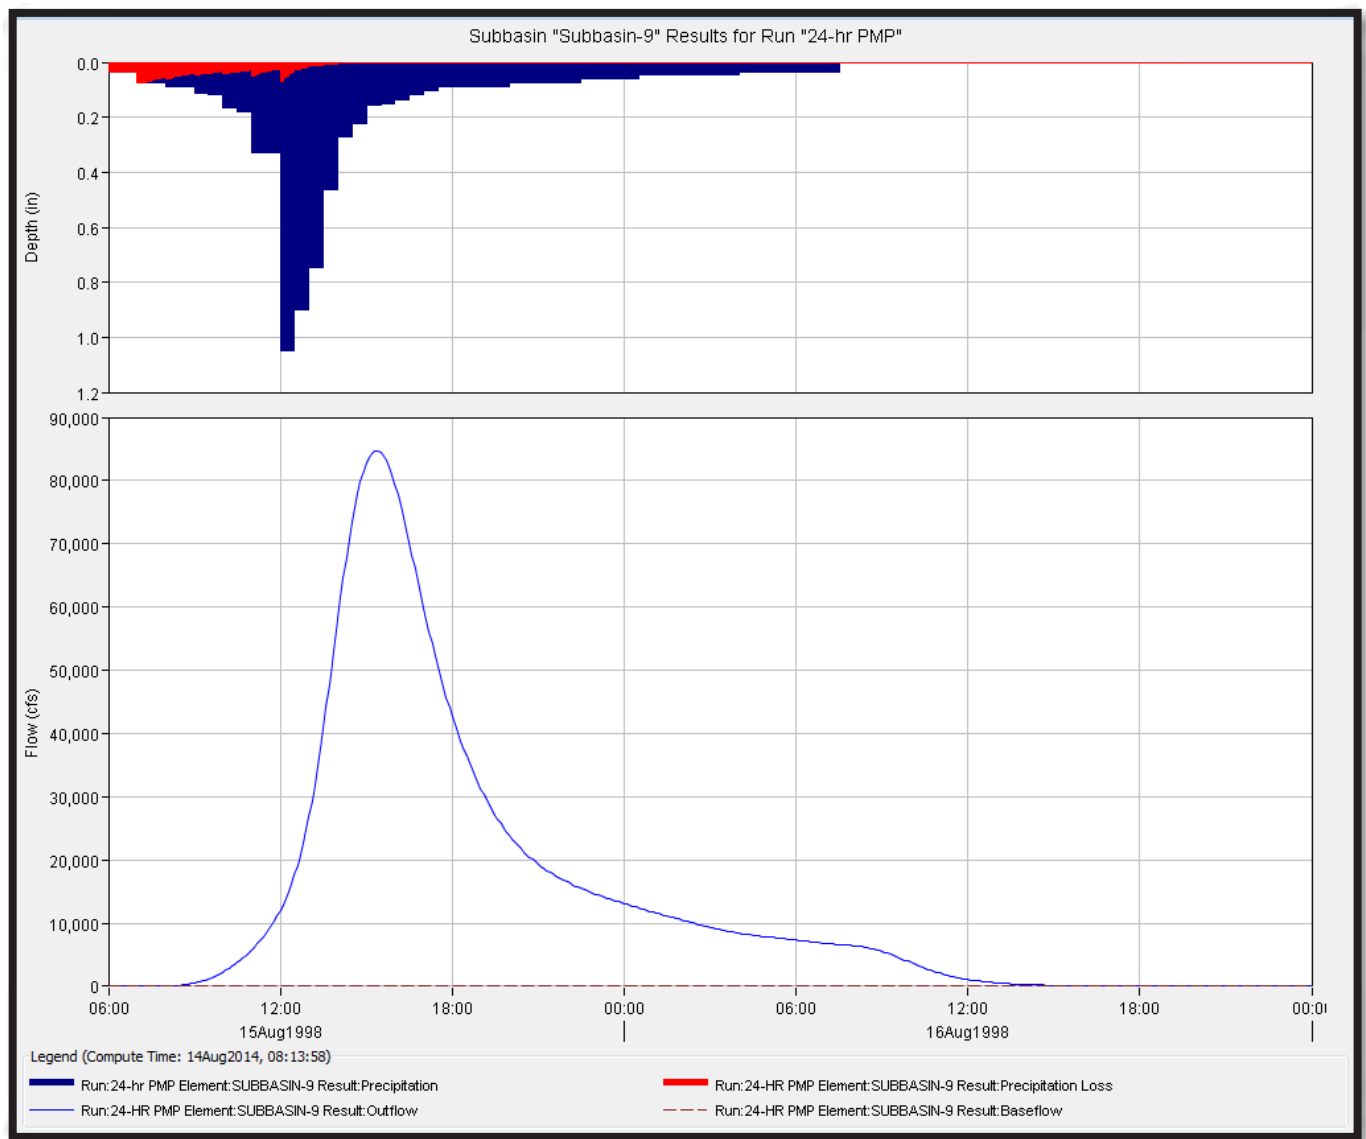
Figure 1–18. Output hydrograph screenshot for subbasin 9 from the 24-hour probable maximum precipitation (PMP) event.

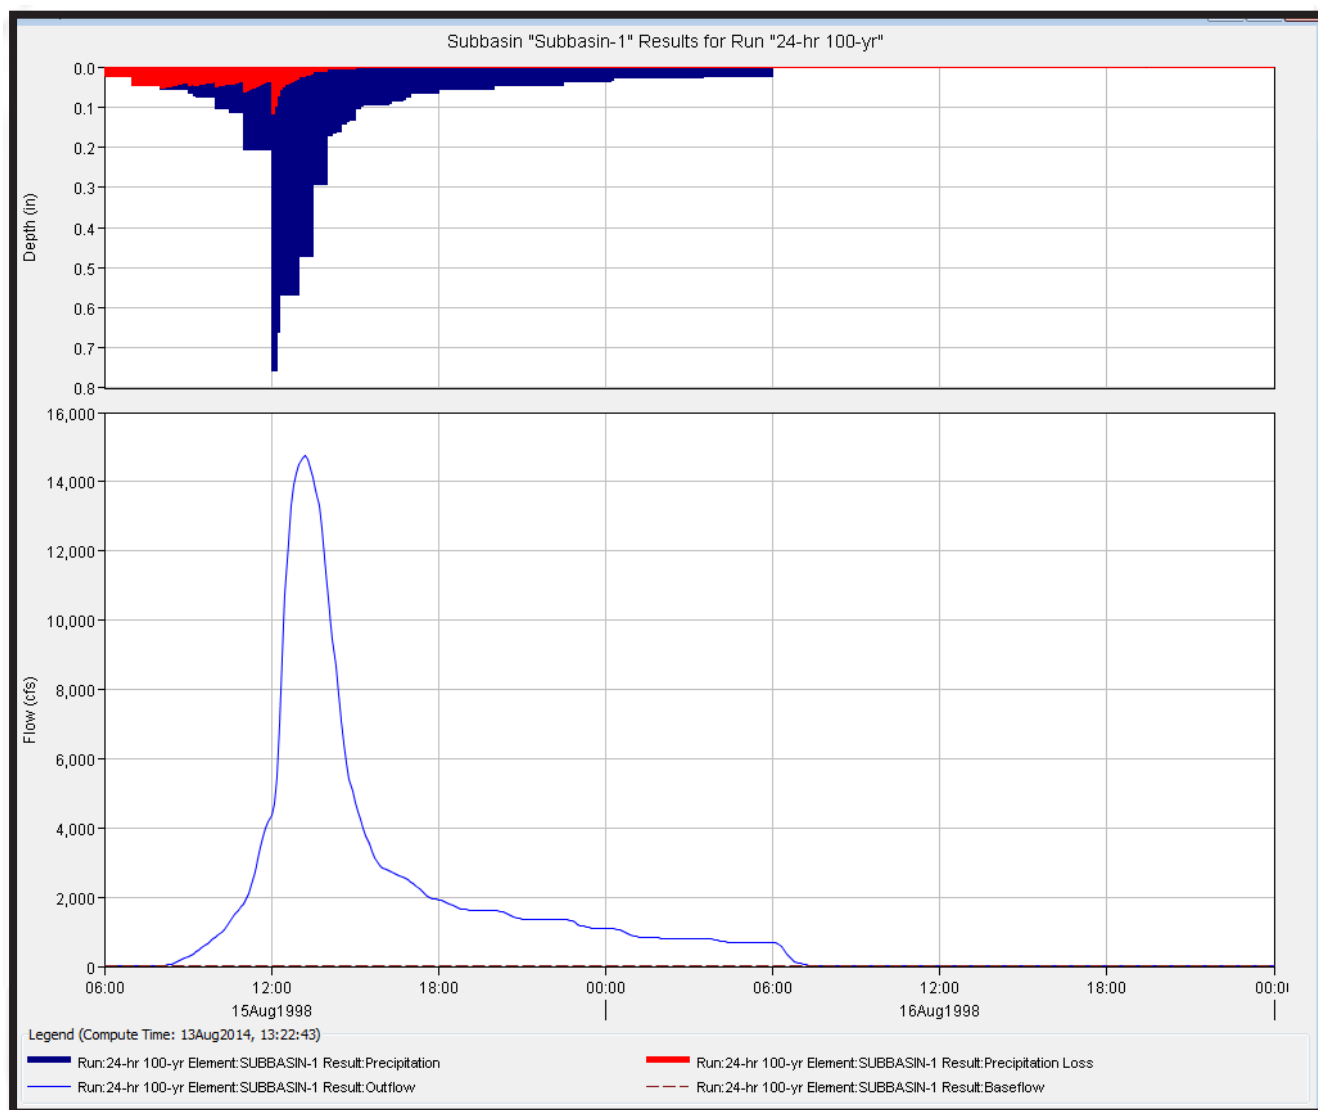
Figure 1–19. Output hydrograph screenshot for subbasin 1 from the 100-year-recurrence, 24-hour rainfall event.

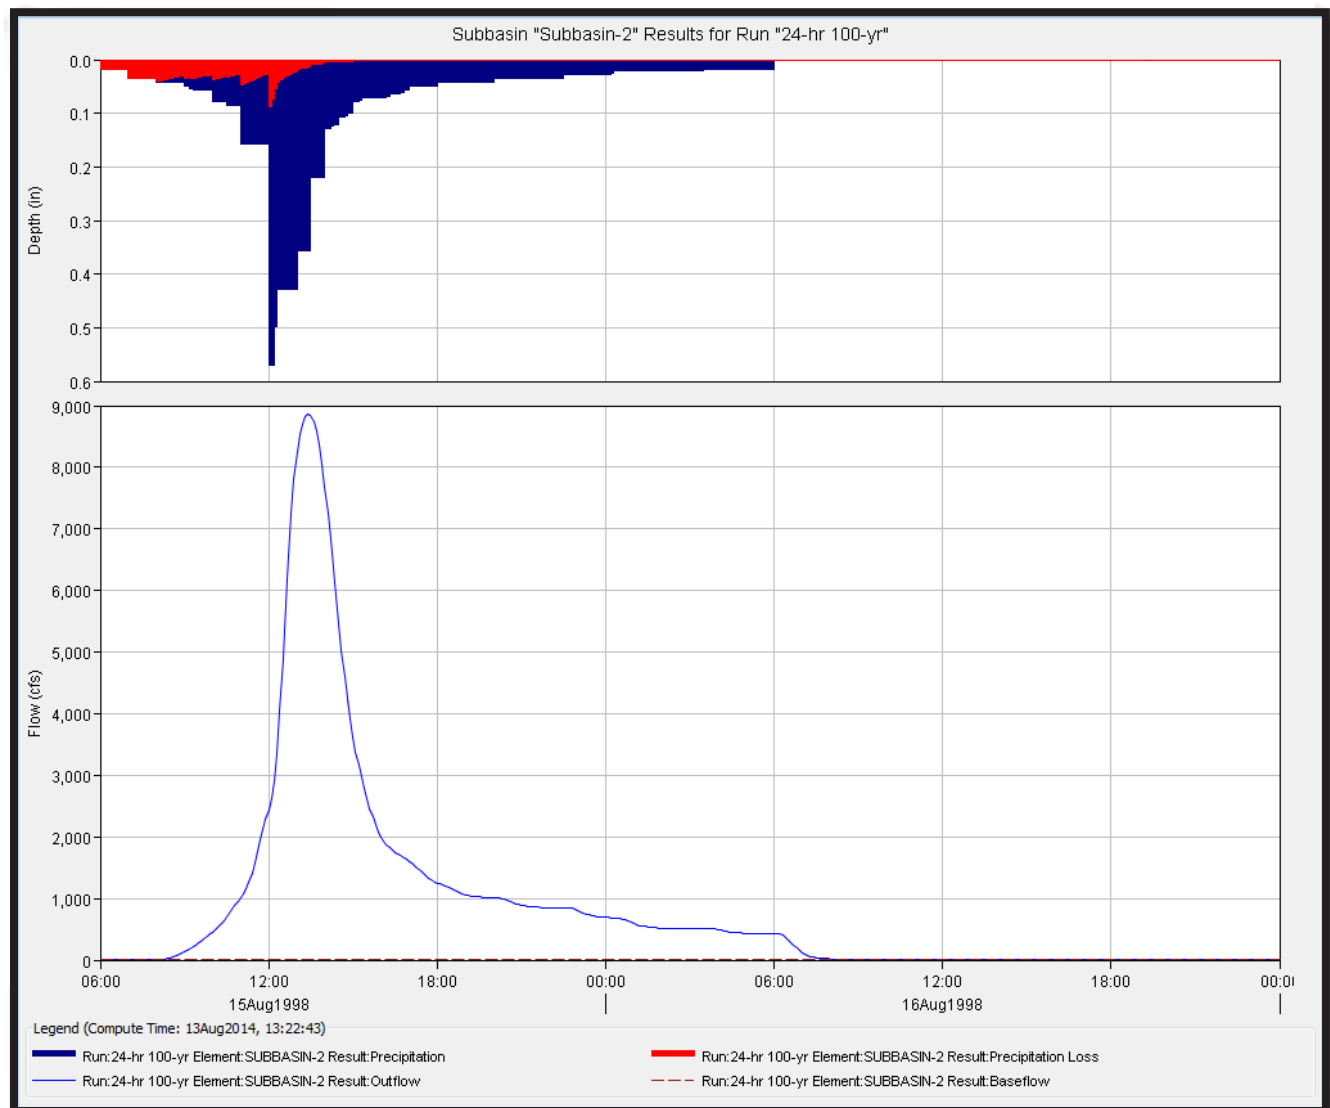
Figure 1–20. Output hydrograph screenshot for subbasin 2 from the 100-year-recurrence, 24-hour rainfall event.

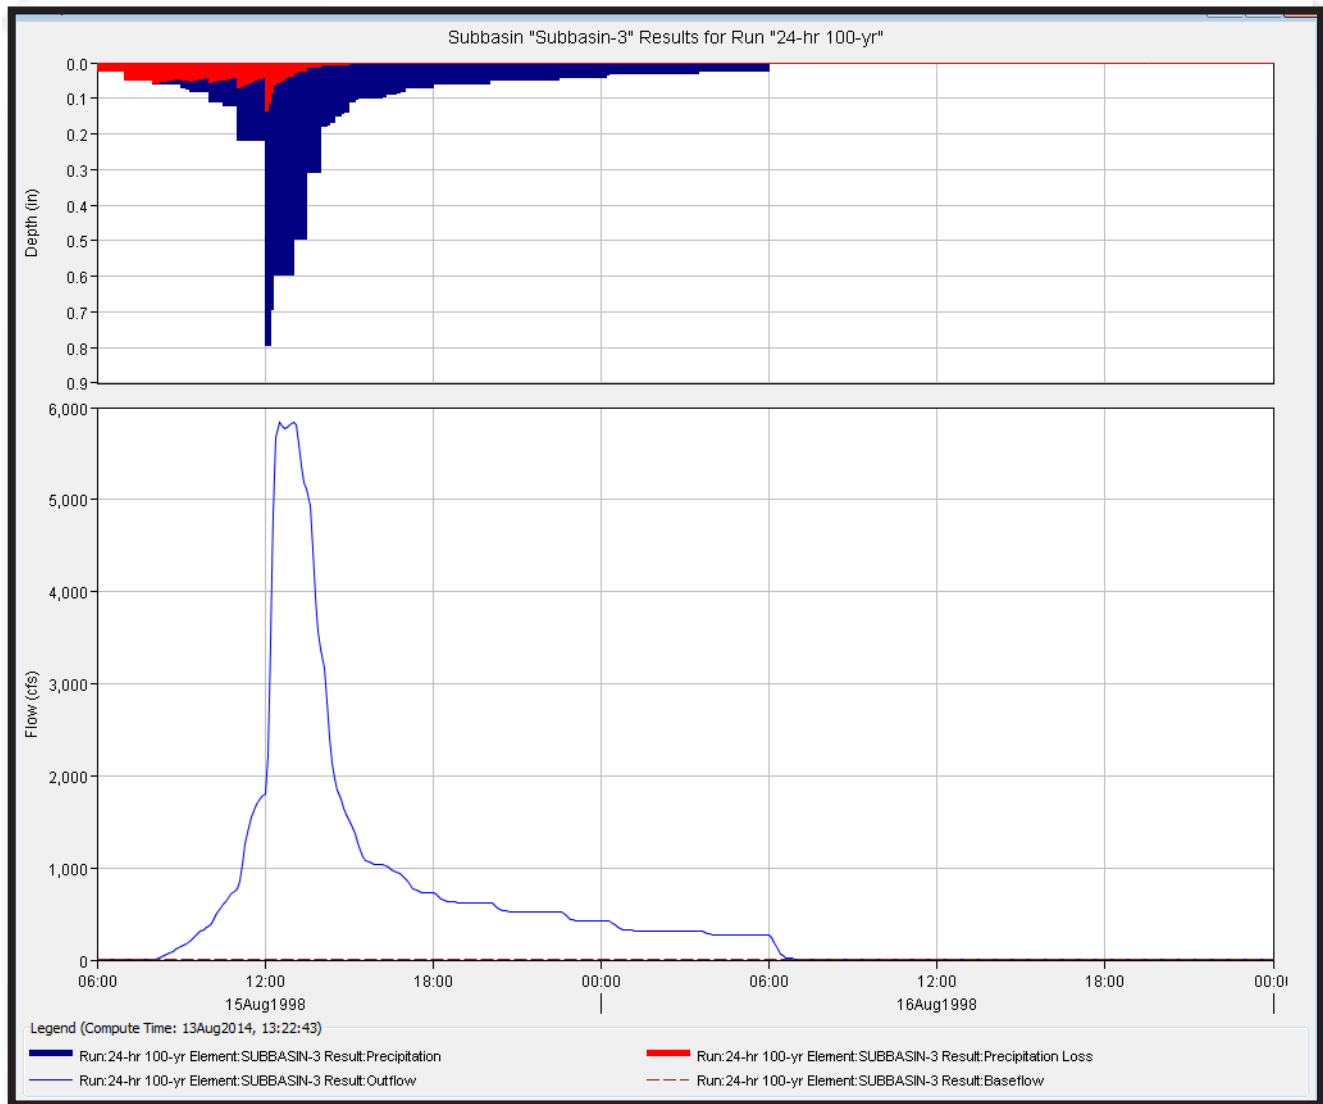
Figure 1–21. Output hydrograph screenshot for subbasin 3 from the 100-year-recurrence, 24-hour rainfall event.

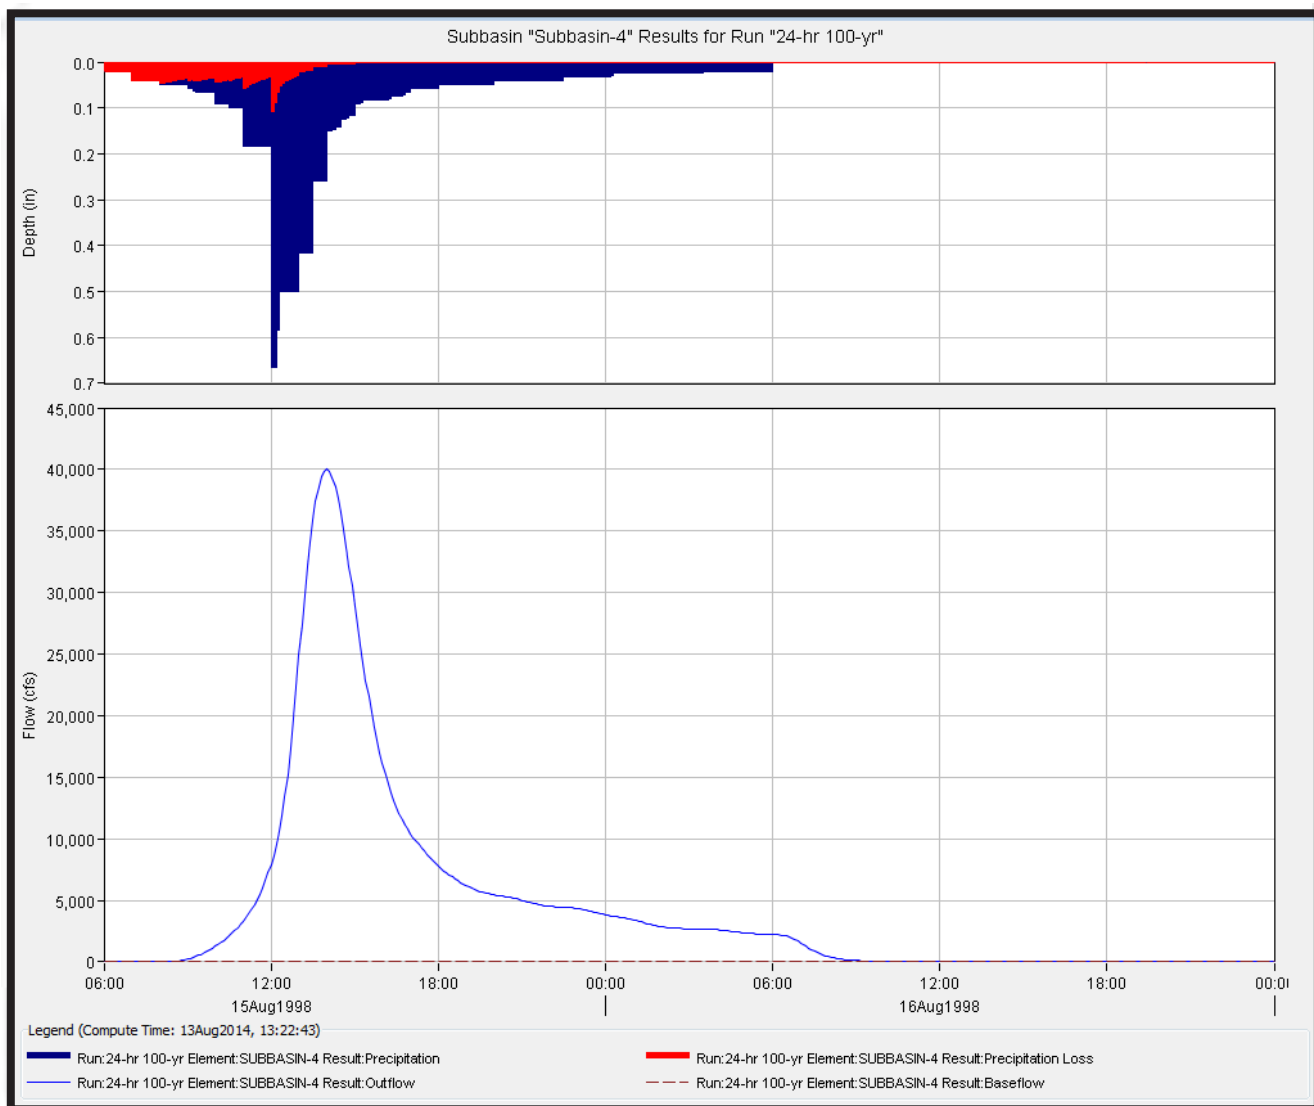
Figure 1–22. Output hydrograph screenshot for subbasin 4 from the 100-year-recurrence, 24-hour rainfall event.

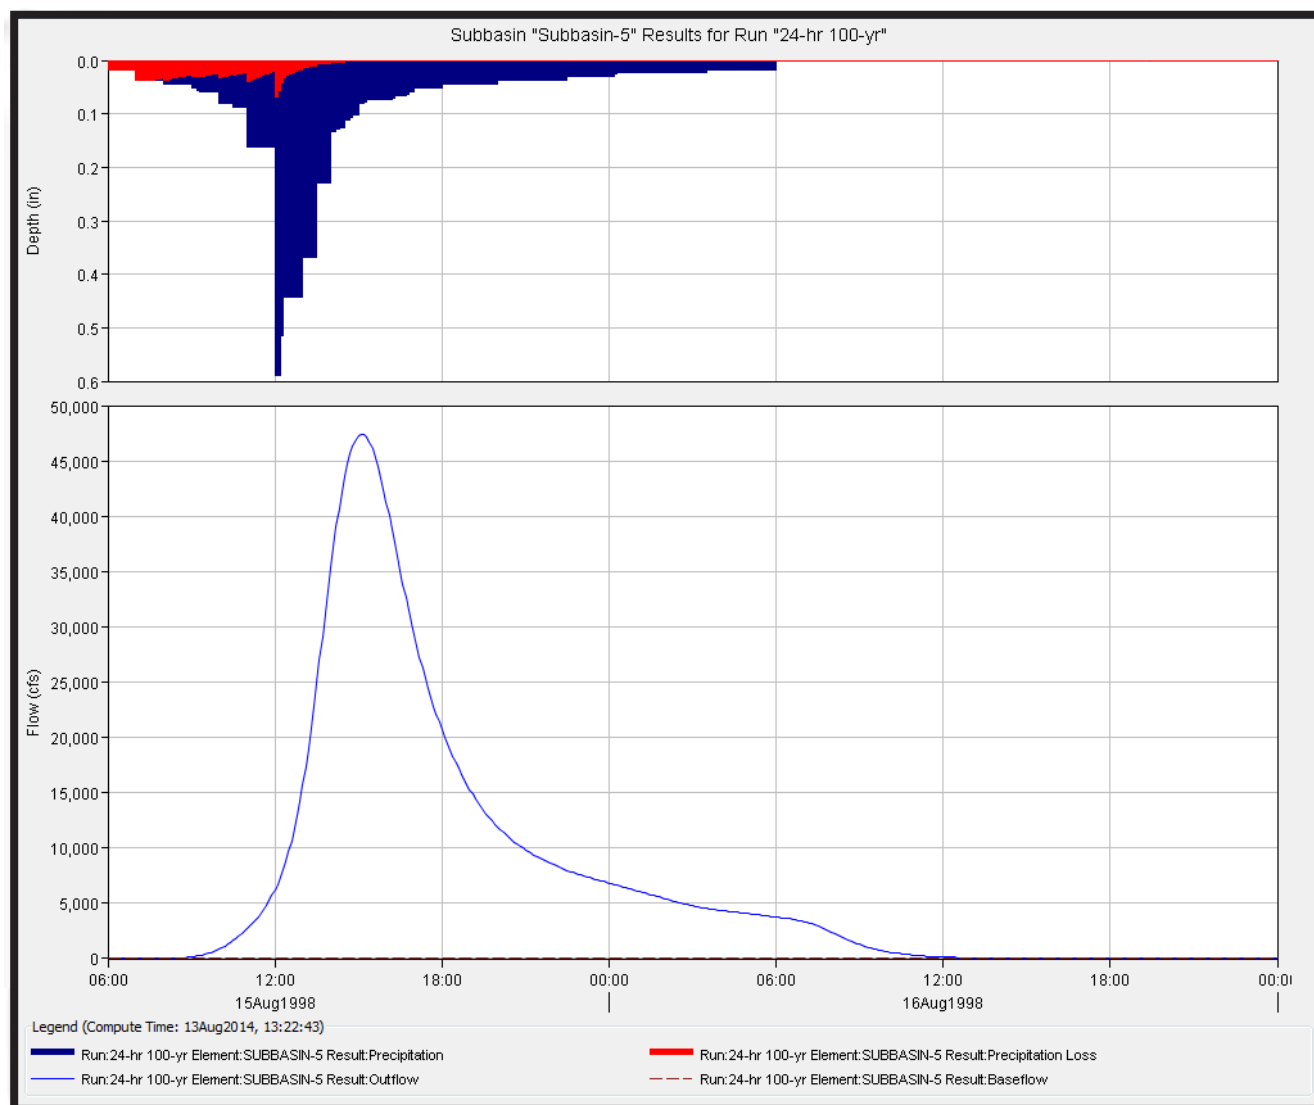
Figure 1–23. Output hydrograph screenshot for subbasin 5 from the 100-year-recurrence, 24-hour rainfall event.

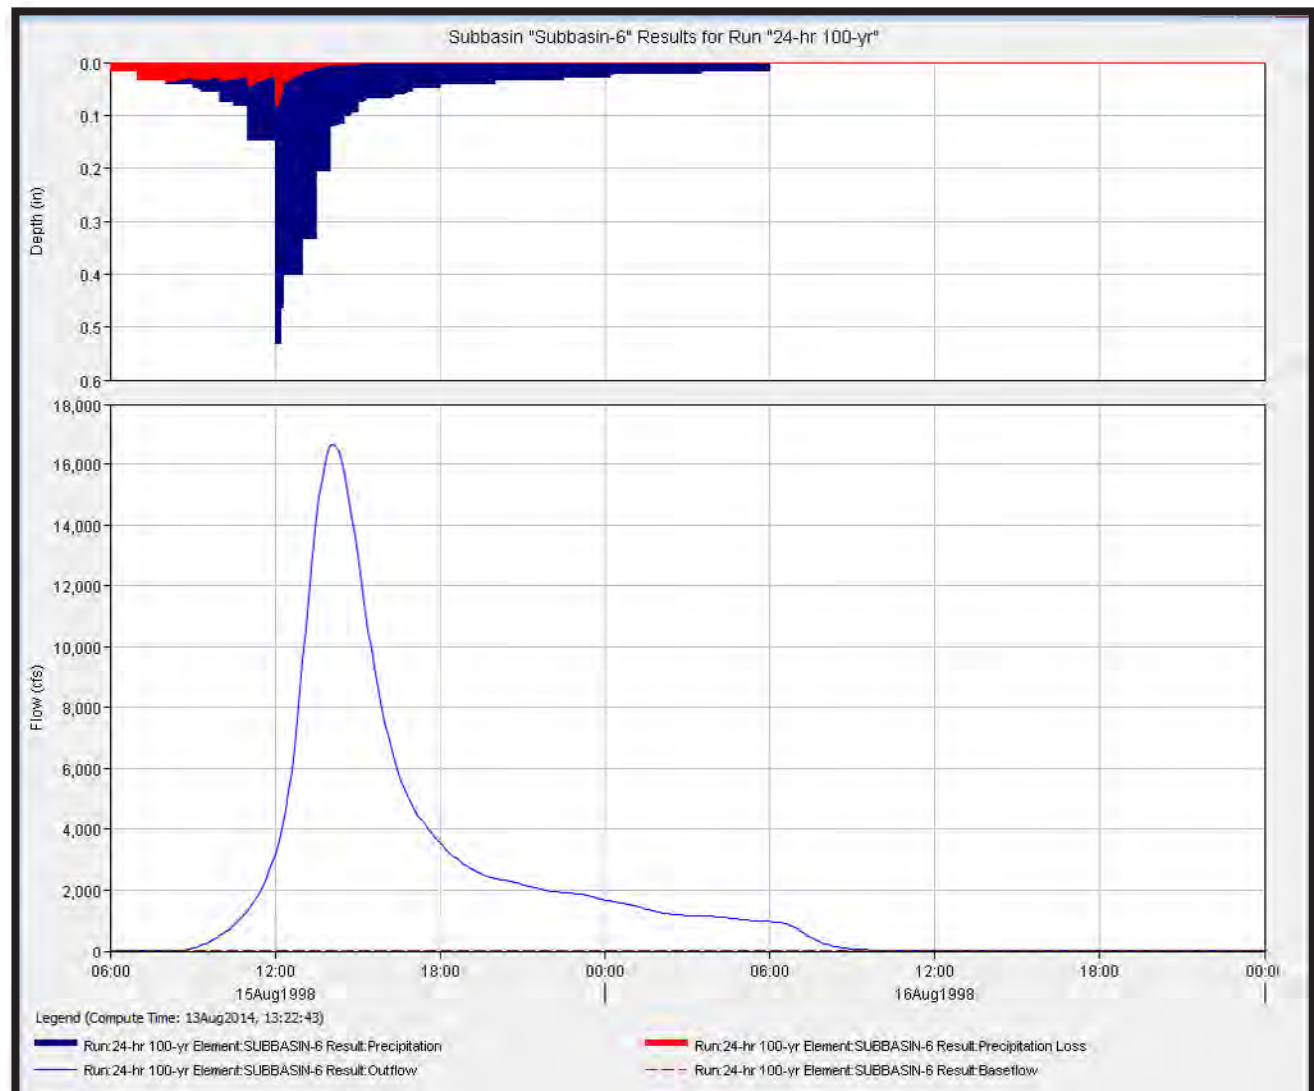
Figure 1–24. Output hydrograph screenshot for subbasin 6 from the 100-year-recurrence, 24-hour rainfall event.

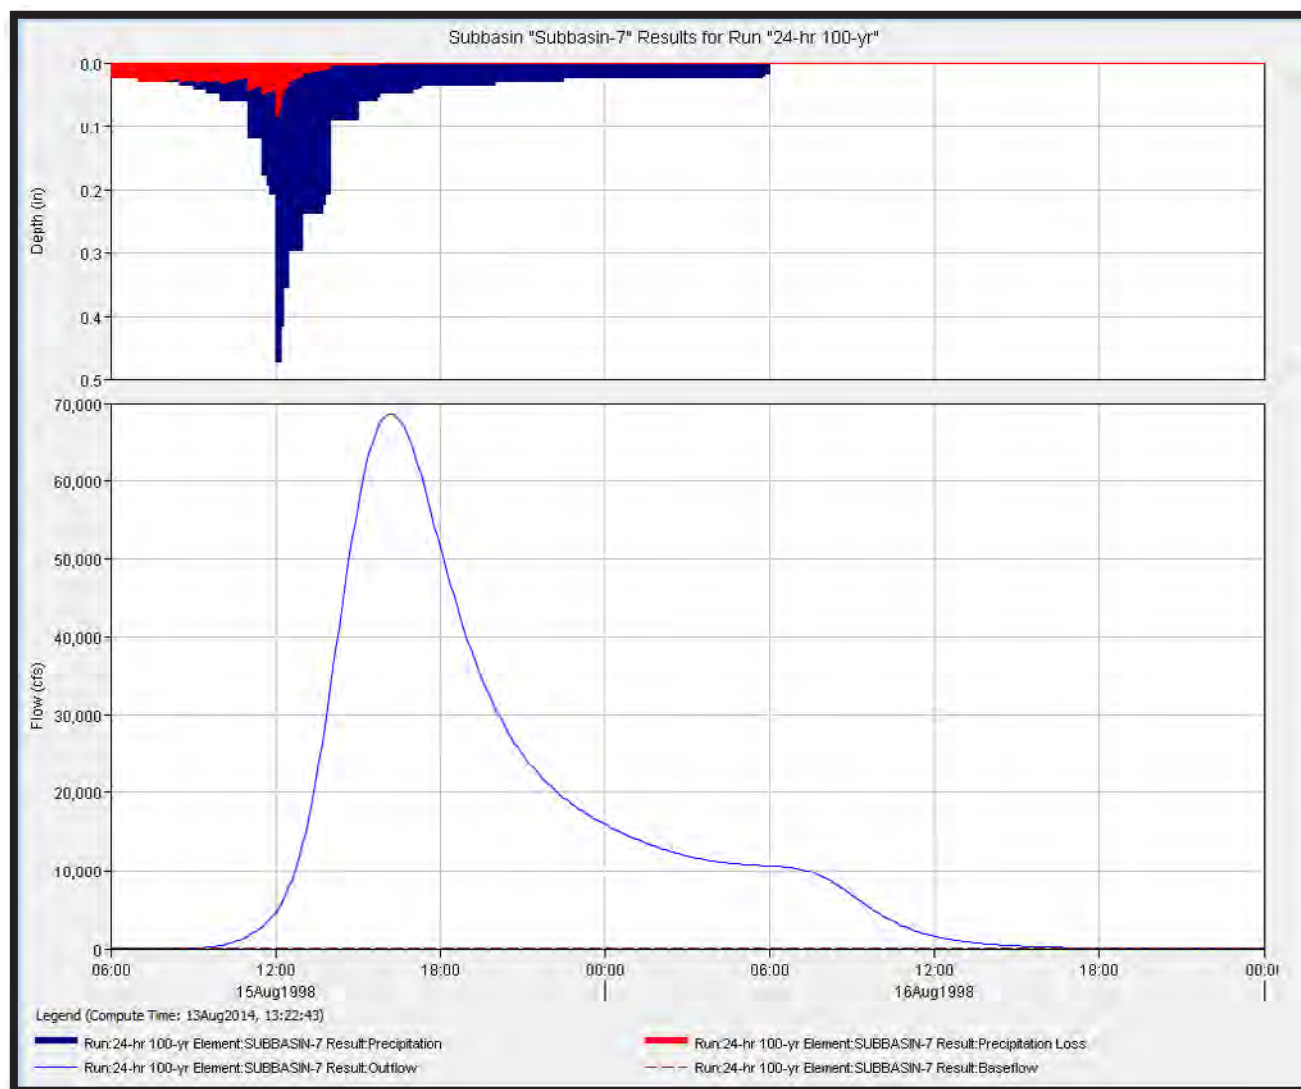
Figure 1–25. Output hydrograph screenshot for subbasin 7 from the 100-year-recurrence, 24-hour rainfall event.

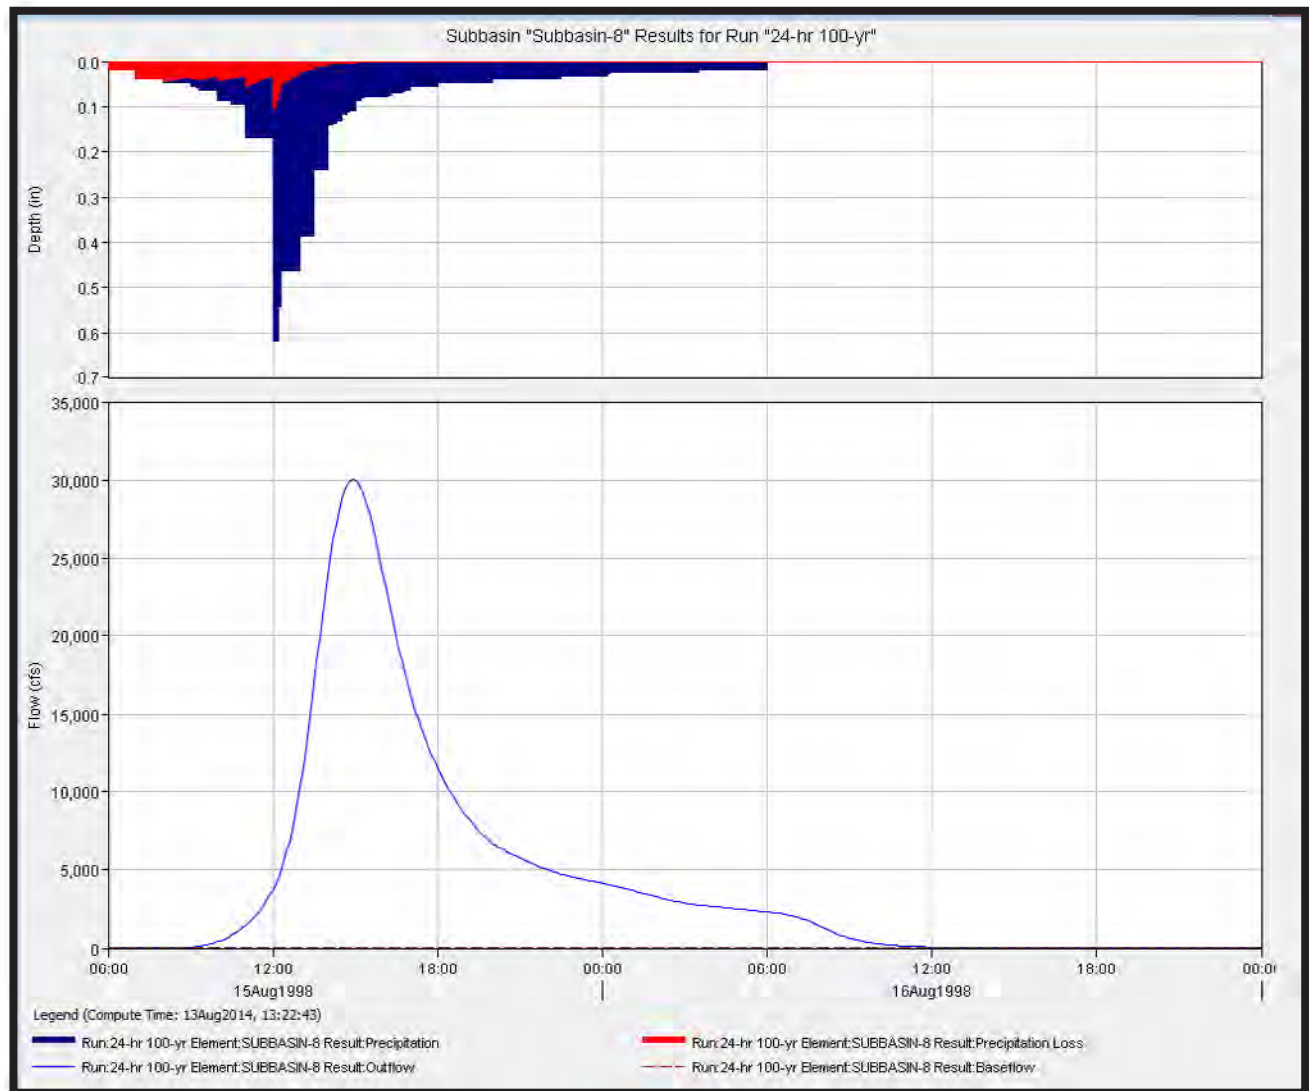
Figure 1-26. Output hydrograph screenshot for subbasin 8 from the 100-year-recurrence, 24-hour rainfall event.

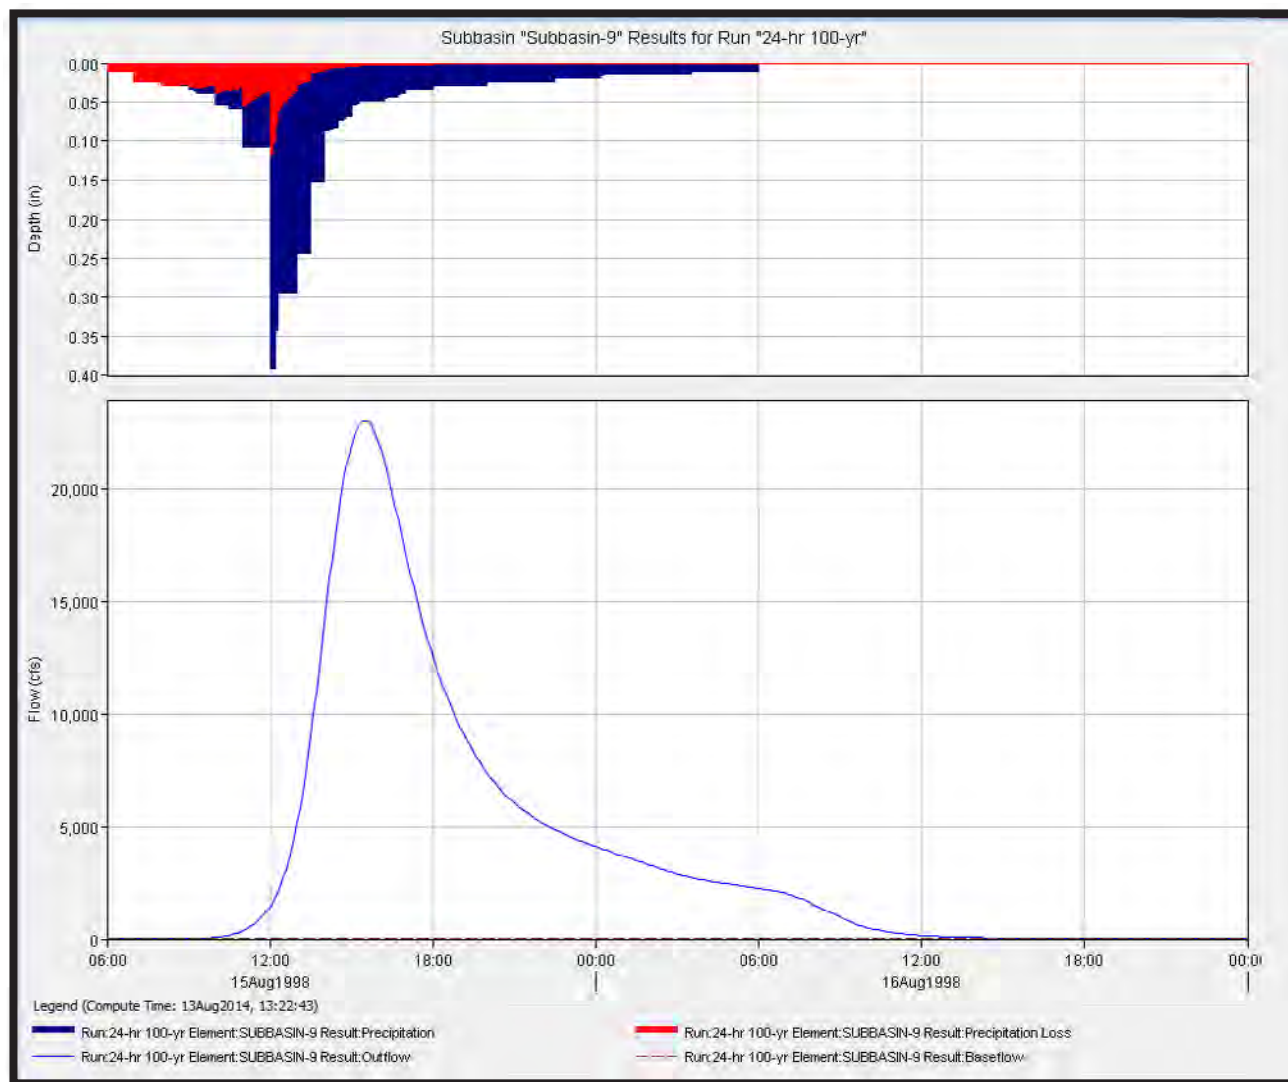
Figure 1–27. Output hydrograph screenshot for subbasin 9 from the 100-year-recurrence, 24-hour rainfall event.
