# Hydrology and Geomorphology of the Taiya River Near the West Creek Tributary, Southeast Alaska

Scientific Investigations Report 2020–5059

By Janet H. Curran

Prepared in cooperation with the National Park Service

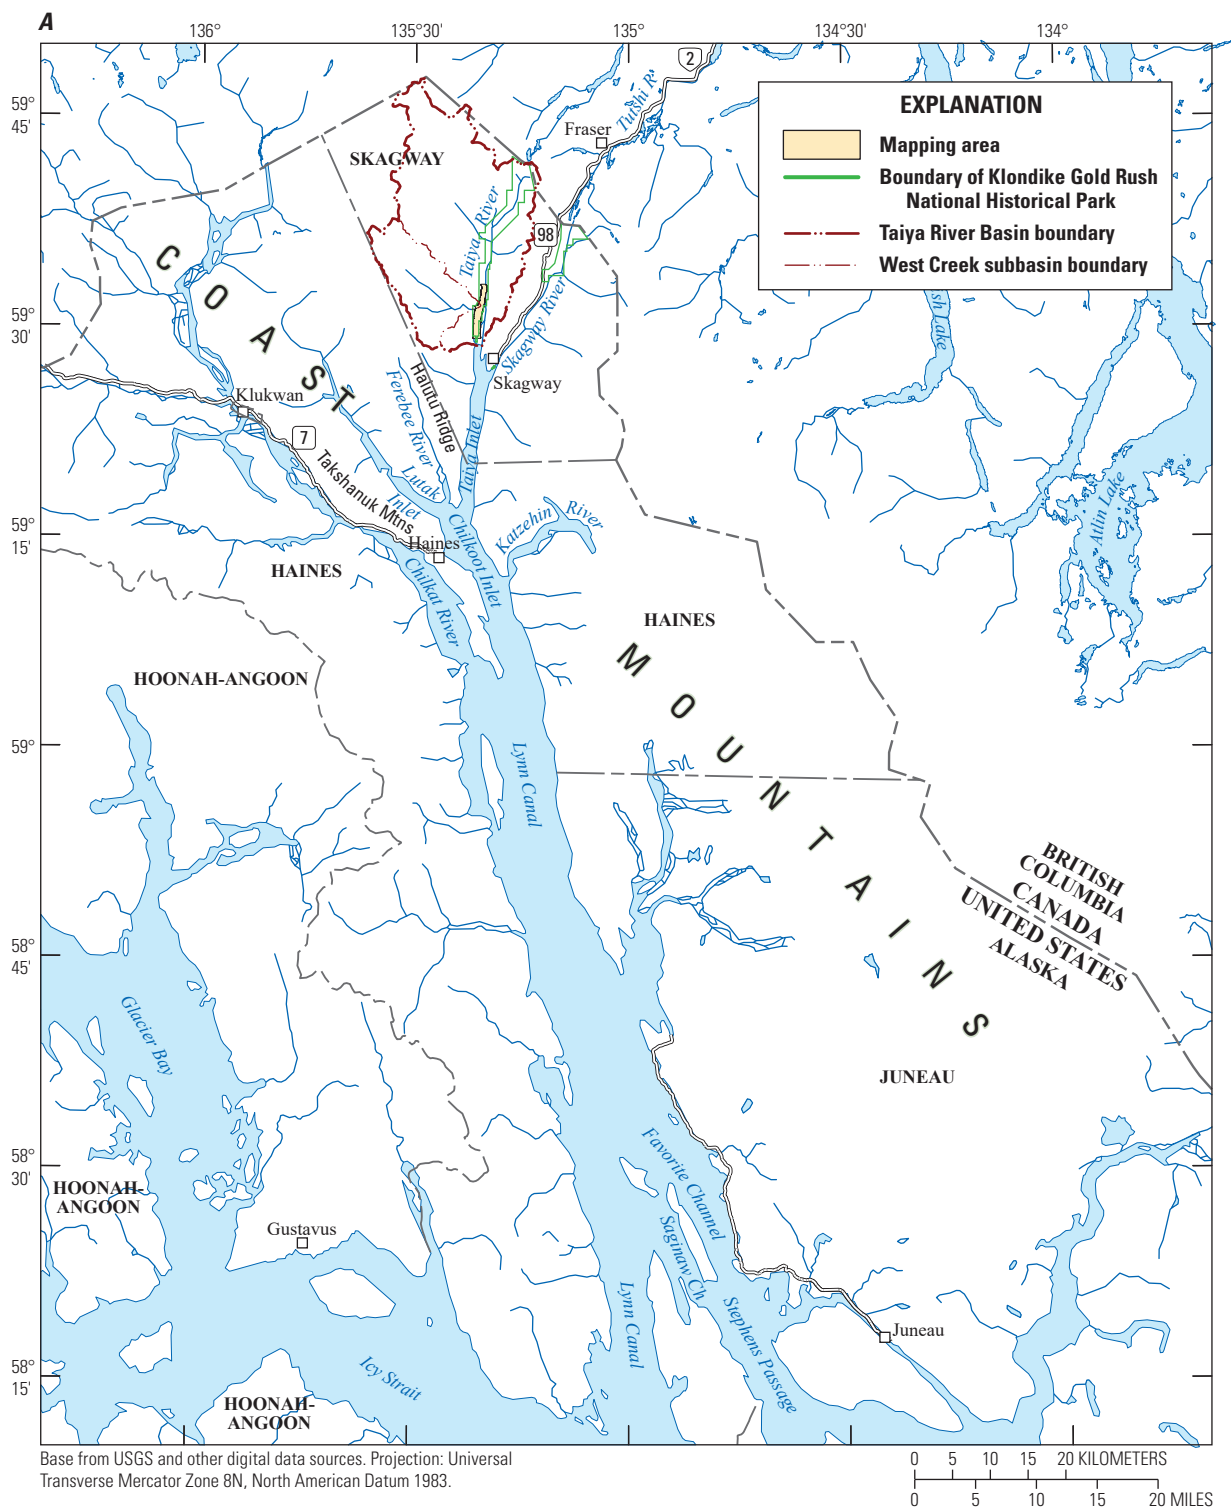
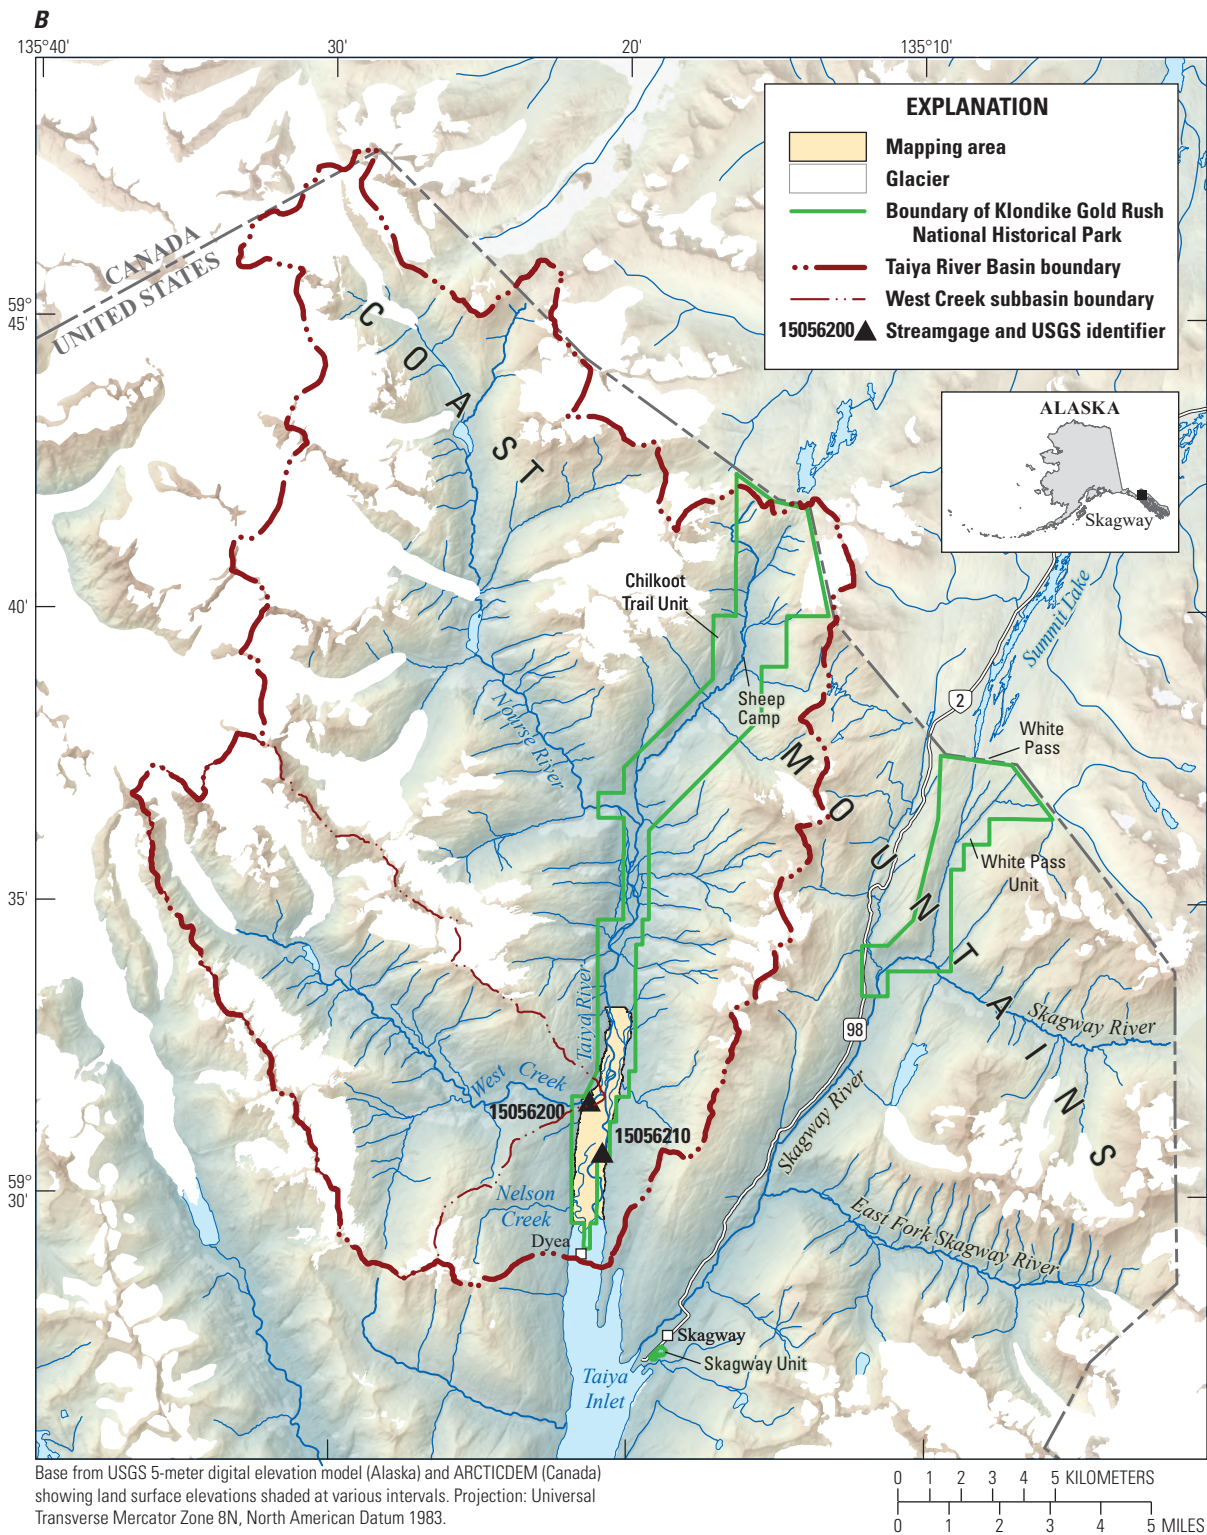
**Figure 1.** A, Taiya River Basin and Lynn Canal, southeast Alaska, and, B, Taiya River Basin and West Creek subbasin drainage basins, Klondike Gold Rush National Historical Park, mapping area, and selected streamgages, southeast Alaska. [USGS, U.S. Geological Survey]

Figure 1.—Continued

On July 23, 2002, a lateral moraine at the confluence of the two glacial valleys at the head of West Creek (fig. 1B), along with a section of the partly saturated, outwash-filled eastern tributary valley behind it, failed and discharged sediment-rich flow over the toe of the glacier and into the adjacent pro-glacial lake below (fig. 10A, B, and C) (Capps, 2004, Denton and others, 2005). The resulting outburst flood damaged property near the West Creek confluence and prompted the evacuation of the NPS campground along the Taiya River (fig. 10D and E, respectively). The outburst flood discharge

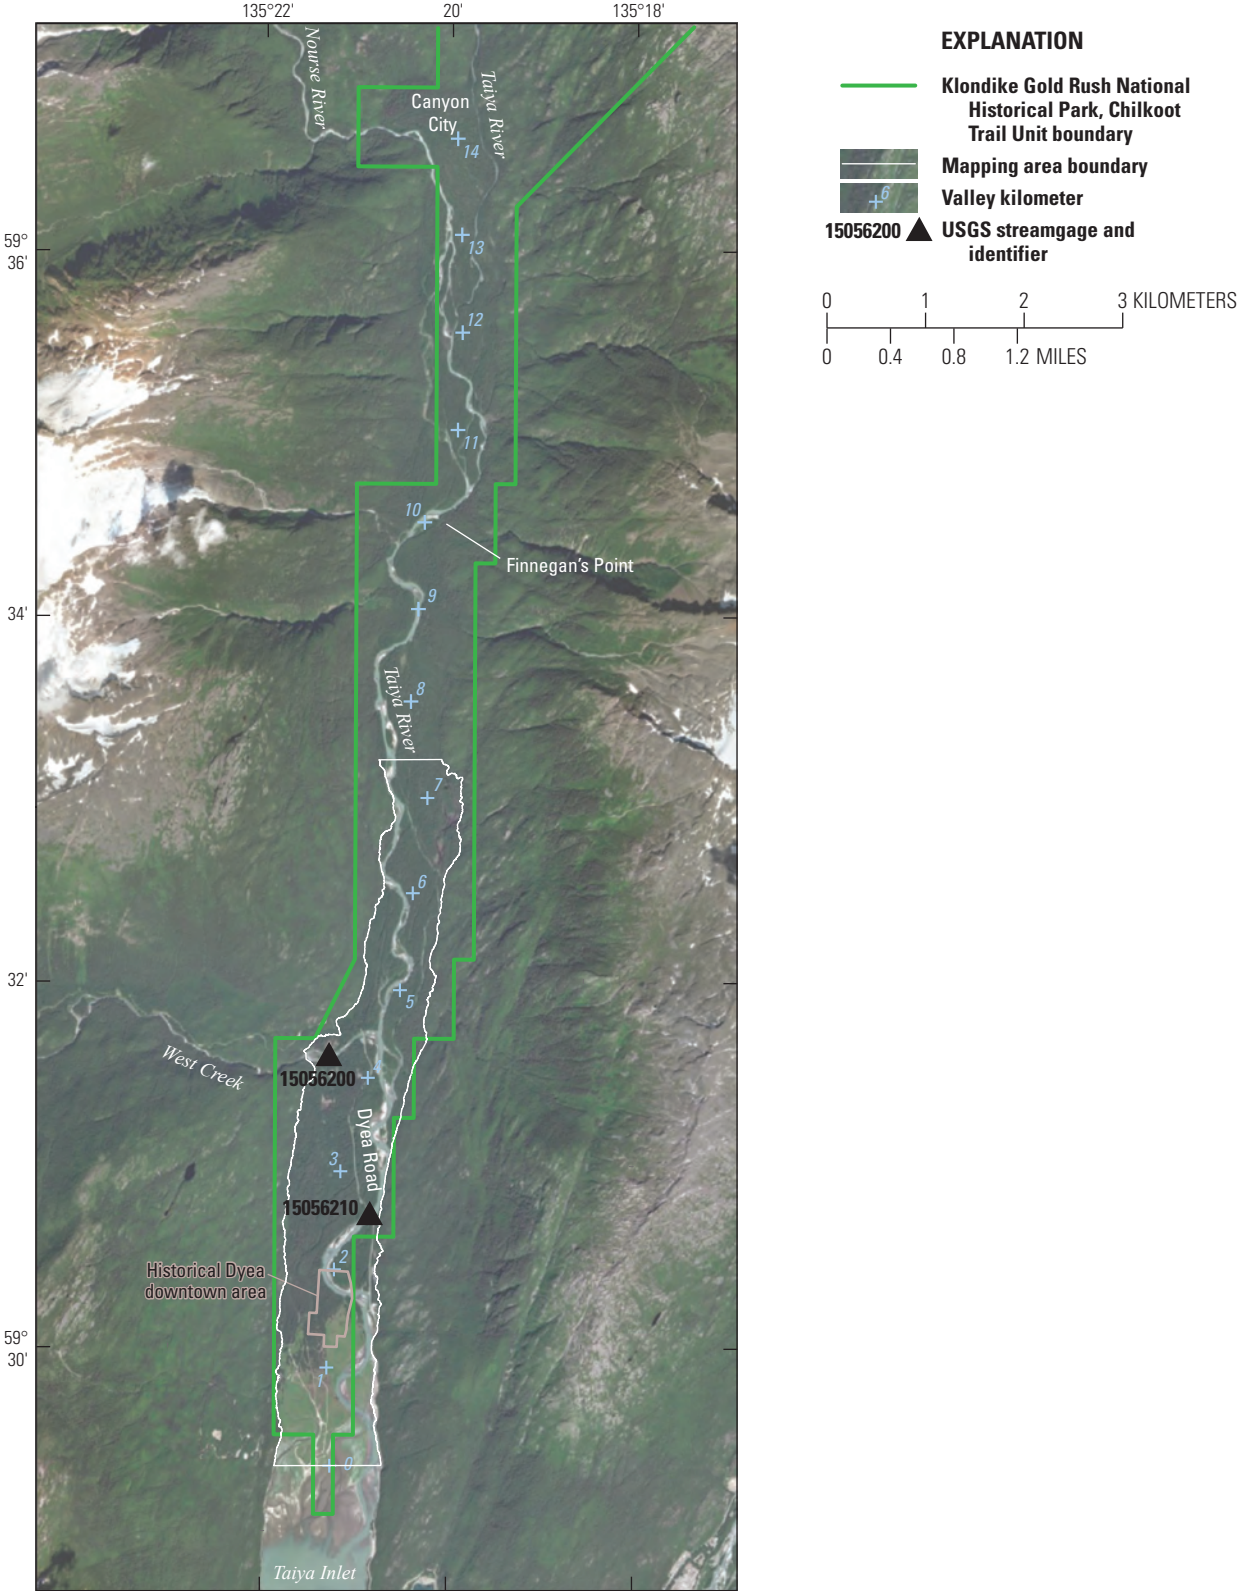
Figure 2. Main stem Taiya River valley bottom and mapping area, Alaska. [USGS, U.S. Geological Survey]

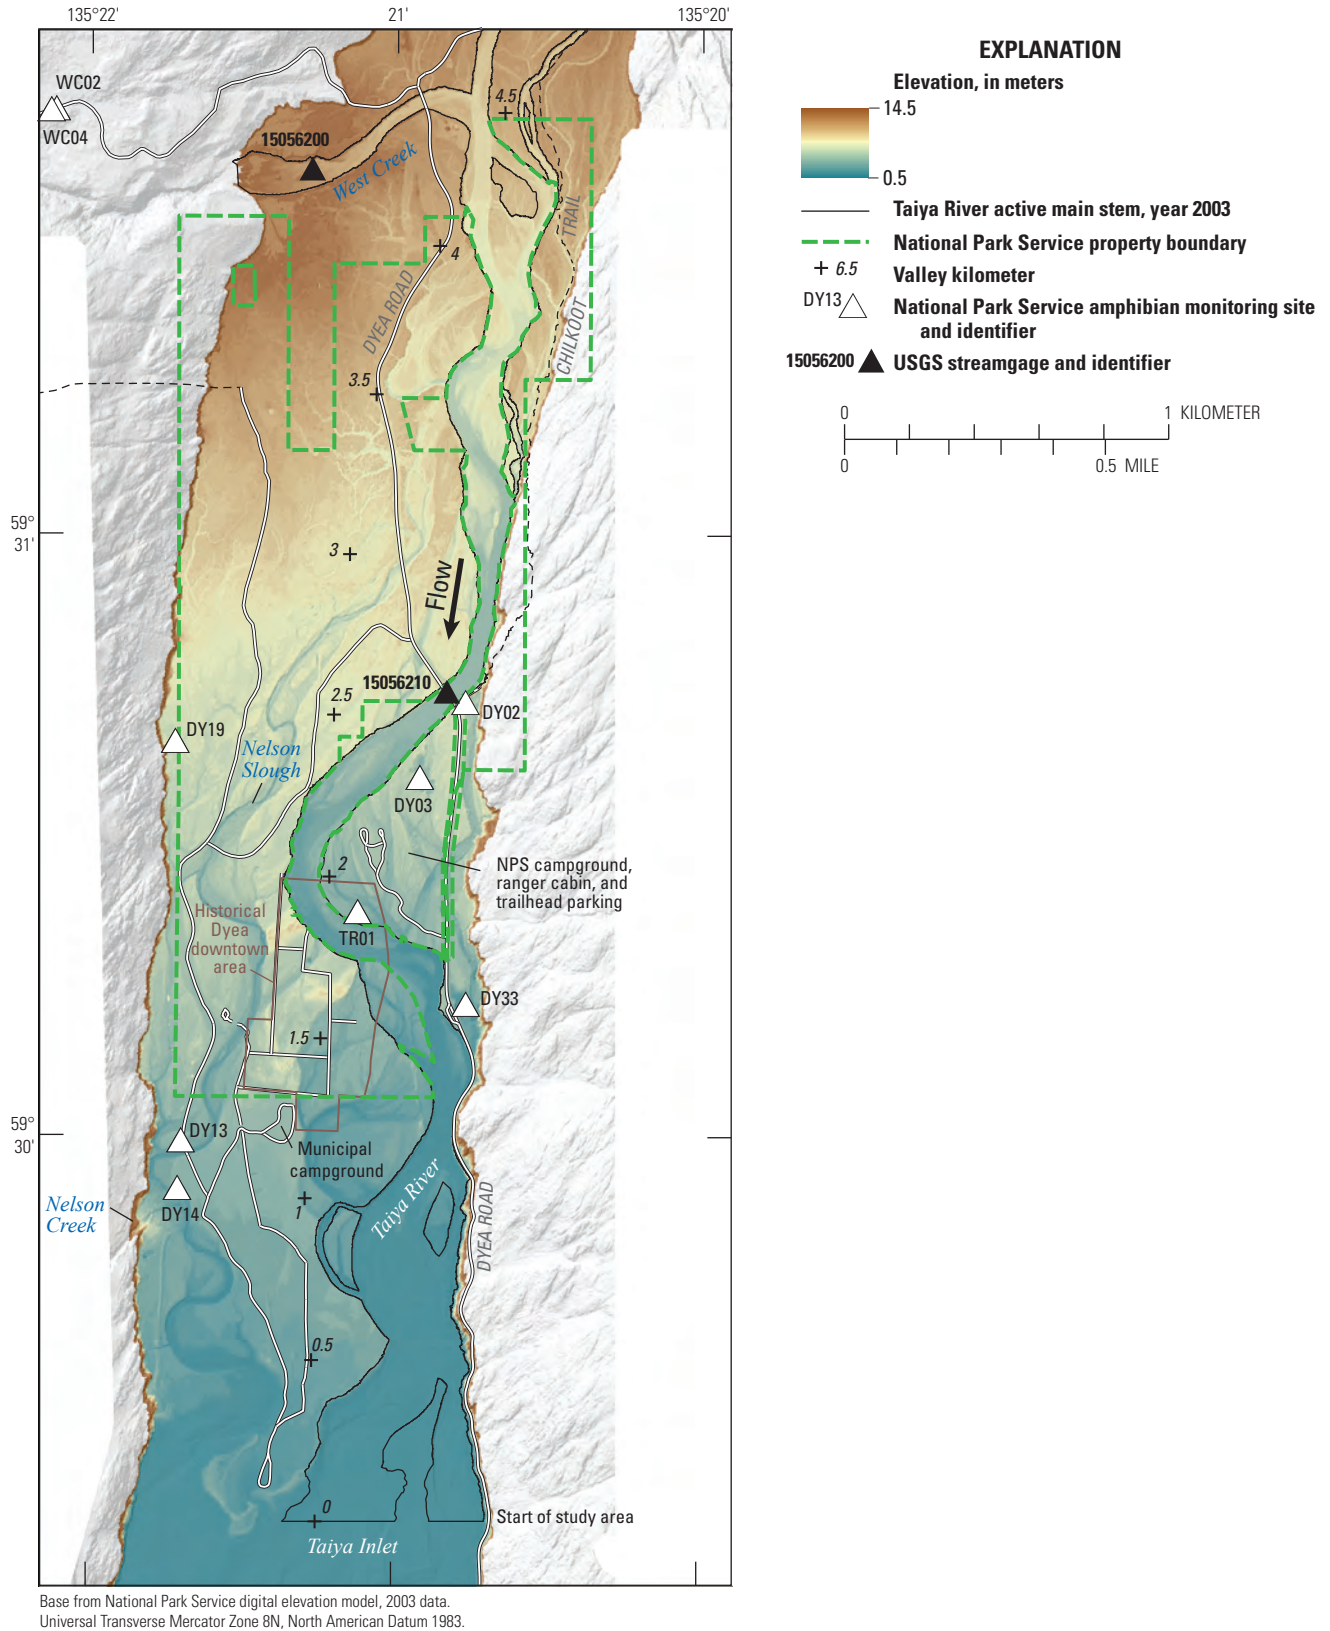
**Figure 3.** Elevation and locations of features within the most developed part of the main stem Taiya River valley bottom, Alaska. [USGS, U.S. Geological Survey]

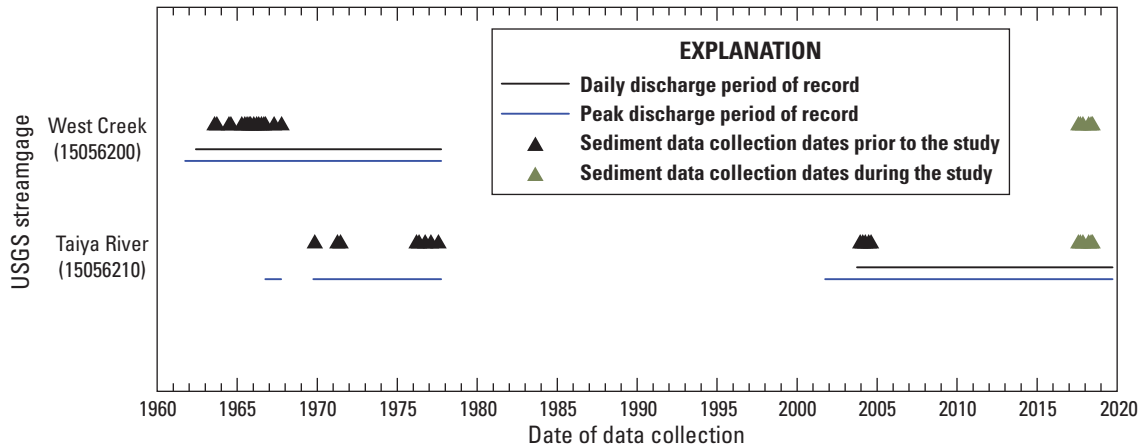
**Figure 4.** Dates for periods of daily discharge and peak discharge record, and dates of suspended sediment sampling, through water year 2019 at U.S. Geological Survey streamgages at West Creek (15056200) and the Taiya River (15056210), Alaska. [USGS, U.S. Geological Survey]

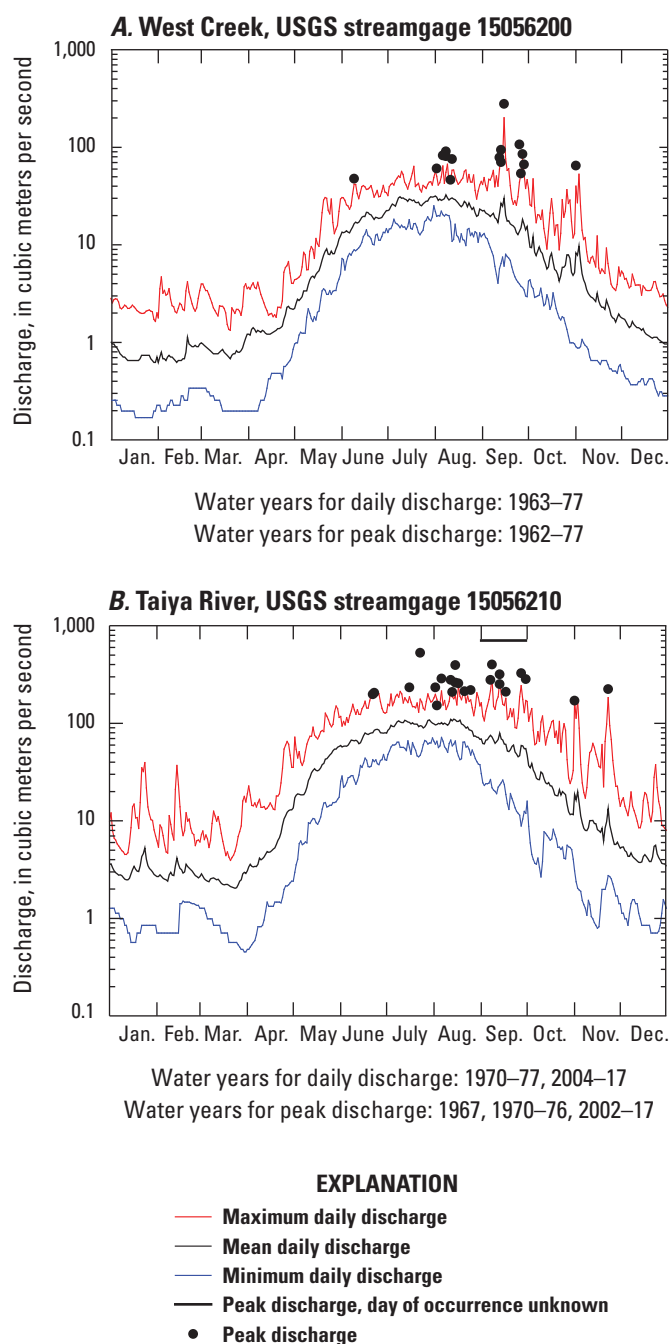
**Figure 5.** Maximum, mean, and minimum daily discharge and peak discharge during the period of record for U.S. Geological Survey streamgages on *A*, West Creek (15056200) and *B*, Taiya River (15056210), Alaska. Values are plotted by calendar year rather than water year to avoid breaks in seasonal patterns. Peak discharge is plotted as a bar for the month when the day is unknown. [USGS, U.S. Geological Survey]

The hydrograph of the maximum, mean, and minimum daily discharge for the period of record (fig. 5) shows low-flow winters followed by a prominent flow increase from spring snowmelt that leads into a prolonged period of more slowly rising flows associated with high-elevation snowmelt and glacier meltwater runoff (glacier snowmelt and ice melt). Following a crest during late July–early August, mean daily discharge slowly declines except for short-duration increases associated with autumn rainfall events. The high-flow season extends from about May to October, and the low-flow season extends from about November to April. The stream is ice covered for periods in the winter. Individual years of record contain more variability on a daily to weekly basis than long-term means in response to short-term precipitation and temperature fluctuations but follow a general pattern close to the long-term discharge pattern. Bernatz and others (2011) examined the two relatively short periods of Taiya River data available through 2009; the data show statistically significant increases in the proportion of flow arriving in May and June and corresponding decreases for July and August, an earlier spring snowmelt pulse onset, and no changes in streamflow magnitude. Bernatz and others (2011) also found streamflow timing shifts indicating the influence of phase alternations in the Pacific Decadal Oscillation, a pattern of climate variability related to sea surface temperature.

Peak discharge for West Creek and the Taiya River has occurred as early as June and as late as November but is most common in August and September (fig. 5). Likely flood-generating mechanisms for these annual peak discharges include glacier meltwater runoff and rainfall for mid-summer peaks and rainfall for autumn peaks. Over the period of record, peak discharges exceeded the maximum daily discharge for the day of occurrence by an average of 30 percent for both streams, indicating that although the processes that generate peaks are more intense than those associated with typical daily discharge, those processes also tend to elevate discharge for much of the day.

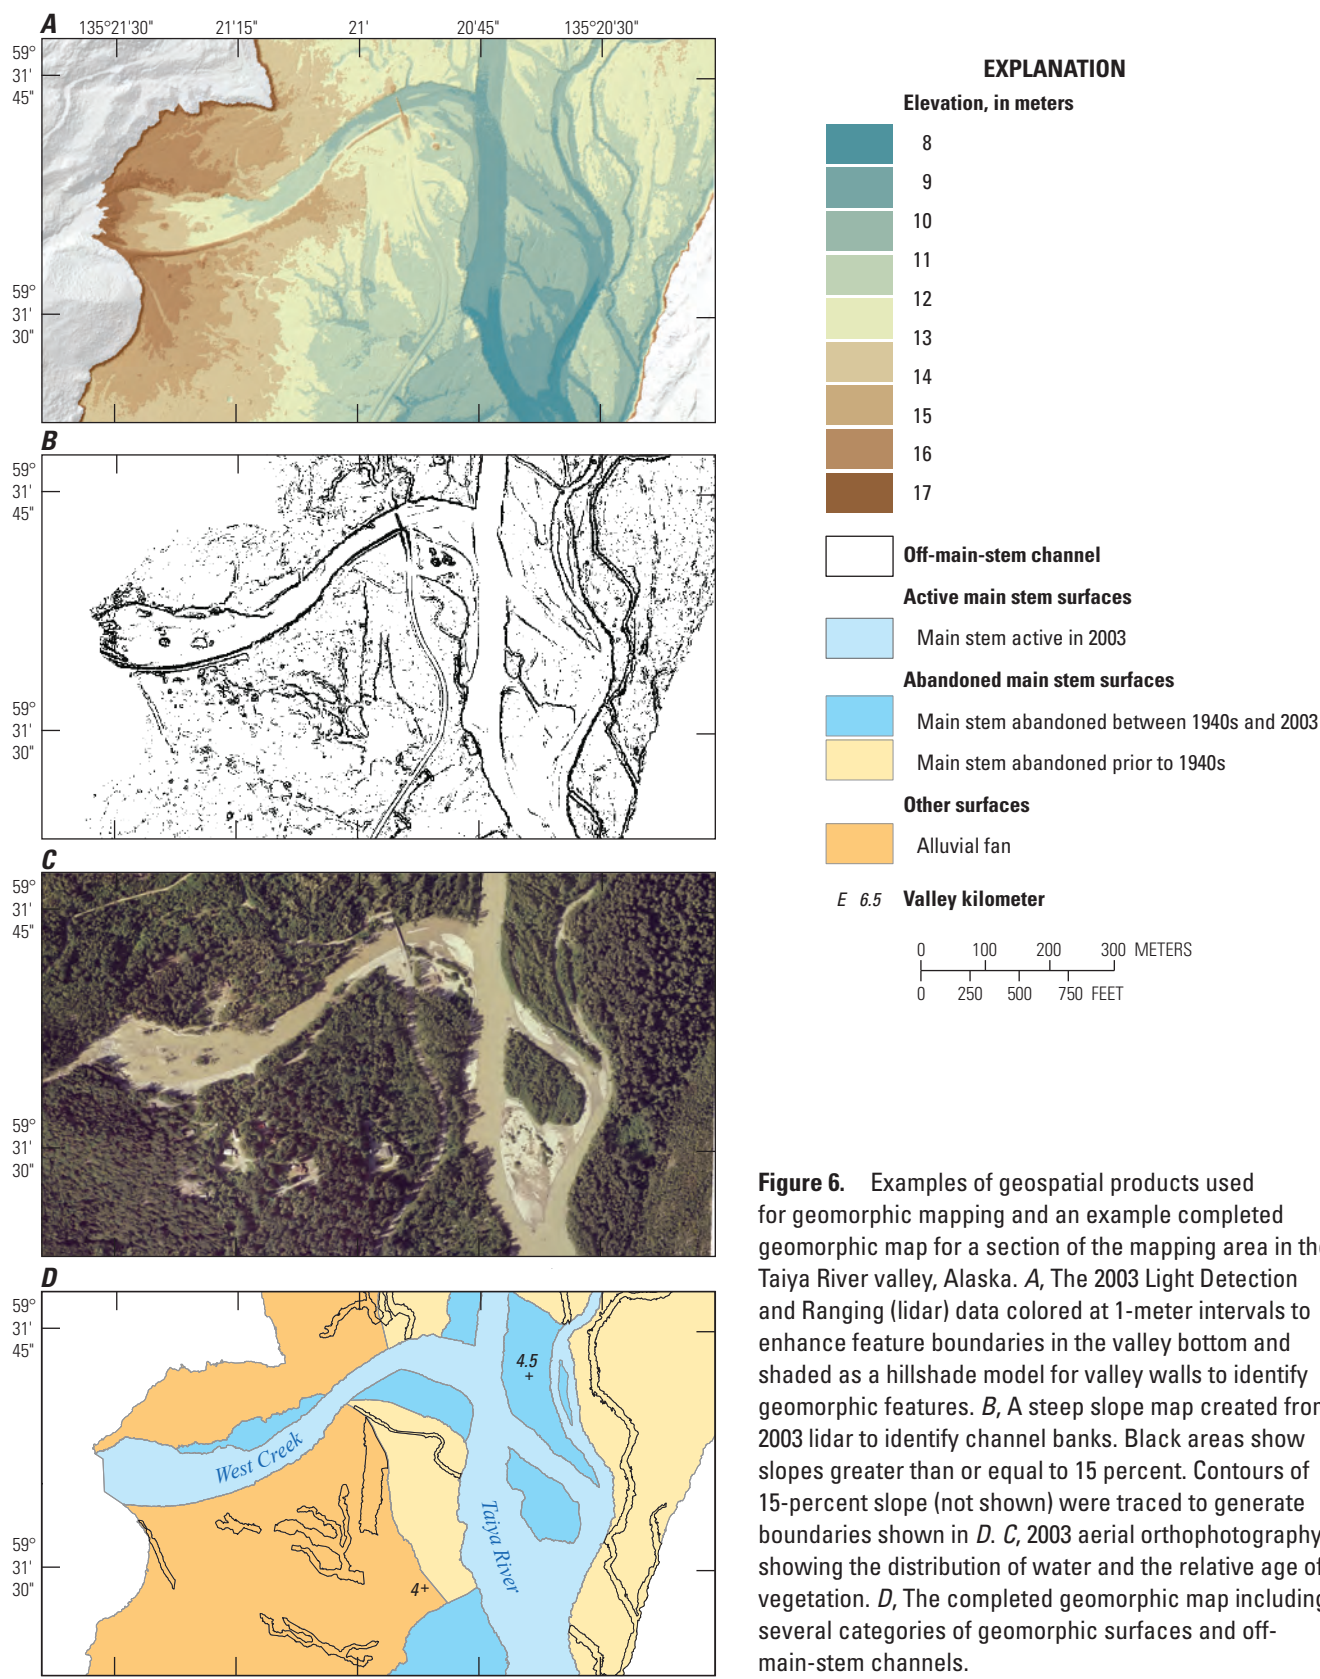
**Figure 6.** Examples of geospatial products used for geomorphic mapping and an example completed geomorphic map for a section of the mapping area in the Taiya River valley, Alaska. *A*, The 2003 Light Detection and Ranging (lidar) data colored at 1-meter intervals to enhance feature boundaries in the valley bottom and shaded as a hillshade model for valley walls to identify geomorphic features. *B*, A steep slope map created from 2003 lidar to identify channel banks. Black areas show slopes greater than or equal to 15 percent. Contours of 15-percent slope (not shown) were traced to generate boundaries shown in *D*. *C*, 2003 aerial orthophotography showing the distribution of water and the relative age of vegetation. *D*, The completed geomorphic map including several categories of geomorphic surfaces and off-main-stem channels.

The 2003 lidar data were viewed in several ways to aid feature interpretation and delineation. First, a digital elevation model was shaded in 0.5-m elevation bands and draped over a hillshade model ([fig. 6A](#)) to enhance visibility of geomorphic features while retaining actual elevation data. Second, a relative elevation model (REM) map, sometimes referred to as height above river map (Jones, 2006) or height above water surface map (Carpenter and others, 2012), was created to better visualize patterns in geomorphic features to aid interpretation. The REM map is an elevation model of the main stem detrended for the local slope of the Taiya River (and Nourse River near the head of the valley). Following procedures in Olson and others (2014, appendix E), water-surface elevations along the stream centerline were extracted from the 2003 lidar digital elevation model (DEM) and used with an inverse distance weighting tool in ArcGIS to create a model of the weighted average elevations of the nearest Taiya River water surfaces for any point across the valley. The original DEM was subtracted from this modeled water-surface elevation, which slopes at approximately the valley slope, to create the REM. The REM map facilitated qualitative analysis of former river positions and cross-cutting relations, such as fan trimlines. Finally, a slope map was prepared as a derivative of the lidar elevation data and then contoured to a range of values using ArcGIS tools to guide mapping. The most prominent steep slopes in the Taiya River valley are present at streambanks and human-modified features like roadway embankments and dikes, making slope a definitive and accurate tool for visualizing and delineating channels, a process used successfully on other streams (Jones, 2006). By visual trial and error, slope contour values were sought that minimized noise but provided enough detail to distinguish geomorphic features. The 15-percent slope contour, one of several suitable contour values, was selected in part because it is a commonly used steep-slope boundary.

Most channels and the valley bottom margins were drawn by tracing 15-percent slope contours and digitizing as needed to connect contours. Tracing results in a repeatable, consistently defined line, but it should be noted that the level of detail conveyed by tracing is often more than warranted given the resolution of the data. Although the steep slope map (areas steeper than or equal to 15 percent; *fig. 6B*) clearly depicts steep-sided feature outlines, additional information gleaned from aerial photographs (*fig. 6C*) and field observations was required for the interpretation of the formative process and relative age of the features (*fig. 6D*).

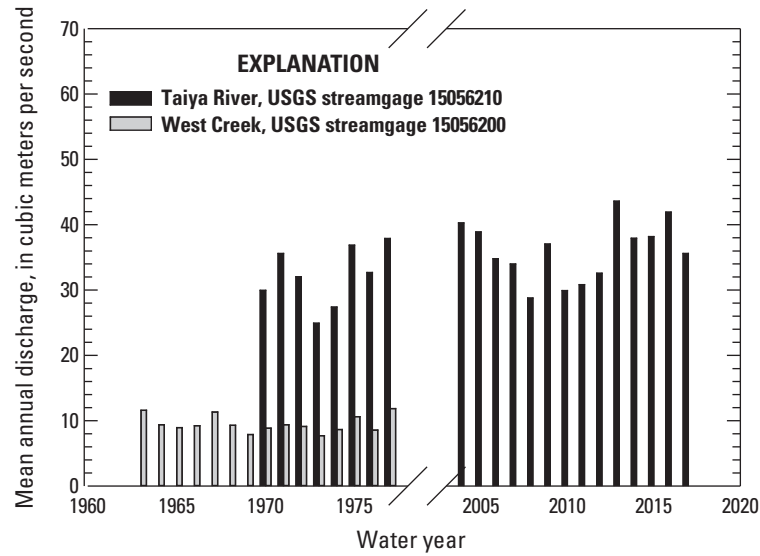
**Figure 7.** Mean annual discharge for each year through water year 2017 at U.S. Geological Survey streamgages at West Creek (15056200) and Taiya River (15056210), Alaska. [USGS, U.S. Geological Survey]

The intermittent and relatively short streamgauge records precluded in-depth trend analysis but permitted comparisons of early to late periods. Using data through WY2009, Bernatz and others (2011) found no statistically significant difference in mean annual discharge of the Taiya River between the respective periods of record in the 1970s and 2000s in a Student's *t* test. Results of an updated analysis using records through WY2017 (fig. 7) (table 5) show that an increase in mean annual discharge in the latter period weakly fails to be statistically significant ( $p = 0.073$ ). The same analysis for West Creek shows no statistically significant difference in the mean annual discharge between the common period of record with the Taiya River in the 1970s and the earlier years of West Creek record (fig. 7).

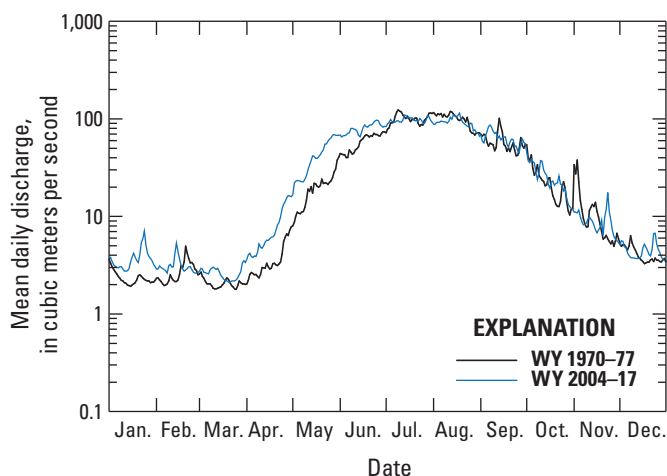
**Figure 8.** Mean daily discharge for the Taiya River at U.S. Geological Survey streamgage 15056210, Alaska, water years 1970–77 and water years 2004–17. [WY, water year]

More closely examining the seasonal distribution of flow for the Taiya River between periods, however, shows discernible changes in flow timing and magnitude for parts of the year (table 5, fig. 8). An overlay of the mean daily discharge for the two periods (fig. 8) shows a shift in timing of an average of 14 days toward earlier spring breakup in the more recent period, which echoes findings of a statistically significant earlier spring pulse onset (sudden increase in discharge associated with spring snowmelt) in Bernatz and others (2011). A corresponding statistically significant increase in mean monthly discharge for April–June during the WY2004–17 period compared to the 1970s period (table 5) is also consistent with the Bernatz and others (2011) seasonal fractional flow analysis showing a higher percentage of the annual discharge being delivered in May and June. Spring and early summer flow increases in the more recent period are not fully compensated by decreases in other parts of the year (table 5). The decrease in flow delivered in July and August reported by Bernatz and others (2011) is minor and not statistically significant in the present analysis. Winter (December–March) mean monthly discharges are slightly higher but not statistically significant or weakly not significant in the more recent period.

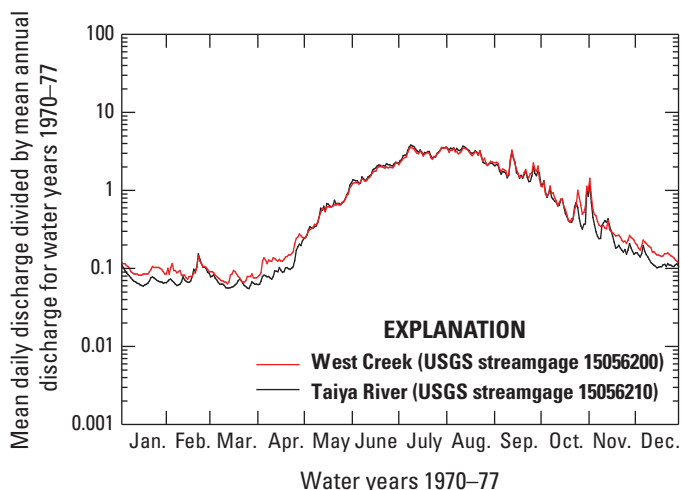
**Figure 9.** Normalized mean daily discharge for West Creek at U.S. Geological Survey (USGS) streamgage 15056200 and the Taiya River at USGS streamgage 15056210, Alaska, for the common period of record, water years 1970–77. The mean daily discharge is divided by the mean annual discharge for the common period of record for each respective stream.

The similarity in long-term average seasonal discharge patterns between the two streams is evident in an overlay of normalized mean daily discharge (mean daily discharge for the common period of record for each stream normalized by the mean annual discharge for the same period for each respective stream) (fig. 9). The Pearson's correlation coefficient ( $r$ ) computed for the logarithms of daily discharge of the two streams is 0.98 for the full common period of record, showing similarity also existed at a daily scale. For the seasonal subsets of this record, this daily scale correlation between streams is closest for the high flow season of May–October (Pearson's  $r = 0.97$ ). West Creek daily discharge is proportionally higher and not as correlated with Taiya River flow from November to April ( $r = 0.90$ ).

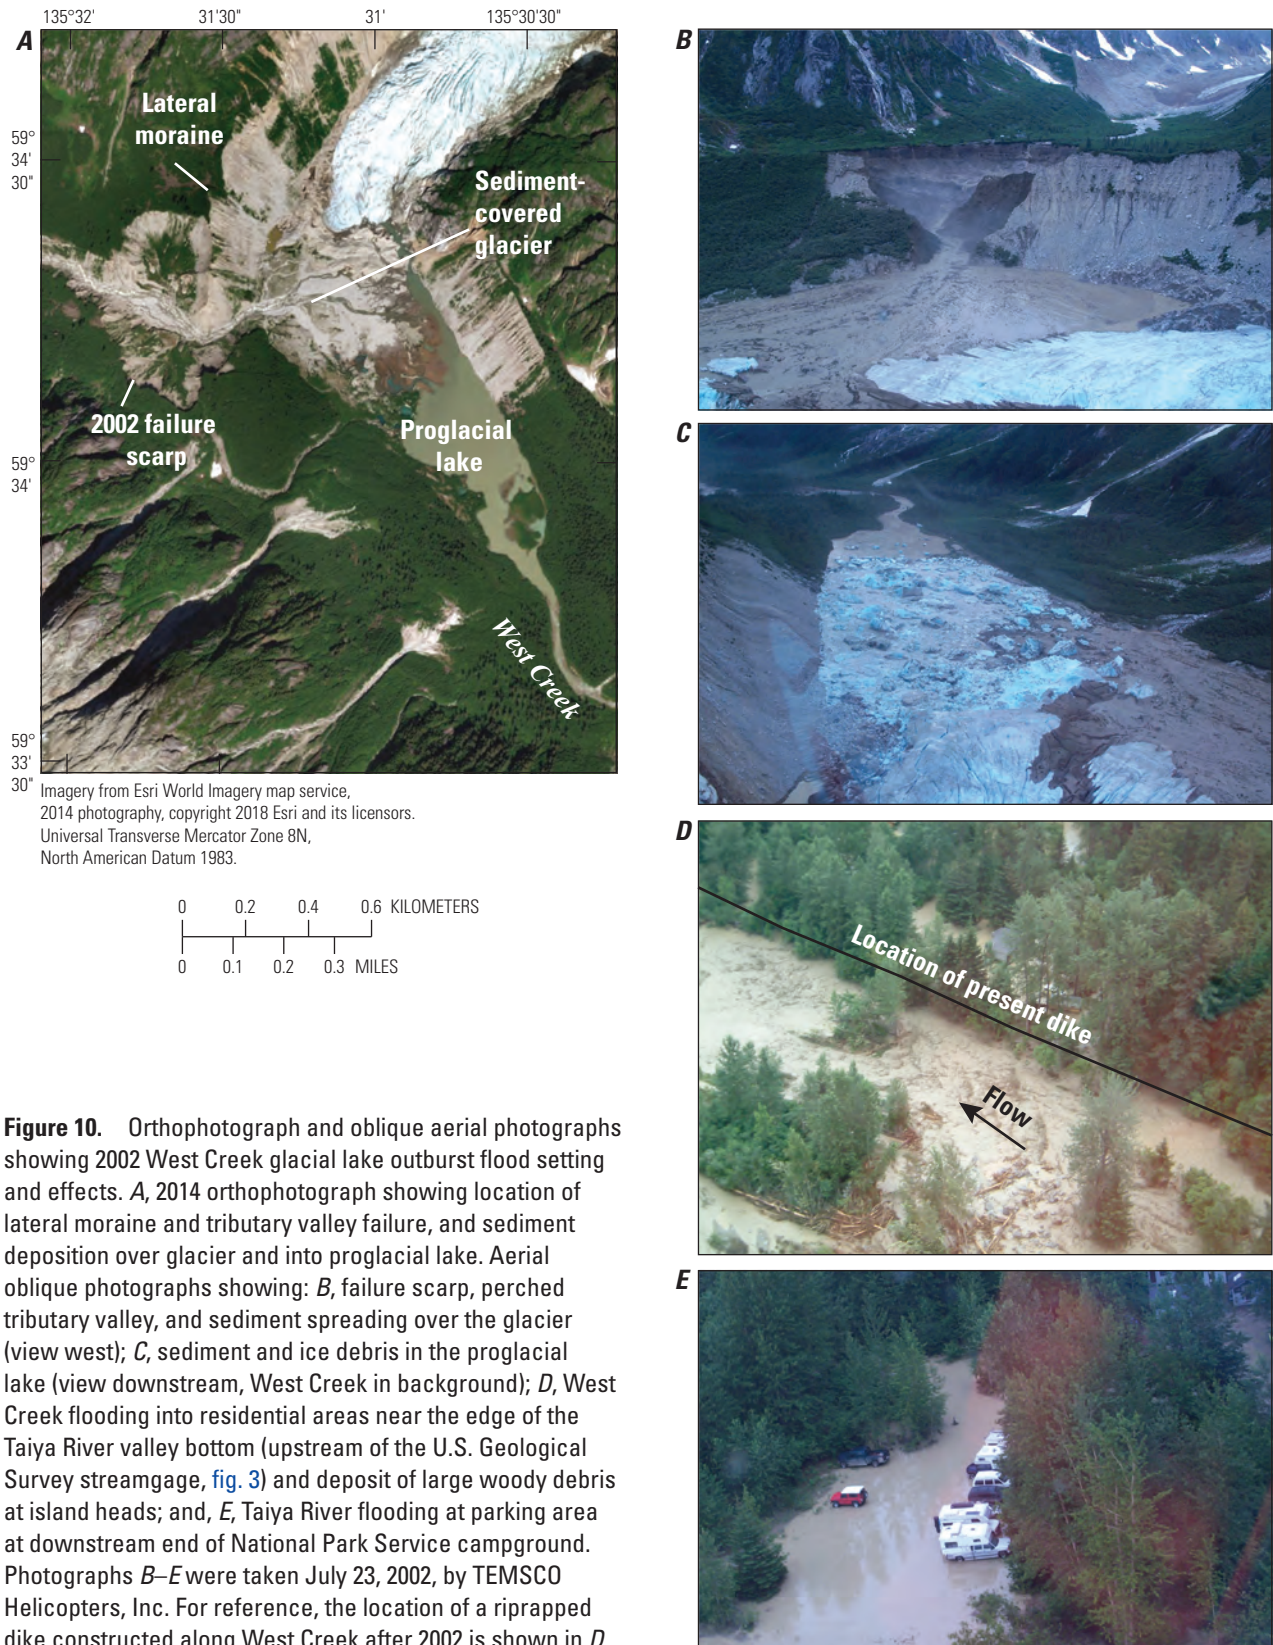
**Figure 10.** Orthophotograph and oblique aerial photographs showing 2002 West Creek glacial lake outburst flood setting and effects. *A*, 2014 orthophotograph showing location of lateral moraine and tributary valley failure, and sediment deposition over glacier and into proglacial lake. Aerial oblique photographs showing: *B*, failure scarp, perched tributary valley, and sediment spreading over the glacier (view west); *C*, sediment and ice debris in the proglacial lake (view downstream, West Creek in background); *D*, West Creek flooding into residential areas near the edge of the Taiya River valley bottom (upstream of the U.S. Geological Survey streamgage, [fig. 3](#)) and deposit of large woody debris at island heads; and, *E*, Taiya River flooding at parking area at downstream end of National Park Service campground. Photographs *B–E* were taken July 23, 2002, by TEMSCO Helicopters, Inc. For reference, the location of a riprapped dike constructed along West Creek after 2002 is shown in *D*.

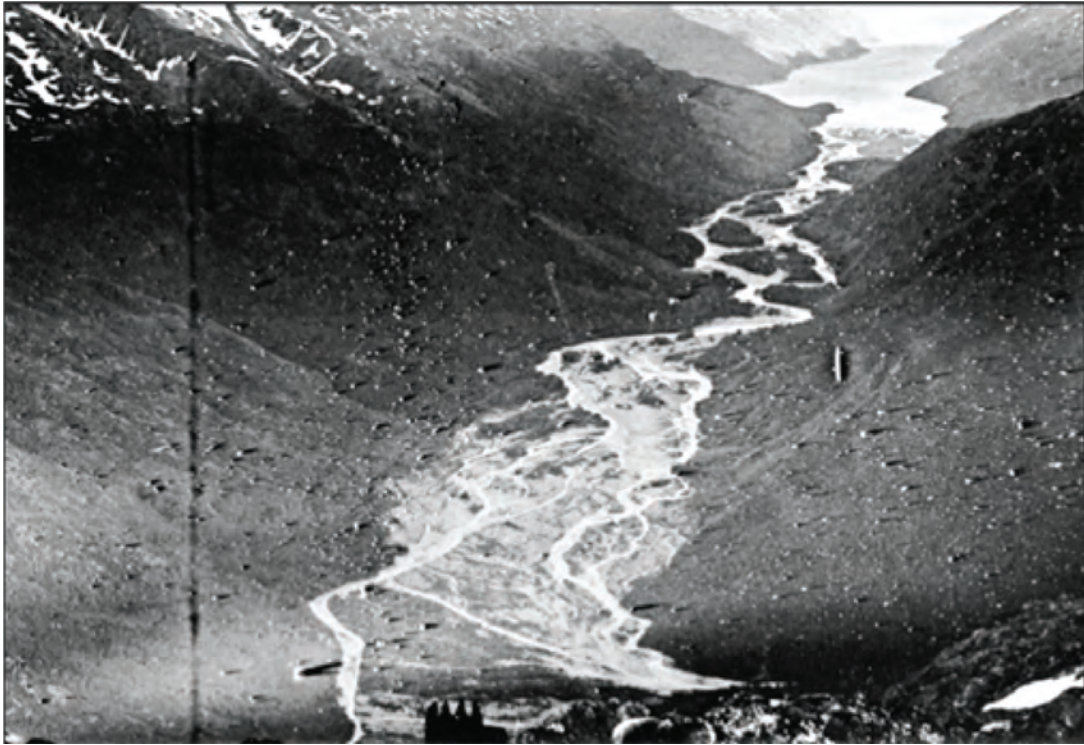
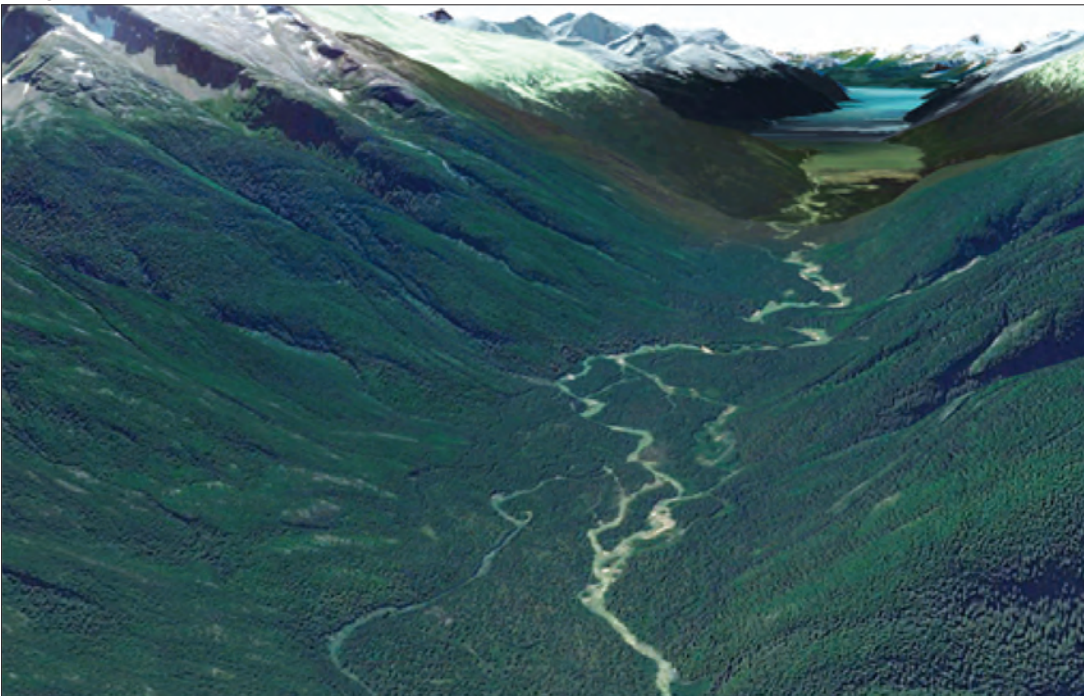
**A. 1894**

**Figure 11.** *A*, Historical aerial photograph looking south down the Taiya River, Alaska main stem taken in 1894 by J.J. McArthur for an international boundary survey. Artifacts from poor scan quality include apparent small lumps and shadows. Poor lighting in the foreground appears to show bare areas on side slopes that are known from other ground photographs to be forested. *B*, An approximate match of view location and angle using Google Earth to display 2014 Digital Globe imagery. The Nourse River enters the Taiya River main stem valley bottom from the right in the foreground, and Taiya Inlet is visible in the background.

The indicated influence of Nourse River glacial lake outburst floods on the geomorphology of the Taiya River main stem has not been comprehensively evaluated. An 1894 photograph looking down the main stem Taiya River (McArthur, 1894) shows a bare to lightly vegetated plain from the mouth of Nourse River canyon to about halfway to Finnegan’s Point (fig. 11A), which has been interpreted by informal studies (Inglis and Pranger, 2002; Capps, 2004; Gurcke, 2010) to indicate denudation from an outburst flood not long before the photo was taken. Inspection of this photograph shows that the combined width of channels and unvegetated bars is wider, and the number of active channels more numerous, than in 2003 or 2014 orthophotos. Varying stages of vegetation can be seen on longitudinal wedges across the Nourse River fan. Within the limitations of the poor print reproduction of this photo, no accumulations of large woody debris indicative of valley-width-scale forest denudation can be detected. Although the number of flow paths has been reduced since 1894, the general locations of the Nourse River, upper Taiya River, and main stem Taiya River channels have been only slightly modified (fig. 11B). Inspection of 2003 lidar data shows that the Nourse River fan shape gradually diffuses downvalley, such that by about 1.5 km downstream, the elevation contours are roughly transverse to the valley. The upper Taiya River is

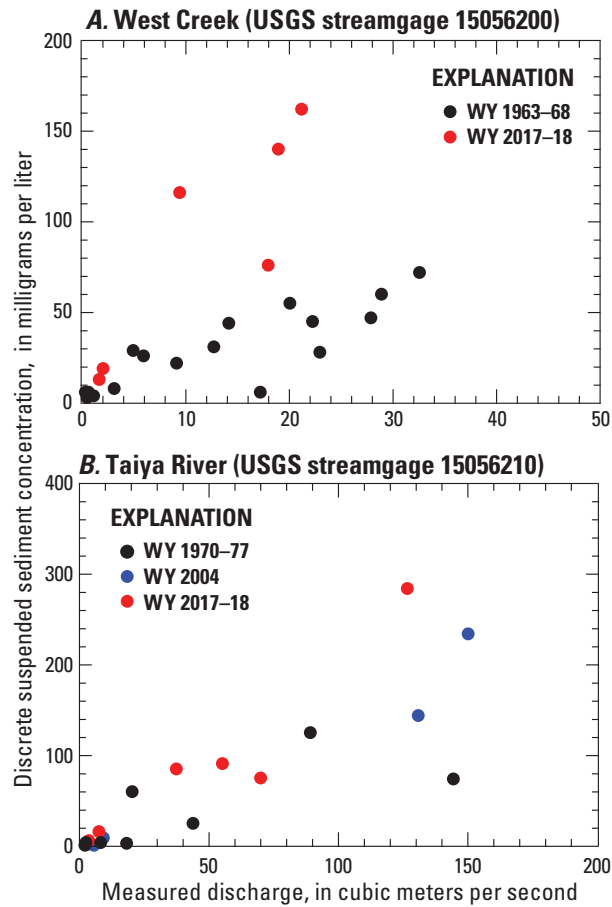
**Figure 12.** Discrete suspended sediment concentration in relation to measured discharge at U.S. Geological Survey streamgages, *A*, West Creek (15056200) and, *B*, Taiya River (15056210), Alaska, during periods of record. [WY, water year]

Collectively over the full period of record, the suspended sediment measurements captured information for a range of discharge magnitudes (fig. 12) and times of year (fig. 13). These measurements provide a basic characterization of the Taiya River Basin that is consistent with glacier-fed streams, where suspended sediment values range from winter background levels that are often high relative to nonglacier-fed streams to higher summer levels that fundamentally vary with discharge but can also vary substantially with a range of factors, including depletion of residual sediment stores and nonglacial processes within the basin (Jaeger and others, 2017).

trend analysis. The concurrent measurements for this study show that Taiya River suspended sediment concentrations spanned a slightly larger range of values than those measured in West Creek during WY2017–18 (fig. 12). The seasonal distribution of suspended sediment concentrations over the full period of record (fig. 13) was similar in both streams. In general, suspended sediment concentrations began to increase from relatively low winter levels in May, peaked in summer (June, July, or August), and declined throughout the autumn. The May–September 2017–18 measurements for both streams frequently had higher values than previous measurements. The 2017–18 and 2004 measurements for both streams and the 2004 measurements for the Taiya River collectively have earlier peak suspended sediment concentrations (June) than the 1960s (West Creek) and 1970s (Taiya River) measurements (August–September).

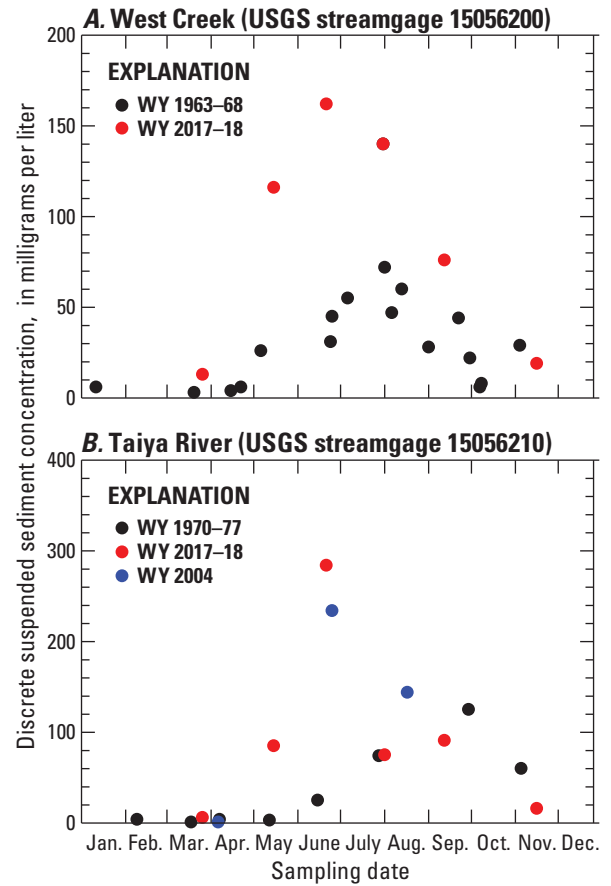
**Figure 13.** Discrete suspended sediment concentration by month and day of sampling for U.S. Geological Survey streamgages, *A*, West Creek (15056200) and, *B*, Taiya River (15056210), Alaska, during periods of record. [WY, water year]
