# Hydrology and Geomorphology of the Taiya River Near the West Creek Tributary, Southeast Alaska

Scientific Investigations Report 2020–5059

By Janet H. Curran

Prepared in cooperation with the National Park Service

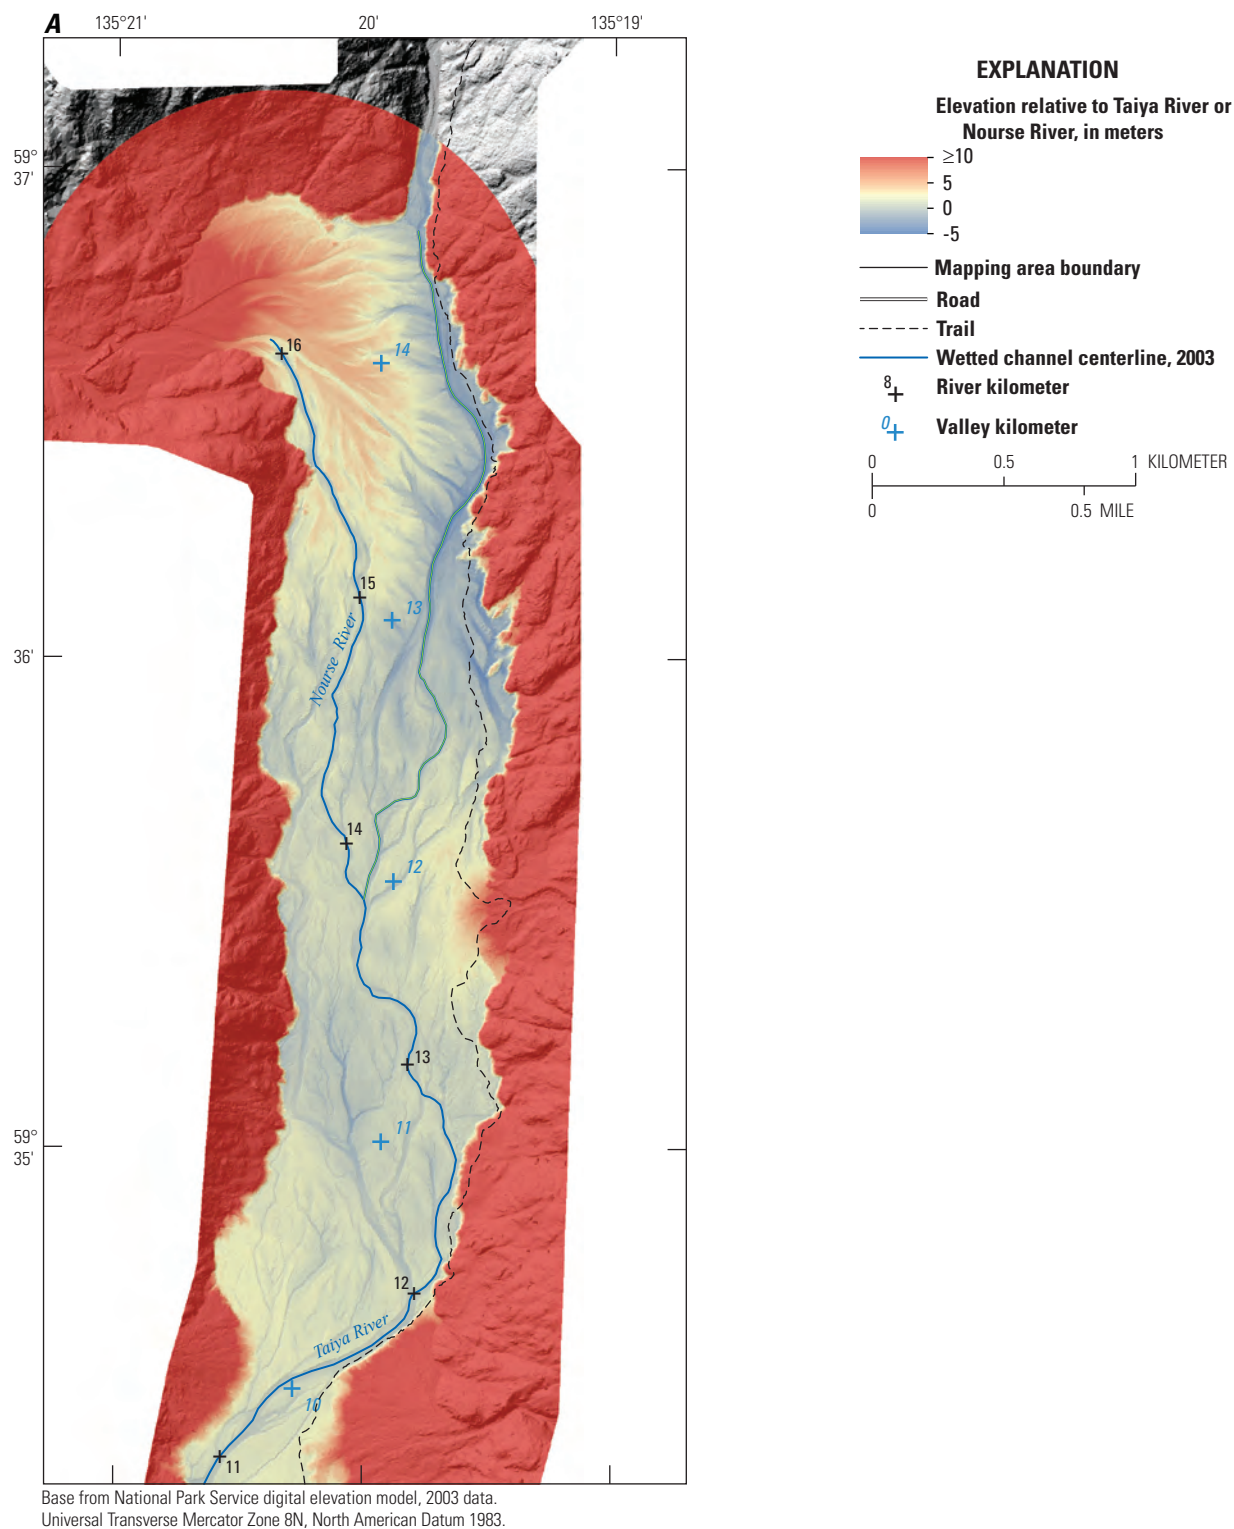
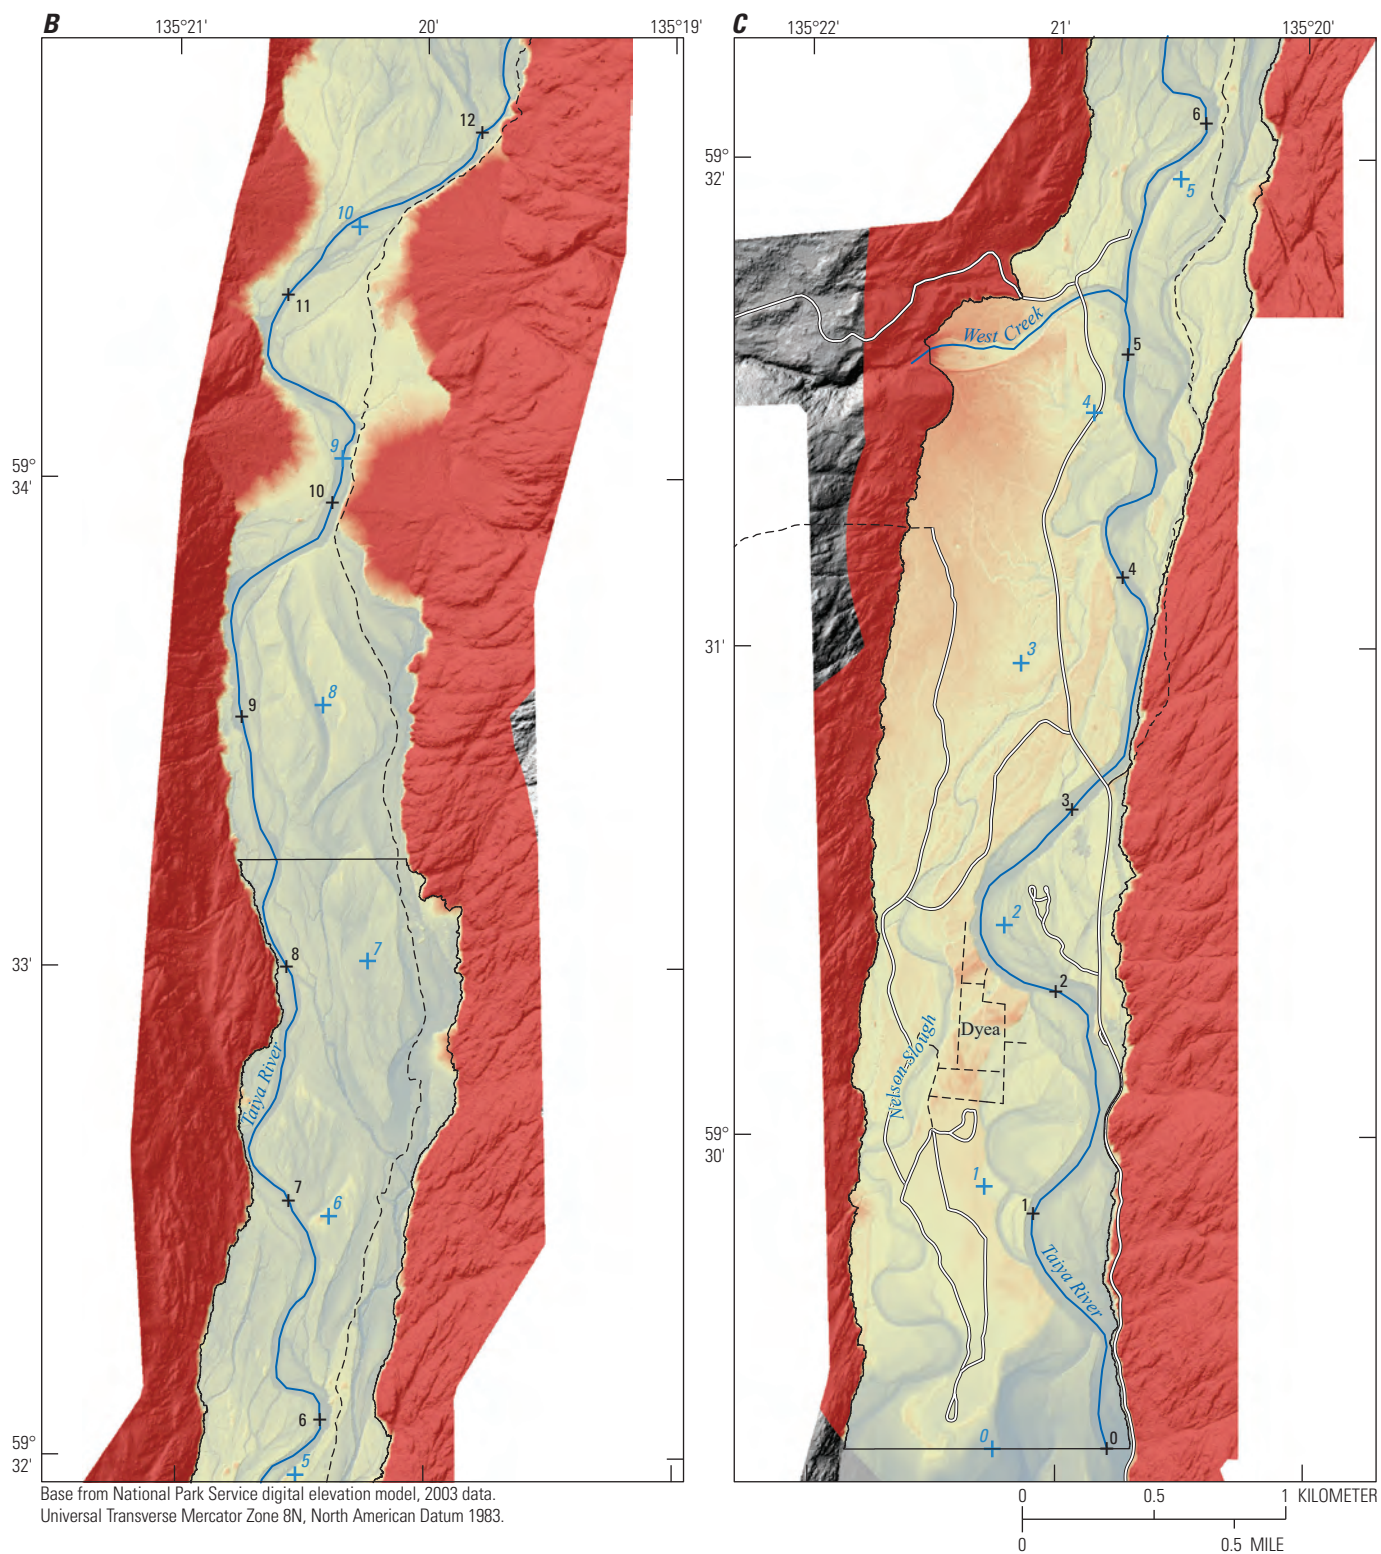
**Figure 14.** Relative elevation model of the Taiya River main stem valley bottom showing height above the water surface of, *A*, Taiya River and Nourse River, *B*, Taiya River, and *C*, Taiya River, Alaska, for 2003 conditions.

Figure 14.—Continued

The Taiya River has abandoned former channel areas within the mapping area via channel migration or avulsion. The abandoned fluvial surfaces have retained channel definition expressed topographically (fig. 14) or through vegetation type and relative maturity for decades, with decreasing feature

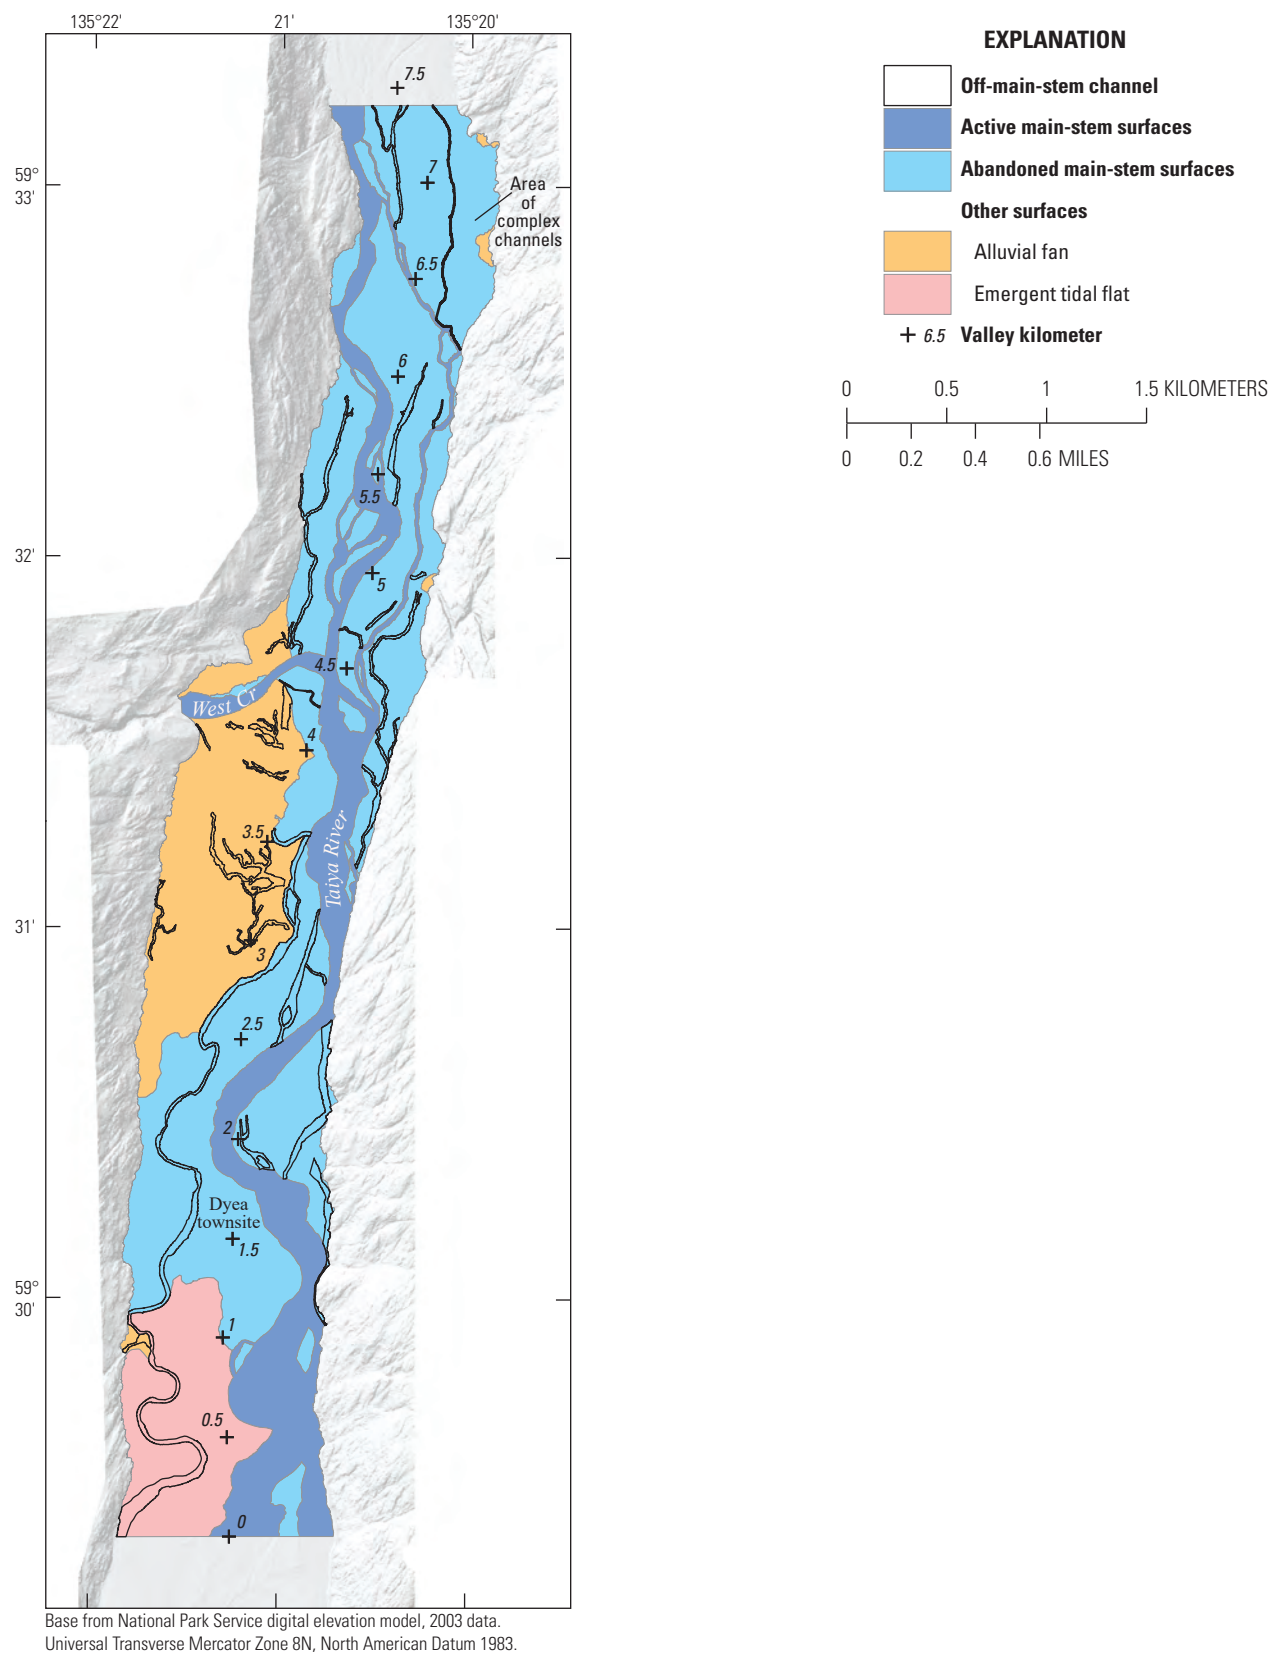
**Figure 15.** Geomorphic surfaces by formative process and off-main-stem channels of the lower 7.5 kilometers of the Taiya River valley bottom, Alaska.

Within the mapping area, a mosaic of fluvial deposits of varying age and origin extend downstream to recently uplifted tidal flats. An overview of the surface mapping units (by formative process without relative ages) and off-main-stem channels is shown in figure 15. Geomorphic surfaces and off-main-stem channels are described and shown in more detail in the “Valley and Main Stem Channel Geomorphology” and “Off-Main-Stem Channels” sections and documented as boundaries and attributes in a data release (Curran, 2020; see also appendix 1 GIS digital files available at <https://doi.org/10.5066/P9XP1SE7>).

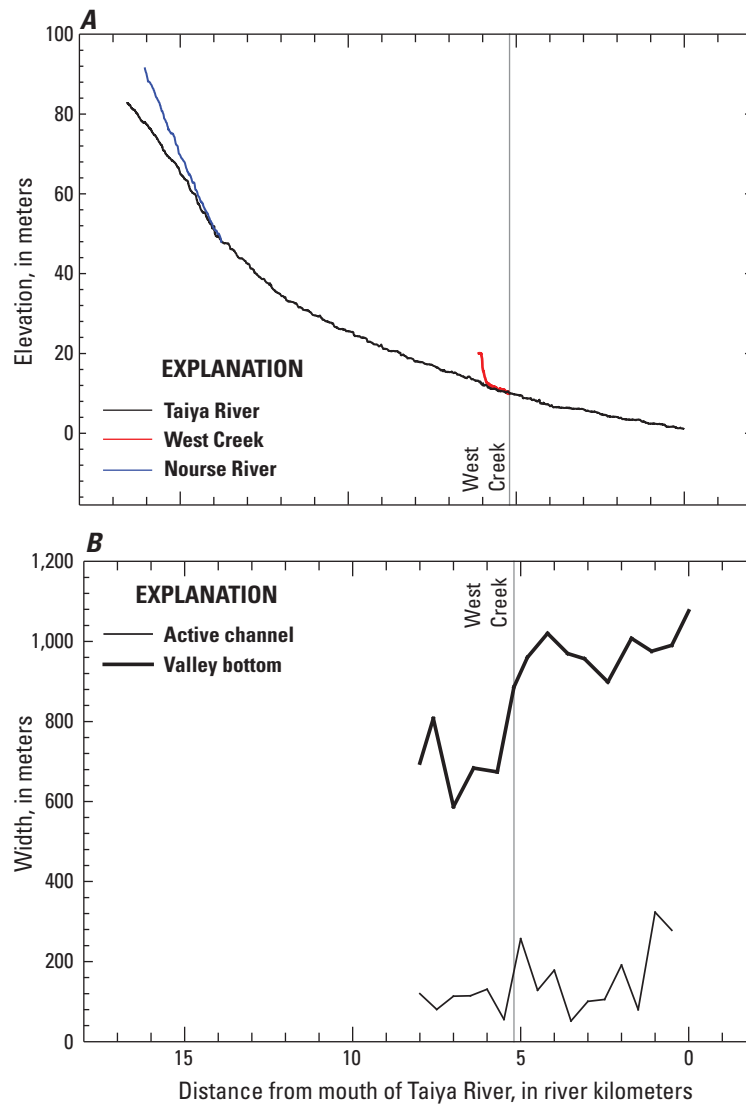
**Figure 16.** A, Stream longitudinal profile for the Taiya River and major tributaries within the Taiya River main stem valley, Alaska, from 2003 lidar data and, B, active Taiya River channel and valley bottom widths within the mapping area. The stream centerline used to generate the profile is shown in figure 14A, B, and C.

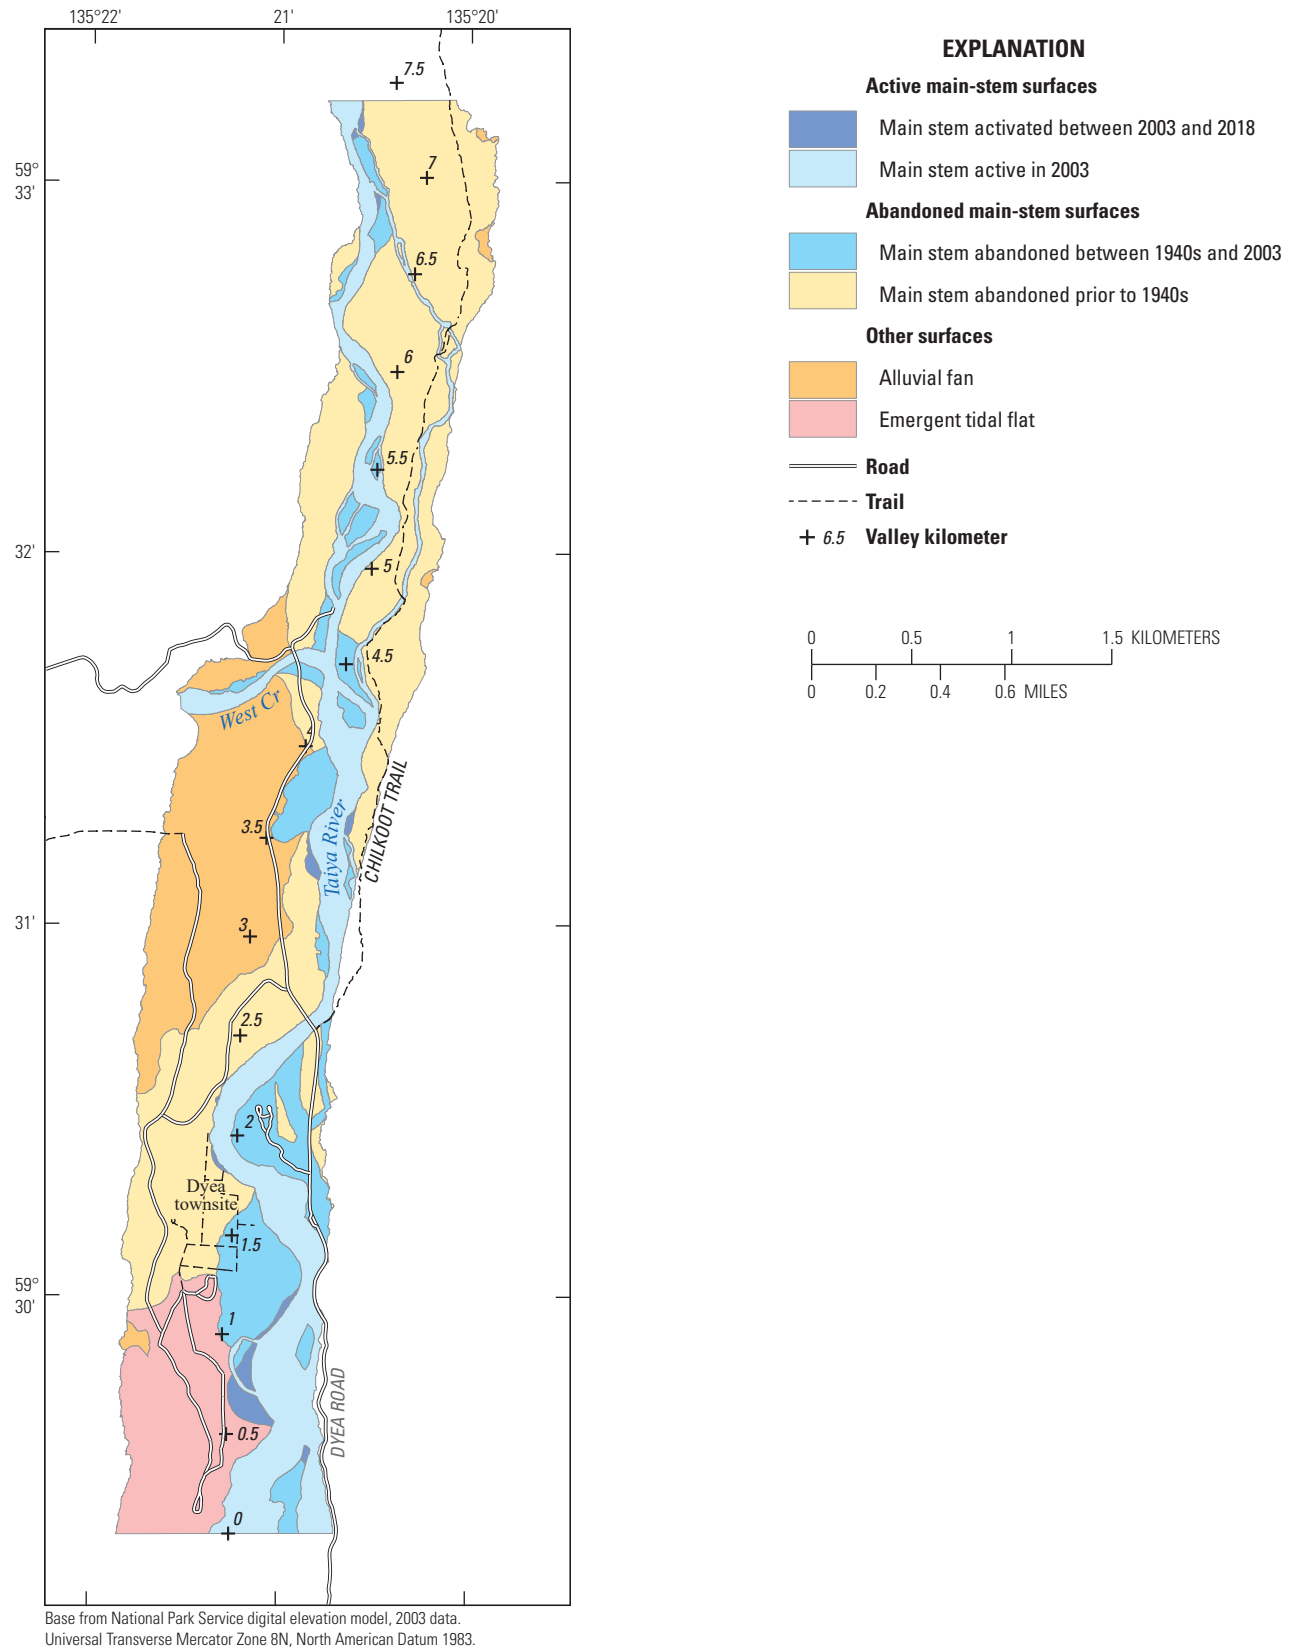
**Figure 17.** Geomorphic map of the lower 7.5 kilometers of the Taiya River valley bottom, Alaska, showing geomorphic surfaces by formative process and relative age.

The active main stem mapping unit includes areas active in 2003 plus small adjacent areas converted to active main stem by erosion by 2018 (fig. 17). Examples of 2017–18 conditions along West Creek and the Taiya River are shown in figure 18. The width of the active channel, which includes channels, bars, and islands, within the mapping area averaged 100 m upstream of West Creek and widened to 170 m downstream, as measured at 0.5-km increments. The channel slope averaged 0.0022 m/m over the mapping area but decreased downstream, averaging 0.0029 m/m from the upstream end of the mapping area to a slight flattening of slope at VK 3.5 and 0.0015 m/m from VK 3.5 to the downstream end of the mapping area. The sinuosity, or channel length relative to valley length, is 1.1 for the mapping area.

Except where the river borders the bedrock valley wall (fig. 17), Taiya River banks are composed of easily erodible unconsolidated sediments consisting largely of sand and gravel. Well-exposed eroding banks at VK 2.0 (fig. 18C) are mostly sand with occasional gravel and are partially lined with large woody debris. Bank heights downstream of West Creek are typically 1–2 m above the typical summer water surface and a maximum of about 5 m. Bank heights are particularly low (less than 1.5 m) adjacent to low terraces shown as surfaces abandoned between the 1940s and 2003 at VK 3.5–4.0 and VK 1.0–1.5 (figs. 14 and 17). The tallest banks exceed 2.5 m for almost 1 km along the right bank (looking downstream) in the large meander at VK 2.0 and for less than 100 m at the Taiya River bridge where the channel flows along surfaces abandoned before 1948.

The 2003 aerial imagery and study field observations show that the active main stem usually includes a prominent main channel and additional features that introduced channel complexity, including lateral and mid-channel bars and back-bar channels. Vegetated islands were most common upstream of and at the West Creek confluence and consisted entirely of former channels abandoned between the 1940s and 2003 (fig. 17). The Taiya River has relatively few sloughs but has historically maintained them on a decadal scale. Presently, in addition to a long slough in the northern half of the mapping area (VK 4.5–7.0), which is about 15 m wide and conveys substantial main stem flow (fig. 18E), a smaller slough at VK 1.0 extends several hundred meters across abandoned fluvial surfaces near the river mouth (fig. 17).

Bank erosion has affected private and public properties and historical artifacts along the developed part of the Taiya River valley bottom since the early 1900s. Although channel migration rates since about the mid-1990s are small relative to those from 1948 until about the mid-1990s, bank erosion in the recent period has threatened structures and resulted in the loss of historical artifacts. Notable areas of bank erosion since the 1990s include a reach at VK 3.5 (fig. 17) and the sweeping meander bend near the Dyea townsite/NPS campground at VK 2.0 (figs. 17 and 20).

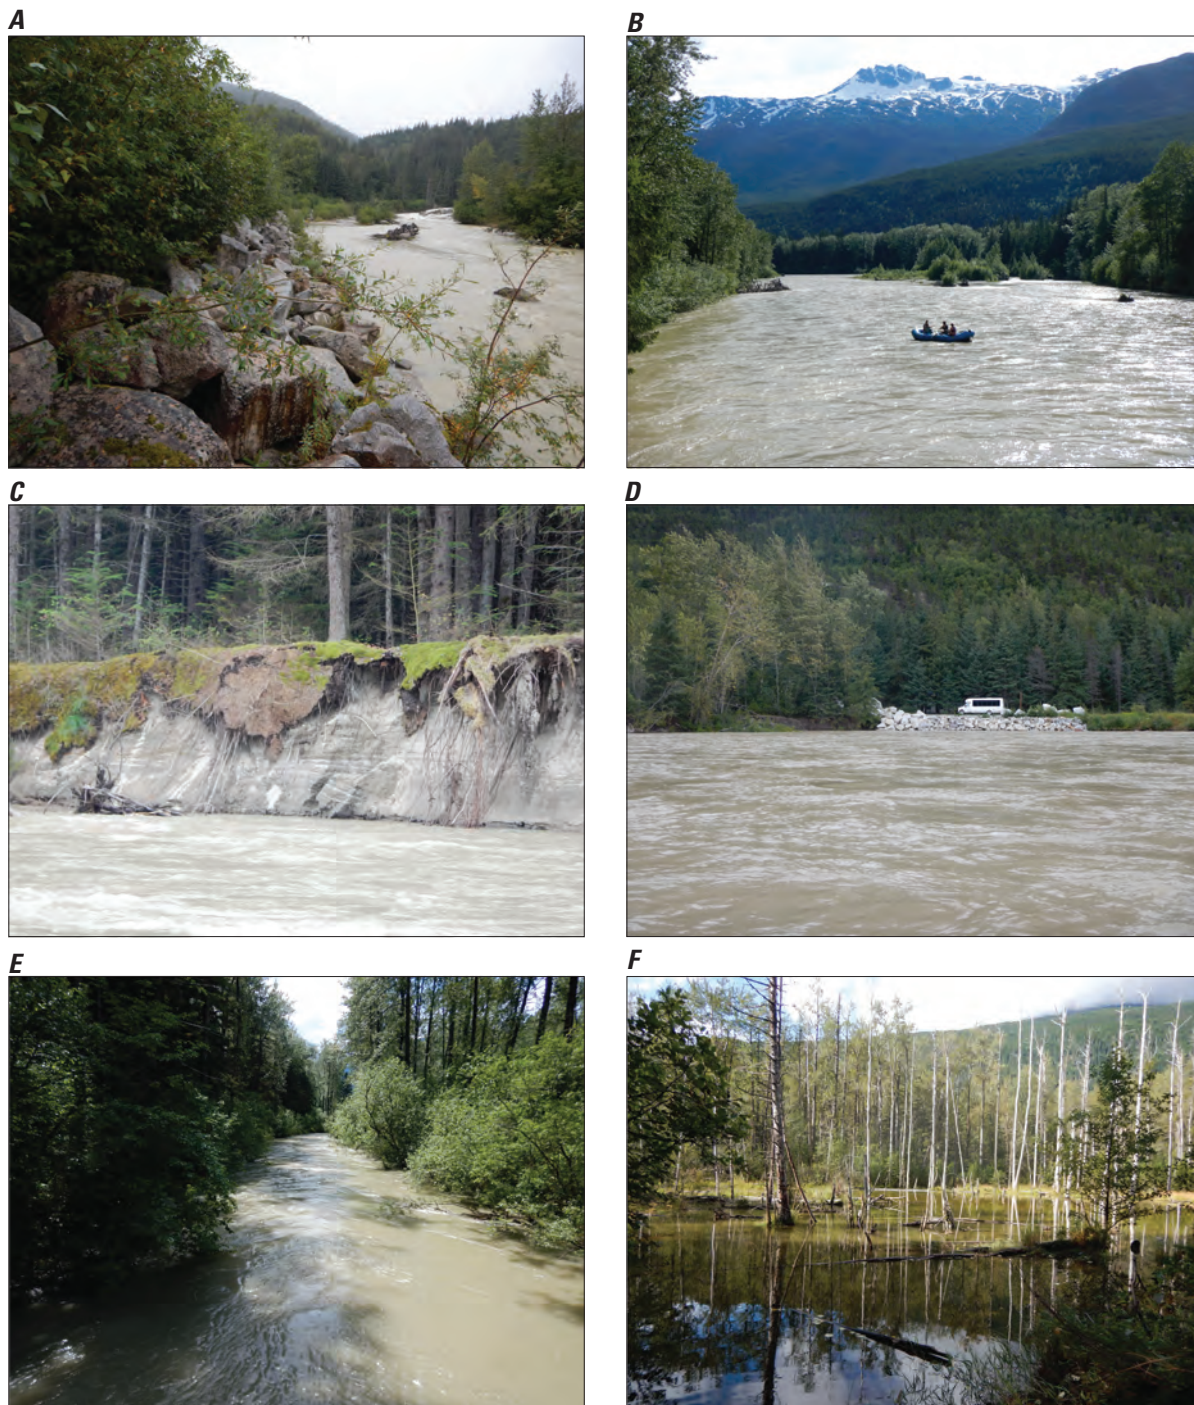
**Figure 18.** West Creek and Taiya River features, Alaska. Photographs from top left: *A*, view upstream along West Creek, showing riprap along the right bank, August 31, 2017; *B*, view downstream along the Taiya River from the Dyea Road bridge, showing recreational rafters, large woody debris, and mid-channel bars, June 19, 2018; *C*, erosion of the right bank in the large meander at valley kilometer (VK) 2.0 actively affecting the Dyea townsite, August 30, 2017; *D*, riprap protects an eroding section of the left bank adjacent to the National Park Service campground, VK 2.0, August 30, 2017; *E*, view downstream along the VK 4.5–7.0 slough from the Chilkoot Trail crossing at VK 5.0, June 19, 2018; and *F*, a large pond at the downstream end of a beaver pond complex at VK 5.5, August 30, 2017. All photographs taken by Janet H. Curran, U.S. Geological Survey.

The location of the West Creek channel within the mapping area has remained essentially fixed upstream of the West Creek bridge since 1948. Riprap bank protection, placed in association with bridge construction and following the 2002 glacial lake outburst flood, enforces the path (fig. 18A). Immediately downstream of the bridge, however, West Creek migrated north after 1948, contributing to erosion of a bar separating the channels that forced stream capture of a section of West Creek by the Taiya River (fig. 21). The complex channel changes that ensued rearranged the Taiya River, effectively straightening a kilometer-long reach and moving the confluence about 200 m upstream.

Beaver dams have effectively regulated hydrologic conditions in selected off-main-stem channels, creating ponds that have persisted over decades and locally altered valley bottom vegetation. Beaver activity is present upstream and downstream of West Creek but has most prominently affected two areas upstream of West Creek. At channel T04, a complex of flooded forest areas and former roads and trails fed by a tributary at VK 5.5 and dammed by beavers extended about 1 km along the channel as of 2018. The second area, an extensive series of beaver ponds and small streams along the Chilkoot Trail near VK 6.5 (fig. 22), was present before 2003 and extended about 600 m along the valley by 2018. Standing trees killed by inundation (fig. 18F) and stressed pond-marginal vegetation indicate hydrologic conditions here are still in flux.

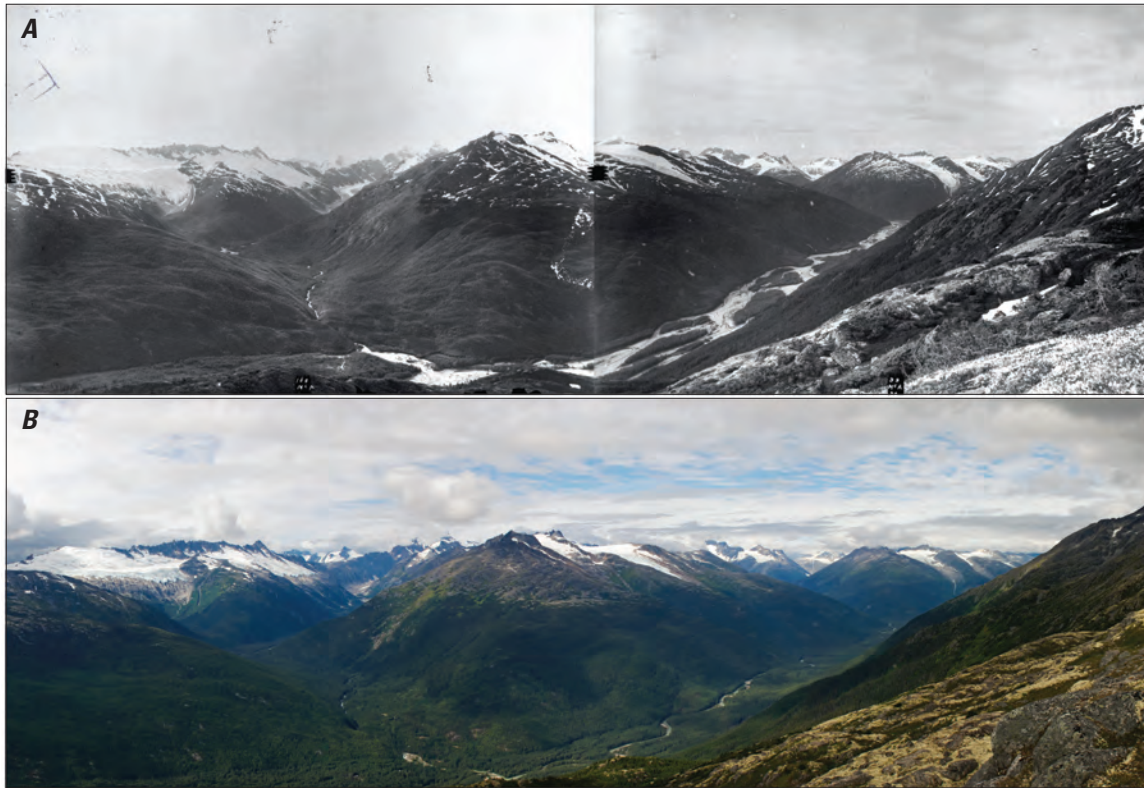
**Figure 19.** Photographs from Klondike Gold Rush National Historical Park photo station CH-14 looking west toward West Creek from AB Mountain above the Taiya River valley, Alaska. *A*, 1894 conditions show multiple main stem flow paths containing wider suites of active channels. *B*, August 27, 2013, conditions show the active main stem channel has consolidated into a single flow path and narrowed. Photographs, *A*, by James J. McArthur, International Boundary Commission and, *B*, by R.D. Karpilo, Jr., National Park Service. Modified from AB Mountain 1 Photo Pair, Chilkoot Trail: Then and Now photo gallery, National Park Service website <https://www.nps.gov/klgo/learn/nature/repeatphotography.htm>.

Photographs from 1894 (table 1) show a series of forested islands in a nearly valley-wide active channel throughout much of the Taiya River valley bottom (figs. 11A and 19A). Relative to modern conditions (figs. 11B and 19B), the Taiya River valley bottom was considerably less vegetated, supported more channel pathways, and had wider active channel belts within those paths. Although the specific cause of change is unclear, the river was more actively shifting channels and braiding in some locations at some time prior to 1894. During the Gold Rush, the Taiya River maintained two major branches in the Dyea area; the channel known as the West Branch Taiya River and later as Nelson Slough was a

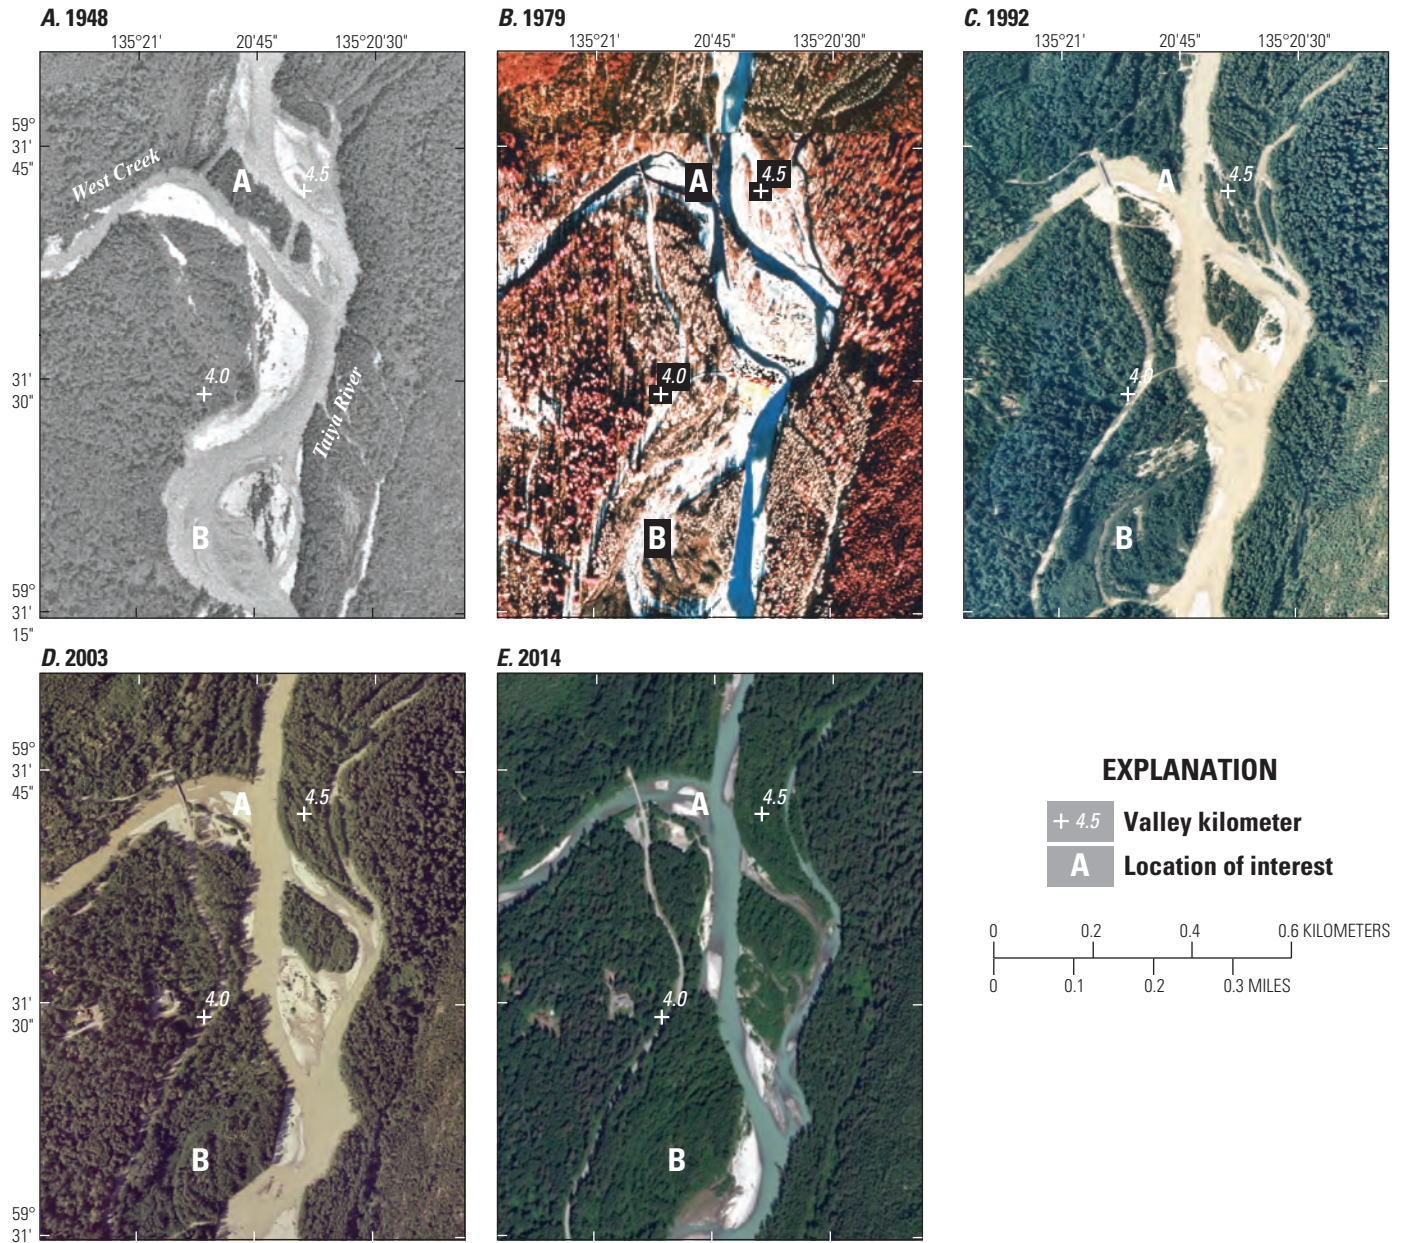
**Figure 21.** Changes to the confluence of West Creek and the Taiya River, Alaska, 1948–2014. *A*, 1948, black and white. *B*, 1979, color infrared. *C*, 1992, color. *D*, 2003, color. *E*, 2014, color. At the confluence, a bar separating the streams (location *A*) was eroded away by channel bend migration, moving the confluence location upstream and straightening the Taiya River channel. Downstream of the confluence, a bend (location *B*) elongated downstream then was abandoned between 1948 and 1979, reversed curvature by about 2003, and continued to erode the left bank (looking downstream) between 2003 and 2014.

At VK 3.5 (fig. 3 and just south of the area shown in fig. 21), channel change in the 1990s eroded the right bank (as viewed by an observer looking downstream) along the only developed bankside private property on the river and motivated the placement of riprap to protect the bank and large woody debris to redirect streamflow by the 2000s. Channel change at this location has involved complex reworking since at least 1948 that is likely associated with the natural reconfiguration of the West Creek confluence. Several episodes of meander migration immediately upstream (fig. 21, location B) resulted in reverse curvature of the 1948 meander and development of a new meander with an apex at VK 3.5. Erosion during 2017–18 continued to affect the left bank, as detected as by NPS monitoring (Richards and others, 2017) and seen in aerial imagery (table 2), and unprotected areas near the private property on the right bank.

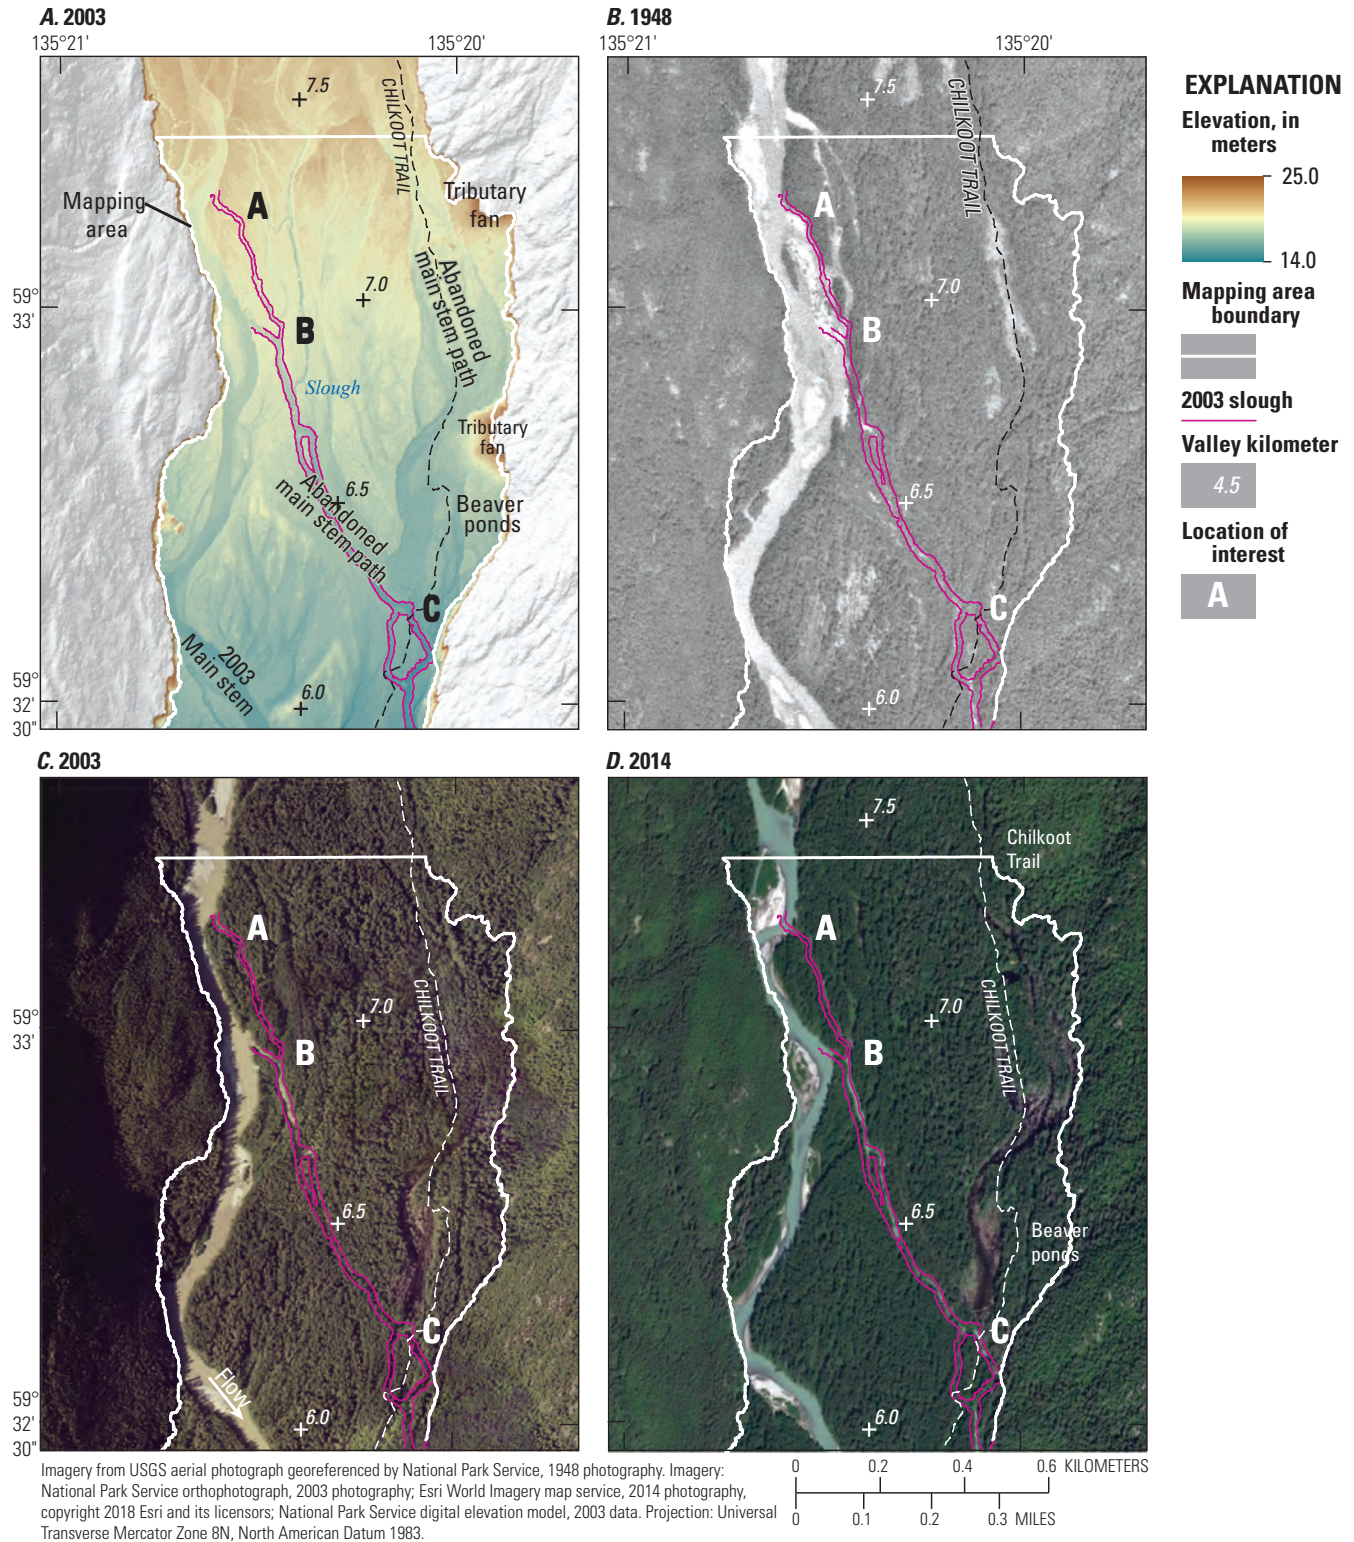
**Figure 22.** Changes to slough entrance conditions and constraints on slough flow path at valley kilometers (VK) 6.0–7.5, Taiya River, Alaska. *A*, Lidar elevation data for 2003 are shaded in 0.5-meter bands showing the upper part of the slough, which extends from VK 4.5 to 7.5, and a tributary stream through a series of beaver ponds (see ground photo in fig. 18*A*) confined within the wide flow path of a suite of former main stem channels abandoned between 1894 and 1948. *B* and *C*, The 1948 slough entrance upstream of location *A* and the part of the slough flowing through location *B* became inactive by 2003. *C* and *D*, Main stem migration near locations *A* and *B* and creation of a log jam near location *A* between 2003 and 2014 (completed by 2010) likely affected the amount of flow entering the slough. Increased flow damaged abutments for a Chilkoot Trail footbridge at location *C*. Main stem activated between 2003 and 2018 is mapped in figure 17.

Flow in Taiya River sloughs is highly dependent on entrance conditions, which changed at some sloughs in response to channel migration, uplift, or log jams. Field observations in 2017 showed that the former entrance to Nelson Slough was perched above likely river flood stages, indicating channel response to some combination of local channel slope change from meander cutoffs and valley uplift from isostatic rebound. Near the head of the VK 4.5–7.0 slough (fig. 22), local Taiya River channel migration and formation of a log jam in the main stem between 2003 and 2010 is inferred to have reapportioned discharge between the main stem and the slough entrances (locations A and B in fig. 22) to generate an increase in slough discharge that contributed to damage to a Chilkoot Trail bridge farther downstream, near prominent beaver ponds (location C in fig. 22). This slough is an underfit channel in abandoned main stem flow paths and, away from the main stem-dependent entrances, has adjusted its channel location only within the confines of the former main stem banks since 1948.

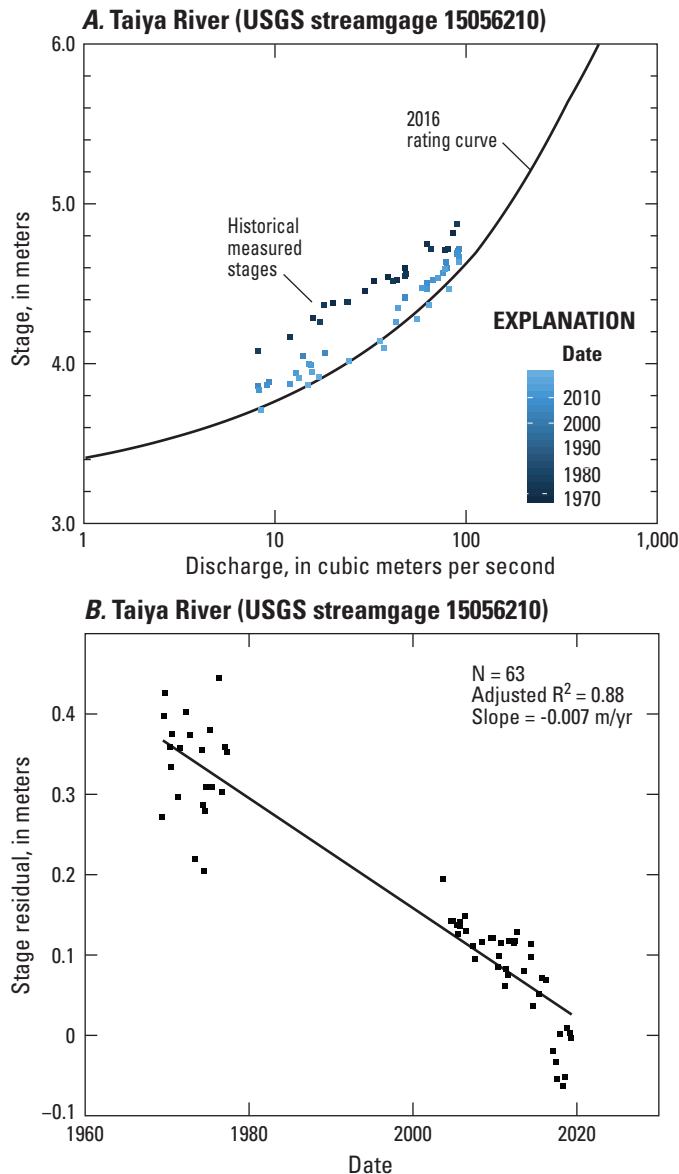
**Figure 23.** Incision inferred from changes in stage for a given discharge at U.S. Geological Survey streamgage at Taiya River, (15056210), Alaska. *A*, Selected subset of historical measured stage, by date, during 1969–2019 and the most recent rating curve, dated 2016. *B*, Regression line fitted to the differences (residuals) between the historical (measured) and recent (estimated from the rating curve) stages for a given discharge during 1969–2019. Positive differences indicate that the measured stage was higher than the stage estimated from the 2016 rating curve. [m/yr, meters per year]

Vertical channel change assessed from 1969–2019 stage at the USGS Taiya River streamgage shows apparent incision since 1969. Historically measured stages from 1969 and the 1970s streamgaging period are elevated above the stage estimated from the most recent (2016) rating curve for a range of discharges, as are many of the measured stages from the 2002 to 2019 streamgaging period (fig. 23A). Over the period of record, the historical–recent stage differences (residuals) for the subsetted discharge measurements show a downward trend (fig. 23B), even when considering only the most recent of the two streamgaging periods. A linear regression with an adjusted coefficient of determination ( $R^2$ ) of 0.88 fitted through the stage differences shows an average bed lowering of about 7 mm/yr at the streamgage over 50 years (1969–2019; fig. 23B). Factors not addressed by this analysis include the large gap between periods of data, the apparent elevated incision indicated for the most recent few years, the location of the streamgage at a relatively laterally stable location that might be more prone to incision as an adjustment mechanism, and the lack of any abrupt changes in the longitudinal profile (fig. 16). Additional analysis to conclusively quantify incision would need to examine these issues and seek to quantify downstream horizontal migration of river base level.

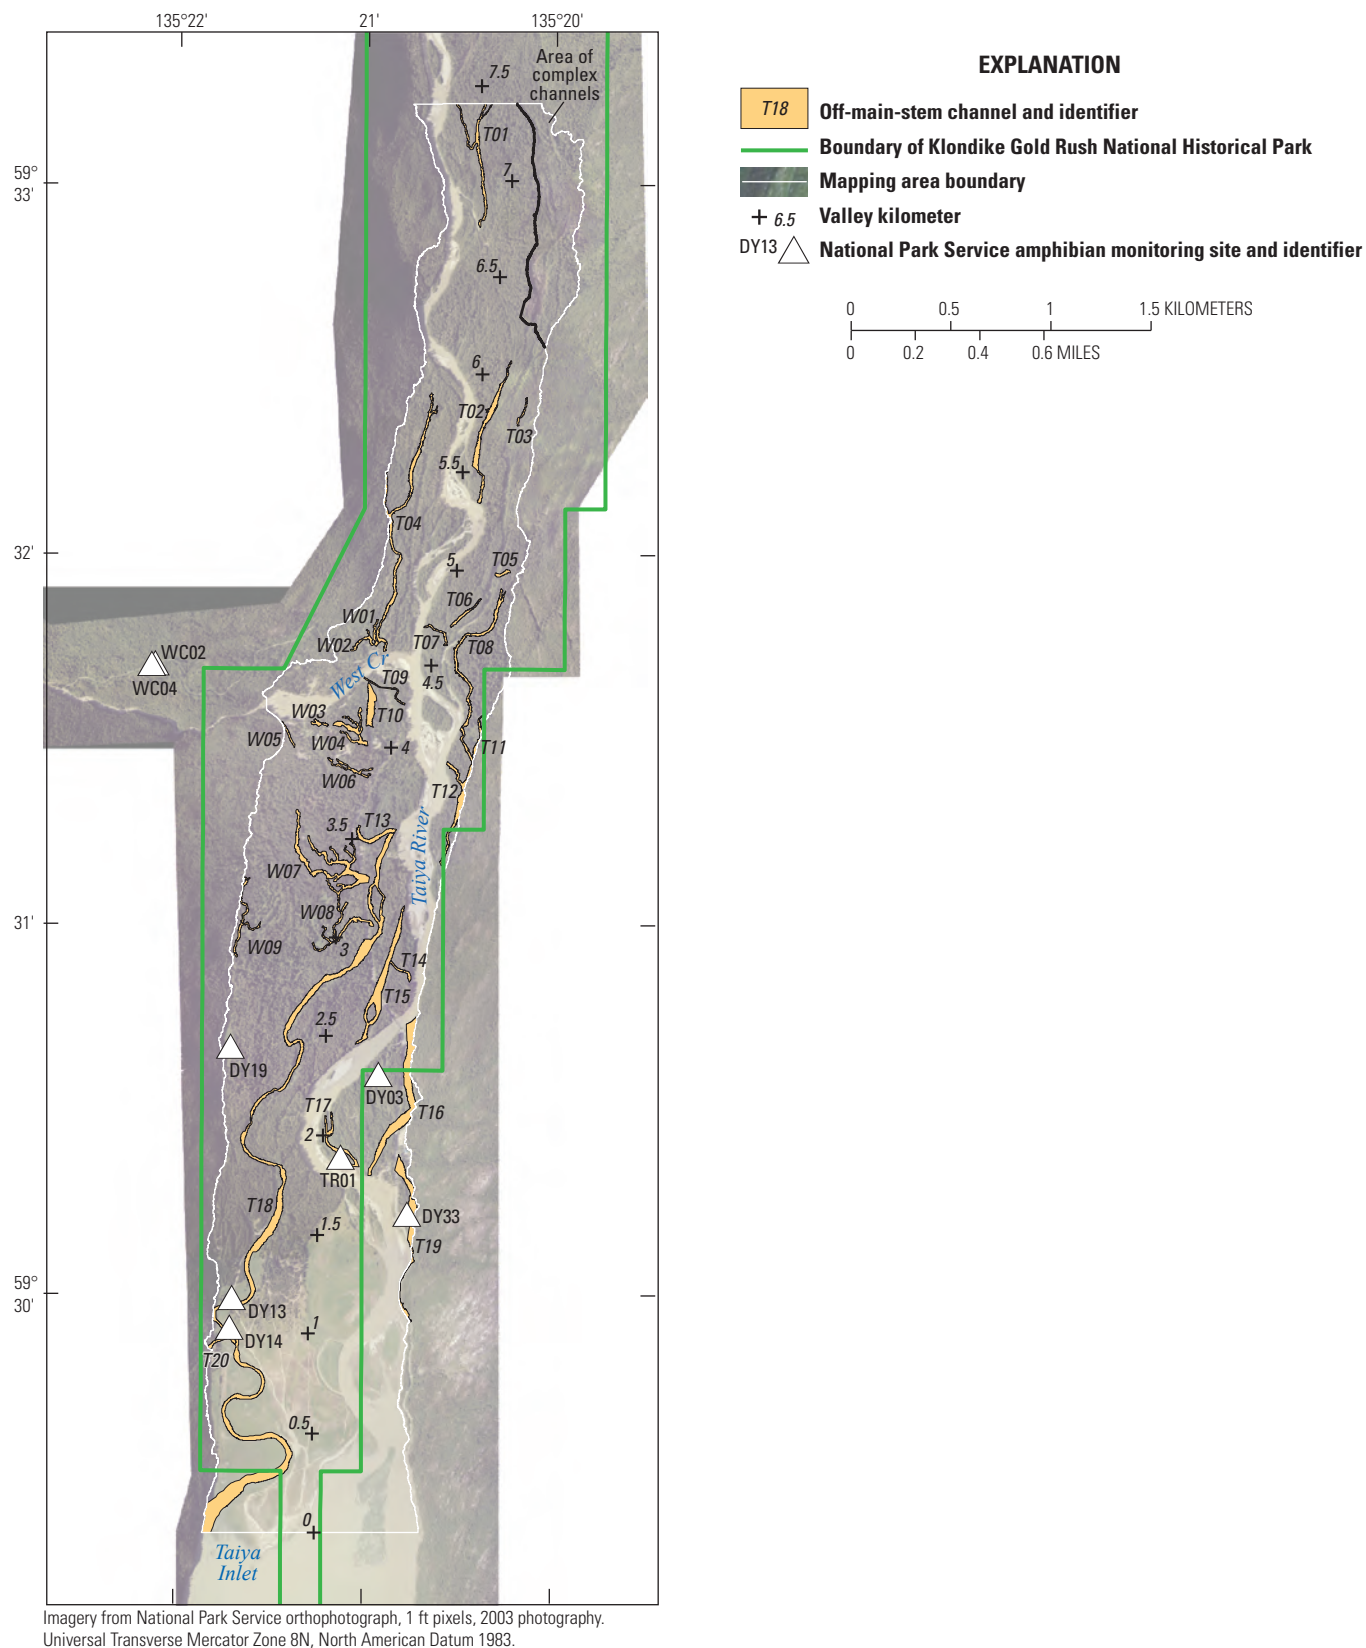
**Figure 24.** Off-main-stem channels in the lower 7.5 kilometers of the Taiya River valley bottom, Alaska, and amphibian monitoring sites maintained by the National Park Service.

[Site locations are shown by channel ID (arbitrary field identifier) in figure 24. Attributes are defined by short name in table 4. Abbreviations: ID, identifier; WY, water year; m<sup>3</sup>/s, cubic meters per second]
