# Hydrology and Geomorphology of the Taiya River Near the West Creek Tributary, Southeast Alaska

Scientific Investigations Report 2020–5059

By Janet H. Curran

Prepared in cooperation with the National Park Service

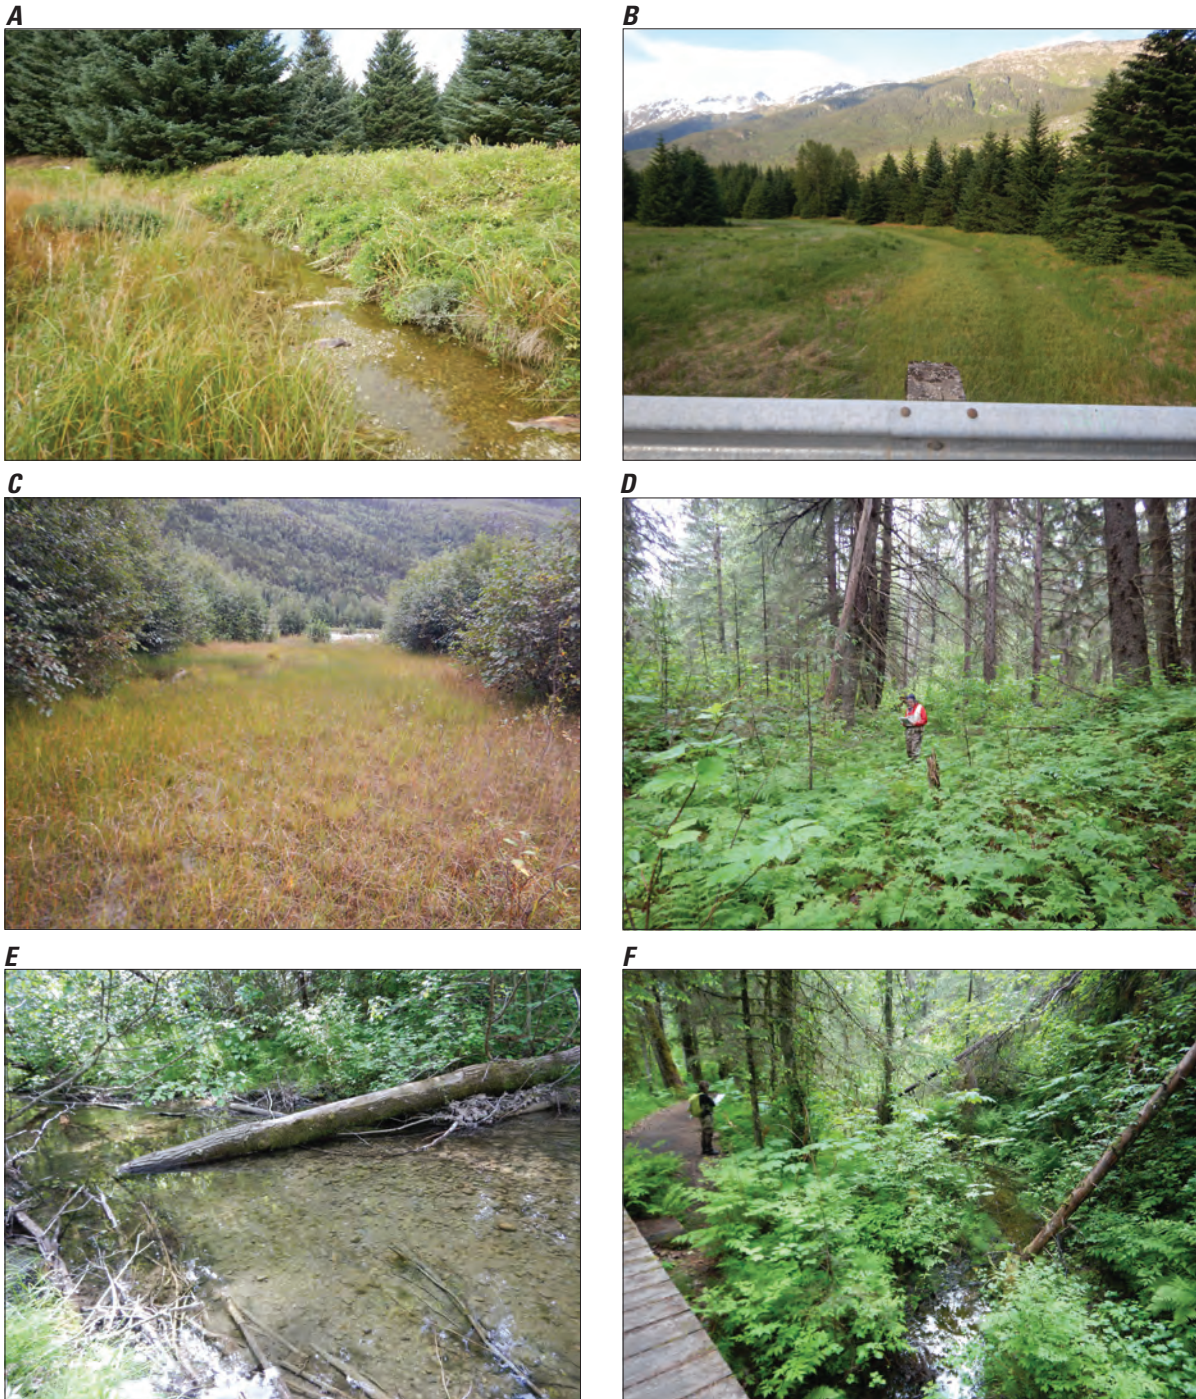
**Figure 25.** Photographs of examples of off-main-stem channels in the Taiya River valley bottom, Alaska. *A*, View upstream, post-spawning salmon carcasses in the tidally affected Nelson Slough (T18) immediately upstream of the confluence with Nelson Creek, valley kilometer (VK) 1.0, August 29, 2017. *B*, View downstream, wetlands in Nelson Slough (T18) at road bridge, VK 1.2, June 18, 2018. *C*, View downstream, shallow water in wetlands in channel T17, VK1.8, August 31, 2017. *D*, View upstream, author standing in center of channel W07, VK 3.3, no water present, June 17, 2018. *E*, View downstream, clearwater side channel in channel T02, VK 5.8, June 19, 2018. *F*, View upstream, Jami Belt of the National Park Service observing clearwater side channel in channel T11 upstream of Chilkoot Trail footbridge, VK 4.0, June 17, 2018. Photographs *A–C* and *E–F* taken by Janet H. Curran, U.S. Geological Survey; photograph *D* taken by Jami Belt, National Park Service.

than main stem processes. The presence of well-established grasses and shrubs but lack of trees (fig. 25D), the interconnected nature of the channels, and the truncation of some channels by Dyea Road indicate that the channels did not form under conditions over the past several decades but could have been active within the past 100 years. Origins for these apparently relict features could include smaller fan channels, groundwater sapping, or other processes not determined as part of this reconnaissance project.

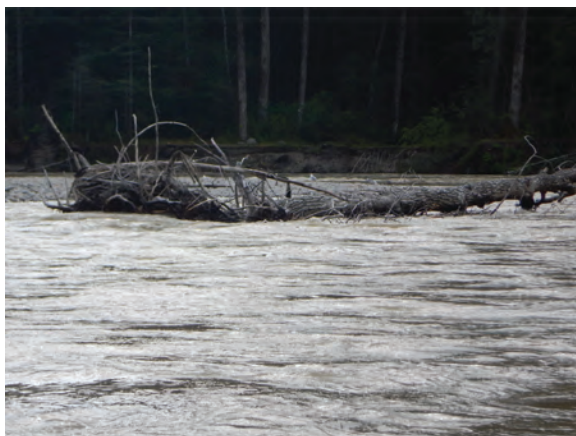
**Figure 26.** Large woody debris in mid-channel, Taiya River, Alaska. Photograph taken by Janet Curran, U.S. Geological Survey, August 30, 2017.

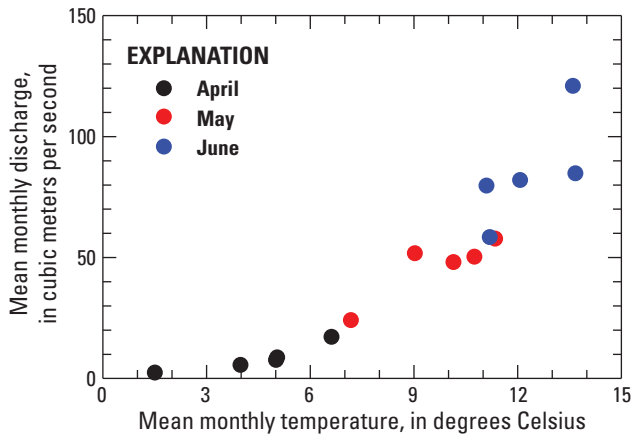
**Figure 28.** Mean monthly discharge during April, May, and June, 2012–16, in relation to mean monthly temperature for the Taiya River at U.S. Geological Survey streamgage 15056210, Alaska. Temperature data for the Taiya River are from the Western Regional Climate Center at <https://raws.dri.edu/cgi-bin/rawMAIN.pl?akATAI>.
