STRATEGIC ENGINEERING STUDY
No. 141

MINDORO (P.I.)

TERRAIN INTELLIGENCE

Prepared by
GEOLOGICAL SURVEY, U.S. DEPARTMENT OF THE INTERIOR
Under direction of
CHIEF OF ENGINEERS, U.S. ARMY

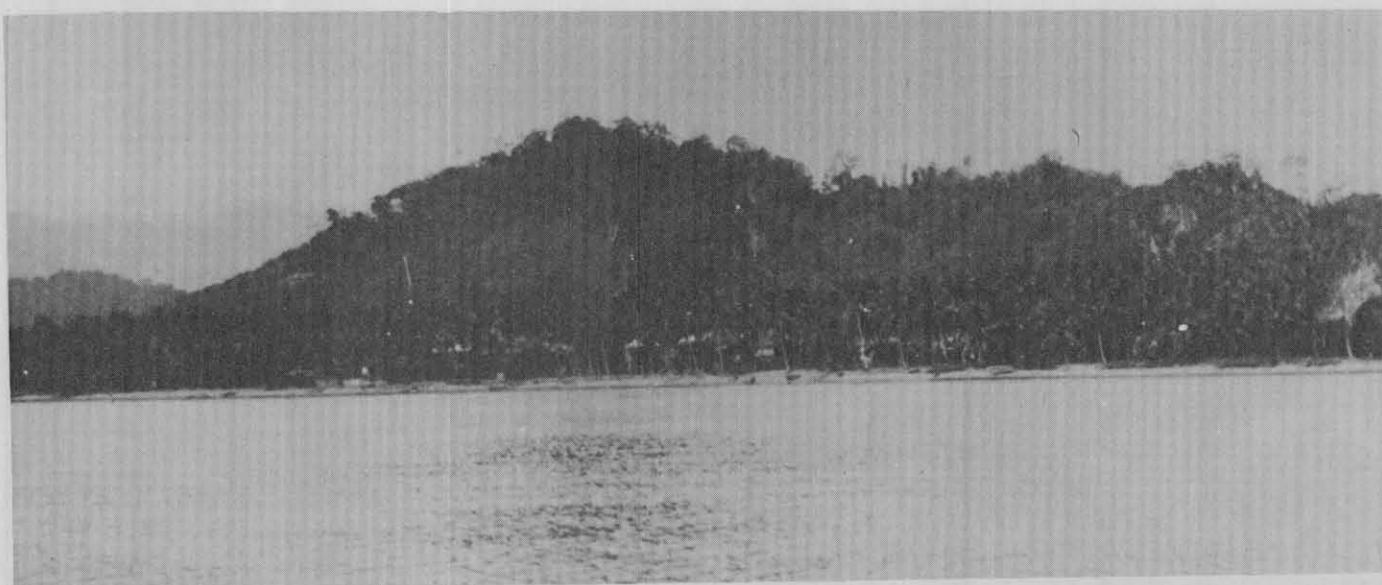
1 Narrow beach (Map Unit 1) planted with coconut palms, backed by wooded hills and mountains (Map Unit 3). Looking southwest toward San Teodoro. (ONI 272-438)

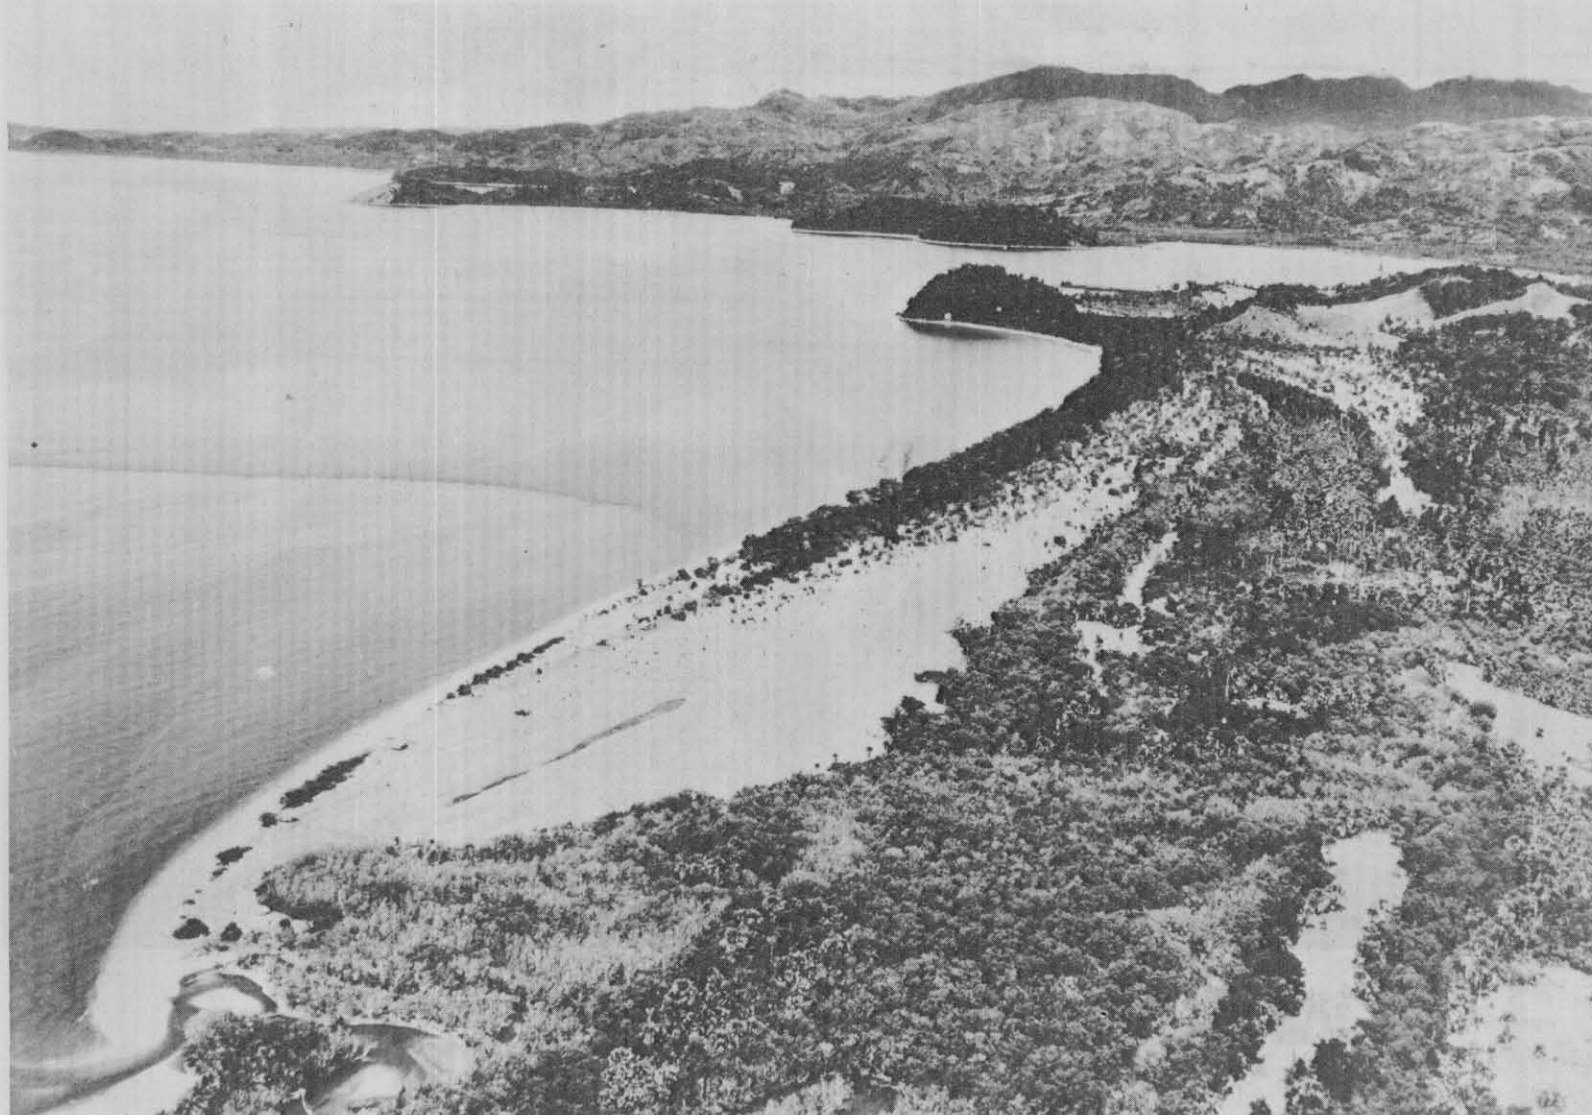
4 Beach fronting eastern coastal lowlands (Map Unit 1) in foreground; rough mountains (Map Unit 3) in far background. Foreground shows southern edge of mangrove swamp and Wasig landing field. Looking southwest across Mansalay Bay. (21250 A. C.)

For Sites 2 and 3 see Terrain Views 2 and 4.

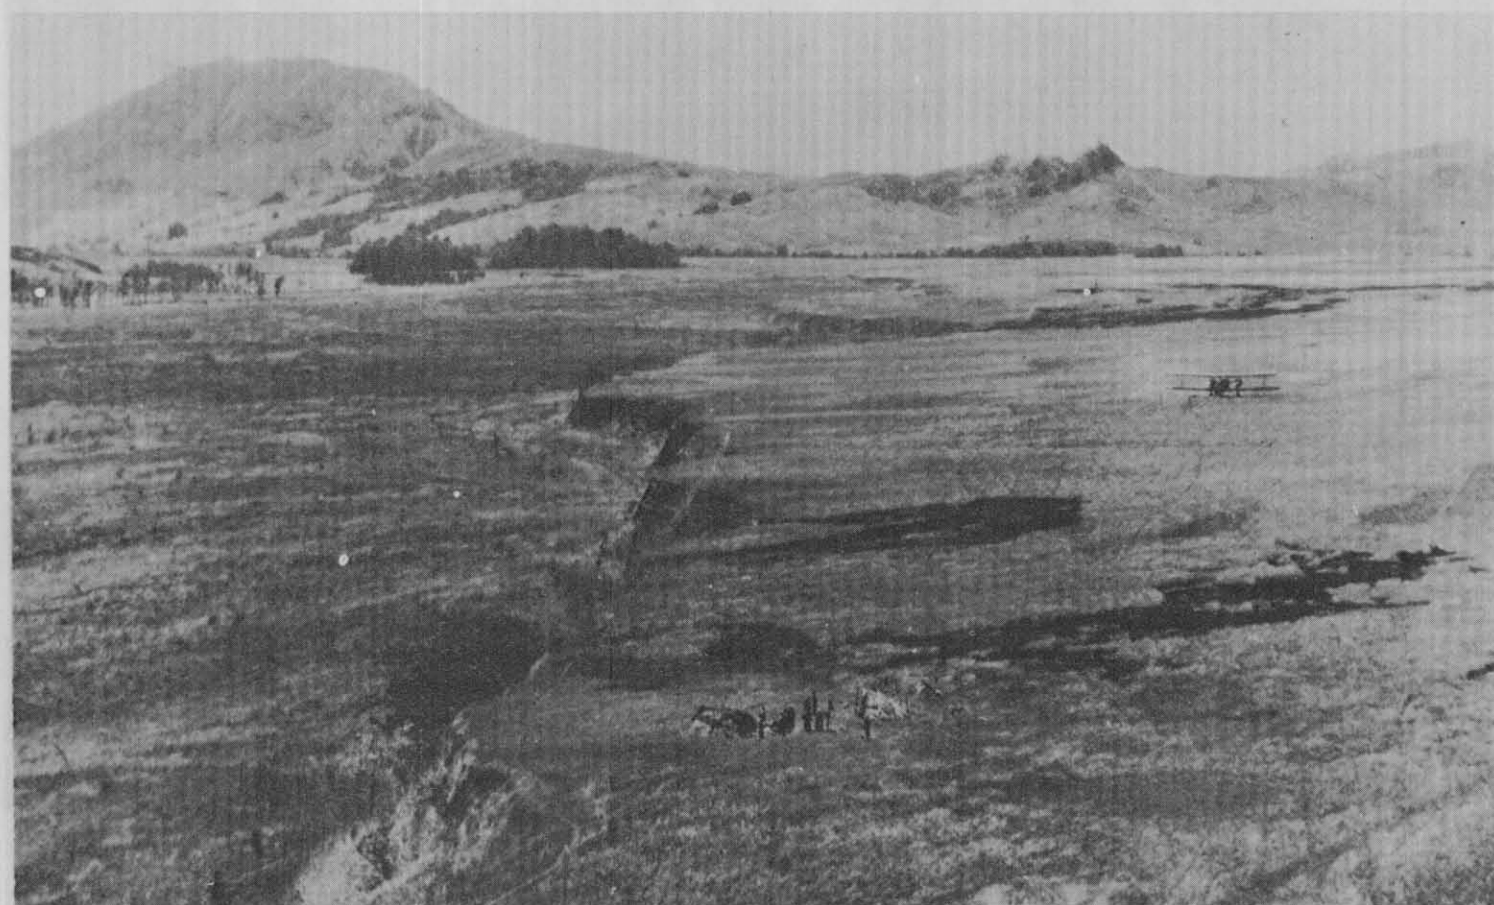
7 Grass-covered terrace common along streams in southern part of Map Unit 2. River floodplain to the left of terrace; southern mountains in background (Map Unit 3). Terrace bordering Bugsanga River, near site of Tamarac airfield. (ONI 322-684)

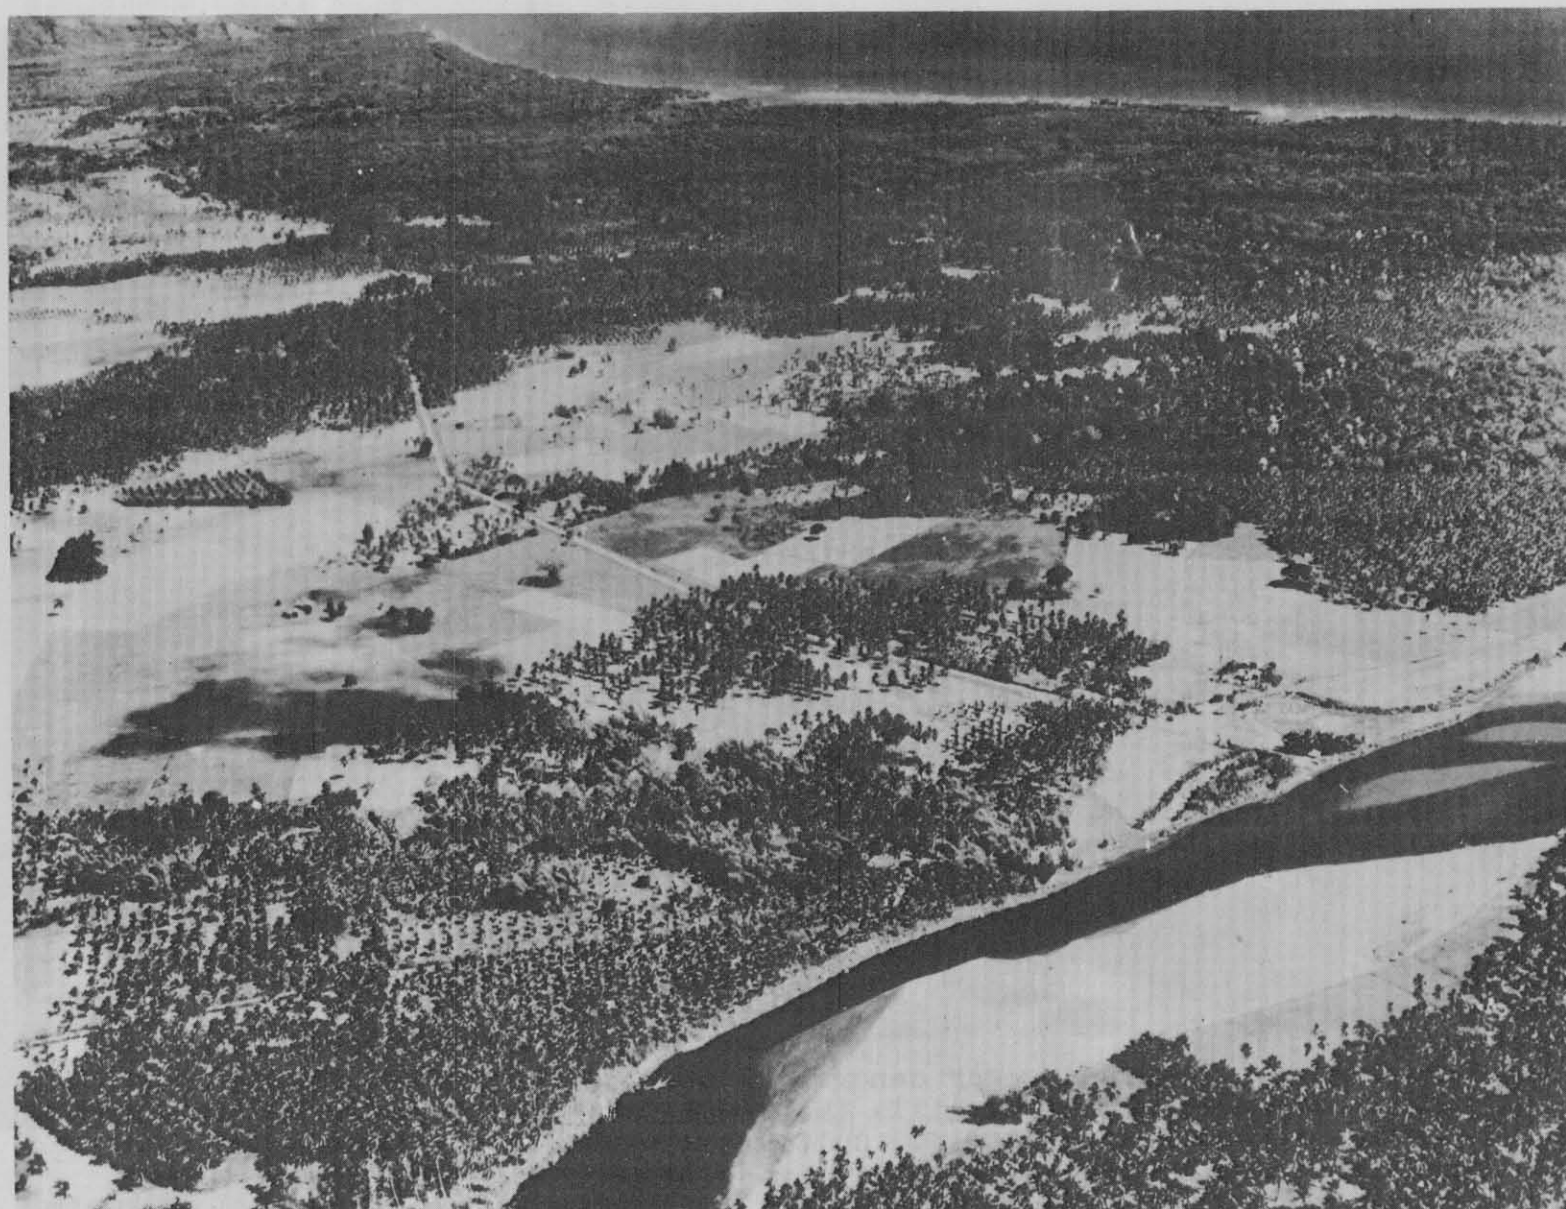
2 Coastal lowlands (Map Unit 1) west of Naujan. Coconut palms planted on better-drained natural levees along rivers; probably rice paddies on poorly drained interstream areas; coconut palms mixed with casuarina and perhaps screw pine in sandy beach sections nearer shore. Much sand and probably some gravel banks along river in foreground. Hills east of Calapan (Map Unit 1) in left background. Looking northwest. (A. C. 21257)

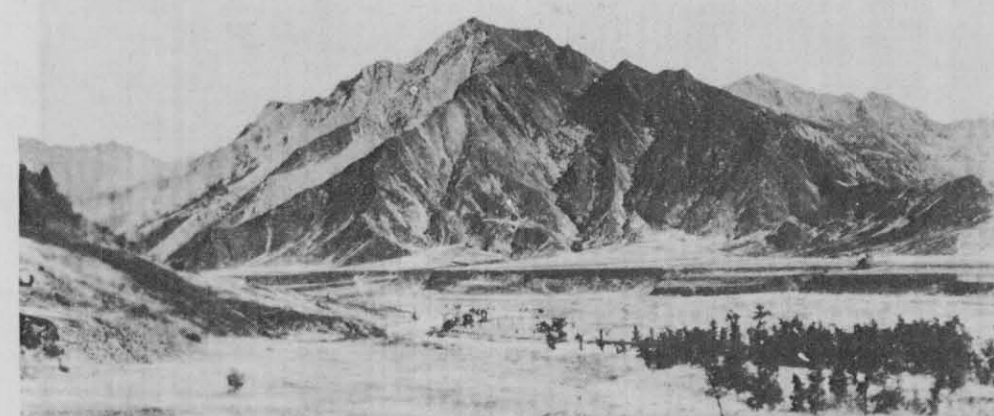
5 River channel cut below terraces along Lumintao River (Map Unit 2) with mountains (Map Unit 3) rising steeply above lowlands. Such terraces are common in Map Unit 2. (See View 7). (MIS 1648.245)

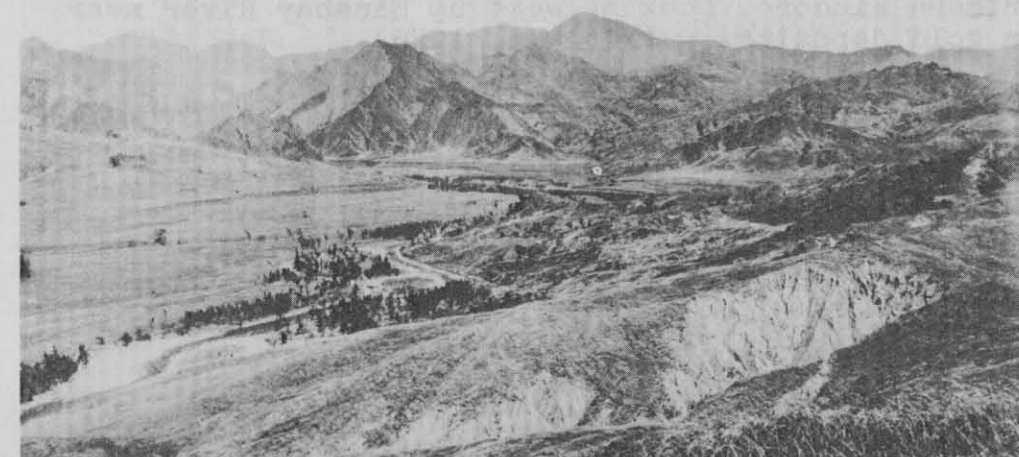
6 Valley of Lumintao River (Map Unit 2) with mountains rising sharply from valley flat Map Unit 3). Looking northeast. (MIS 1648.248)

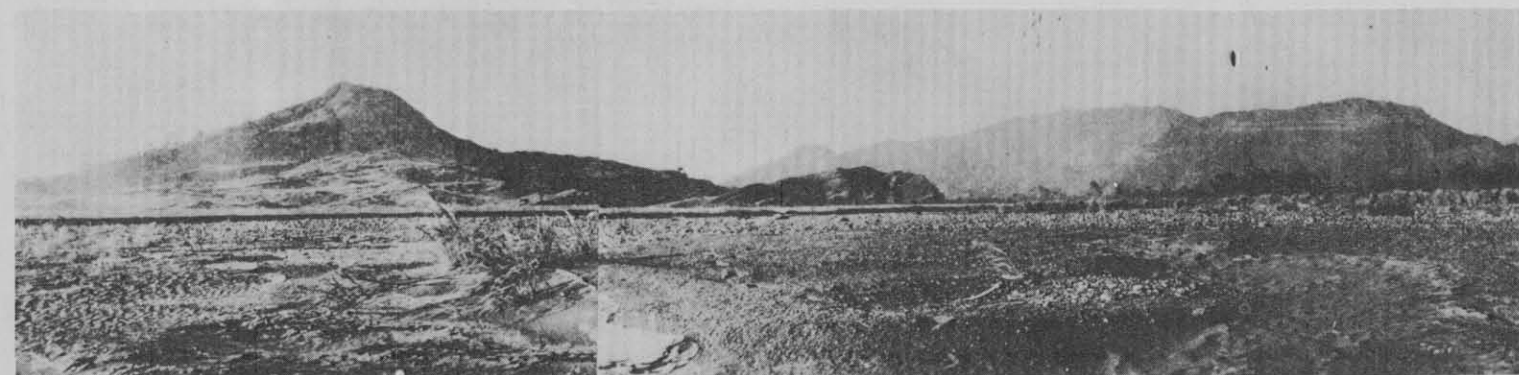
8 Sandy and gravelly bed of Bugsanga River (Map Unit 2) in foreground; edge of terrace and high hill on terrace in middle ground; mountains (Map Unit 3) right background. Looking north. (MIS 1648.267, 1648.267A)

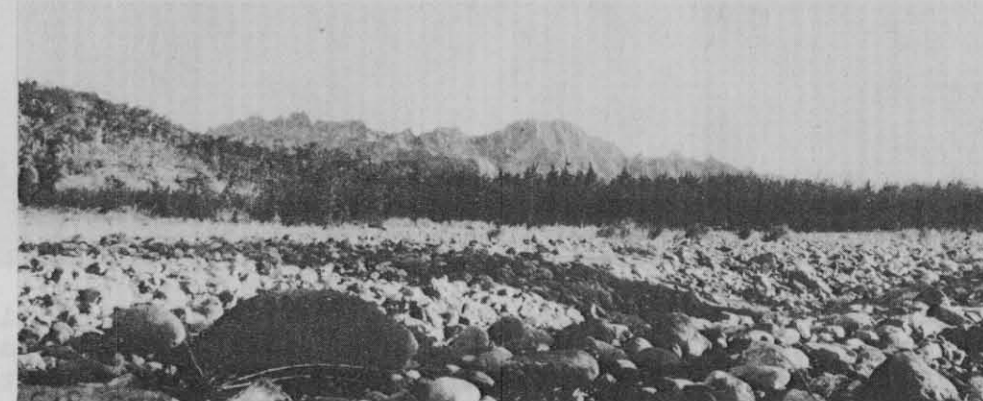
9 Bouldery bed of Bugsanga River (Map Unit 2) during dry season; mountains (Map Unit 3) on left and in background. Such bouldery beds are characteristic of the streams near and in the foothills. Looking northeast. (MIS 1648.250)

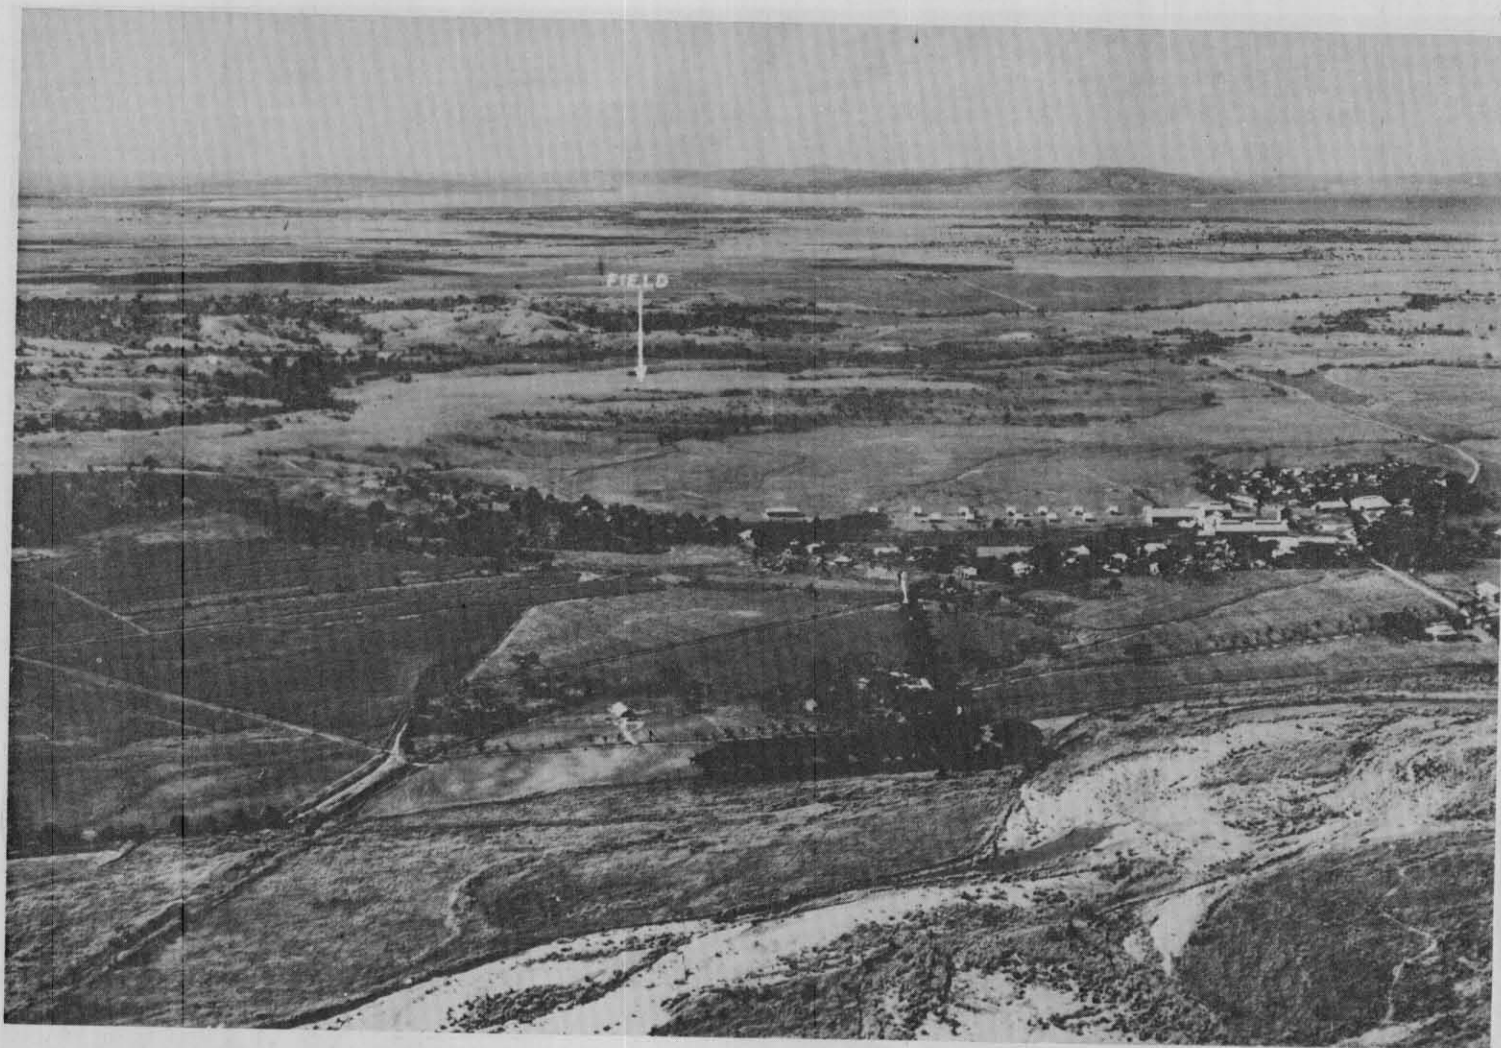
10 San Jose and sugar central on west coastal lowlands (Map Unit 2); low undulating hills (Map Unit 2) in middle ground on which is San Jose airfield. Cultivated fields are in sugarcane. View to south towards Mangarin Bay. (21204 A. C.)

Site 10. Landing field east of San Jose; looking south-southeast. (CFL 1657525) See also Terrain View 10.

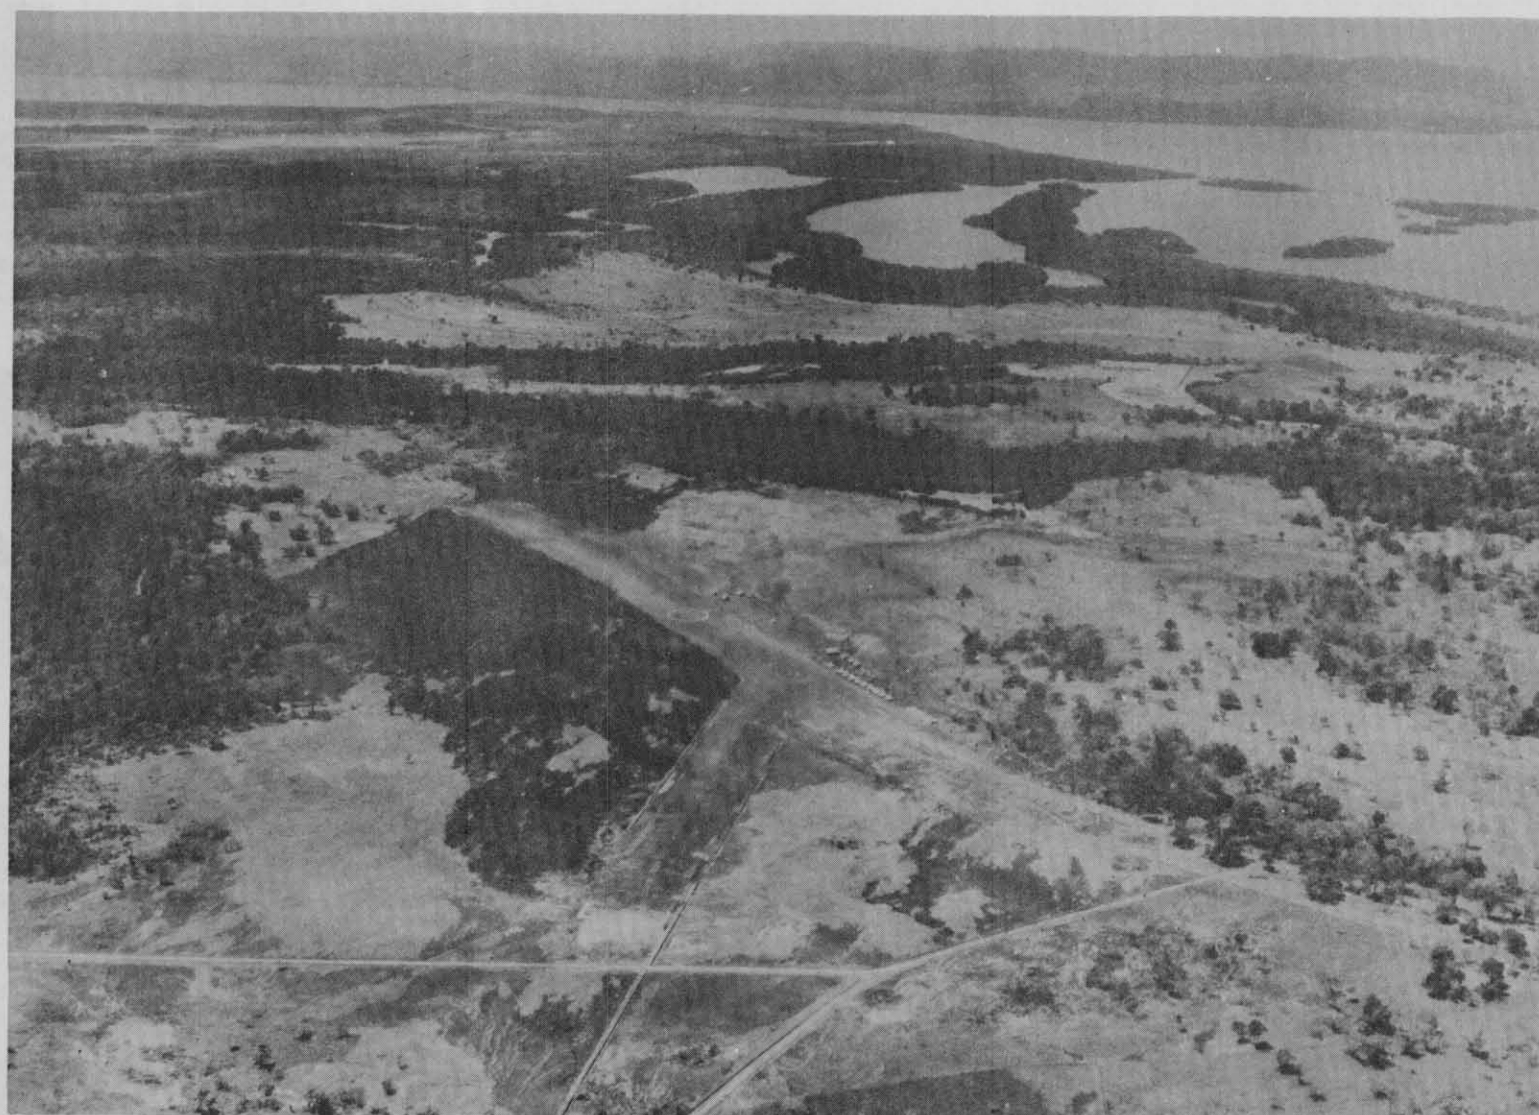
11 West coastal lowlands (Map Unit 2) with Mangarin Field in foreground, mangrove swamps along shore. Ilin Island in background. Pattern in black area left of landing strips is in burned cogon grass. Looking south. (ONI 320-253)

Site 6. Mangarin (Watrous) field, east and north of Mangarin Bay; looking north. (ONI 320-254) See also Terrain View 11.

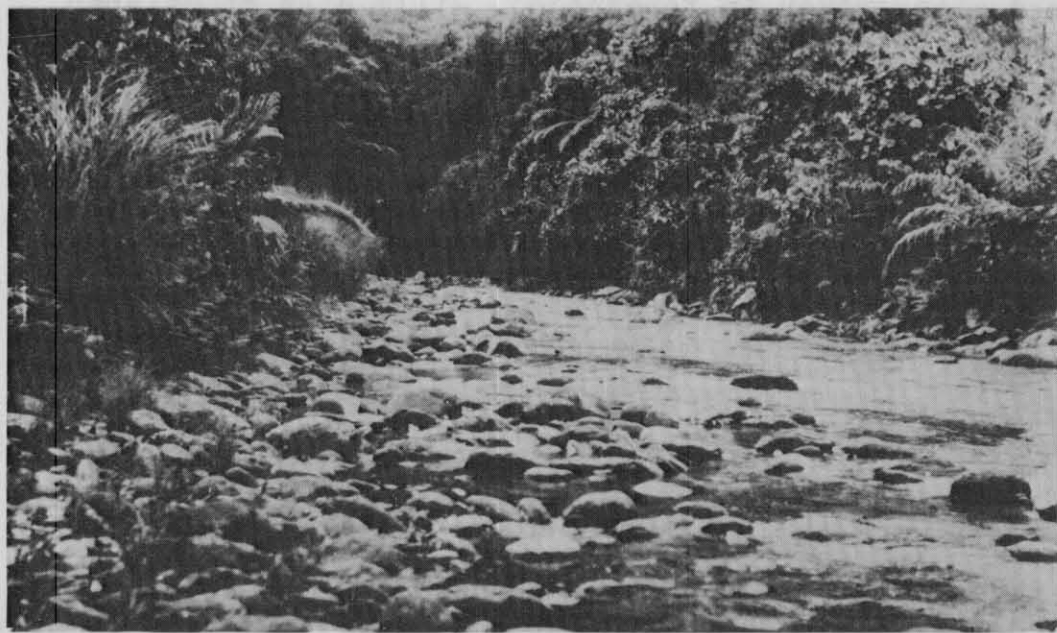
12 Typical swift stream with boulders in bed and thick vegetation along banks; typical of mountains (Map Unit 3) of northern Mindoro. Looking west up Binabay River near placer gold deposits. (Millard, 1936)

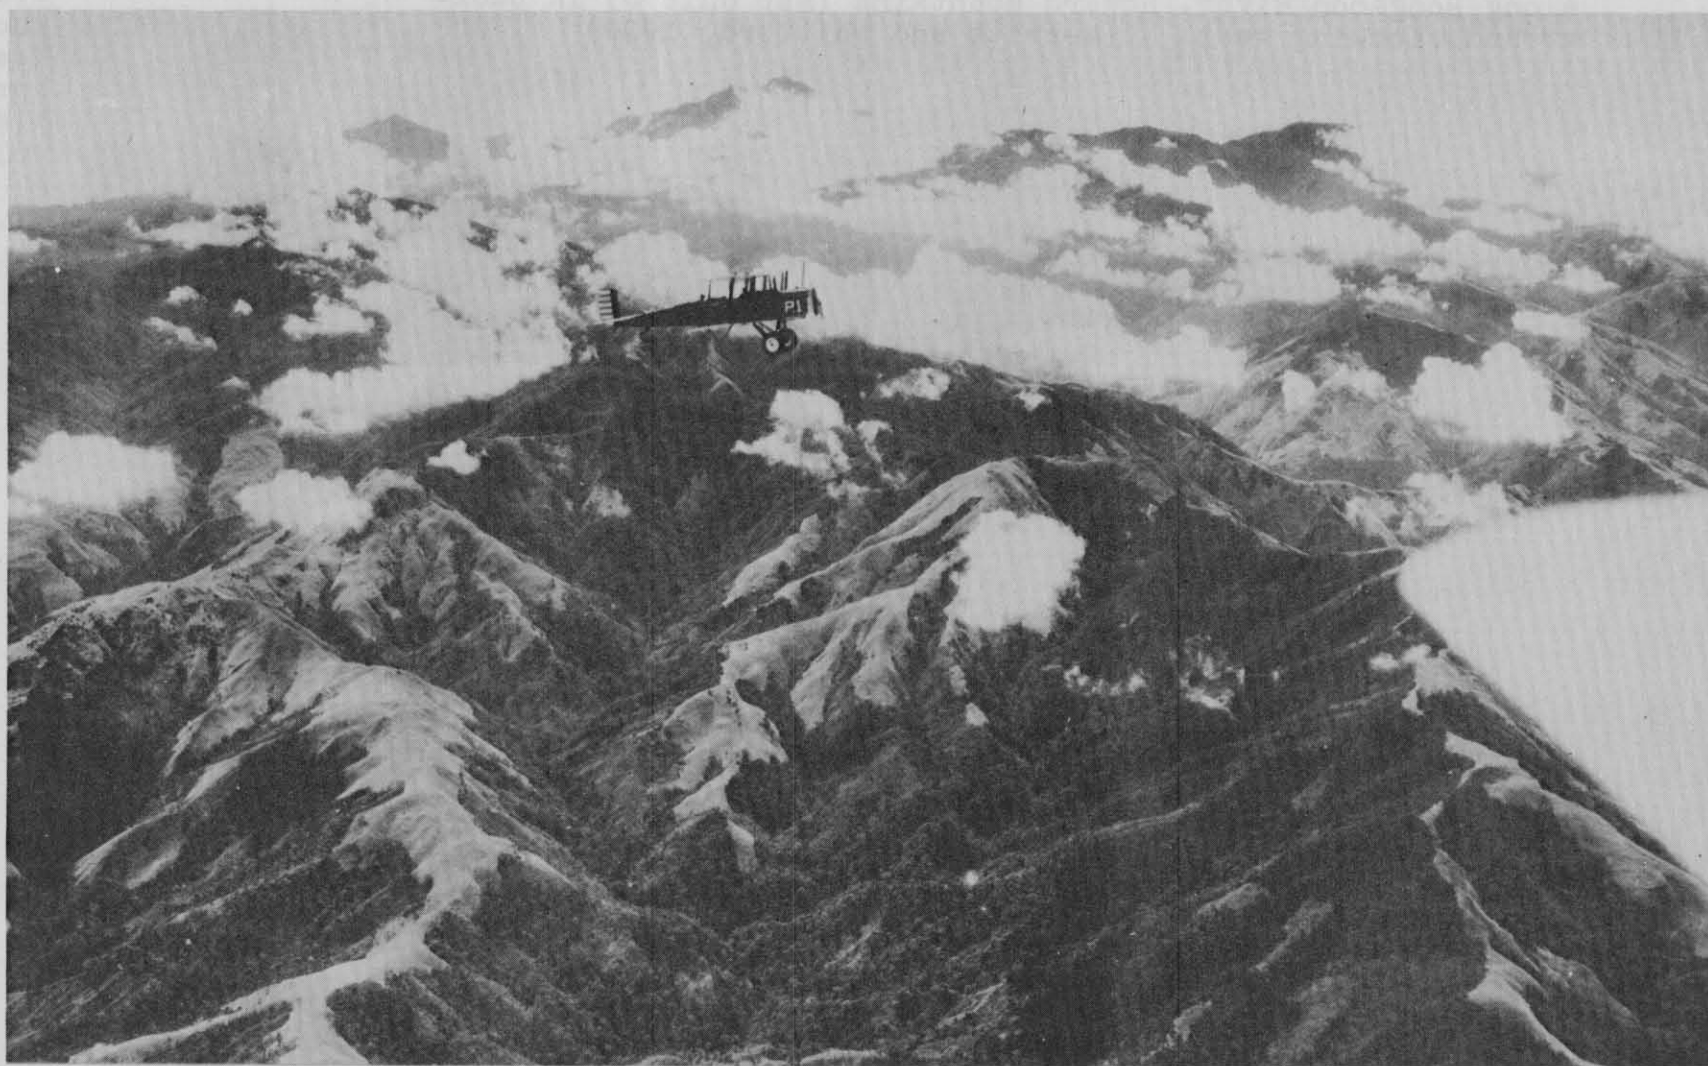
13 Rugged forested mountains (Map Unit 3) of northern Mindoro; many ridge crests are grass covered. Probably looking towards Mt Halcon. (ONI 50554)

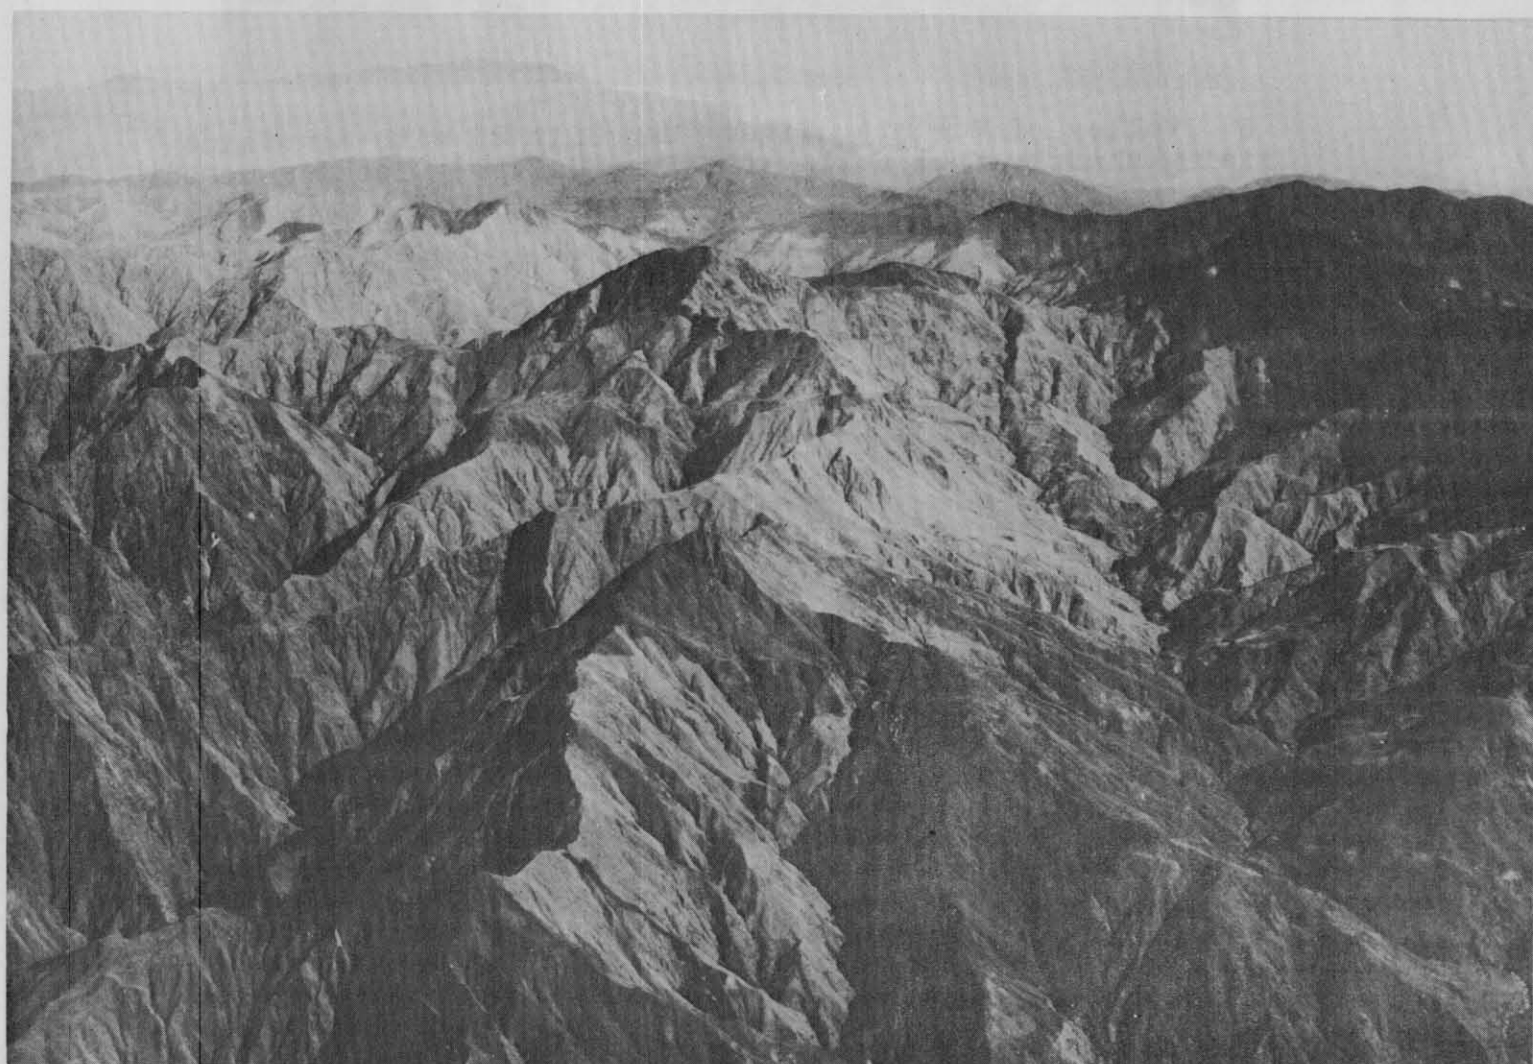
14 Extremely rugged grass-covered mountains (Map Unit 3) in southwestern Mindoro. Such terrain prevents operations in much of the interior of the island. Looking north from northeast of San Jose. (ONI 72892)

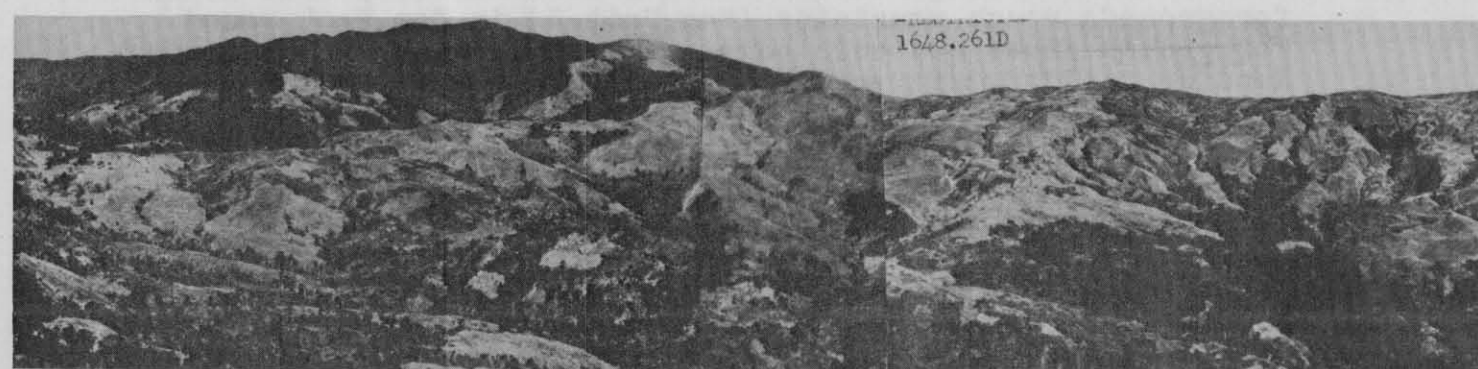
15 Lower mountain slopes (Map Unit 3) in southern Mindoro. Most ridge tops grass covered with trees in ravines. (MIS 1648.261A, 1648.261, 1648.261D)

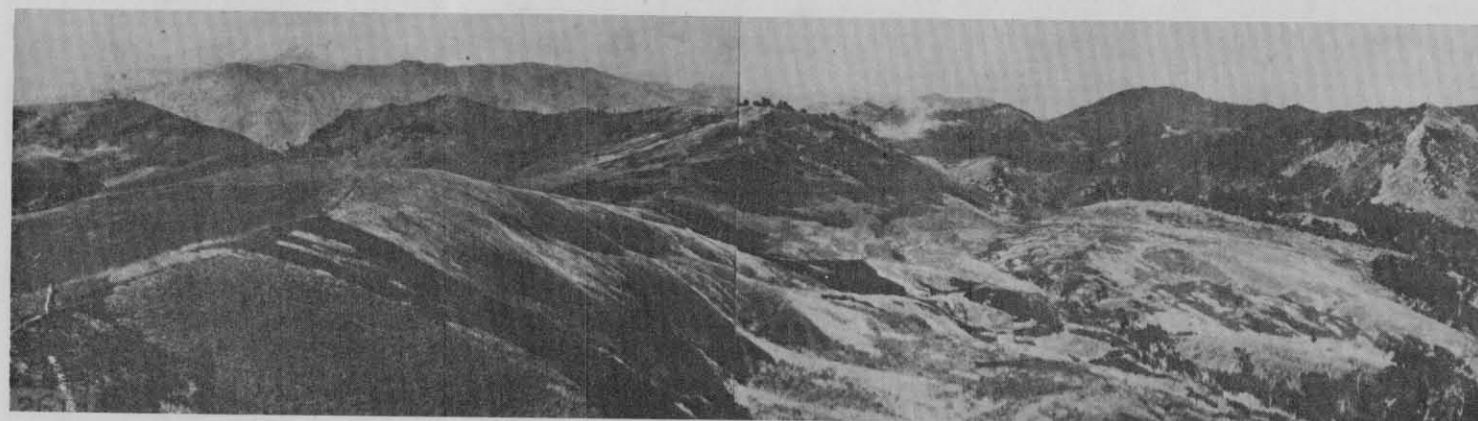
16 Mountainous upland (Map Unit 3) in southern Mindoro; mostly grass covered with trees in valleys and ravines; high cloud-covered mountains in left background. Note trail along ridge crest, typical of most mountain routes. (MIS 1648.261C, 1648.261B)

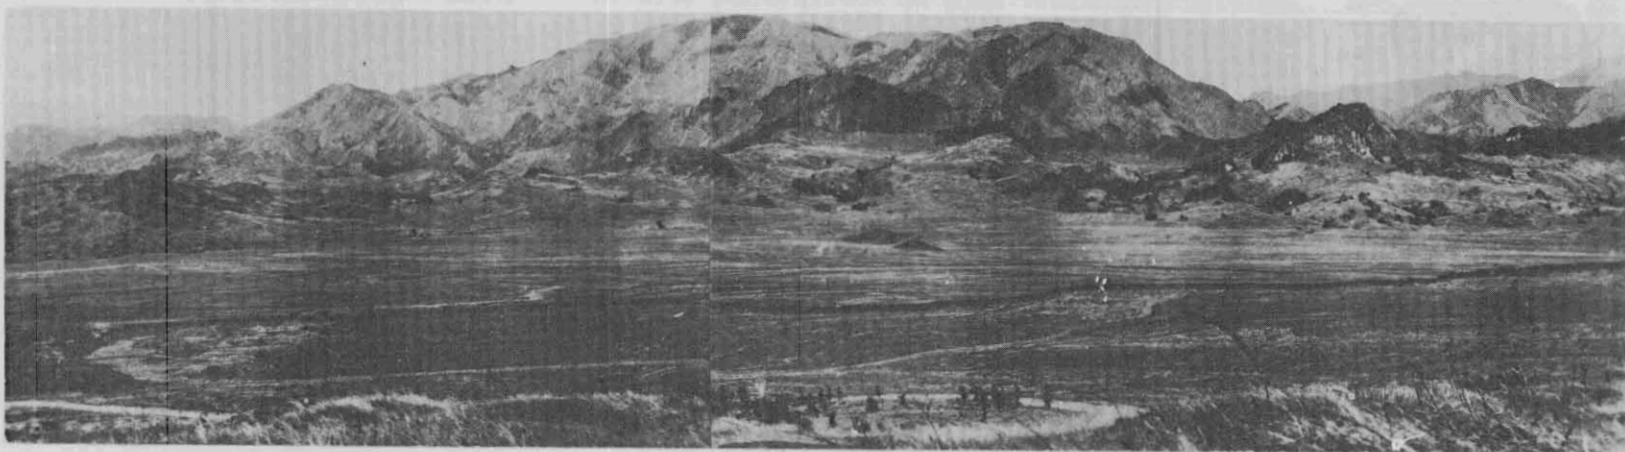
Site 7. Tamarao field; looking east. River terrace on east side of Bugsanga River. (MIS 1648.262 - 1648.262A)

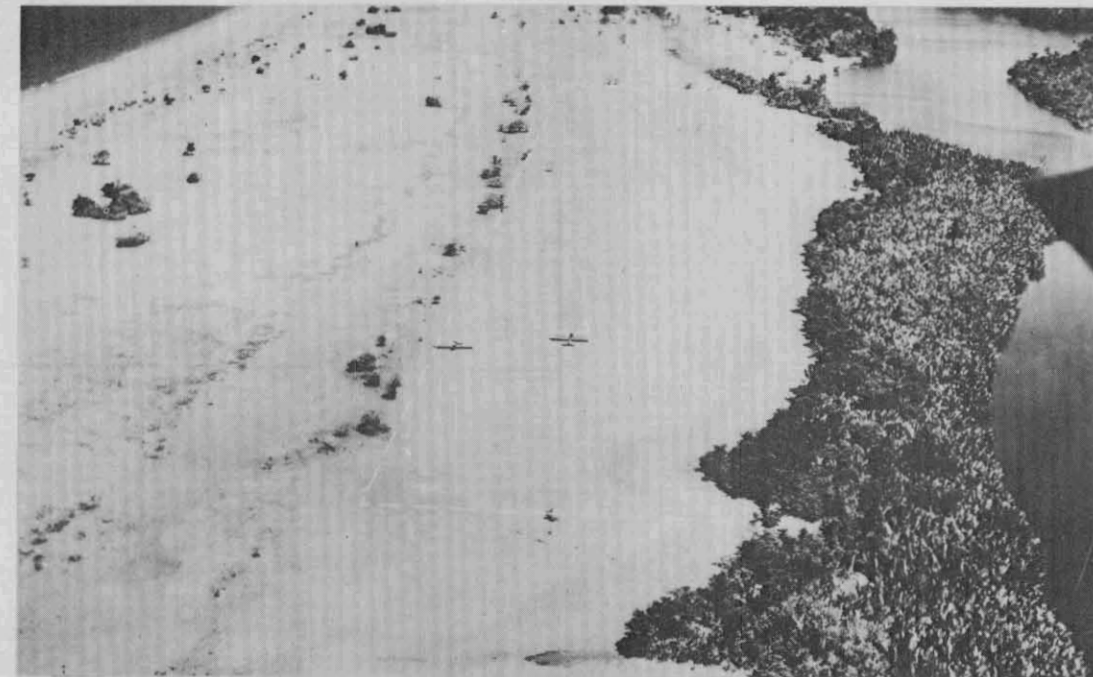
Site 8. Landing strip south of Barahan; looking north. (21271 A.C.)

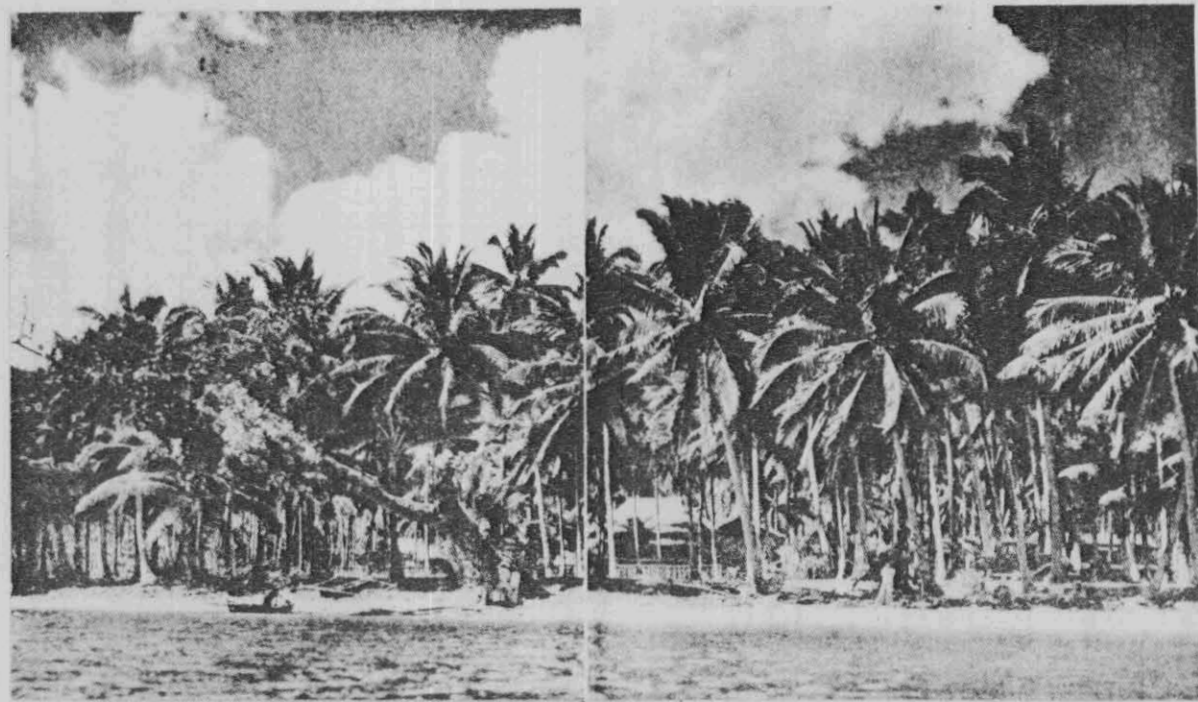
1 Typical stand of coconut palms along beach, restrict ground observation and provide fairly good concealment from aerial observation; movement easy, clearing light. Trees regularly spaced in well-organized plantations. (Craig, Philippines and Filipinos of Yesterday, Manila, 1934)

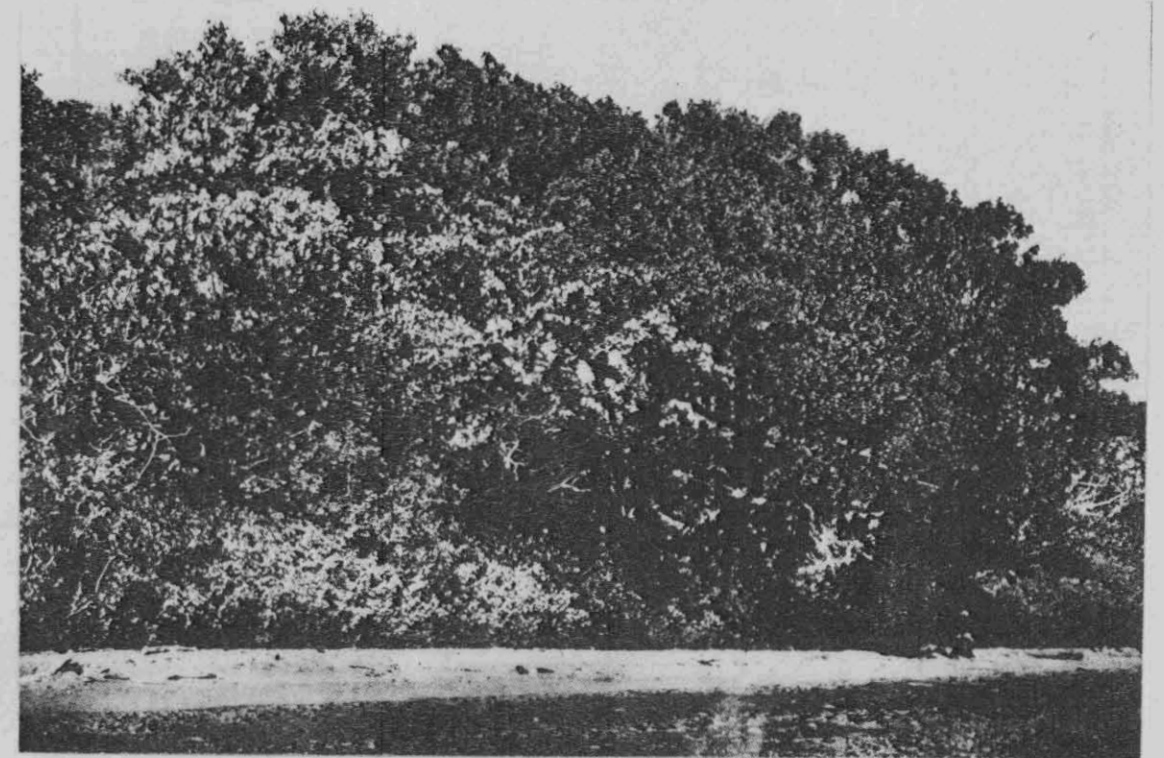
3 One type of beach flora; dense forests hamper movement and visibility, provide good concealment. Casuarina beaches are more open. (Whitford, Forests of the Philippines)

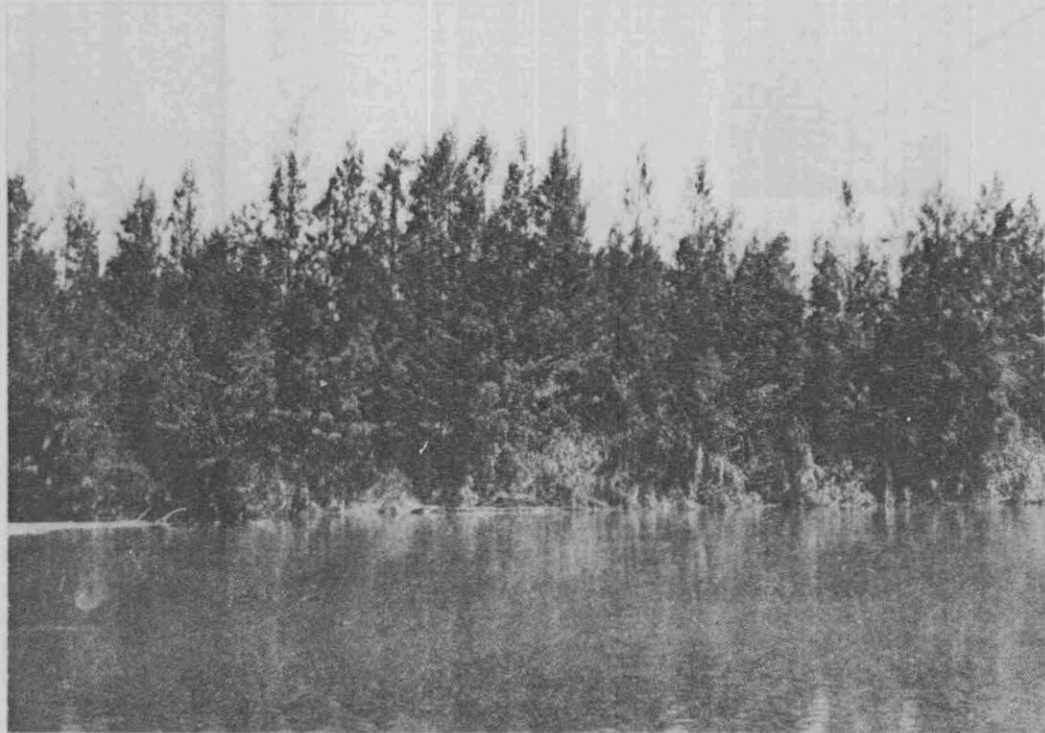
4 Casuarina trees, found along some beaches and streams on Mindoro. View does not show typical character; such forests usually open and commonly free of brush; easily penetrated by motor transport and foot troops. Good concealment. Grows in sandy soil. Wood heavy and hard. View along Bongabon River. (Merritt and Whitford, Bull. 6, Bur. Forestry, 1906)

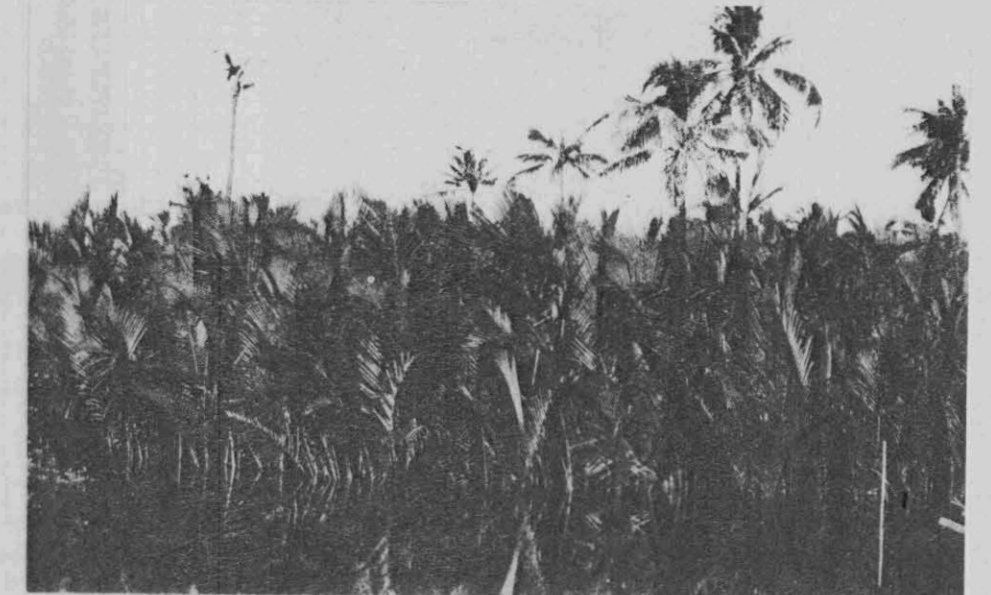
6 Uncultivated nipa swamp. Difficult to penetrate, except in places where small boats can be forced through. (Brown, W. H., and Fischer, A. F., Philippine Mangrove Swamps, Philippine Bur. Forestry, Bull. 17, 1918)

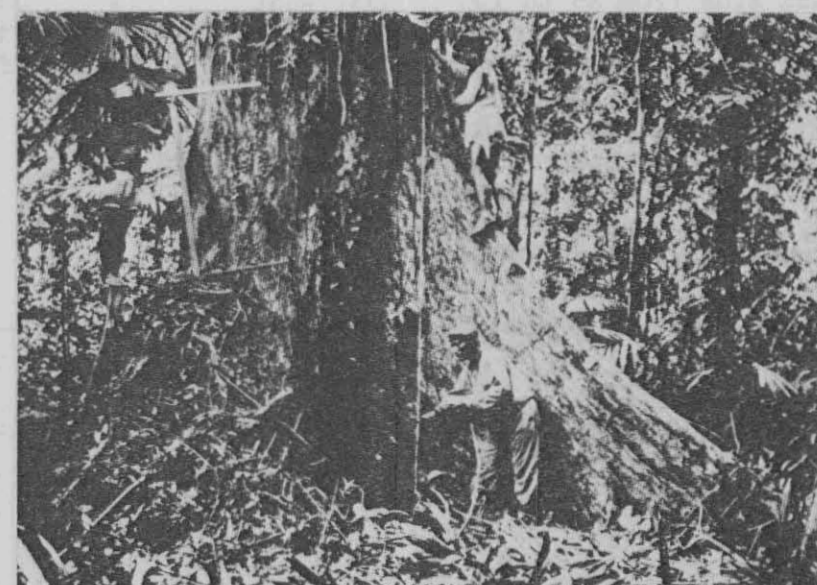
13 Base of trunk of large forest tree in primary forest, showing root buttresses. Commonly four or five such buttresses, up to 20 feet in height, 10 feet long at base and a few inches to a foot thick, radiate from trunk; provide limited cover for personnel. (Whitford, Forests of the Philippines)
