STRATEGIC ENGINEERING STUDY
No. 141

MINDORO (P.I.)

TERRAIN INTELLIGENCE

Prepared by
GEOLOGICAL SURVEY, U.S. DEPARTMENT OF THE INTERIOR
Under direction of
CHIEF OF ENGINEERS, U.S. ARMY

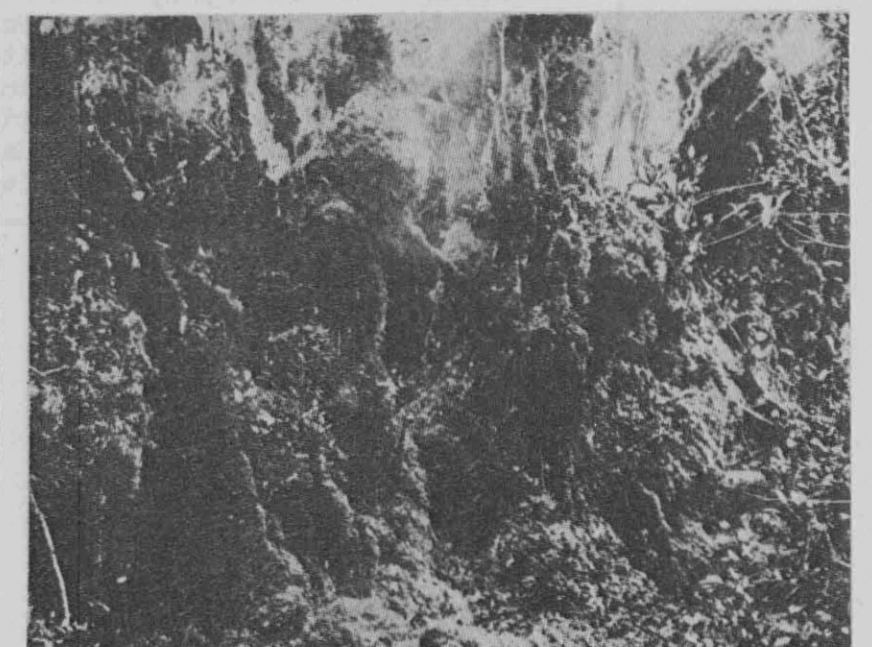
14 Mossy forest. This type of growth may extend as low as 3,000 feet, depending on prevailing cloud level. The tangle of roots and underbrush is covered with mosses which are continually saturated with moisture. (Janis)
