SUBSURFACE AND SURFACE WASTE-DISPOSAL PRACTICE ON ISLAND OF HAWAII

SUBSURFACE AND SURFACE WASTE-DISPOSAL PRACTICE ON THE ISLAND OF HAWAII

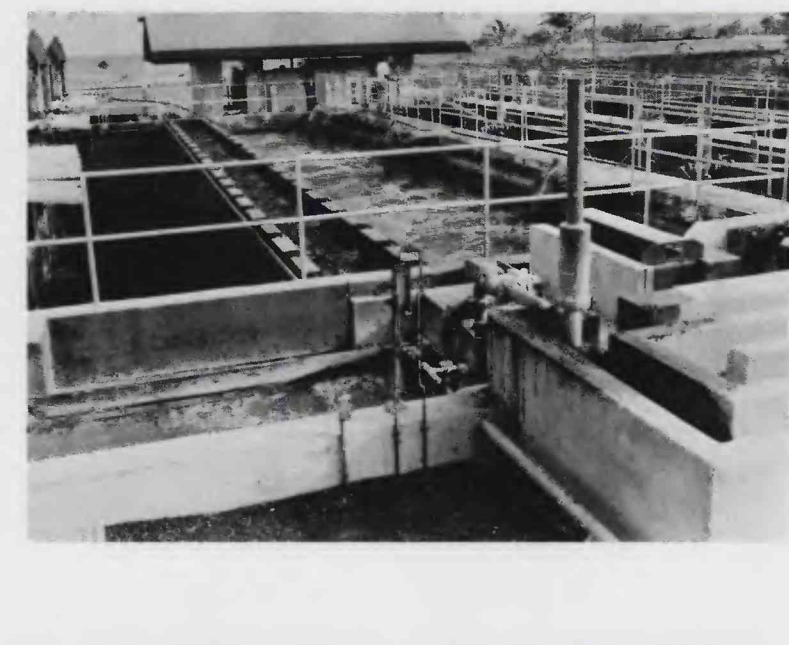
FIGURE 6. PHOTOGRAPH OF SITE 21, KEAHOU SEWAGE-TREATMENT PLANT

The injection well for heated water at the Hilo Electric Co. is shown in figure 5. A photograph of site 21, the Keahou sewage treatment plant, is shown in figure 6.
