SUBSURFACE AND SURFACE WASTE-DISPOSAL PRACTICE ON KAUAI

HYDROLOGIC CONDITIONS RELATED TO SUBSURFACE AND SURFACE DISPOSAL OF WASTES IN HAWAII

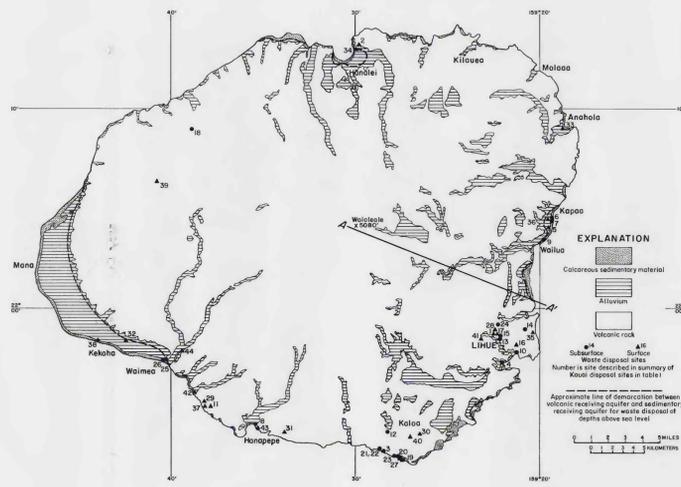
FIGURE 1. MAP OF KAUAI SHOWING GENERALIZED GEOLOGY, WASTE-DISPOSAL SITES, AND PRINCIPAL WASTE-RECEIVING AQUIFERS.

There are at least 19 subsurface waste-disposal sites in areas not serviced by sewers. At four of these sites, untreated sewage is disposed of in multiple cesspools. At some others, effluent from small private aerobic treatment plants is injected into the subsurface. At five other disposal sites, treated sewage effluent is discharged to sugarcane irrigation ditches. At the large resort complex near Hanalei, some treated sewage is used for the irrigation of a 27-hole golf course. Wastes from sugar mills are ponded in five locations and used for irrigation and landfill. These sites and other surface-disposal sites, including solid-waste dumps, are shown on the simplified geologic map (fig. 1, sheet 5). Subsurface waste-disposal sites are shown on the same figure.

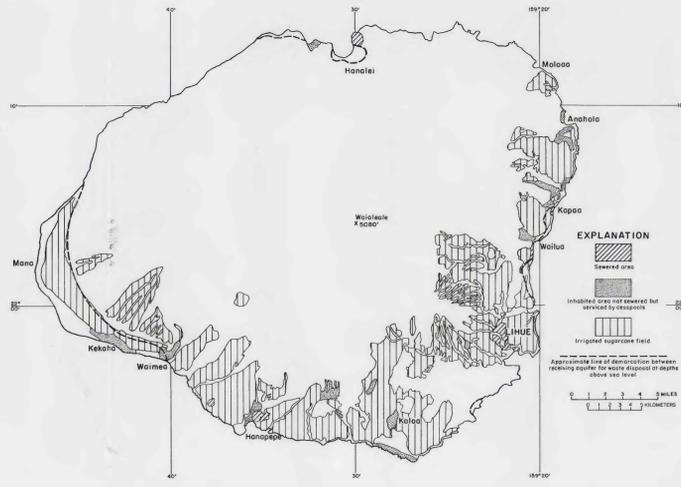
FIGURE 3. MAP OF KAUAI SHOWING SEWERED AREAS, INHABITED AREAS NOT SEWERED, AND SUGARCANE FIELDS.

The second map (fig. 3, sheet 5) shows the areas severed, inhabited areas not severed but serviced by cesspools, and areas in sugarcane cultivation. The areas severed in 1972 and those proposed to be severed by 1980 are shown on figure 4, sheet 5. The data on figure 5 are taken from the County of Kauai General Plans prepared in 1963 by Samp, Low, Tom, and Hara, Inc. The general plans, however, for water, sewerage, and drainage on Kauai are being revised by Samp, Low, Tom, and Hara, Inc. and are scheduled for completion in 1974. Waste-disposal sites which were pending in 1972 are also shown on figure 4.

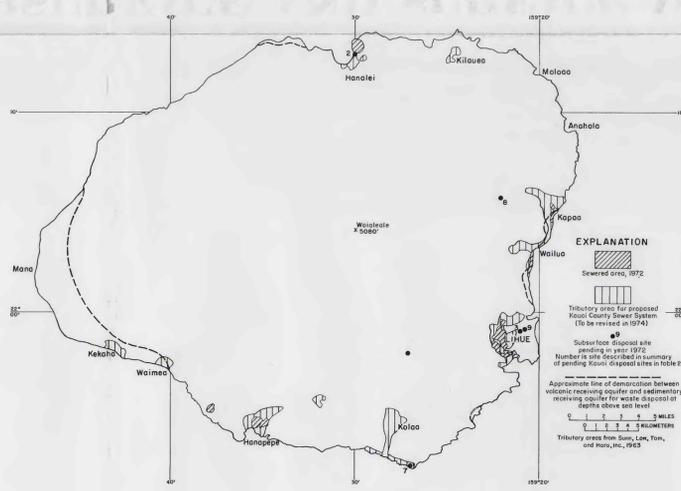
FIGURE 4. MAP OF KAUAI SHOWING SEWERED AREAS IN 1972, PENDING WASTE-DISPOSAL SITES, AND TRIBUTARY AREAS TO SEWER SYSTEM PROPOSED FOR YEAR 1980.

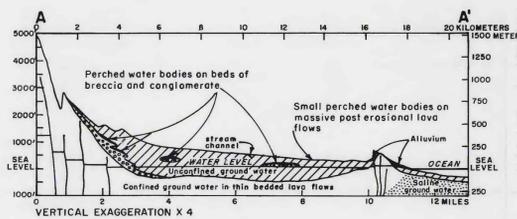
FIGURE 2. GEOHYDROLOGIC SECTION THROUGH BURIED GRABEN NEAR LIHUE (AFTER MACDONALD AND OTHERS, 1960).

The geohydrologic cross section, A-A', (fig. 2, sheet 5) is drawn across the buried semicircular graben on the eastern flank of the volcano near Lihue. Massive post-erosional lava flows make up most of the surface outcrops. Owing to the heterogeneous nature of the graben-filling lava flows and the beds of breccia and conglomerate intercalated in them, overall permeability of this formation is generally low. Water levels are generally high and well above sea level, and where water bodies are perched on even less permeable rocks, the water levels differ greatly from place to place. Except for remnant ridges surrounded by post-erosional flows, outcrops of earlier formed thin-bedded basalts are absent in the eastern half of the island. Ground water in the basalts is generally confined, owing to the overburden of post-erosional lavas or sediments of low permeability. Outcrops of sediments are limited in the eastern half of the island, where outcrops of post-erosional lava flows largely compose the present shoreline. In contrast, coastal-plain sedimentary deposits are extensive in the western part, where post-erosional flows are absent.
