# Potential Flood Hazards and Hydraulic Characteristics of Distributary-Flow Areas in Maricopa County, Arizona

By H.W. HJALMARSON

Water-Resources Investigations Report 93—4169

Prepared in cooperation with the  
FLOOD CONTROL DISTRICT OF MARICOPA COUNTY

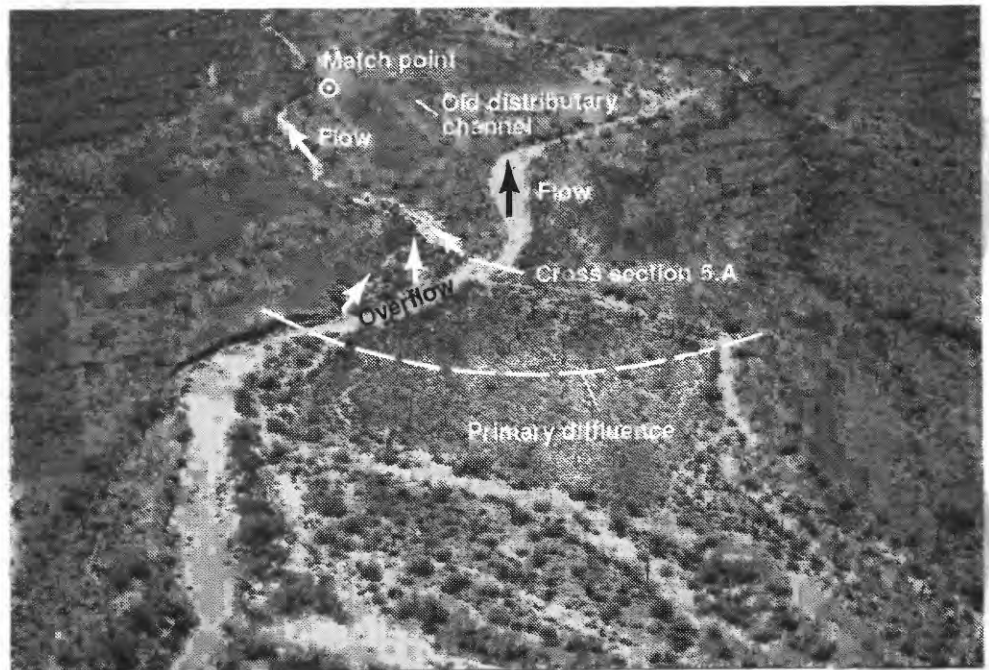
A, Looking downstream and south at the primary diffluence and upper distributary-flow area. The primary diffluence is two channels and a wide overflow area between the channels. The larger channel on the left conveys nearly all the flow and is considered the primary diffluence. The distributary flow to the left occurs only during high flows and is the result of flow that overtops the 4-foot-high left bank of the larger channel. The frame of the square grid is 1.5-foot outside dimension with an internal square of 1 foot on a side and grid spacing of 1 inch.

Site 30 is near the western edge of Maricopa County on the southern slopes of the Harquahala Mountains. This site is an example of the simplest type of distributary flow (flood-hazard degree of 2) with a single diffluence and two distributary channels (fig. 2). A few hundred feet above the PD, tributary inflow occurs with a small amount of flow from a small channel to the west of the main channel (fig. 3A). The subtle hump in the stream profile (fig. 4) shown by the smaller slope (fig. 4B) reflects sedimentation at the confluence of the channels. The slope of the main channel steepens above the PD and then flattens. Just downstream from the PD, floodwater of large floods can overtop the left side of the main channel and enter a deeply incised distributary channel on the east through an overflow area (figs. 3A, 3B, and 3D). At the PD, the 100-year flood is confined on the left by a high, erosion-resistant vertical bank (fig. 5A). The channel bed at the PD is composed of sand, gravel, and scattered boulders (fig. 3E). At the overflow area, the capacity of the channel is about equal to the peak discharge of the 10-year flood (fig. 5B). Floodflows less than about the 10-year flood remain in a single channel, whereas larger floods overtop the 4-foot-high left bank from the PD to about 600 ft downstream and spill into a well-defined distributary channel to the east (figs. 5C and 3A–D).

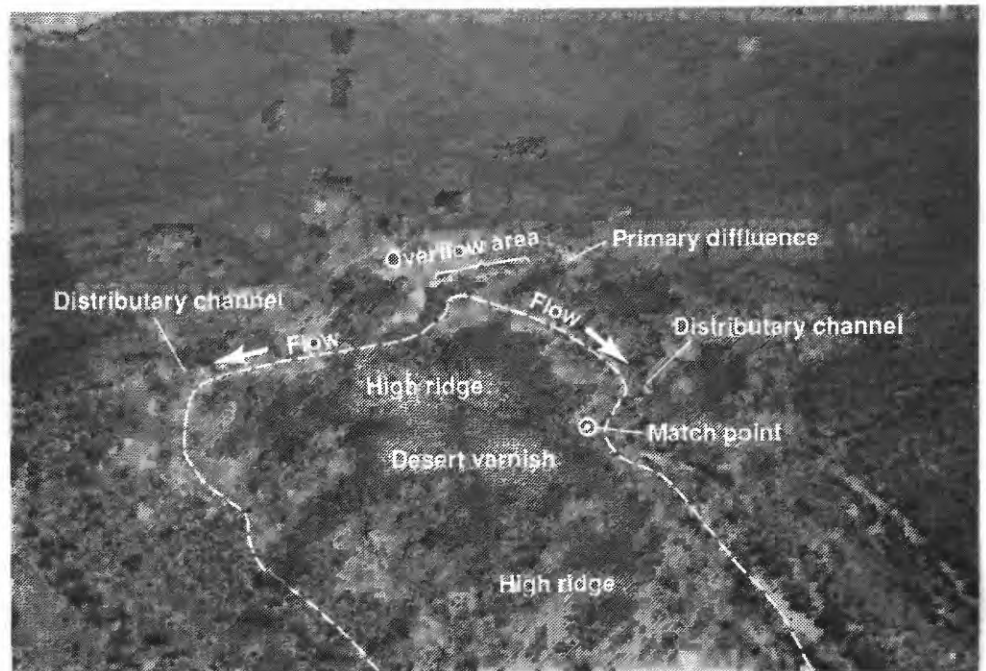
B, Looking upstream at the primary diffluence and two distributary channels. Considerable desert varnish is on the old-fan remnant between the channels in the foreground of the scene. The drainage basin is much of the mountainous area in the background. The ridge between the distributary channels is about 10 feet above the maximum level of the 100-year flood and about 15–20 feet above the channel beds. Match point corresponds to match point on figures 2, 3A, and 3C.

The two distributary channels are separated by a high ridge downstream from the overflow reach (figs. 3C and 5C). About 1,300 ft downstream from the PD, the ridge is 500 ft wide and 15–20 ft above the two stream channels. The high separating ridge is covered with desert varnish (fig. 3B). The varnished interfluvie is about 3 mi long and about 2 mi wide (maximum) with a tributary network of channels for local drainage (fig. 2). The soils of the interfluvie area are well developed.

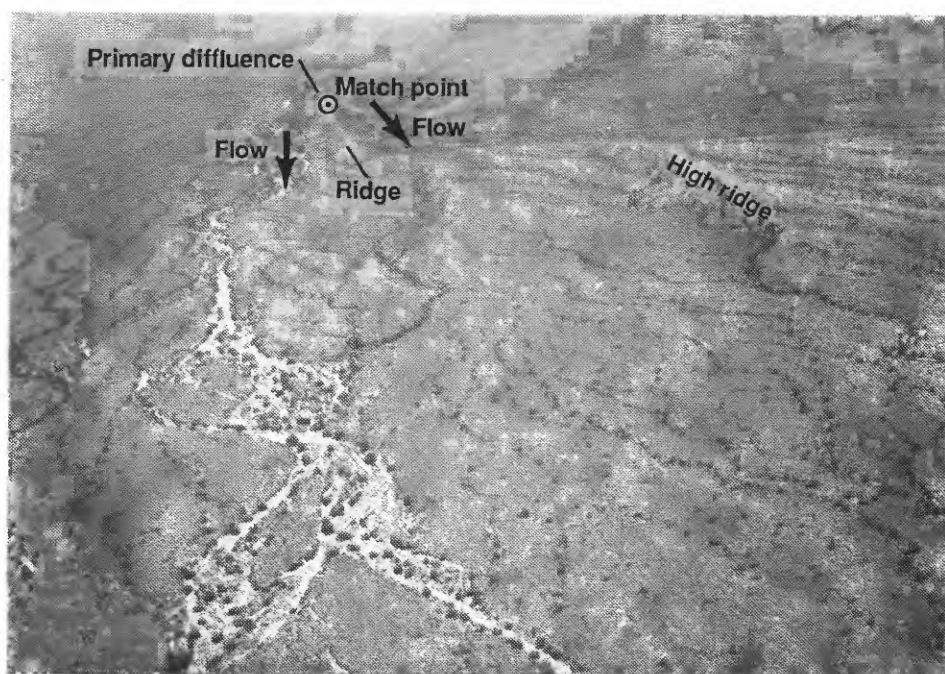
C, Looking upstream at the two distributary channels and the large area with high ridges between the channels from above the larger distributary channel. Some distributary flow is in the foreground of the channel to the left of the scene, but this flow is considered minor. In the middle and upper distributary-flow areas, the flow is separated by high ridges, and only two distinct distributary channels are present. Match point corresponds to match point on figures 2, 3A, and 3B.

Small areas of distributary flow are in the downstream reaches of the two major distributary channels. These small DFA's are within the estimated flood boundaries (fig. 2) but are too small to be considered in the overall classification of the type of DFA. On a large, general scale, the distributary flow is in two channels (fig. 2), but along each of the channels, small areas of different types of distributary flow occur (fig. 3C). The small DFA's are classified separately.

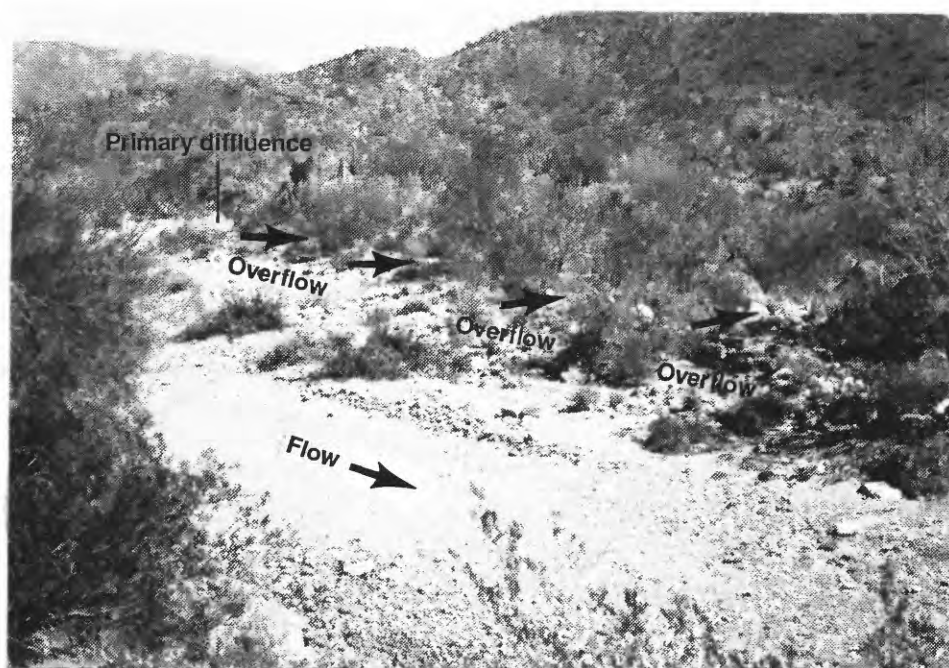
D, Looking upstream at the larger channel where floodflow spills over the 4-foot-high left bank in the center of the scene.

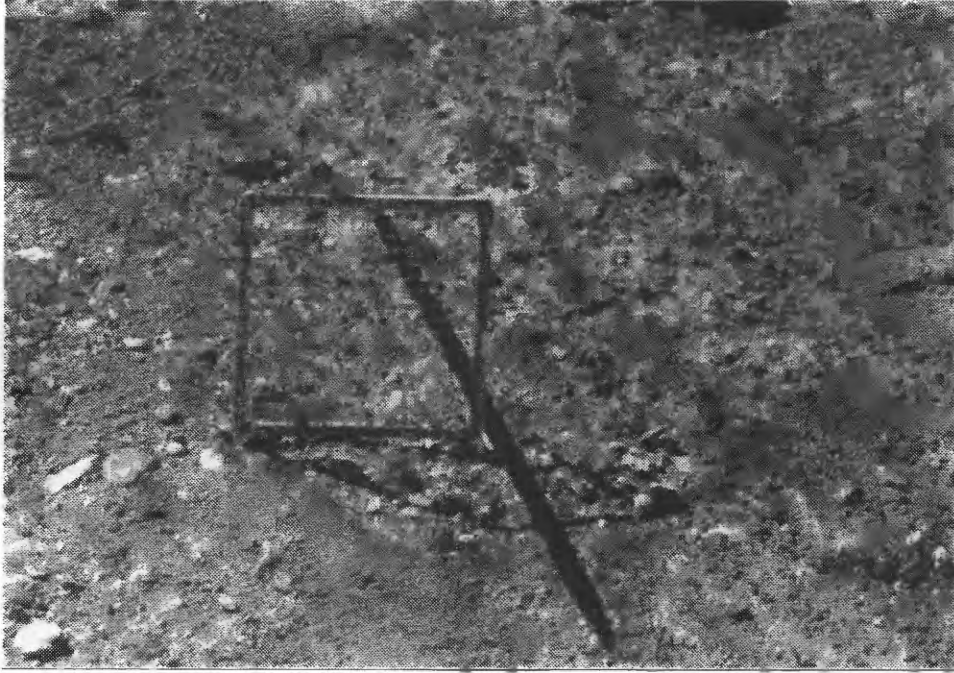
*E*, Looking south at the bed of the channel at the primary diffluence.

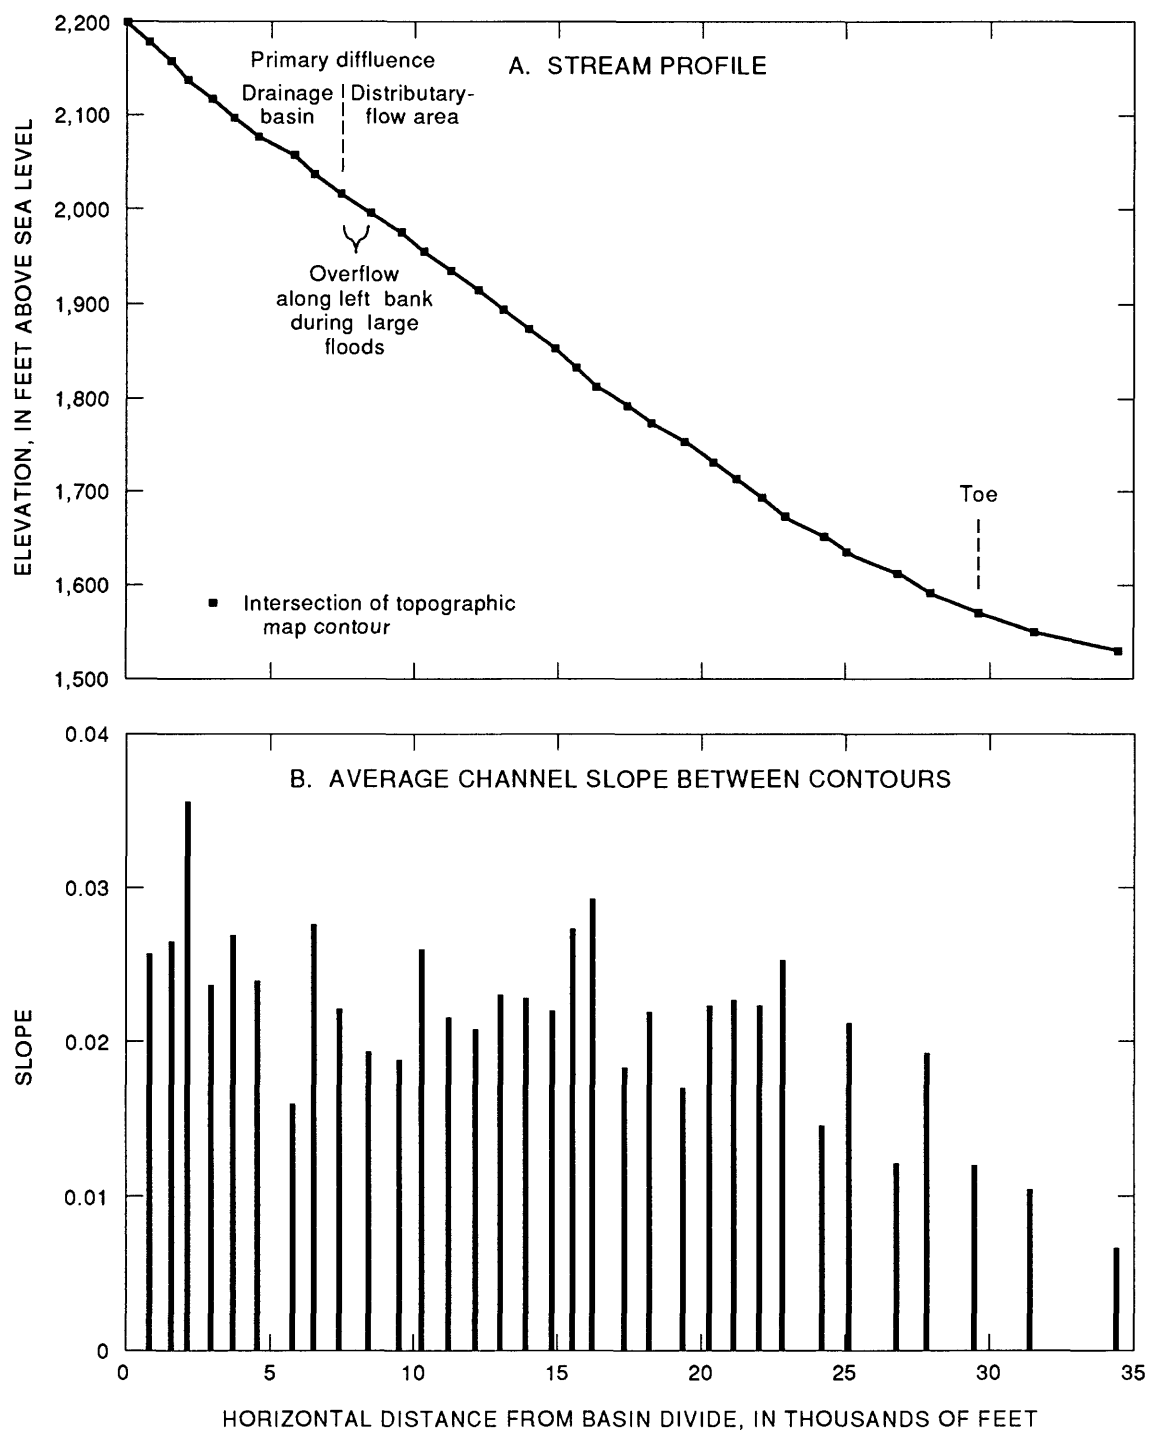
**Figure 4.** Stream profile and average slope of the west channel between topographic-map contours showing location of primary difffluence and toe of distributary-flow area for site 30.

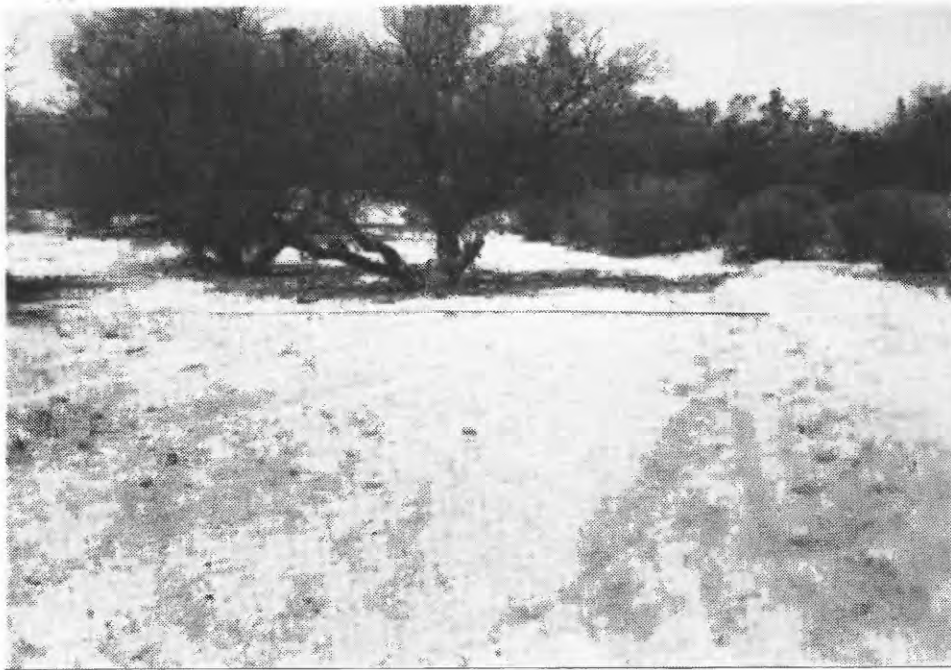
A, Looking downstream at the left channel downstream from the primary diffuence of site 2. The frame of the square grid is 1.5-foot outside dimension on a side.

The location and extent of the PD of site 2 was difficult to precisely define because the loss of confinement of floodflow is gradual. Also, as mentioned previously, floodflow is in two channels at the PD, and floodflow in the left channel (fig. 6) divides and joins the right channel in the pediment area. The transition from pediment to alluvial plain is gradual with only a subtle change in channel slope where the PD was located (fig. 7). For a few hundred feet upstream from the PD, the slope is about 0.022. At the PD, the slope changes to about 0.018 for a few hundred feet. Evidence of sediment deposition exists in the zone where the slope flattens (fig. 8A).

The two trees near the center of the channel at the PD are buried partially by deposited sediment (fig. 8A). The root collar of the trees is about 3 feet below the channel indicating the former level of the channel when the trees germinated. There are no visible scars on the bark that indicate damage from large floods. The absence of visible scarred bark does not necessarily indicate there has not been large floods because (1) the velocity and depth of the floodflow are not great because the floodflow spreads over a wide area and (2) scarring, if any, may be hidden below the bark. Channels that are filled with sediment may be more susceptible to lateral movement or channel avulsion during floodflow. The older trees in this area, like those shown in figure 8A, are commonly along the defined distributary channels.

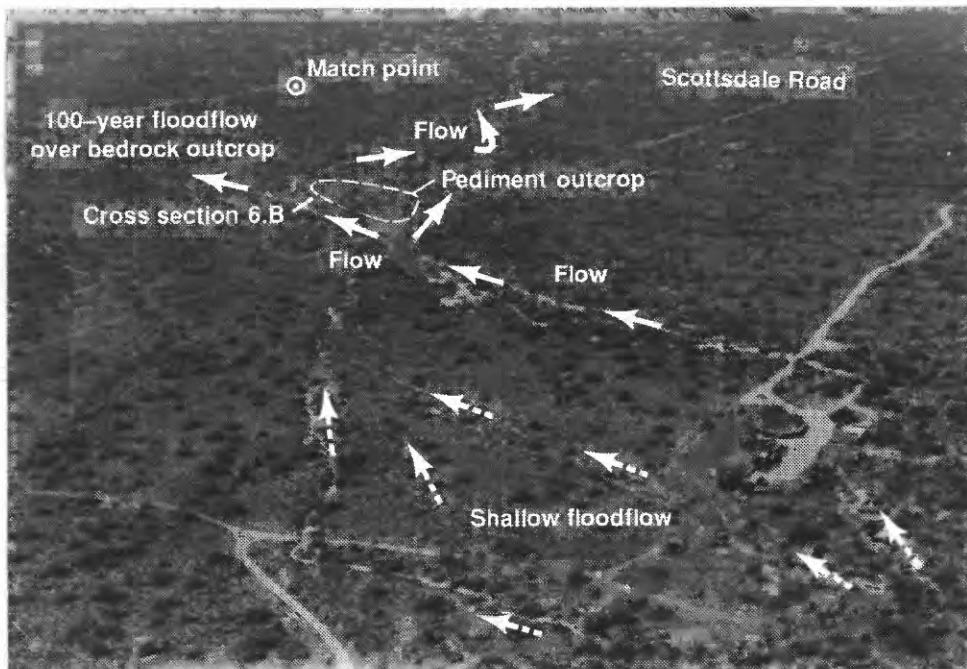
B, Looking downstream and west at the north channel of site 2. Two diffuences are upstream from the pediment outcrop where about 30 percent of the 100-year floodflow leaves the main channel to the right. About 200 feet downstream from cross section B (photograph 8C) about 10 percent of the 100-year floodflow in the main channel overtops a bedrock outcrop that forms the left bank. Much of the land in the right foreground of the scene will be inundated by shallow 100-year floodwater. Match point corresponds to match point on figure 6.

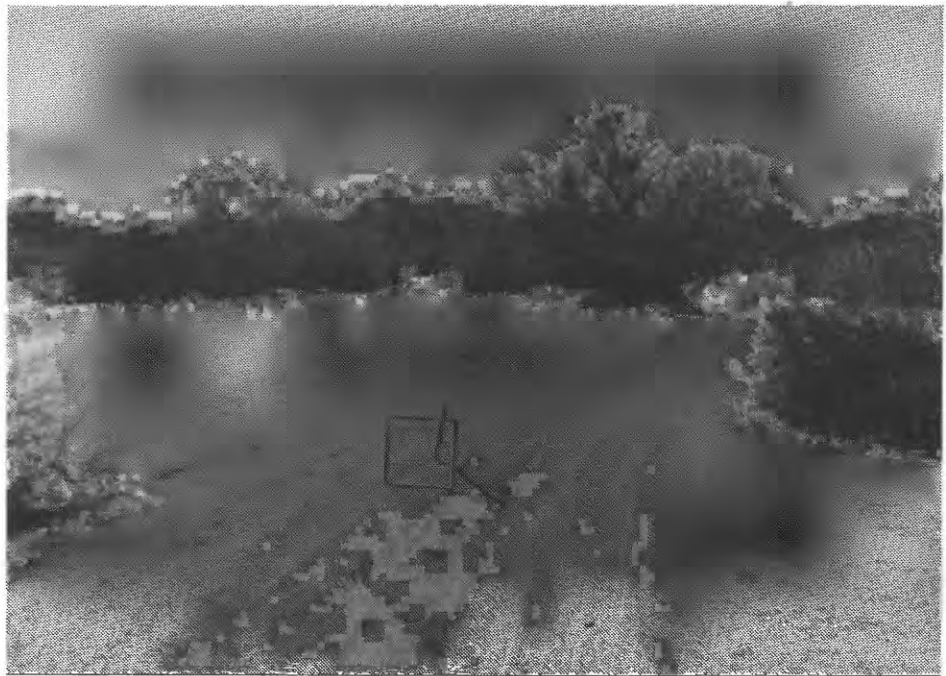
C, Looking downstream at the main channel from cross section B. The width of floodflow widens in the reach shown and the deposited sand and gravel form a wide, flat channel bed. The trees and bushes commonly withstand the force of floodflow and greatly decrease the conveyance capacity of the channel. The dense vegetation along the channel acts to stabilize the channel location by resisting lateral erosion and by reducing the kinetic energy of floodflow. The frame of the square grid is 1.5-foot outside dimension with an internal square of 1 foot on a side and grid spacing of 1 inch.

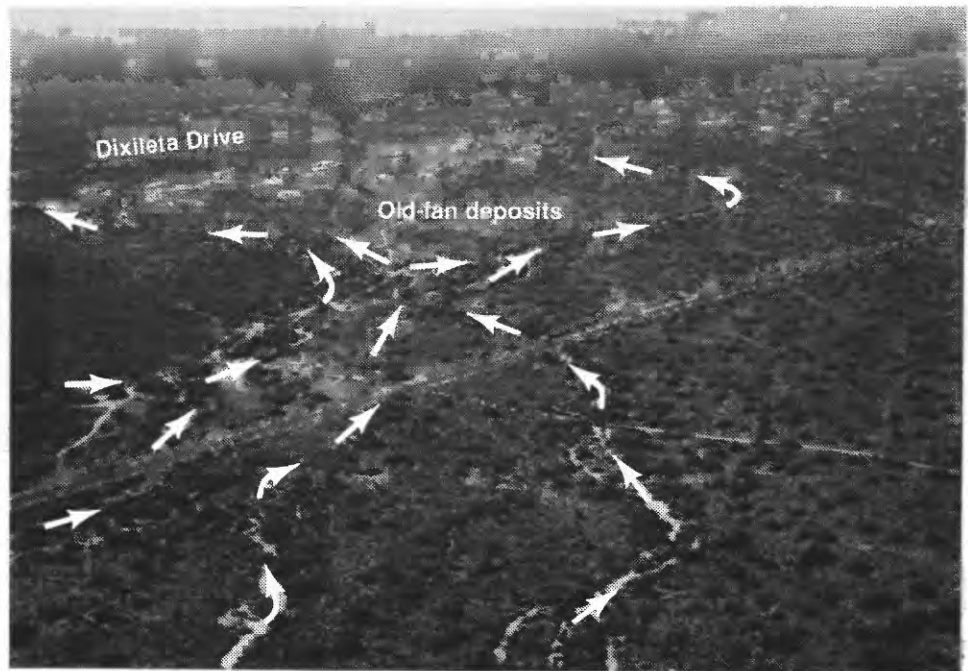
D, Looking downstream and southwest at distributary channels and old-fan remnants of site 3 on the south side of site 2. The two distributary channels are separated by the island of old-fan deposits that are above the level of the 100-year floodwater that emanates from above the primary diffidence. Local runoff on the old-fan deposits is drained by distributary channels that are not clearly visible in the scene. The vegetation on the old-fan deposits is less dense than the vegetation along the distributary channels and on the nearby recent alluvial deposits.

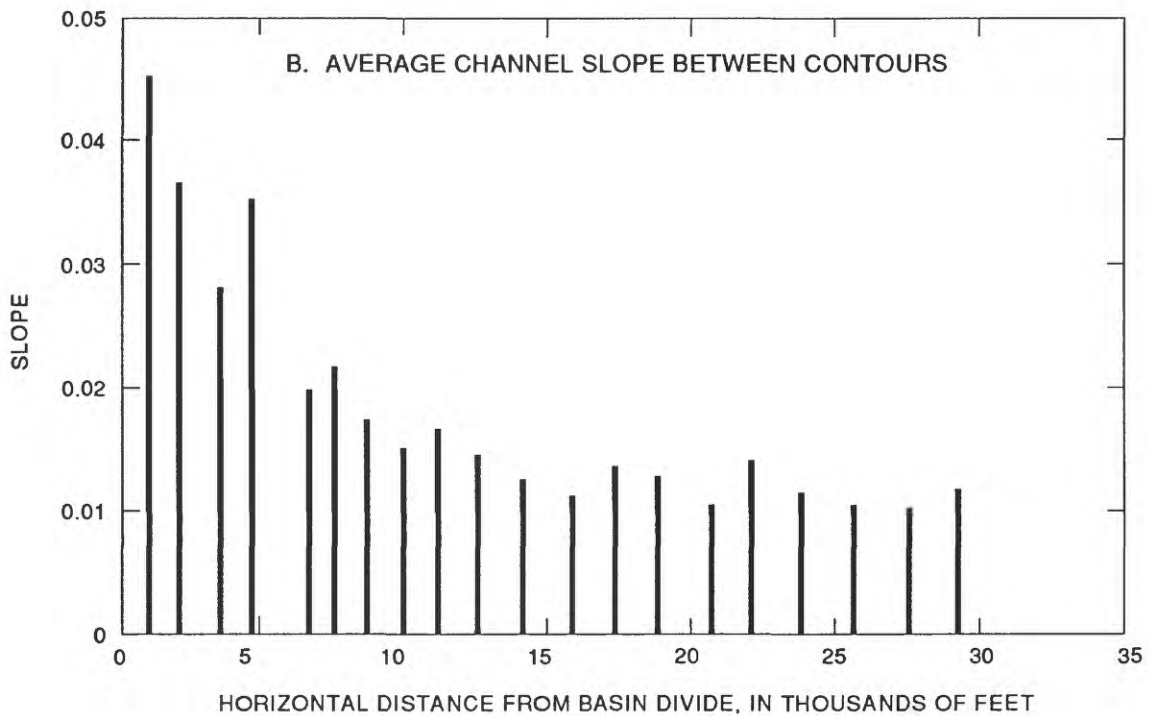
**Figure 11.** Stream profile and average slope of channel between topographic-map contours showing location of primary diffluence and toe of distributary-flow area for site 39.

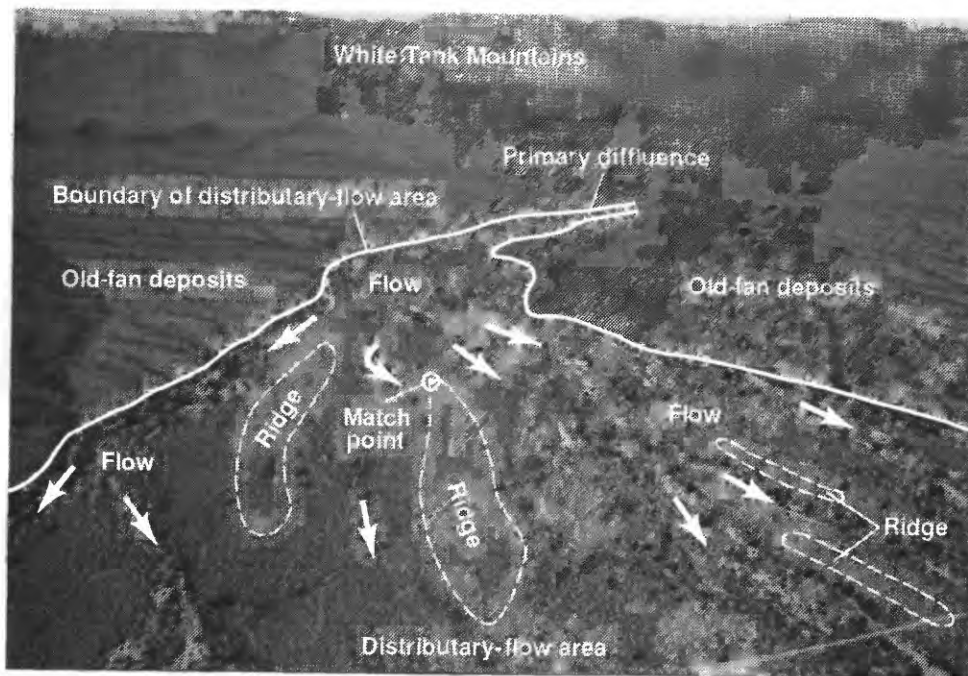
A, Looking upstream and northeast at the upper distributary-flow area and primary diffidence. The camera is above the lower middle of the distributary-flow area about 5 miles to the southwest of the head of the basin at the crestline of the White Tank Mountains in the left background. Two interfluvies with ridges are above the level of the 100-year flood in the center foreground. Except for the two high-ridge areas and other smaller high-ridge areas that are not defined (figure 13B, for example), most of the distributary-flow area appears to have been inundated by flood-flow. Match point corresponds to match point on figures 10 and 12B.

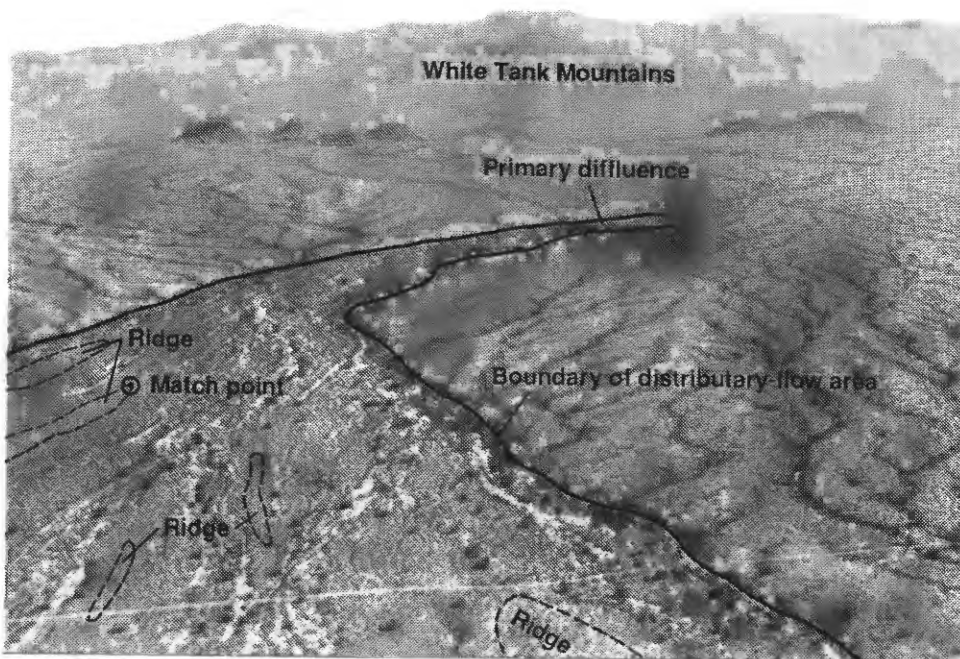
B, Looking upstream and northeast at the left-bank side of the distributary-flow area where the paths of flow, as indicated by the location of the light-colored channels, appear chaotic. A distinct difference in the size and density of vegetation occurs on the distributary-flow area and the adjacent land. The boundary between the distributary-flow area and the adjacent tributary-flow areas on the old-fan deposits is distinct. This boundary is less obvious in other areas of southwestern Arizona where the vegetation cover is more dense. Match point corresponds to match point on figures 10 and 12A.

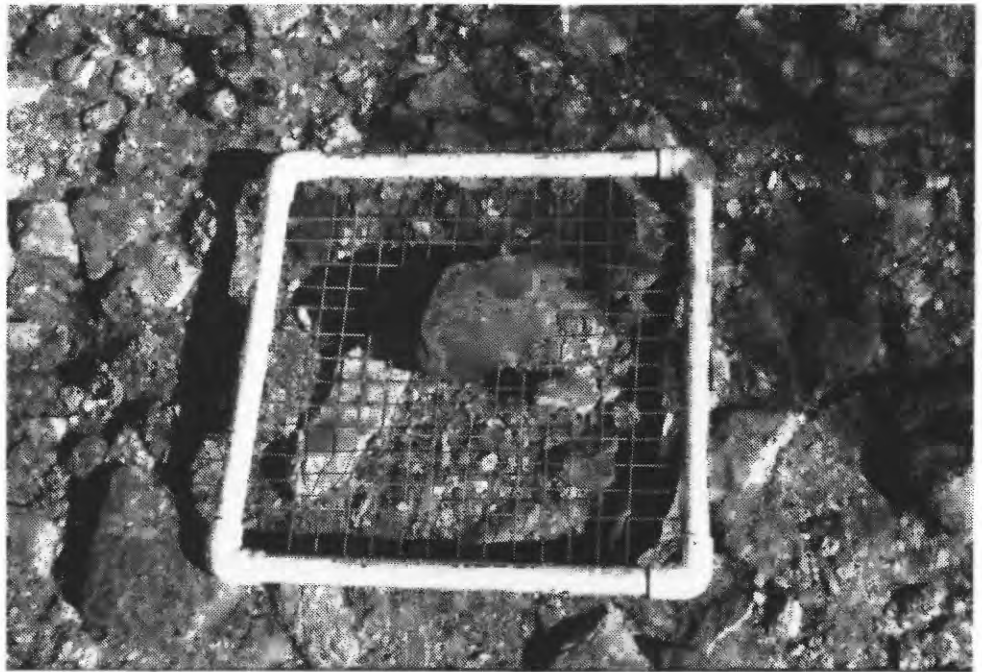
C, Looking down at overturned stone on string grid with oxidation on bottom of stone located at top of the right bank at the primary diffluence. The iron oxide is found on the bottoms of nearly all stones along the top of both banks at the primary diffluence. The frame of the square grid is 1.5-foot outside dimension with an internal square of 1 foot on a side and grid spacing of 1 inch.

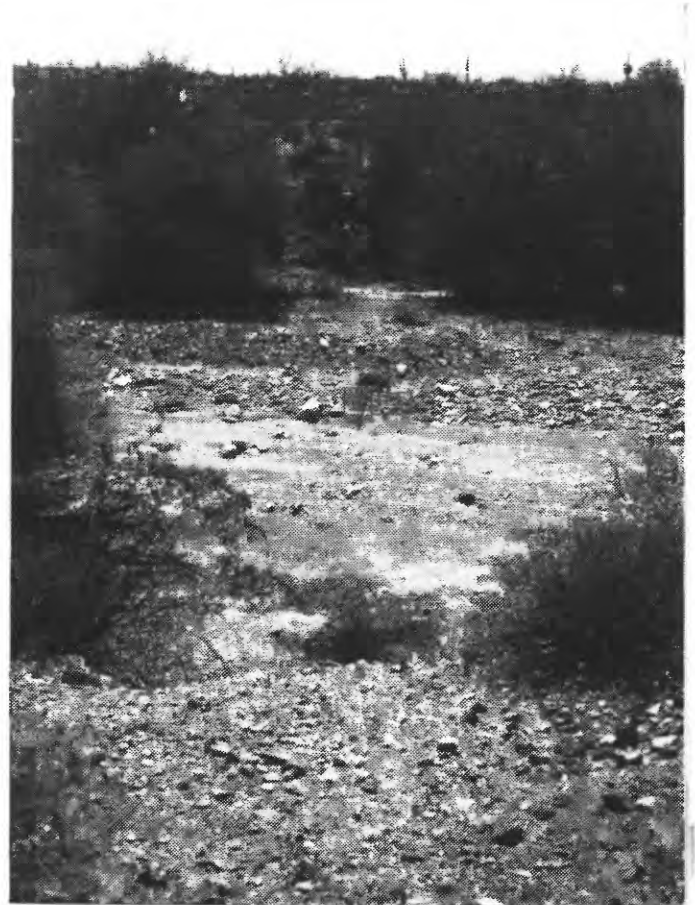
D, Looking southwest and across at left bank of primary diffluence from near top of right bank. The level of the 100-year flood is about 3 to 4 feet above the channel bed. The banks are cemented old-fan deposits that are resistant to erosion by floodflow. The frame of the square grid is 1.5-foot outside dimension on a side.

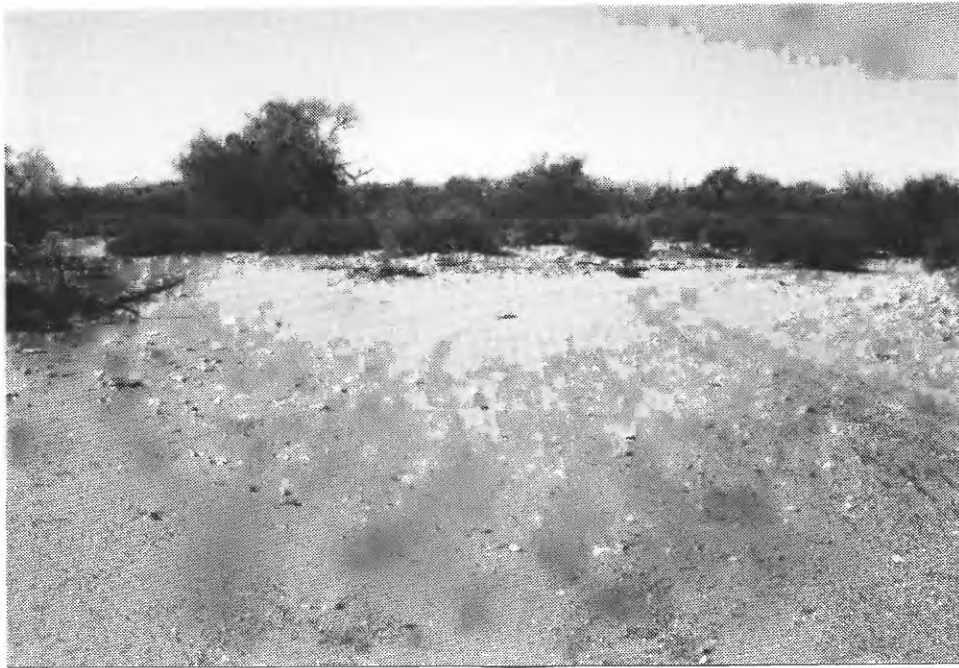
*E*, Looking downstream from the center of the channel about 500 feet downstream from the primary diffluence where the floodflow spreads over a wide area. The largest channel is to the right, and floodflow is unconfined beyond this point. Recent deposition across this aggrading area is apparent, and the distribution of floodflow in the defined distributary channels downstream is controlled by the amount and distribution of deposited material in this area. The frame of the square grid is 1.5-foot outside dimension on a side.

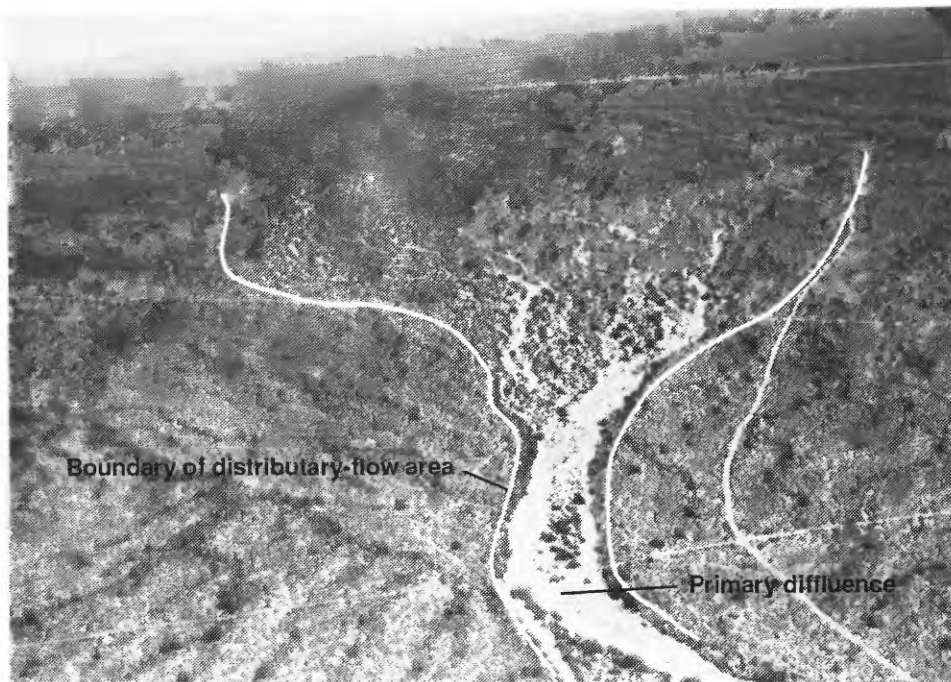
**Figure 14.** Looking downstream and southwest at the primary diffluence and distributary-flow area at site 36. The bushes and trees in the middle part of the distributary-flow area are larger than those outside the distributary-flow area. The soils are light colored, and most of the area has the appearance of being inundated during a single large flood.

are rather uniformly distributed across the DFA (fig. 14). Few interfluvial ridges are in the upper DFA of site 36. The flood-hazard degree of site 36 is 10, and flood water of the 100-year flood can inundate any part of the DFA.

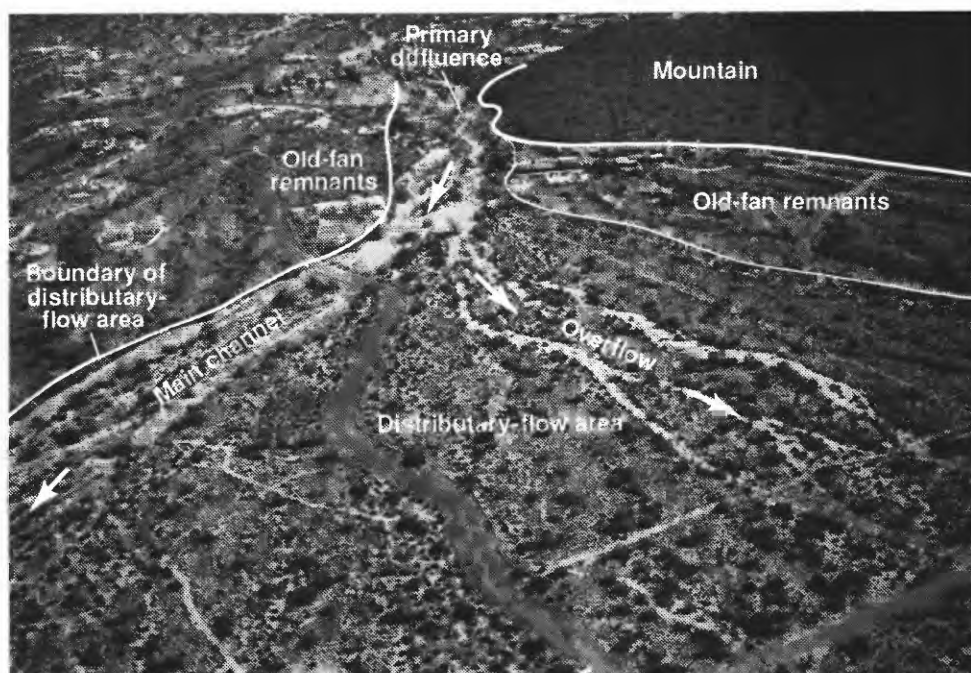
A, Looking upstream and northeast at the upper part of the distributary-flow area of site 6. The primary diffidence is confined by the mountain on the left-bank side and the old-fan remnant on the right-bank side.

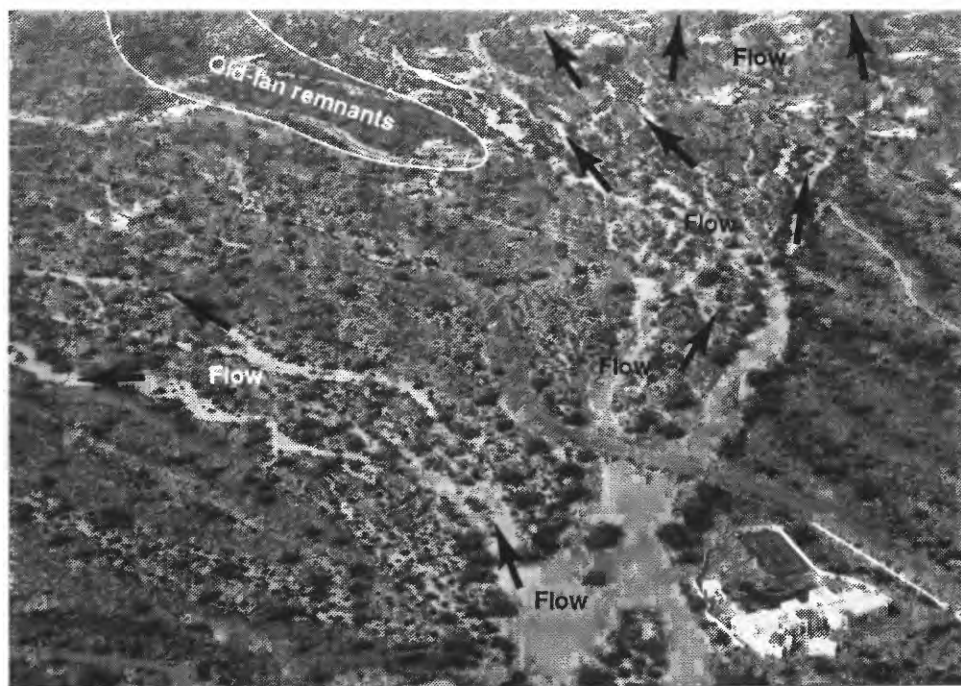
B, Looking downstream and west from above the primary diffidence at the upper distributary-flow area. Most of the floodflow probably will be in the large channel to the right adjacent to the old-fan remnants. As indicated by the light-colored deposited material in the many channels, floodflow can inundate much of the area except for a few ridges. The larger trees are along the more obvious-appearing channels, but there also are scattered trees over much of the other areas that indicate the presence of distributary channels.

Figure 16. Site 6, primary diffidence, and distributary-flow area.

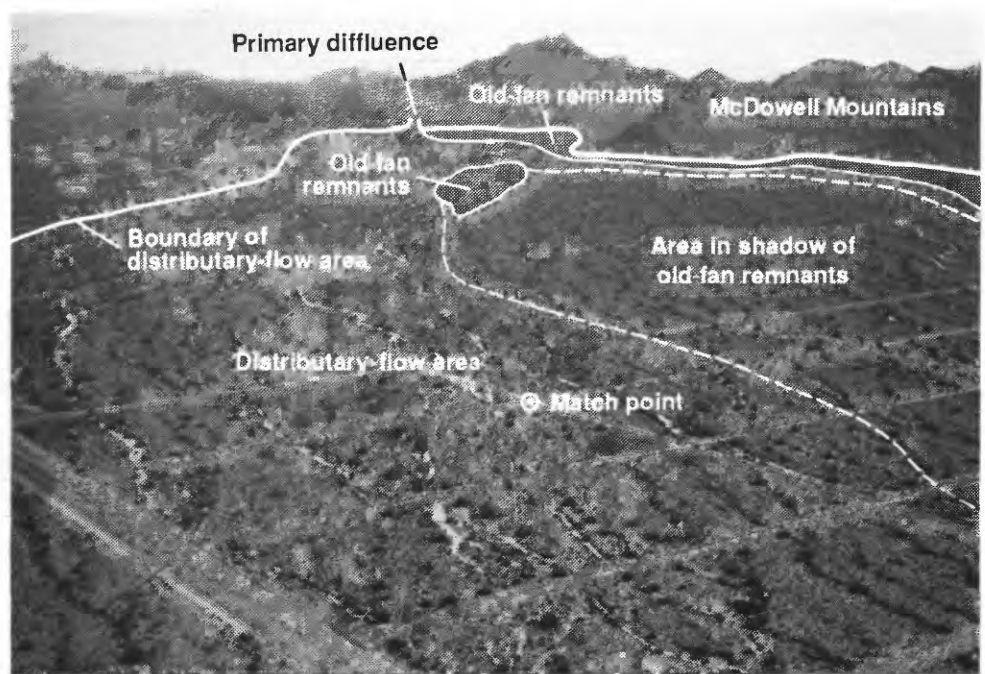
C, Looking upstream at the middle of the distributary-flow area. The primary diffluence is in the background at the toe of the mountain. Many distributary channels are apparent where the soil color is lighter than the soil of the "shadow" area to the right of the scene. Most of the channels that drain the darker area to the right are tributary. The darker-colored soils of the few interfluvial areas in the distributary-flow area indicate these areas are above the level of the 100-year flood. Match point corresponds to match point on figure 15.

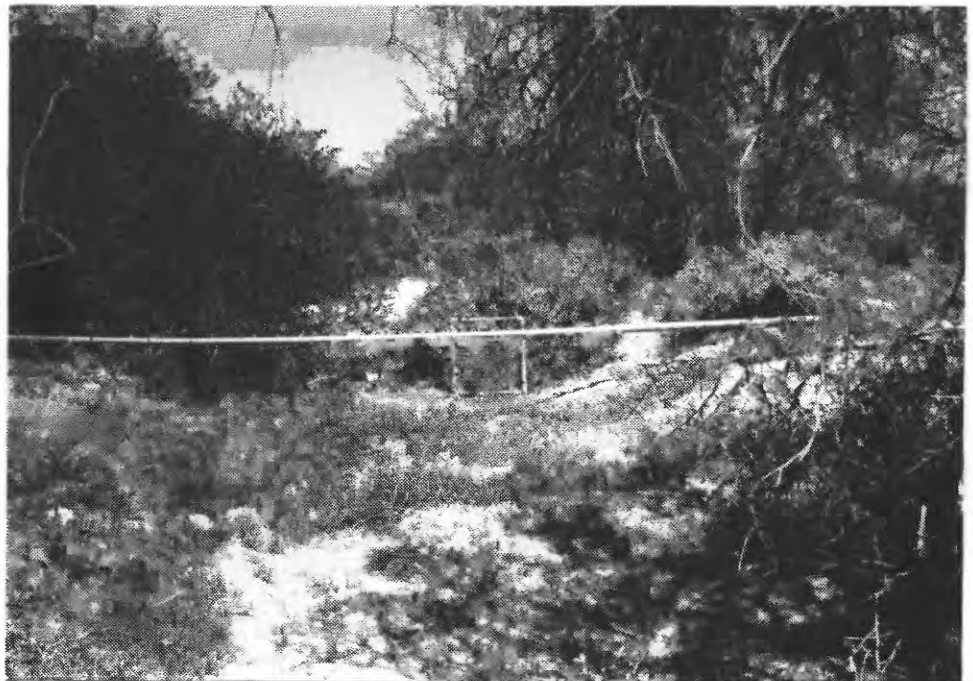
D, Looking upstream at distributary channel. This channel is typical of the many channels across the distributary-flow area at this elevation. The bankfull capacity is about 60 cubic feet per second or only about 1 percent of the 100-year flood. The combined capacity of the channels west of the "shadow" area at this elevation across the distributary-flow area is about 10 to 20 percent of the potential discharge of the 100-year flood. The frame of the square grid is 1.5-foot outside dimension with an internal square of 1 foot on a side and grid spacing of 1 inch.

Figure 16. Continued.

because of the vegetation-lined, erosion-resistant banks (fig. 16D). The separated flow along and near the toe of the McDowell Mountains generally is confined, and flow depths and velocities are large. In the "shadow" area, most of the ridges are above the 100-year flood and most of the channels are stable. The "shadow" area has a flood-hazard degree of about 5. A flood-hazard degree of 9 was used for the entire DFA.

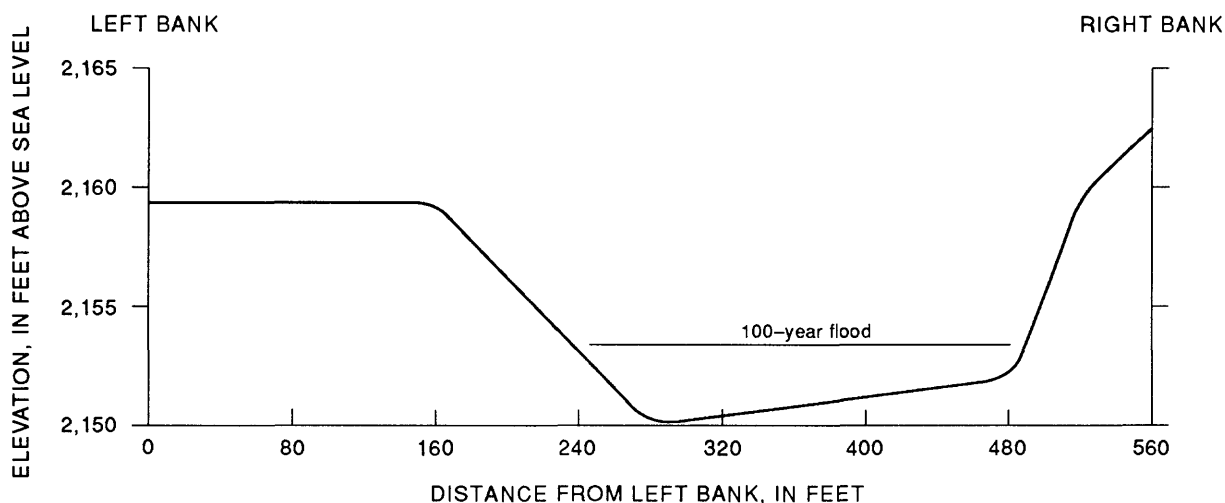
**Figure 17.** Cross section of primary diffuence and upper distributary-flow area showing approximate level of the 100-year flood for site 6.

has been changed for construction of a road on the left side and for protection of the land on the right side. The amount of change does not appear to be large, and the surveyed cross section of the channels at the PD approximately represents the natural channel (fig. 17). The level of the 100-year flood is about 6 ft below the top of the left bank.

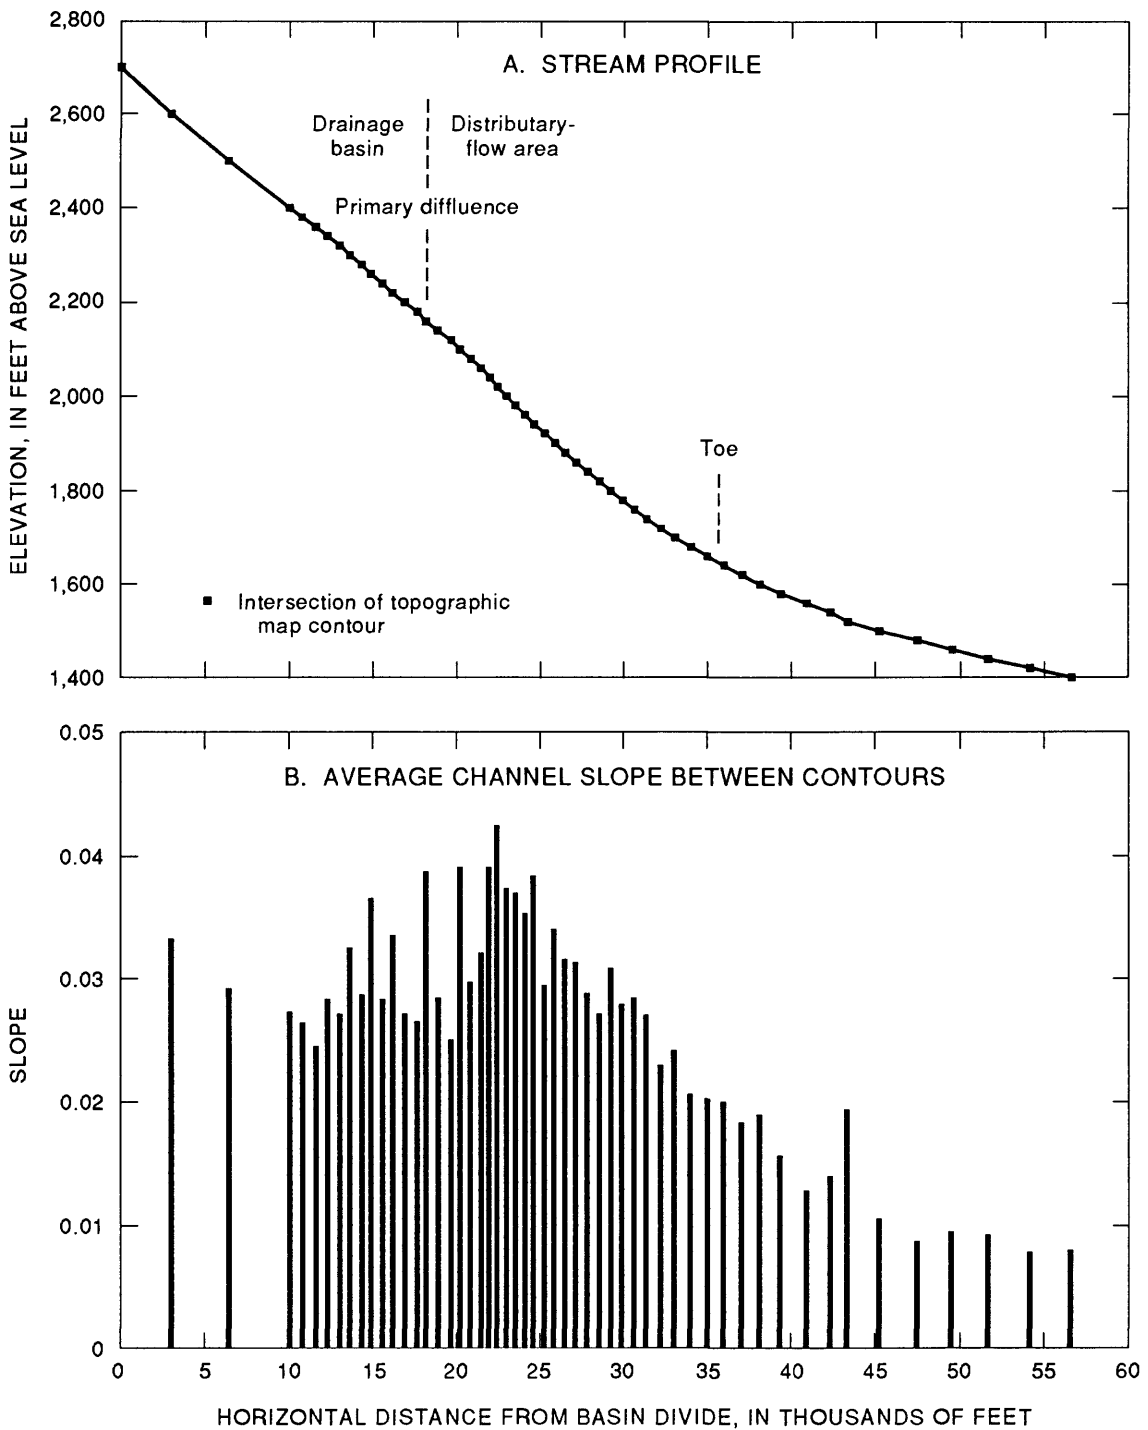
**Figure 18.** Stream profile and average slope of channel between topographic-map contours showing location of primary diffluence for site and toe of distributary-flow area for site 6.

The slope of the DFA flattens downstream from the PD and then steepens for about 4,000 ft (fig. 18). Near the island of old-fan remnants, the slope of the DFA progressively flattens to the toe where the channels become tributary. About 8,000 ft downstream from the toe, the slope generally is constant.

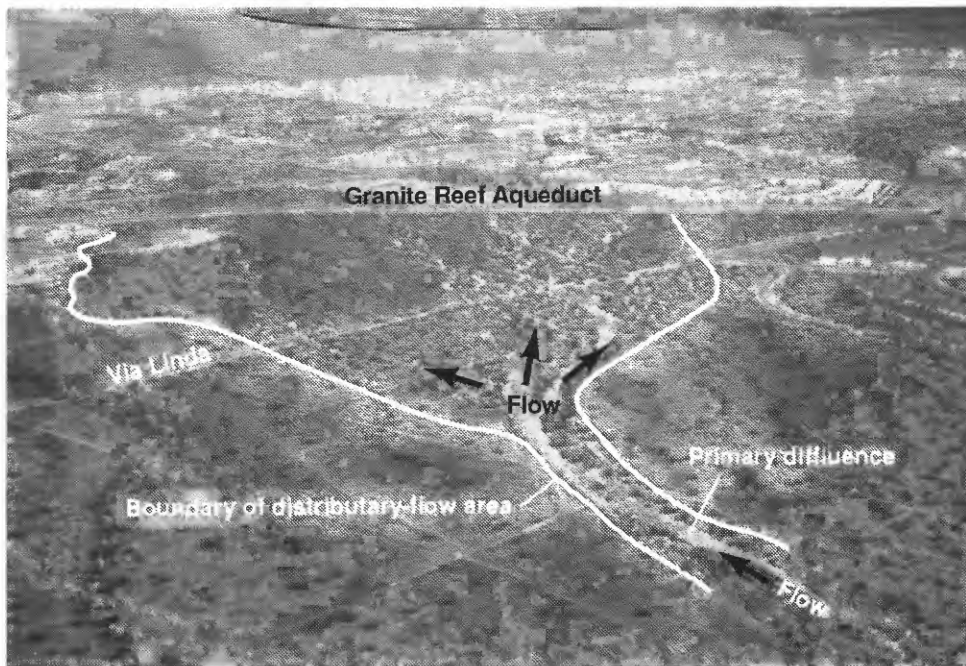
A, Looking downstream and southwest at primary diffidence at distributary-flow area of site 23. The number and rather heterogeneous distribution of the larger trees on the distributary-flow area are markedly different from those of the trees on adjacent land. Trees on adjacent old-fan remnants are mostly along tributary channels. The lighter colored soils on the right side of the distributary-flow area indicate recent deposition and the probable location of recent floodflow. The absence of high interfluvies, the presence of large deposits of angular boulders, and the presence of old trees indicate that floodflow is likely over the entire distributary-flow area.

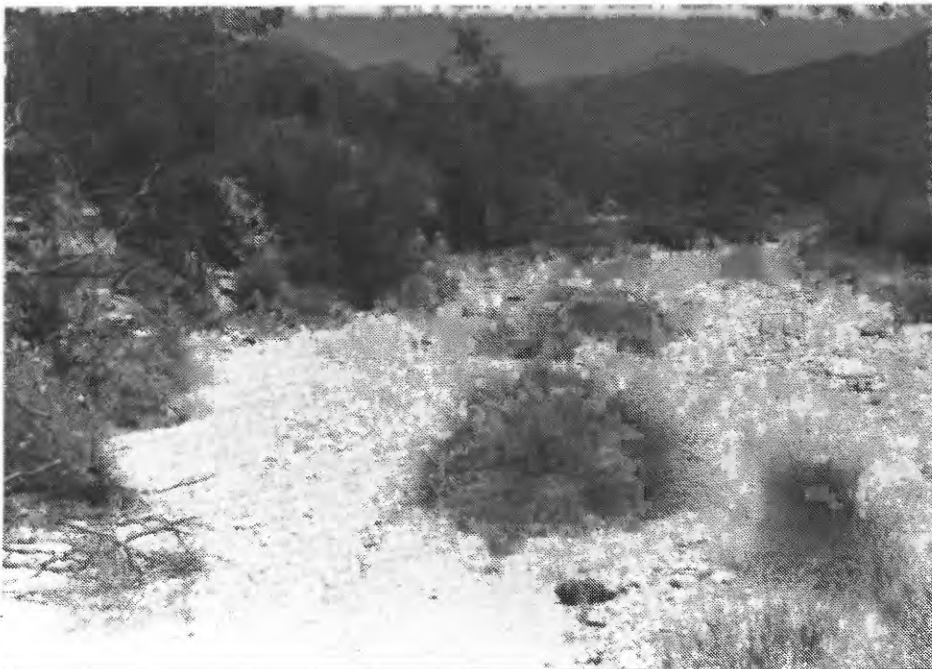
B, Looking upstream at the main channel and right bank of the primary diffidence. The bank is cemented conglomerate consisting of many boulders. Several cobbles and boulders at the top of the bank are coated with a dark desert varnish, and the bottoms of stones are covered with a highly oxidized material. The frame of the square grid is 1.5-foot outside dimension on a side.

**Figure 20.** Site 23, primary diffidence, and distributary-flow area.

At some of the sites, at least one of the channel banks at the PD is erosion-resistant bedrock (fig. 20B). At other sites, the banks and channel bed are erosion-resistant, cemented conglomerate (fig. 12D). The channels at most of these sites are not fully free to self-form, and the channel geometry is influenced to a large degree by older erosion-resistant rock and (or) cohesive material. Most of the channels may be incised because the rate of mountain-channel downcutting is greater than or equal to both the rate of mountain uplift, if any, and the erosion of the alluvial-fan deposits adjacent to the mountains as previously described.
