# Potential Flood Hazards and Hydraulic Characteristics of Distributary-Flow Areas in Maricopa County, Arizona

By H.W. HJALMARSON

Water-Resources Investigations Report 93—4169

Prepared in cooperation with the  
FLOOD CONTROL DISTRICT OF MARICOPA COUNTY

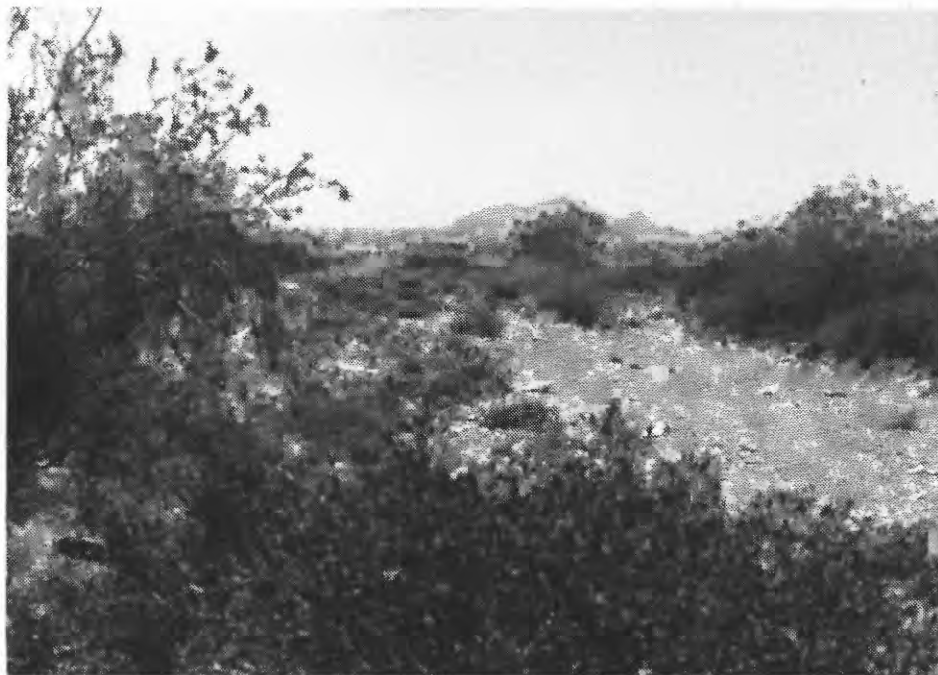
*C*, Looking downstream at the upper distributary-flow area where floodflow is unconfined. Many of the large boulders are from the old-fan deposits in which the present channel is incised for about 0.4 mile upstream.

*D*, Looking upstream and northwest at deposited boulders on the left-bank side of the distributary-flow area where recent flooding is not apparent. The saguaro cactus in the background appears to be a few hundred years old and is on adjacent land. The frame of the square grid is 1.5-foot outside dimension on a side.

overtop the left bank about 700 ft downstream from the PD (fig. 20C). About 1,100 ft downstream from the PD, the 100-year flood will overtop the right bank of the main channel (fig. 21B). The 2- and 10-year floods are confined within the banks of the main channels to about 1,500 ft downstream from the PD where the banks are low and several small channels are present (fig. 21C). At 1,800 ft downstream from the PD, the capacity of the main channel is greater than the 10-year flood (fig. 21D), but significant amounts of floodflow will overtop the low banks upstream and enter adjacent distributary channels. Near the top of the subtle hump in the profile of the DFA (fig. 22) at about 2,800 ft downstream from the PD, several distributary channels are separated by ridges that are about 3 ft high (fig. 23).

The average exponents at the cross sections of site 23 for the 2-year flood resemble exponents for a rectangular channel (table 7). The small standard deviation for the velocity exponent, however, indicates the average value of 0.30 is different from a value of 0.20 for a rectangular channel. The average exponents for the 10-year flood are different from theoretical and other values of exponents (table 4). These differences may be related to the debris-flow processes that are evident on the DFA of site 23. Along many of the channels of the DFA, unstratified deposits of boulders occur with little imbrication. Some horizontal stratification of recent deposits from small flows exists, but there is a general unstratified jumbled appearance of the deposited boulders (figs. 20C and 20D).

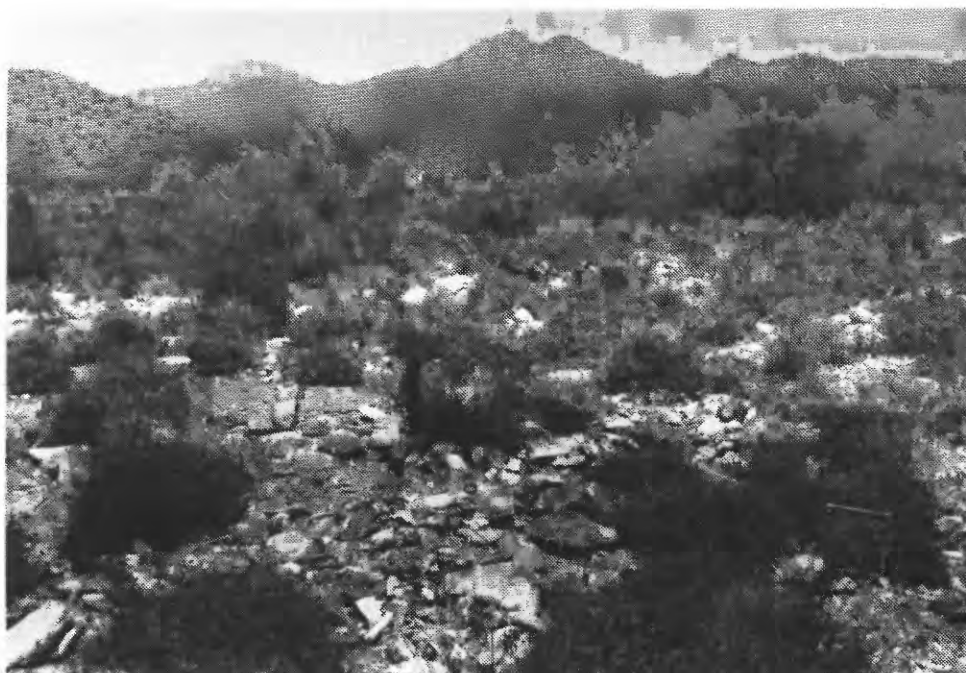
**Figure 20.** Continued.

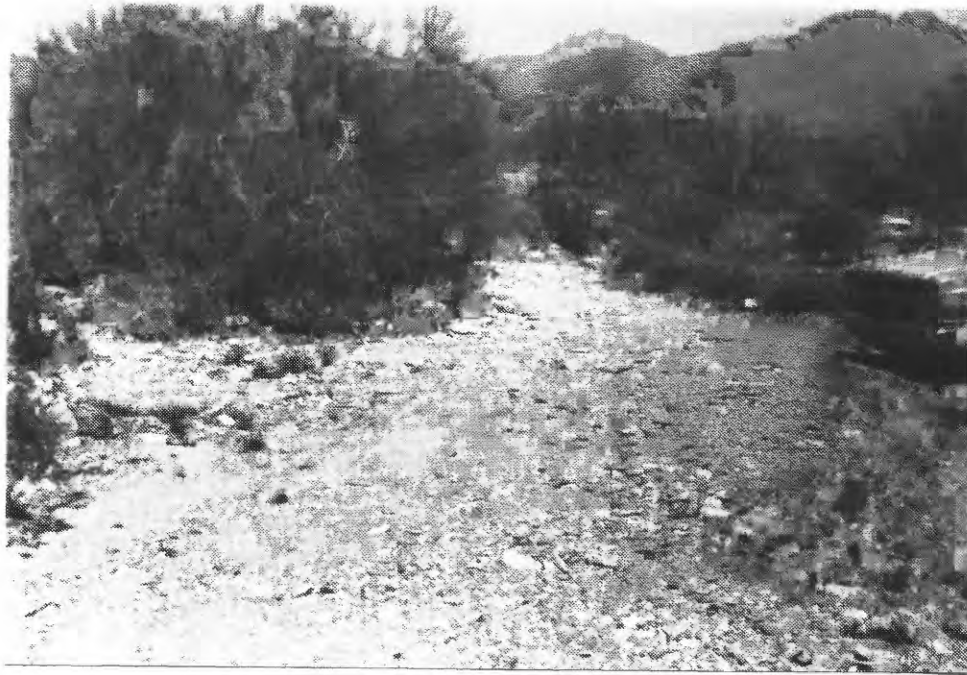
*E*, Looking upstream and northeast at the largest defined distributary channel on the right side of the distributary-flow area. The small ridge on the right behind the truck is about 3 feet high and is the left side of the bed. A ridge to the left of the scene is only about 1 foot high and is difficult to distinguish when viewed on the ground. Most of the deposited material in the middle and upper distributary-flow area is larger than the rocks in the photograph. The frame of the square grid is 1.5-foot outside dimension on a side.

**Figure 20.** Continued.

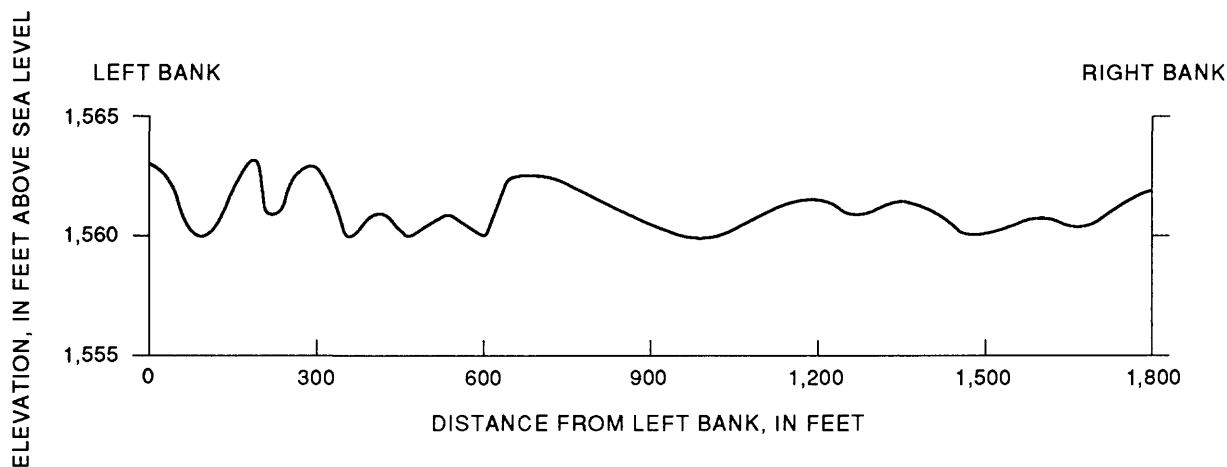
**Figure 23.** Cross section of upper distributary-flow area about 2,800 feet downstream from the primary diffuence at the 1,560-foot elevation contour of site 23.
