Identification, Characterization, and Analysis of Hydraulically Conductive Fractures in Granitic Basement Rocks, Millville, Massachusetts

U.S. GEOLOGICAL SURVEY

Water-Resources Investigations Report 94-4185

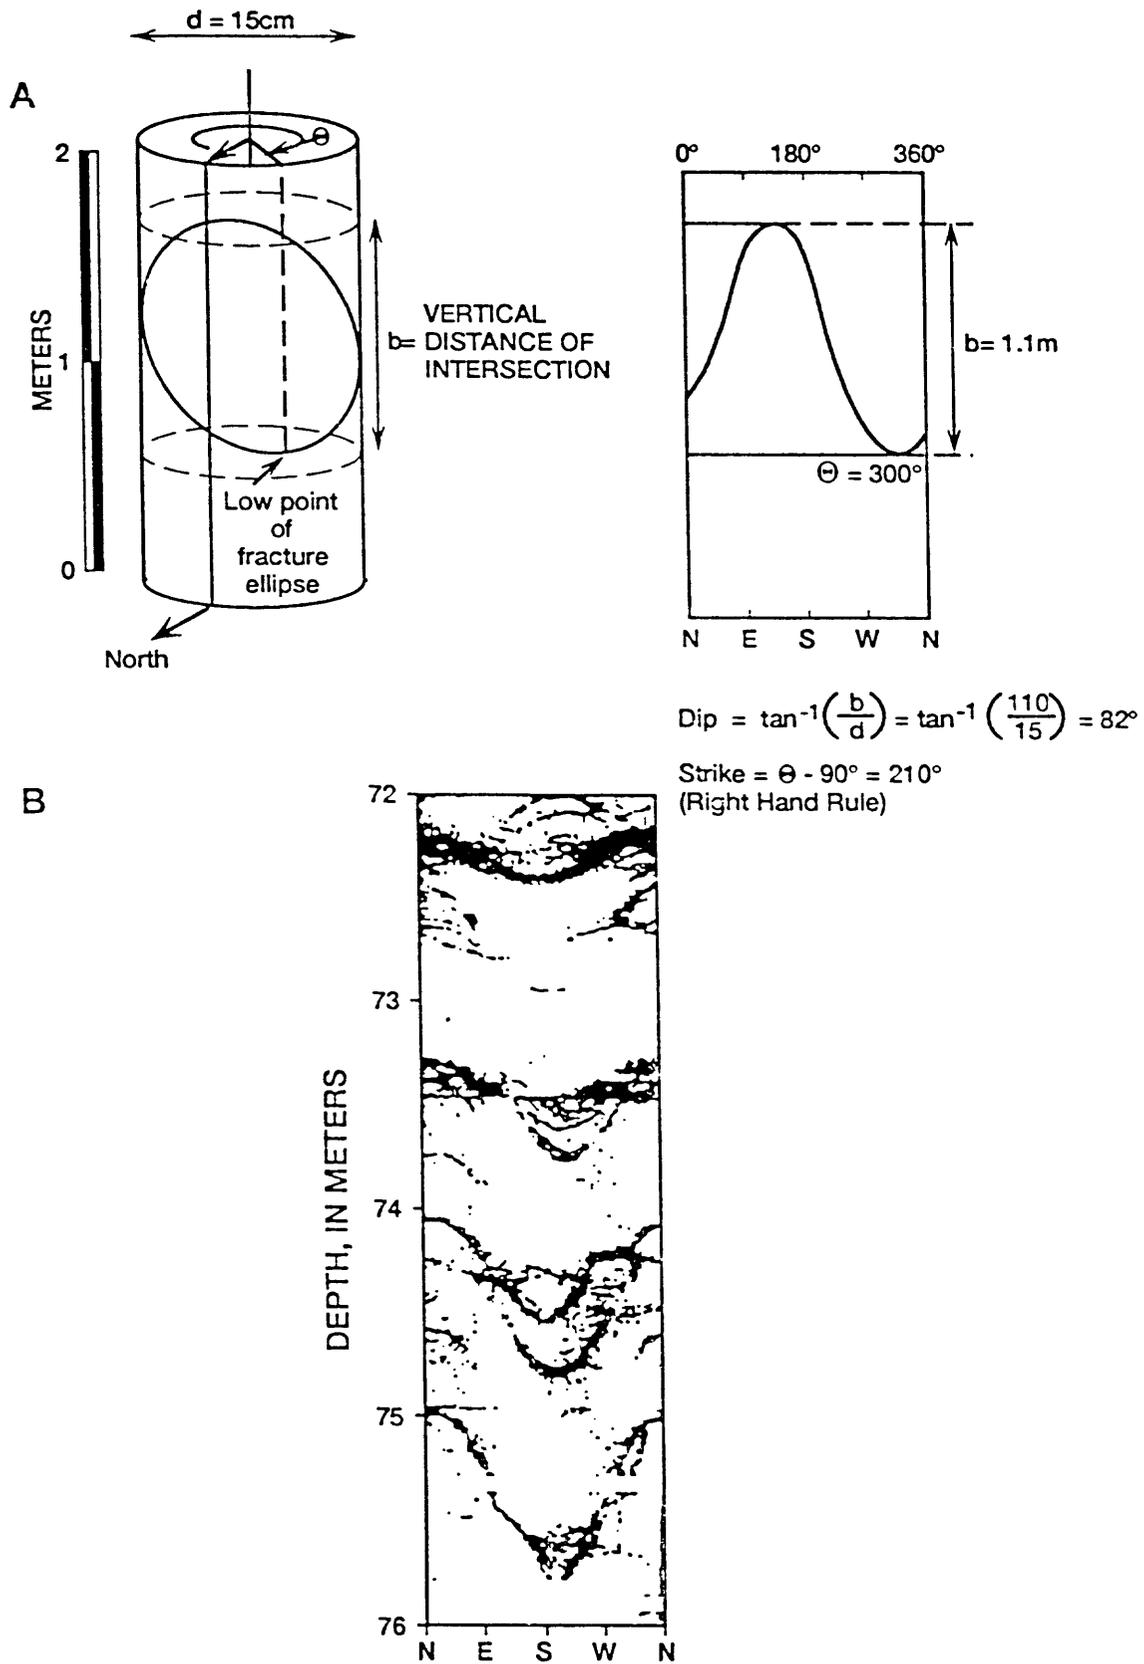
Figure 3. Schematic illustration of fracture plane intersecting a cylindrical borehole, indicating how the strike and dip of the fracture is interpreted from televiewer log images of the intersection between the fracture plane and the borehole wall.

BHTV logs provide a qualitative indication of fracture size because fractures with larger apertures appear as wider, darker features on the BHTV display. The width of the linear feature associated with a fracture can be inferred from the scale of the photographic output of the logging system, but the width of these lines represents fracture aperture at the borehole wall convolved with the 0.3-inch-wide source beam. The fracture width at the borehole wall has also been enlarged during drilling, so an aperture measured there would not be representative of the fracture aperture in the undamaged formation. Specific examples of the interpretation of fracture aperture using BHTV logs are given by Keys (1979), Paillet and others (1985), and Paillet (1991). The general term "size" is used here as a way of describing all of the attributes on the BHTV log that are associated with local hydraulic aperture. These attributes include the thickness of the linear feature on the log interpreted as a fracture, the degree of interconnectedness of fractures within a fracture zone, and the amount of alteration and drilling damage associated with the fracture image. These attributes are difficult to quantify. However, it is important to include some qualitative estimate of the size and possible permeability of fractures in the interpretation. The qualitative information on the BHTV log is translated into a quantitative scale by assigning a score to each fracture identified on the BHTV log. The scores range from 1 for a fracture that has only a small probability of transmitting flow to 5 for a very large opening with an apparent aperture of more than 0.5 ft in the immediate vicinity of the borehole. This analysis is based on an extensive comparative analysis of BHTV logs, core studies, and packer tests where the relative sizes of BHTV fracture images are found to indicate the relative apertures of fractures within a small distance from the borehole wall (less than 0.1 ft) after allowance is made for the effects of drilling and erosion of infilling minerals (Paillet and others, 1985; Paillet and others, 1987b). Detailed explanation and documentation of the fracture scoring method is given by Paillet and Kapucu (1990).

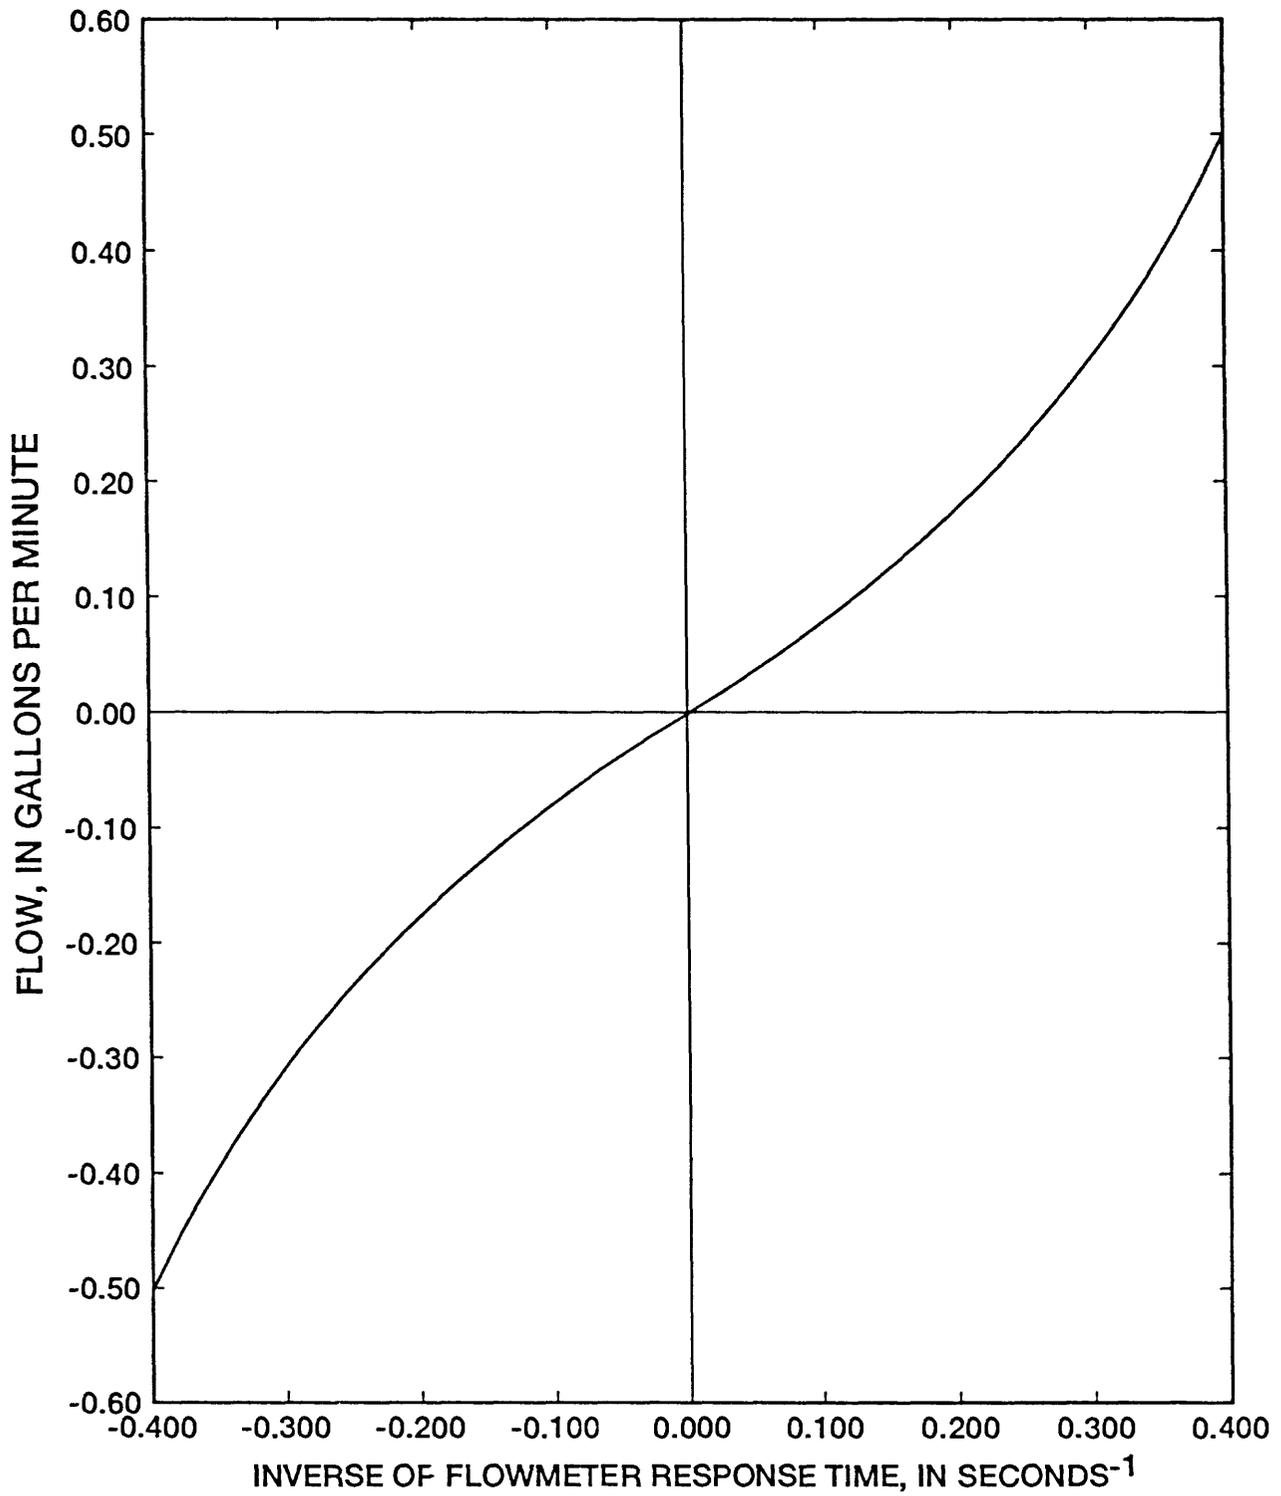
Figure 4. Calibration of heat-pulse flowmeter measurements; the inverse of heat-pulse travel time either up or down the borehole is related to borehole discharge in gallons per minute when the downhole packer is inflated.

The HPFM was developed to provide a borehole flowmeter with greater sensitivity than conventional impeller flowmeters, which require axial flow velocities larger than several feet per minute to turn the impeller blades (Keys, 1991). The HPFM measures axial flows along the borehole at discrete depths by detecting the time required for a small volume of thermally tagged water to travel from a heat grid to a thermistor in the measurement section of the tool (Hess, 1986). The sensitivity of the HPFM is increased by the use of a downhole packer system that uses an inflatable bladder to block the annulus around the tool, which forces all flow through the measurement section. With the packer inflated, the inverse of heat-pulse travel time is calibrated in terms of borehole discharge in gallons per minute (fig. 4). Experiments at the U.S. Geological Survey flowmeter calibration facility demonstrate that the HPFM can detect flows as small as 0.02 gal/min (Hess and Paillet, 1990).

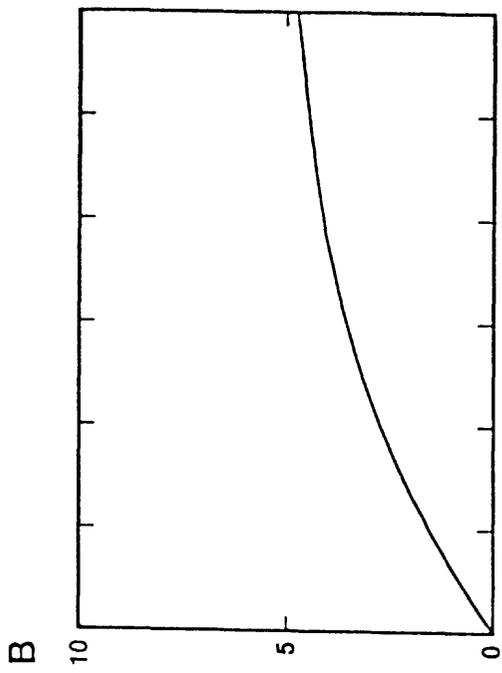
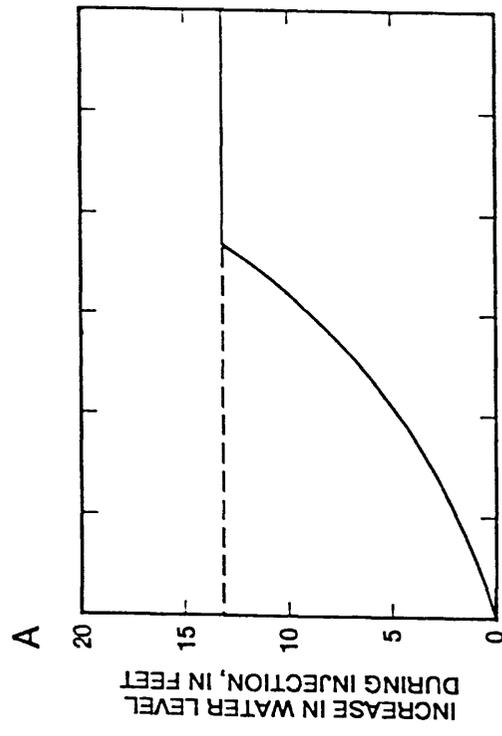
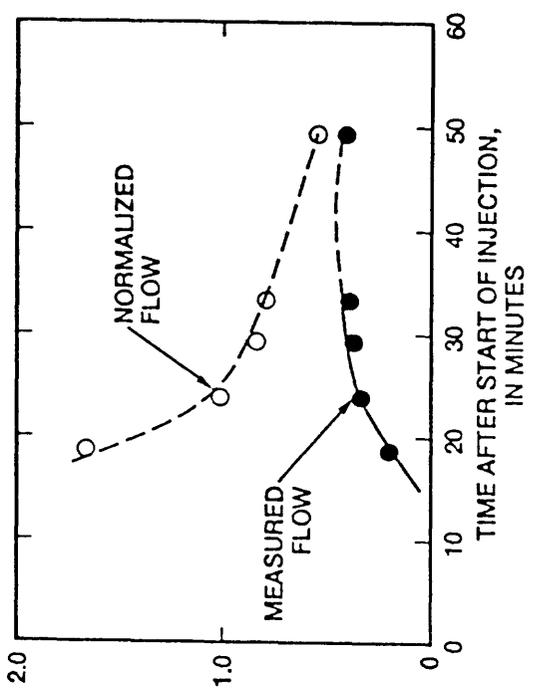
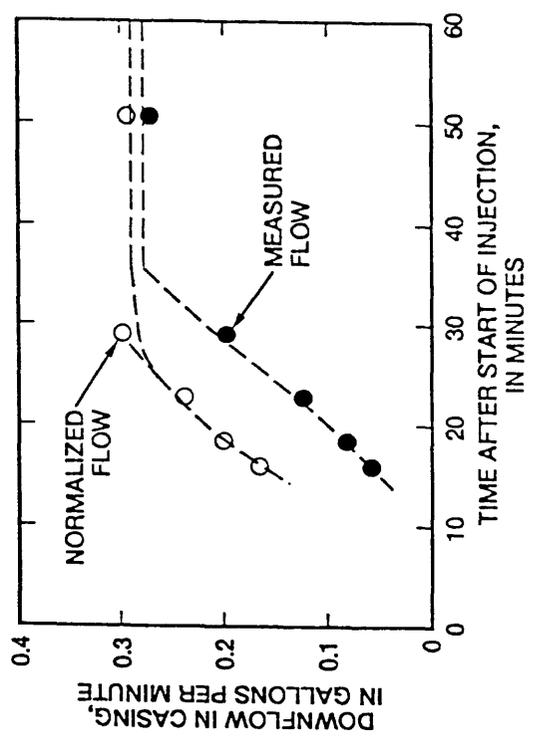
Figure 5. Water-level increase in casing during injection and downflow measured near the bottom of casing; downflow measurements are given before and after normalization for (A) borehole KR-3, and (B) borehole KR-30.

For example, the normalization using equation (1) increases the flow by only about two-thirds of the amount needed for effective normalization of flows measured at a depth of 30 ft in borehole KR-3 (fig. 5A). The results are even less effective for borehole KR-30 (fig. 5B), where the normalization appears to overcompensate for the effects of water-level buildup in casing. Both of these examples indicate that flow in fractured aquifers cannot always be treated as quasi-steady flow in a single confined aquifer, where outflow during injection is known to be nearly proportional to driving hydraulic head. The effects of fractures above the ambient water level in the aquifer being saturated during the injection almost certainly influenced the measured downflow. Water levels in some of the boreholes were occasionally changing in a way that did not seem related to the injection tests, and these changes are assumed to be caused by pumping from the aquifer by nearby water wells. These extraneous drawdowns may also have affected the ability to normalize the HPFM data using equation (1). The departures from effective normalization indicated in figure 5 are assumed to be a consequence of the complexity of flow in the fractured rocks adjacent to boreholes KR-3 and KR-30, superimposed on the effects of the filling of storage above the water table in the shallow fractures, possibly coupled with the extraneous drawdowns attributed to pumping from the aquifer by adjacent water users.

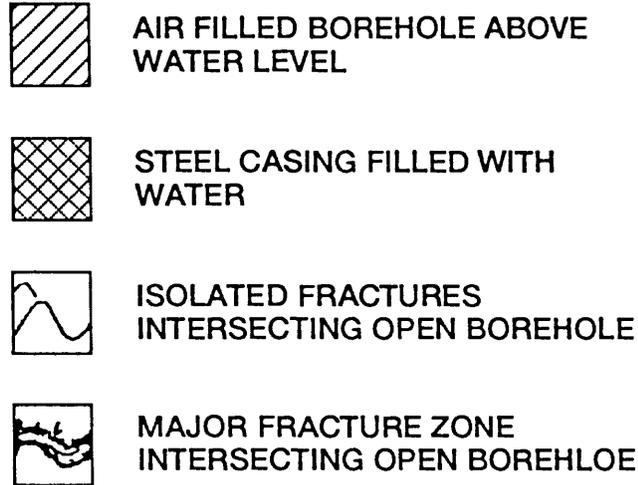
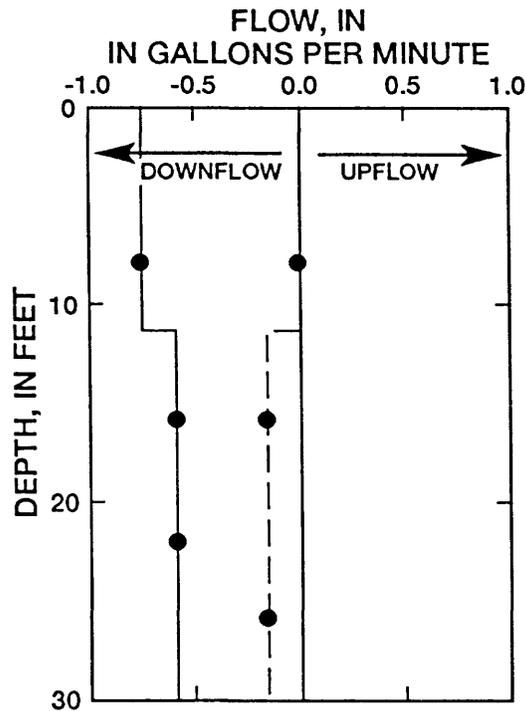
EXPLANATION OF TELEVIEWER LOG DATA DISPLAY

EXPLANATION OF HEAT PULSE FLOWMETER DATA DISPLAY

Figure 7. Explanation of acoustic borehole televiewer and flowmeter log data representation used in this report.

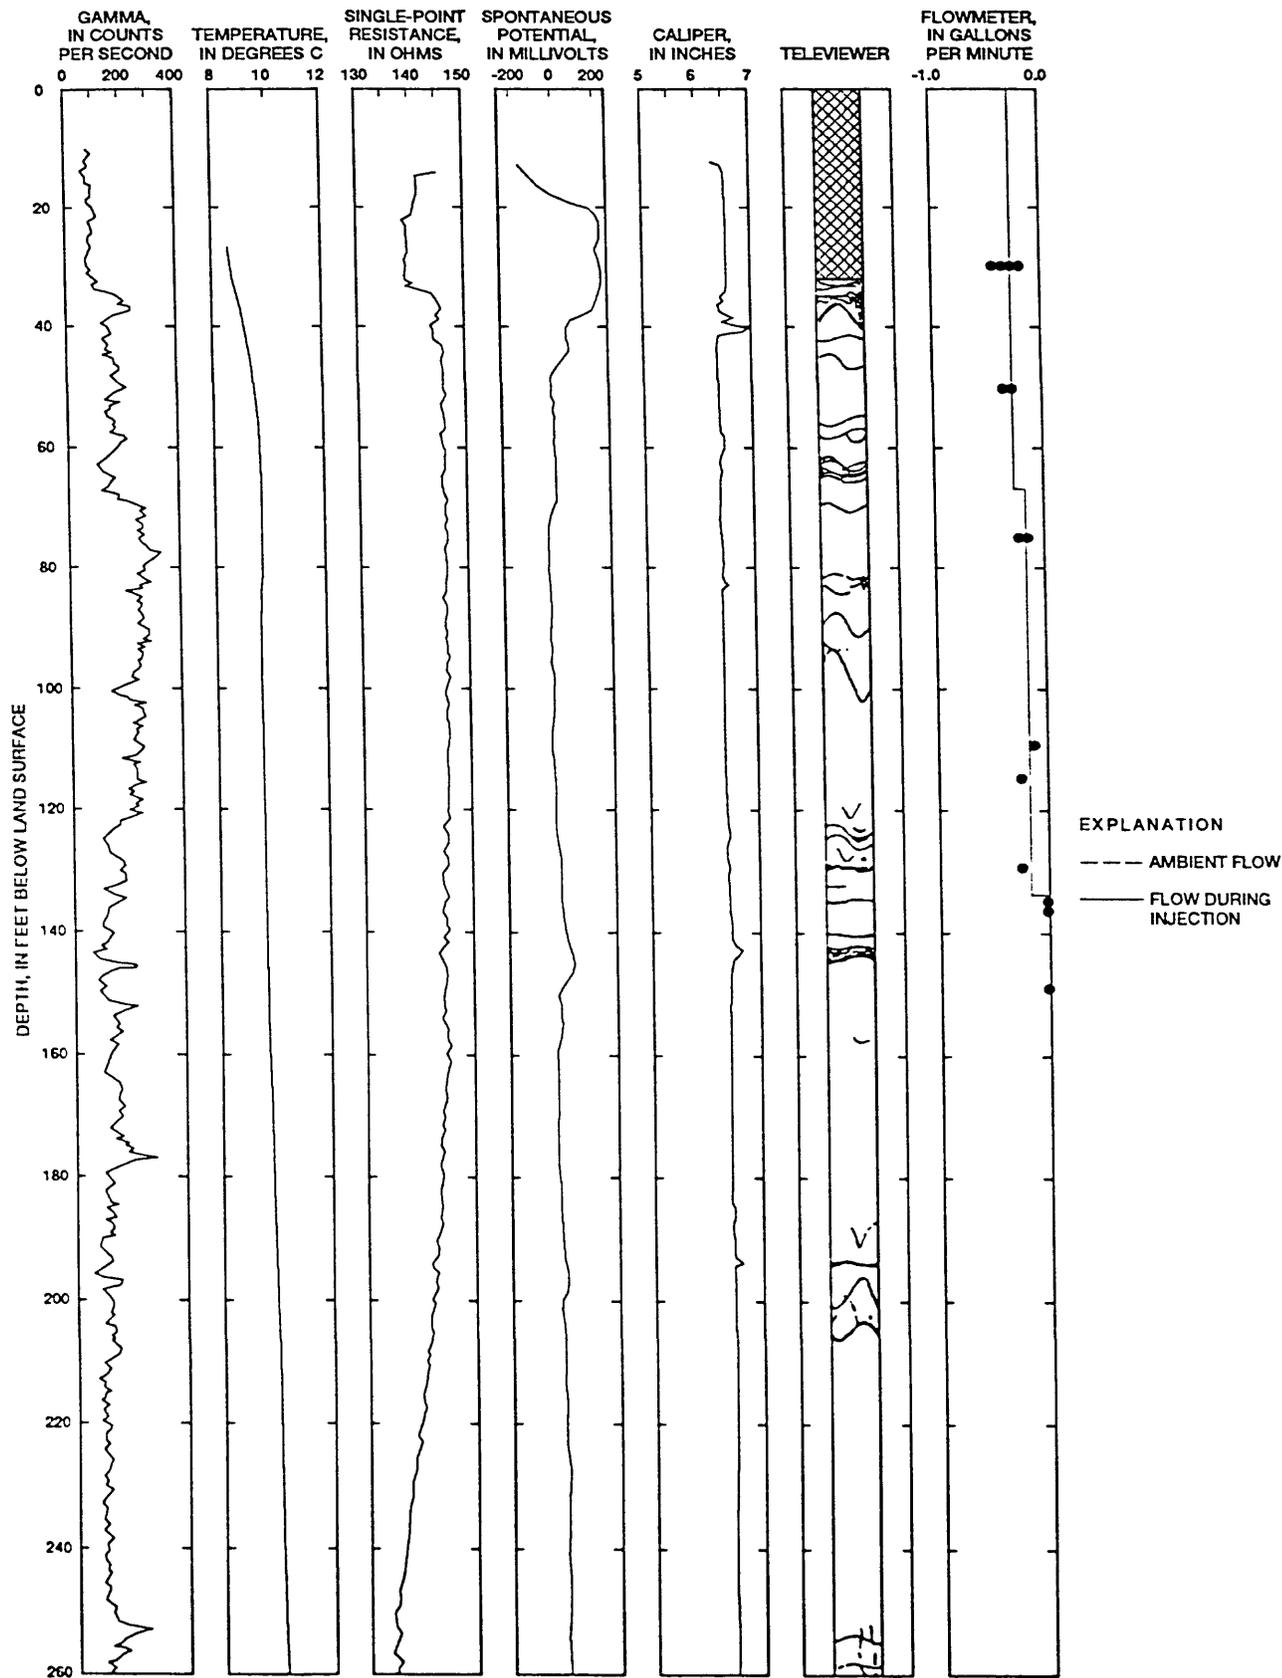
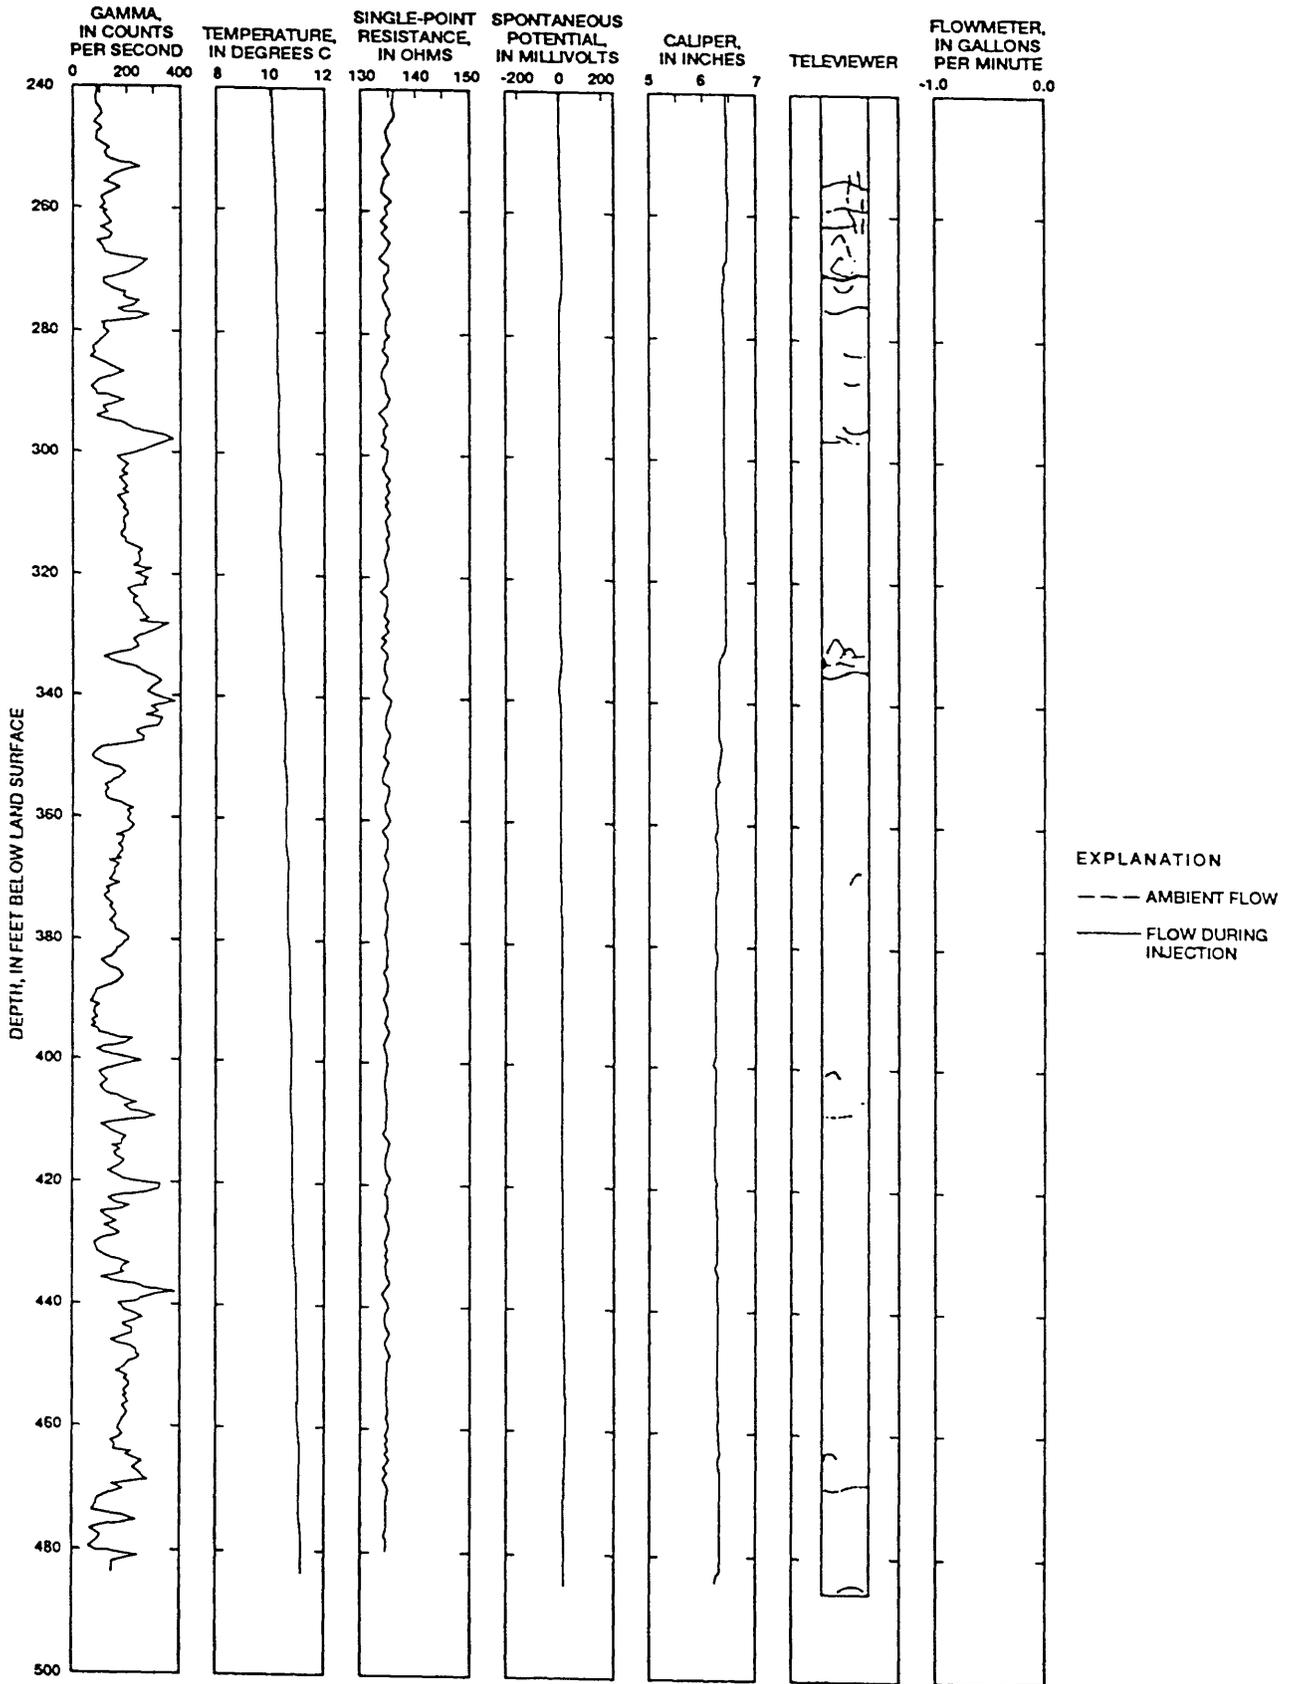
Figure 8. Natural gamma, temperature, single-point resistance, spontaneous potential, caliper, and acoustic televiewer logs and flowmeter logs obtained under ambient hydraulic-head conditions and during injection in borehole KR-3.

Figure 8. Continued.

The caliper and BHTV logs for borehole KR-3 indicate a few fractures and fracture zones above 200 ft in depth in borehole KR-3 and very few or no fractures below that depth (fig. 8). Only fractures near 196, 144, and 40 ft in depth appear associated with significant borehole enlargements on the caliper log. The single-point resistance log shows a gradual decrease in resistance over the interval from 180 to 240 ft in depth that may indicate a change in water quality in the borehole. Although such stratification could be associated with flow under ambient conditions in the borehole, the temperature log does not contain any significant anomalies that would be associated with such flow except for a gradual increase in geothermal gradient below about 140 ft in depth, which does not appear to indicate inflow or outflow at any specific depth.

Naturally occurring flow under ambient hydraulic-head conditions was not detected with the HPFM in borehole KR-3 (fig. 8). Based on the known resolution of the HPFM, any flow would have been less than 0.01 gal/min. HPFM measurements obtained during injection at about 0.5 gal/min indicated that a significant part of the flow was going into storage in casing. Of about 0.3 gal/min downflow obtained during the last minutes of the injection experiment, about 0.1 gal/min exited at a fracture zone between 60 and 70 ft in depth, and the remaining 0.2 gal/min exited at a single, isolated fracture near 135 ft in depth. The change in water quality below 180 ft in depth shown on the single-point resistance log may indicate a very slow downward flow under ambient conditions that is below the minimum flow detectable with the HPFM and too small to induce a recognizable anomaly on the temperature log.

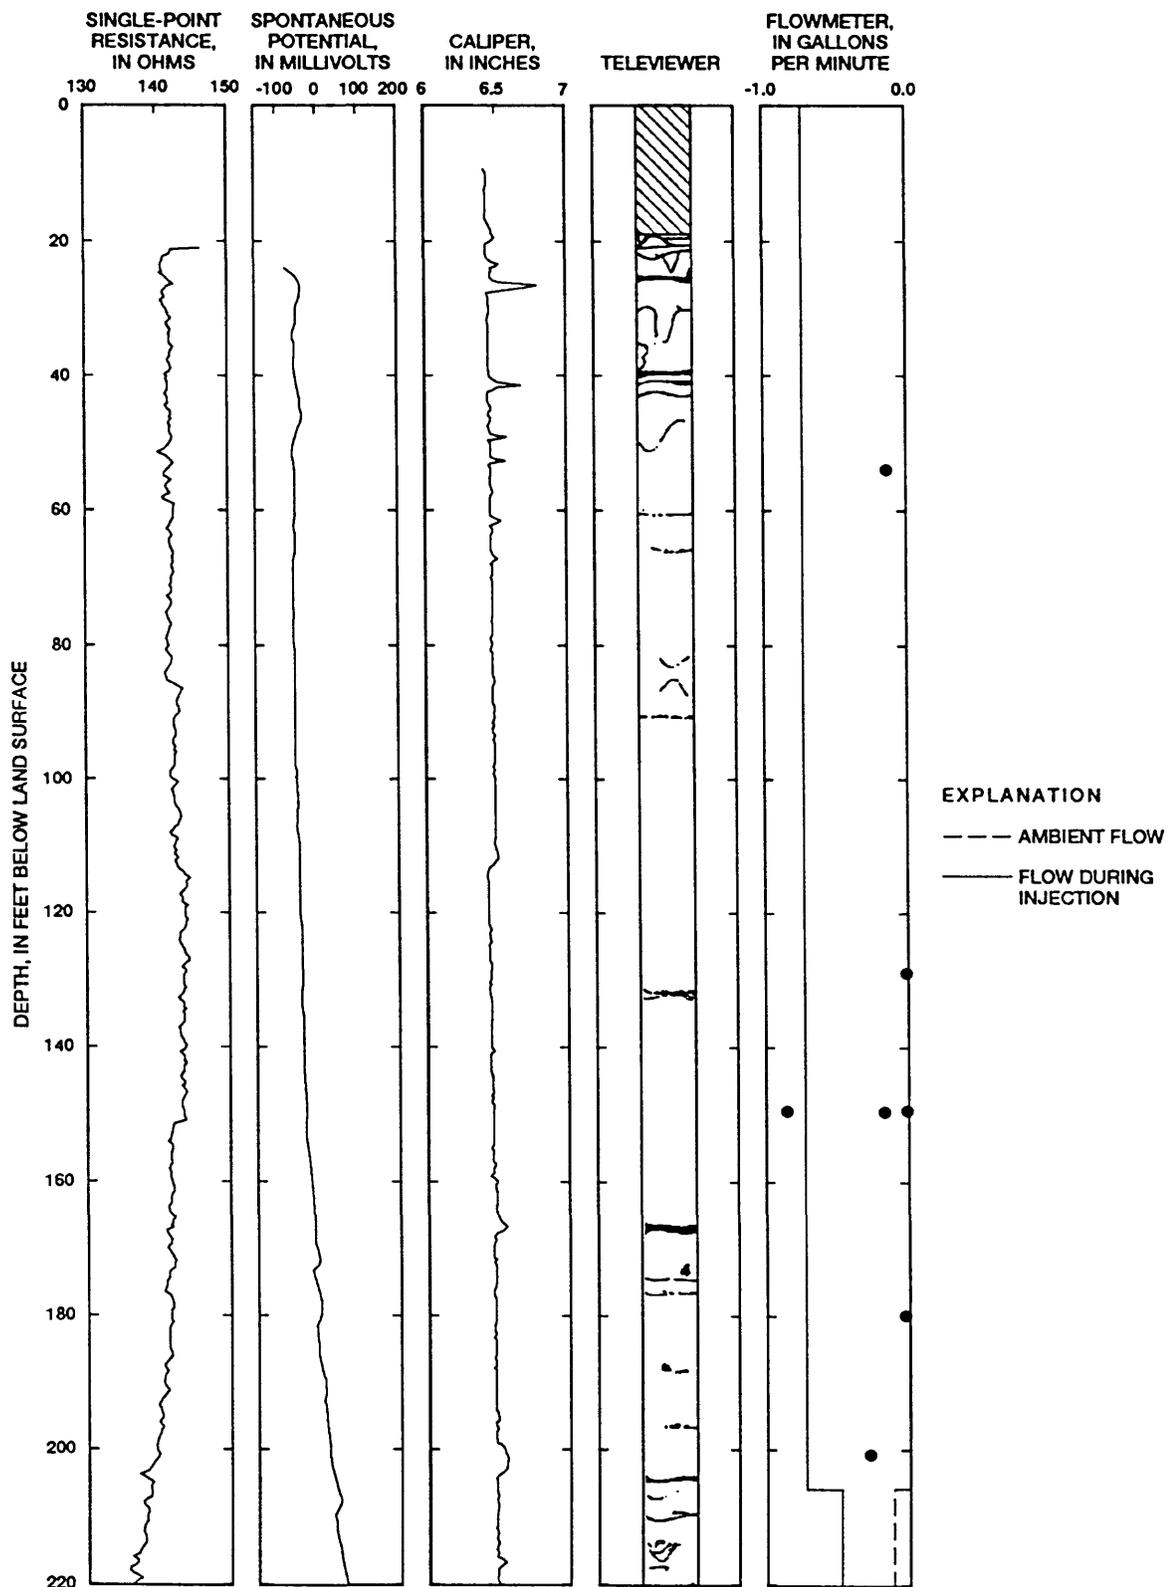
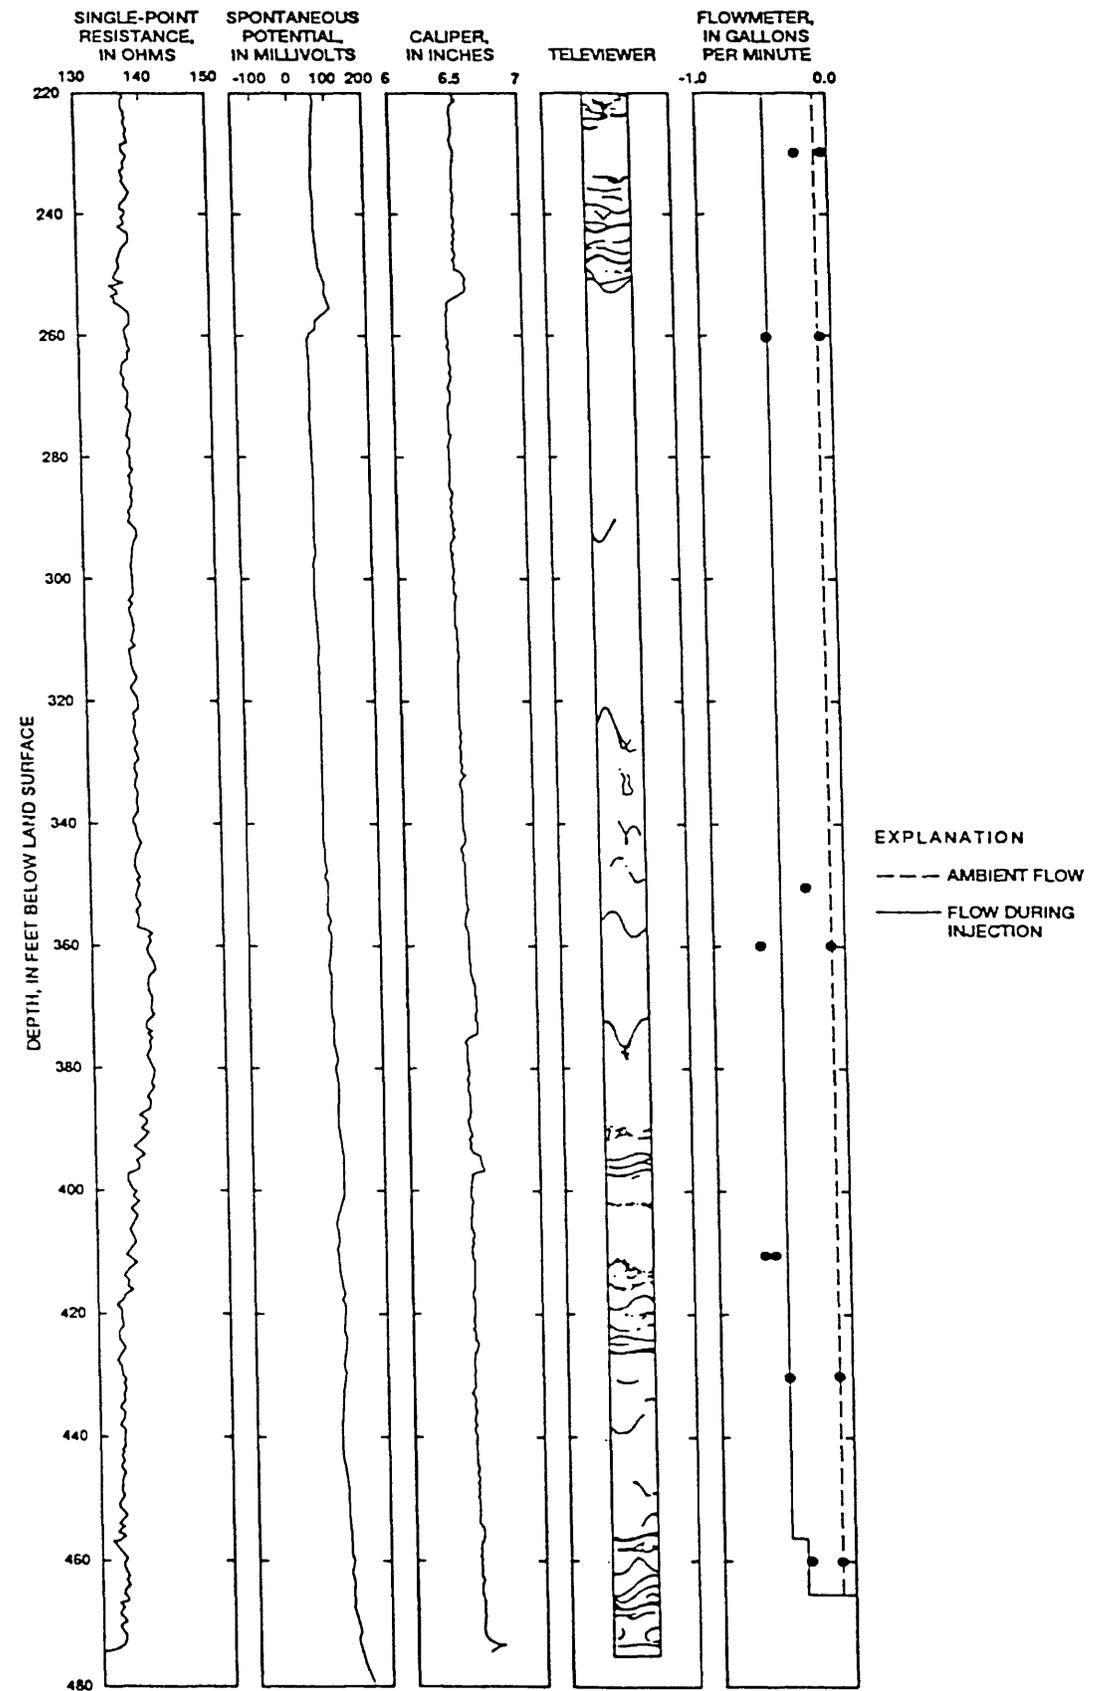
Figure 9. Single-point resistance, spontaneous potential, caliper, borehole televiwer logs and flowmeter logs obtained under ambient hydraulic-head conditions and during injection in borehole KR-15A.

Figure 9. Continued.

The caliper and BHTV logs for borehole KR-15A indicate a number of fractures and fracture zones distributed over the entire depth of the borehole (fig. 9). Many of the fractures and fracture zones indicated on the BHTV log correspond to borehole enlargements evident on the caliper log, and several large fracture zones are intersected by the borehole below 400 ft in depth. The single-point resistance log indicates changes in water quality in the fluid column filling the borehole near 180 and 390 ft in depth.

Naturally occurring downflow under ambient hydraulic-head conditions of about 0.1 gal/min was detected over the interval from 205 to 465 ft in depth (fig. 9). Inflow occurred at a single fracture near 205 ft in depth, and outflow occurred in a large fracture zone extending from 455 ft in depth to the bottom of the borehole. During injection tests about 0.7 gal/min of downflow was induced in borehole KR-15A. About one-third of this flow exited at the fracture near 205 ft in depth associated with inflow under ambient conditions. The other two-thirds of this downflow exited in the large fracture zone below 450 ft in depth. The single-point resistance log is consistent with slightly more saline water entering the borehole at the fracture near 205 ft in depth and exiting near the bottom of the borehole. The second, deeper shift in resistance of the fluid column may be related to a small amount of inflow under ambient conditions and outflow during the injection test that could not be detected with the HPFM. The relatively poor results of the flow normalization (fig. 5) indicate that as much as 0.01 gal/min outflow could have occurred in the fracture zone near 398 ft in depth without being detected by the HPFM during the injection tests. This small amount of flow could account for the observed shift in the fluid resistance indicated by the single-point resistance log at this depth.

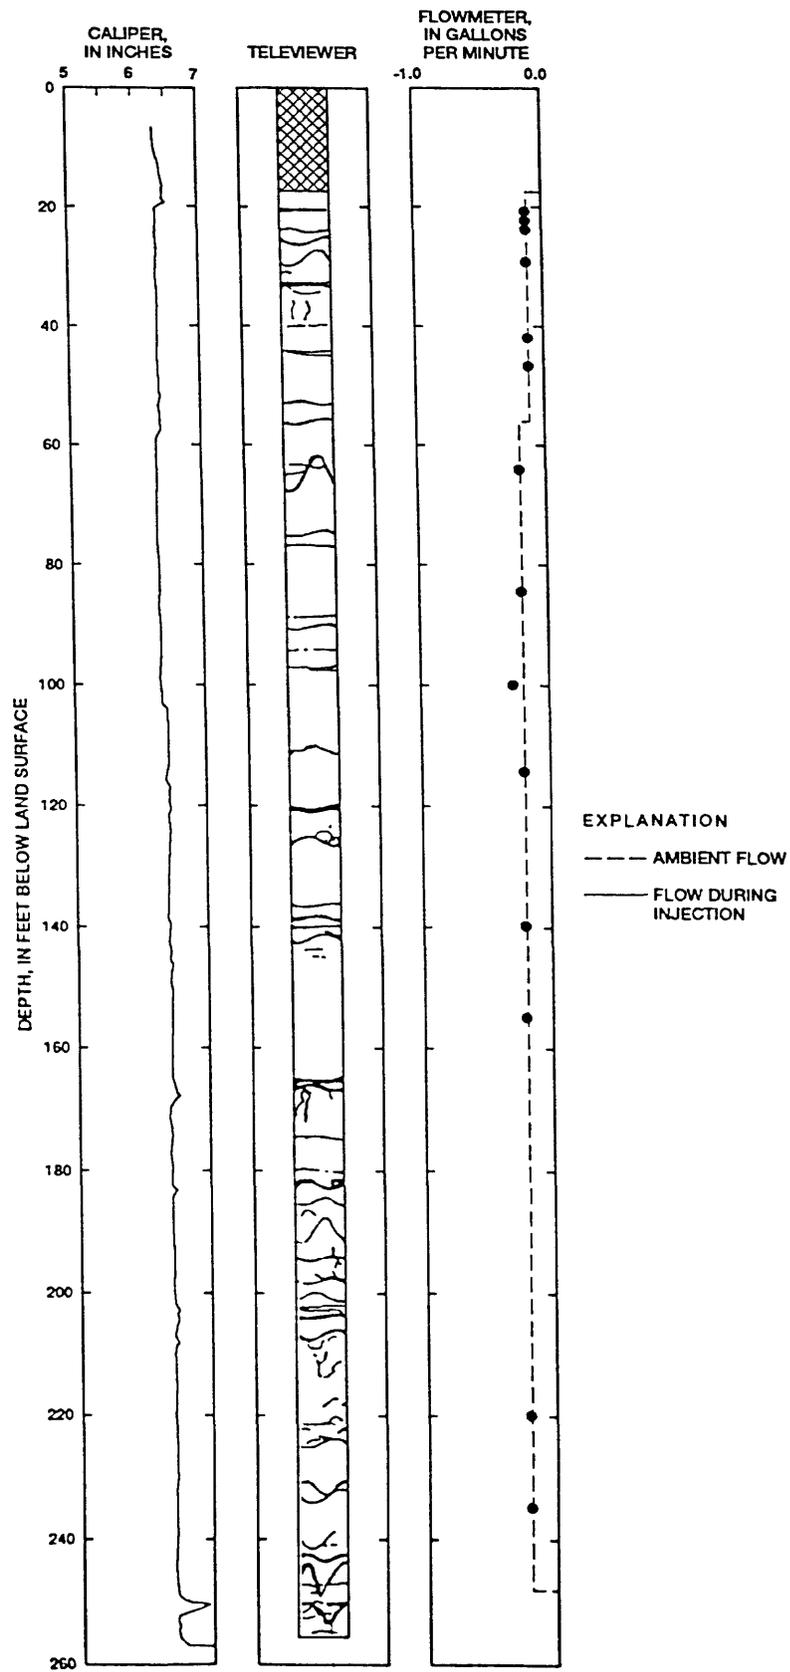
Figure 10. Caliper, acoustic televiewer, and flowmeter logs obtained under ambient hydraulic-head conditions in borehole KR-29.

The caliper and BHTV logs for borehole KR-29 indicate a number of fractures and fracture zones distributed over the entire depth of the borehole (fig. 10). However, only the large fracture zone near the bottom of the borehole is associated with a significant borehole enlargement indicated on the caliper log. The single-point resistance log was not run in this borehole.

Naturally occurring flow under ambient hydraulic-head conditions was measured over almost the entire depth of borehole KR-29 (fig. 10). About 0.1 gal/min entered near the bottom of casing near 28 ft in depth, and an additional 0.1 gal/min entered at a single, isolated fracture near 57 ft in depth. All of this flow exited in the major fracture zone below 240 ft in depth.

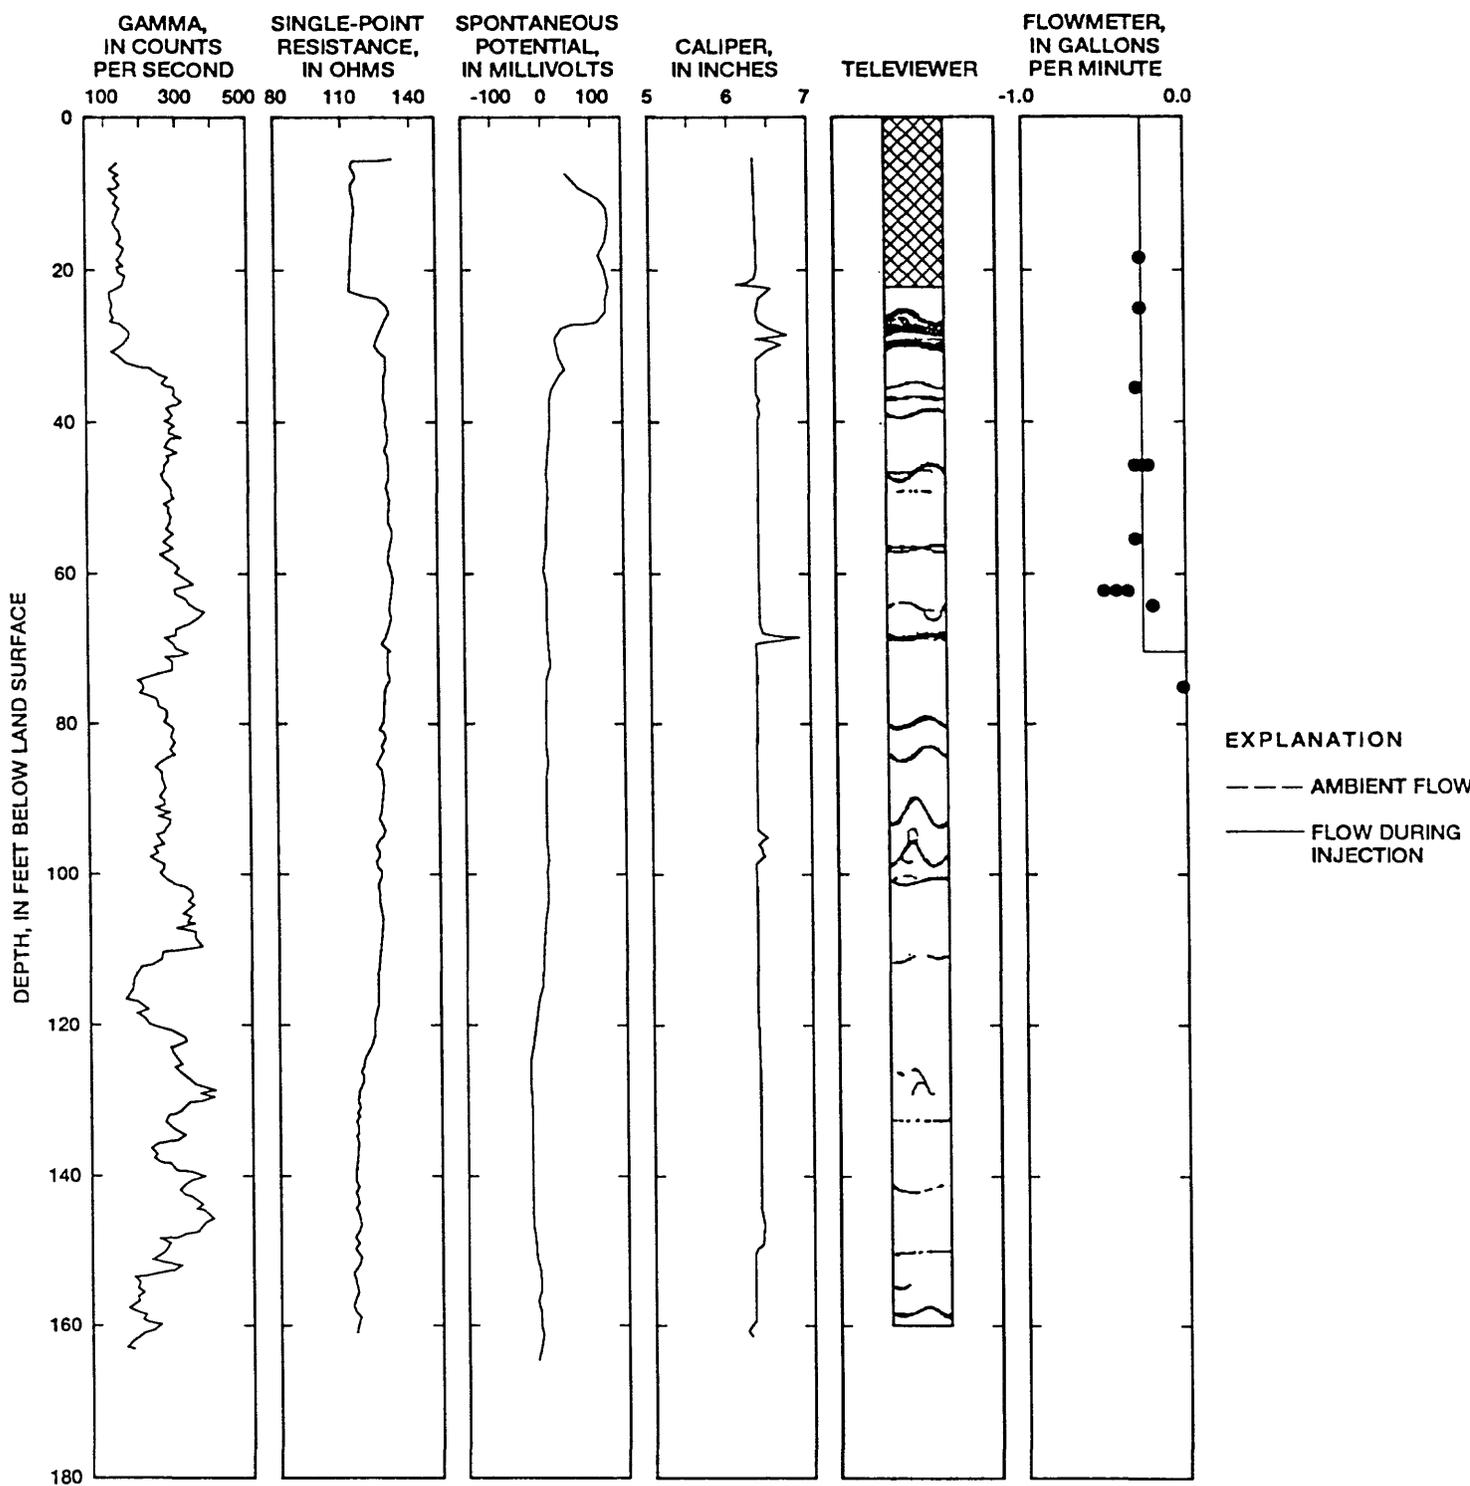
Figure 11. Natural gamma, single-point resistance, spontaneous potential, caliper, acoustic borehole televiewer logs and flowmeter log obtained during injection in borehole KR-30.

The BHTV log for borehole KR-30 indicates several large fractures above 100 ft in depth; two of these are associated with significant borehole enlargements indicated on the caliper log (fig. 11). The single-point resistance log indicates a constant fluid-column resistance above about 60 ft in depth, a gradual decrease in the interval between 60 and 120 ft in depth, and an abrupt decrease below 120 ft in depth.

Naturally occurring flow under ambient hydraulic-head conditions was not detected in borehole KR-30. About 0.3 gal/min of downflow was induced during the injection test, and all of this flow was found to exit the borehole at a single major fracture or fracture zone near 69 ft in depth (fig. 11). The fluid column resistivity indicated by the single-point resistance log is consistent with weak downflow too small to detect with the HPFM under ambient hydraulic-head conditions. Most of this flow was probably exiting at the fracture near 69 ft in depth, with an even smaller amount of downflow exiting at one or more deeper fractures between 70 and 120 ft in depth.
