Identification, Characterization, and Analysis of Hydraulically Conductive Fractures in Granitic Basement Rocks, Millville, Massachusetts

U.S. GEOLOGICAL SURVEY

Water-Resources Investigations Report 94-4185

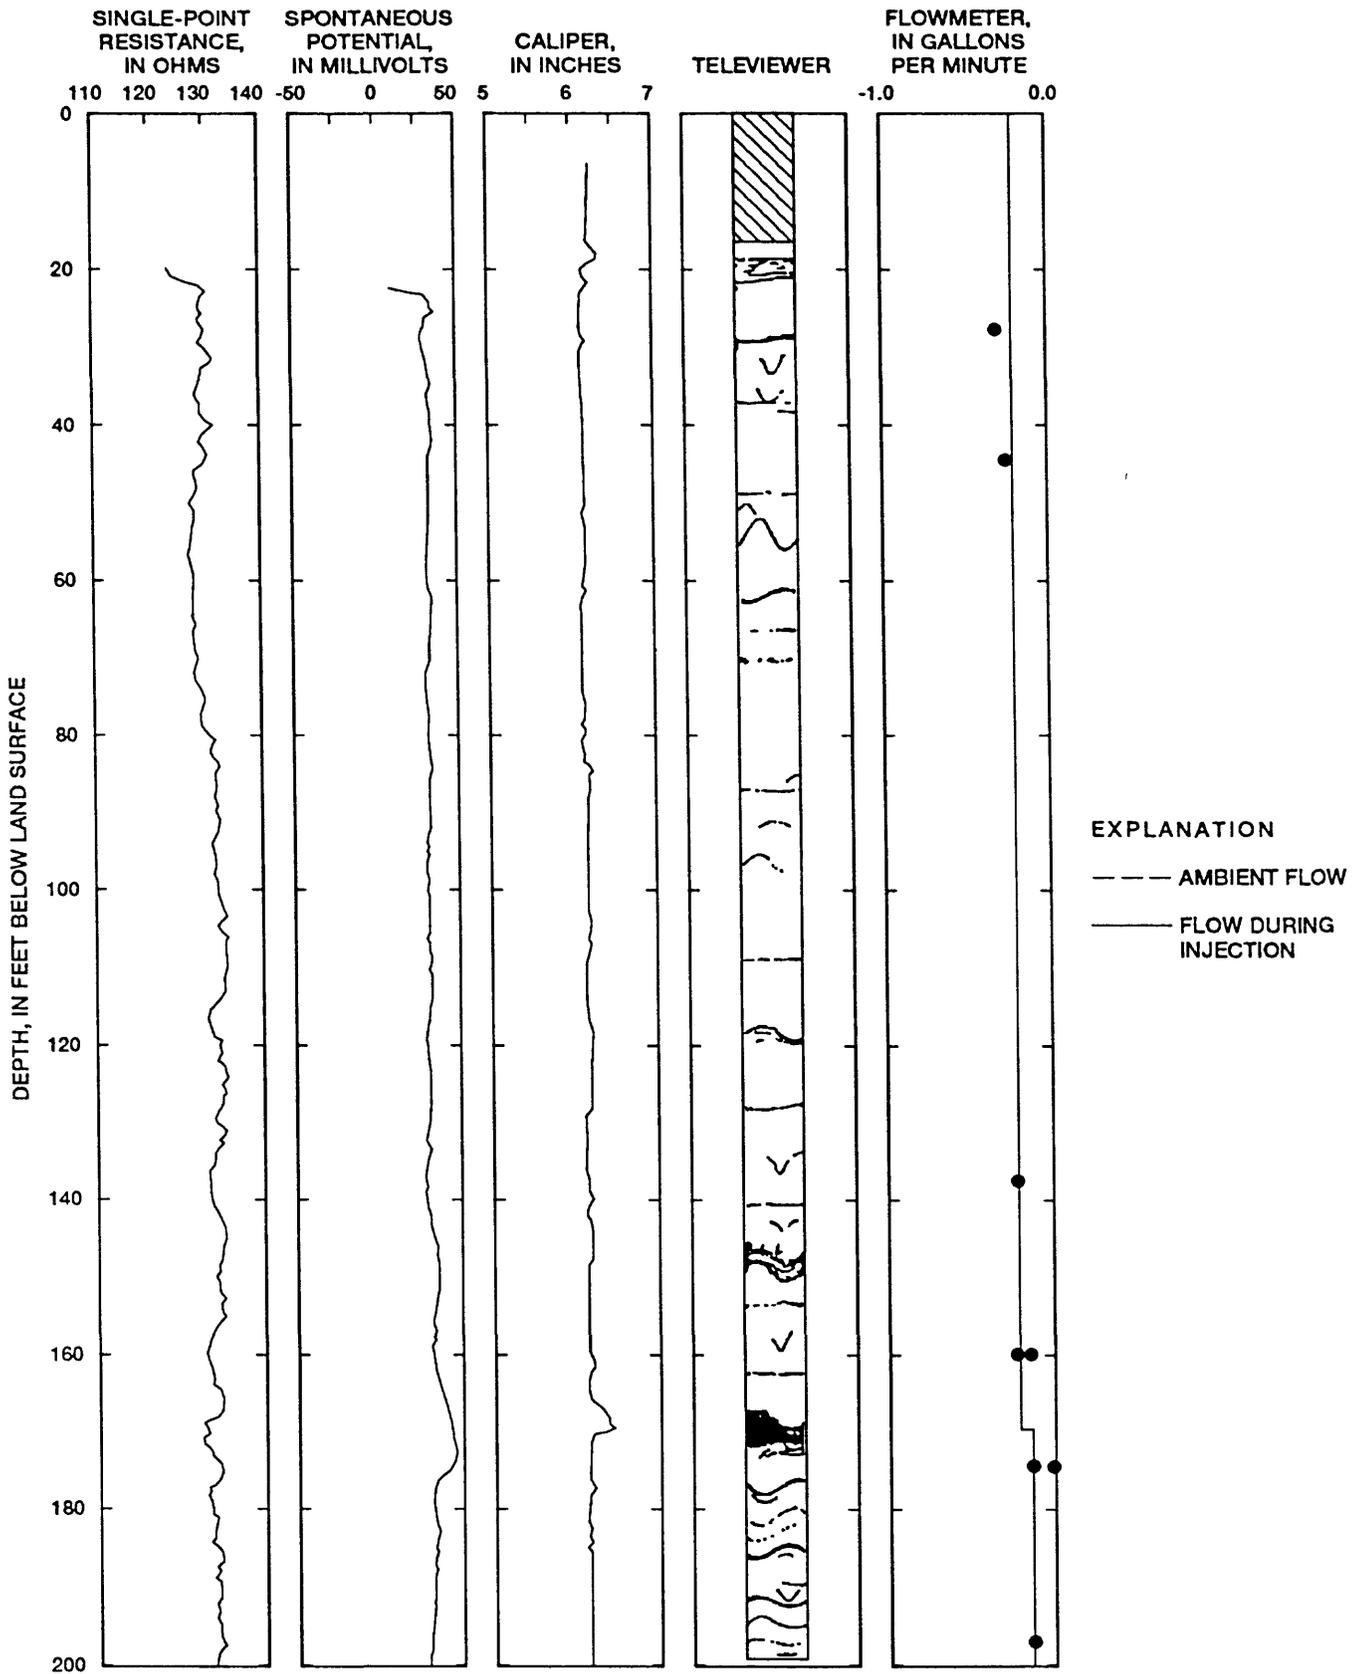
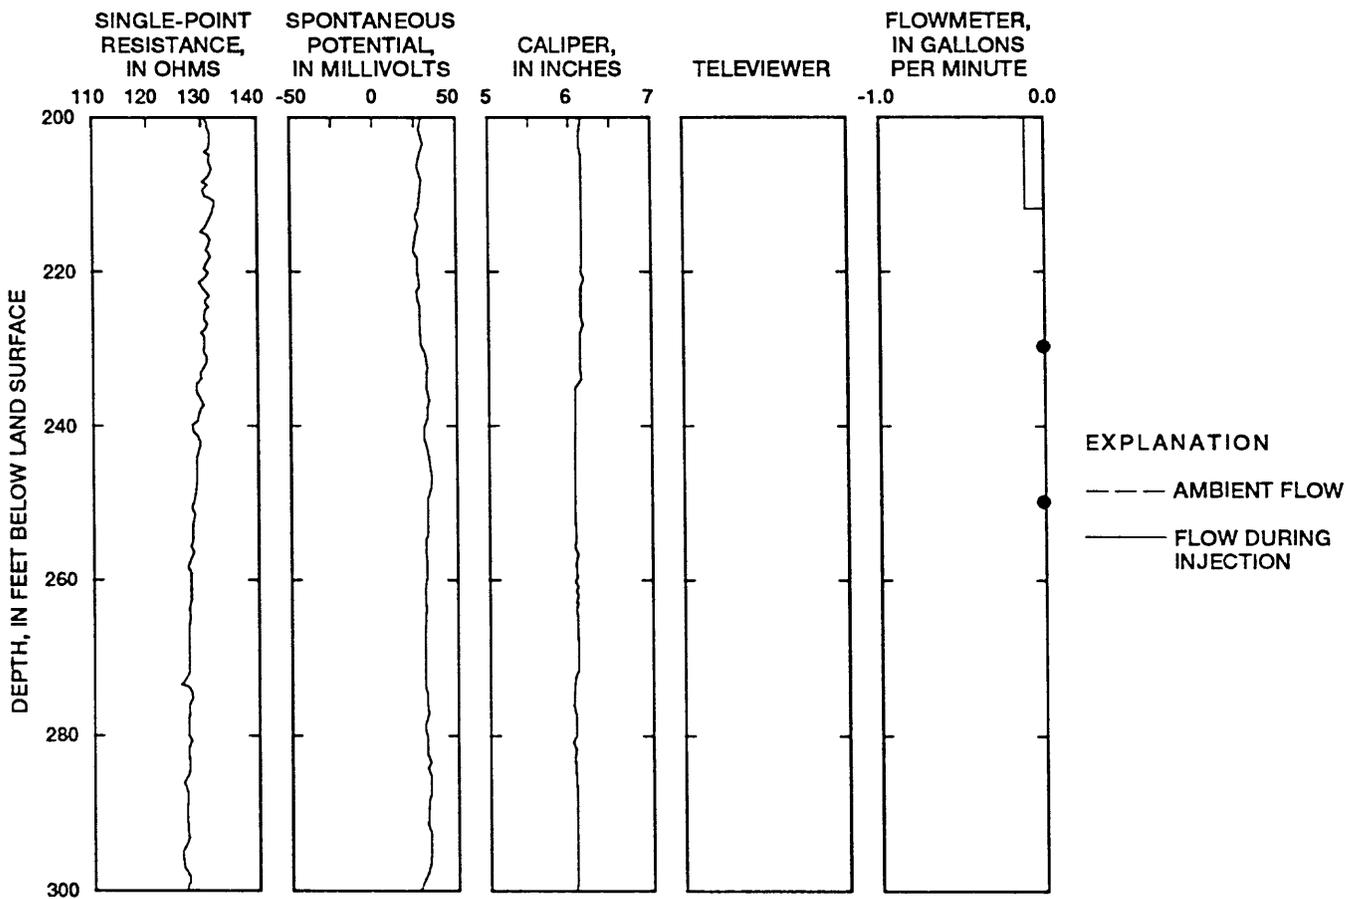
Figure 12. Single-point resistance, spontaneous potential, caliper, and acoustic borehole televiwer logs and flowmeter log obtained during injection in borehole KR-508.

Figure 12. Continued.

The caliper and BHTV logs for borehole KR-508 indicate a number of isolated fractures above 200 ft in depth (fig. 12); BHTV logs were not obtained below a depth of about 200 ft in this borehole. One fracture zone near 170 ft in depth is associated with an especially thick interval of borehole enlargement. The single-point resistance log indicates a nearly uniform fluid-column resistivity, except for a very weak decrease in resistivity below 240 ft in depth.

Naturally occurring flow under ambient hydraulic-head conditions was not detected in borehole KR-508. About 0.2 gal/min of downflow was induced during the injection test. About one-half of this downflow exited at the large fracture zone near 170 ft in depth; the rest of the downflow exited at one or more fractures between 200 and 230 ft in depth. The fluid-column resistivity indicated by the single-point resistance log is consistent with very weak downflow under ambient conditions, exiting below 200 ft in depth.

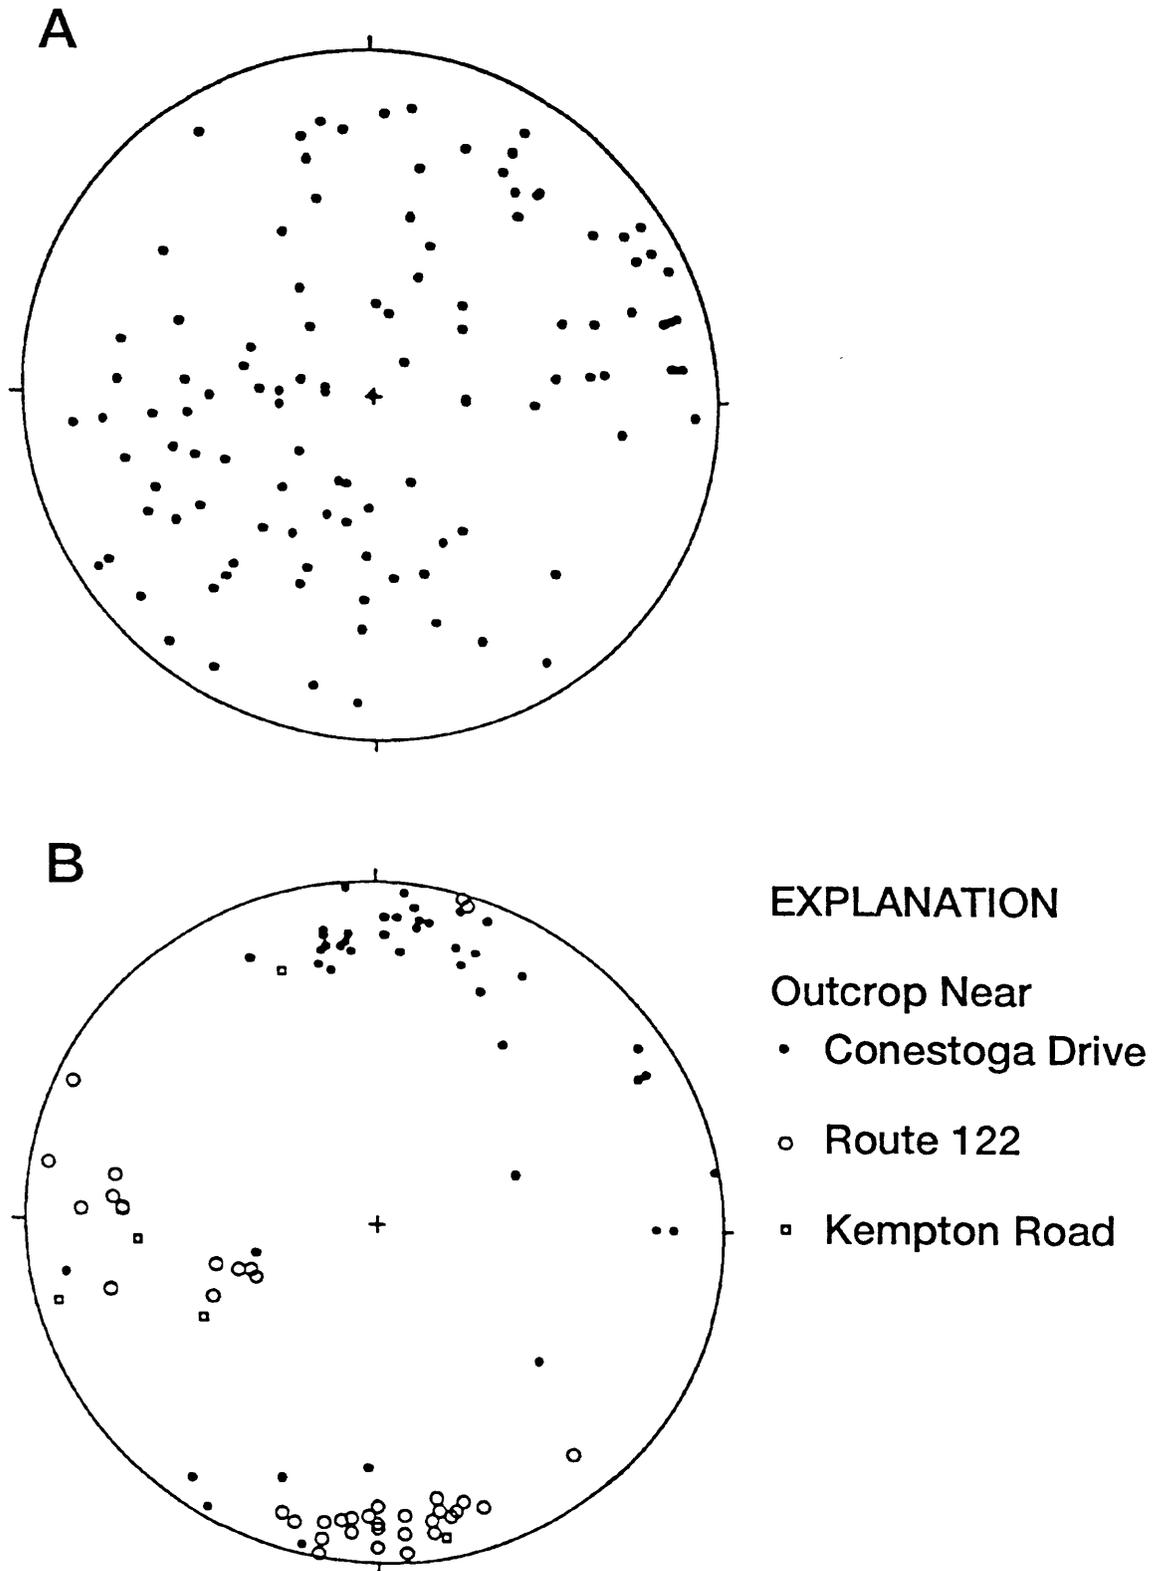
Figure 13. Equal area plots showing (A) poles to all fractures detected on televiewer logs for the Millville boreholes, and (B) poles to joints mapped on surface bedrock exposures at the Millville study site.

In general, the population of fracture planes identified on the BHTV logs do not show any consistent orientation (fig. 13), nor do the subpopulation of those fractures that appear especially large (size scores of 3 or greater, fig. 14) or those associated with inflow or outflow under natural conditions or during injection (fig. 14). The only consistent pattern indicated by the fracture orientations is the lack of poles to fractures in the northwest and southeast quadrants, corresponding to fracture planes dipping steeply to the northwest and southeast (fig. 13). Although 157 fractures appear to be a large population, this number may still not be large enough to provide a statistically significant representation of the properties of a heterogeneous fracture population. Furthermore, many of the fractures identified on the BHTV logs are associated with smaller size interpretation scores. The BHTV log data provide a much smaller population of relatively large fractures. The population of fractures identified on the BHTV logs that are associated with ground-water flow in the HPFM studies is even smaller.

A comparison of the orientations of the fractures identified on the BHTV logs (fig. 13) with those identified on outcrops (fig. 13) shows that the groupings of fractures and joints on the outcrops are not well represented by the televiewer data except for a similar absence of fractures dipping steeply to the northwest and southeast. The outcrop data are represented by concentrations of poles corresponding to sets of steeply dipping joints. Near-vertical boreholes are not likely to intersect a large number of such steeply dipping features. In addition, joints were sampled at the bedrock surface where they are opened by weathering and stress release. The boreholes intersect fractures at depth, where joints may be so tight that they are not detected by the televiewer. The nearly vertical bedrock boreholes and the nearly horizontal, laterally limited surface outcrops probably sample very different populations of bedrock discontinuities.

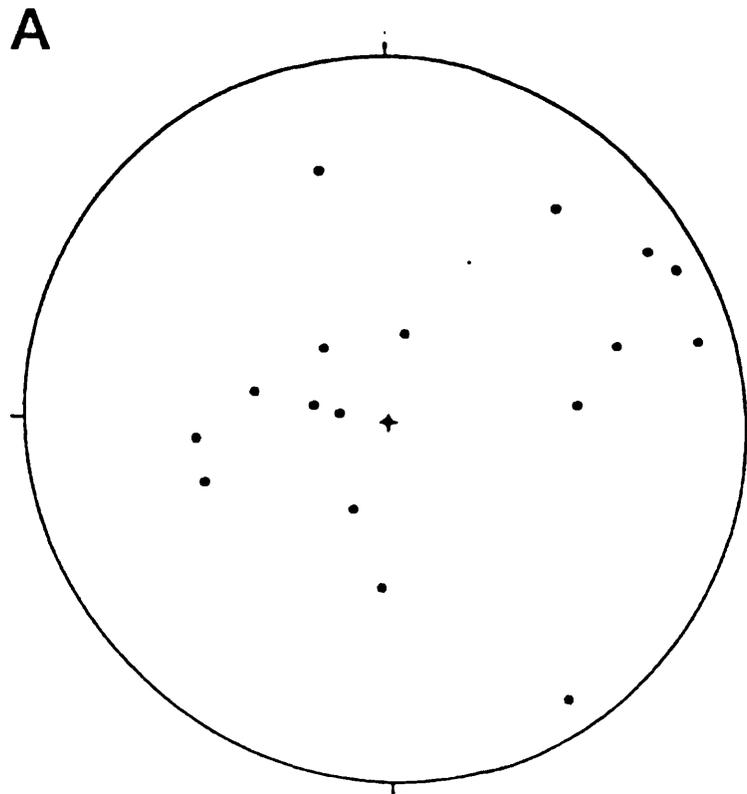
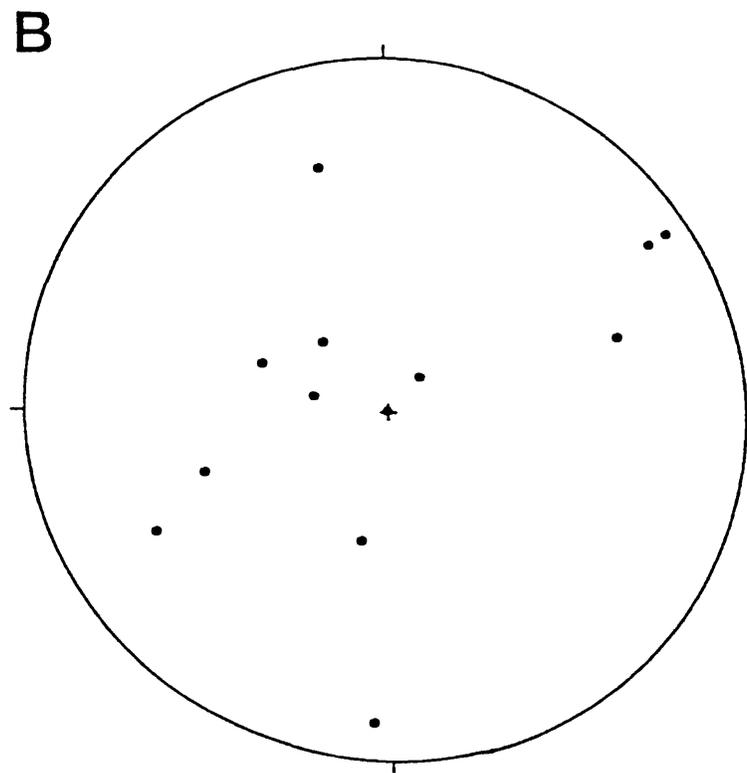
Figure 14. Equal plots showing (A) poles to fractures associated with televiewer size scores greater than 2, and (B) poles to fractures associated with inflow or outflow under ambient hydraulic-head conditions or during injection tests at the Millville study site.
