HYDROGEOLOGIC FRAMEWORK, WATER LEVELS, AND TRICHLOROETHYLENE CONTAMINATION, NAVAL AIR WARFARE CENTER, WEST TRENTON, NEW JERSEY, 1993-97

Water-Resources Investigations Report 98-4167

By Pierre J. Lacombe

U.S. Geological Survey

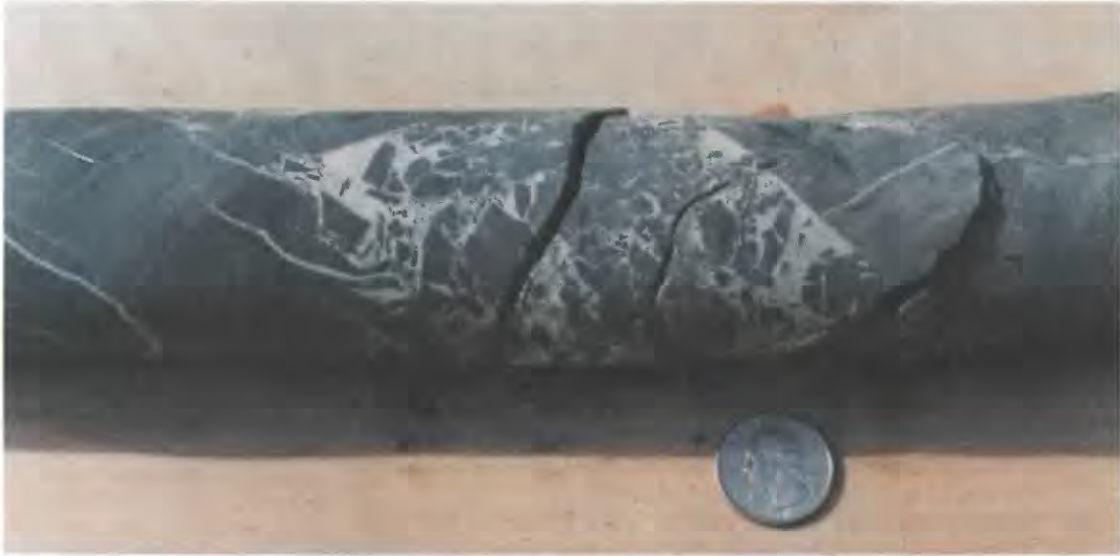
Figure 20. Rock core from well 42BR at 68 feet below land surface showing steeply dipping beds on either side of brecciated and cemented fault zone. [Right side of photograph is nearer to land surface.]

The best evidence of a fault zone is in rock cores from well 42BR at depths of 68, 111, and 127 ft below land surface (figs. 20, 21, and 22). Evidence of faulting consists of stratigraphic layers showing bedding offsets, brecciated zones, and slickensides. Rock core from a depth of 68 ft below land surface (fig. 20) shows a brecciated rock zone cemented with calcite. Bedding above and below the fault has a measured dip angle of 45° and an interpreted dip direction of N20°W. The fault has a measured dip angle of 50° and an interpreted dip direction of about S20°E. Rock core from a depth of 111 ft below land surface

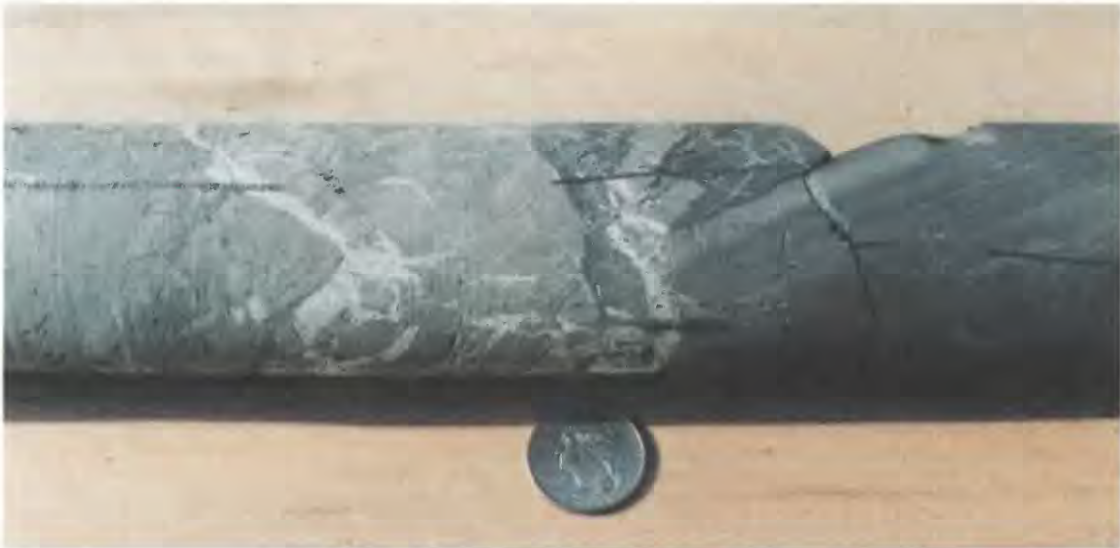
Figure 21. Rock core from well 42BR at 111 feet below land surface showing steeply dipping beds and shallow dipping fault. (Fault zone shows brecciation and cementation. Fault is nearly perpendicular to the plain of the bedding). [Left side of photograph is nearer to land surface.]

(fig. 21) shows a 3-in fault contact. Bedrock above the fault consists of light gray mudstones; bedrock below the fault zone consists of dark gray mudstone. The strike and dip of the bedrock above and below the fault is N65°E and 30° NW, and the dip angle and direction of the fault is 40° and S20°E; therefore, the fault is nearly perpendicular to the plane of the bedding. Rock core from a depth of 127 ft below land surface (fig. 22) shows a 2-in fault zone. Bedrock above and below the fault has a measured dip angle of about 70° and an dip direction of N20°W. The measured dip angle of the fault is about 30°, and the dip direction is S10°E. Again the fault plane is nearly perpendicular to the bedding.

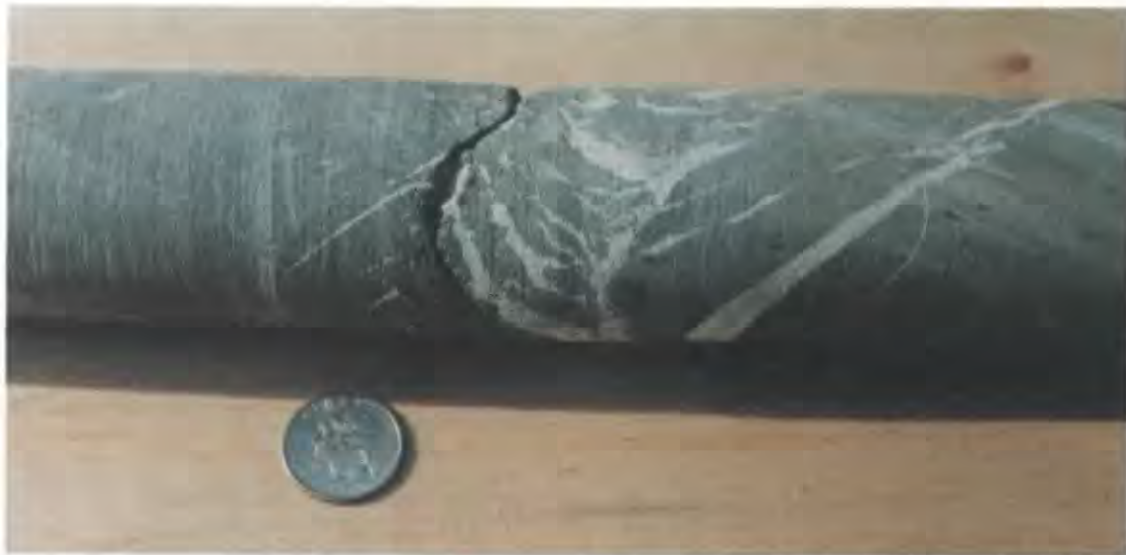
Figure 22. Rock core from well 42BR at 127 feet below land surface showing steeply dipping beds and brecciated in the fault zone. [Left side of photograph is nearer to land surface.]

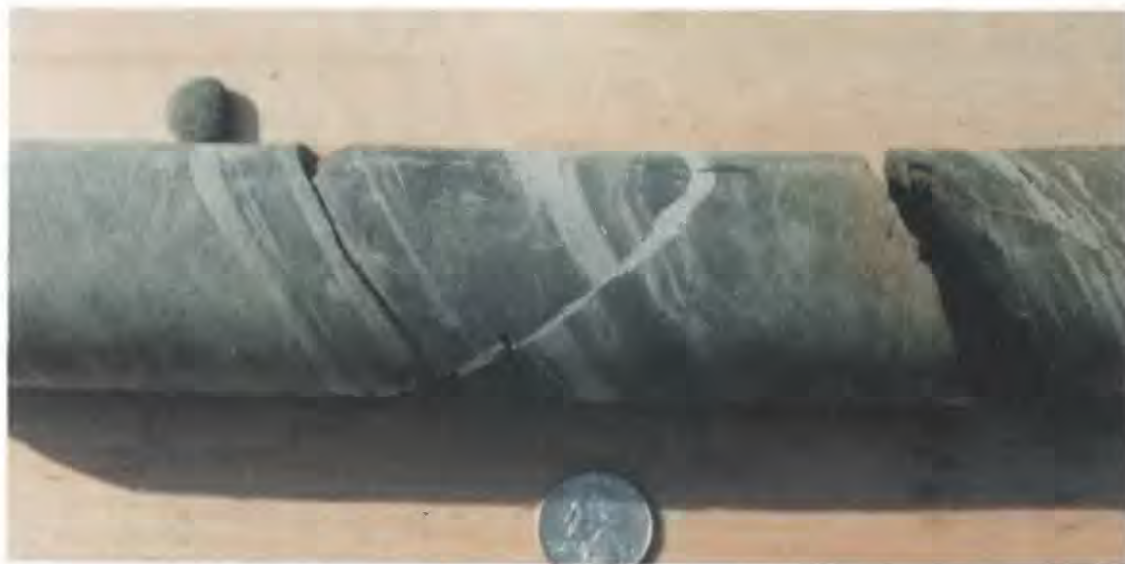
Figure 23. Rock core from well 17BR at 55 feet below land surface showing gently dipping beds and steeply dipping fault. (Fault plane is nearly perpendicular to the bedding plane. Fault zone is cemented.) [Left side of photograph is nearer to land surface.]

Offset bedding, fault brecciation, and slickensides also are found in rock cores from wells 17BR (fig. 23) and 51BR (fig. 24). The core from monitoring well 17BR shows the dip of the bedding is about 25°, and the dip of the fault is nearly perpendicular to the dip of the bedding. The core from well 51BR shows a brecciated zone that is 8 to 10 in. wide. Based on these and other cores that show faulting, the fault plane is typically perpendicular to the bedding plane and the strike of the two planes is offset by about 20°.

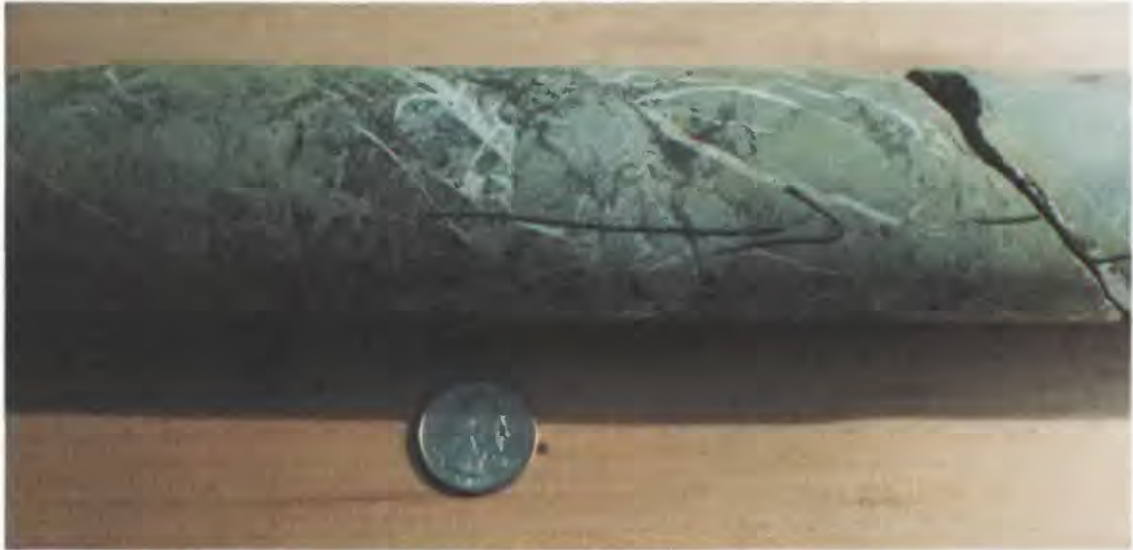
Figure 24. Rock core from well 51BR at 95 feet below land surface showing brecciation in fault zone. (Fault zone is cemented) [Left side of photograph is nearer to land surface.]

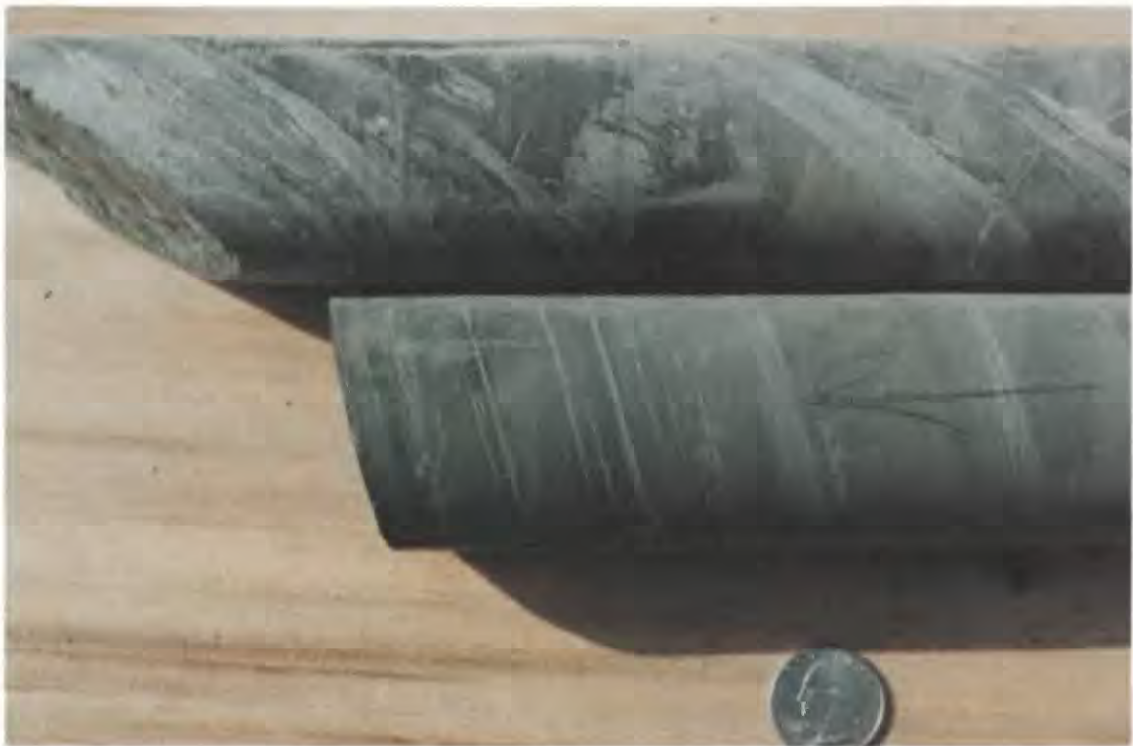
Figure 25. Rock core from well 42BR showing shallow dipping bedrock and well 43BR showing steeply dipping bedrock. [Left side of photograph is nearer to land surface.]
