EFFECTS OF GROUND-WATER DEVELOPMENT ON THE PROPOSED PALMETTO BEND DAM AND RESERVOIR IN SOUTHEAST TEXAS

U.S. GEOLOGICAL SURVEY

Water-Resources Investigations 18-73

Prepared in cooperation with the U.S. Bureau of Reclamation

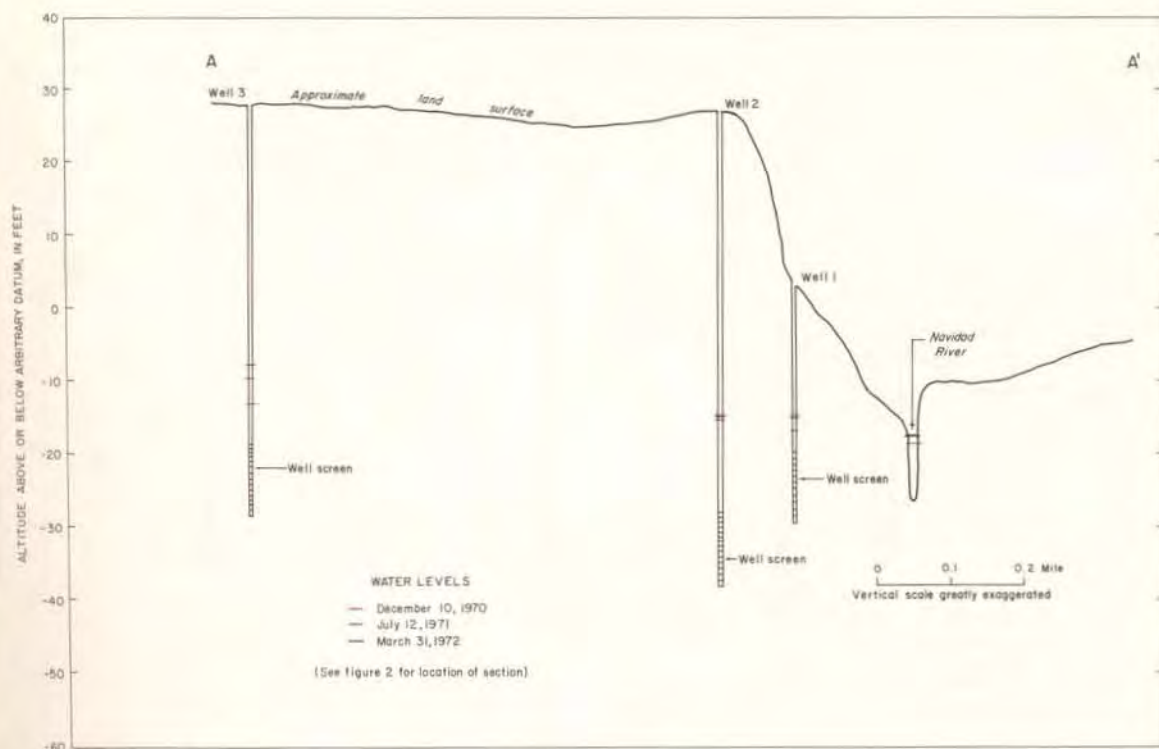
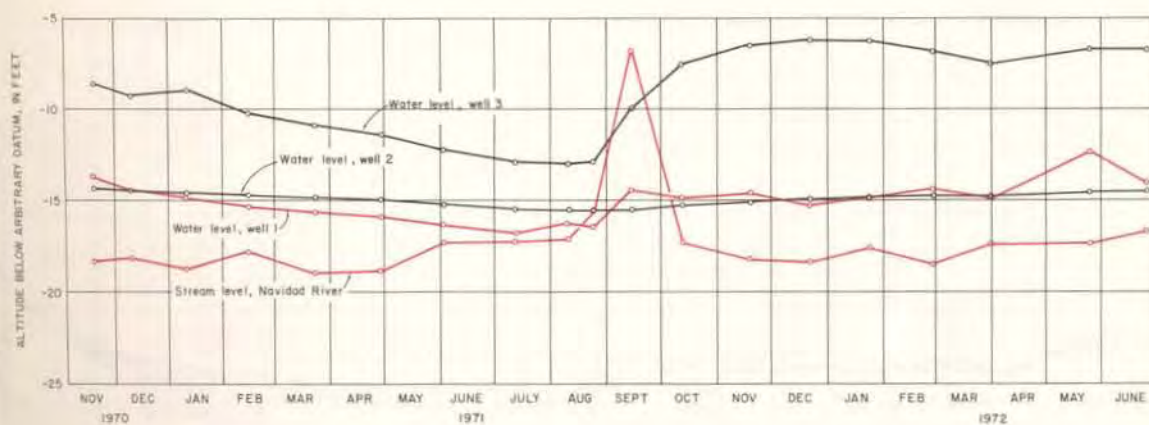
FIGURE 3.- Altitudes of water levels in wells and stream at Navidad River monitoring site I

The sections and hydrographs in figures 3 to 11 show the stream-surface altitudes of the Lavaca and Navidad Rivers and the altitudes of the adjacent water levels plotted to a common arbitrary datum. The altitudes of the water levels indicated on the sections were measured at a time when evapotranspiration and ground-water pumpage were small (December 1970), when evapotranspiration and ground-water pumpage were large (July 1971), and at an intermediate time in early spring (March 1972). The hydrographs show the levels of the Lavaca and Navidad Rivers and levels of the adjacent water levels in wells from November 1970 to June 1972.

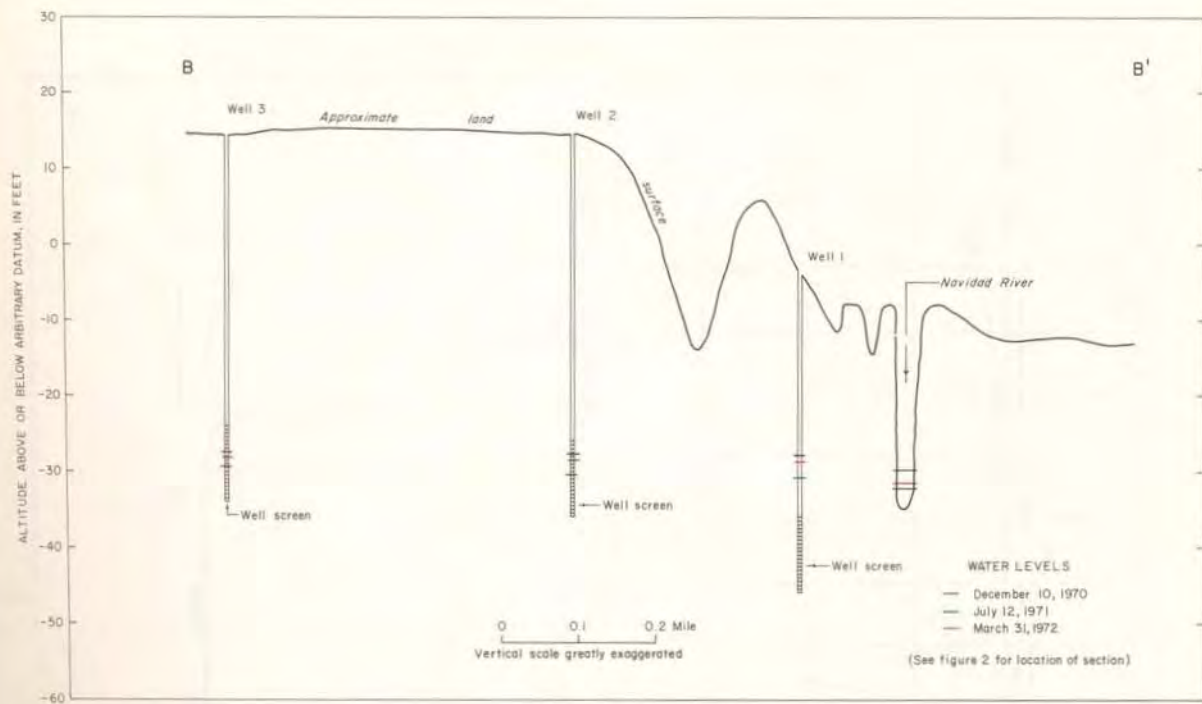
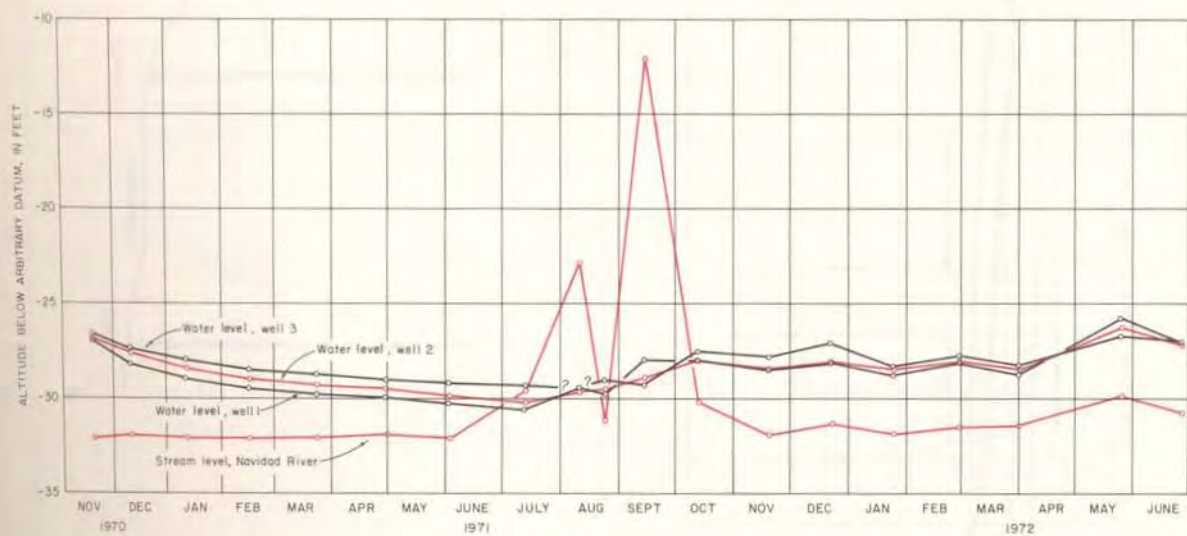
FIGURE 4.—Altitudes of water levels in wells and stream at Navidad River monitoring site 2

Not all water levels in the wells can be assumed to represent the water table because some wells penetrated too deeply (several feet to several tens of feet) below the air-water interface. These wells tend to have water levels that probably are either higher or lower than the water table, depending on the distance and altitude of the wells with respect to the streams and on various pressure heads acquired by the individual sand lenses. Many of the wells, however, penetrated only a few feet below the air-water interface. The water levels in these wells probably represent the water table. Such wells were installed in places at Navidad River monitoring sites 2, 3, and 5 (figs. 4, 5, and 7) and at Lavaca River monitoring sites 1 and 2 (figs. 10 and 11).

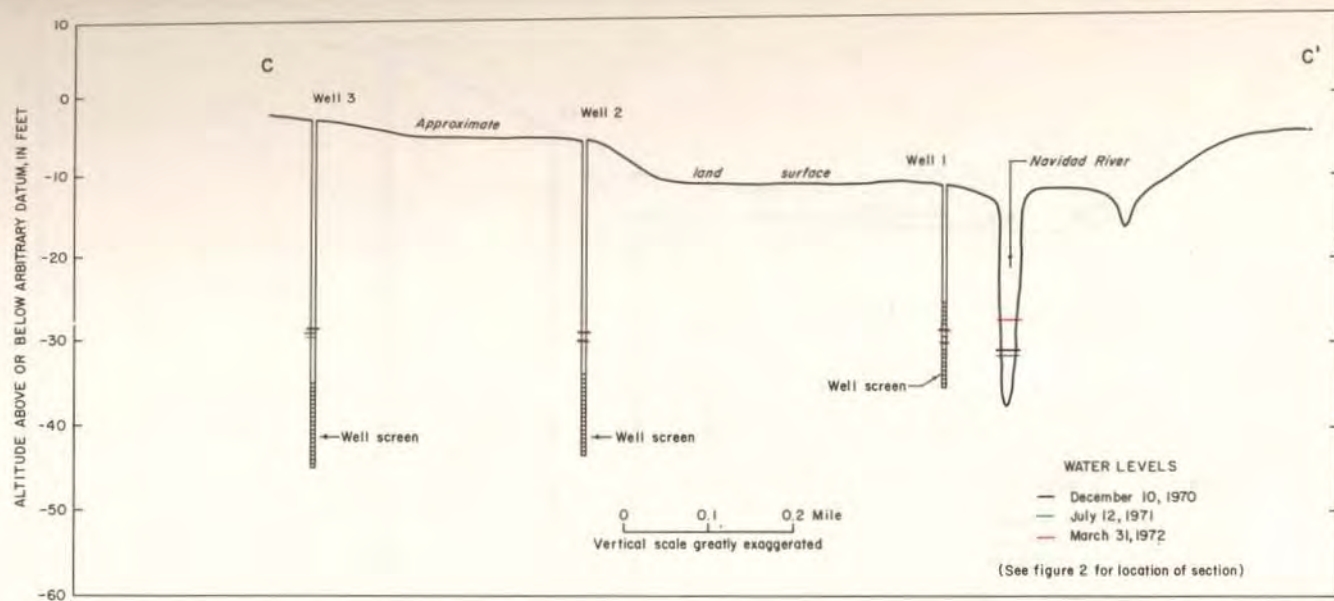
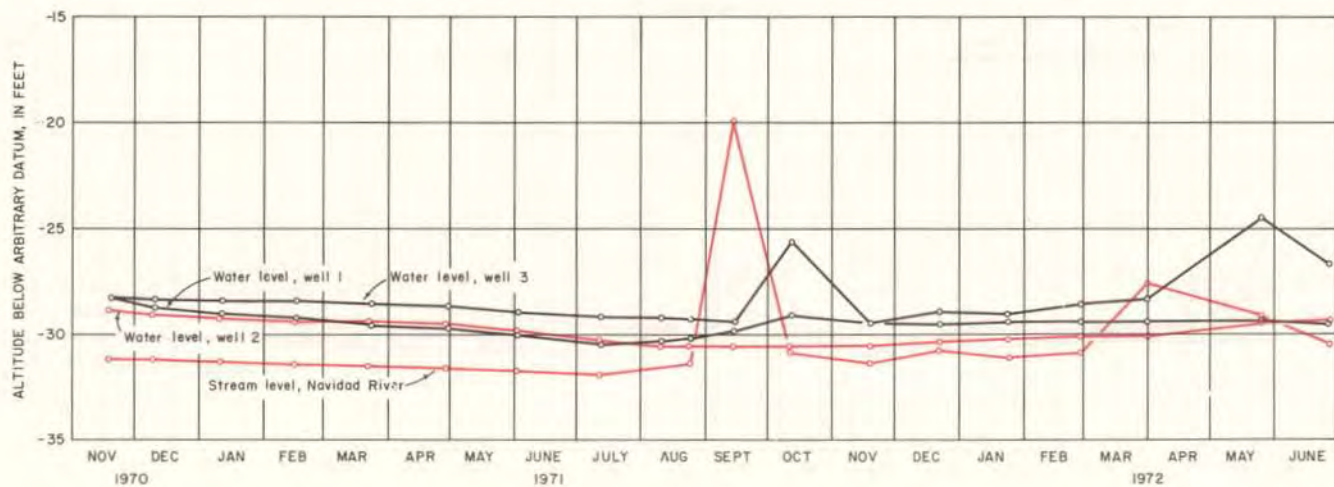
FIGURE 5.-Altitudes of water levels in wells and stream at Navidad River monitoring site 3

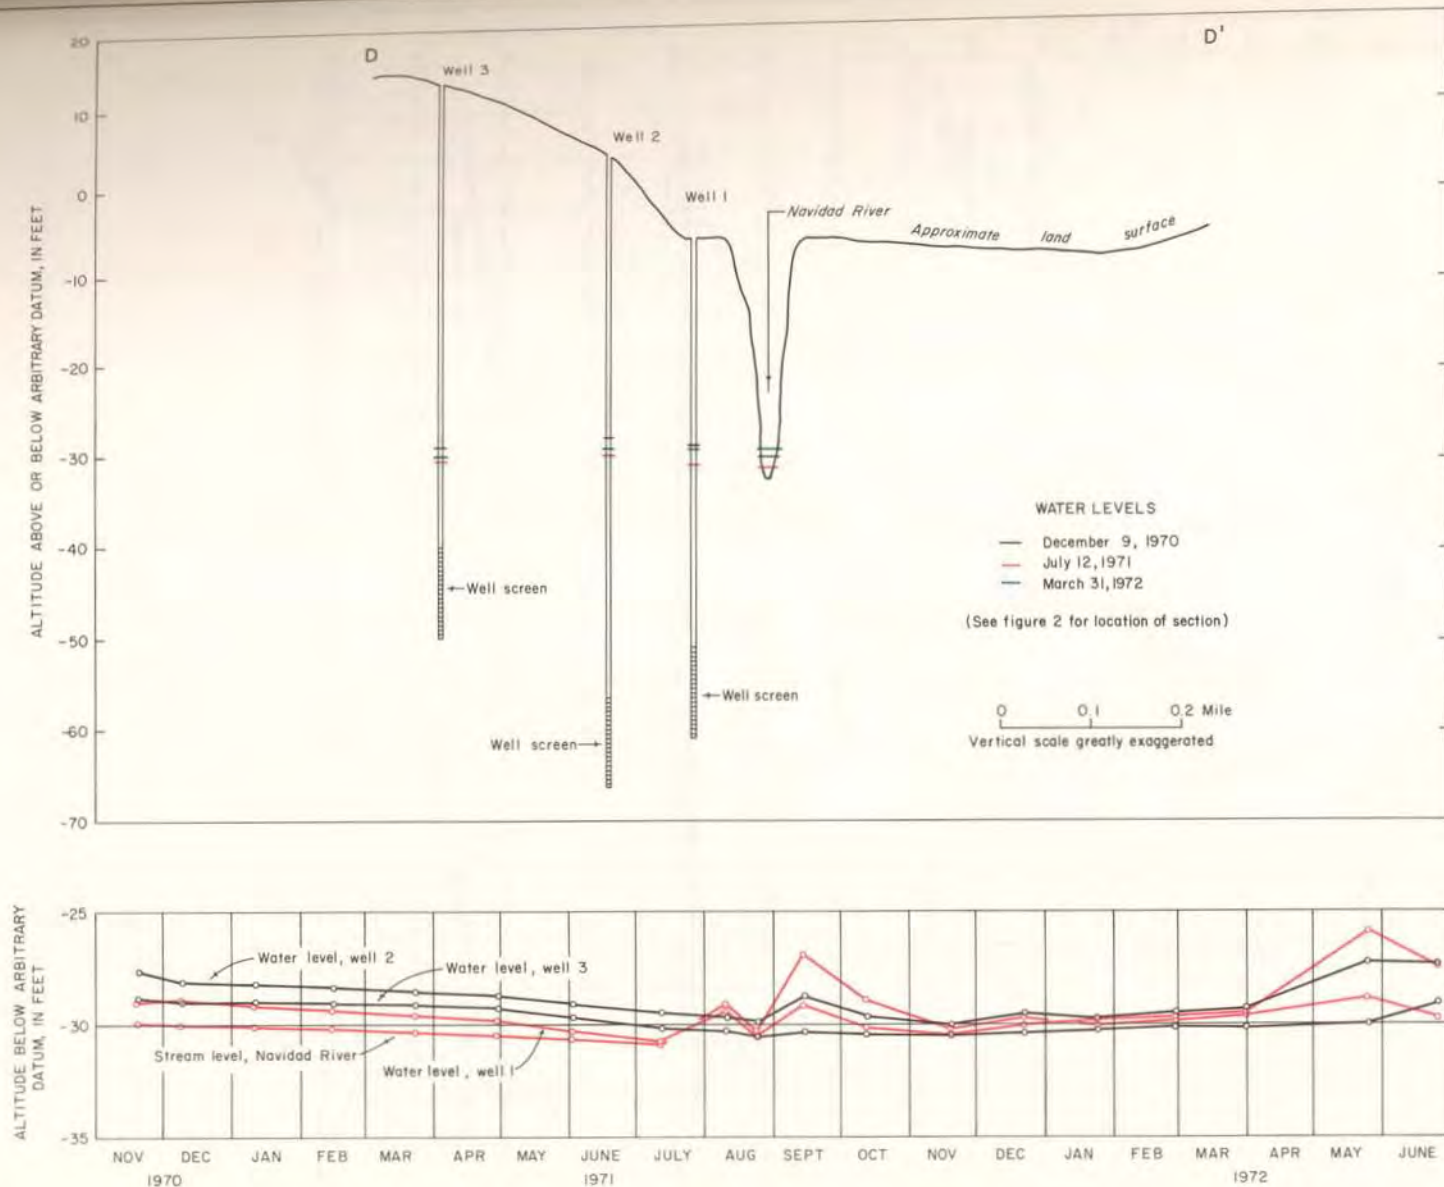
FIGURE 6.-Altitudes of water levels in wells and stream at Navidad River monitoring site 4

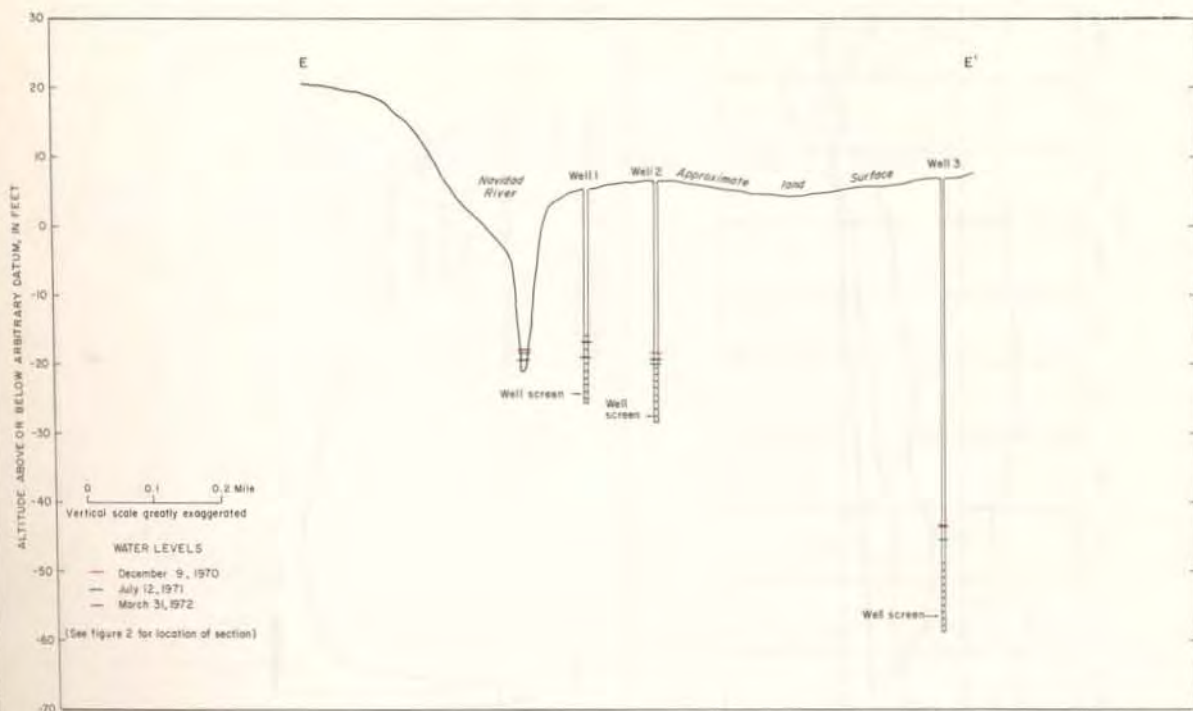
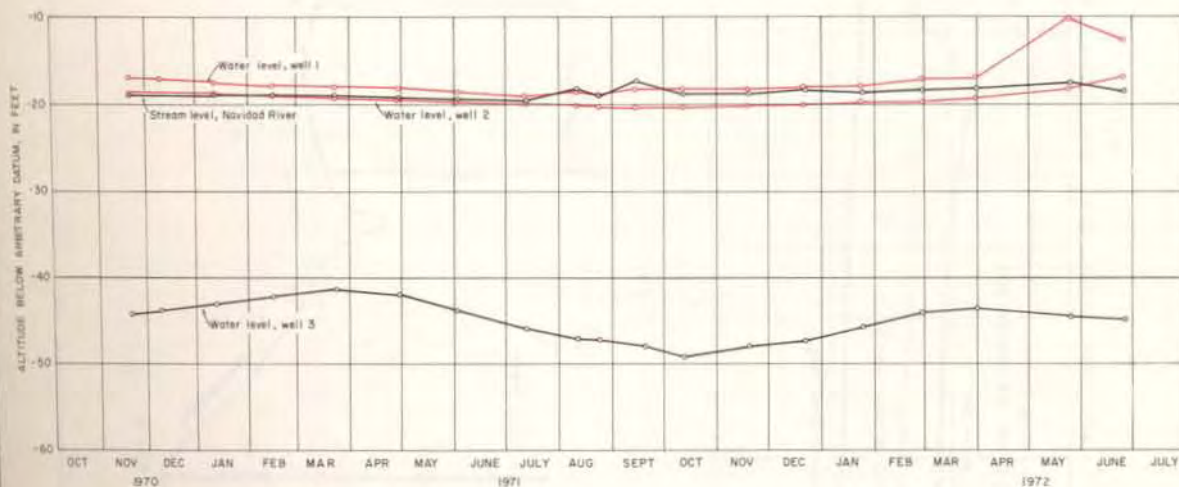
FIGURE 7.-Altitudes of water levels in wells and stream at Navidad River monitoring site 5

The cyclic fluctuations of the water levels in well 3 at Navidad River monitoring site 5 (fig. 7), and in wells 3 and 4 at Lavaca River monitoring site 2 (fig. 11), which correspond closely with the seasonal irrigation pumpage, indicate relatively good hydraulic continuity between the shallow and deeper aquifers in the local areas of these wells.

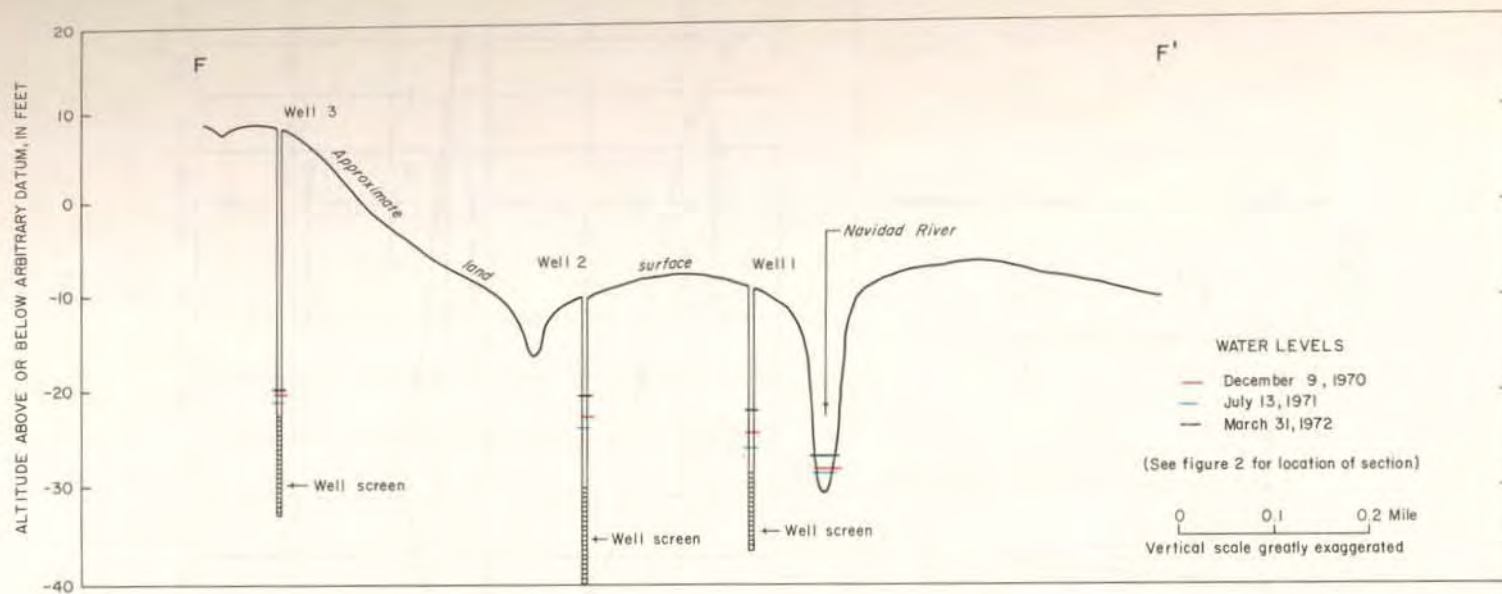
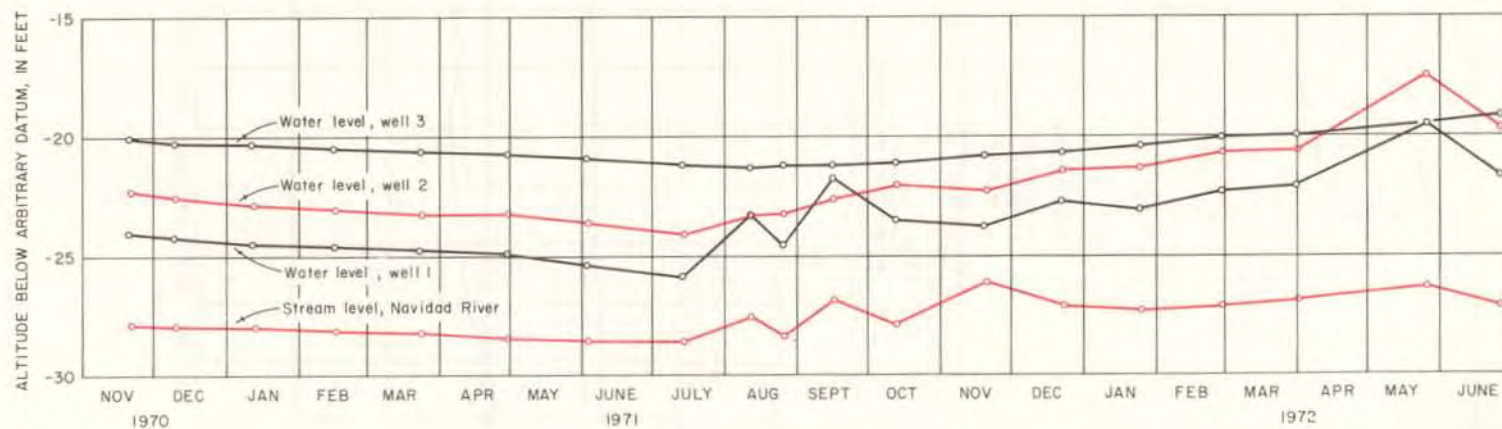
FIGURE 8.- Altitudes of water levels in wells and stream at Navidad River monitoring site 6

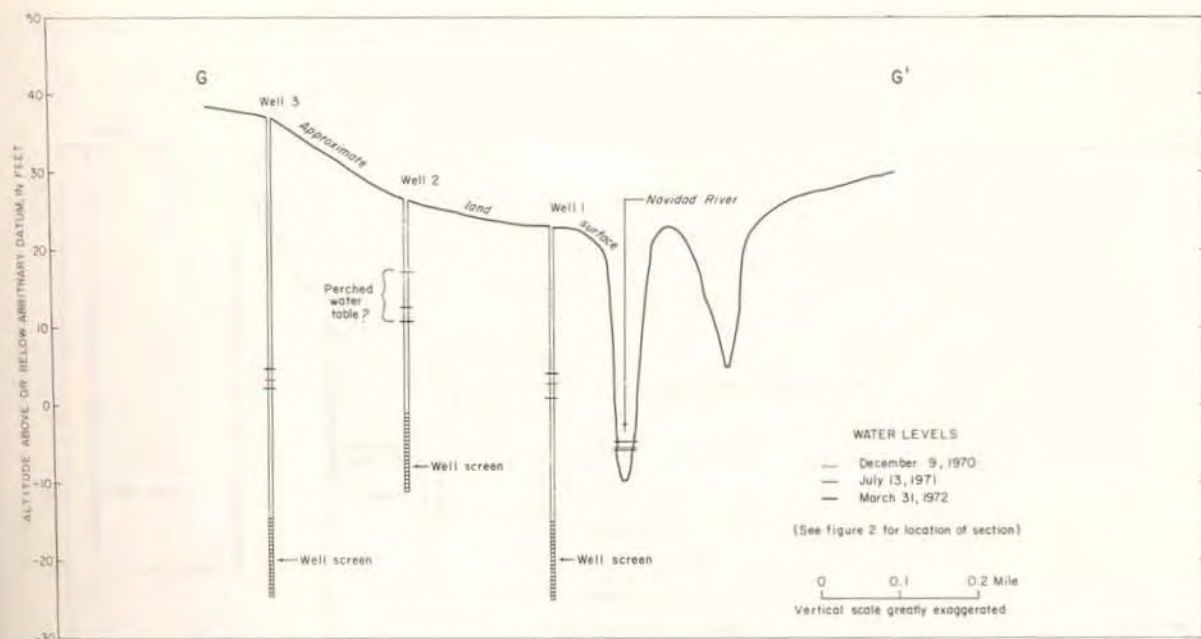
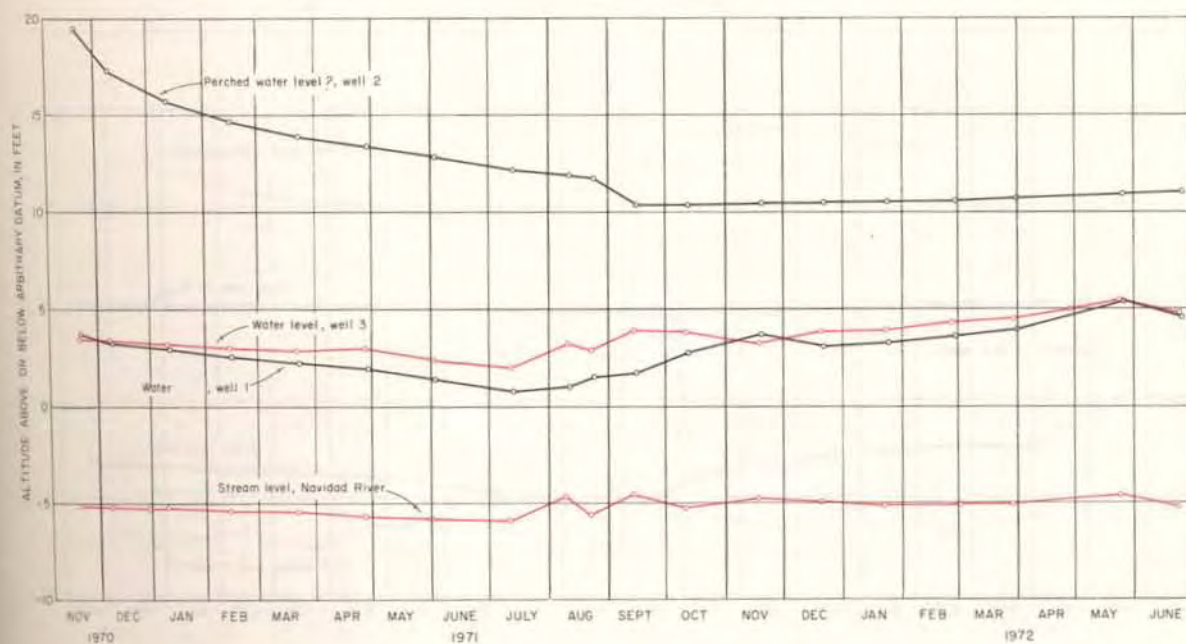
FIGURE 9—Altitudes of water levels in wells and stream at Navidad River monitoring site 7

Figure 9.	Section G-G' and hydrographs showing altitudes of water levels in wells and stream at Navidad River monitoring site 7-----	14
10.	Section H-H' and hydrographs showing altitudes of water levels in wells and stream at Lavaca River monitoring site 1-----	15

Low vertical hydraulic conductivity, which causes poor hydraulic connection of the shallow beds with the deeper beds, may be demonstrated by the behavior of the water levels in most of the wells at the monitoring sites. Extremely poor hydraulic connection is evident at Navidad River monitoring site 7, well 2 (fig. 9) and Lavaca River monitoring site 1, well 1 (fig. 10). Both wells, which were properly functioning when tested, probably tapped a perched water table. Alternate well 1-A, which was a few feet from well 1 but about 30 feet deeper, had a water level from 10 to 15 feet below the perched water table (fig. 10).

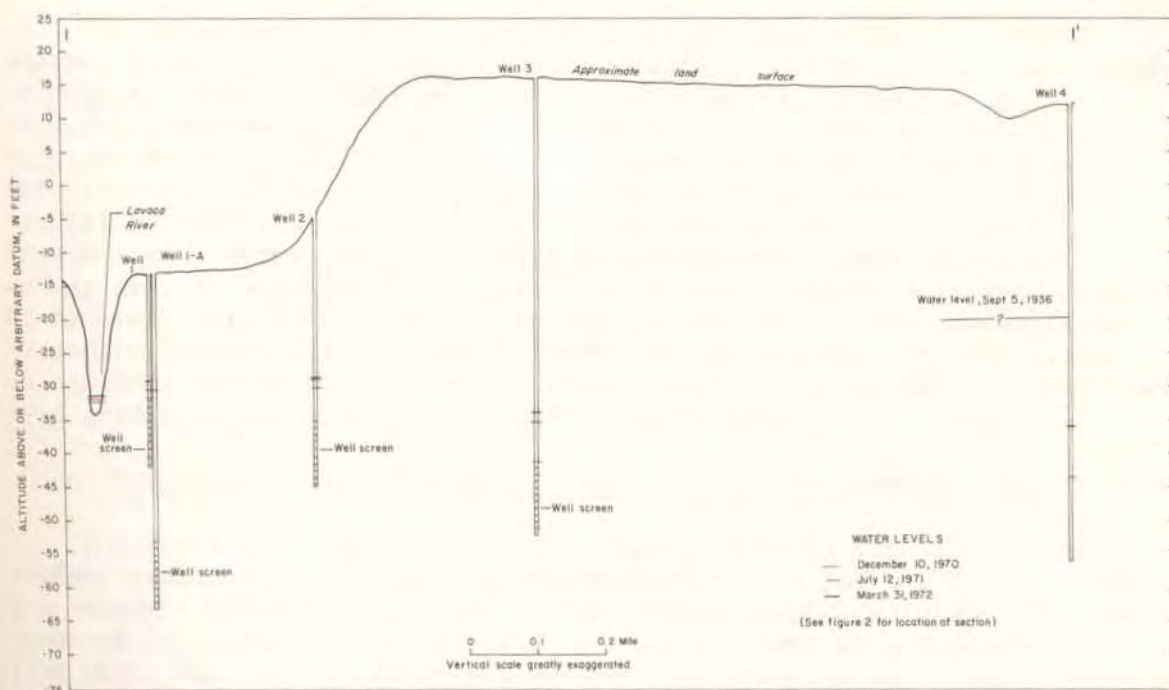
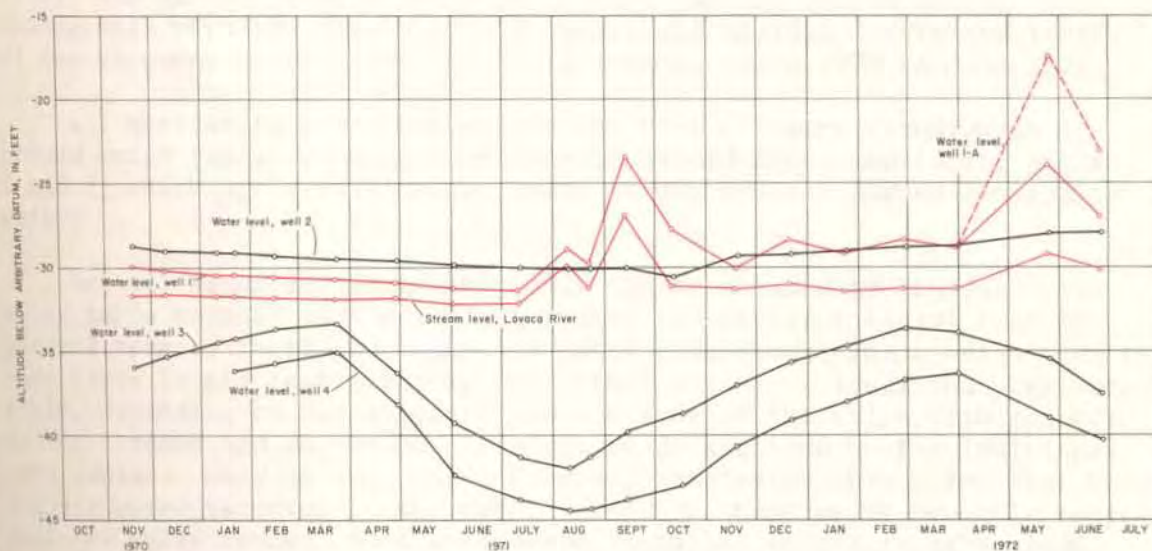
FIGURE II.—Altitudes of water levels in wells and stream at Lavaca River monitoring site 2

With few exceptions, ground-water levels in wells at the monitoring sites were higher than the low-flow surfaces of the streams throughout the 19-month period of observation. The relatively high standing levels persisted even during the hot summer months when evapotranspiration and ground-water pumpage were large. Only in a few wells, mainly those relatively far from the streams at Navidad River monitoring site 5 (fig. 7) and Lavaca River monitoring site 2 (fig. 11), did the water levels fluctuate frequently below stream level.

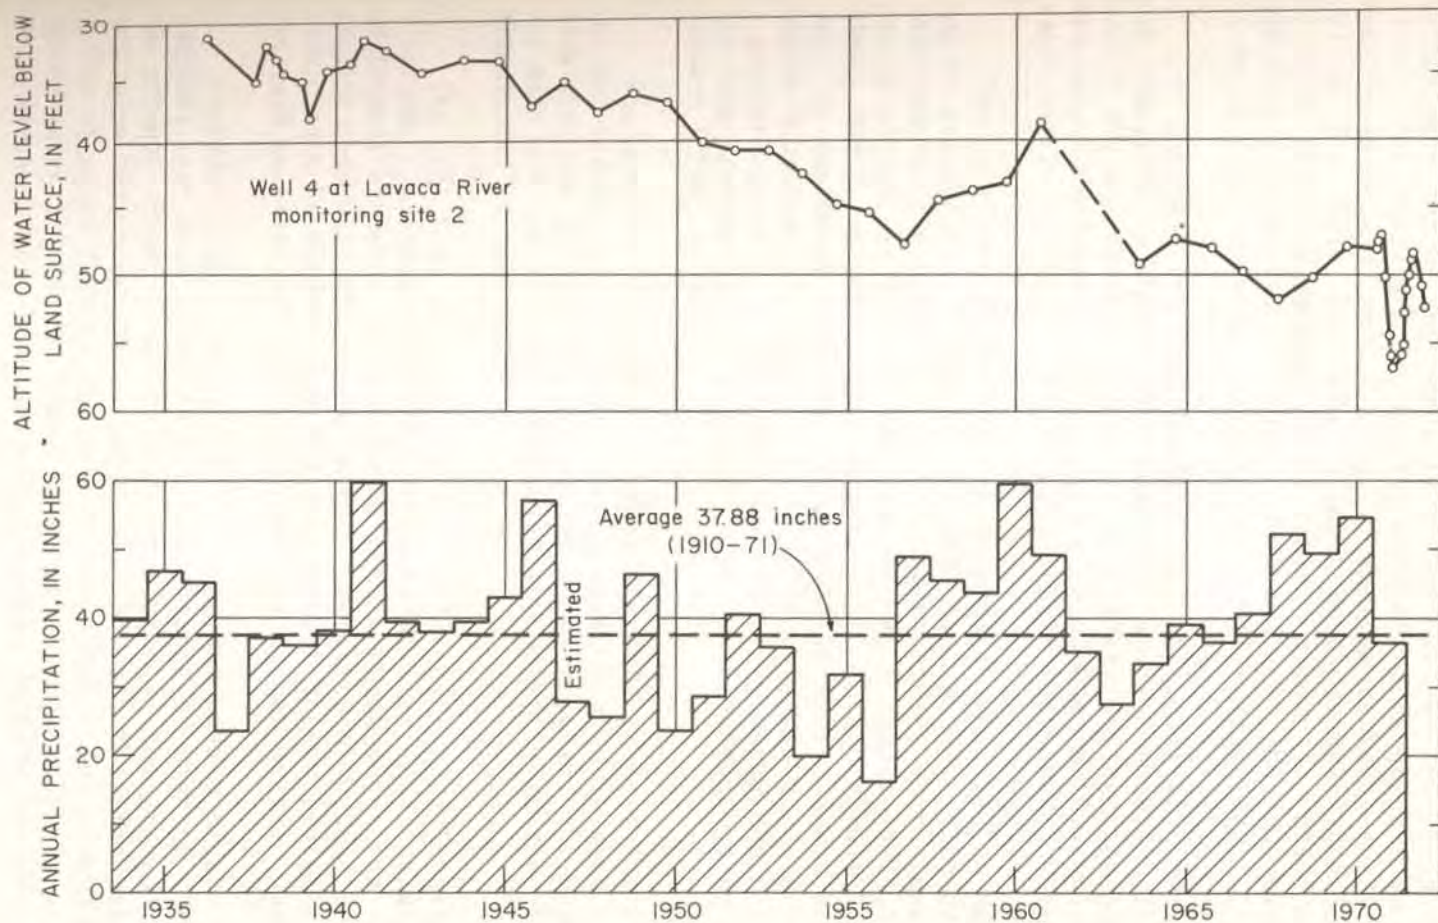
FIGURE 12.-Decline of the water level at well 4 (Lavaca River monitoring site 2) 1936-72 and precipitation at Edna, 1934-71

Between September 1936 and June 1972, the water level in well 4 has declined at least 25 feet, although about one-third of this decline is temporary and is recovered after the end of the irrigation season (fig. 12). The net decline, however, has been sufficient to change the regional position of the shallow ground-water levels at Lavaca River monitoring site 2 (and probably elsewhere in some areas of heavy ground-water pumpage) from being persistently higher than the stream level to being partly lower than the stream level (fig. 11). This change is significant because the reduction in the regional gradient of the shallow water levels toward the stream probably has reduced seepage outflow and consequently decreased the streamflow. The rate of the probable decrease in streamflow is not known.

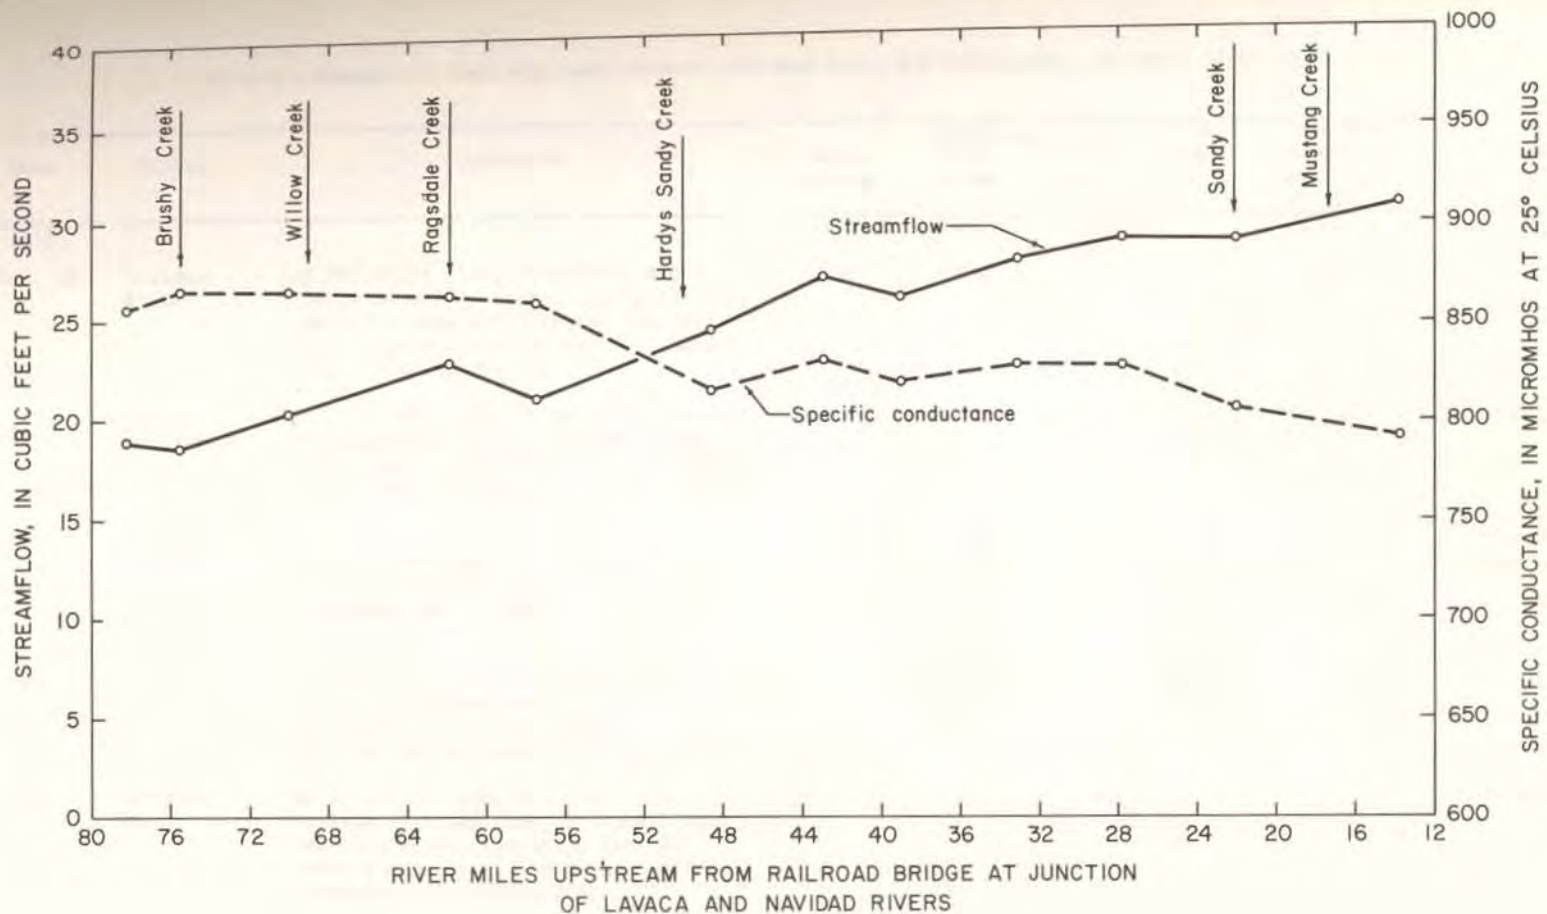
FIGURE 13.-Streamflow and specific conductance of water, Navidad River, December 14-16, 1970

With the exception of indicated losses in streamflow between miles 78.2 and 75.4, 61.8 and 57.4, 42.9 and 39.0, and 27.8 and 22.0, greater increases in flow per channel-mile occurred in the upper half of the reach than in the lower half (fig. 13). A reduction in the rate of gain in streamflow occurred below mile 42.9, or below Navidad River monitoring site 4. This reduced rate of gain in the lower reach is attributed to a lower transmissivity of the flood-plain alluvium.

The mineralization of the water in the Navidad River decreases slightly from the upper end of the reach to the lower end (fig. 13). Within the 64.4 mile reach, the specific conductance decreased from 855 micromhos at 25°C at site N-1 to 792 micromhos at 25°C at site N-18.

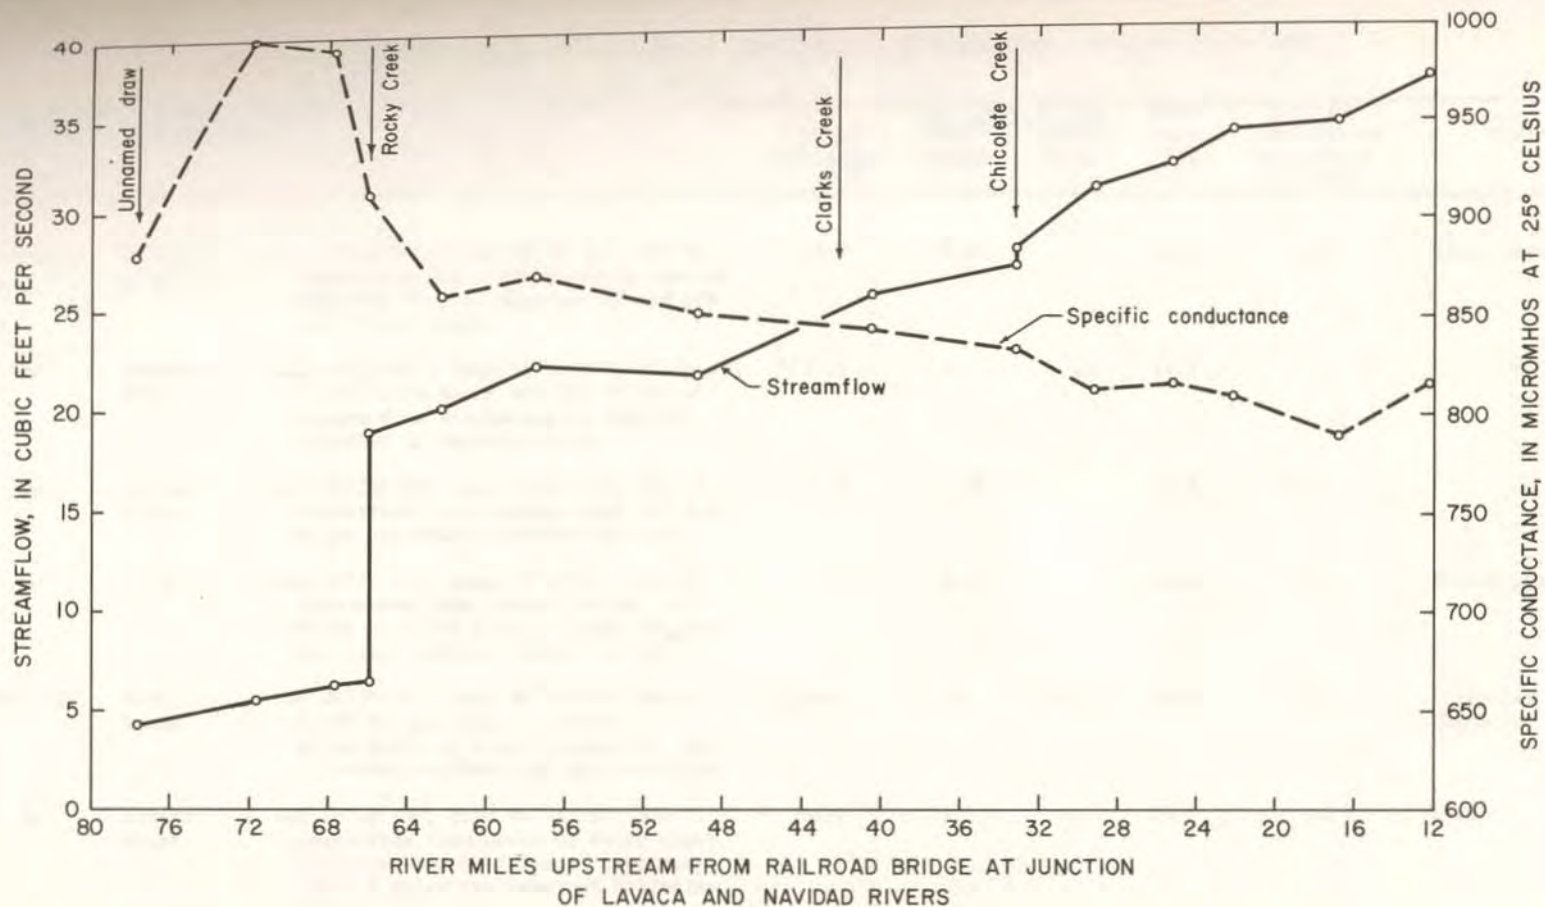
FIGURE 14.- Streamflow and specific conductance of water, Lavaca River, December 14-17, 1970

With the exception of the one moderate loss in streamflow and the large gain in inflow from Rocky Creek, the rate of increase in flow between the upper and lower ends of the reach, though fairly uniform, was slightly greater in about the lower four-fifths of the reach than in the upper one-fifth (fig. 14). This slightly greater rate of gain in the lower four-fifths of the reach is attributed to a greater transmissivity of the water-bearing formations adjacent to the stream.

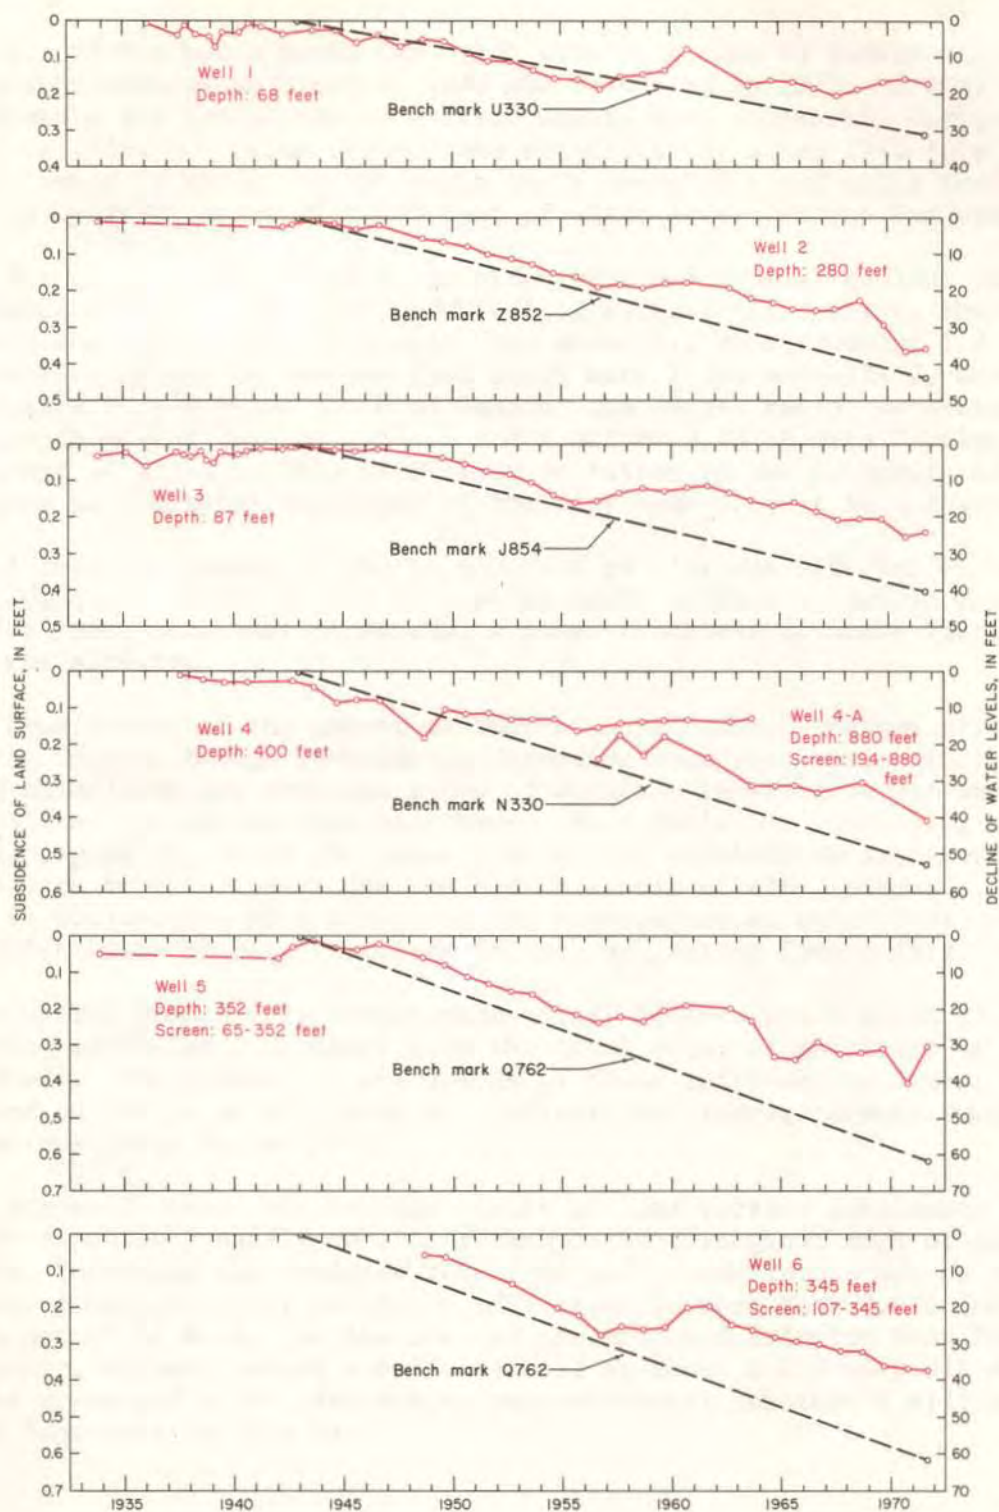
FIGURE 15.-Subsidence of selected bench marks in relation to the decline of water levels in nearby wells

The rate of land-surface subsidence depends upon a number of factors, chiefly the rate of water-level decline (artesian pressure), and the total thickness of the clay beds that are affected by the decline. The correlation between land-surface subsidence and water-level declines in Jackson County is shown on figure 15 by the graphs of subsidence of individual bench marks and the decline of water levels in nearby wells.

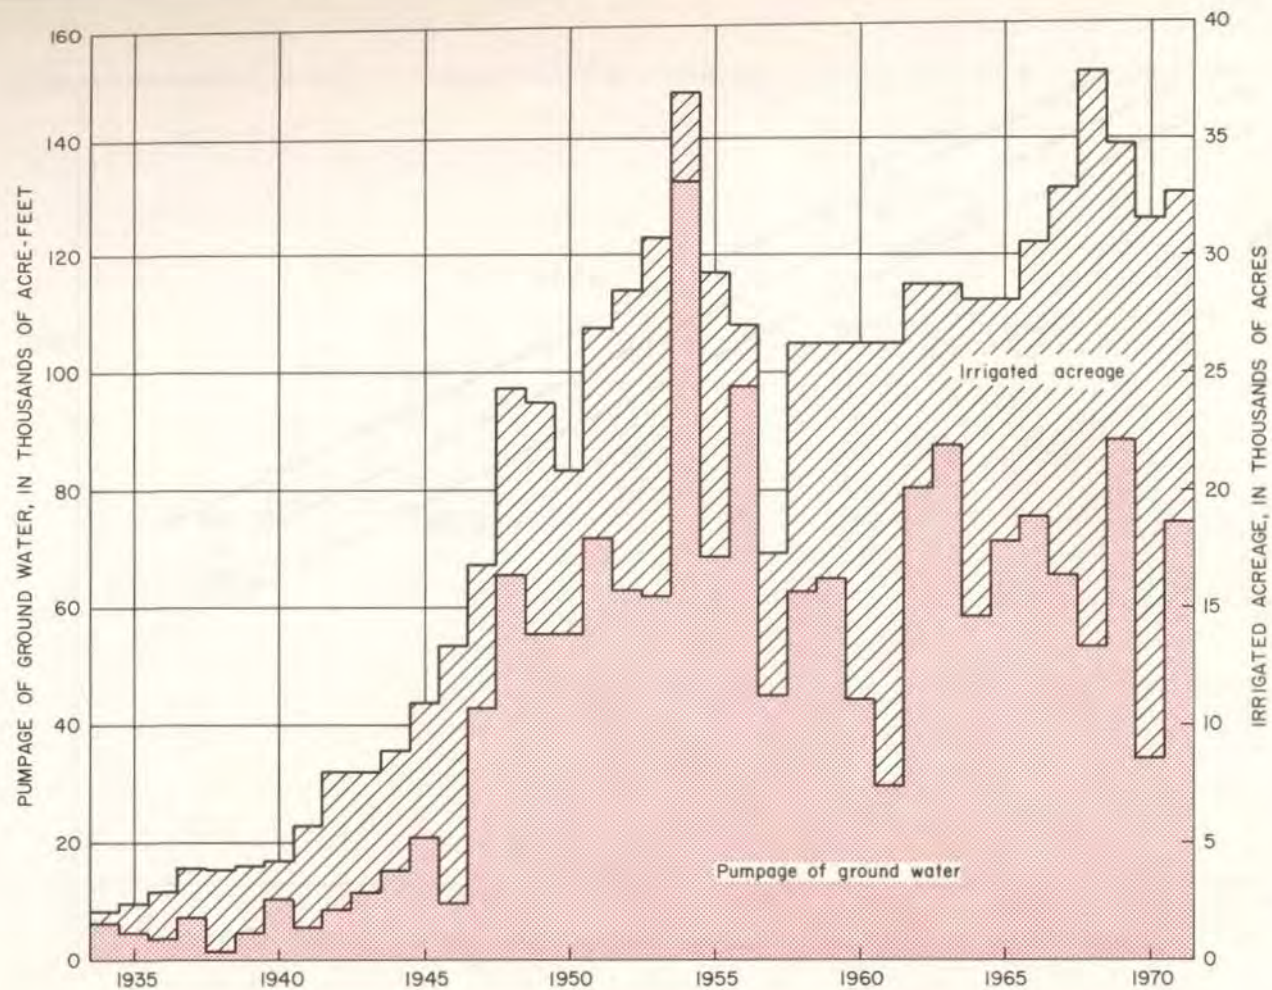
FIGURE 16. - Pumpage of ground water for irrigation and irrigated acreage in Jackson County, 1934-71

All of the bench marks for which data were used in construction of the graphs were established in 1943 and releveled in 1972. Ground-water withdrawals for irrigation in Jackson County were relatively insignificant prior to 1943, but began to increase significantly after 1943 (fig. 16). Water levels in wells did not begin their downward trend until the early 1940's; by 1972, about 20 to 40 feet of water-level decline had occurred.

The amount of irrigated acreage, which has been controlled since 1950 by U.S. Government allotments, usually has varied annually and has increased slightly since 1965 (fig. 16); but ground-water pumpage has not yet increased in proportion to the increase in irrigated acreage because of above normal rainfall during the irrigation season. Nevertheless, water levels are expected to continue to decline because future pumpage in Jackson County probably will exceed, at times, the 1963 draft of 92,000 acre-feet per year for all types of use--a rate that is approximately equal to the rate of recharge to the aquifer (Baker, 1965, p. 80).

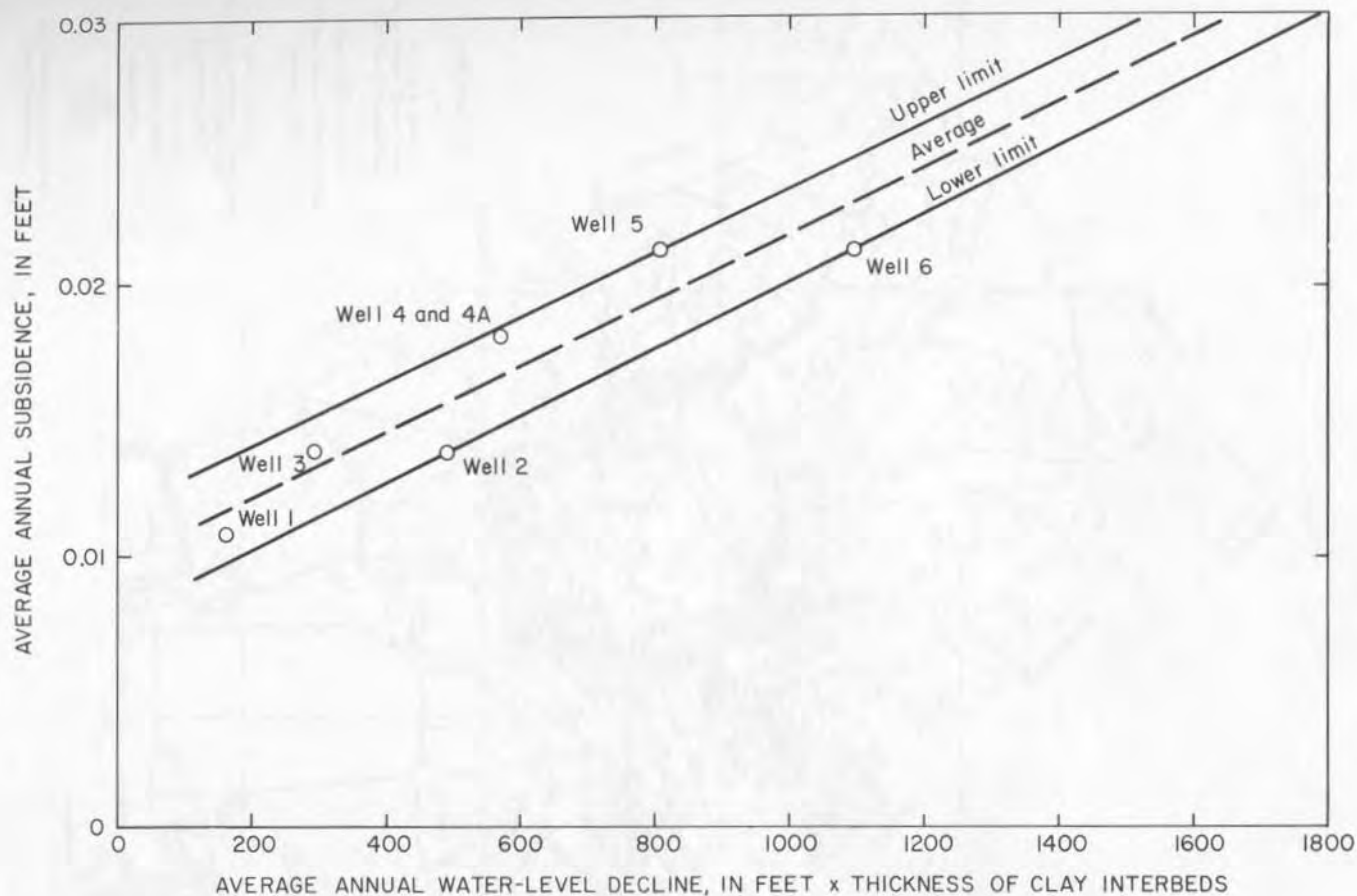
FIGURE 17.- Relation of subsidence to water-level decline (1943-72) and thickness of clay interbeds

Predictions of the amount of future subsidence in various areas of Jackson County, though necessarily depending upon some assumptions, are based chiefly on the previous rates of declines in water levels and on the thicknesses of the clay interbeds. As a basis for predicting subsidence, figure 17, which graphically shows the relation of land-surface subsidence to water-level decline and thickness of clay interbeds, was used in conjunction with a map showing average annual water-level declines and thicknesses of clay interbeds in much of Jackson County (fig. 18).

Control points were established mainly by the intersection of lines of equal water-level declines with the lines of equal thickness of clay interbeds. The product of the values of these intersecting lines, when plotted on the graph in figure 17, indicate the average annual subsidence at various sites in the area.
