EFFECTS OF GROUND-WATER DEVELOPMENT ON THE PROPOSED PALMETTO BEND DAM AND RESERVOIR IN SOUTHEAST TEXAS

U.S. GEOLOGICAL SURVEY

Water-Resources Investigations 18-73

Prepared in cooperation with the U.S. Bureau of Reclamation

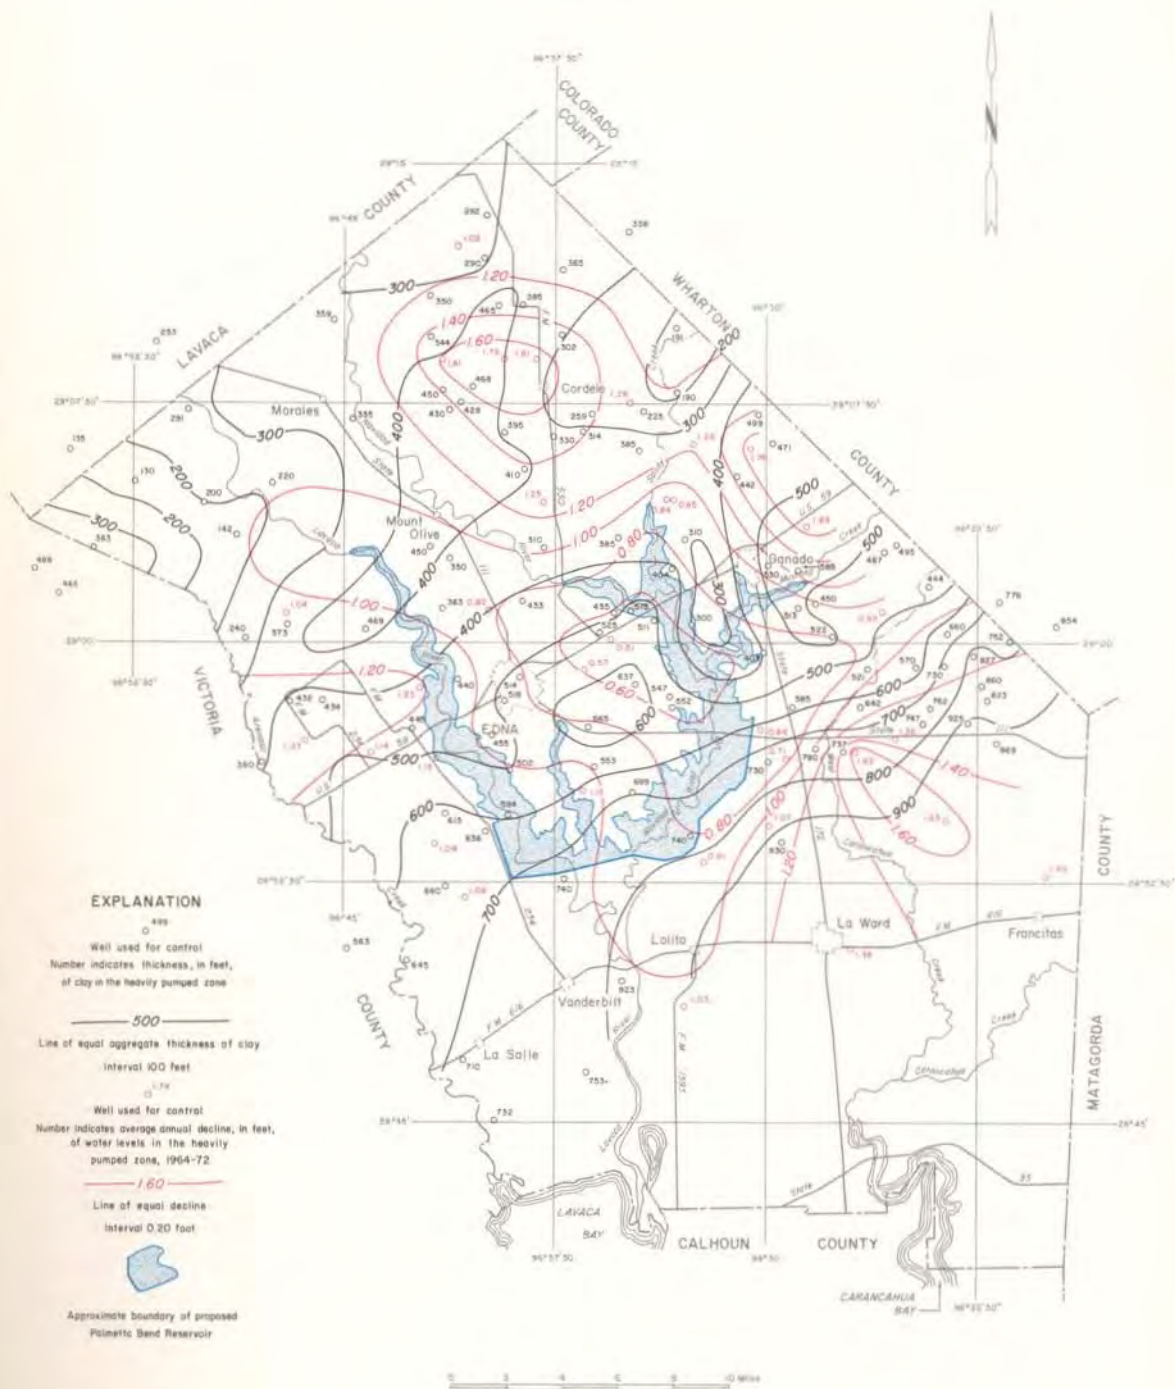
FIGURE 18.—Thickness of clay interbeds and average annual decline of water levels in the heavily pumped zone in Jackson County and adjacent areas

Predictions of the amount of future subsidence in various areas of Jackson County, though necessarily depending upon some assumptions, are based chiefly on the previous rates of declines in water levels and on the thicknesses of the clay interbeds. As a basis for predicting subsidence, figure 17, which graphically shows the relation of land-surface subsidence to water-level decline and thickness of clay interbeds, was used in conjunction with a map showing average annual water-level declines and thicknesses of clay interbeds in much of Jackson County (fig. 18).

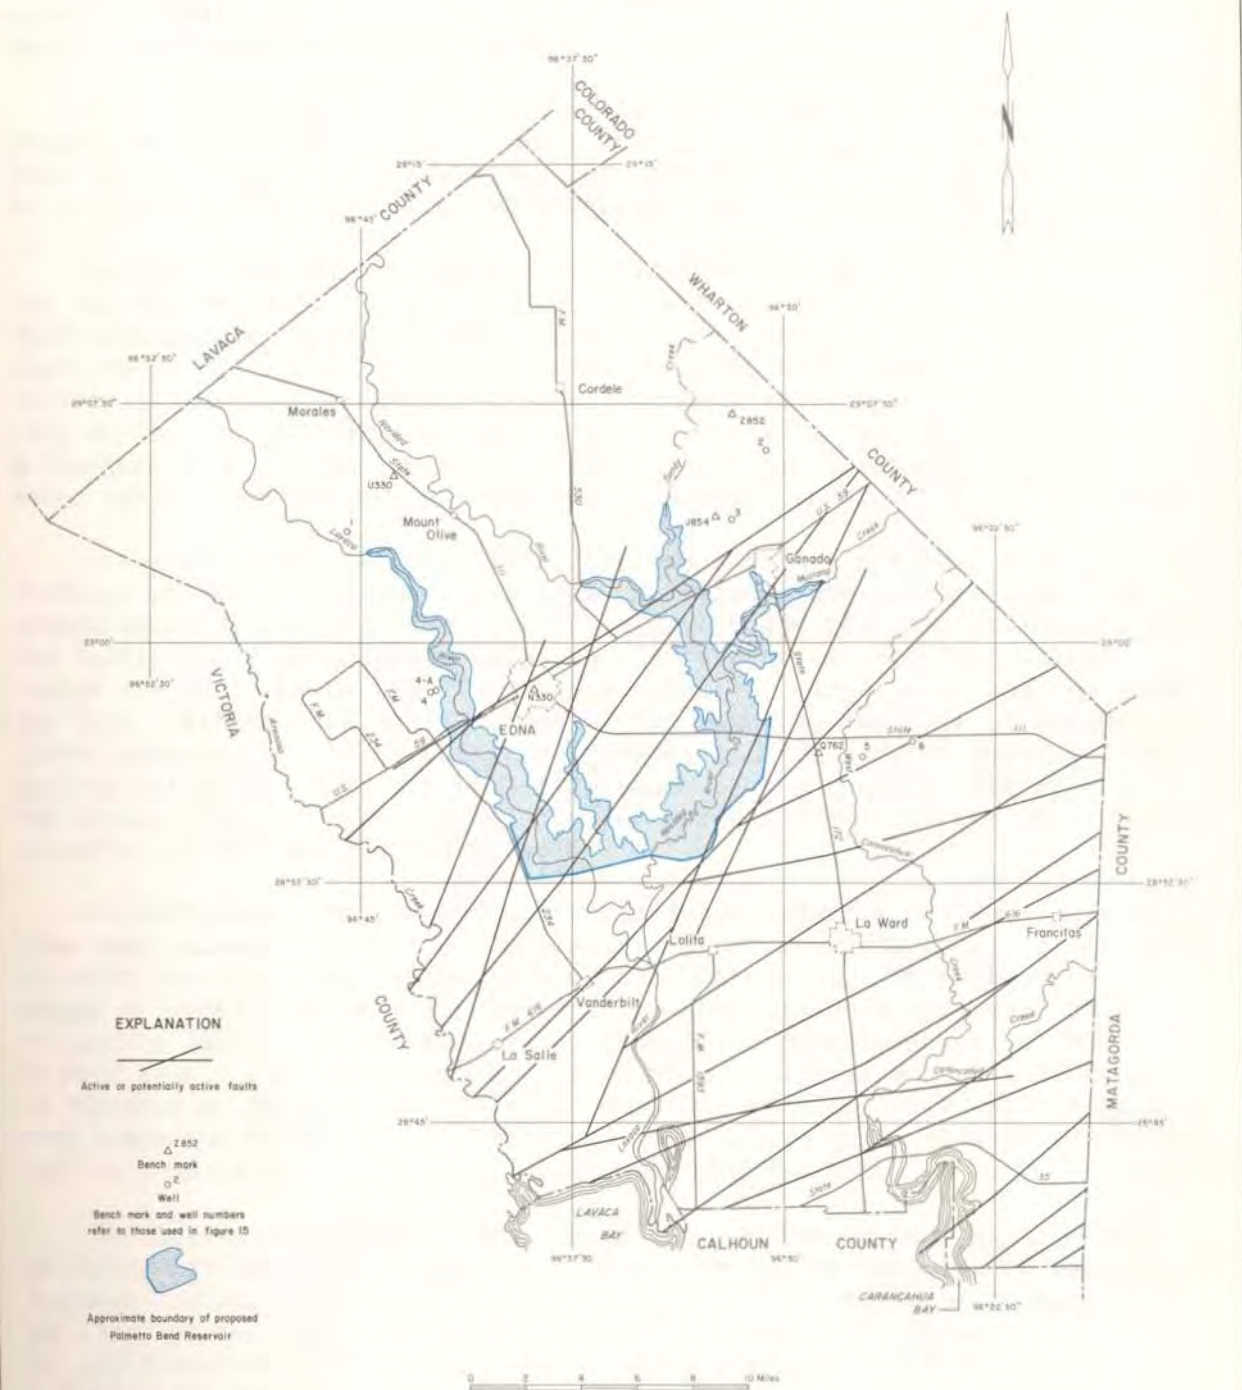
FIGURE 20.—Active or potentially active faults in the southern half of Jackson County

The faults that have been mapped in the southern half of Jackson County and surrounding areas, including much of the area of the proposed Palmetto Bend Dam and Reservoir are shown on figure 20. Most of the faults probably are inactive, but because of the large ground-water withdrawals and the attendant land-surface subsidence, some additional displacements may occur along some of the fault planes. These faults probably do not present any significant hazards, but construction design that would avoid the faults or would allow for displacements that probably will not exceed the total subsidence would minimize any hazard.
