# CONTRIBUTIONS TO THE HYDROLOGY OF THE UNITED STATES, 1928

## GEOLOGY OF RESERVOIR AND DAM SITES

By KIRK BRYAN

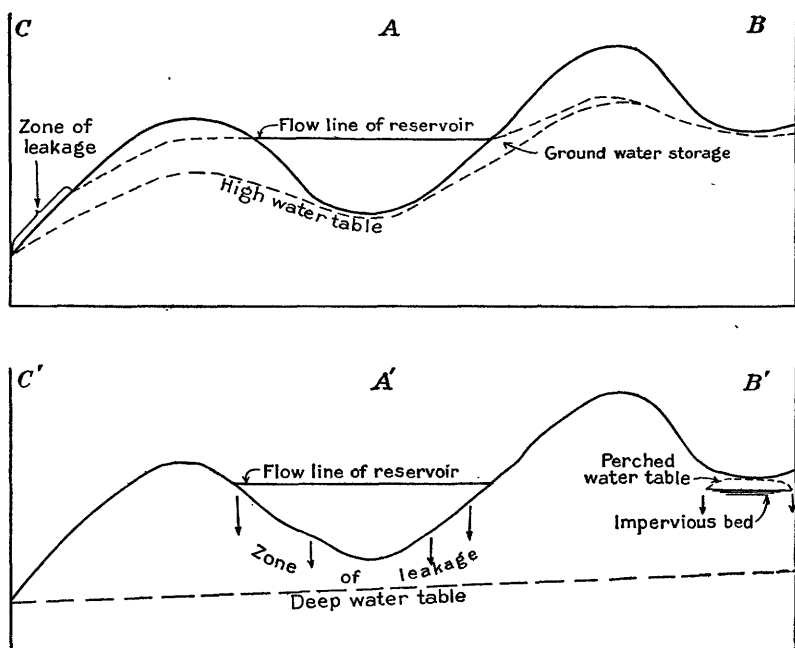
FIGURE 1.—Diagram showing the relation of reservoirs to the water table

In general, little difficulty is experienced with reservoirs built in areas of high water table when the reservoir occupies a stream valley and the stream is fed by ground water. Under conditions shown at point *C*, Figure 1, leakage is possible from overtopping the ground-water divide at a low point, but it will be moderate if the material of the ridge is fine grained. Where part of the inclosing rim of the reservoir consists of open-textured material; such as basalt, cavernous limestone, or an accumulation of glacial boulders, the ground-water divide is always low also, and thus the low position of the water table, if determined, would speak for caution, but proof of the presence of these open-textured materials makes it certain that large leakage will result. It should be noted that leakage through gypsum or rock salt and to a less extent through limestone will increase by reason of solution of the rock and the removal of debris from caves already formed, but leakage through basalt will be constant or only slightly increased. Leakage through boulders or gravel may, by the

In Figure 1 the reservoir *A'* is constructed in an area with a deep water table draining on a flat gradient to valley *C'*. The losses from the reservoir are proportionate to the hydraulic head and the capacity of the rock to transmit water. In the absence of data by which they can be estimated, judgment must be used as to whether the losses will be excessive or not. In one locality part of the bed of a proposed reservoir in extrusive basalt was annually flooded by farmers with water from the spring freshets of near-by creeks. Water 15 feet deep disappeared in six weeks, and as the proposed dam contemplated a depth of 60 feet of water, it seemed likely that the whole content of the reservoir might be lost in say three months. Part of the floor was covered with fine-grained soil which retarded leakage, but with the high velocities engendered by a 60-foot head much of this material would undoubtedly be carried down into the basalt and the rate of leakage would increase. Consequently the project was abandoned.

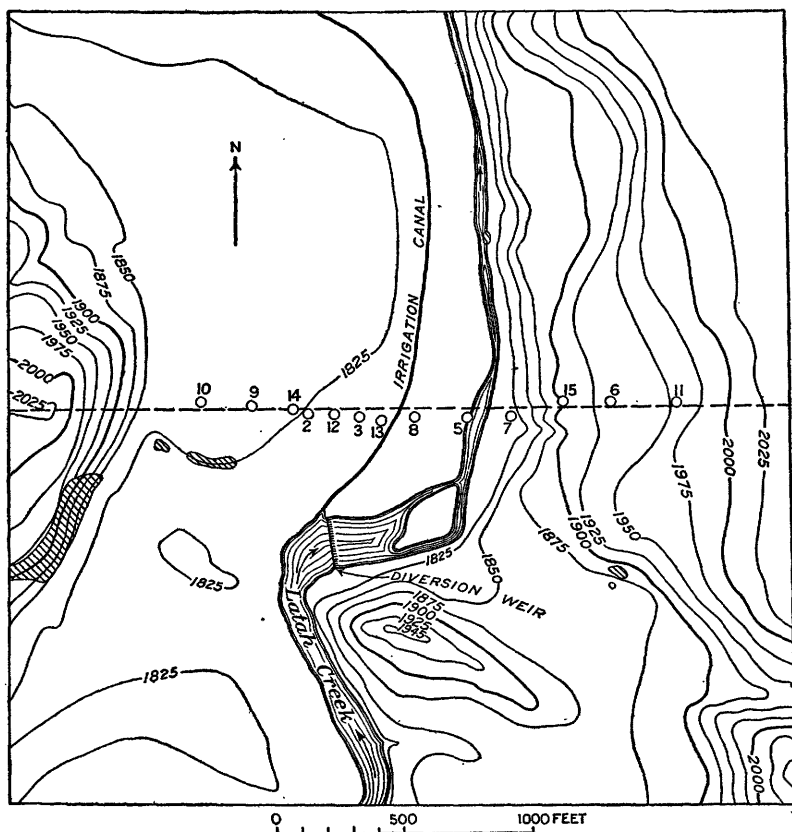
FIGURE 2.—Map showing geology of Latah Creek dam site, Columbia Basin irrigation project, Washington, as interpreted from outcrops and test wells. Diagonal shading indicates outcrops of basalt; the rest of the area is occupied by sand and gravel. Numbered circles indicate drill holes; dashed line, center of proposed dam. See also Figure 3

A reasonable success in prediction is all that may be expected. What may be deemed to be an unusually close prediction is illustrated in Figure 3. On the map of the site (fig. 2) are shown the

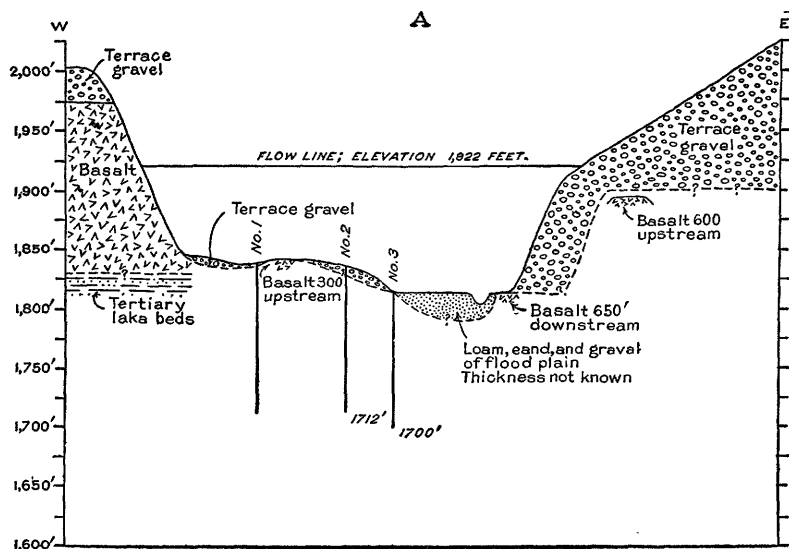
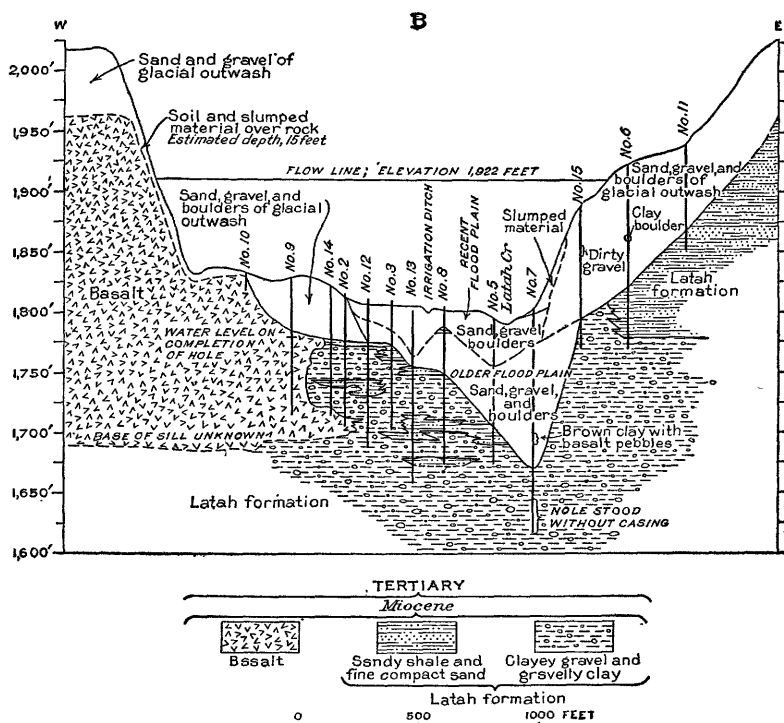
FIGURE 3.—Geologic cross sections of Latah Creek dam site, Columbia Basin irrigation project, Washington. A, Showing known and inferred relations; B, based on completed examination and results of test drill holes.

outcrops of basalt, and the only other visible materials were sand and gravel of the flood plain and the terraces. In the cross section A, Figure 3, on the center line of the proposed dam is the prediction based on a general study of the geology, as the drill holes 1, 2, and 3, already put in, could not be interpreted. In B, Figure 3, is given the cross section as constructed after the drilling of 13 test holes. The first three holes could then be interpreted, and the conjectured cross section was confirmed except for the depth of the stream channel and the thickness of the sand in the terrace on the right abutment.

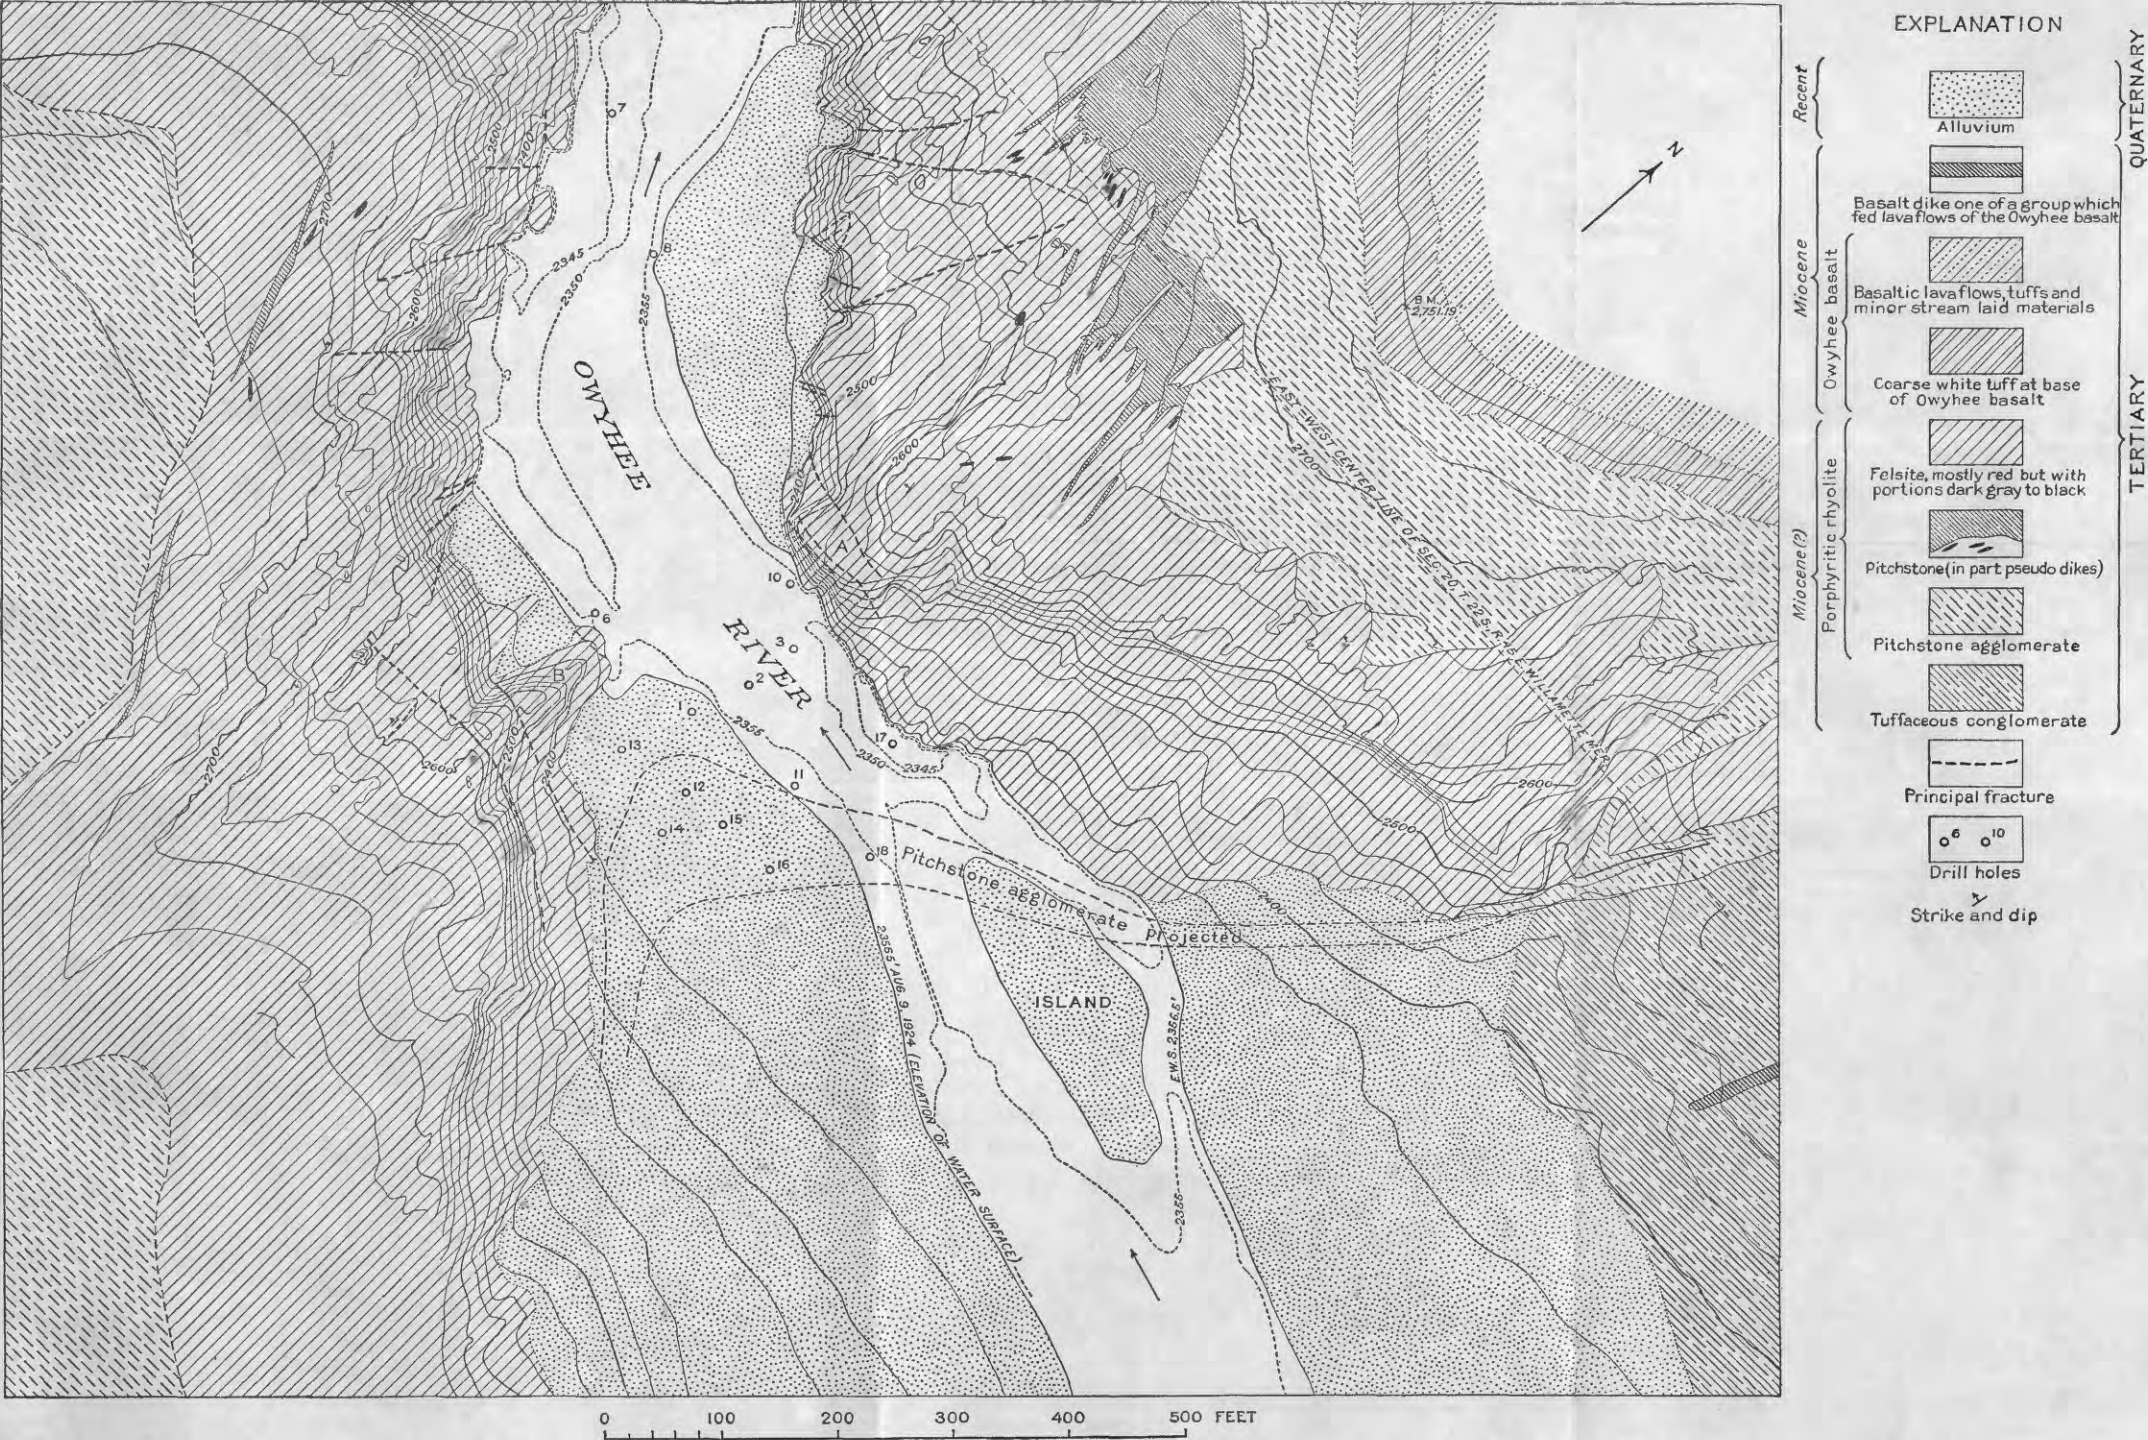
MAP SHOWING GEOLOGY OF THE OWYHEE DAM SITE, OWYHEE IRRIGATION PROJECT, OREGON

The vertical fracture system consists of fractures that follow nearly vertical planes having several trends. The most extensive of these fractures in the upper part of The Box are shown on Plate 4. The fractures have clean, continuous walls, which in many places are slickensided. Where the walls are separated there are in places open cavities, but in general the space between them, which may be from 2 inches to 10 feet wide, is filled with fragments of rock. In most places the fragments are more or less cemented and form a breccia, but this breccia is obviously inferior to the original rock in strength and resistance to weathering. The breccia also forms channels for the movement of water through the abutments of the dam. The nature of the fractures and the breccia is shown in Plate 9, *B*. In Plate 9, *A*, the dark vertical band is one of these fractures that cuts across the flow structure.

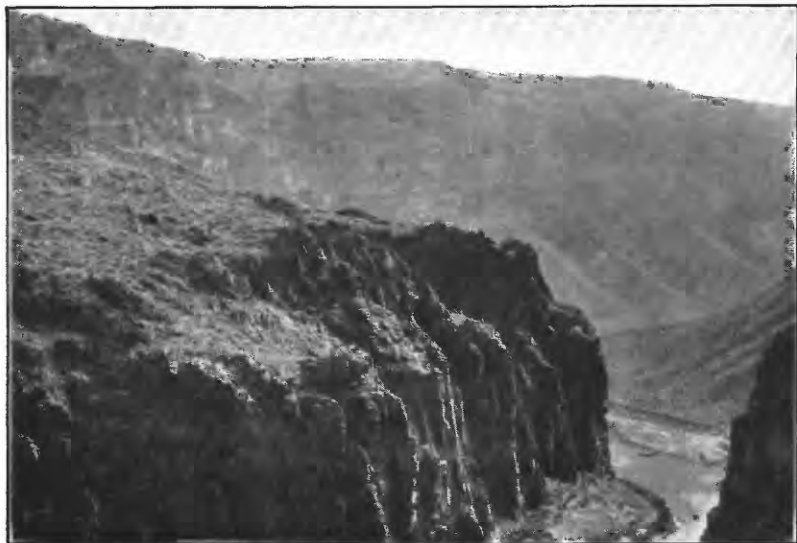
A. VIEW UPSTREAM, SHOWING THE UPPER END OF THE BOX AND PROBABLE POSITION OF THE DAM

Cliffs in foreground are red felsite; shelf above them pitchstone agglomerate; benched cliffs in background Owyhee basalt

The dam will stand in a narrow inner gorge known as The Box, whose side walls are precipitous for about 350 feet and above this height flare to normal width. (See pls. 5 and 6.)

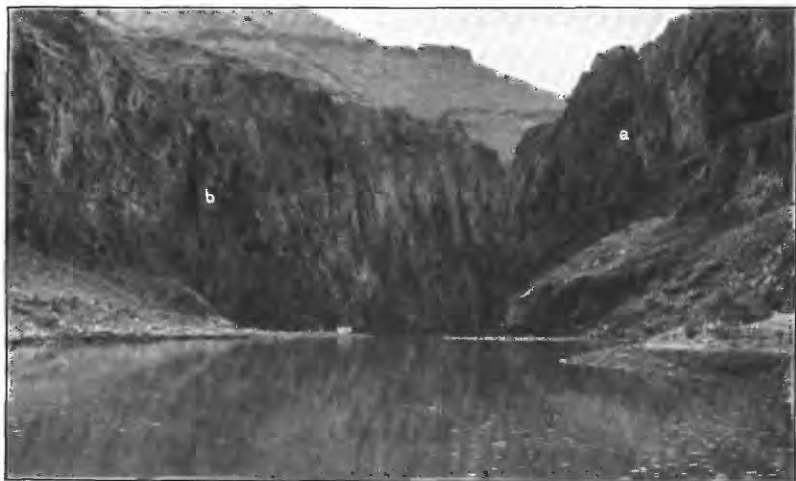
B. VIEW DOWNSTREAM TOWARD ENTRANCE OF THE BOX

Drilling rig on proposed line of dam. Note prominent vertical fracture on the narrow ridges. Points a and b marked A and B on Plate 4

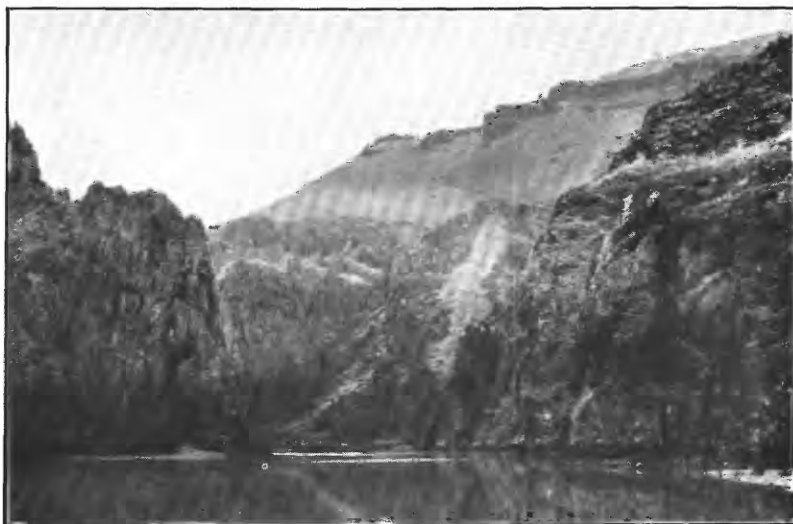
A. CENTRAL PORTION OF THE BOX

Showing the precipitous walls of felsite and the characteristic joints and fissures

The greater part of this mass consists of the red felsite previously described. This rock is massive and resistant to erosion so that it stands in great bare cliffs, as shown in Plates 5 and 6. It is marked by a well-defined flow structure, which throughout The Box is nearly vertical and generally has a north or northeast trend. Locally there are great sweeping curves by which the strike and dip of the flow structure change rapidly. Part of one of these curves is shown in Plate 9, *A*. In addition to the flow structure there are strong fractures, generally nearly vertical but having diverse trends. Some of these fractures are clean breaks and resemble ordinary joints. Many have sharp walls separated by 2 inches to 10 feet of fault breccia. As shown in Plate 9, *B*, these fractures resemble faults in their clean walls and contained breccia, but there is no evidence of great displacement. Also, as shown on Plate 4, they are relatively numerous near the base of the rhyolite but can not be traced through to the top of the cliffs. A few of these fractures occur at the top of the cliff but can not be traced downward any great distance. In addition to these fractures, there is a minute platting or jointing by which, on weathering, the rock breaks in slabs about half an inch thick. This minute jointing is generally nearly at right angles to the flow structure and is well shown in Plate 9.

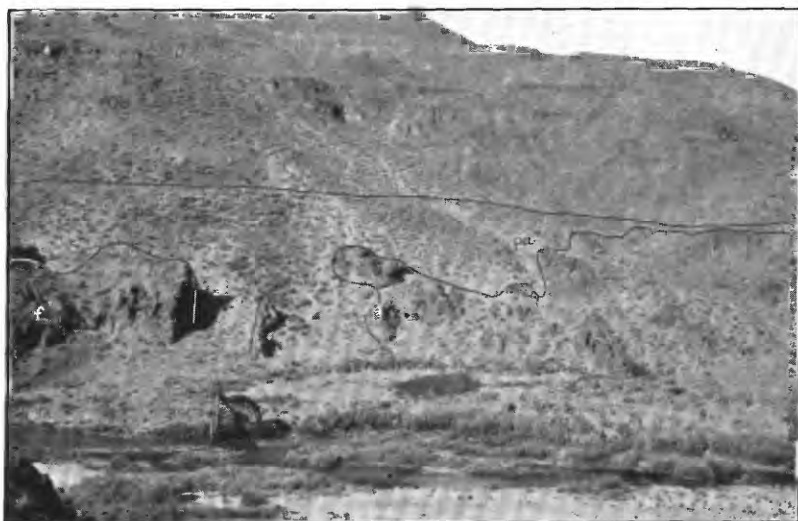
B. LOWER END OF THE BOX

Shows vertical masses of pitchstone agglomerate (pa) in the felsite (f) and the overlying Owyhee basalt (Ob). Water wheel raises water for irrigation of small field downstream

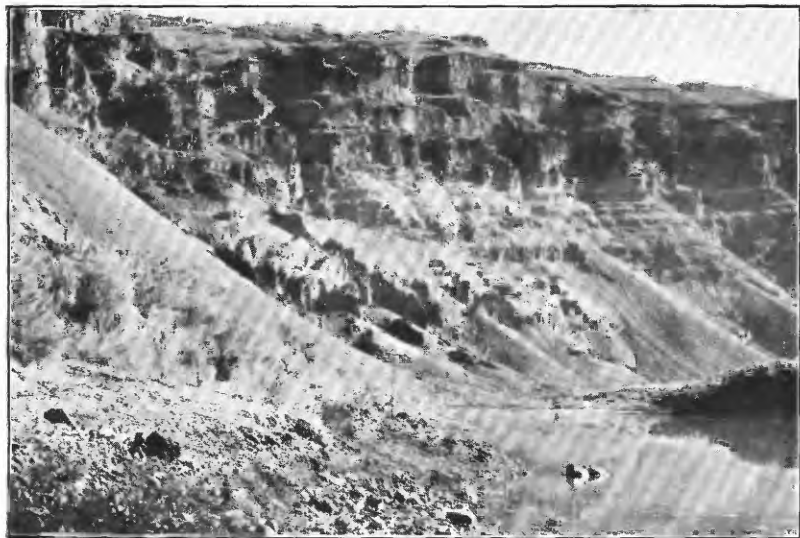
A. VIEW UPSTREAM FROM DAM SITE, SHOWING OPEN GORGE

Benched cliffs are flows and tuffs of Owyhee basalt; the slopes largely covered with talus are underlain by tuffaceous conglomerate; that in the middle ground is cut by a network of basalt dikes

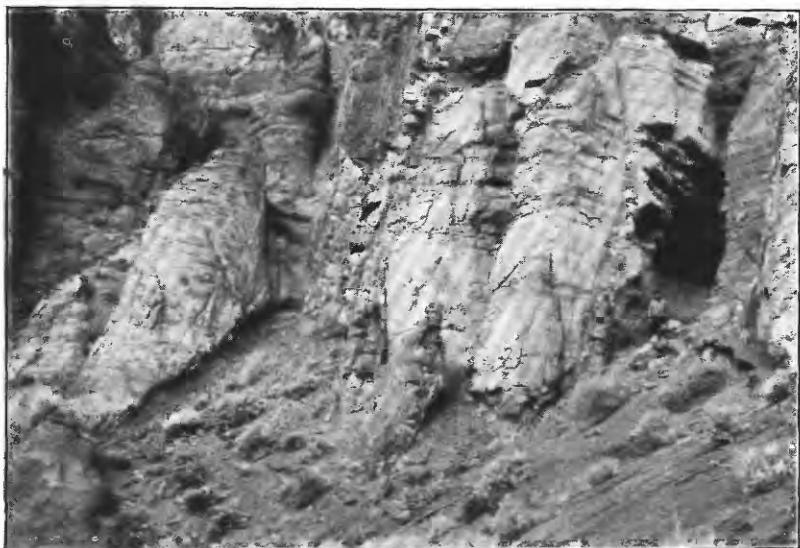
B. BASALT DIKES INTRUDED IN TUFFACEOUS CONGLOMERATE

Detail of network of dikes shown in A

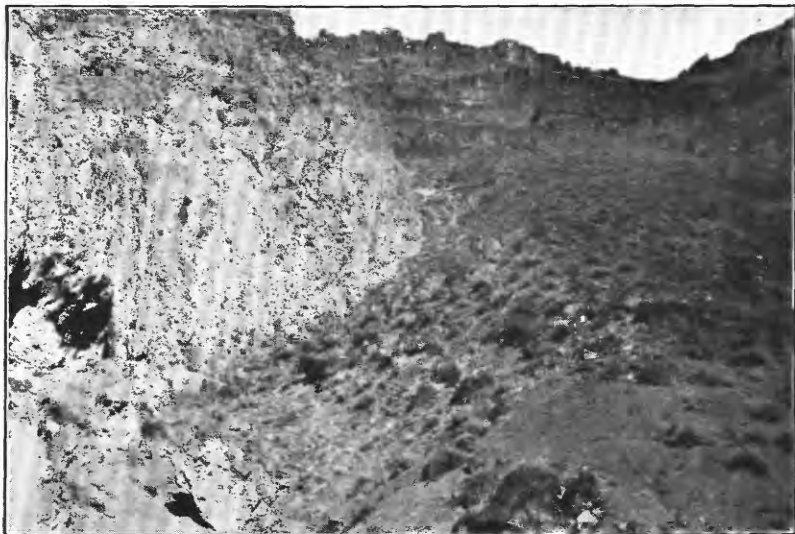
A VERTICAL MASS OF PITCHSTONE AGGLOMERATE THAT FORMS CONTACT ZONE OF PORPHYRITIC RHYOLITE ON EAST SIDE OF RIVER ABOVE THE BOX

Covered slope is occupied by tuffaceous conglomerate overlain by the Owyhee basalt, which forms the benched cliffs in the background

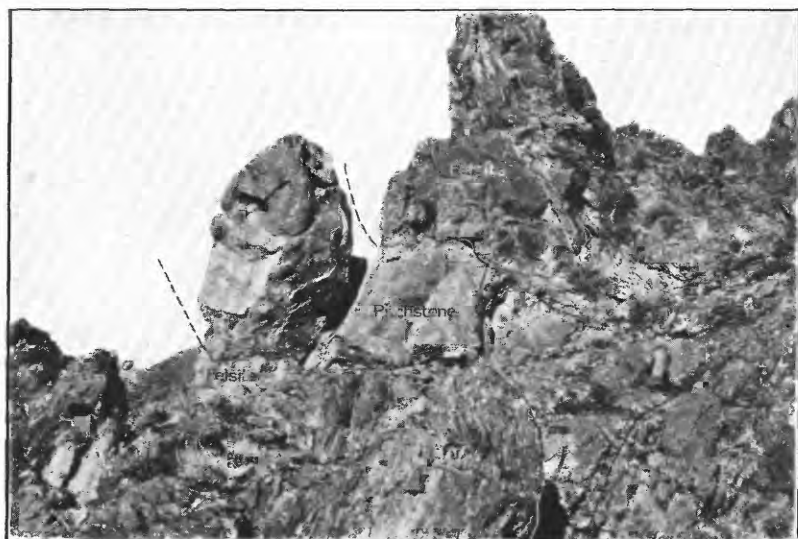
B. PITCHSTONE PSEUDODIKE IN RED FELSITE ON RIGHT ABUTMENT

In addition to the pitchstone blocks in the agglomerate there are bodies of pitchstone within the red felsite. These bodies are generally long and narrow and have nearly vertical contacts, so that they appear to be dikes. In general, they lie parallel to and between the plates of the flow structure of the red felsite. They were mapped in detail over the area shown on Plate 4. Many are isolated pseudodikes, but near the north end of the area they unite in a considerable mass, in which smaller bodies of red felsite are completely inclosed.

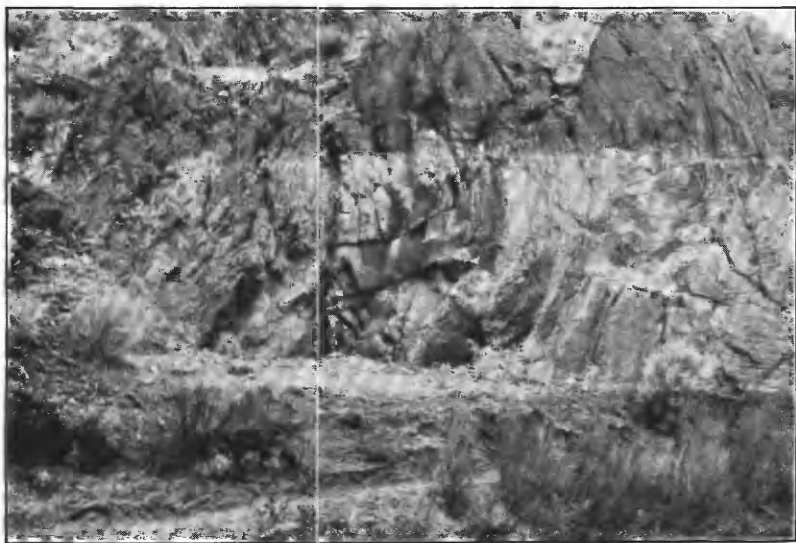
**A. CURVED AND NEARLY VERTICAL FLOW STRUCTURE IN RED FELSITE**

Note numerous closely spaced horizontal joints, also vertical fracture, which shows as a narrow dark band. The horizontal line at the top of the light-colored zone is a high-water mark

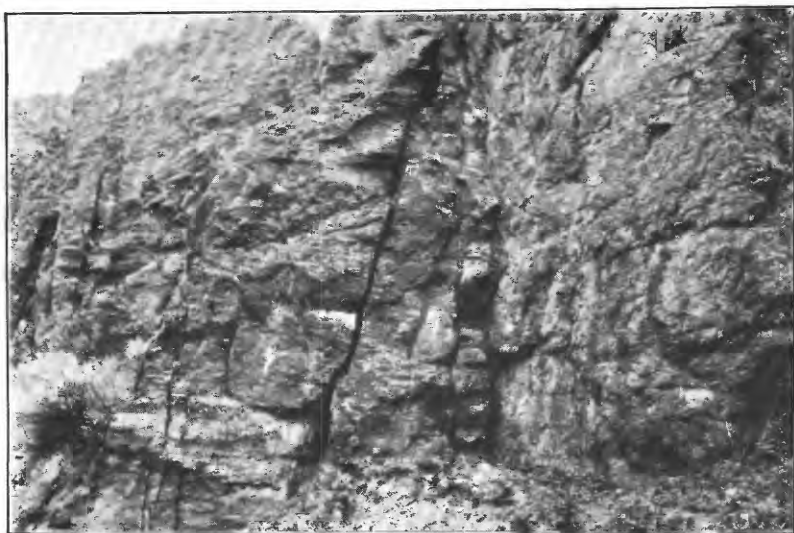
**B. VERTICAL FRACTURES IN RED FELSITE**

Some are clean breaks; others have a mass of comminuted rock fragments between the walls. Closely spaced horizontal fractures show at the left

The fractures are of two types—the minute horizontal sheeting and the nearly vertical fracture system. The horizontal fractures are intensified by weathering, and on exposed surfaces the rock is divided into wavy plates from half an inch to 2 inches thick, as is well shown in Plate 9, *B*, in the lower left corner. These fractures do not appear in the drill cores of test holes and are not open in depth, though they doubtless exist in an incipient form. Although they doubtless slightly lower the strength of the rock, they can have little effect on the proposed structure.

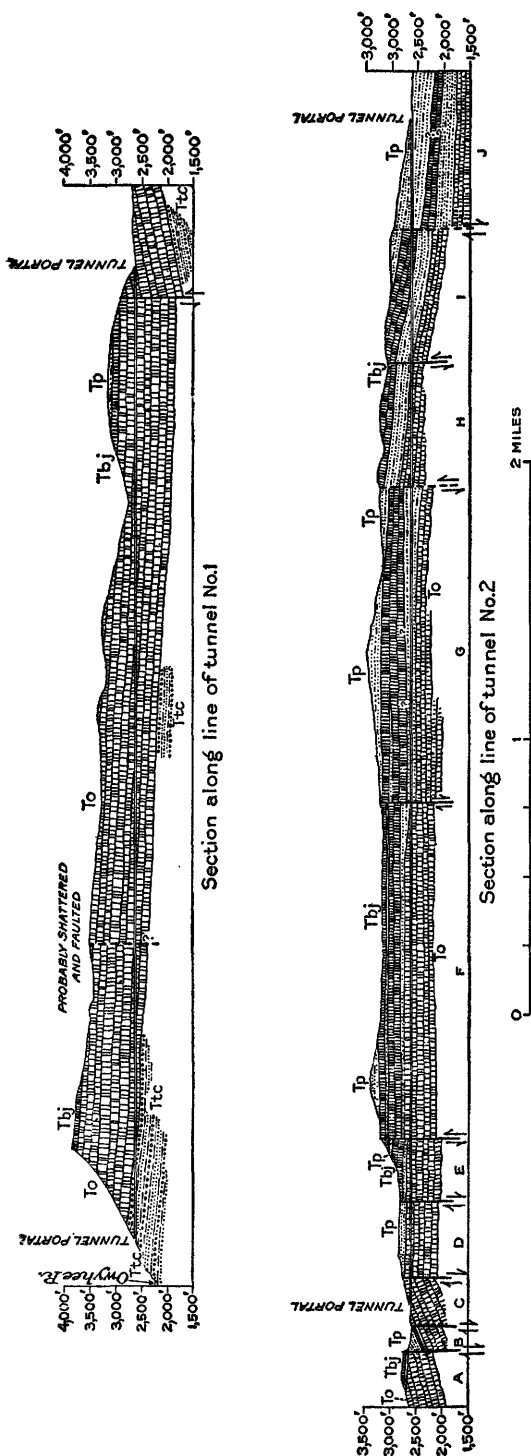
FIGURE 5.—Geologic cross sections on line of tunnels 1 and 2, H line, Owyhee Irrigation project, Oregon

Tunnel 1:	Miles
Tuffaceous conglomerate.....	0.43(?)
Owyhee basalt, horizontal.....	2.95
inclined .....	.2
	<hr/> 3.58 <hr/>
Tunnel 2:	
Owyhee basalt, horizontal .....	2.36
inclined.....	.79
Payette formation.....	1.12
Blackjack basalt, inclined.....	.13
	<hr/> 4.4 <hr/>

Tunnel 2 has the most complicated structure of all listed, and the uncertainties are the greatest. Tunnels 7, 8, and 14 of the G line are used also in this line.
