In cooperation with the National Park Service

# Streamflow Information for the Jacks Fork and Current River in the Ozark National Scenic Riverways, South-Central Missouri

—Gary Lee Wilson

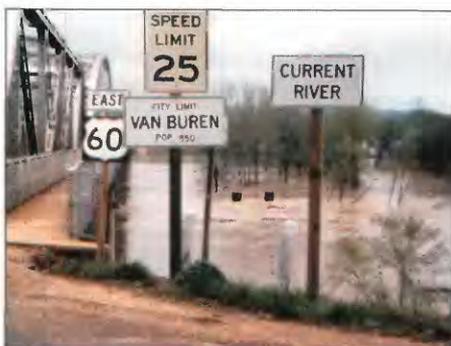
### Flood on the Current River at Van Buren, Missouri, April 1983.
