A Study of Earthquake Losses in the
Salt Lake City, Utah Area

Open-File Report 76-89

1976

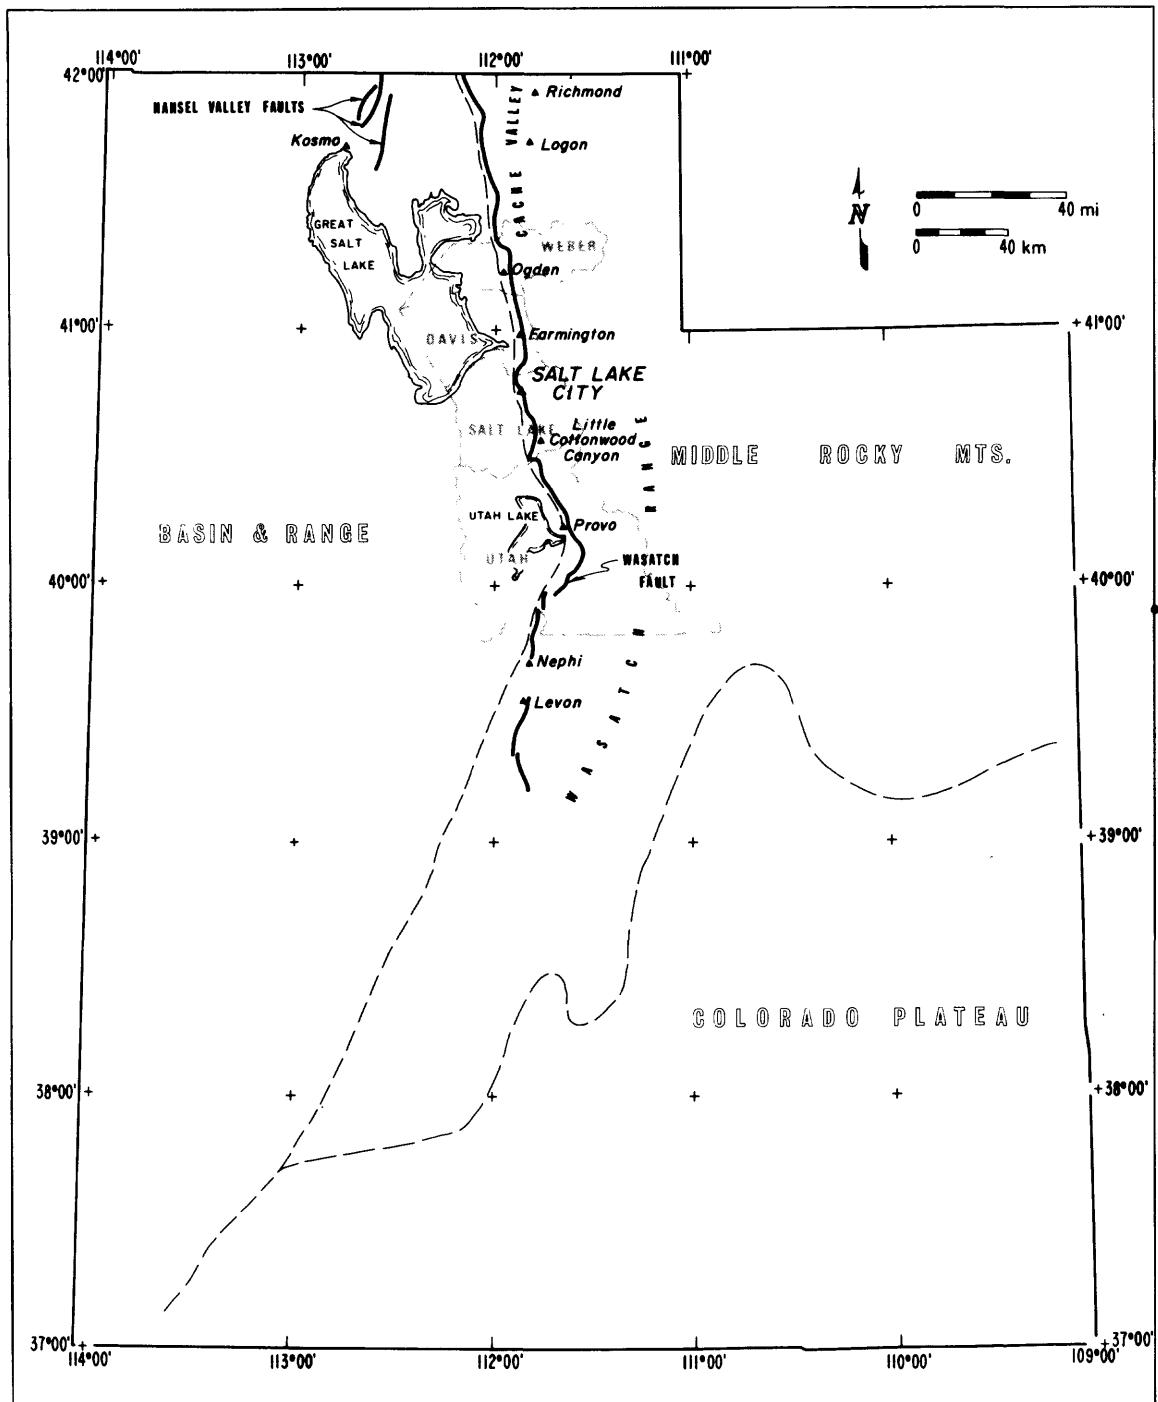
Figure 1.--Map of Utah showing the four-county study area, Basin and Range, Middle Rocky Mountains, and Colorado Plateau physiographic provinces, and the major fault zones in or near the study area.

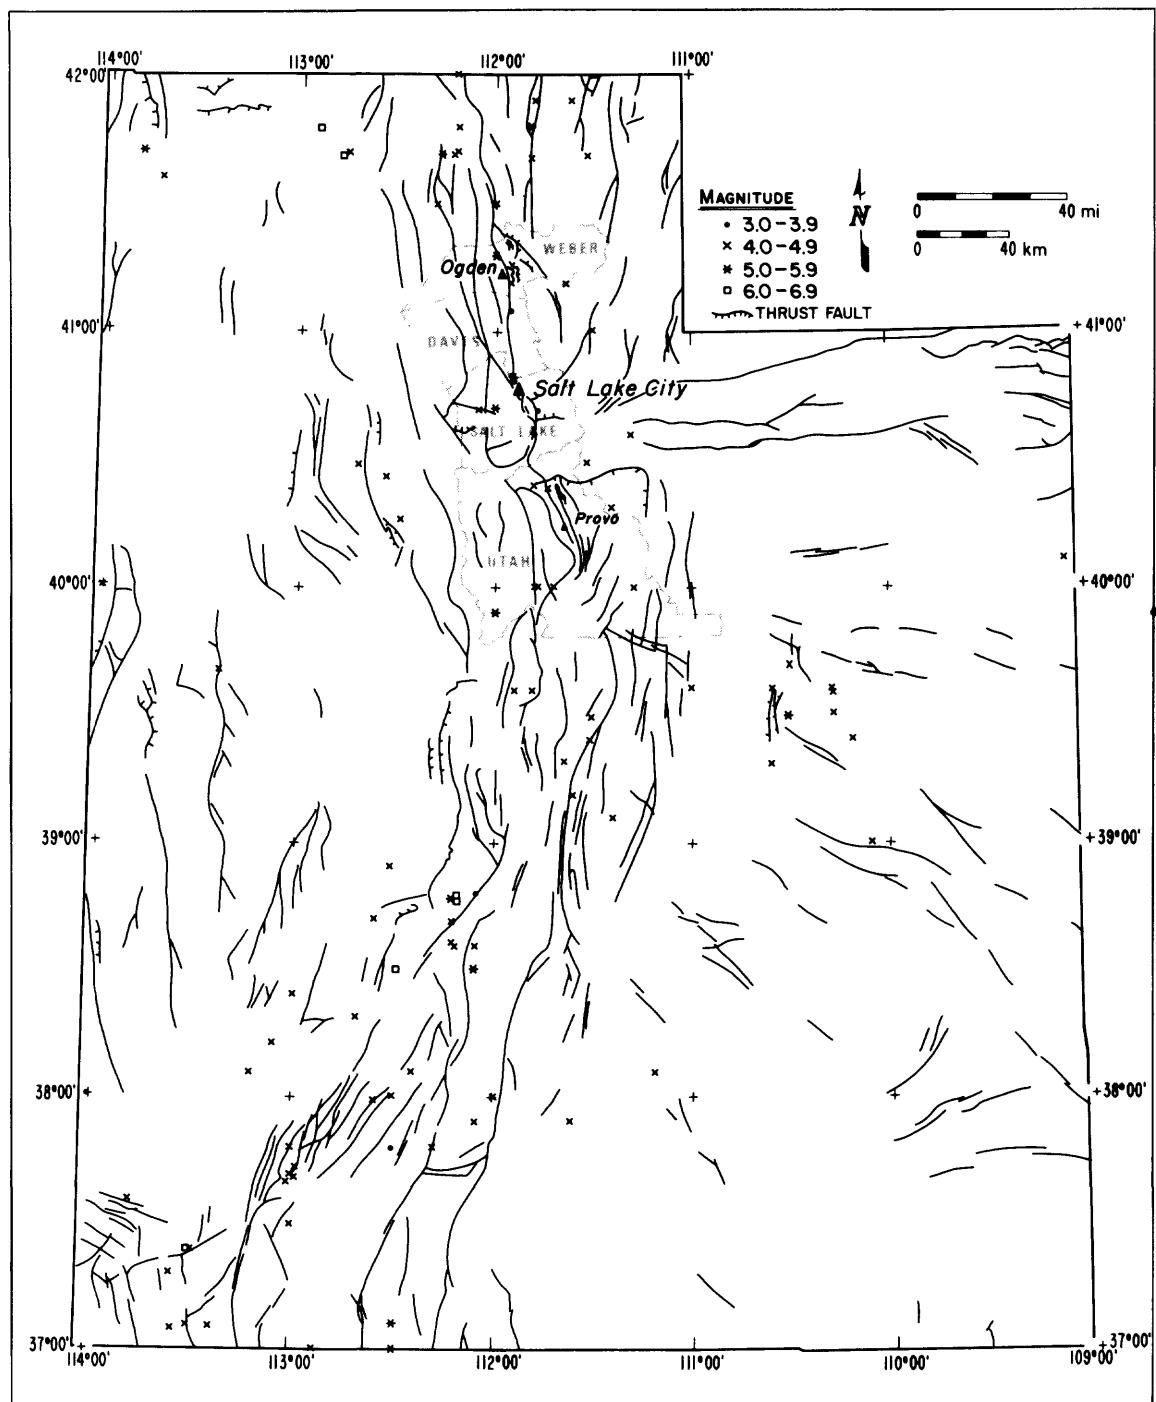
Figure 2.--Map of Utah showing the Intermountain Seismic Belt and the major fault systems.

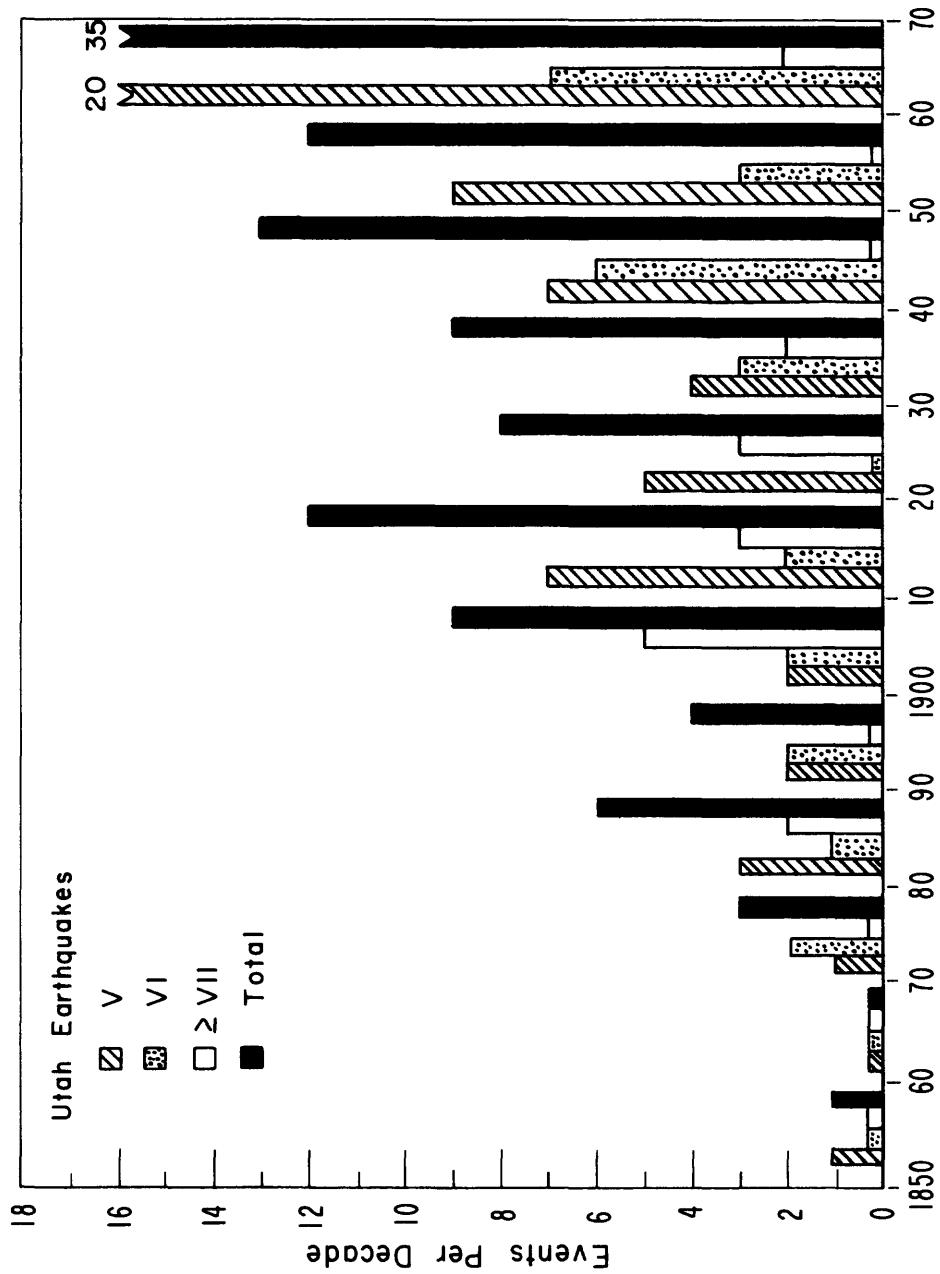
Figure 3.--Histograms showing the number of events in Utah per 10-year period versus decade. Events are grouped according to the maximum epicentral MM intensity.

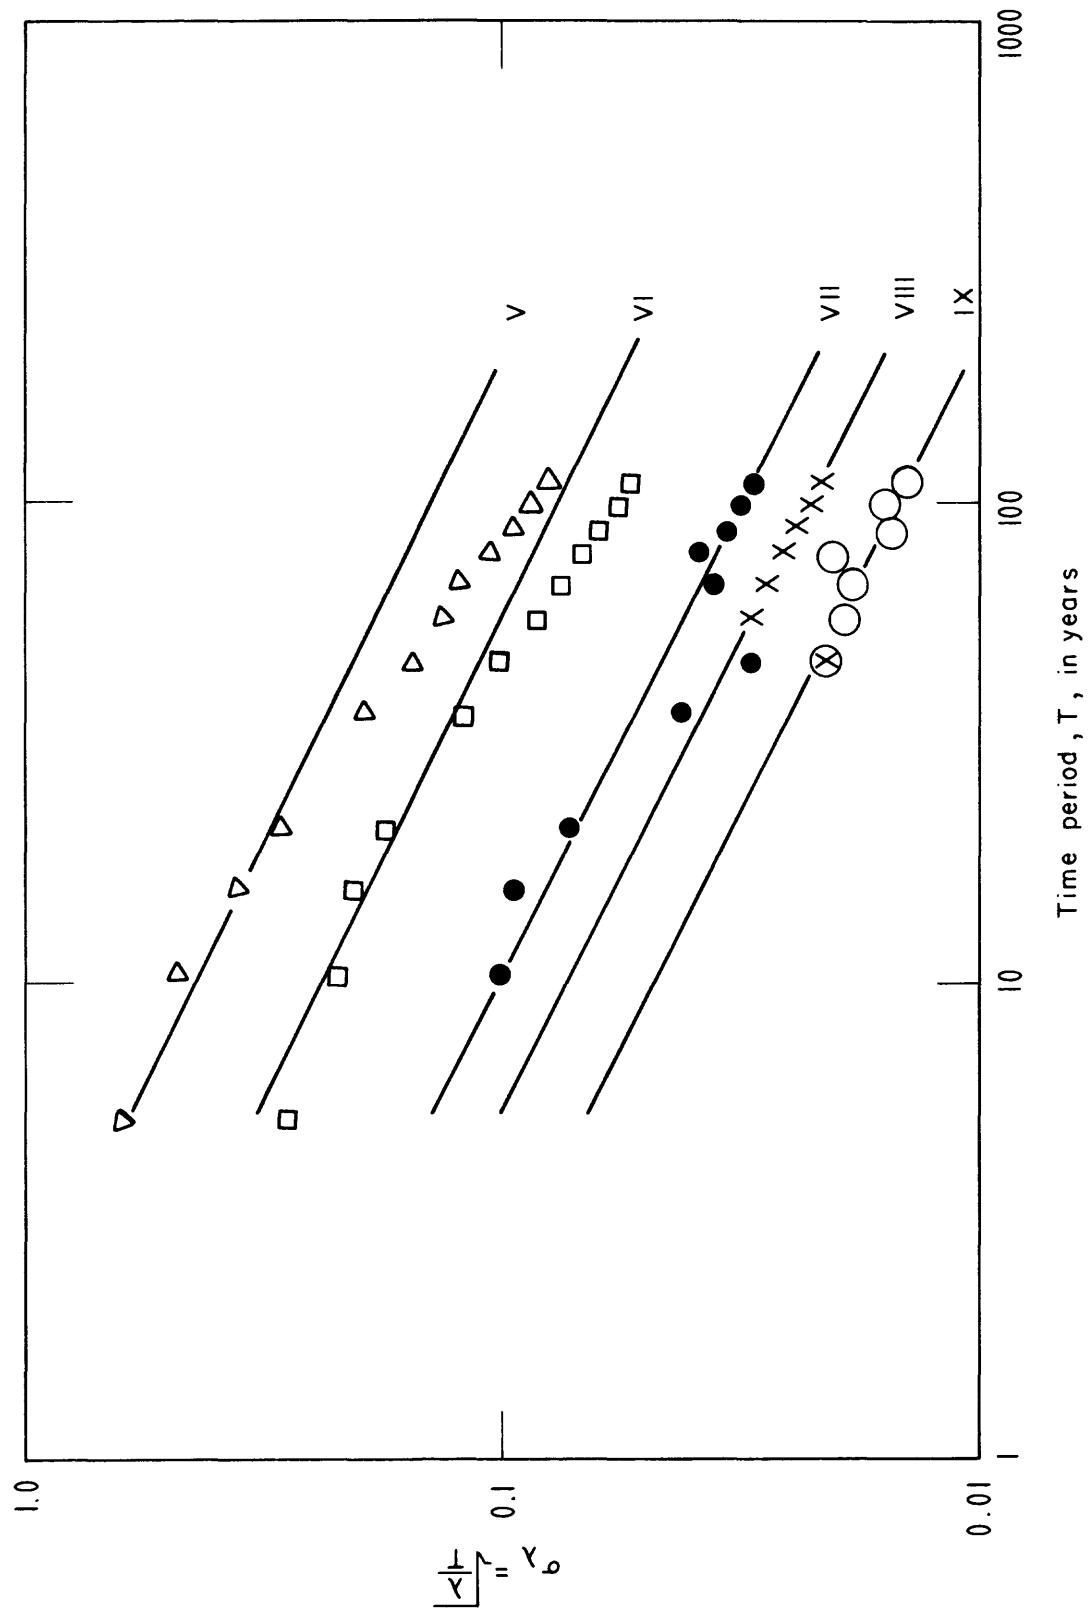
Figure 4.--The square root of the mean rate of earthquake occurrence divided by time interval versus successively longer time intervals. Data through May 1974.

Stepp's (1972) technique for minimizing the effects of incompleteness of the data sample have been employed. Table 4 and figure 4 show the required calculations. σ_λ , square root of the mean rate of earthquake occurrence (λ) divided by the time interval (T), is plotted versus

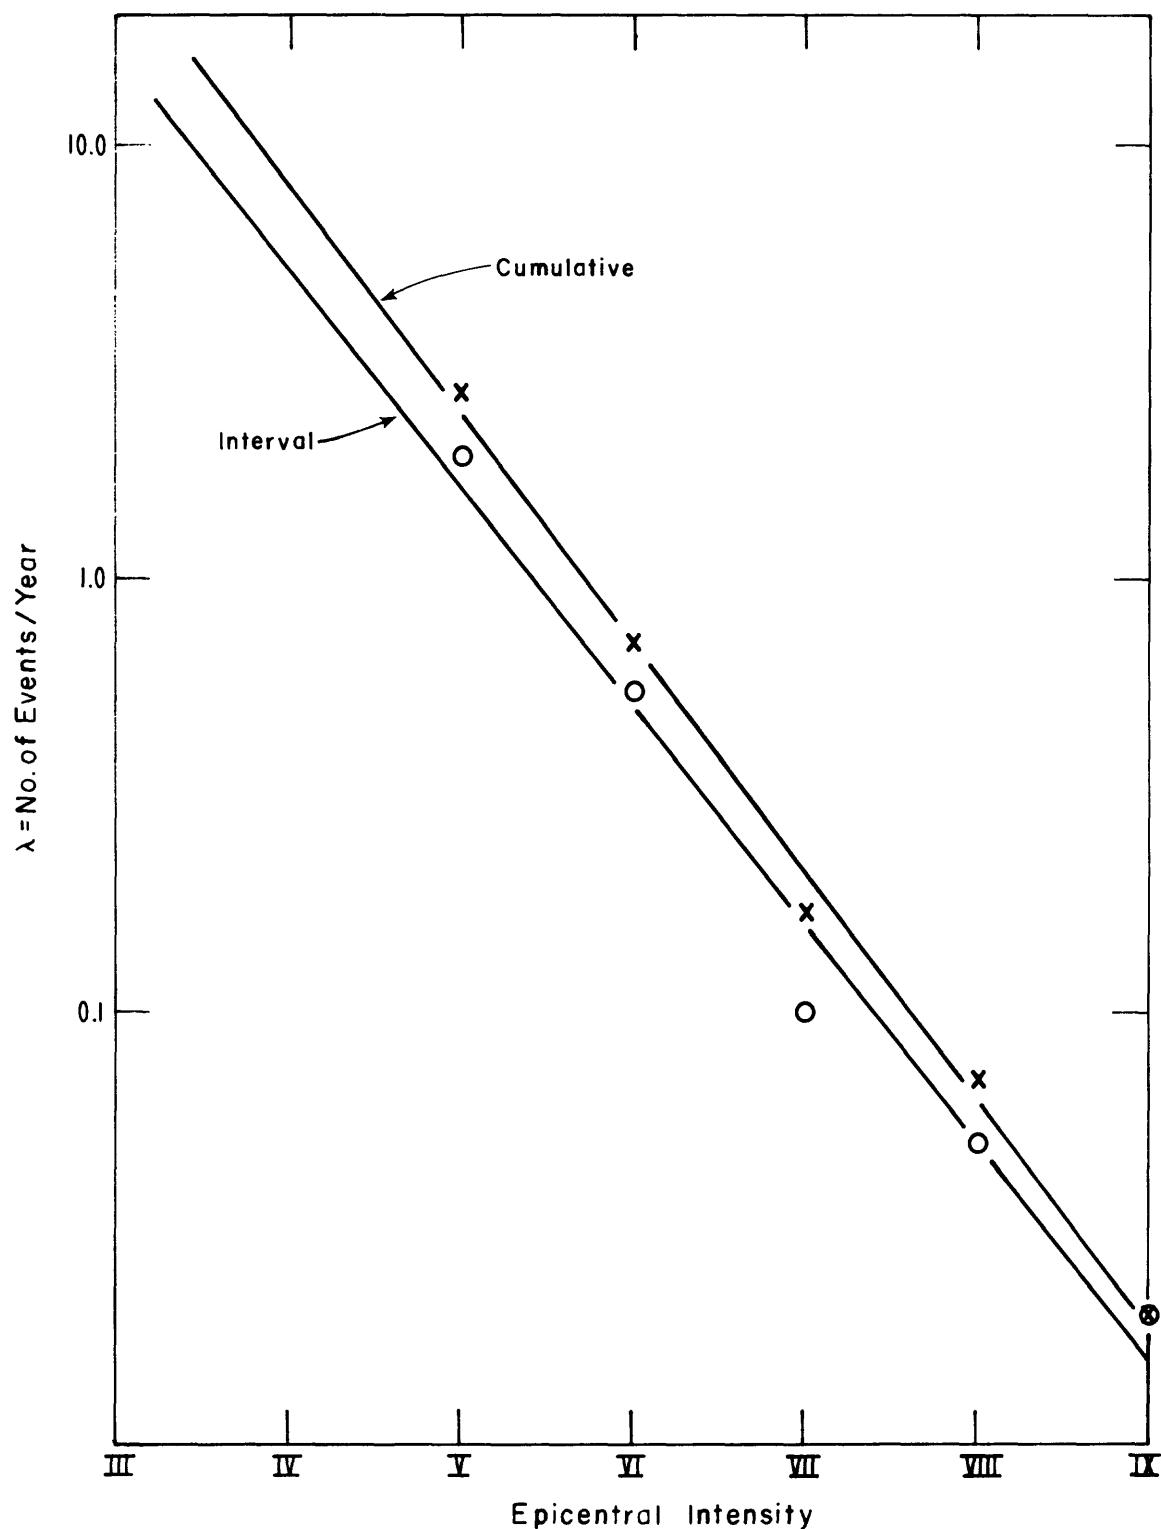
Figure 5.--The interval and cumulative frequency of recurrence for epicentral intensity-Utah earthquakes.

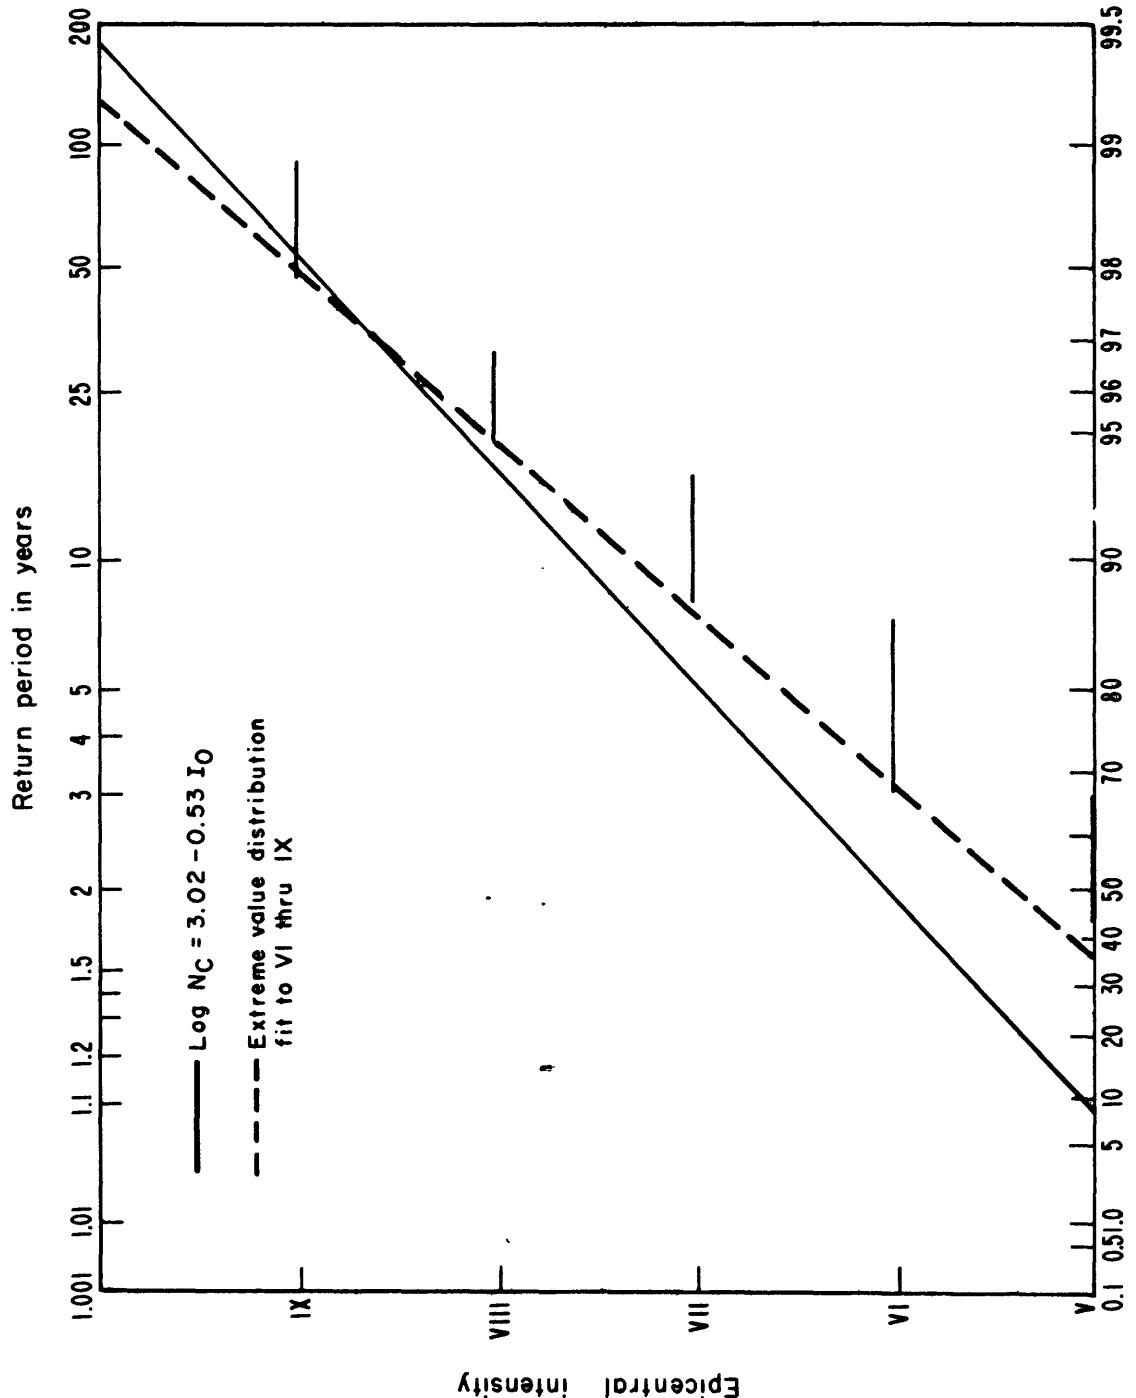
Extreme probability
 Figure 6--Intensity versus extreme probability or the probability that a given intensity is the largest intensity in a given year. Return period or the interval in which a given intensity or greater has a 63% probability of occurrence and the recurrence relation transformed to extreme probability are also shown.

Figure 6 also compares a transformation of the recurrence relation to an extreme probability distribution suggested by Epstein and Lomnitz (1966) and the observed extreme probability. The recurrence relation,

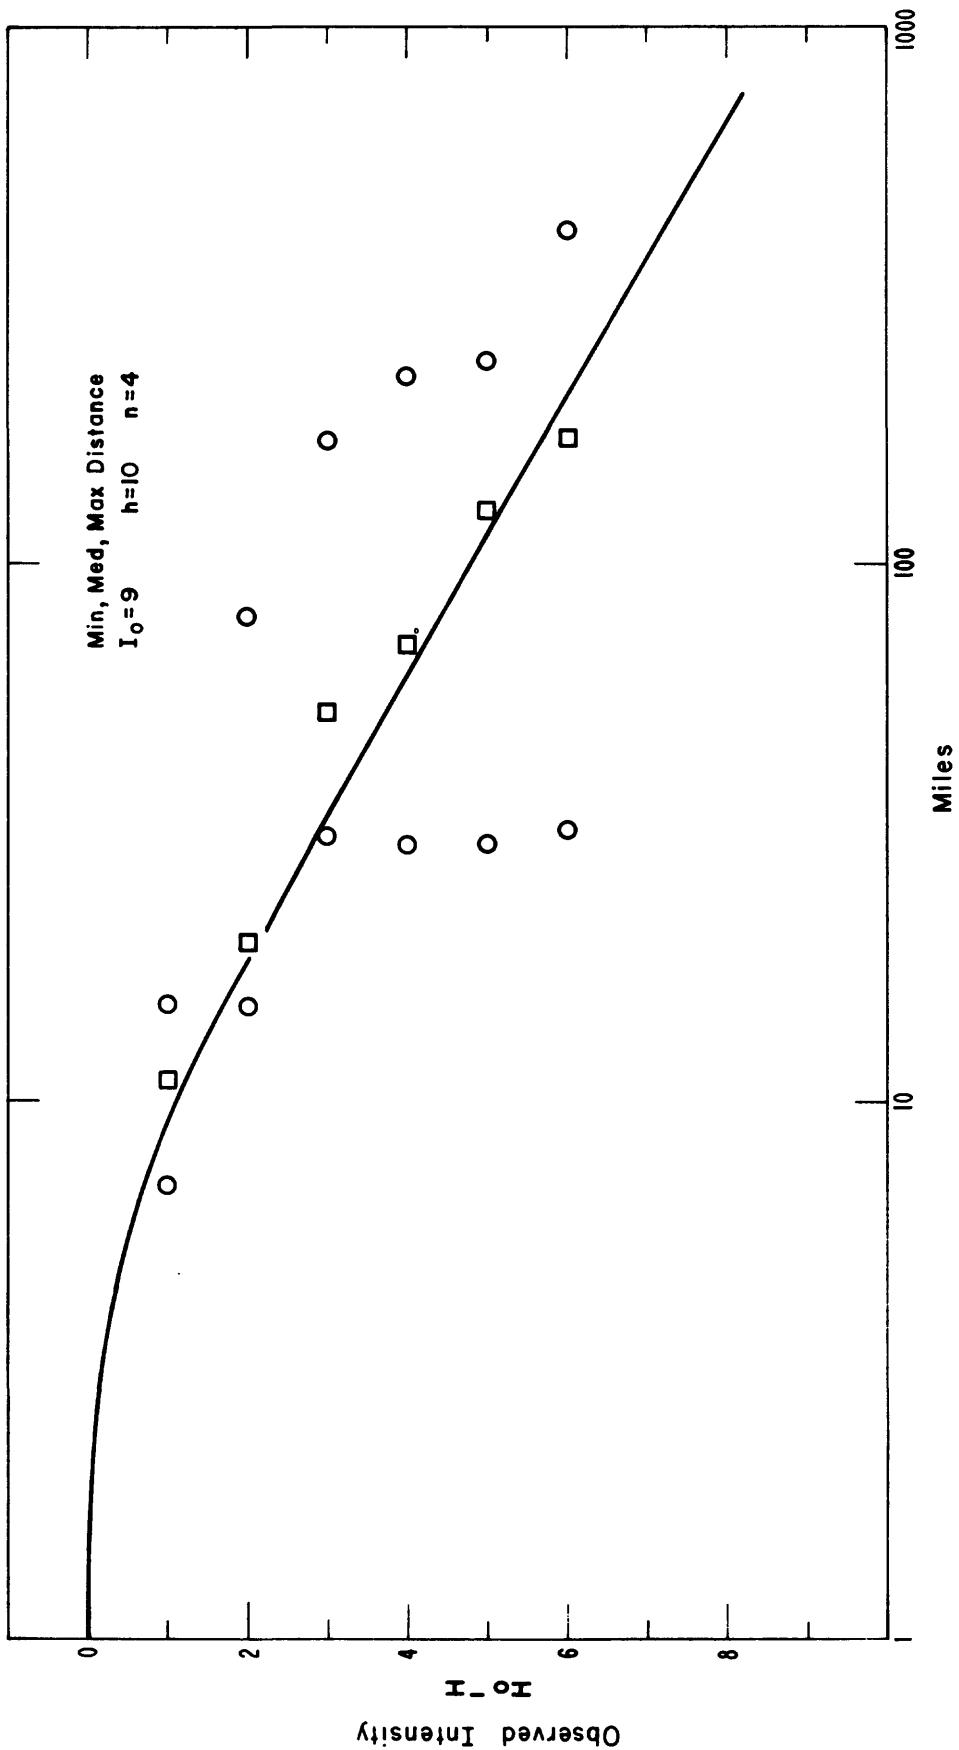
Figure 7.--Observed intensity versus epicentral distance for the 1934 Hansel Valley earthquake. Circles indicate the minimum and maximum distances at which that intensity was observed; square indicates median distance at which that intensity was observed. h =focal depth in km; I_0 =max. intensity at the epicenter; n =exponent in Ergin's 1969 relation. The solid line is Ergin's 1969 curve.

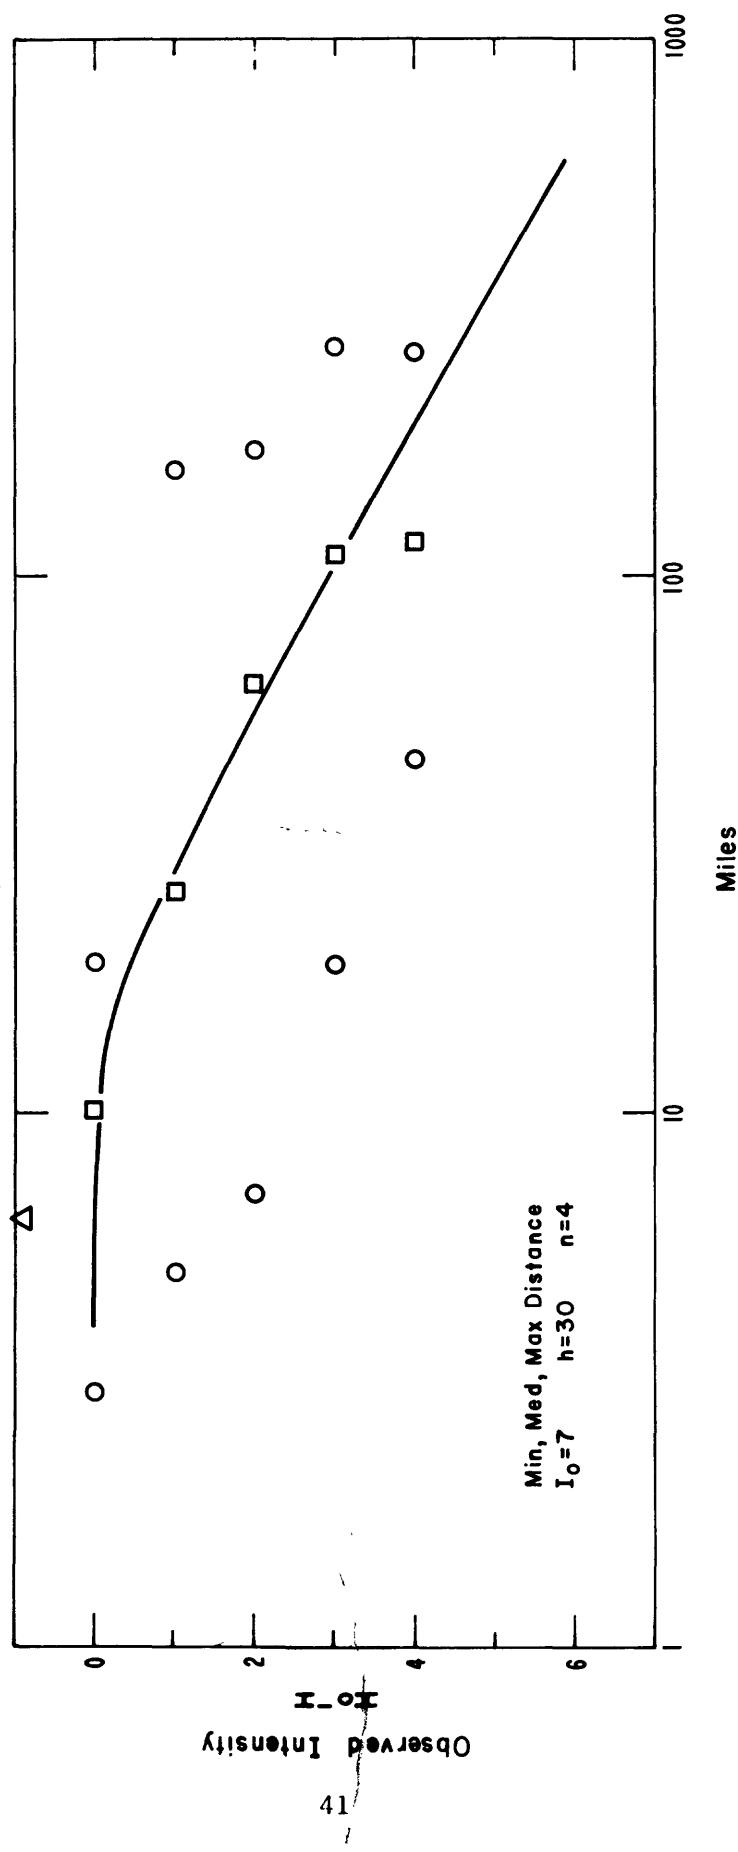
Figure 8.-Observed intensity versus epicentral distance for the 1962 Cache valley earthquake. Circles indicate the minimum and maximum distances at which that intensity was observed; square indicates median distance at which that intensity was observed. h =focal depth in km; I_0 =max. intensity at the epicenter; n =exponent in Ergin's 1969 relation. The solid line is Ergin's 1969 curve. The Δ symbol indicates one point instrumentally determined using the peak acceleration recorded at Logan during this earthquake.

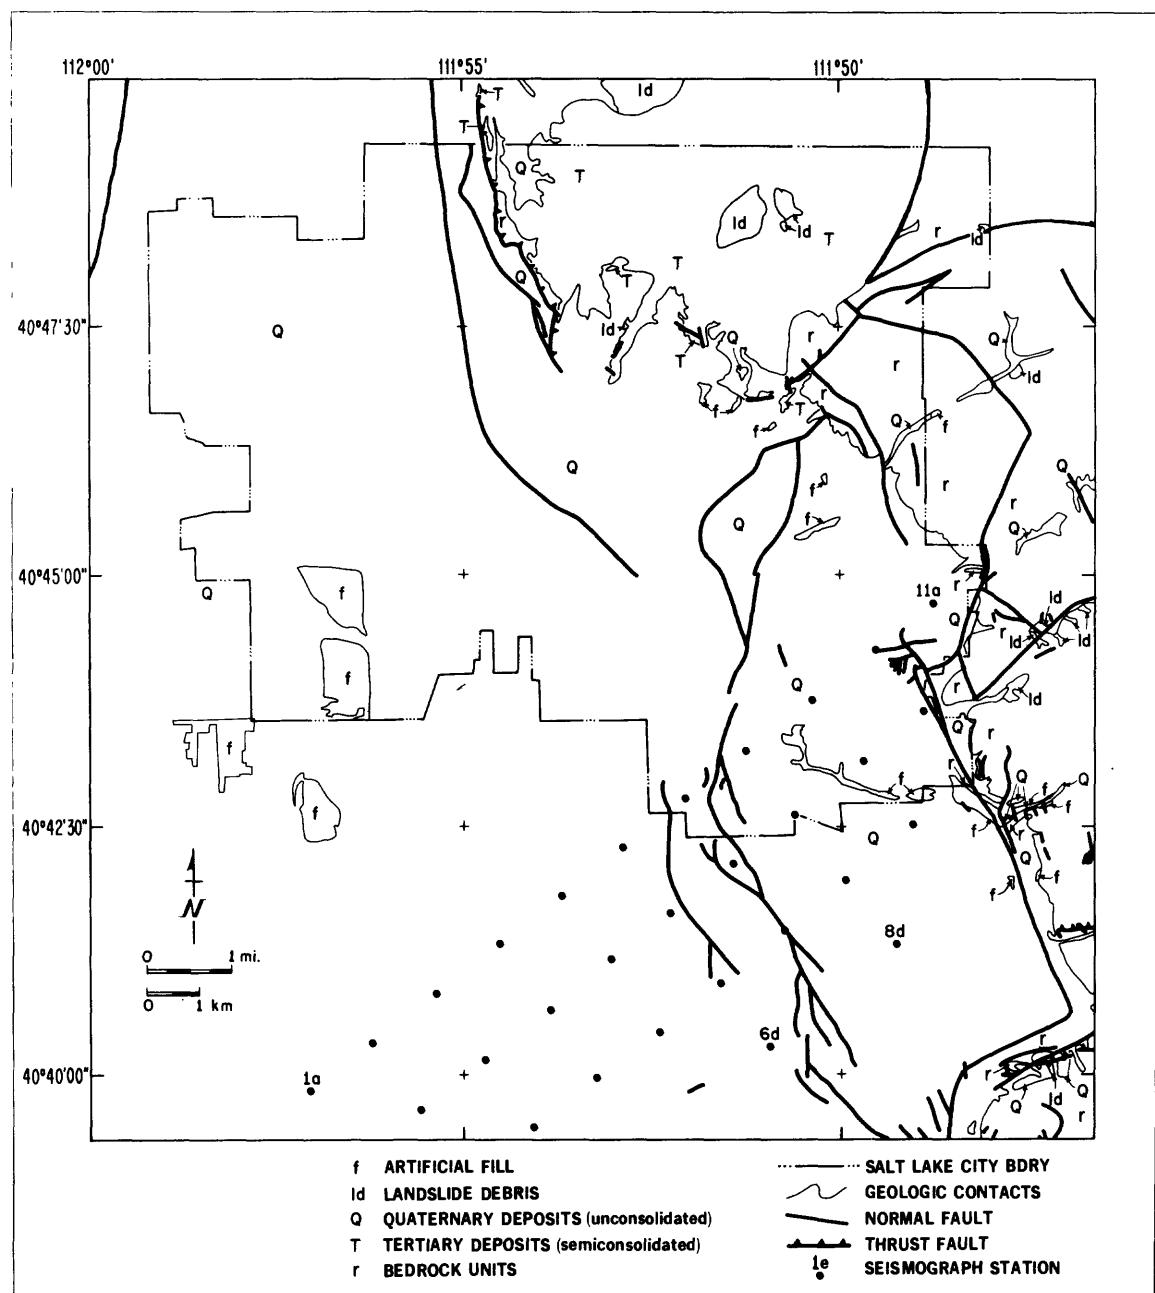
Figure 9.--Map showing the seismic array configuration in Salt Lake Valley. Each dot represents a three-component seismograph system recording on magnetic tape (L-7 system). All stations were occupied simultaneously and recorded several Bingham mine blasts as well as one Nevada Test Site nuclear blast.

In order to determine the separation between the extreme curves and the median curve, an array of 32 stations was deployed across Salt Lake Valley to measure the soil-response variation for Bingham mine blasts and an NTS (Nevada Test Site) explosion. Figure 9 shows the array configuration. The long axis of the array is approximately alined radially with both the Bingham mine and NTS. Three seismometers at each station recorded the vertical, transverse, and radial ground motion. Records for two stations recording a mine blast are shown in figure 10; they demonstrate the kind of differences that were observed between ground velocities recorded at different stations.

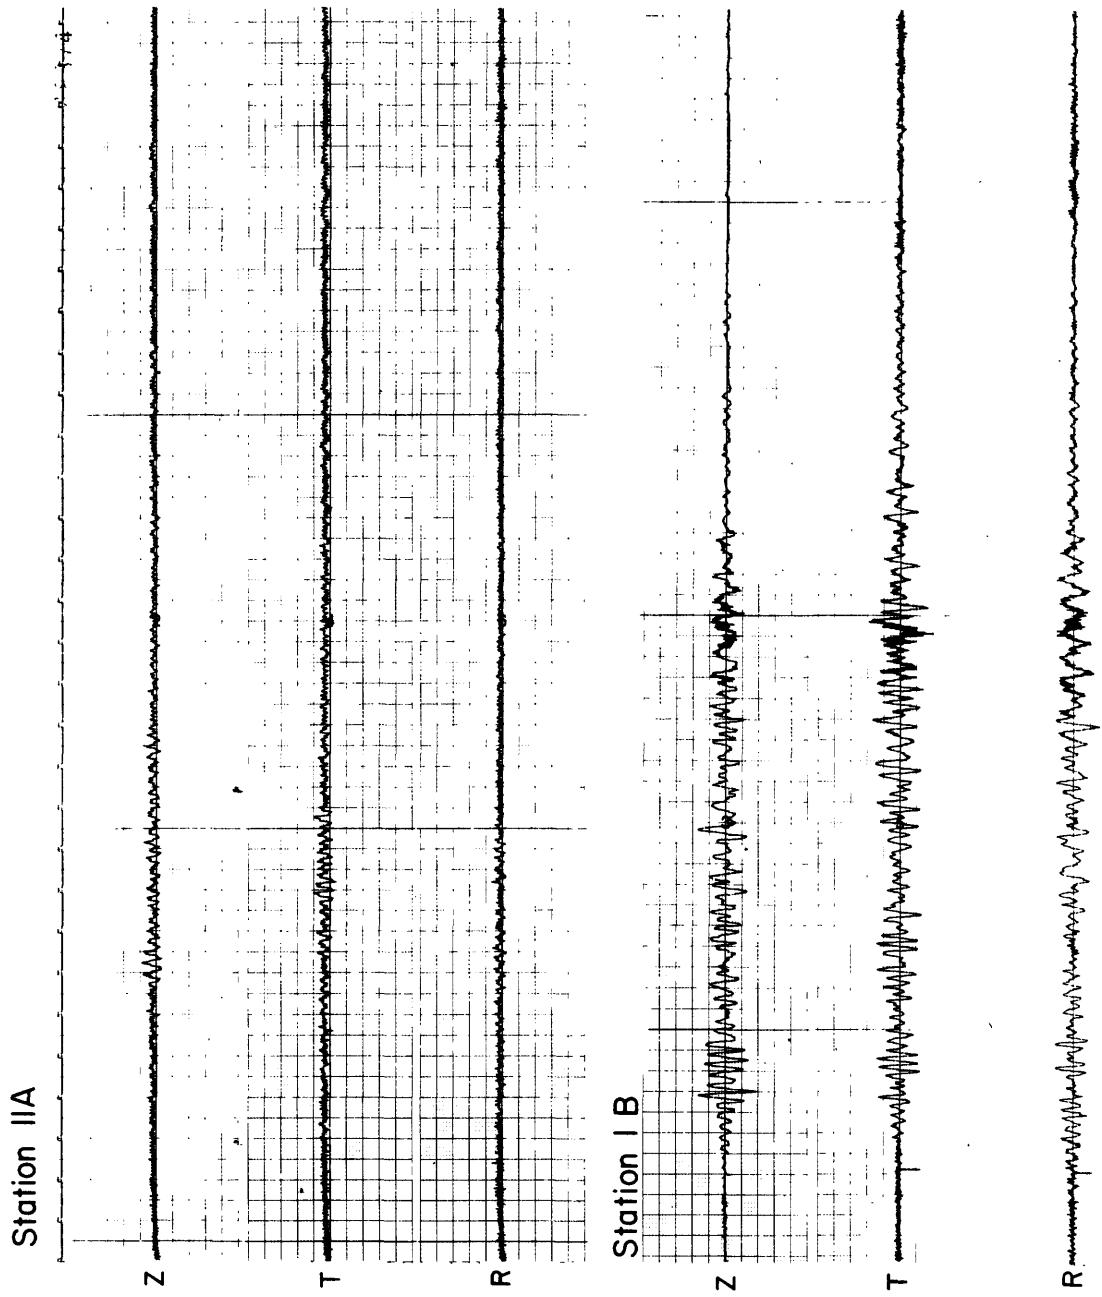
Figure 10.--Seismograph records showing vertical (Z), transverse (T), and radial (R) components of ground velocity at two stations for the same mine blast. All amplitude scales are equal.

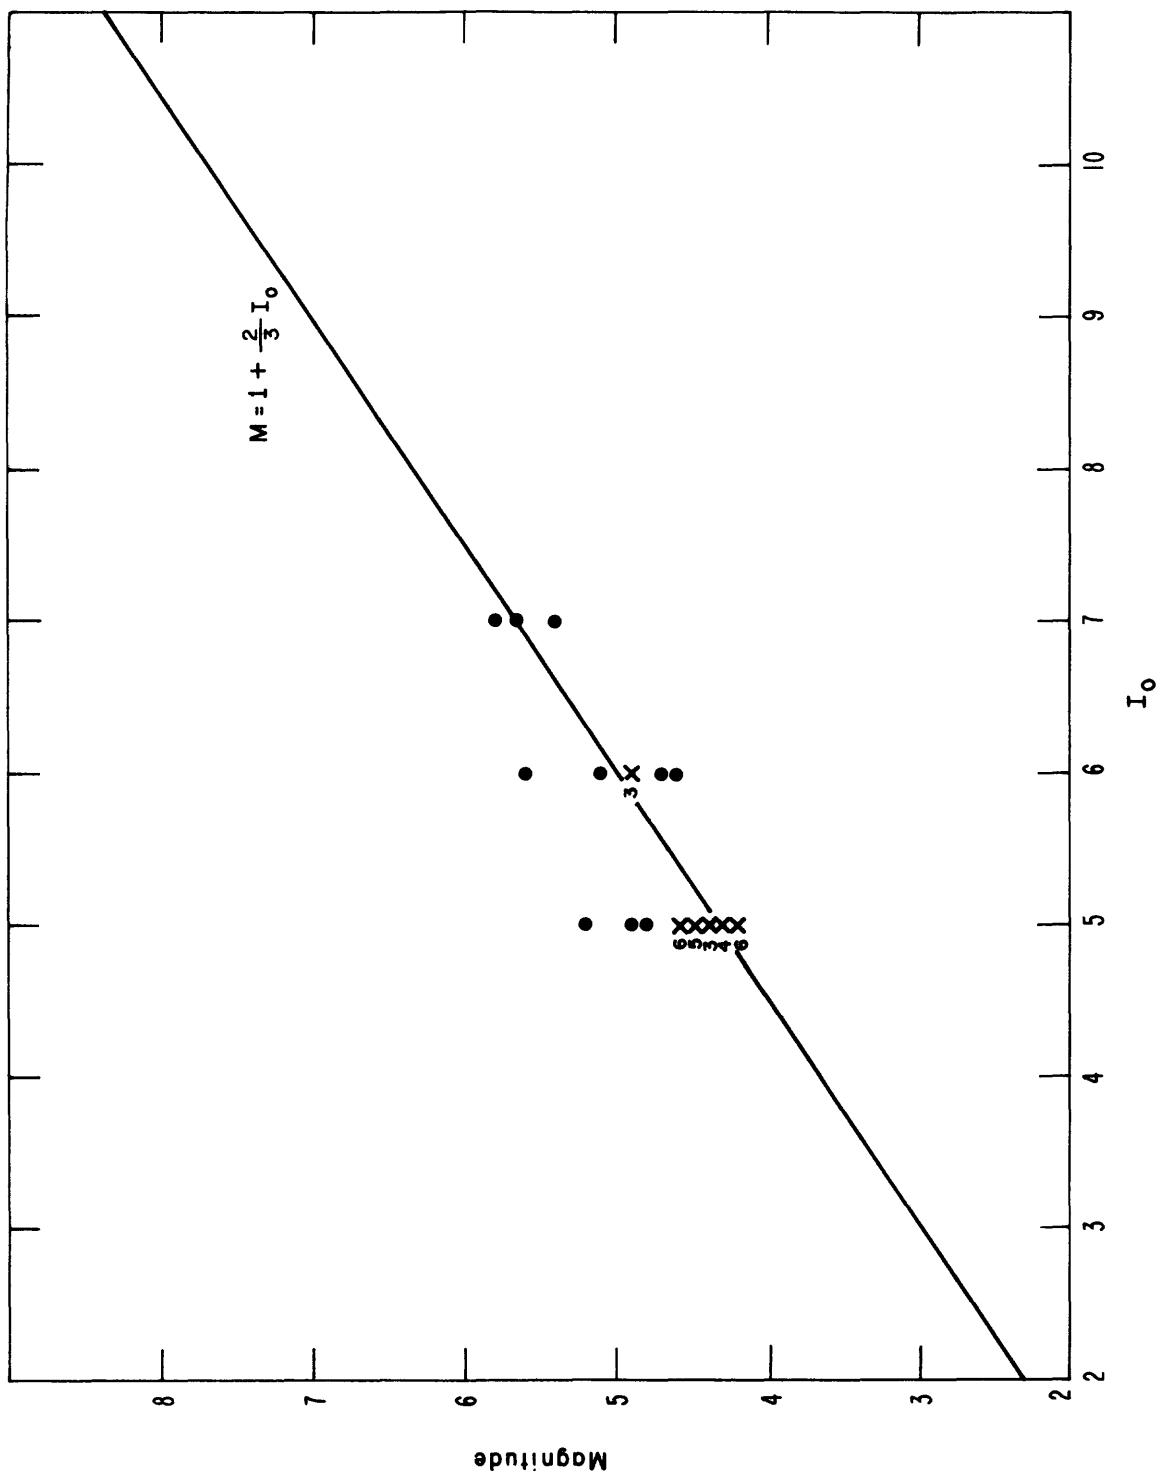
Figure 11.--Graph showing magnitude versus maximum intensity for Utah earthquakes. The line shows the Gutenburg-Richter relation. The numbers indicate the number of overlapping data points.

That this relation is reasonable to use in Utah is demonstrated by figure 11, which compares observations in Utah with equation (5).

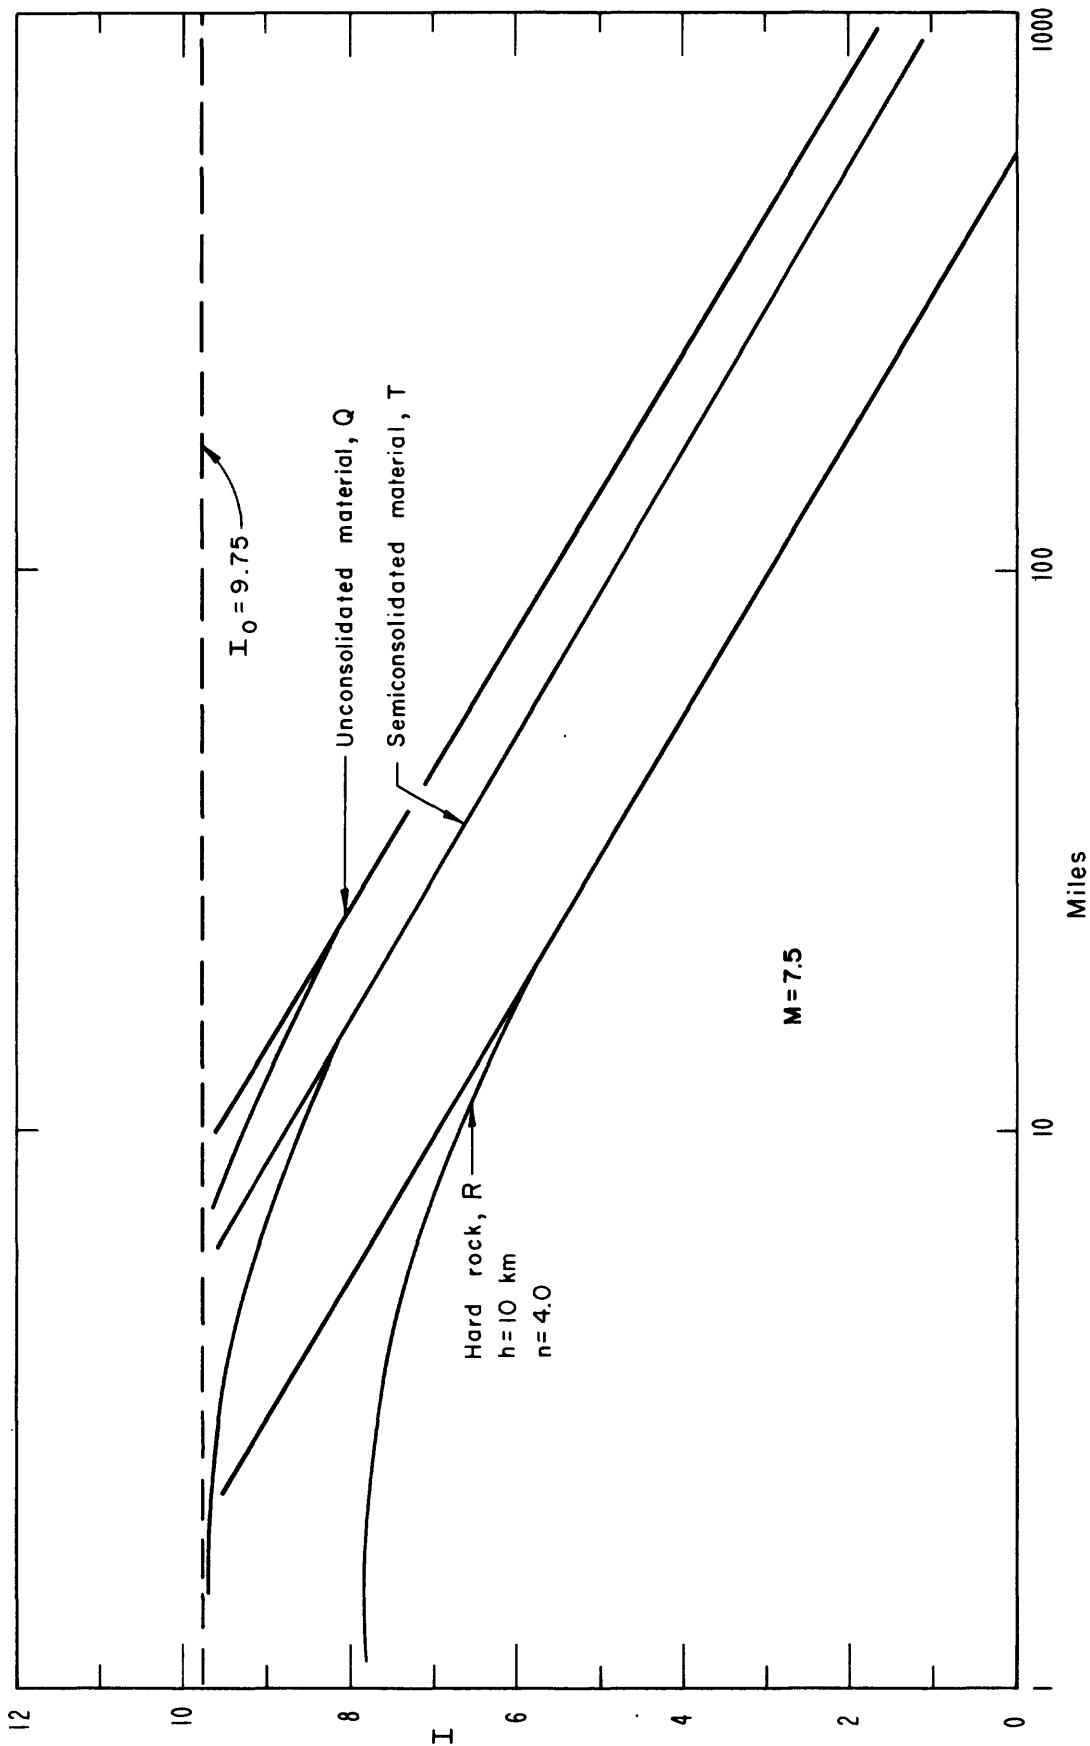
Figure 12.--Graph showing intensity versus distance for a magnitude-7.5 earthquake for locations on unconsolidated soils, semiconsolidated soils, or hard rock.

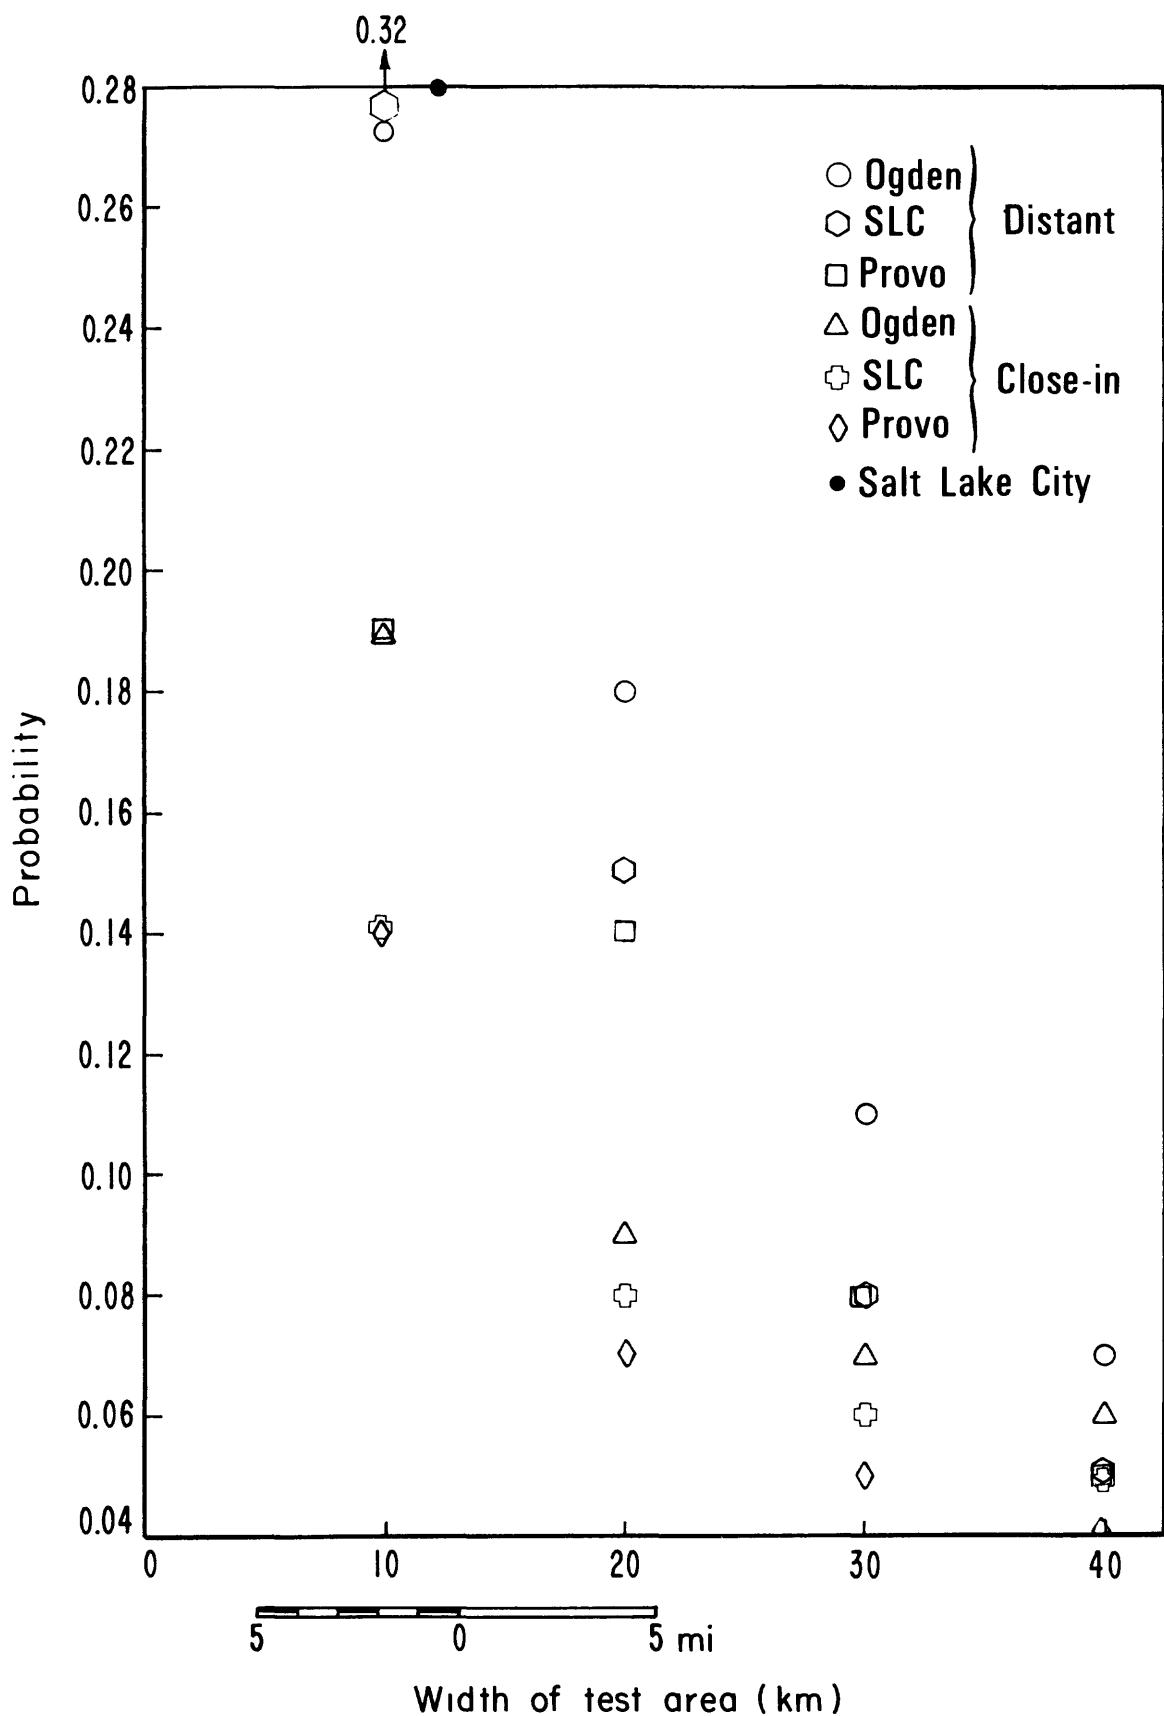
Figure 13.--Graph showing probability of faulting at given site on a fault as a function of the width of the rectangle assumed.
