A Study of Earthquake Losses in the
Salt Lake City, Utah Area

Open-File Report 76-89

1976

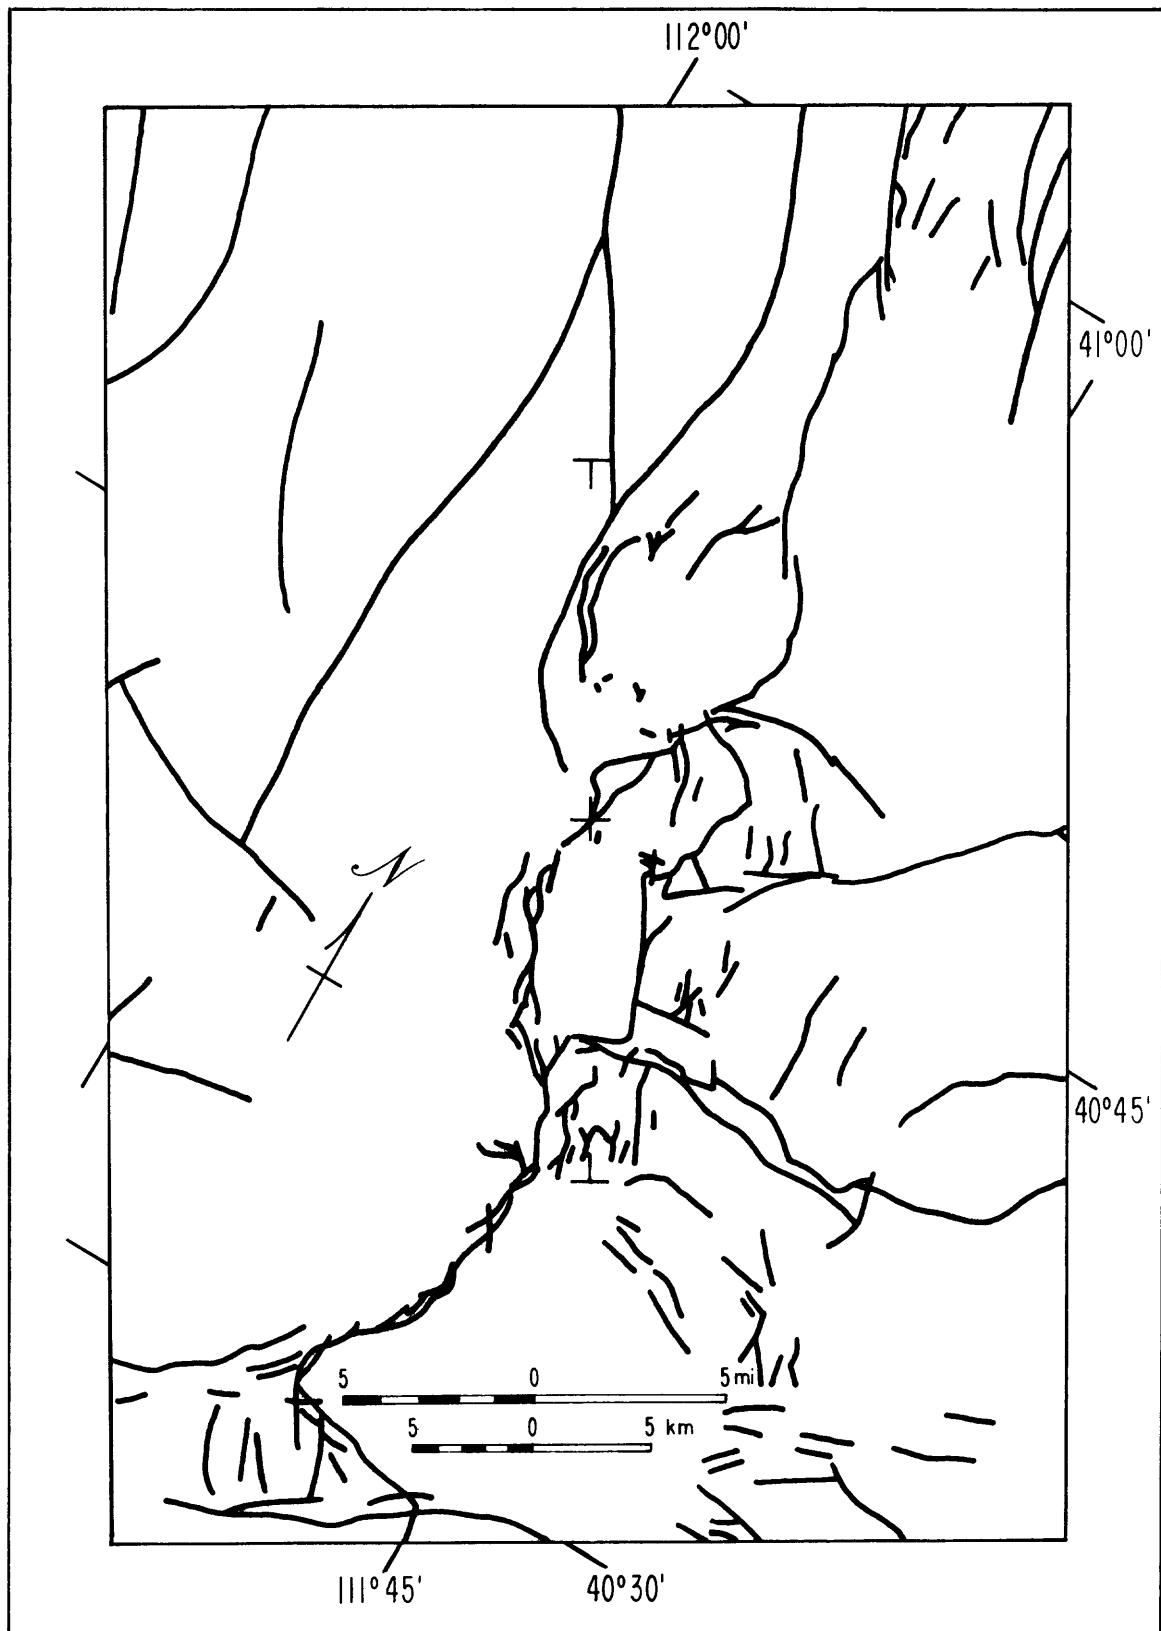
Figure 14.--Area of probable faulting for the Salt Lake City close-in event. + indicates the assumed epicenter; \perp or T indicates the ends of the assumed fault.

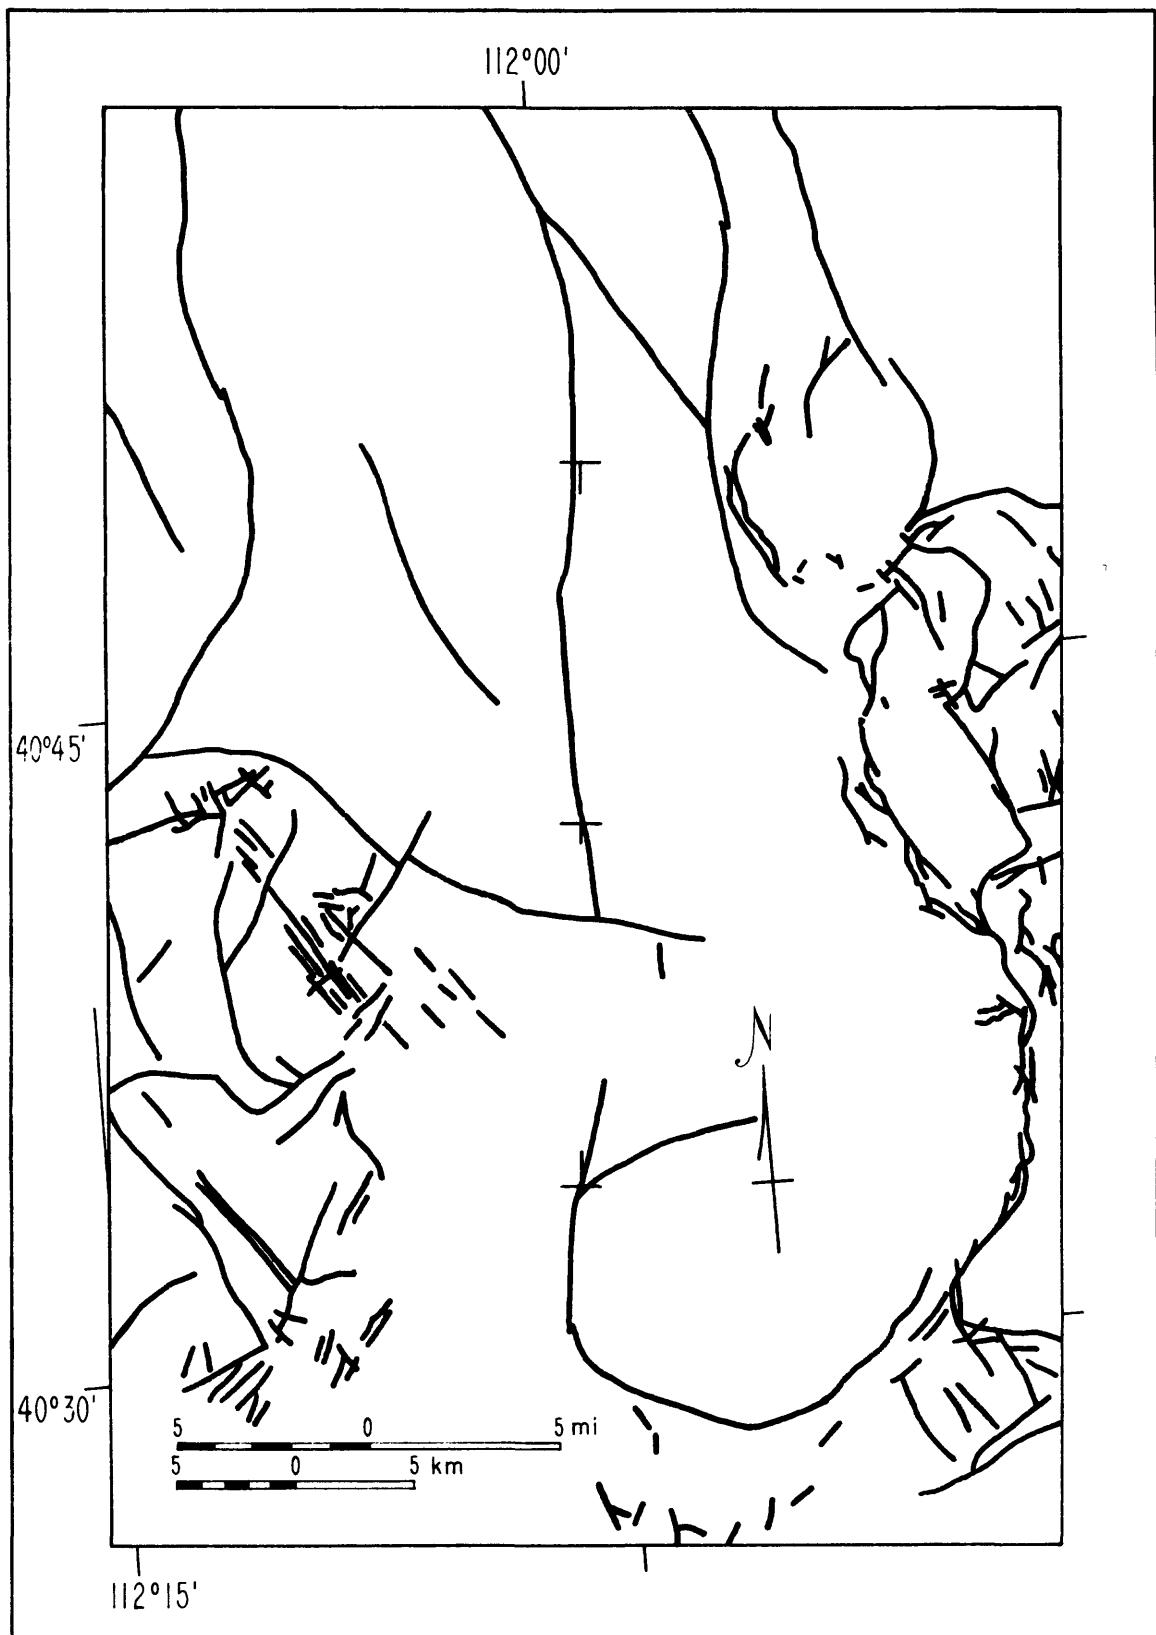
Figure 15.--Area of probable faulting for the Salt Lake City distant event. + indicates the assumed epicenter; — and — indicate the ends of the assumed fault.

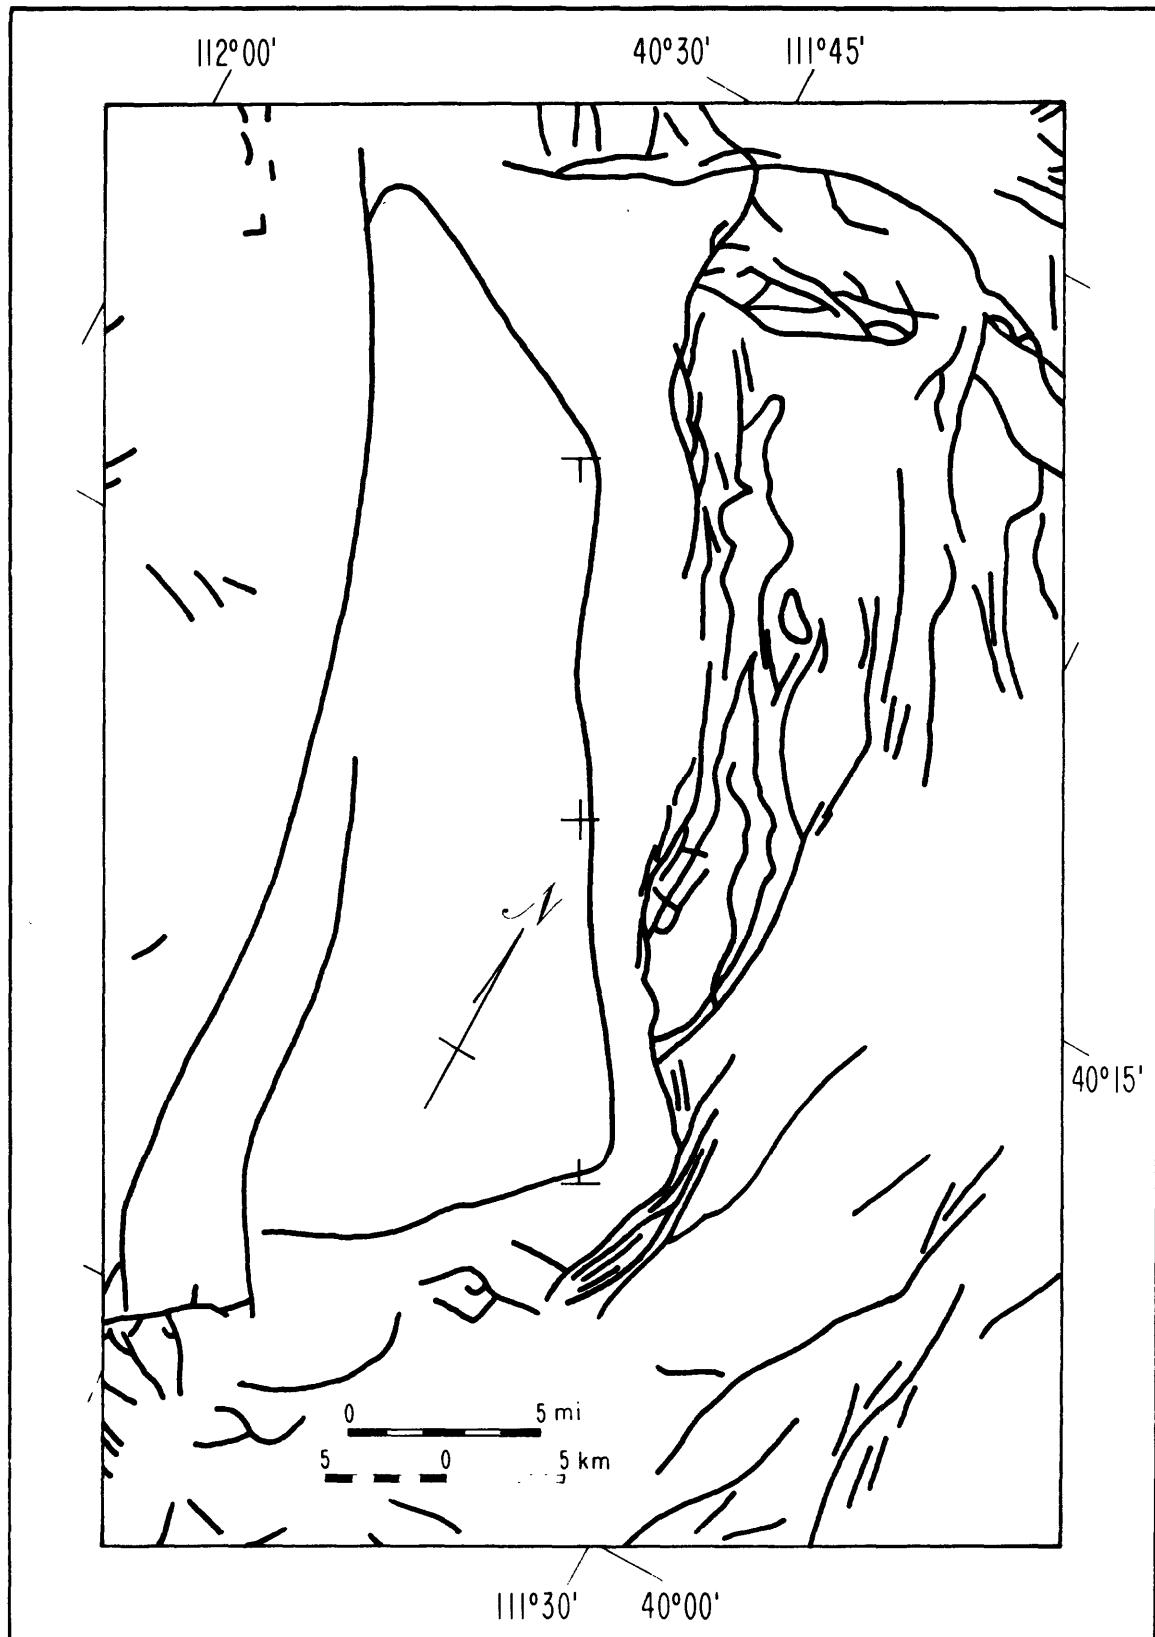
Figure 16.--Area of probable faulting for the Provo close-in event. + indicates the assumed epicenter; \perp and \top indicate the ends of the assumed fault.

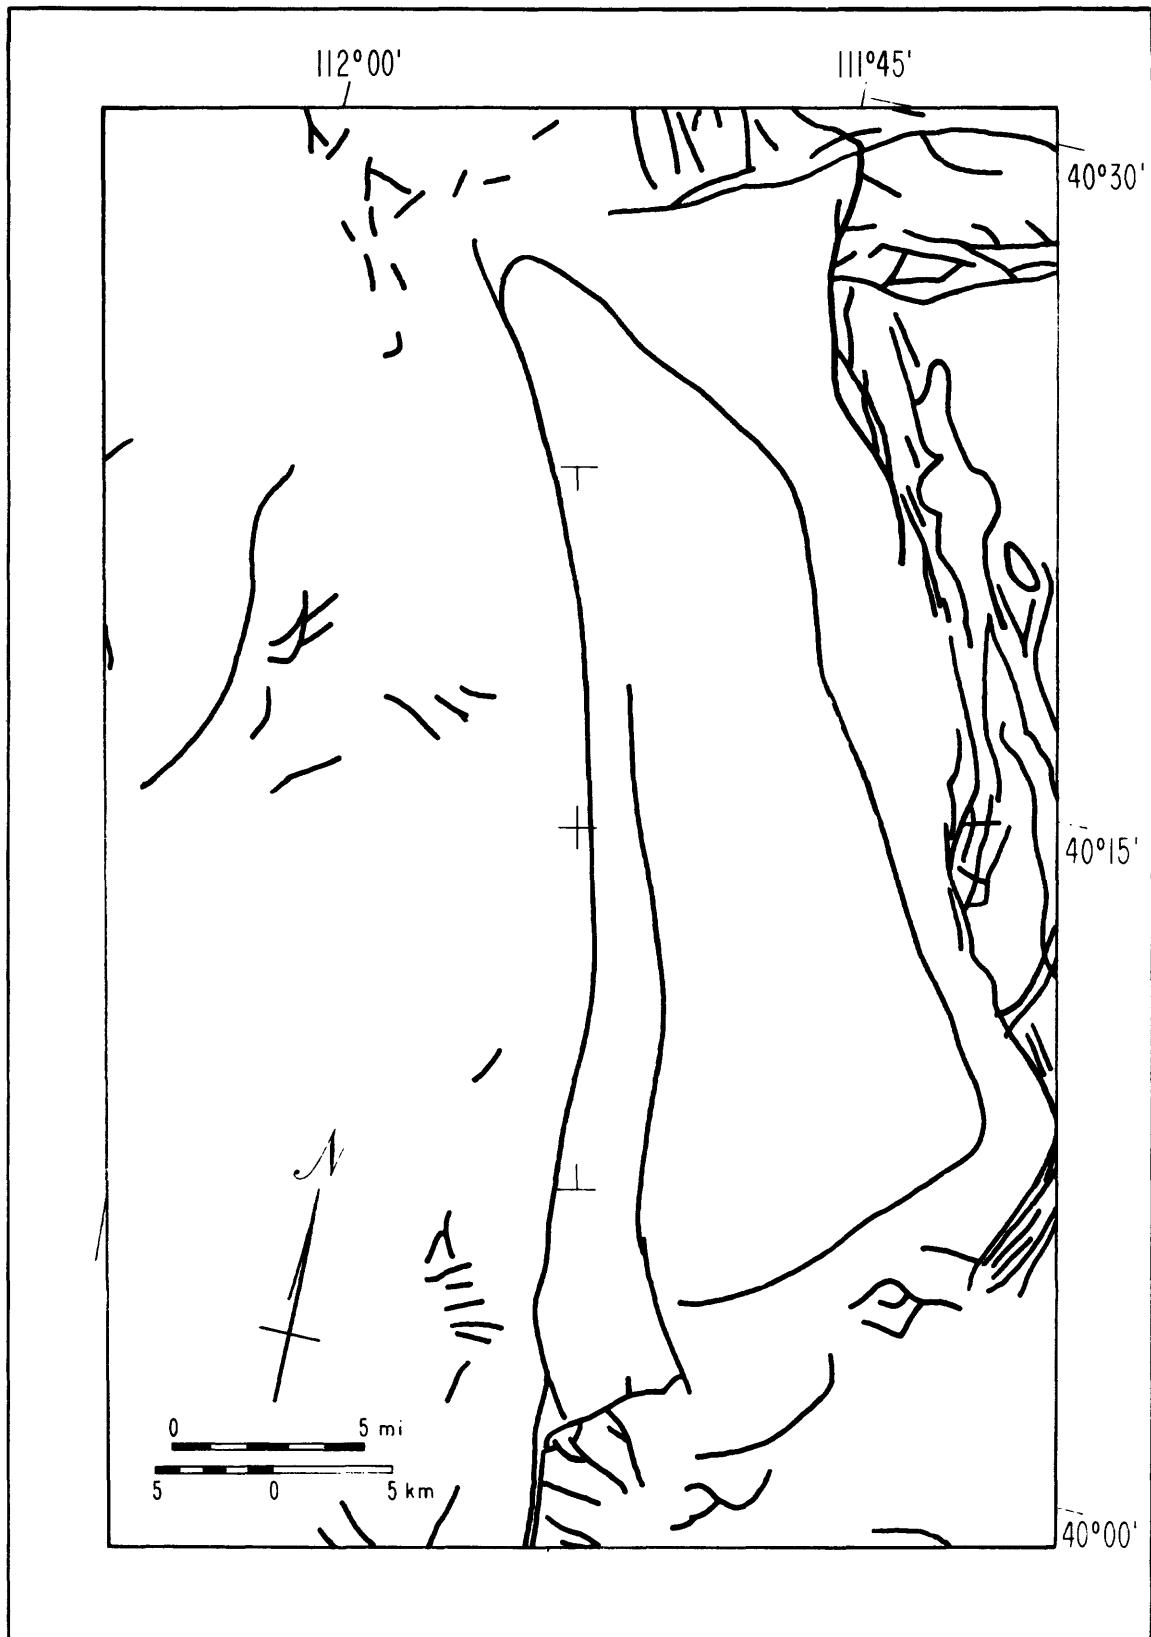
Figure 17.--Area of probable faulting for the Provo distant event. + indicates the assumed epicenter; \perp and \top indicate the ends of the assumed fault.

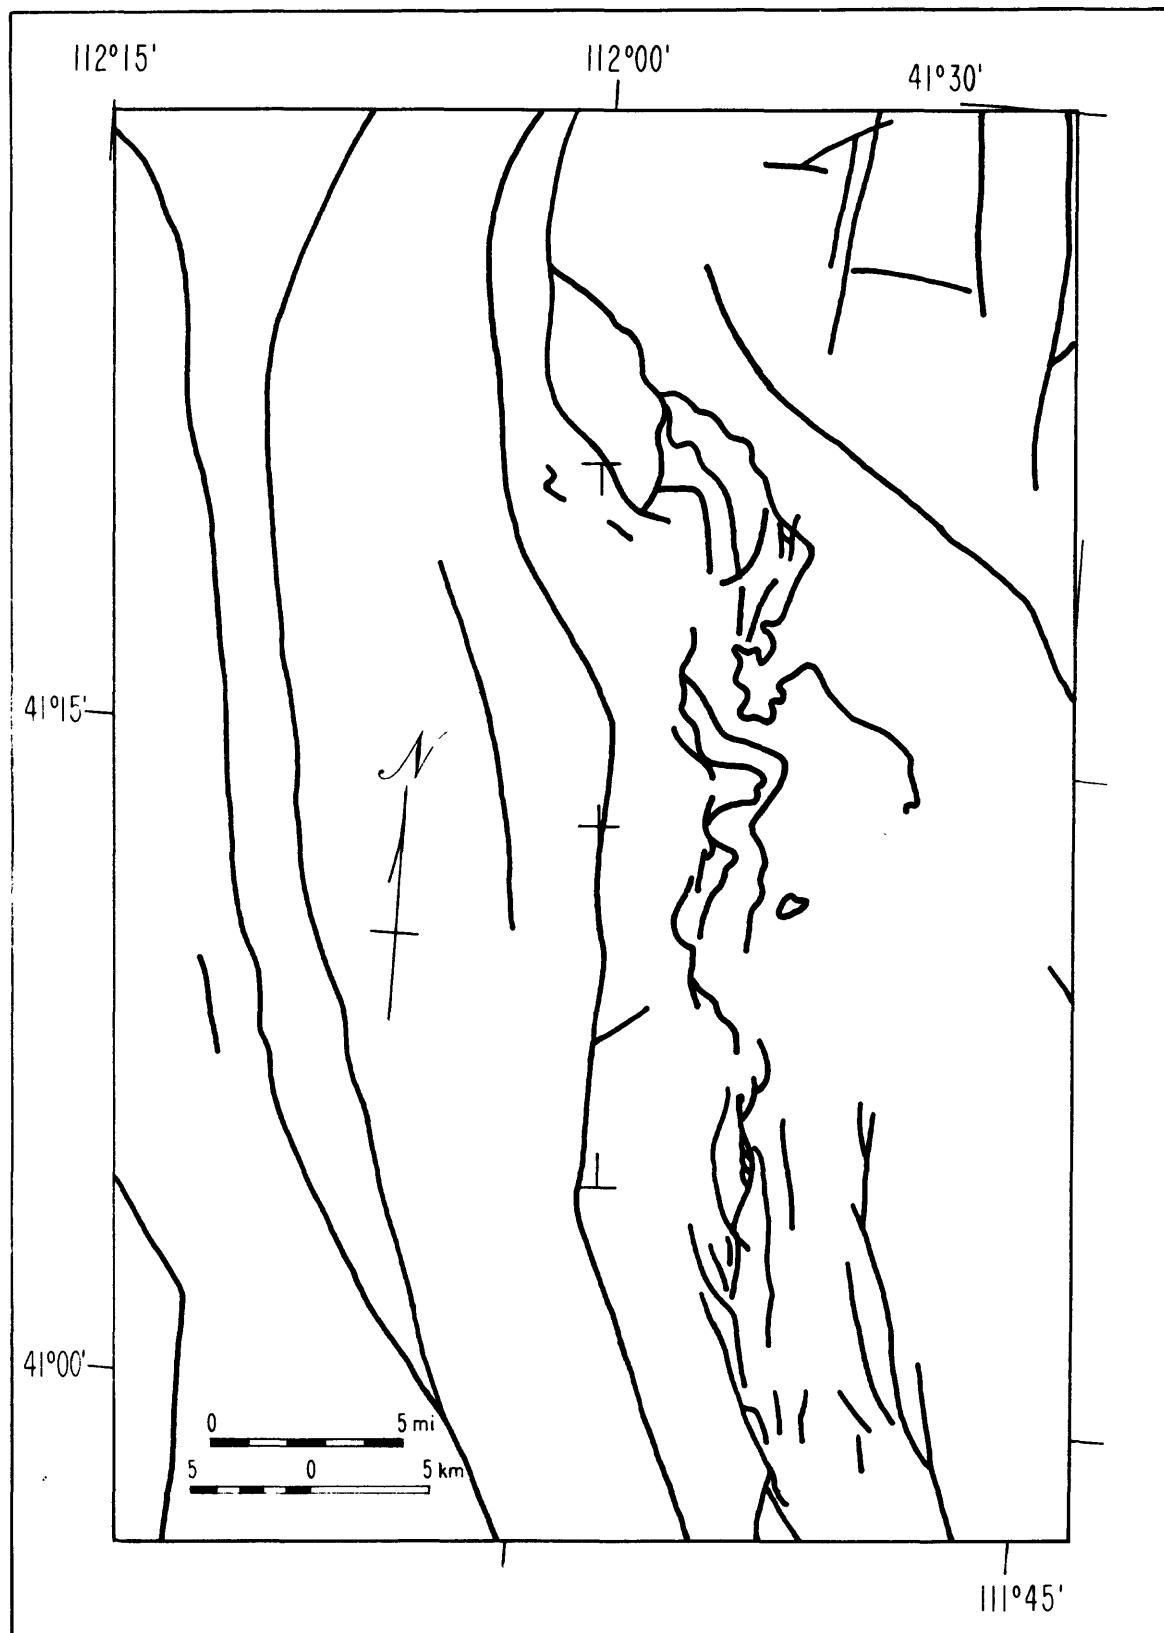
Figure 18.--Area of probable faulting for the Ogden close-in event. + indicates the assumed epicenter; — and | indicate the ends of the assumed fault.

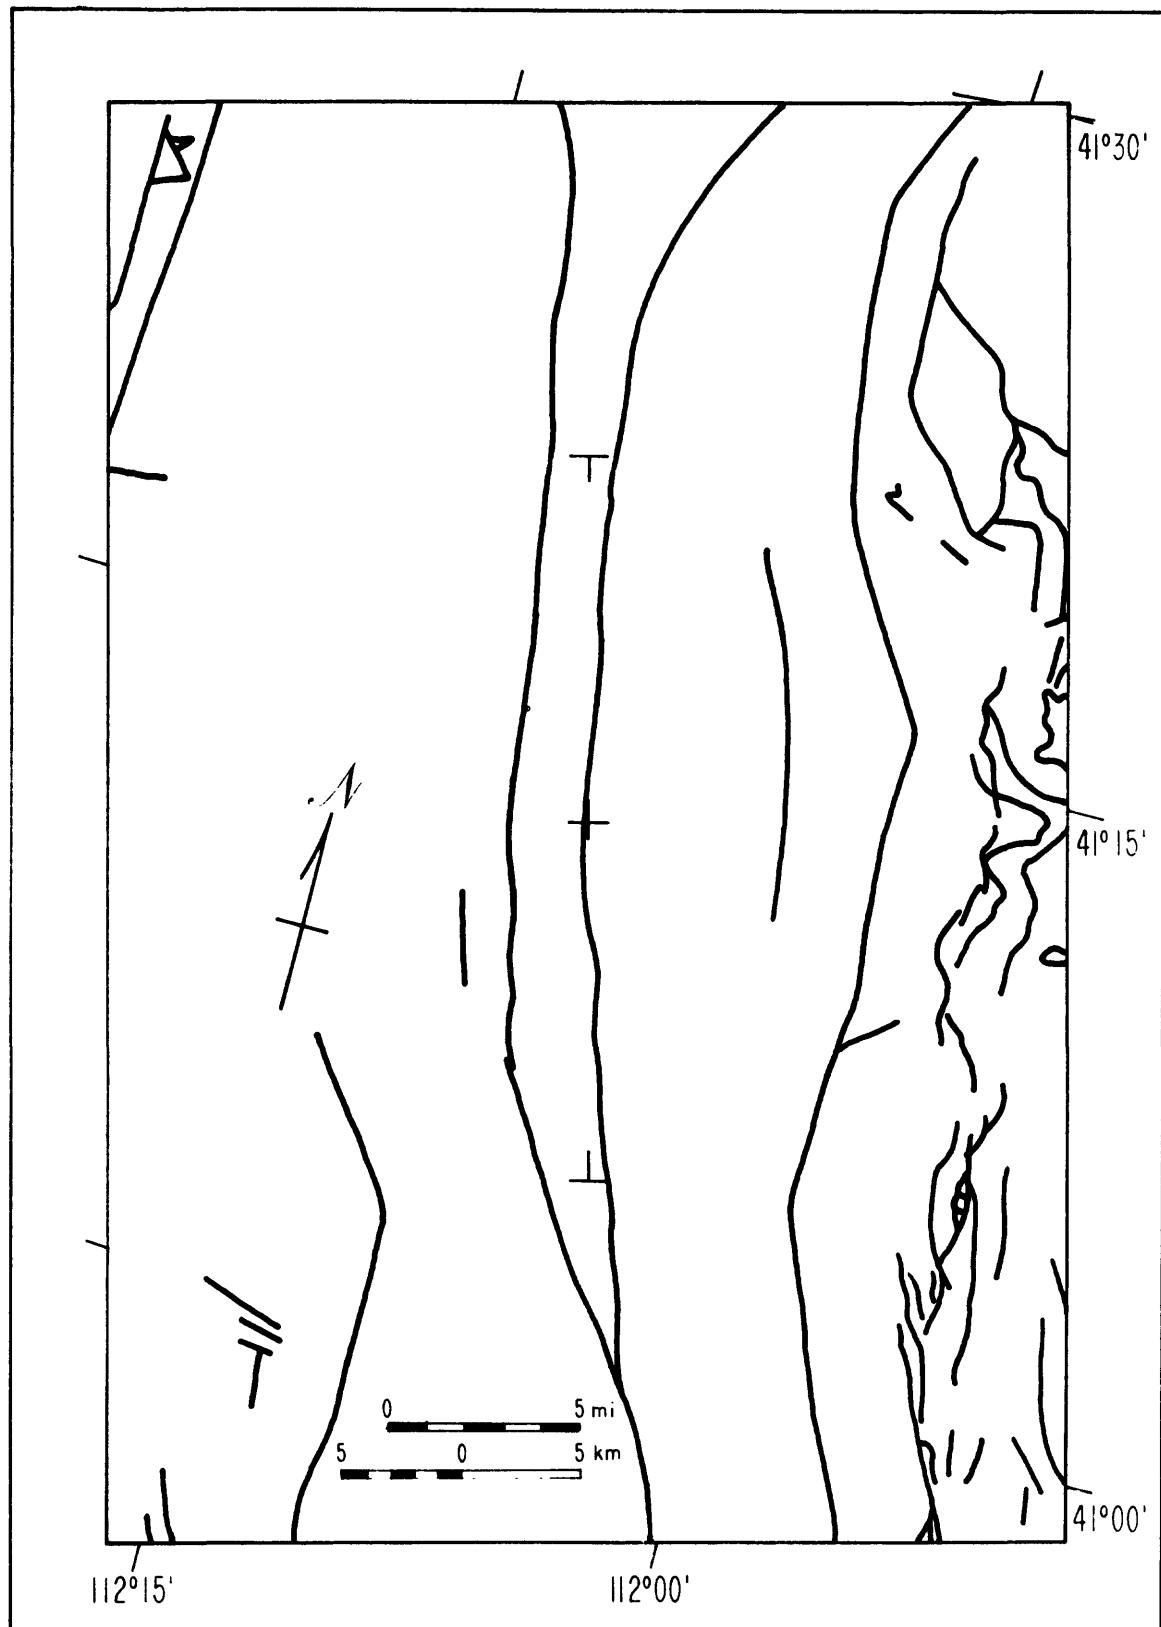
Figure 19.--Area of probable faulting for the Ogden distant event. + indicates the assumed epicenter; | and T indicate the ends of the assumed fault.

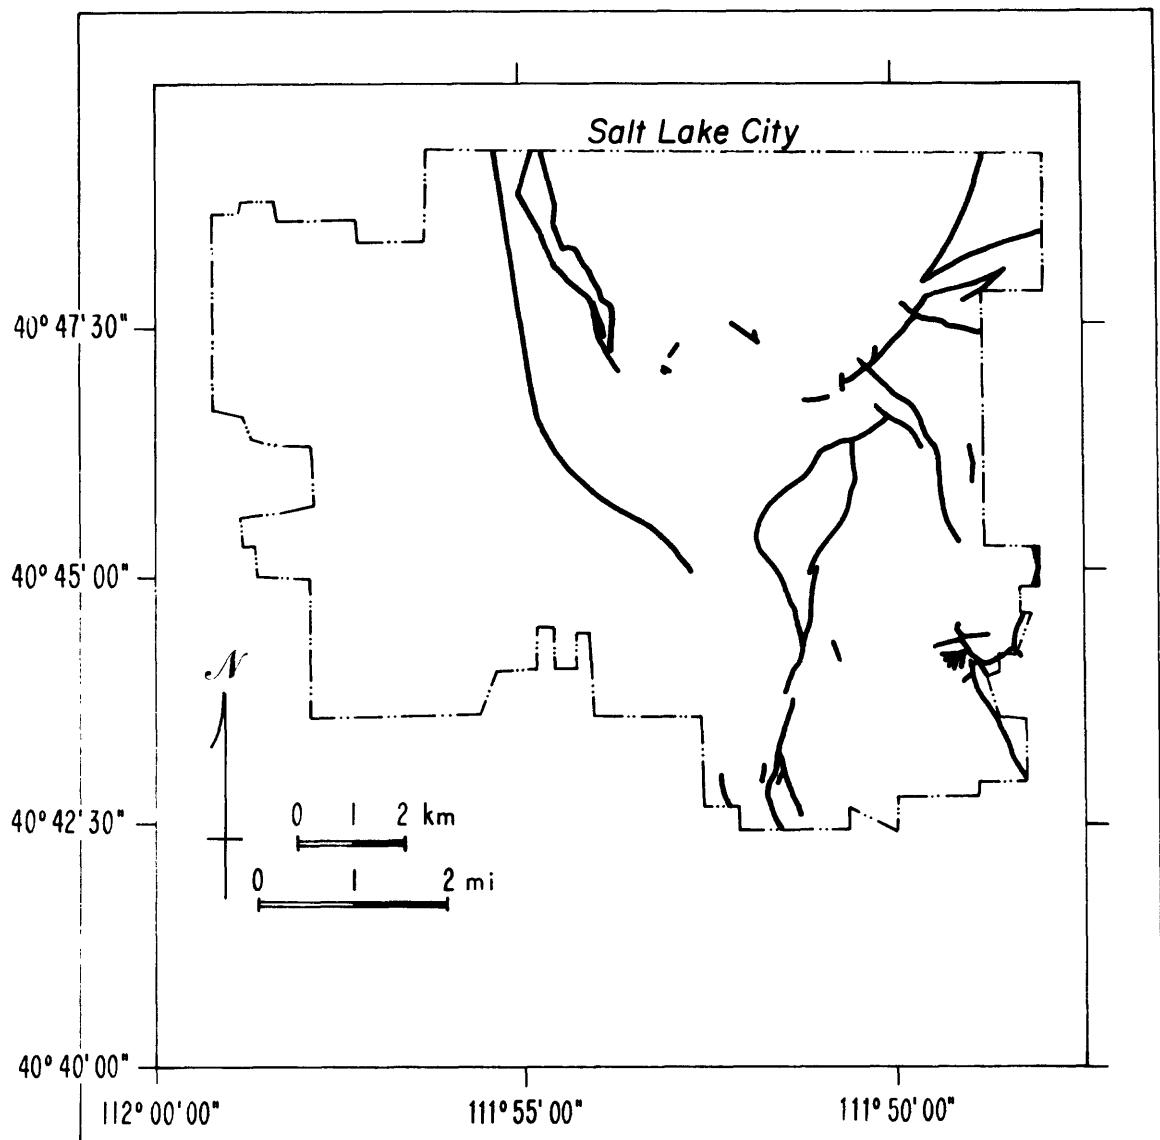
Figure 20.--Map showing Salt Lake City boundary and enclosed faulting. The total length of faulting is about 63 km, and the largest dimension of the city boundary is about 17 km.

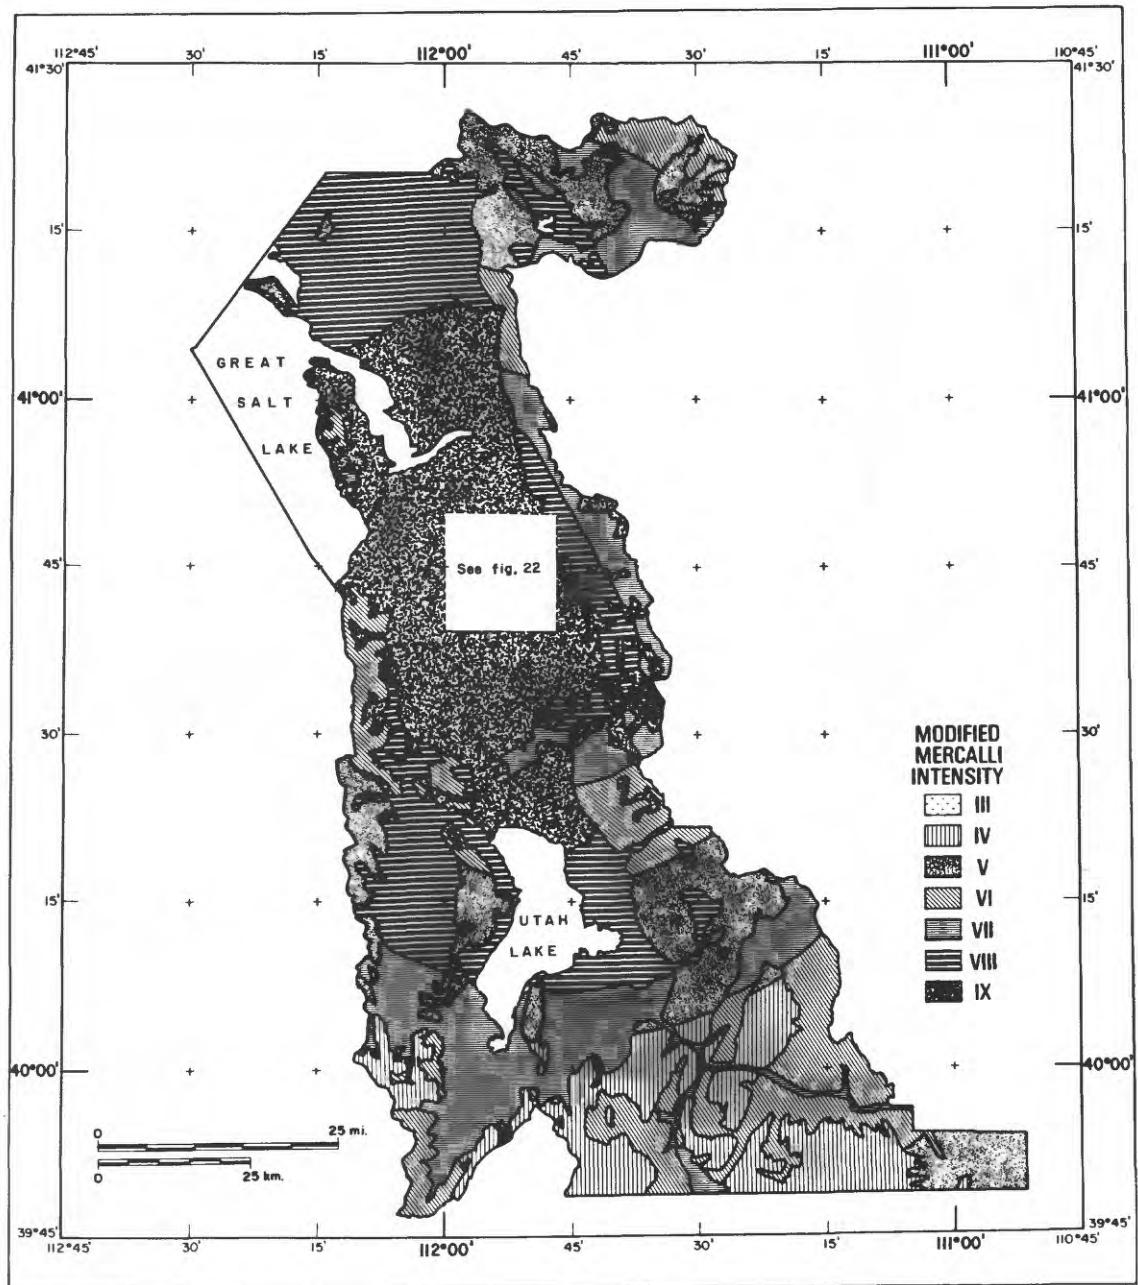
Figure 21.--Estimated Modified Mercalli intensity distribution in the four-county study area for a hypothetical earthquake of magnitude 7.5 located at $40^{\circ} 44.35'N$, $111^{\circ} 51.16'W$, 10 km deep.

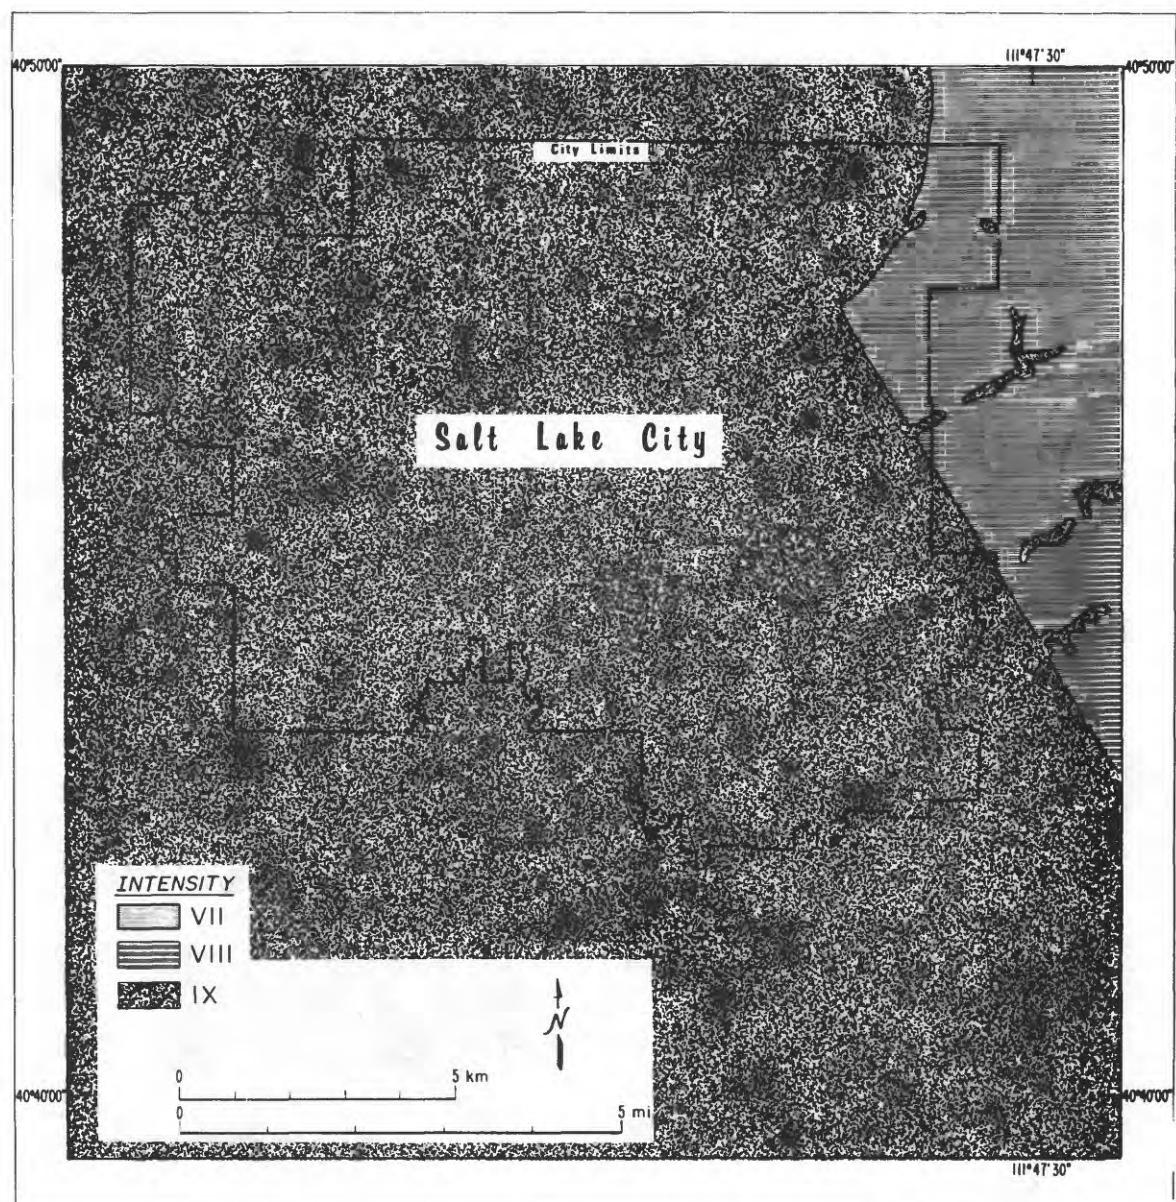
Figure 22.--Estimated Modified Mercalli intensity in the Salt Lake City area for a hypothetical earthquake of magnitude 7.5 located at 40° 44.35'N, 111° 51.16'W, 10 km deep.

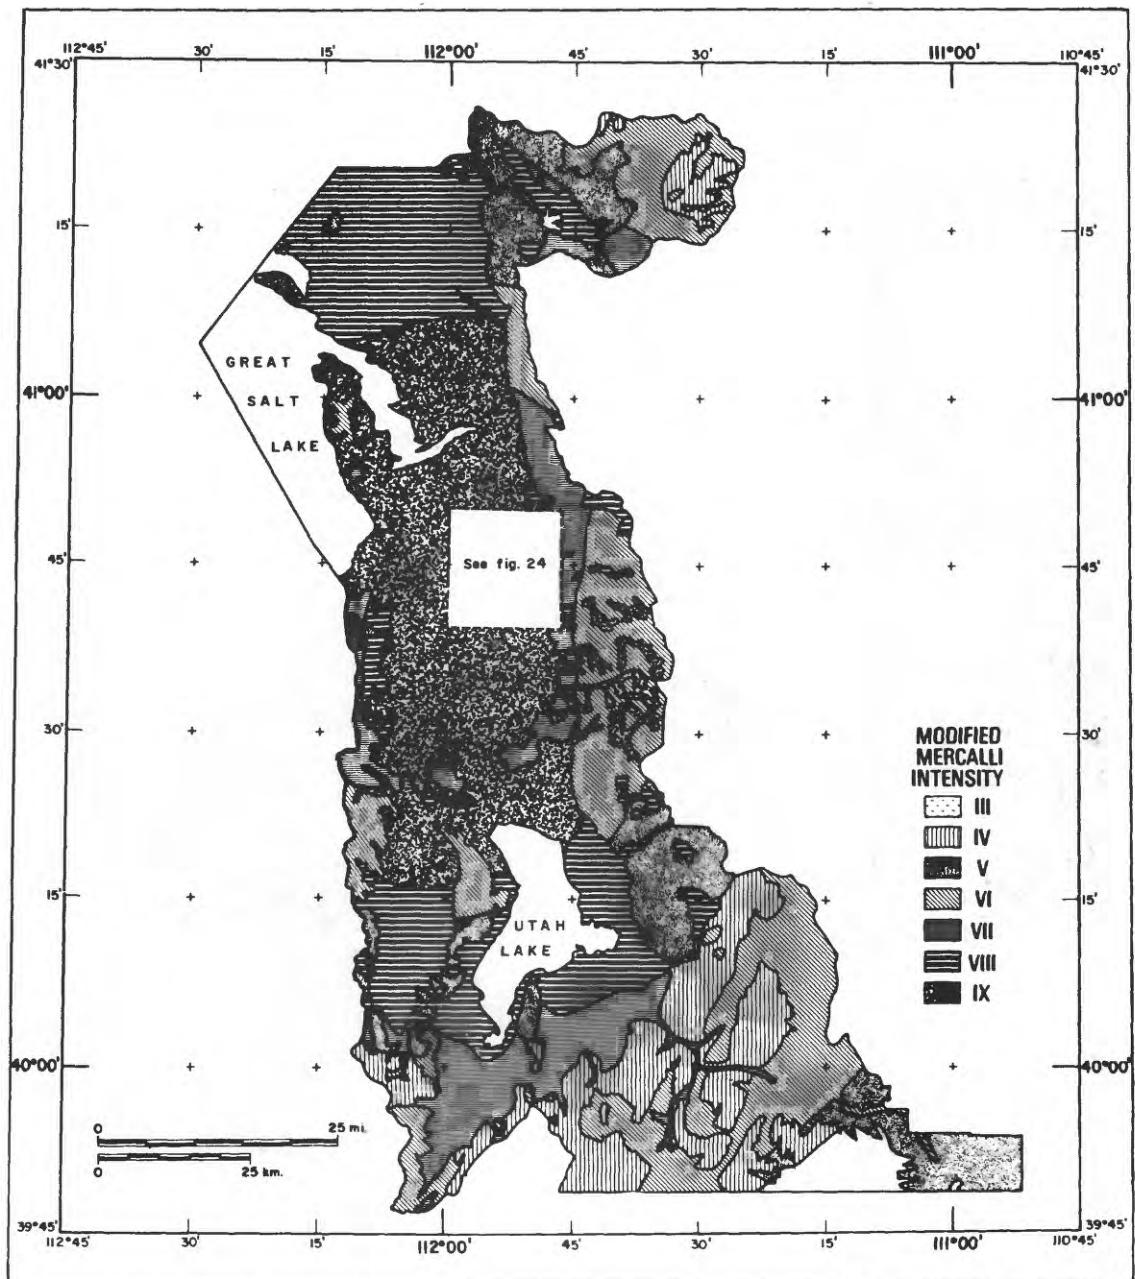
Figure 23.--Estimated Modified Mercalli intensity in the four-county study area for a hypothetical earthquake of magnitude 7.5 located at 40° 42.00'N, 112° 00.00'W, 10 km deep.

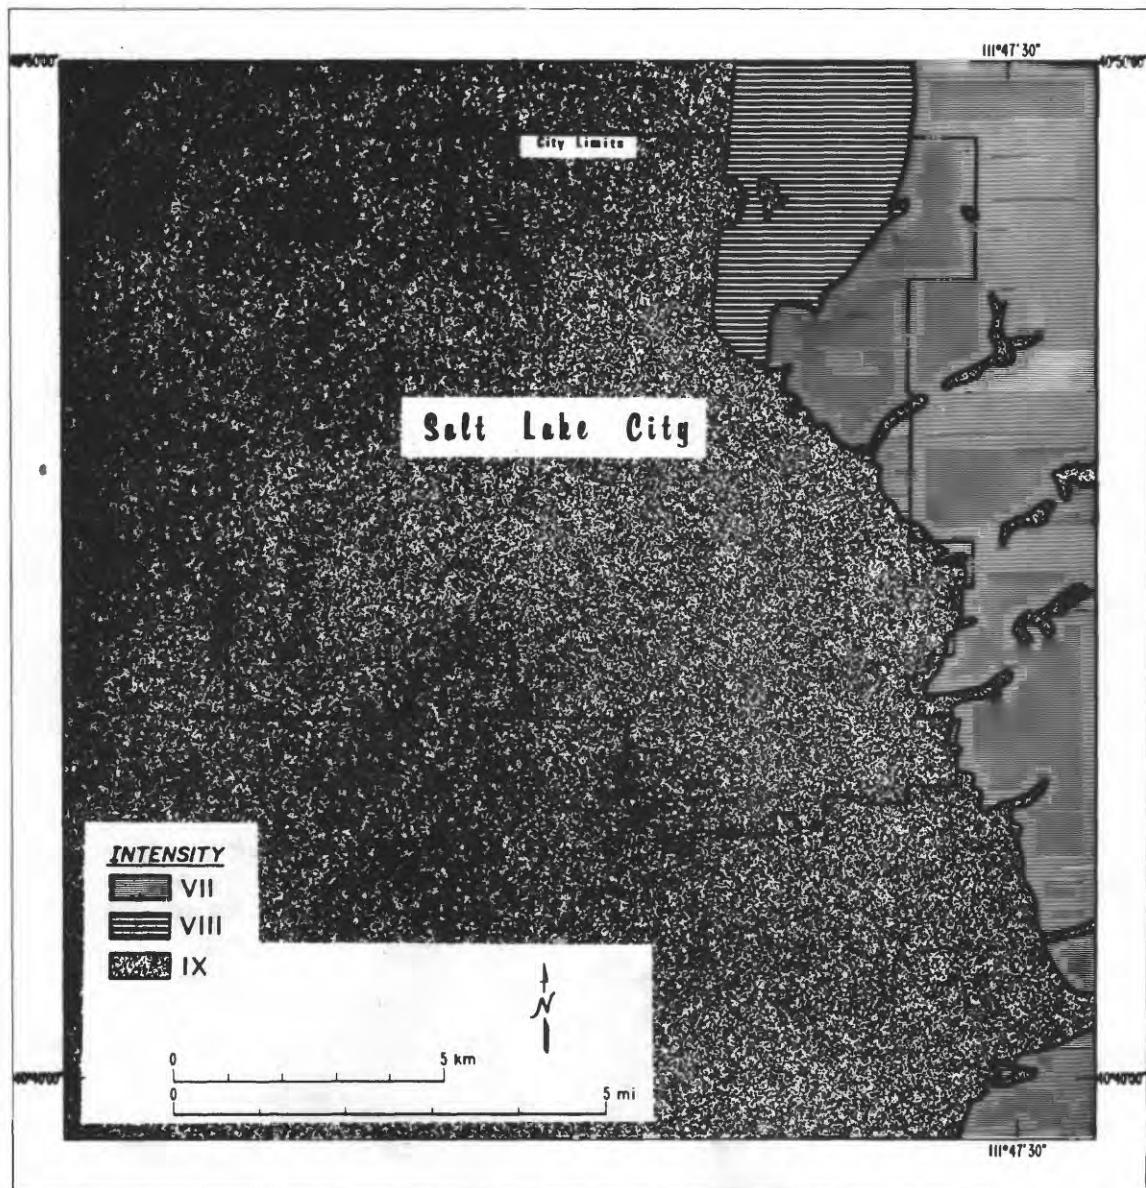
Figure 24.--Estimated Modified Mercalli intensity in the Salt Lake City area for a hypothetical earthquake of magnitude 7.5 located at $40^{\circ} 42.00'N$, $112^{\circ} 00.00'W$, 10 km deep.

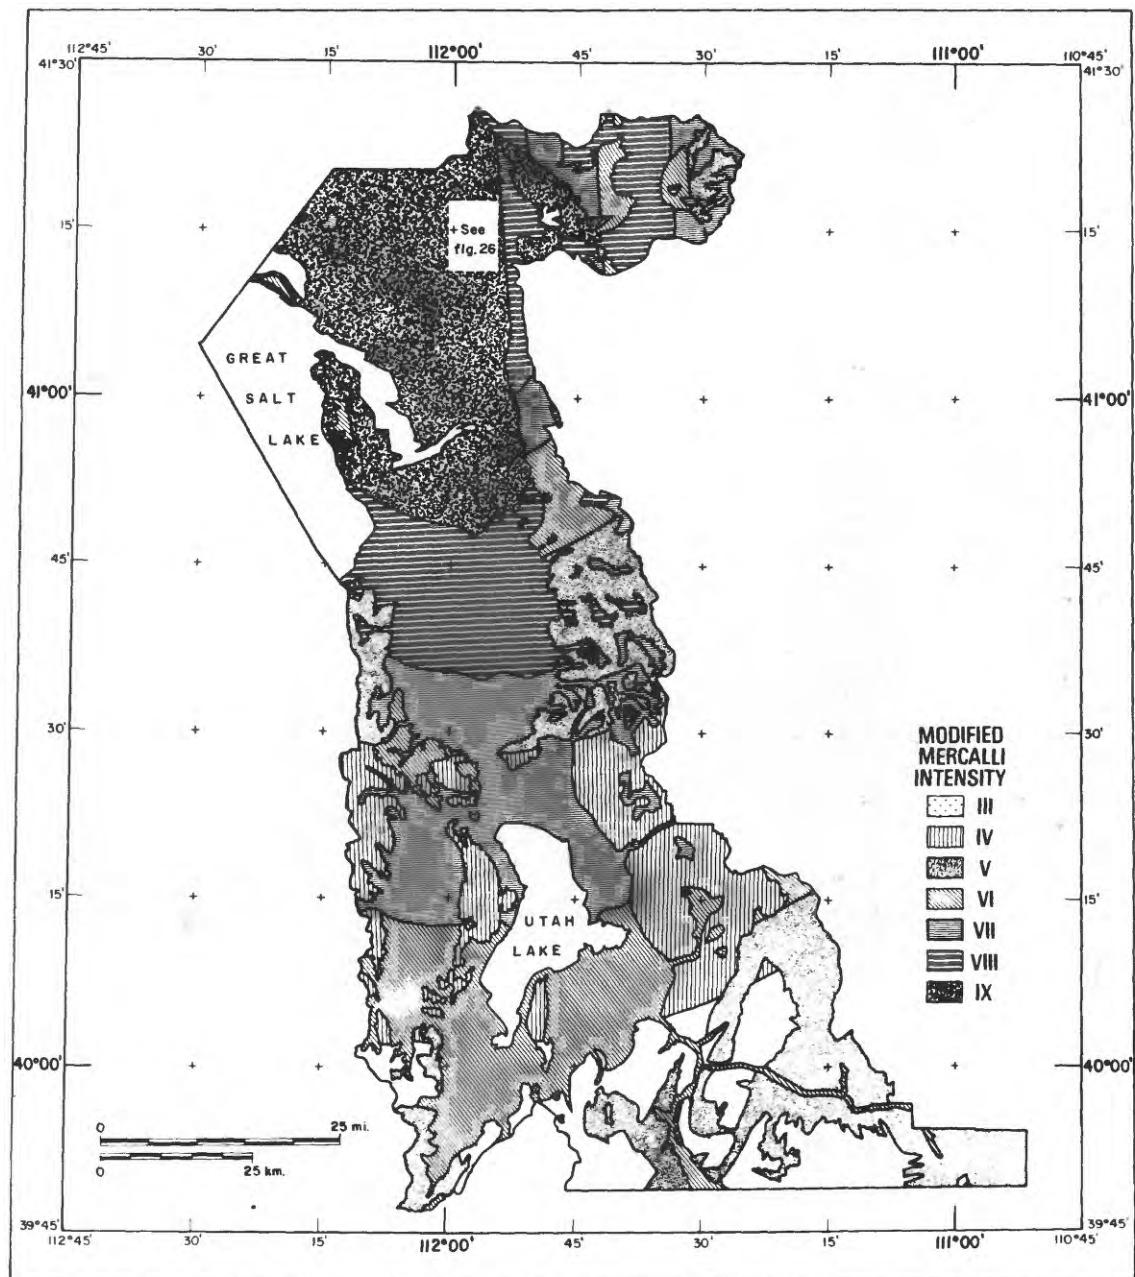
Figure 25.--Estimated Modified Mercalli intensity in the four-county study area for a hypothetical earthquake of magnitude 7.5 located at $41^{\circ} 12.52'N$, $111^{\circ} 58.80'W$, 10 km deep.

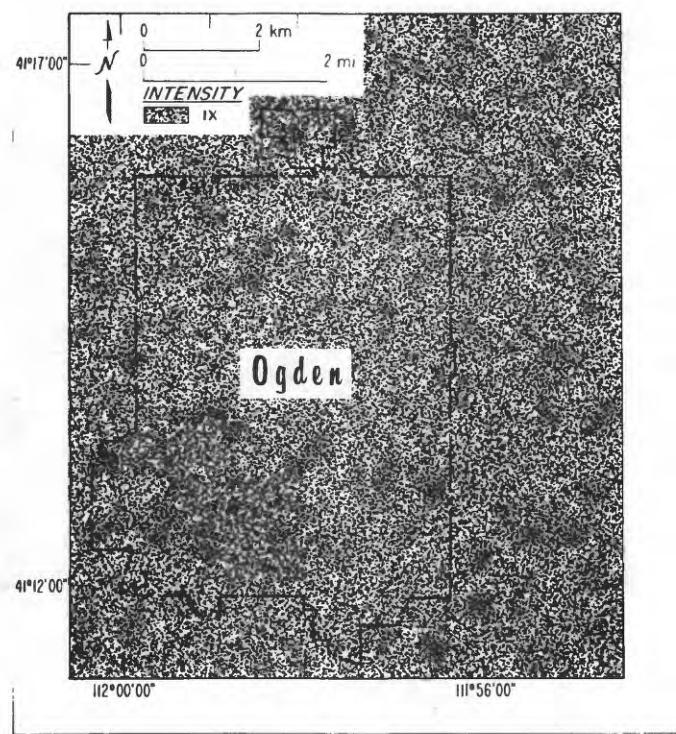
Figure 26.--Estimated Modified Mercalli intensity in the Ogden area for a hypothetical earthquake of magnitude 7.5 located at $41^{\circ} 12.52'N$, $111^{\circ} 58.80'W$, 10 km deep.

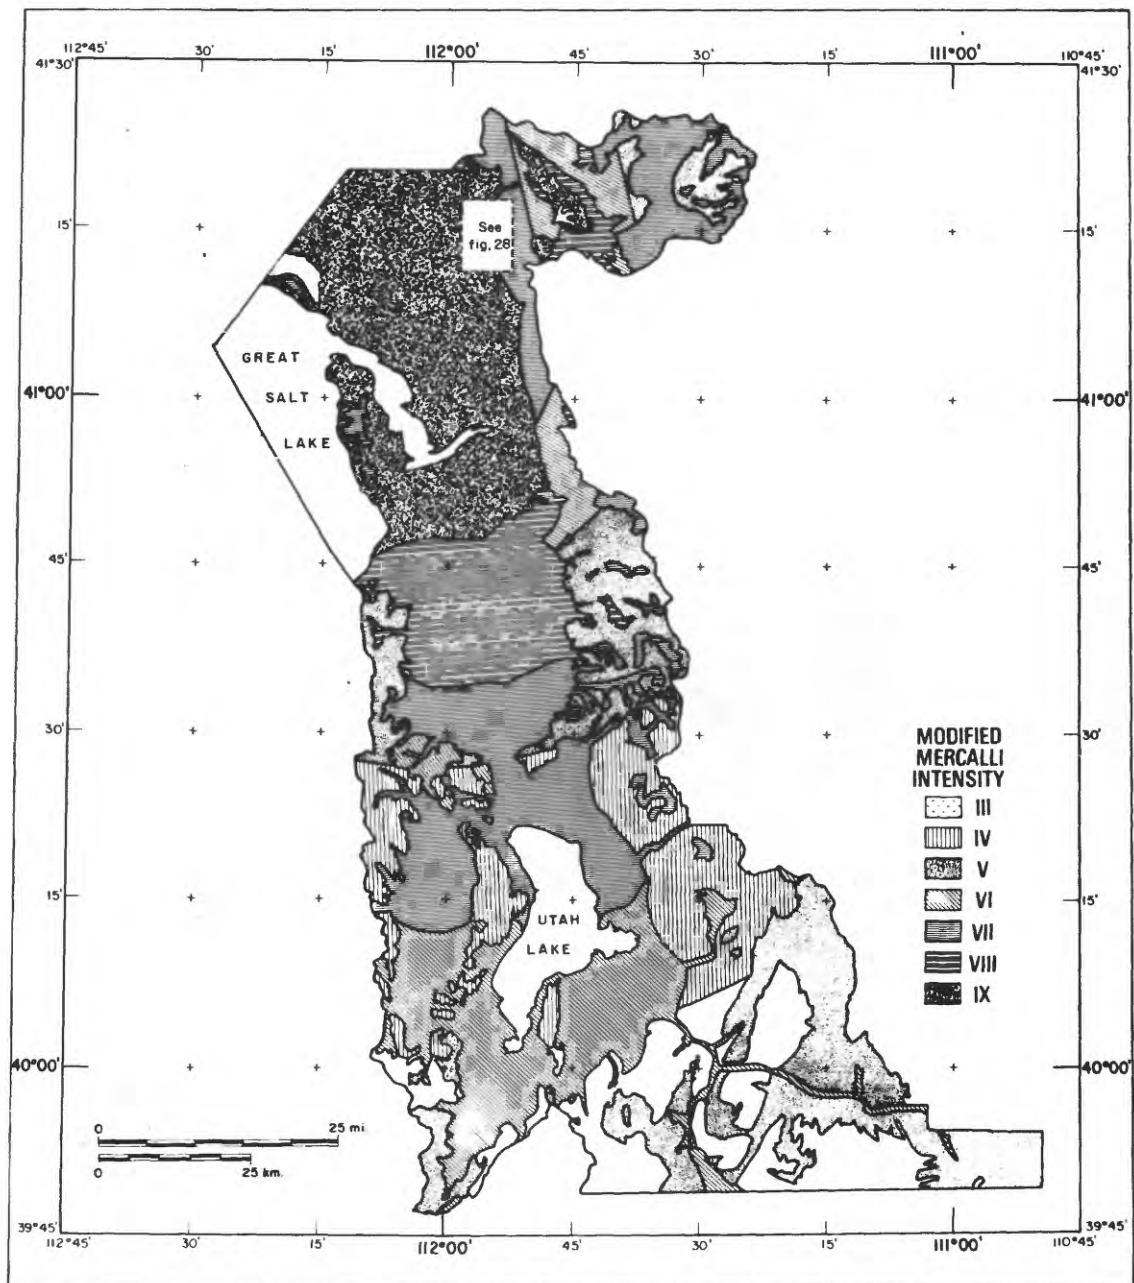
Figure 27.--Estimated Modified Mercalli intensity in the four-county study area for a hypothetical earthquake of magnitude 7.5 located at 41° 12.07'N, 112° 7.46'W, 10 km deep.

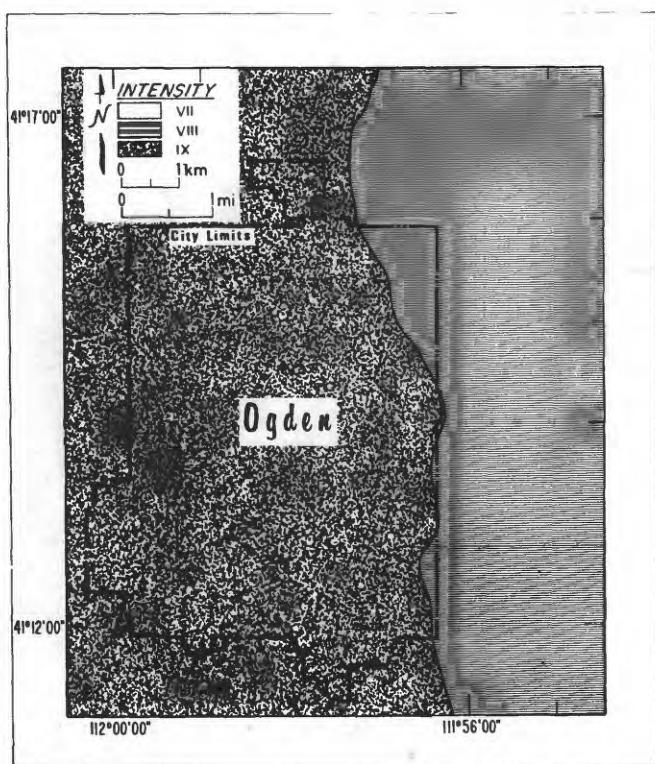
Figure 28.--Estimated Modified Mercalli intensity in the Ogden area for a hypothetical earthquake of magnitude 7.5 located at $41^{\circ} 12.07'N$, $112^{\circ} 7.46'W$, 10 km deep.
