A Study of Earthquake Losses in the
Salt Lake City, Utah Area

Open-File Report 76-89

1976

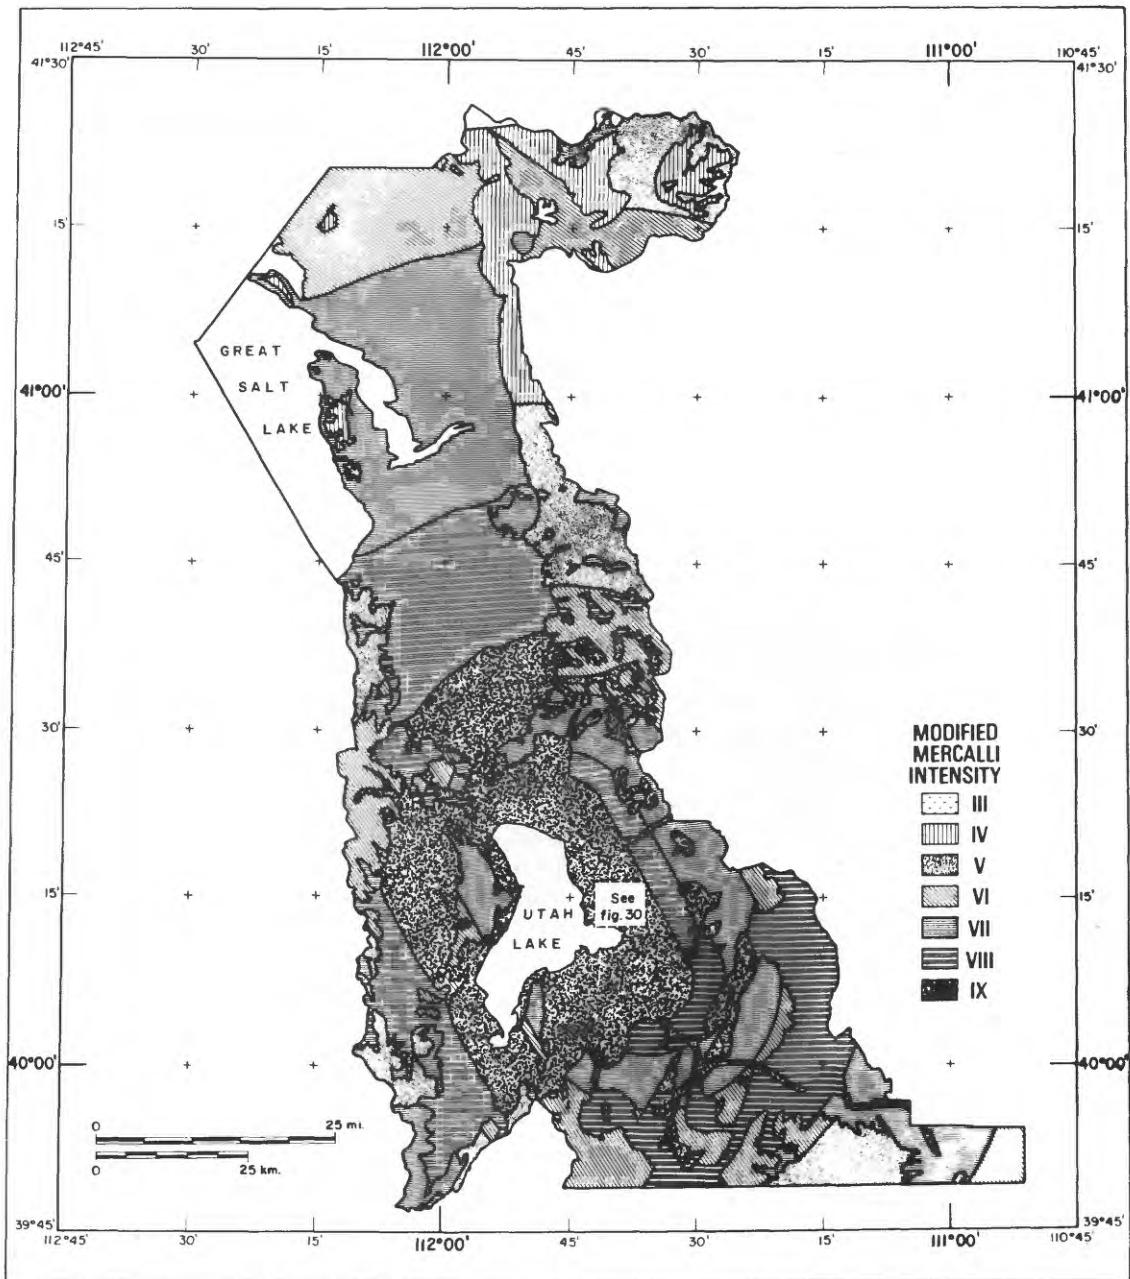
Figure 29.--Estimated Modified Mercalli intensity in the four-county study area for a hypothetical earthquake of magnitude 7.5 located at 40° 14.00'N, 111° 40.42'W, 10 km deep.

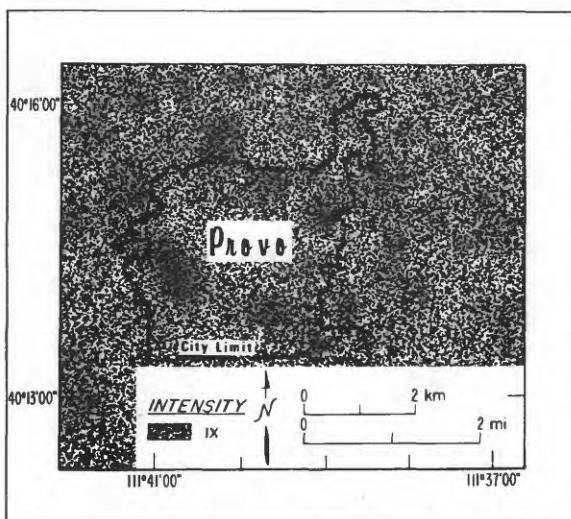
Figure 30.--Estimated Modified Mercalli intensity in the Provo area for a hypothetical earthquake of magnitude 7.5 located at $40^{\circ} 14.00'N$, $111^{\circ} 40.42'W$, 10 km deep.

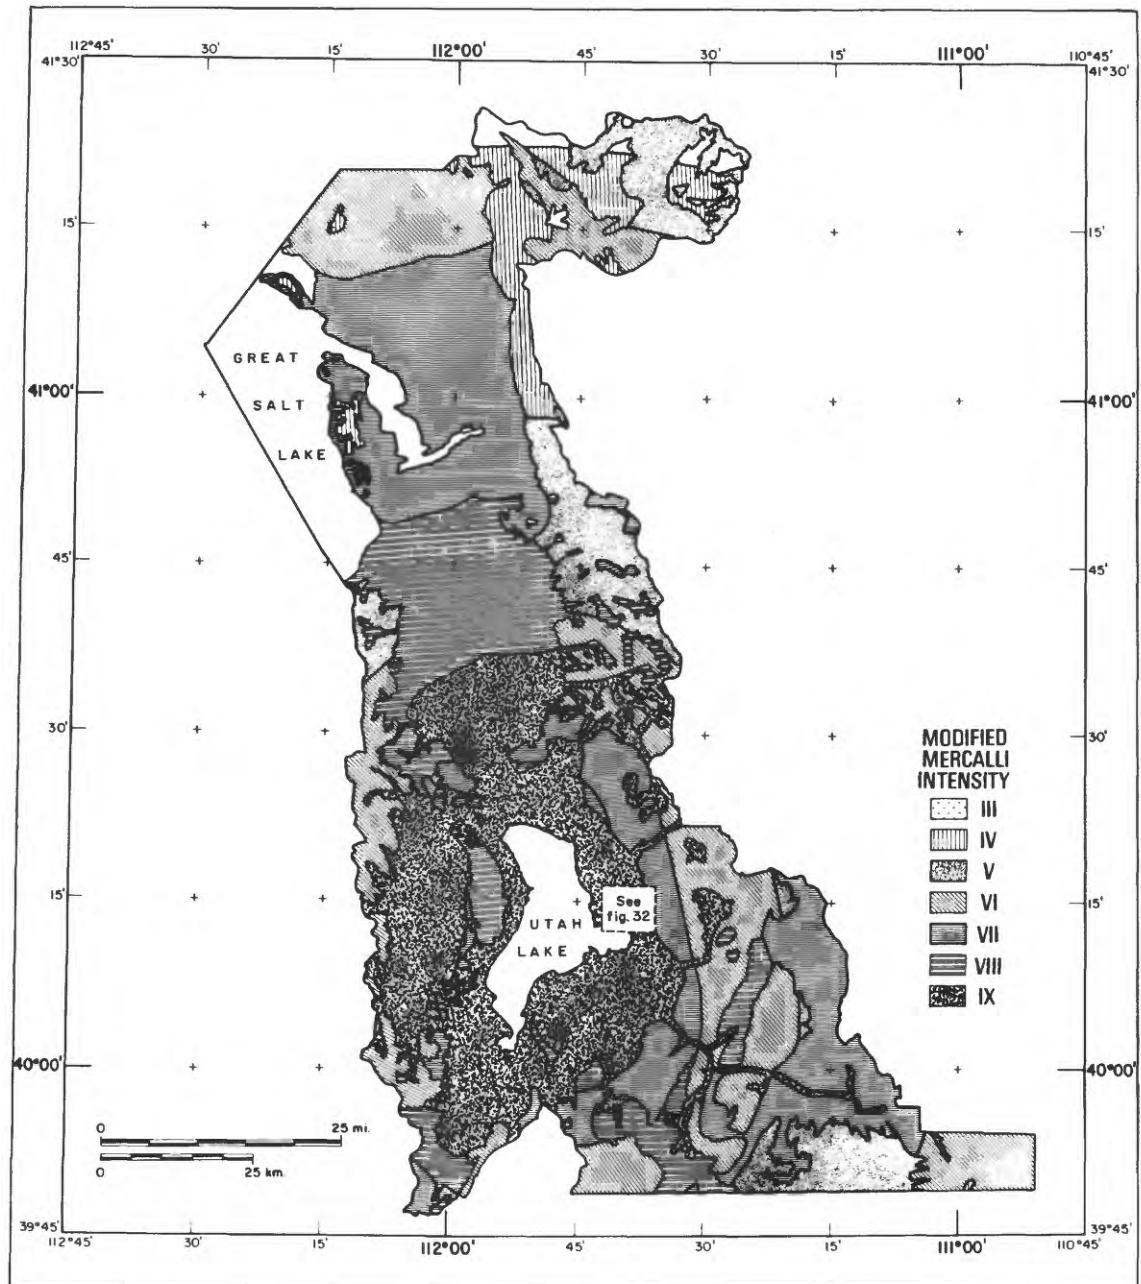
Figure 31.--Estimated Modified Mercalli intensity in the four-county study area for a hypothetical earthquake of magnitude 7.5 located at $40^{\circ} 12.54'N$, $111^{\circ} 45.82'W$, 10 km deep.

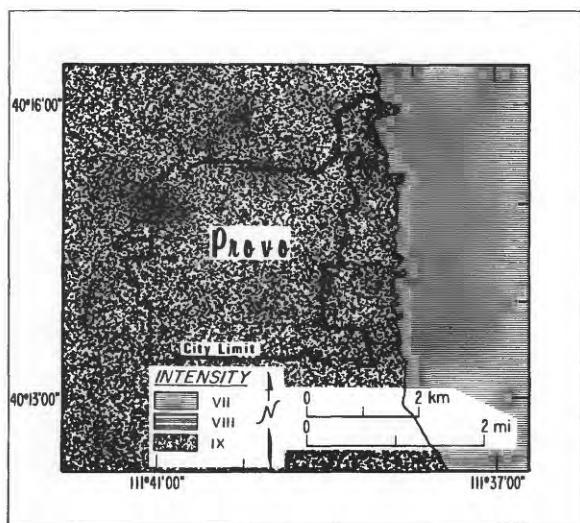
Figure 32.--Estimated Modified Mercalli intensity in the Provo area for a hypothetical earthquake of magnitude 7.5 located at $40^{\circ} 12.54'N$, $111^{\circ} 45.82'W$, 10 km deep.

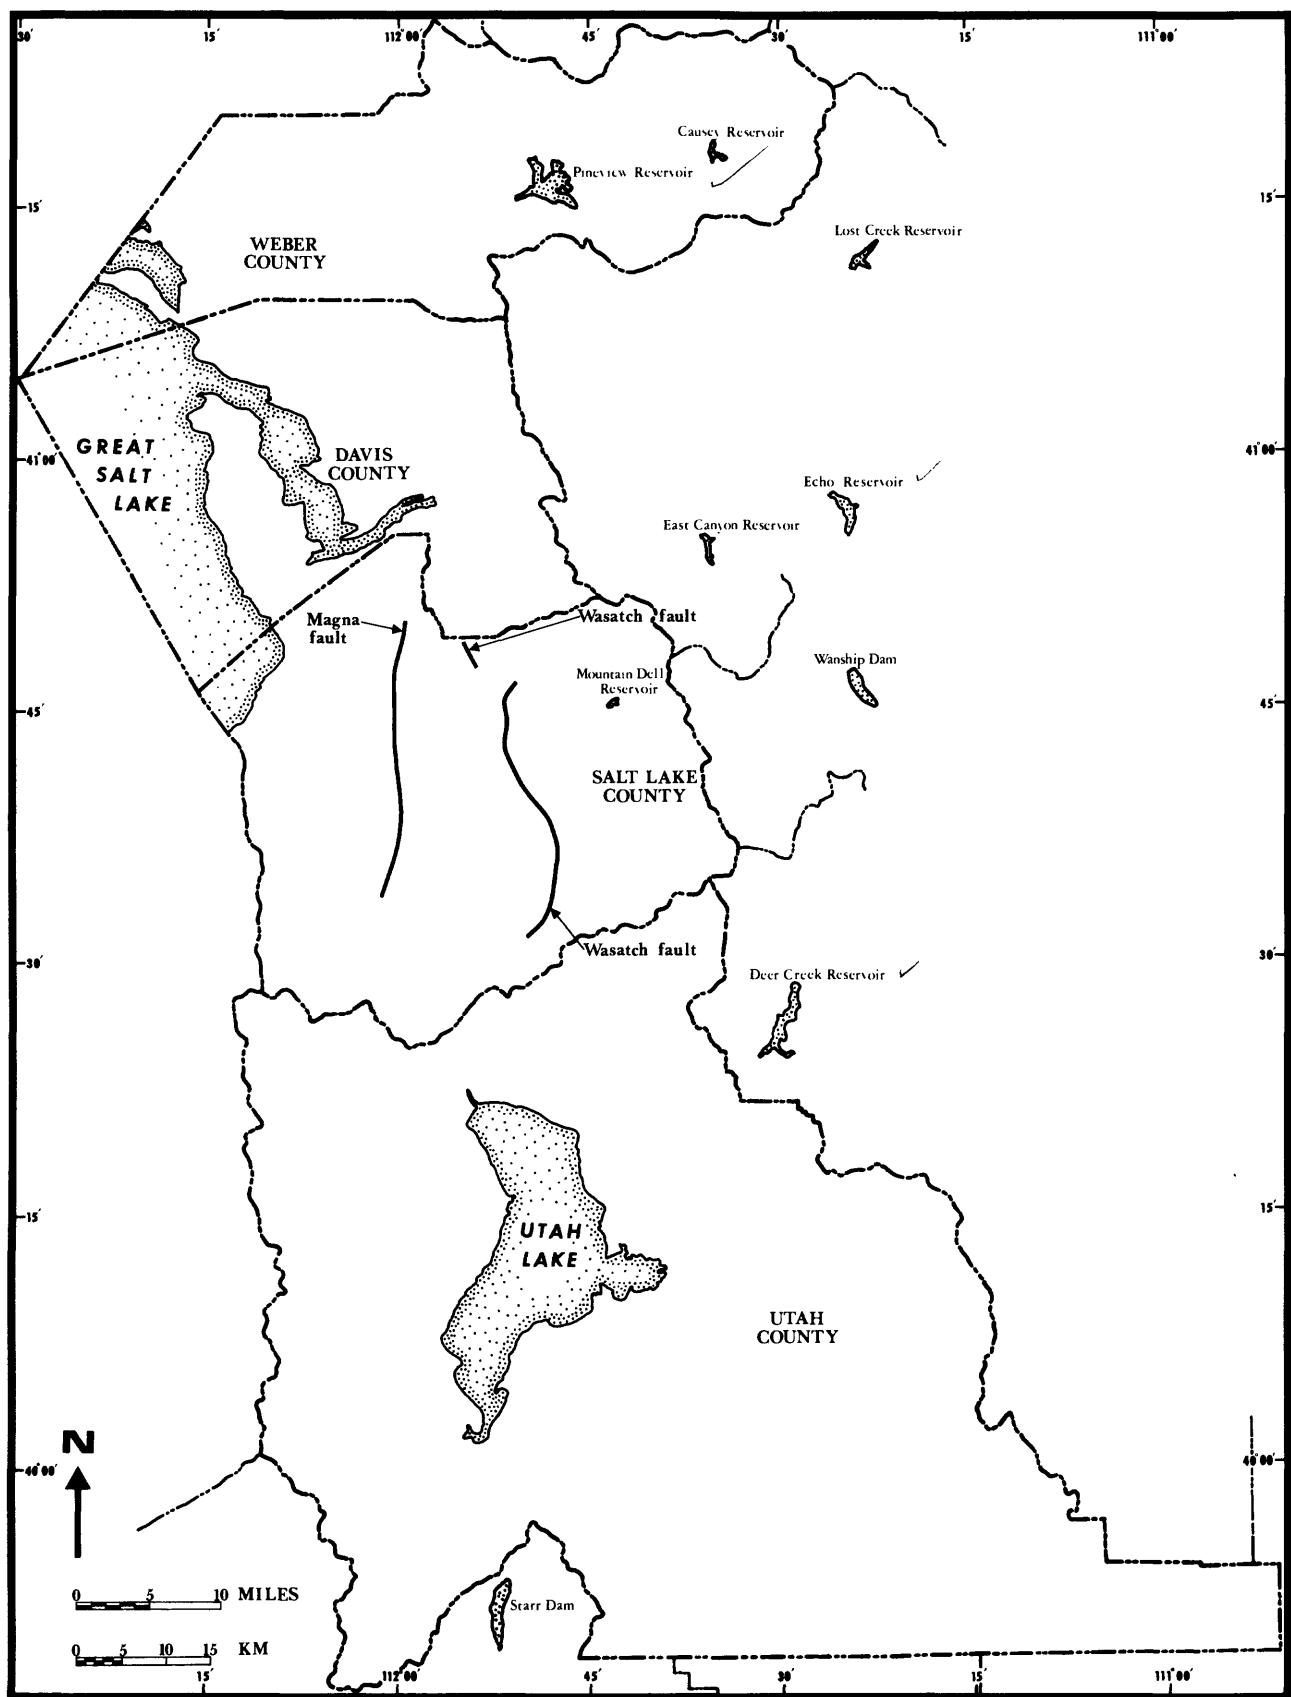
Figure 41.--Major dams and reservoirs with capacities greater than 3,000 acre-feet.
(Shown fault breakage is assumed for planning purposes.)

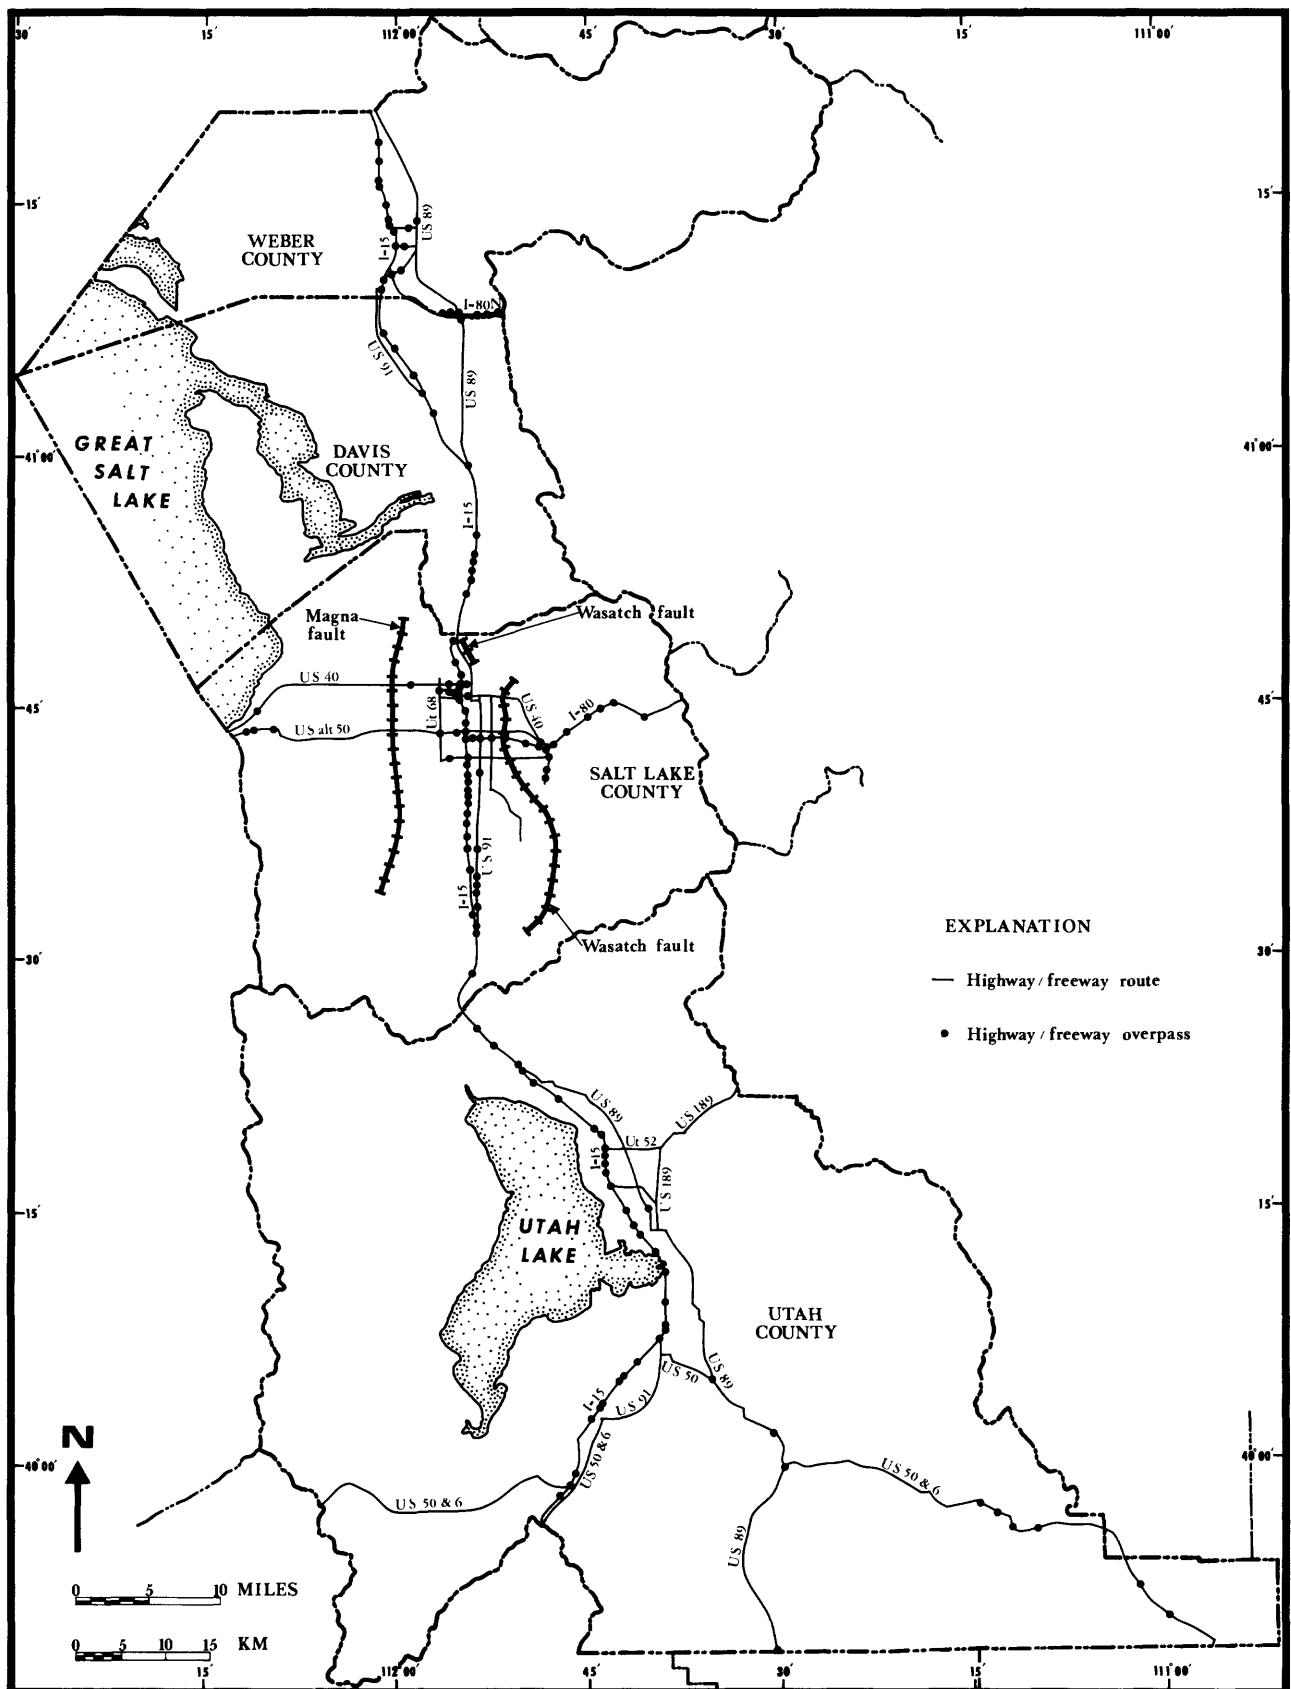
Figure 51.--Selected highway routes, bridges, and overpasses. (Shown fault breakage is assumed for planning purposes.)

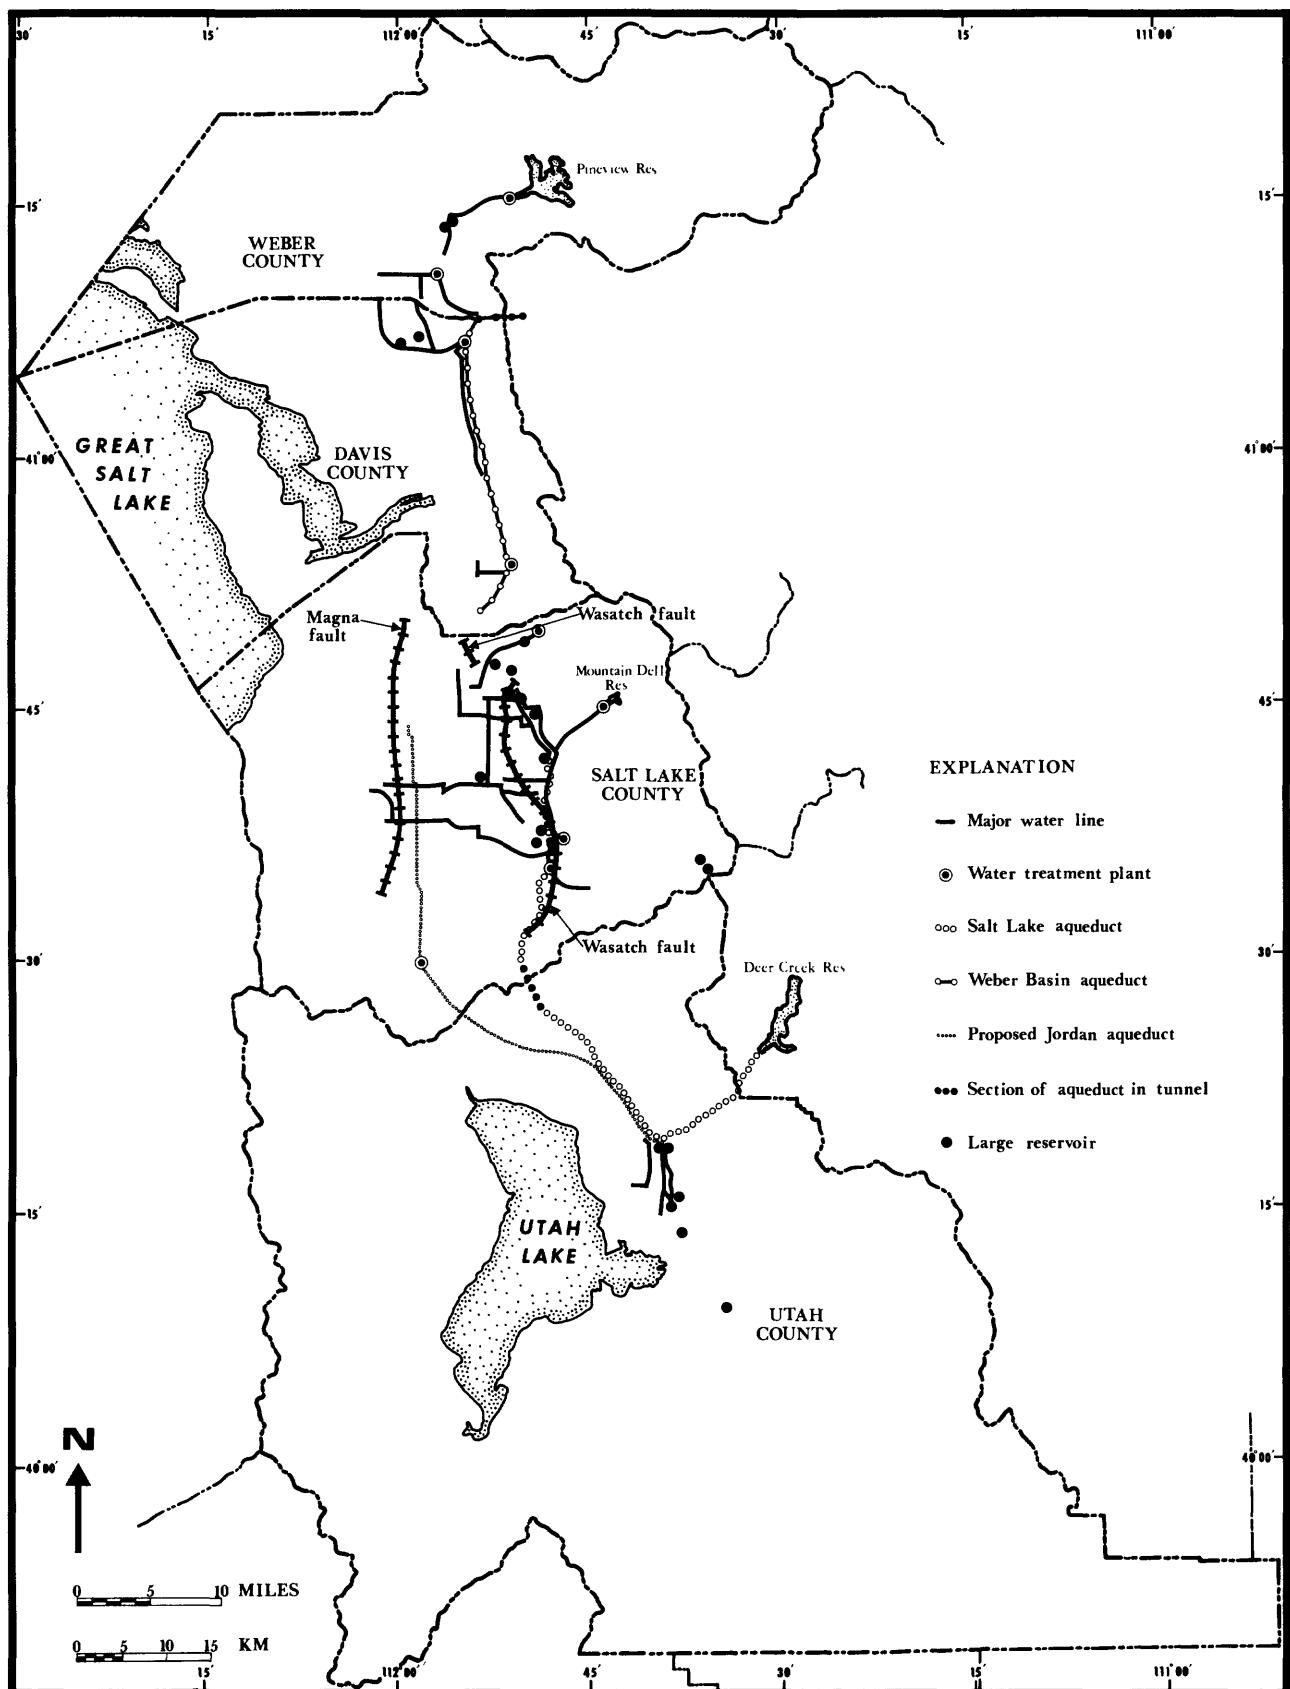
Figure 53.--Major water lines (24 inch and larger), water treatment plants, and large reservoirs. (Shown fault breakage is assumed for planning purposes.)

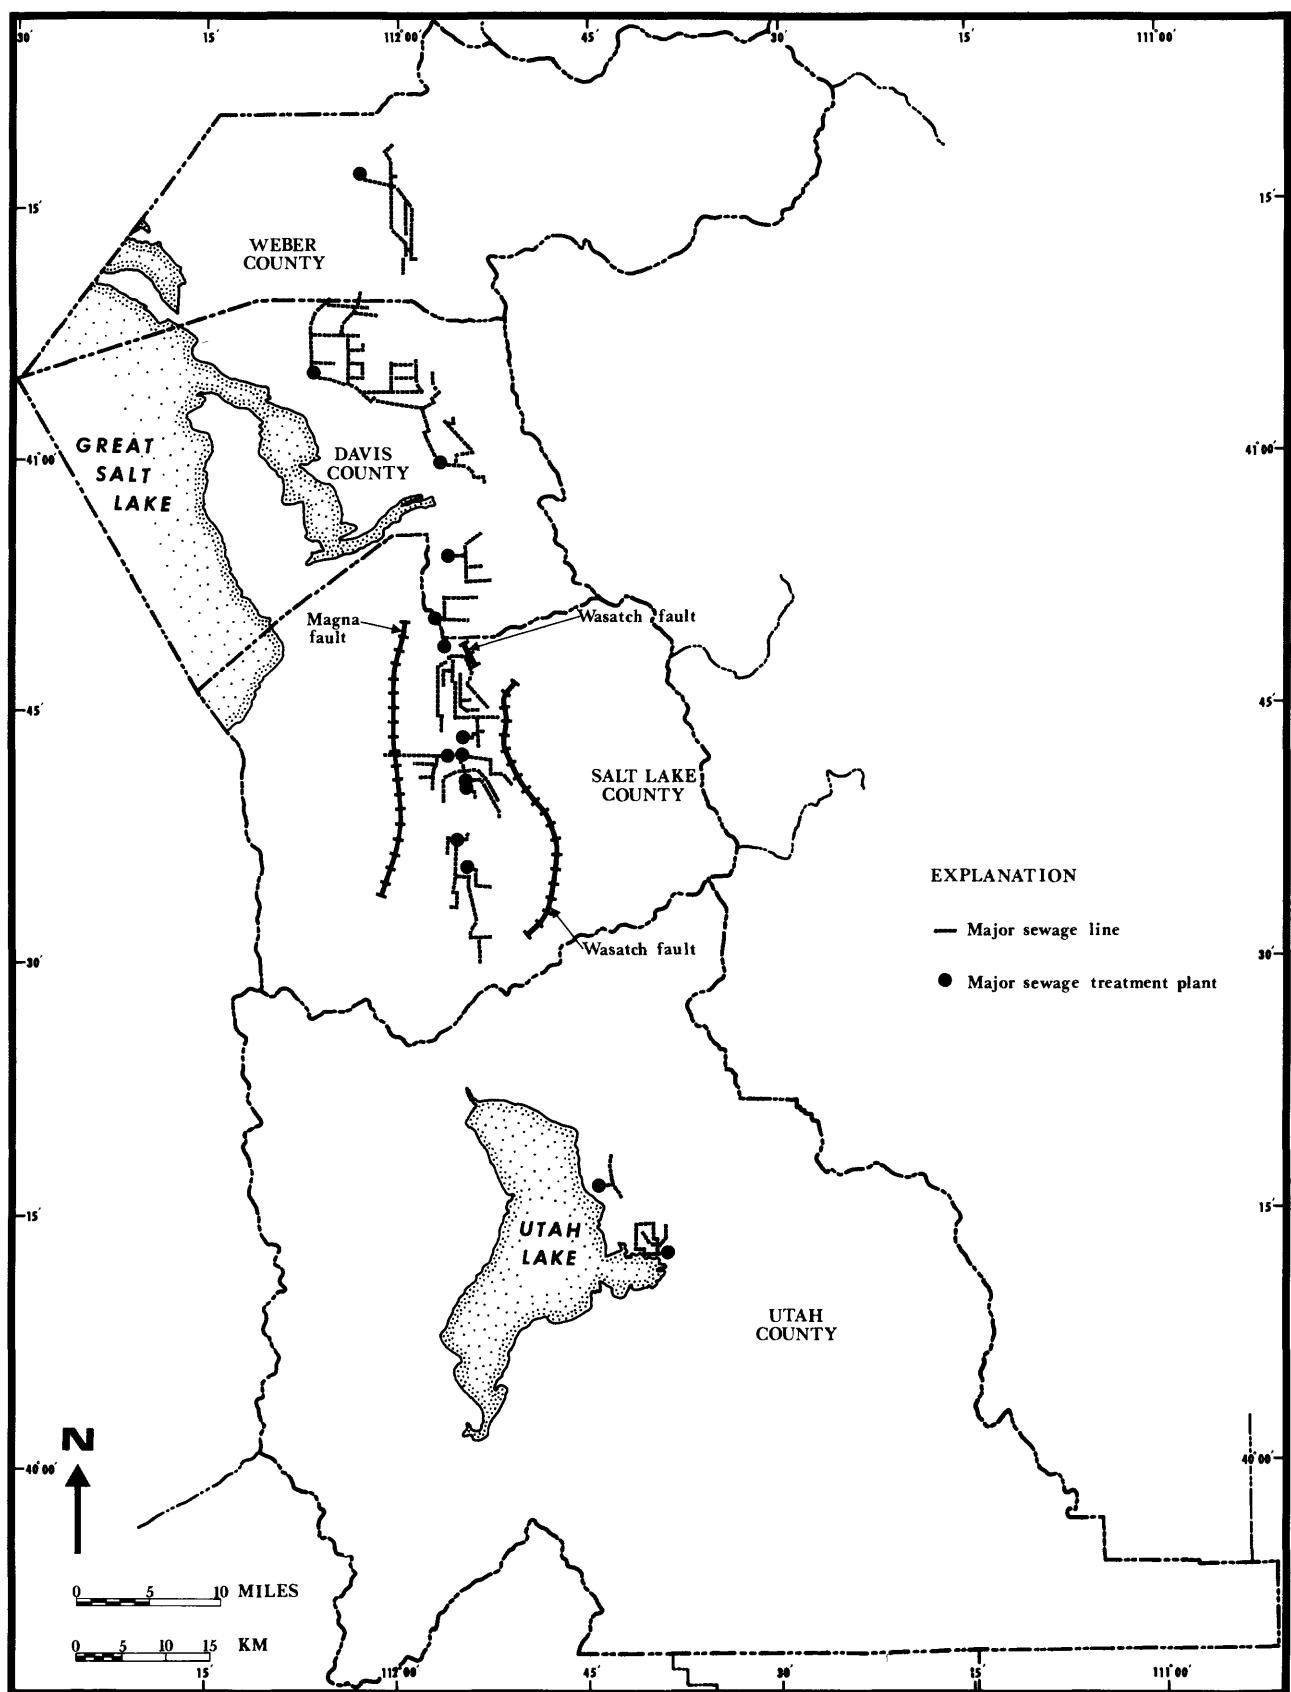
Figure 54.--Major sewage lines (24 inch or larger) and sewage treatment plants.
(Shown fault breakage is assumed for planning purposes.)

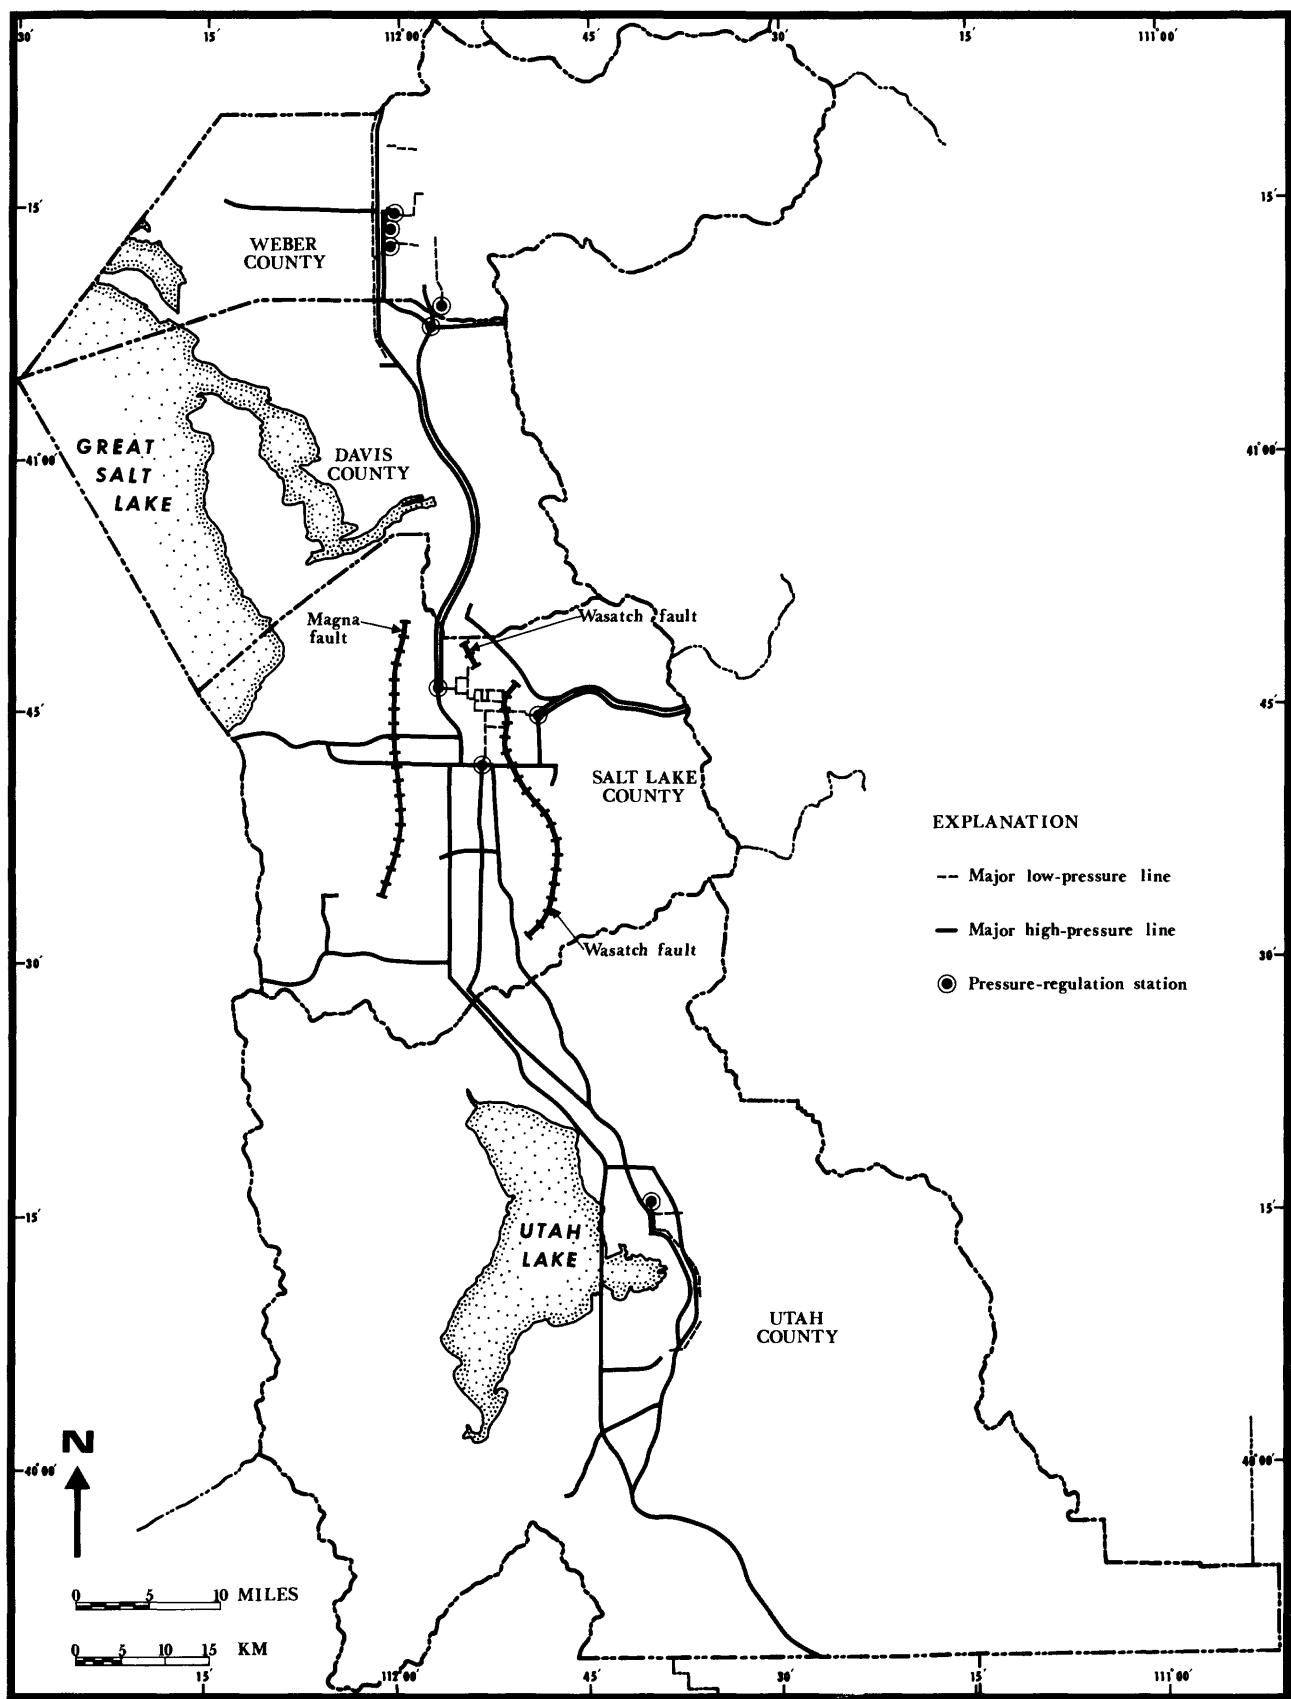
Figure 55.--Major natural gas transmission facilities. (Shown fault breakage is assumed for planning purposes.)

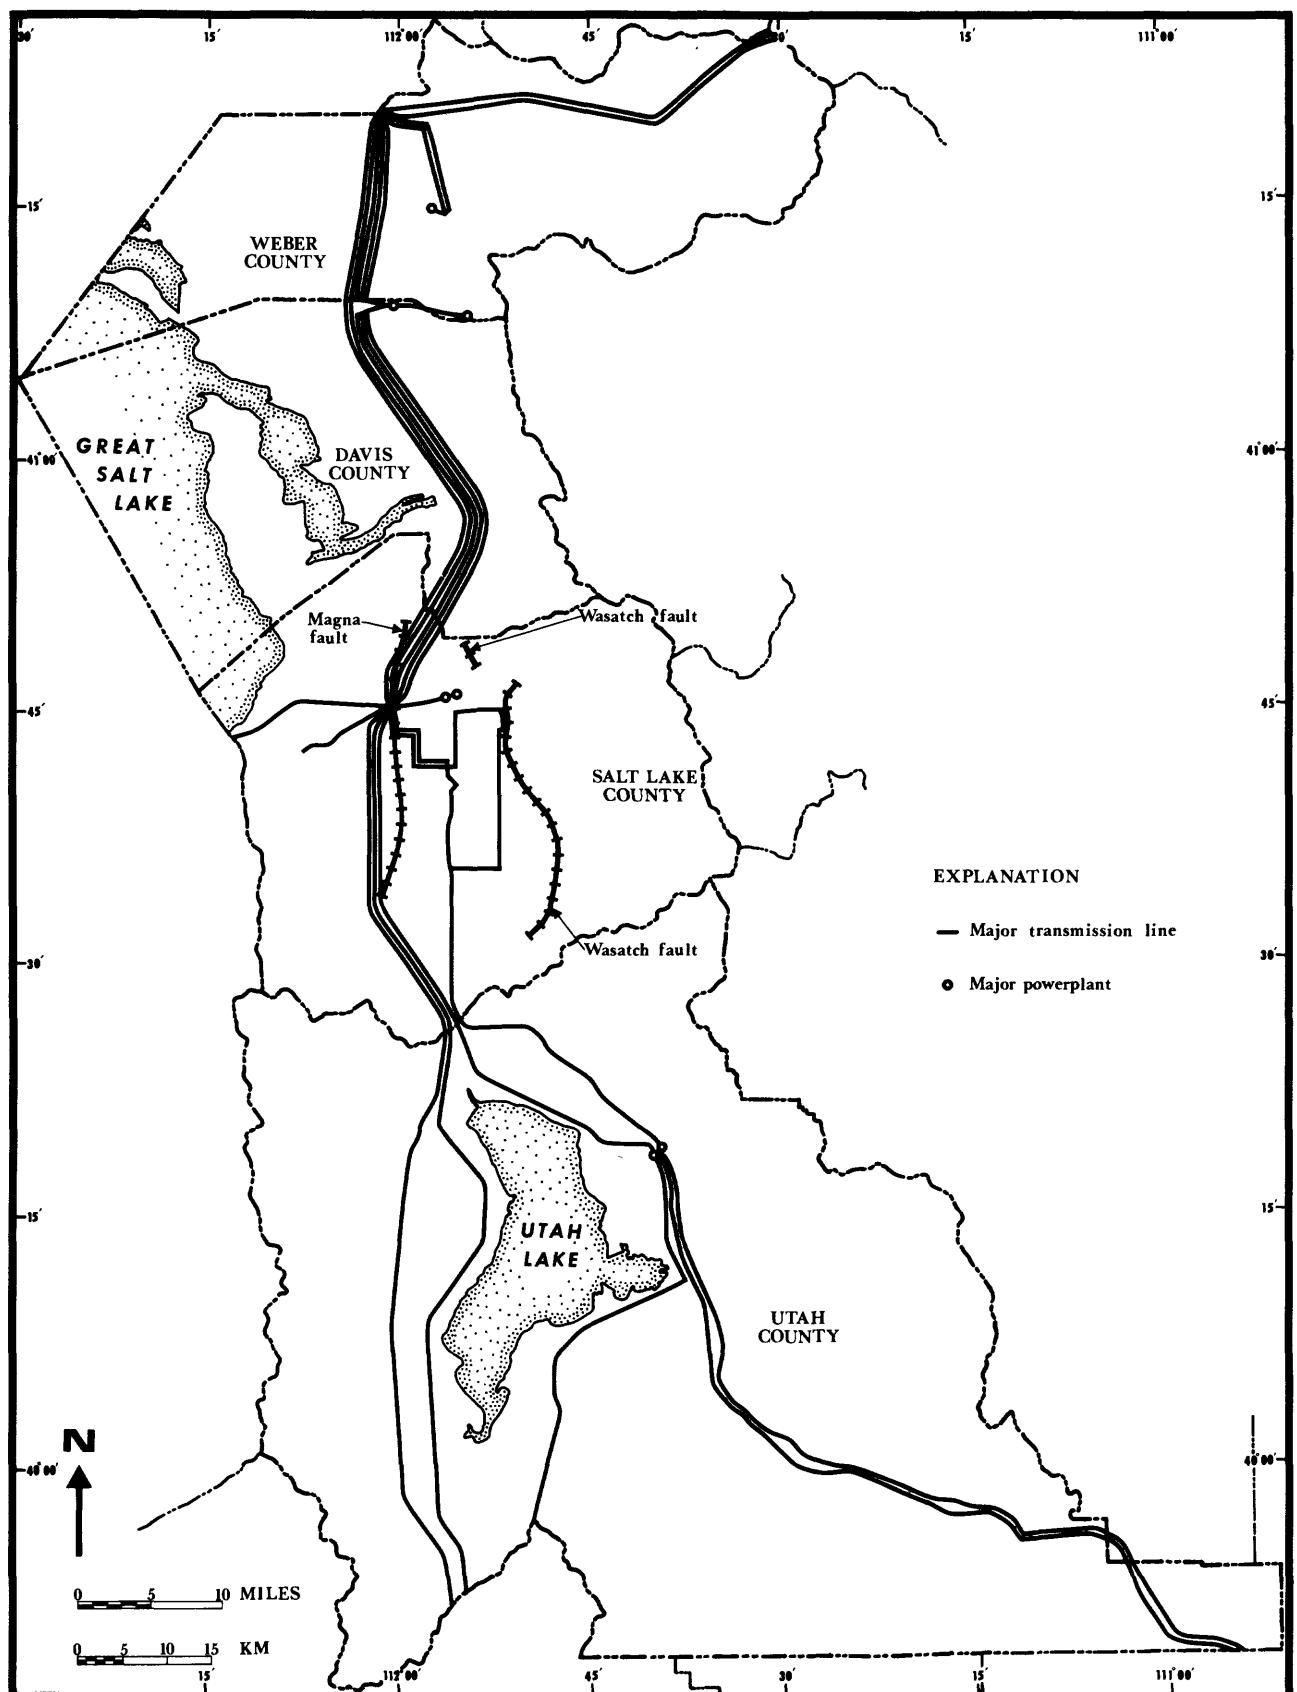
Figure 56.--Major power transmission lines and electric power generating facilities.
(Shown fault breakage is assumed for planning purposes.)

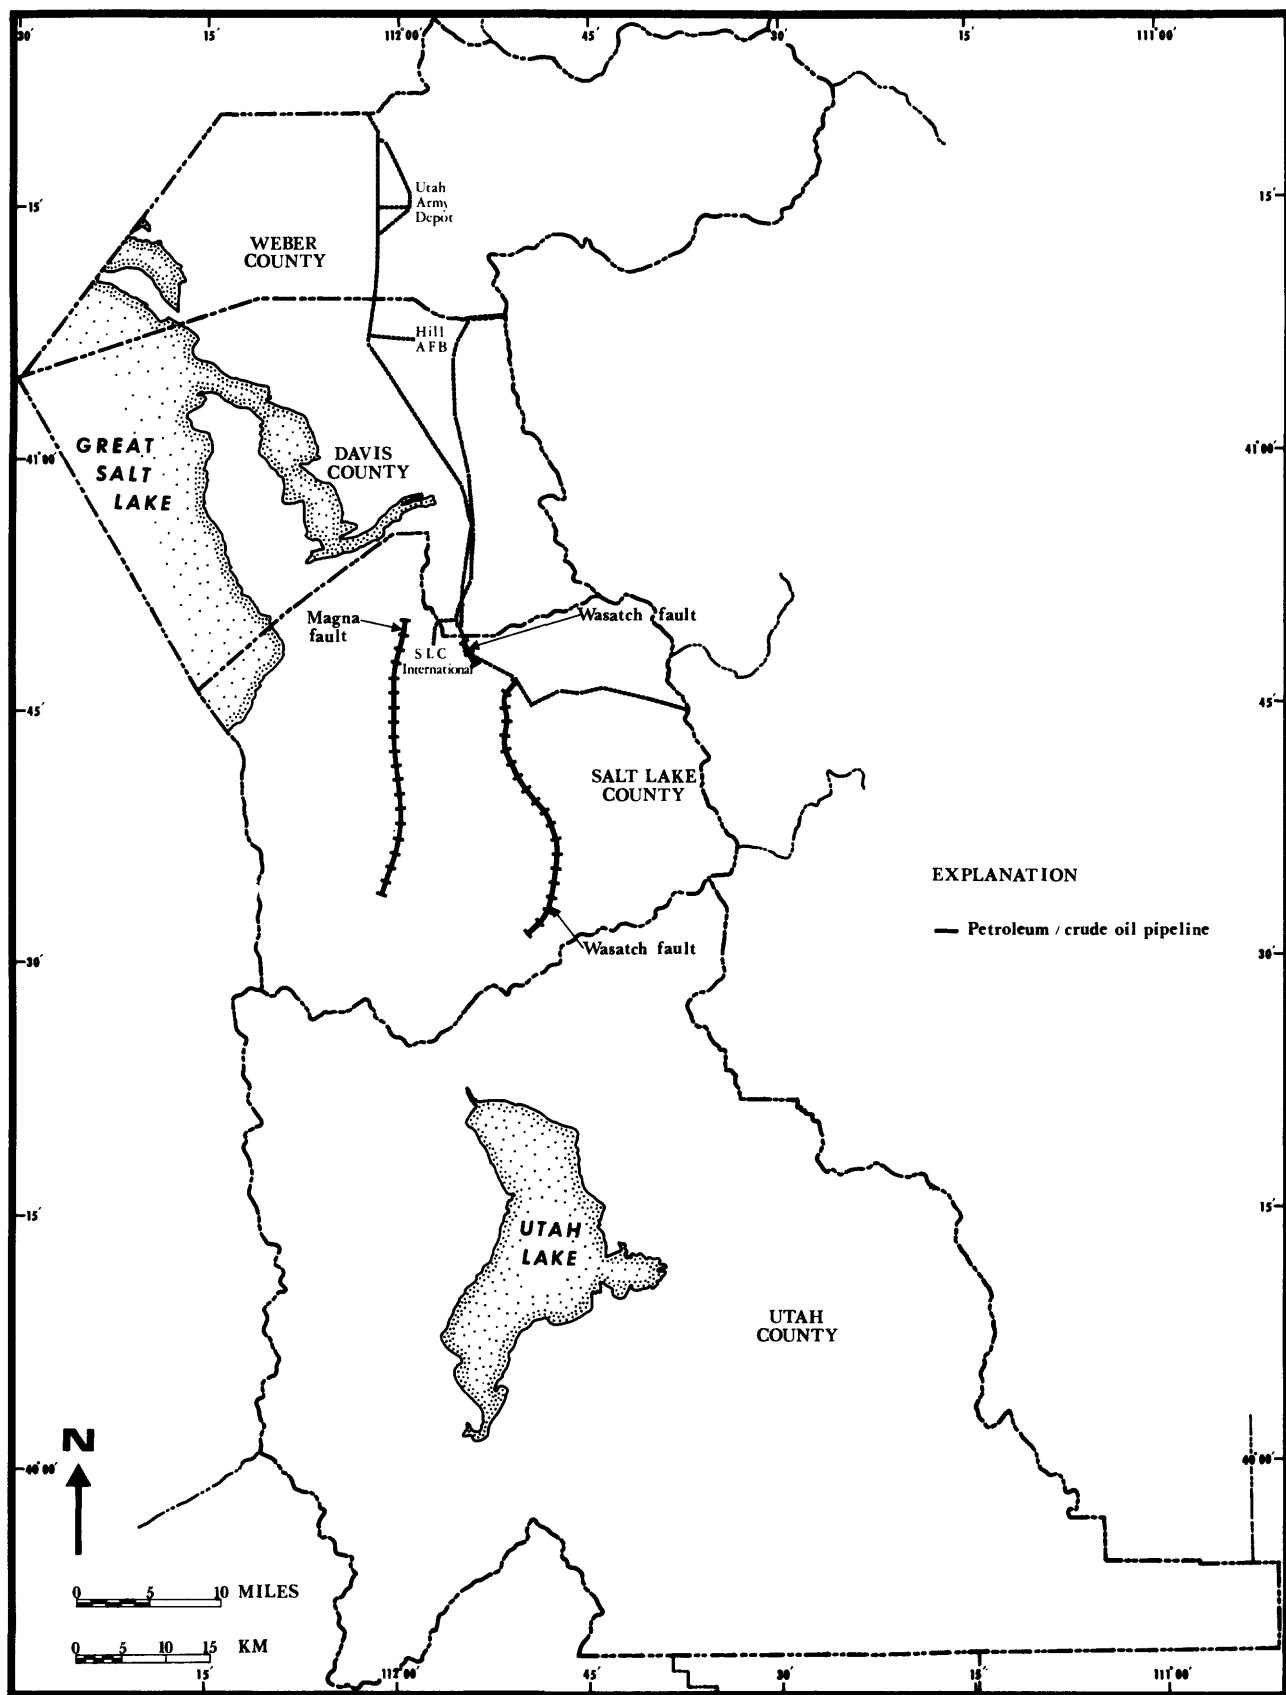
Figure 57.--Major Petroleum/crude oil pipelines. (Shown fault breakage is assumed for planning purposes.)
