SAMPSON, TENN.
N 3537.5 - W 8515.7.5
1954
PHOTOREVISED 1974

Landslides and related features interpreted
from aerial photographs:
1:79,000 (Black and White) 1974
1:40,000 (Black and White) 1979

Photointerpretation and field check 1981
This report is preliminary and has not
been reviewed for conformity with U.S.
Geological Survey editorial standards.

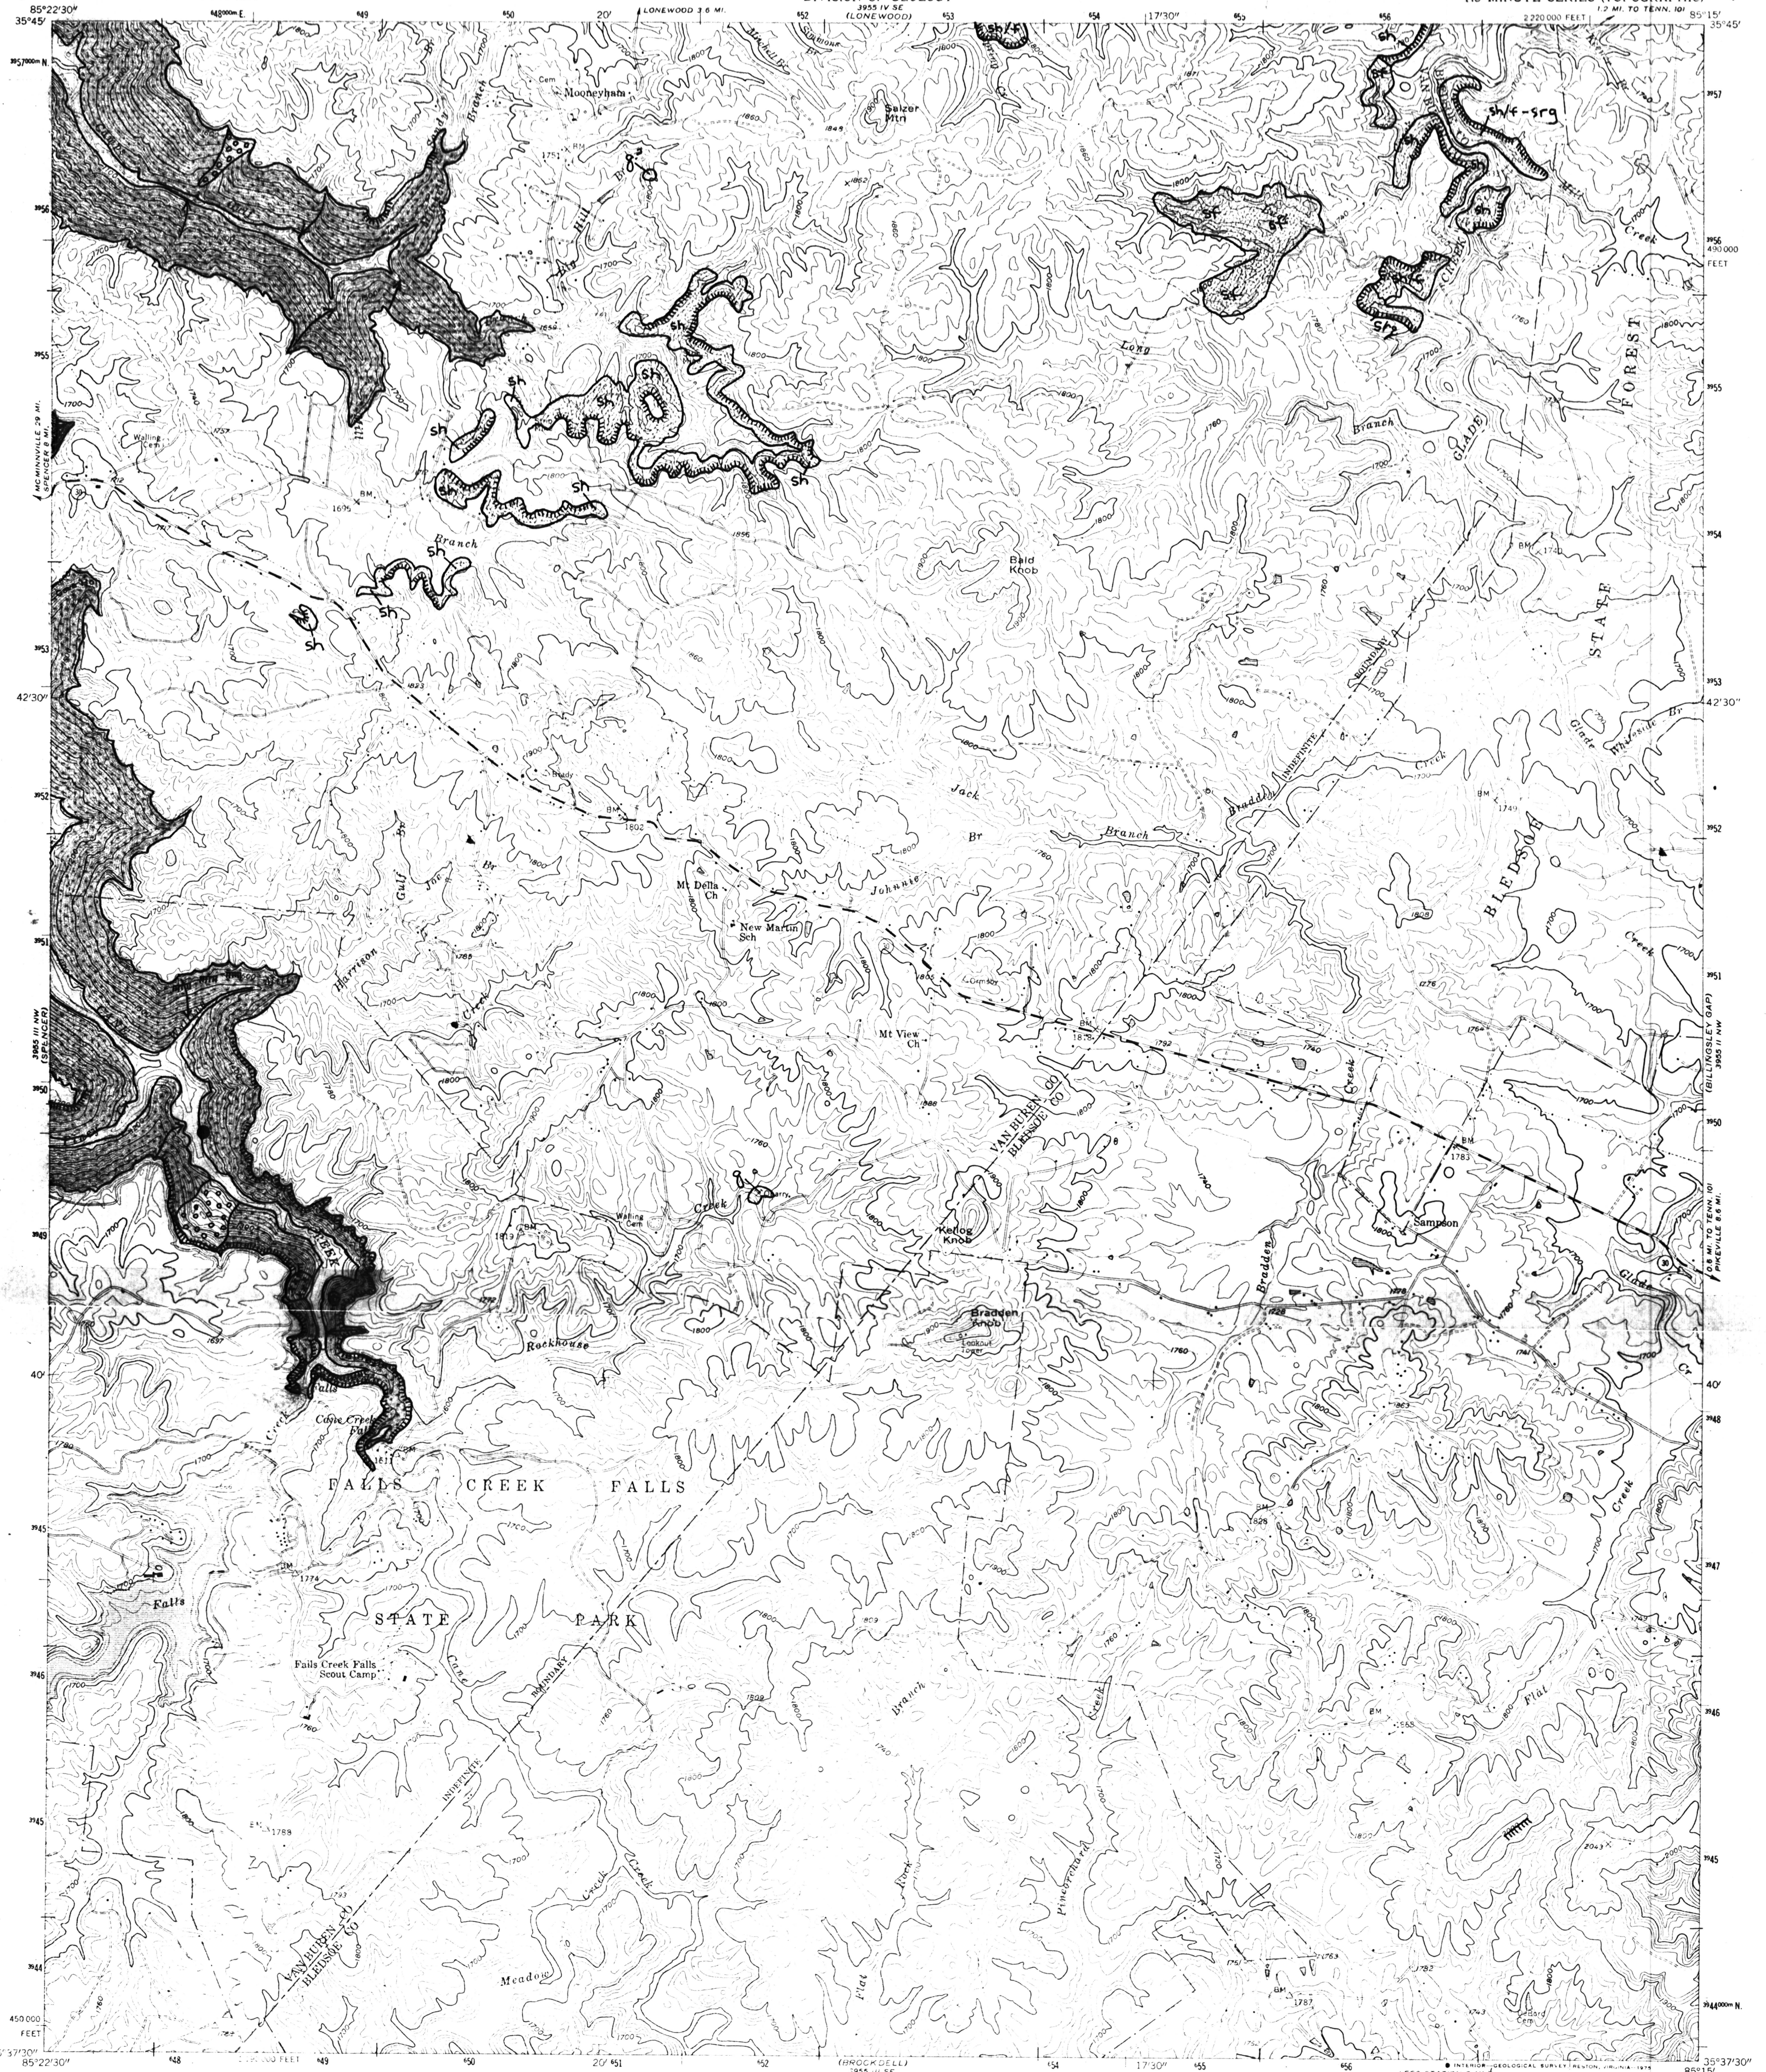
ACTIVE OR RECENTLY ACTIVE LANDSLIDE
Complex landslide composed of earthflow, debris
slide, earth and rock slump. Identified from
historical records, and from scars, debris and
other field evidence. Ground extremely unstable;
sliding accelerated by excavation, loading and
changes in drainage conditions. May include
areas with several active slides too small to
be shown separately. Questioned where doubtful.

OLD LANDSLIDE
Area of extensive hummocky ground caused by
earthflow and earth and rock slump. Lacks
clear evidence of active sliding. Relatively
stable in natural, undisturbed state,
generally not affected by small structures properly
sited in areas away from the edge of the toe;
can be reactivated by extensive, rapid excavation,
loading, and changes in ground water and
surface water conditions. Area of old landslide
probably includes recent ones not identified
from field evidence or otherwise documented.
Upslope boundary of landslide generally defined
by modified scarp, but downslope (toe) may be
gradational and not well defined. Questioned
where doubtful.

COMBINATION LANDSLIDE
Area of recent and old slides in which
individual slides are not identified.

COLLUVIAL SLOPE
Valley wall along major streams with slope as
steep as 40 (85%); stony, clayey silt soil up
to 50 ft. (15 m) thick; commonly buttressed by
a terrace or bench at the toe of the slope; very
susceptible to sliding by cutting of toe area,
removal of terrace or bench, and overloading;
slide commonly activated without apparent cause.

COLLUVIAL SLOPES WITH LANDSLIDES
Landslides too small or obscure to map
individually.

**AREAS SUSCEPTIBLE TO DEBRIS FLOWS AND DEBRIS
AVAILANCES**
Primarily shallow, narrow ravines and chutes with
accumulation of stony colluvium generally 10 ft.
(3 m) or less in thickness; susceptible to rapid
movement during intense rainfall. Most ravines
and chutes designated show evidence of former
debris flows and avalanches.

AREAS SUSCEPTIBLE TO ROCKFALL
Steep, locally vertical, natural and man-made
slopes and cliffs, 15 ft. (4.5 m) or more high;
formed dominantly of sandstone, limestone, sandy
shale, mudstone and claystone. Interbedded mud-
stone, claystone and shale weather rapidly leav-
ing sandstone and limestone rock faces unsupported.

SOIL AND ROCK SUSCEPTIBLE TO LANDSLIDING
Soil and rock similar to that involved in land-
slides elsewhere in map area; primarily areas
underlain by claystone, mudstone and shale
associated with other rock types. Rock weathers
rapidly on exposure forming clayey soil highly
susceptible to sliding. Includes coves (U-shaped,
shallow valleys) containing thick layers of clayey
soil that are very susceptible to sliding where
excavation breaks continuity of slope and where
overloaded by artificial fill.

AREAS LEAST PRONE TO LANDSLIDES
Map areas in which no patterns or symbols are shown;
primarily valley floors, ridge tops and broad
benches; modification by excavation and fill may
lead to local landslides.
