## LANDSLIDES AND RELATED FEATURES

OF THE KETNER GAP, QUADRANGLE

by  
Roger E. Thomas  
1981

U.S. Geological Survey  
OPEN FILE MAP 81-1318 (8-5)

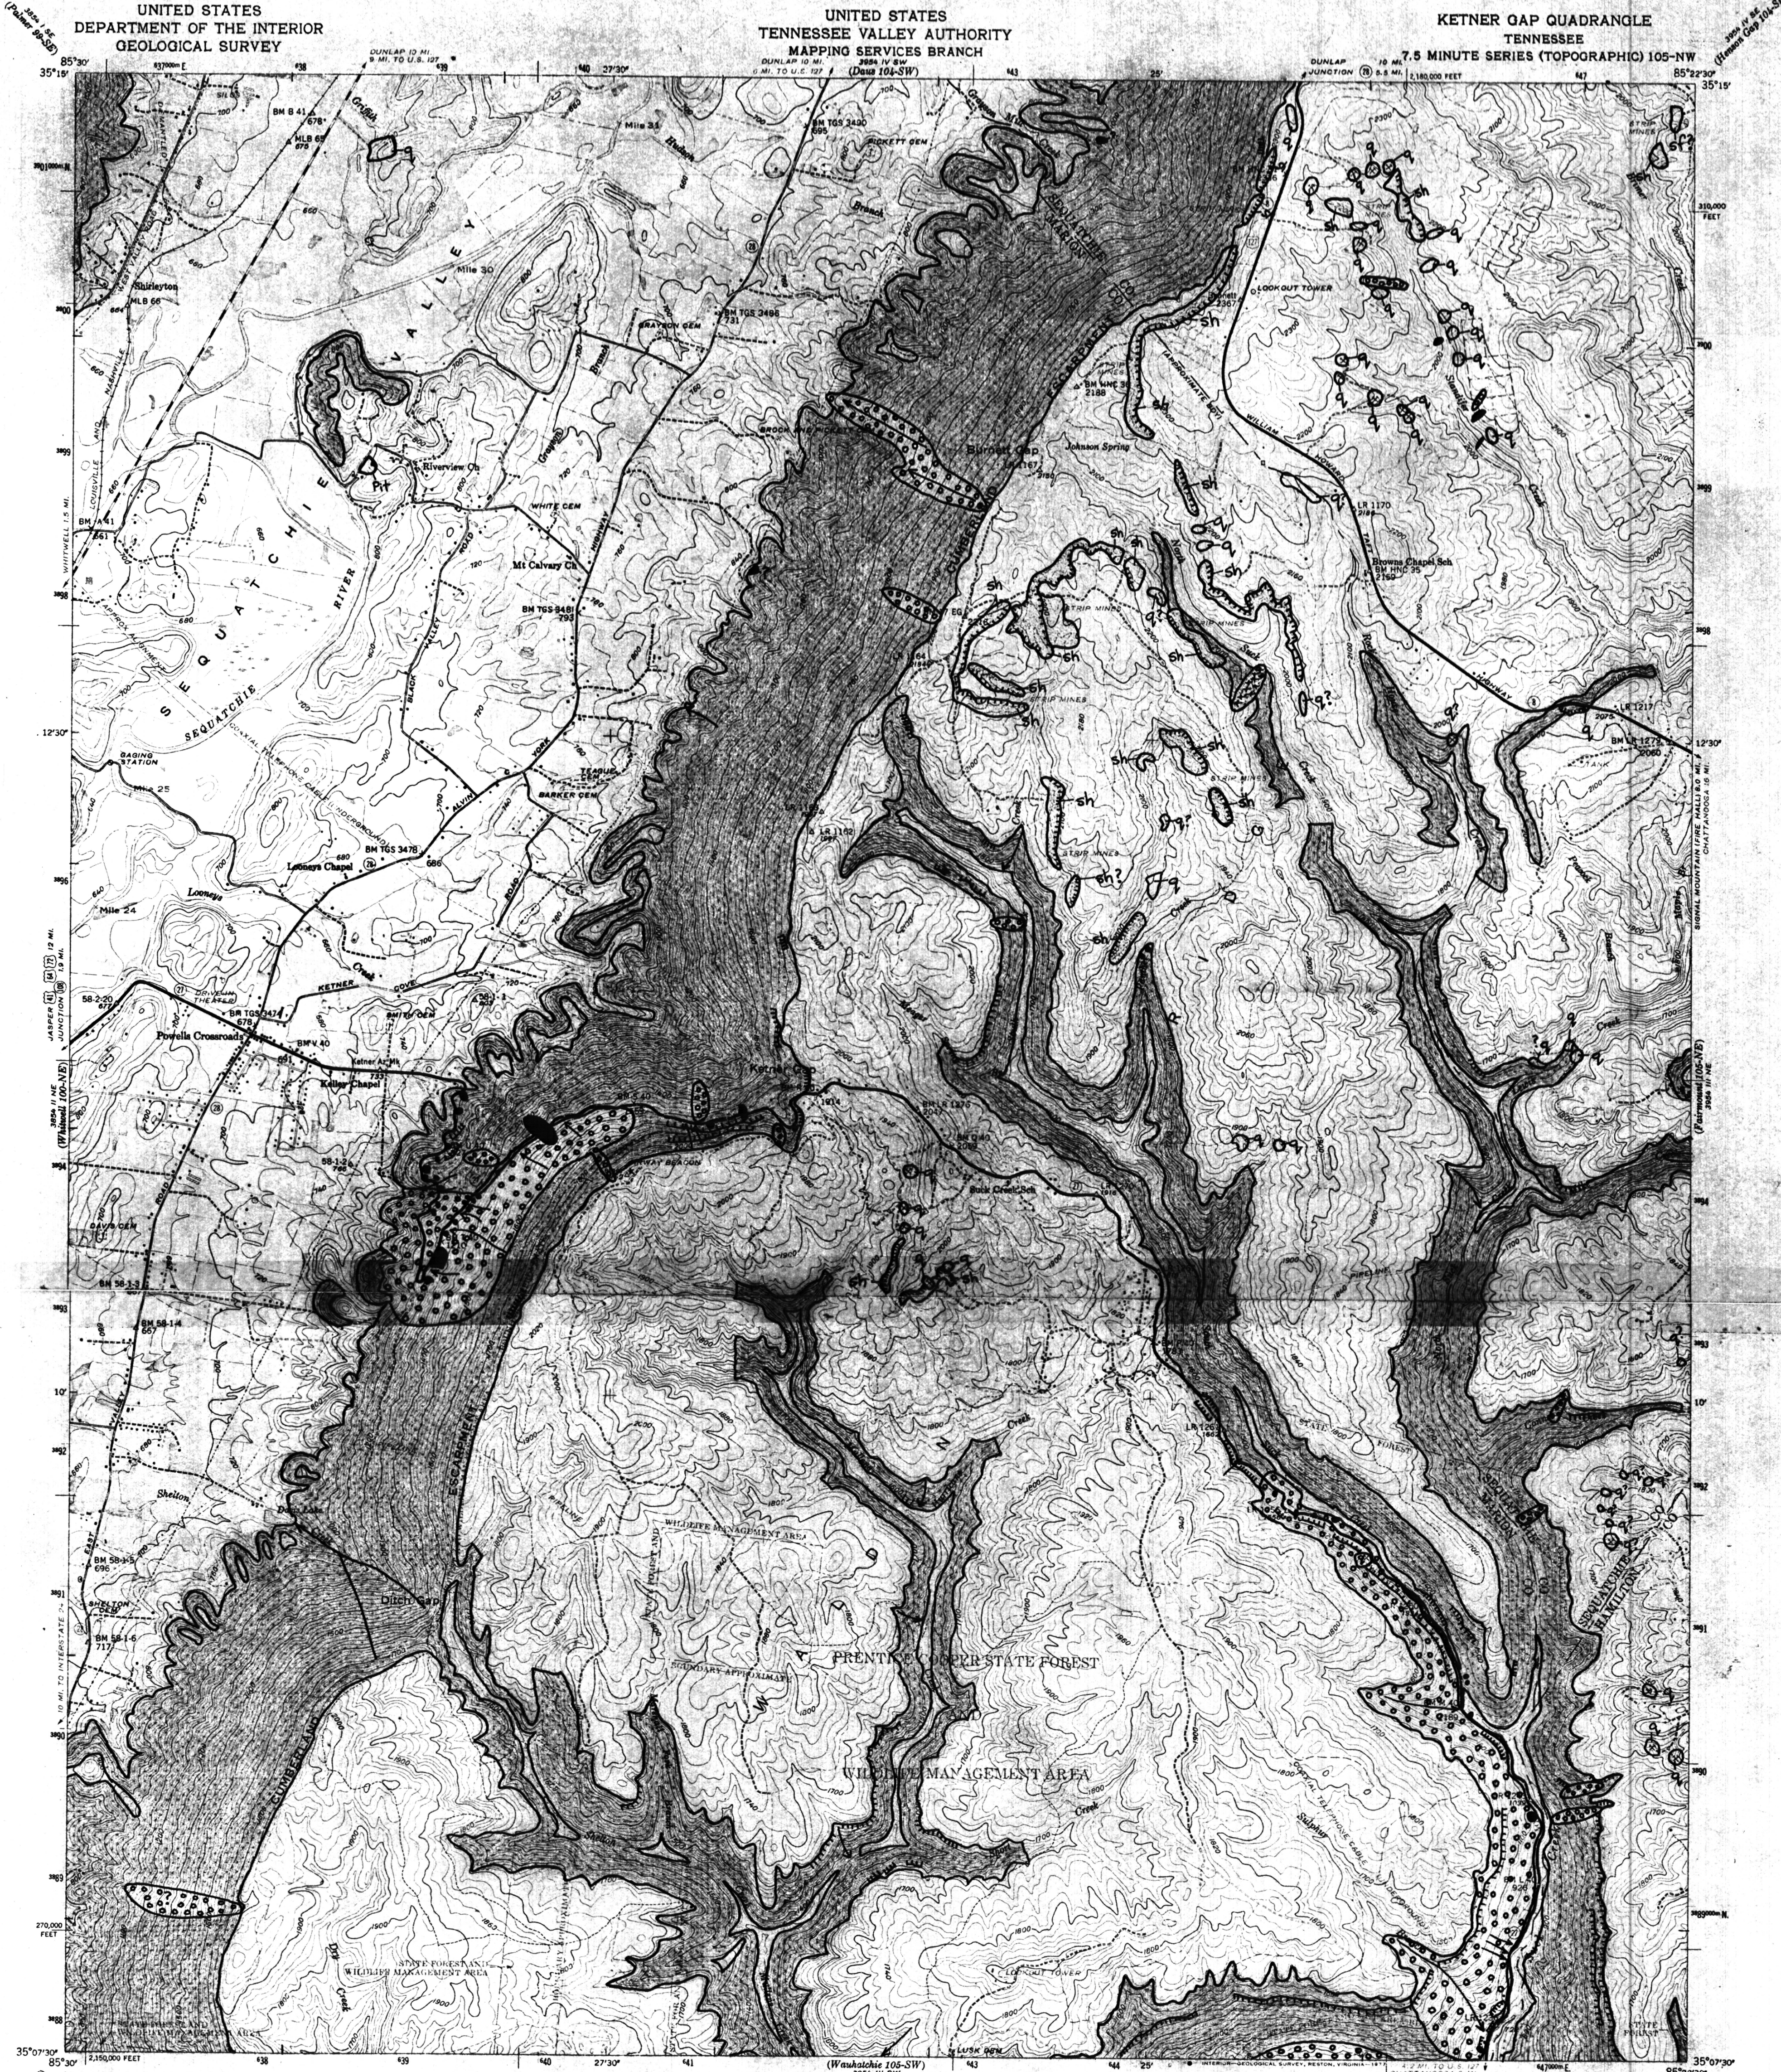
KETNER GAP, TENN.  
N3507.5-W8522.5/7.5  
1943  
PRINTED/REVISED 1976

Landslides and related features interpreted  
from aerial photographs:  
1:20,000 (Black and White) 1970  
1:20,000 (Black and White) 1973

Photointerpretation and field check 1981

**ACTIVE OR RECENTLY ACTIVE LANDSLIDE**  
Complex landslide composed of earthflow, debris  
slide, earth and rock slump. Identified from  
historical records, and from scars, debris and  
other field evidence. Ground extremely unstable;  
sliding accelerated by excavation, loading and  
changes in drainage conditions. May include  
areas with several active slides too small to  
be shown separately. Questioned where doubtful.

**OLD LANDSLIDE**  
Area of extensive hummocky ground caused by  
earthflow and earth and rock slump. Lacks  
clear evidence of active sliding. Relatively  
stable in natural, undisturbed state,  
generally not affected by small structures properly  
sited in areas away from the edge of the toe;  
can be reactivated by extensive, rapid exca-  
vation, loading, and changes in ground water and  
surface water conditions. Area of old landslide  
probably includes recent ones not identified  
from field evidence or otherwise documented.  
Upslope boundary of landslide generally defined  
by modified scarp, but downslope (toe) may be  
gradational and not well defined. Questioned  
where doubtful.

**COMBINATION LANDSLIDE**  
Area of recent and old slides in which  
individual slides are not identified.

**COLLUVIAL SLOPE**  
Valley wall along major streams with slope as  
steep as 40 (85%); stony, clayey silt soil up  
to 50 ft. (15 m) thick; commonly buttressed by  
a terrace or bench at the toe of the slope; very  
susceptible to sliding by cutting of toe area,  
removal of terrace or bench, and overloading;  
slide commonly activated without apparent cause.

**COLLUVIAL SLOPES WITH LANDSLIDES**  
Landslides too small or obscure to map  
individually.

**AREAS SUSCEPTIBLE TO DEBRIS FLOWS AND DEBRIS  
AVANCHES**  
Primarily shallow, narrow ravines and chutes with  
accumulation of stony colluvium generally 10 ft.  
(3 m) or less in thickness; susceptible to rapid  
movement during intense rainfall. Most ravines  
and chutes designated show evidence of former  
debris flows and avalanches.

**AREAS SUSCEPTIBLE TO ROCKFALL**  
Steep, locally vertical, natural and man-made  
slopes and cliffs, 15 ft. (4.5 m) or more high;  
formed dominantly of sandstone, limestone, sandy  
shale, mudstone and claystone. Interbedded mud-  
stone, claystone and shale weather rapidly leaving  
sandstone and limestone rock faces unsupported.

**SOIL AND ROCK SUSCEPTIBLE TO LANDSLIDING**  
Soil and rock similar to that involved in land-  
slides elsewhere in map area; primarily areas  
underlain by claystone, mudstone and shale  
associated with other rock types. Rock weathers  
rapidly on exposure forming clayey soil highly  
susceptible to sliding. Includes coves (U-shaped,  
shallow valleys) containing thick layers of clayey  
soil that are very susceptible to sliding where  
excavation breaks continuity of slope and where  
overloaded by artificial fill.

**AREAS LEAST PRONE TO LANDSLIDES**  
Map areas in which no patterns or symbols are shown;  
primarily valley floors, ridge tops and broad  
benches; modification by excavation and fill may  
lead to local landslides.

**NOTE**  
Information shown is intended as a  
general guide to ground conditions as of  
the date of field check. Additional  
landslides and rockfalls should be anticipated  
in all map units. The map unit depicts  
the dominant condition in the area delineated  
and variations in slope stability may occur  
at any point in the unit. This map is suit-  
able for general planning purposes and as a  
supplement to more detailed studies for site  
selection. The map cannot be used as a sub-  
stitute for detailed geologic and engineering  
investigations to establish design and  
construction criteria of specific sites.  
Some symbols may not appear on this map  
because the description is applicable to a  
series of maps.

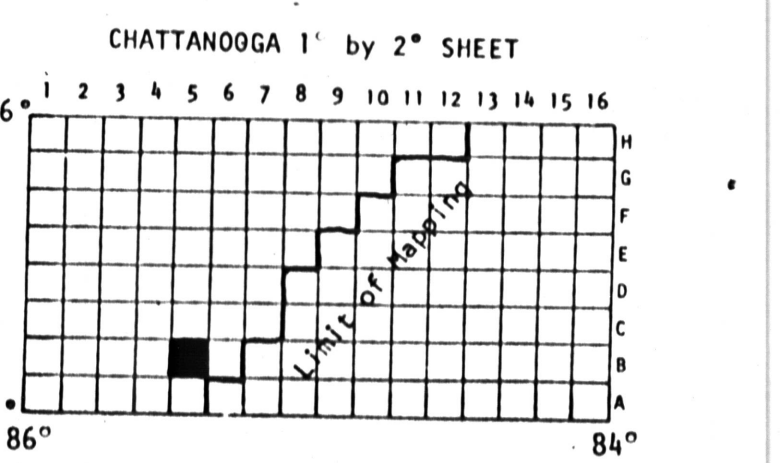
The first six digits of the open file number designate the  
specific 1:250,000 scale map sheet of which this quadrangle  
is a part. The last two digits designate the position of the  
quadrangle in a subdivision of the 1:250,000 scale map based  
on rows and tiers shown in the diagram to the right. The  
location of this quadrangle is shown by the black square.
