LANDSLIDES AND RELATED FEATURES

OF THE MORRISON, TENN. QUADRANGLE

by
Roger E. Thomas
1981

U.S. Geological Survey
OPEN FILE MAP 81-1318 (E-1)

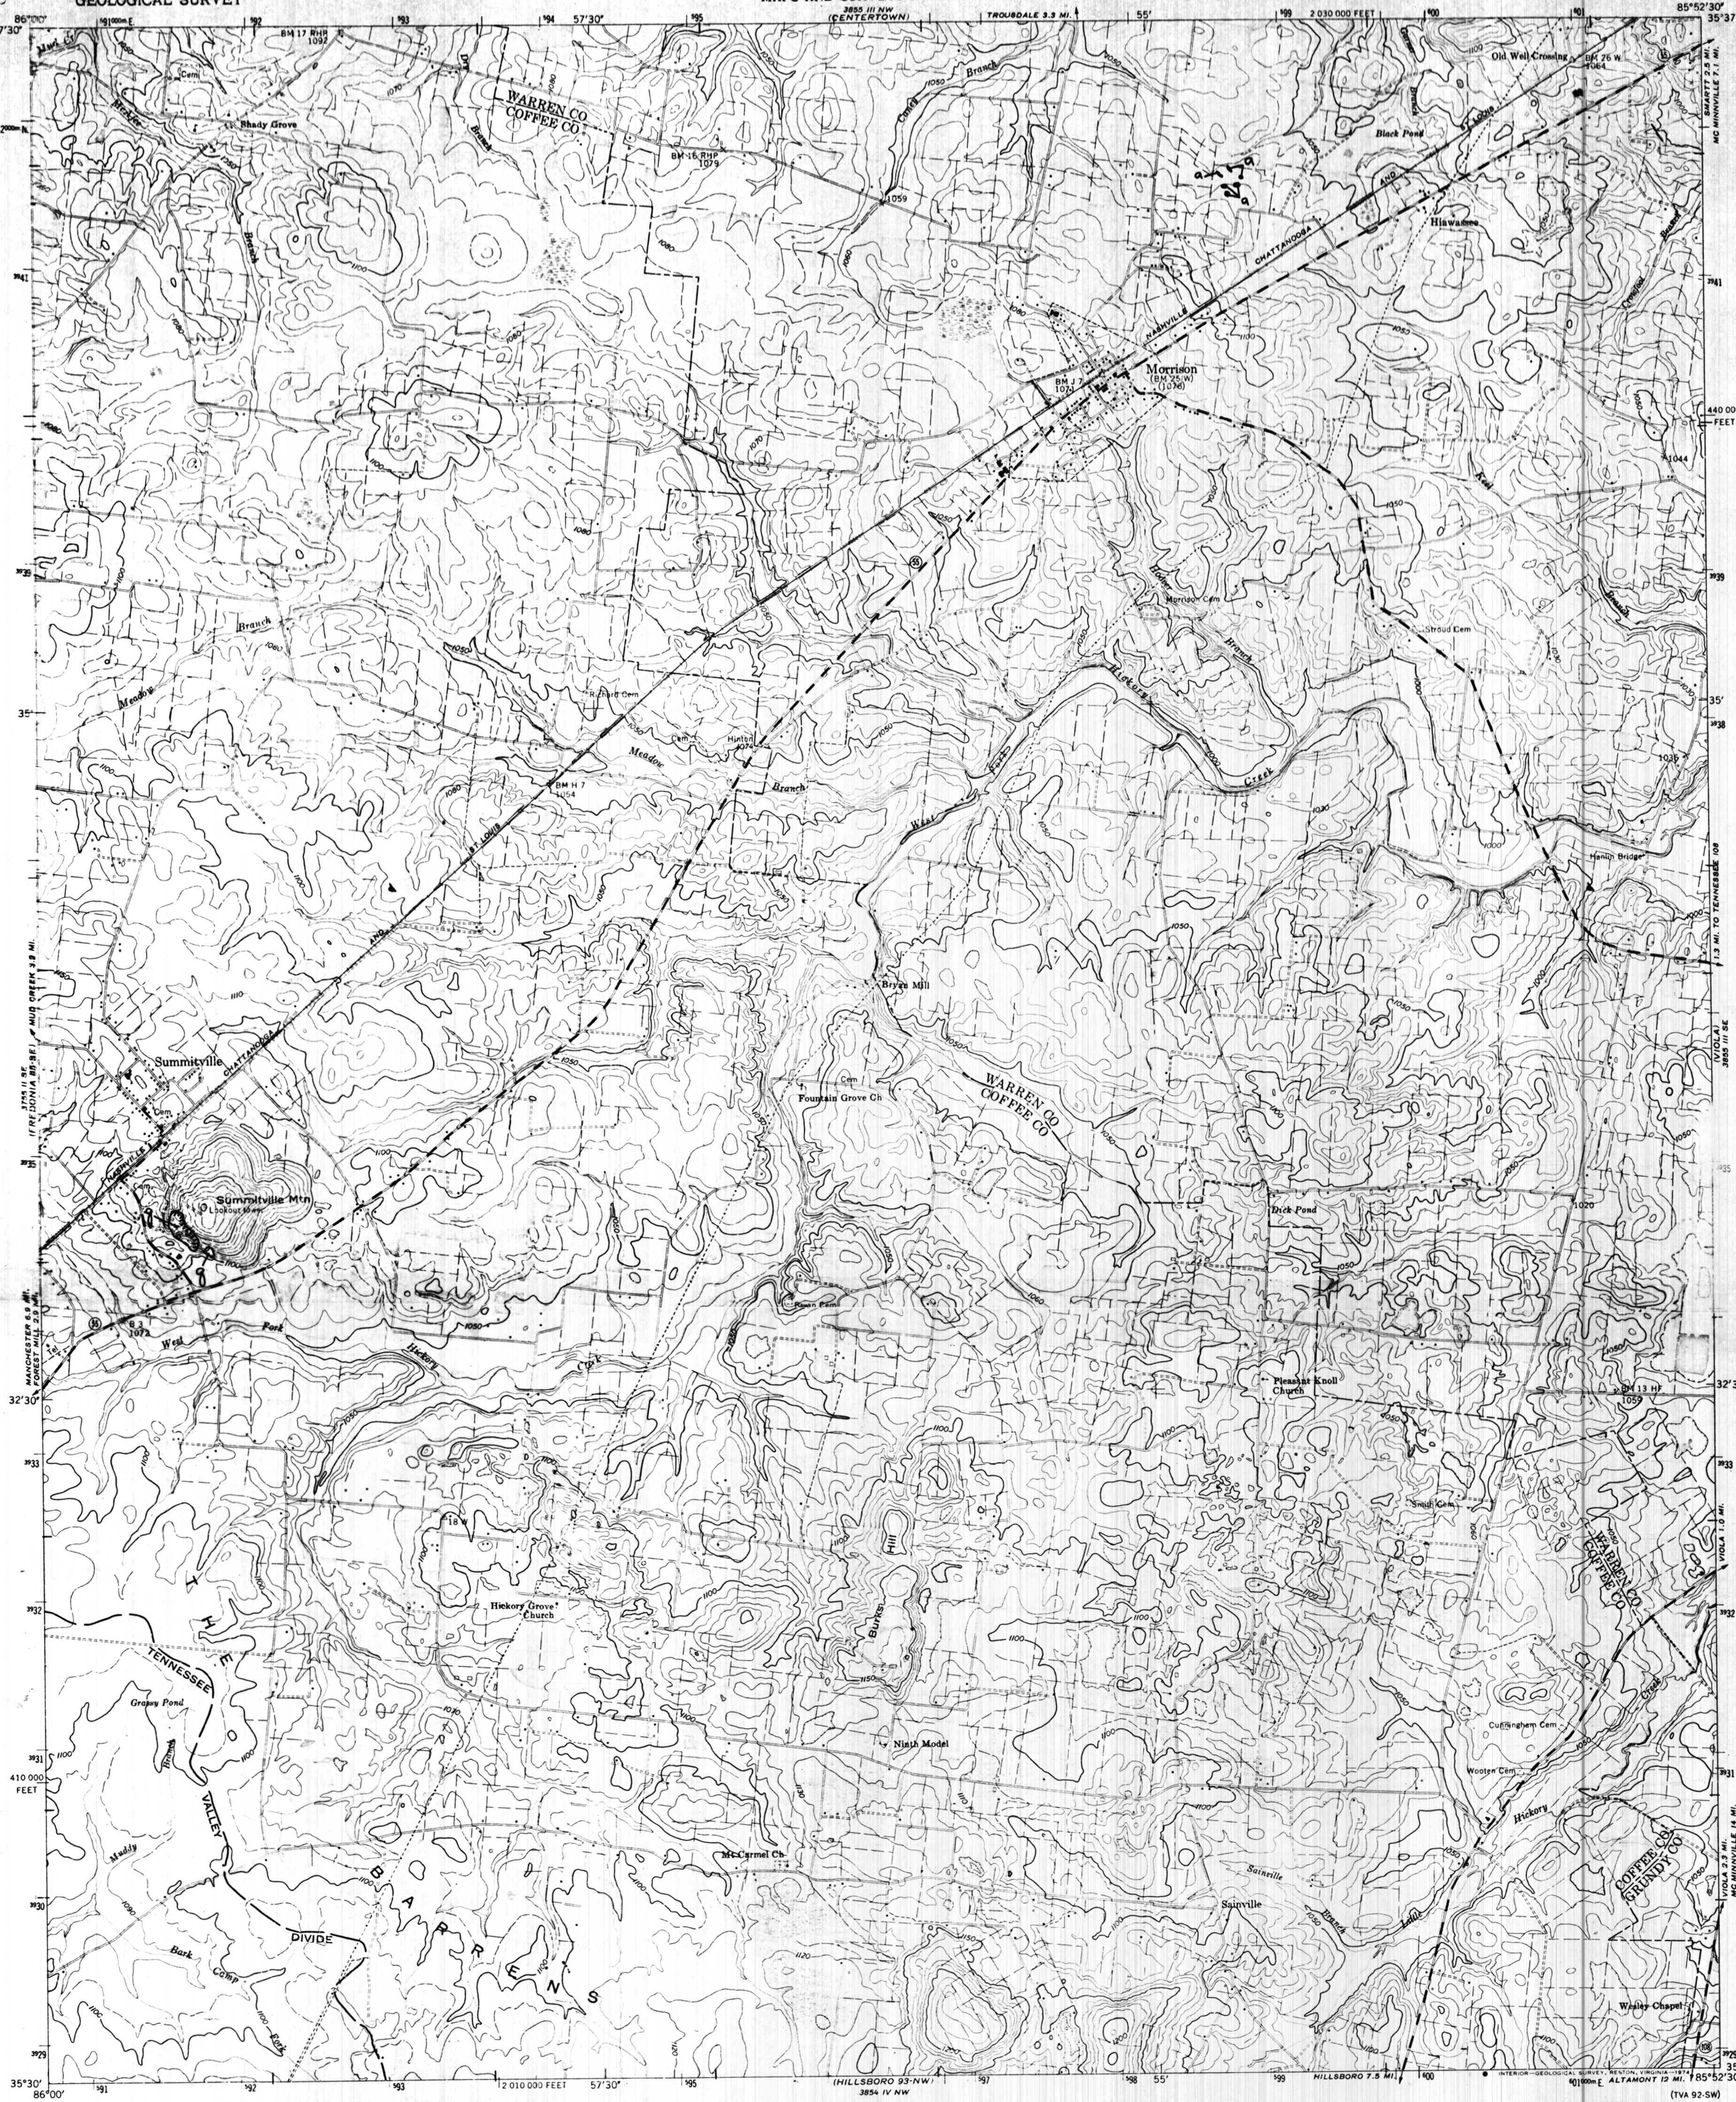
Landslides and related features interpreted from aerial photographs:

ACTIVE OR RECENTLY ACTIVE LANDSLIDE
Complex landslide composed of earthflow, debris slide, earth and rock slump. Identified from historical records, and from scars, debris and other field evidence. Ground extremely unstable; sliding accelerated by excavation, loading and changes in drainage conditions. May include areas with several active slides too small to be shown separately. Questioned where doubtful.

OLD LANDSLIDE
Area of extensive hummocky ground caused by earthflow and earth and rock slump. Lacks clear evidence of active sliding. Relatively stable in natural, undisturbed state, generally not affected by small structures properly sited in areas away from the edge of the toe; can be reactivated by extensive, rapid excavation, loading, and changes in ground water and surface water conditions. Area of old landslide probably includes recent ones not identified from field evidence or otherwise documented. Upslope boundary of landslide generally defined by modified scarp, but downslope (toe) may be gradational and not well defined. Questioned where doubtful.

COMBINATION LANDSLIDE
Area of recent and old slides in which individual slides are not identified.

COLLUVIAL SLOPE
Valley wall along major streams with slope as steep as 40 (85%); stony, clayey silt soil up to 50 ft. (15 m) thick; commonly buttressed by a terrace or bench at the toe of the slope; very susceptible to sliding by cutting of toe area, removal of terrace or bench, and overloading; slide commonly activated without apparent cause.

AREAS SUSCEPTIBLE TO DEBRIS FLOWS AND DEBRIS AVALANCHES
Primarily shallow, narrow ravines and chutes with accumulation of stony colluvium generally 10 ft. (3 m) or less in thickness; susceptible to rapid movement during intense rainfall. Most ravines and chutes designated show evidence of former debris flows and avalanches.

AREAS SUSCEPTIBLE TO ROCKFALL
Steep, locally vertical, natural and man-made slopes and cliffs, 15 ft. (4.5 m) or more high; formed dominantly of sandstone, limestone, sandy shale, mudstone and claystone. Interbedded mudstone, claystone and shale weather rapidly leaving sandstone and limestone rock faces unsupported.

SOIL AND ROCK SUSCEPTIBLE TO LANDSLIDING
Soil and rock similar to that involved in landslides elsewhere in map area; primarily areas underlain by claystone, mudstone and shale associated with other rock types. Rock weathers rapidly on exposure forming clayey soil highly susceptible to sliding. Includes coves (U-shaped, shallow valleys) containing thick layers of clayey soil that are very susceptible to sliding where excavation breaks continuity of slope and where overloaded by artificial fill.

AREAS LEAST PRONE TO LANDSLIDES
Map areas in which no patterns or symbols are shown; primarily valley floors, ridge tops and broad benches; modification by excavation and fill may lead to local landslides.
