LANDSLIDES AND RELATED FEATURES

OF THE RICHARDSON, KY. QUADRANGLE

William F. Outerbridge

OPEN FILE MAP 82-51 (H-11)

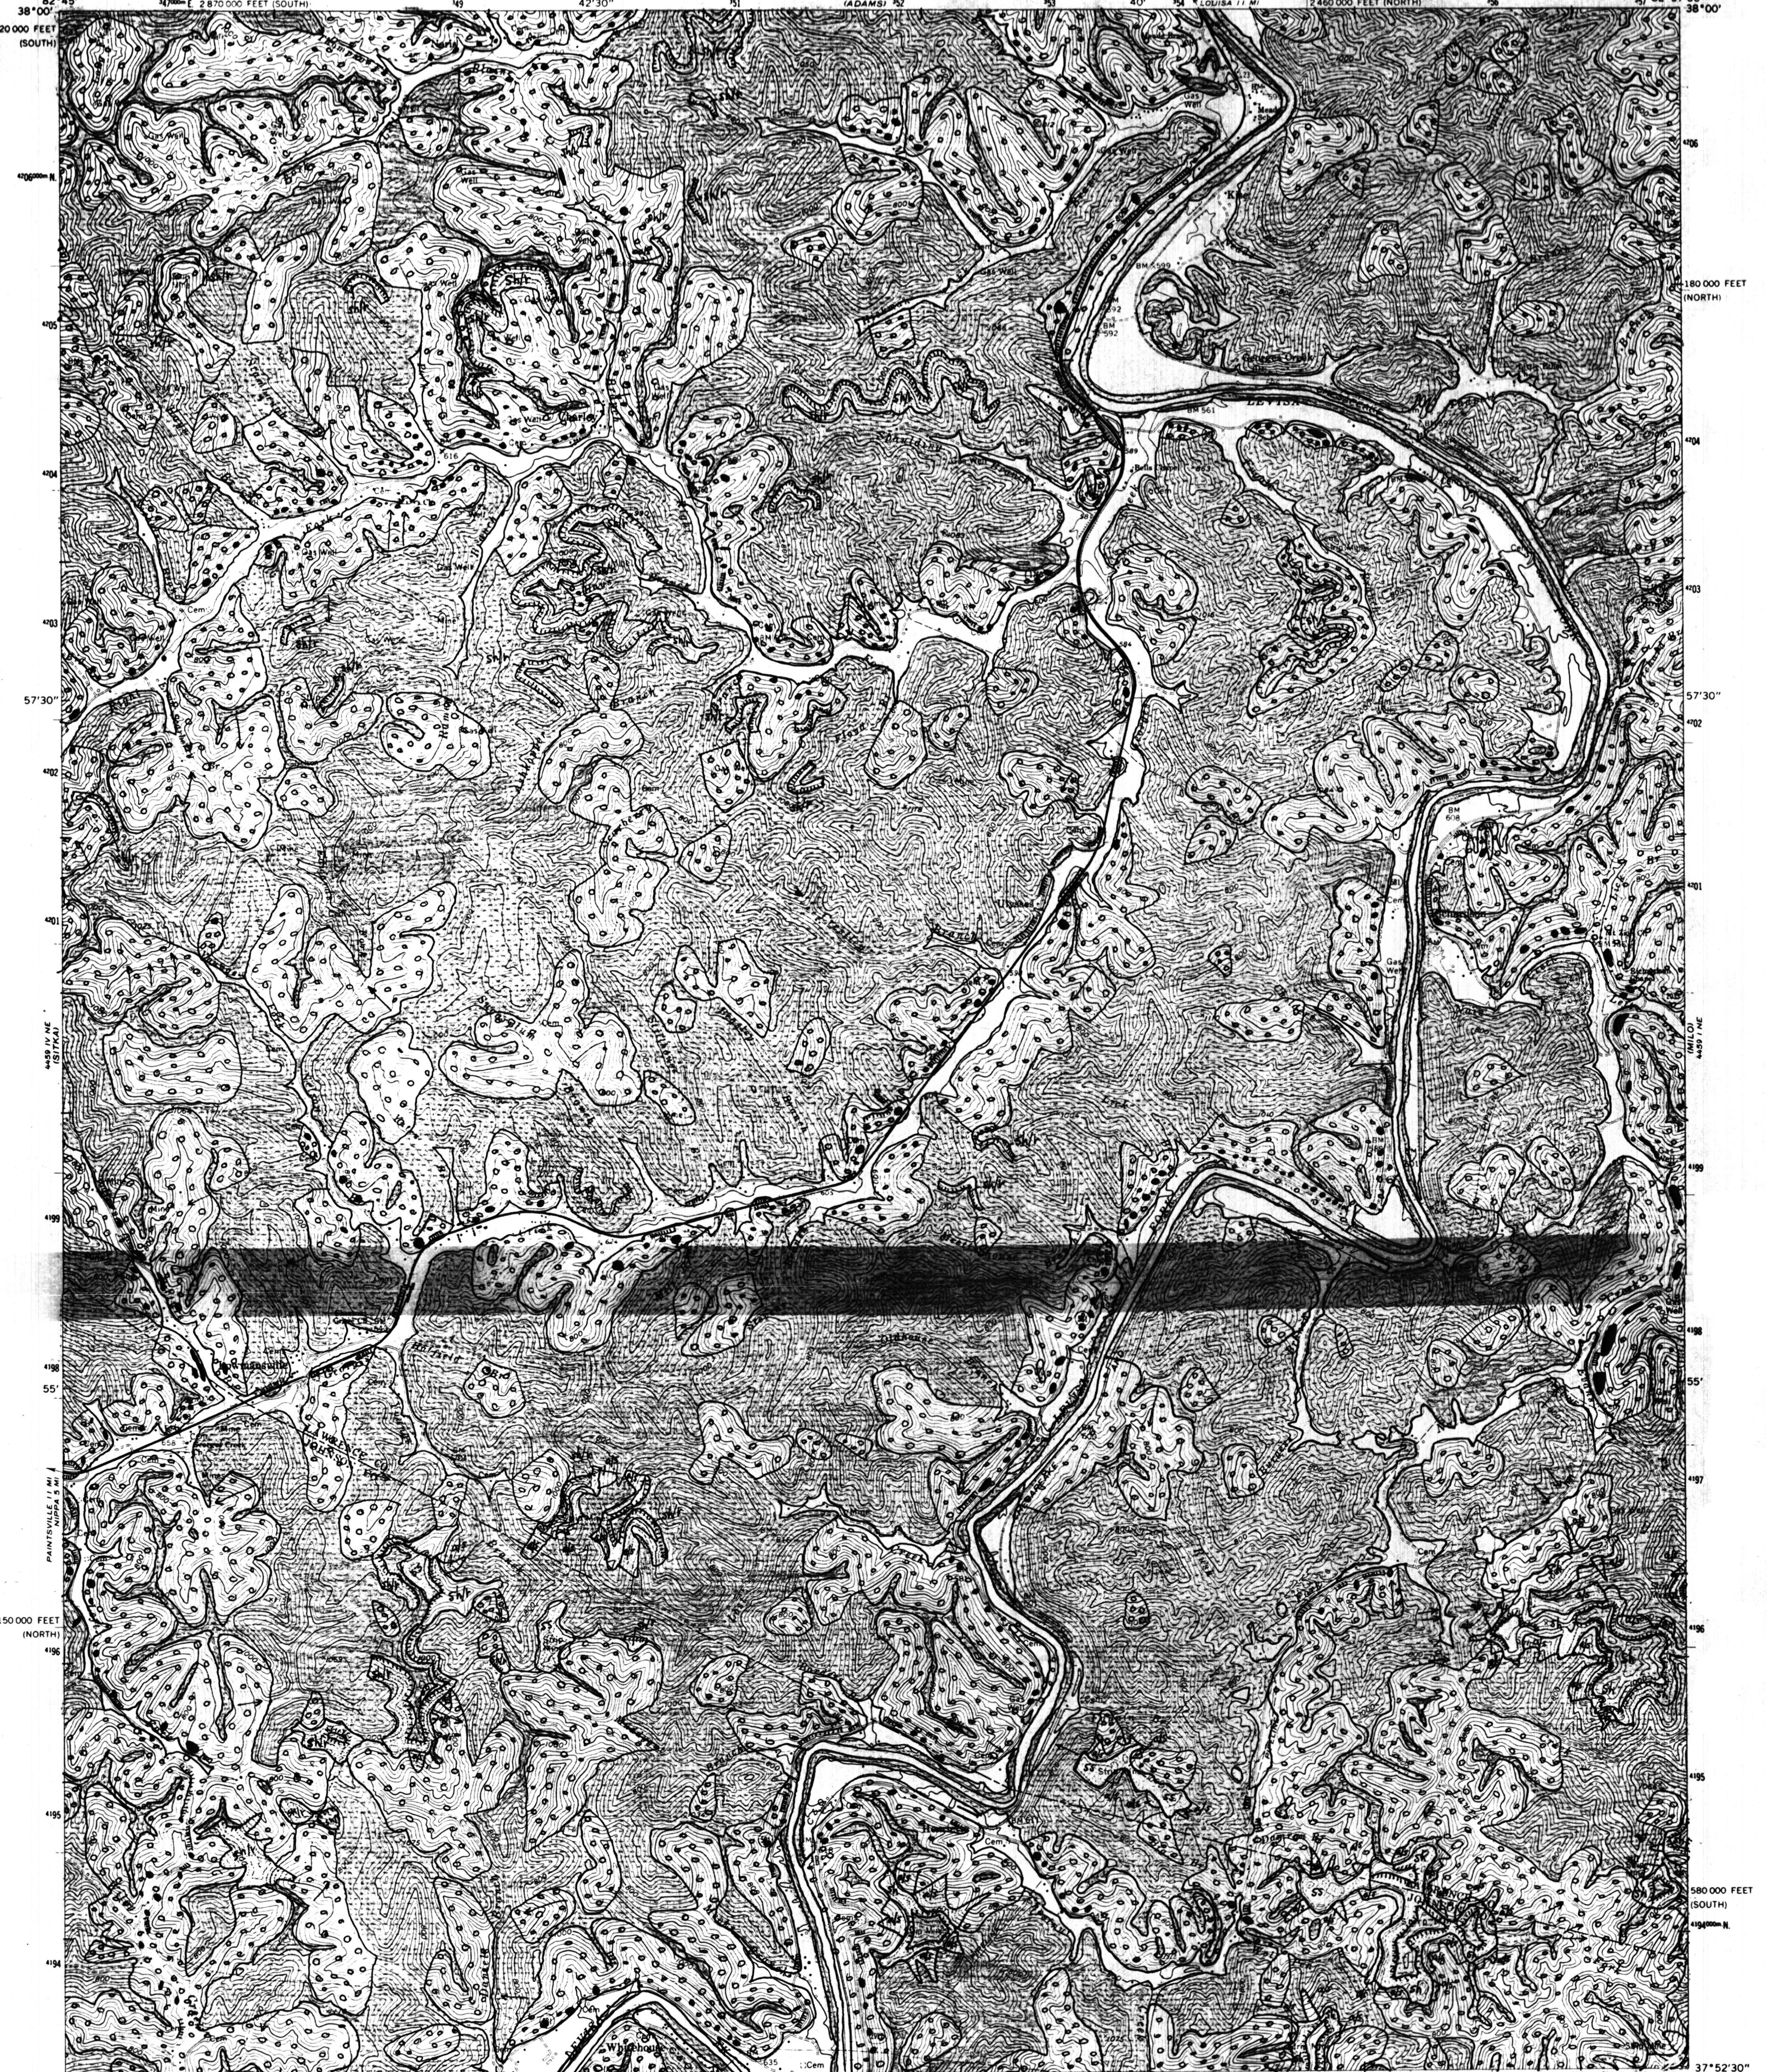
**ACTIVE OR RECENTLY ACTIVE LANDSLIDE**  
Complex landslide composed of earthflow, debris slide, earth and rock slump. Identified from historical records, and from scars, debris and other field evidence. Ground extremely unstable; sliding accelerated by excavation, loading and changes in drainage conditions. May include areas with several active slides too small to be shown separately. Questioned where doubtful.

**OLD LANDSLIDE**  
Area of extensive hummocky ground caused by earthflow and earth and rock slump. Lacks clear evidence of active sliding. Relatively stable in natural, undisturbed state, generally not affected by small structures properly sited in areas away from the edge of the toe; can be reactivated by extensive, rapid excavation, loading, and changes in ground water and surface water conditions. Area of old landslide probably includes recent ones not identified from field evidence or otherwise documented.

**COMBINATION LANDSLIDE**  
Area of recent and old slides in which individual slides are not identified.

**COLLUVIAL SLOPE**  
Valley wall along major streams with slope as steep as 40° (85%); stony, clayey silt soil up to 50 ft. (15 m) thick; commonly buttressed by a terrace or bench at the toe of the slope; very susceptible to sliding by cutting of toe area, removal of terrace or bench, and overloading; slide commonly activated without apparent cause.

**COLLUVIAL SLOPES WITH LANDSLIDES**  
Landslides too small or obscure to map individually.

Primarily shallow, narrow ravines and chutes with accumulation of stony colluvium generally 10 ft. (3 m) or less in thickness; susceptible to rapid movement during intense rainfall. Most ravines and chutes designated show evidence of former debris flows and avalanches. Symbol & designates historical debris flow or debris avalanche.

Steep, locally vertical, natural and man-made slopes and cliffs, 15 ft. (4.5 m) or more high; formed dominantly of sandstone, limestone, sandy shale, mudstone and claystone. Interbedded mudstone, claystone and shale weather rapidly leaving sandstone and limestone rock faces unsupported.

Soil and rock similar to that involved in landslides elsewhere in map area; primarily areas underlain by claystone, mudstone and shale associated with other rock types. Rock weathers rapidly on exposure forming clayey soil highly susceptible to sliding. Includes coves (U-shaped, shallow valleys) containing thick layers of clayey soil that are very susceptible to sliding where excavation breaks continuity of slope and where overloaded by artificial fill.

Map areas in which no patterns or symbols are shown; primarily valley floors, ridge tops and broad benches; modification by excavation and fill may lead to local landslides.

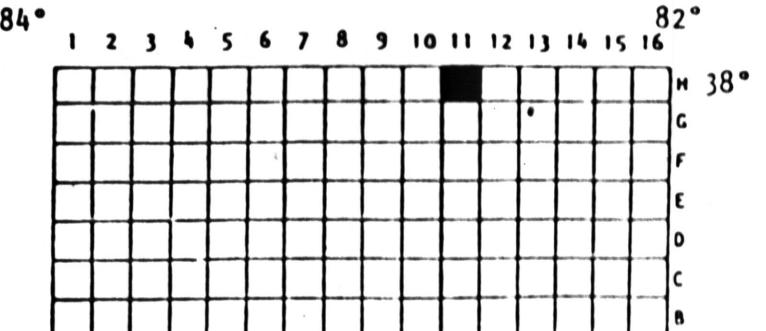
JENKINS 1°x2° SHEET

The first four digits of the open file number designate the specific 1:250,000 scale map sheet of which this quadrangle is a part. The last two digits designate the position of the quadrangle in a subdivision of the 1:250,000 scale map based on rows and tiers shown in the diagram to the right. The location of this quadrangle is shown by the black square.
