## LANDSLIDES AND RELATED FEATURES

OF THE SAXTON, KY. QUADRANGLE

by  
Alfred R. Taylor and Roger E. Thomas

U.S. Geological Survey  
OPEN FILE MAP 82-653(F-16)

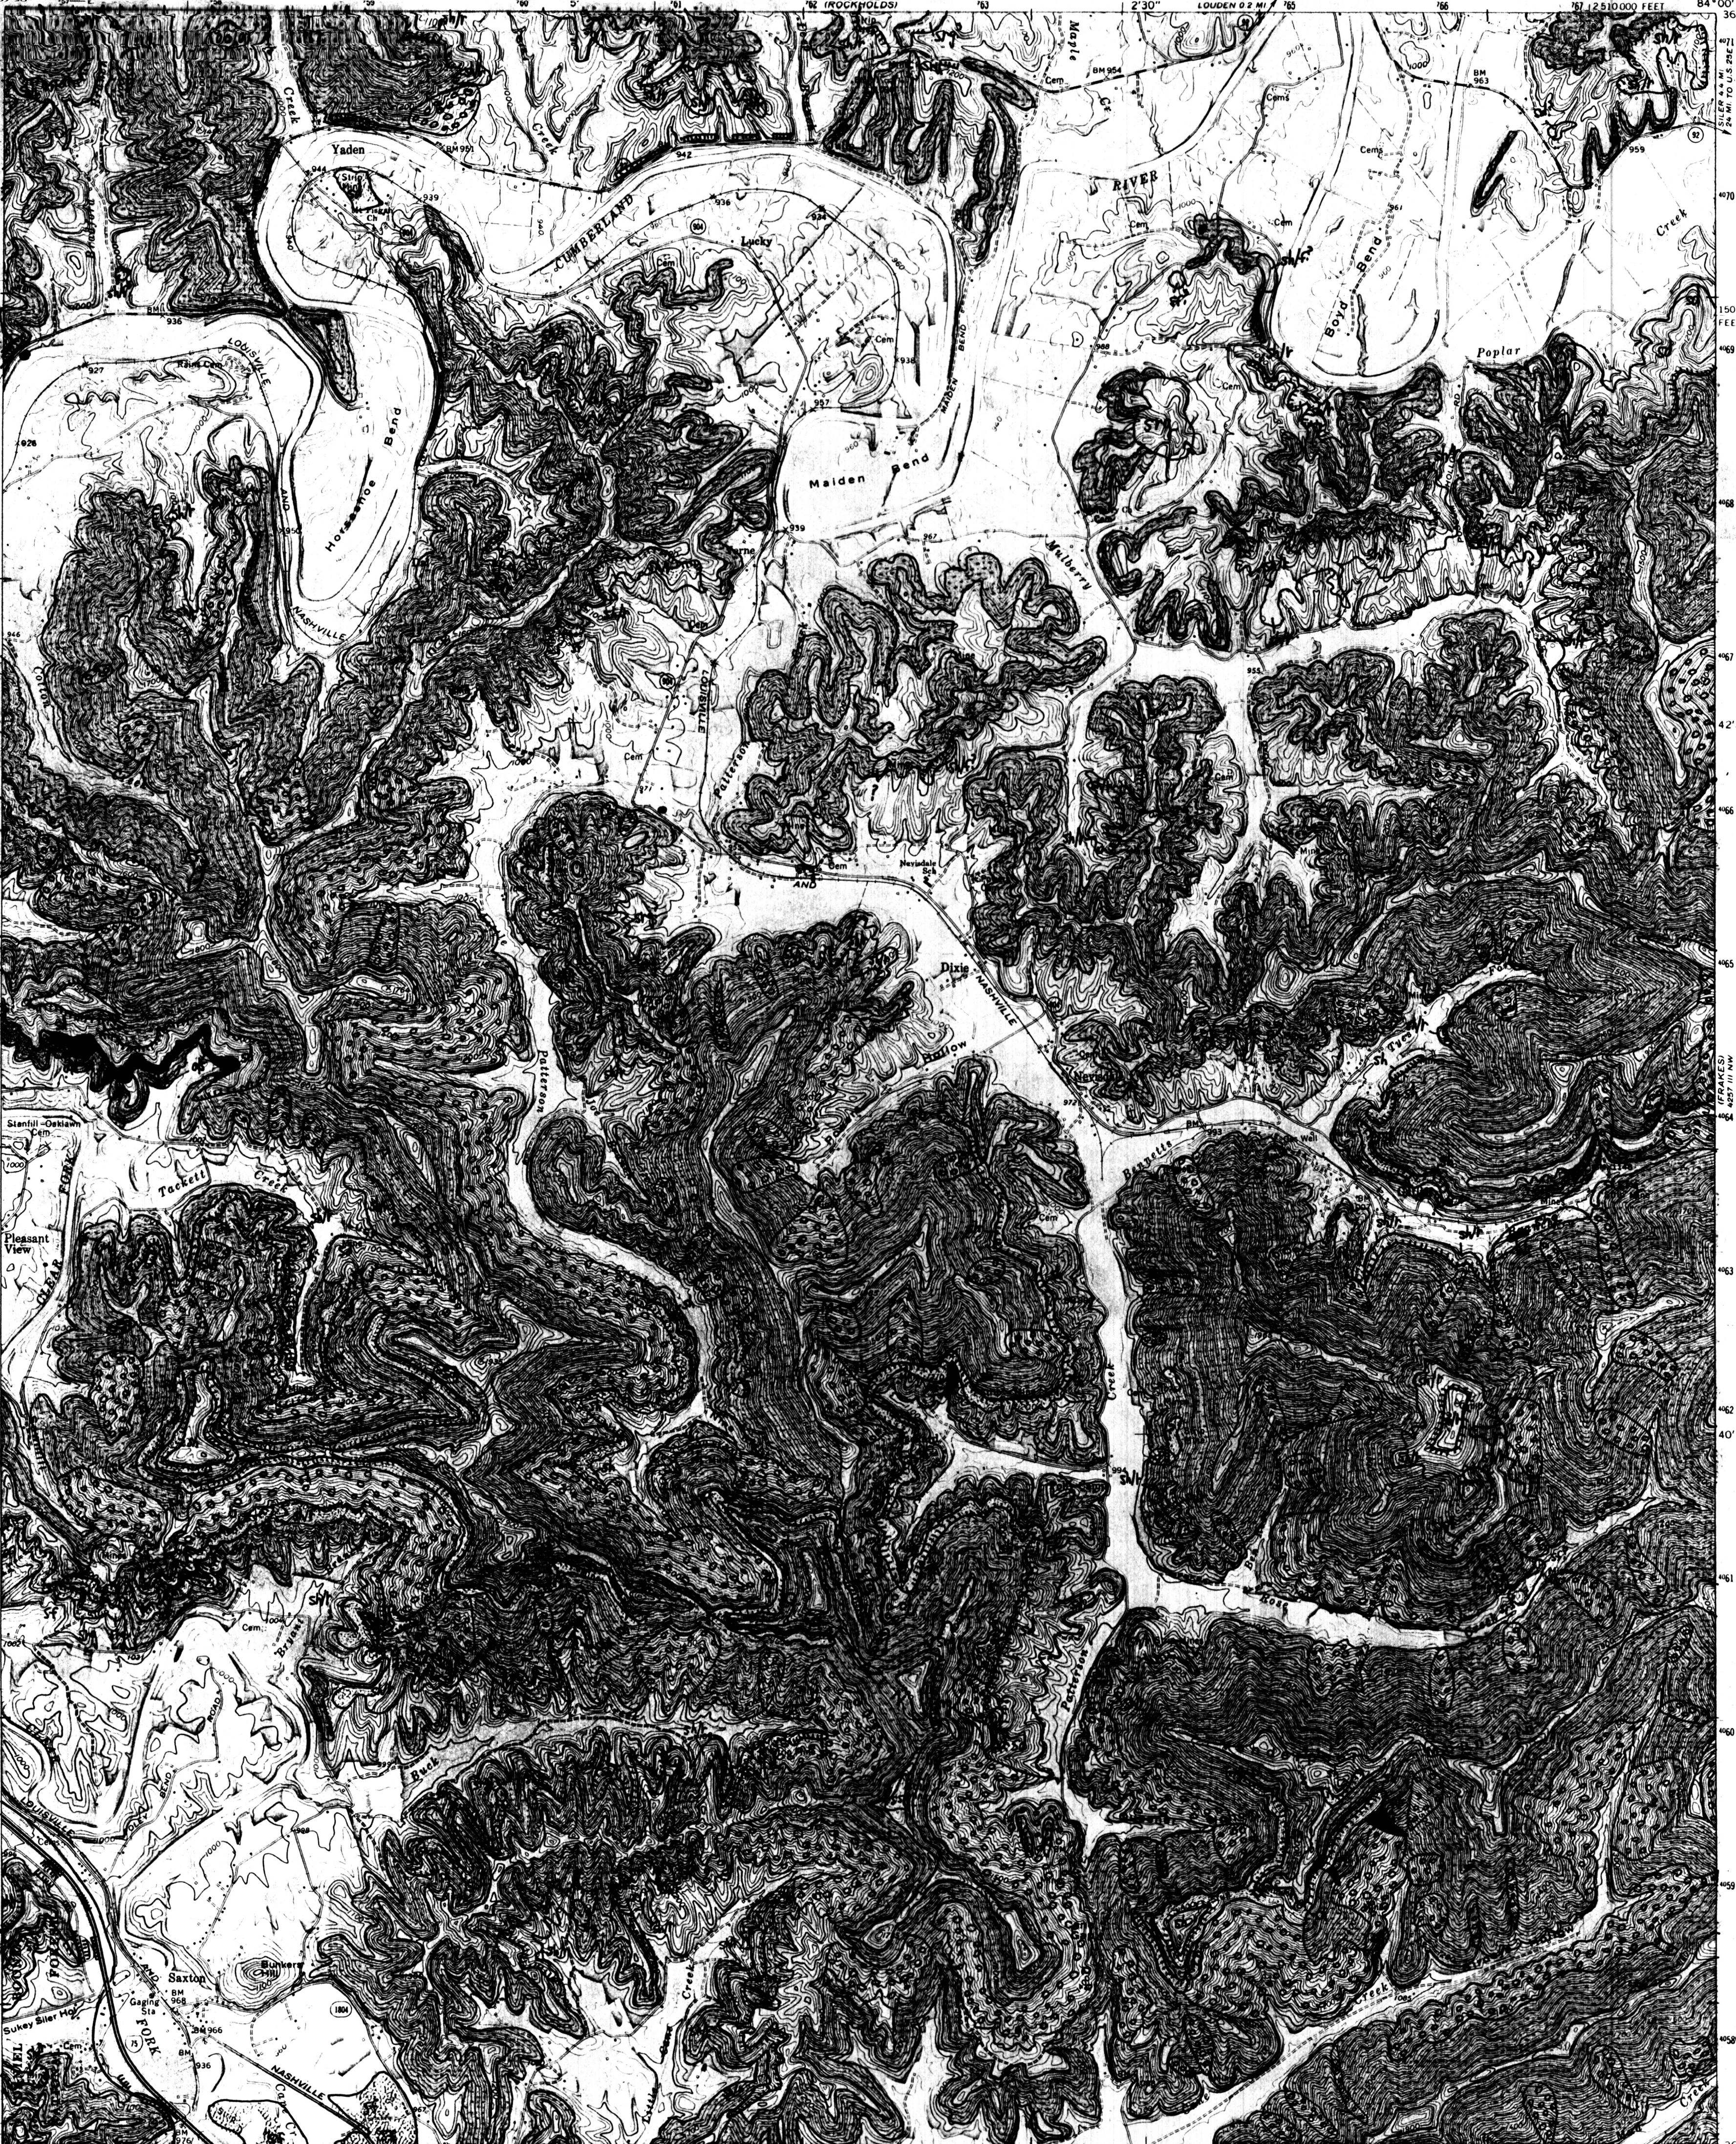
SAXTON, KY.  
NE 1/4 JELICO 15' QUADRANGLE  
N3637.5-W8400/7.5  
1970

Landslides and related features interpreted from aerial photographs:

### ACTIVE OR RECENTLY ACTIVE LANDSLIDE

Complex landslide composed of earthflow, debris slide, earth and rock slump. Identified from historical records, and from scars, debris and other field evidence. Ground extremely unstable; sliding accelerated by excavation, loading and changes in drainage conditions. May include areas with several active slides too small to be shown separately. Questioned where doubtful.

### OLD LANDSLIDE

Area of extensive hummocky ground caused by earthflow and earth and rock slump. Lacks clear evidence of active sliding. Relatively stable in natural, undisturbed state, generally not affected by small structures properly sited in areas away from the edge of the toe; can be reactivated by extensive, rapid excavation, loading, and changes in ground water and surface water conditions. Area of old landslide probably includes recent ones not identified from field evidence or otherwise documented. Upslope boundary of landslide generally defined by modified scarp, but downslope (toe) may be gradational and not well defined. Questioned where doubtful.

### COLLUVIAL SLOPE

Valley wall along major streams with slope as steep as 40° (85%); stony, clayey silt soil up to 50 ft. (15 m) thick; commonly buttressed by a terrace or bench at the toe of the slope; very susceptible to sliding by cutting of toe area, removal of terrace or bench, and overloading; slide commonly activated without apparent cause.

### AREAS SUSCEPTIBLE TO DEBRIS FLOWS AND DEBRIS AVALANCHES

Primarily shallow, narrow ravines and chutes with accumulation of stony colluvium generally 10 ft. (3 m) or less in thickness; susceptible to rapid movement during intense rainfall. Most ravines and chutes designated show evidence of former debris flows and avalanches.

### AREAS SUSCEPTIBLE TO ROCKFALL

Steep, locally vertical, natural and man-made slopes and cliffs, 15 ft. (4.5 m) or more high; formed dominantly of sandstone, limestone, sandy shale, mudstone and claystone. Interbedded mudstone, claystone and shale weather rapidly leaving sandstone and limestone rock faces unsupported.

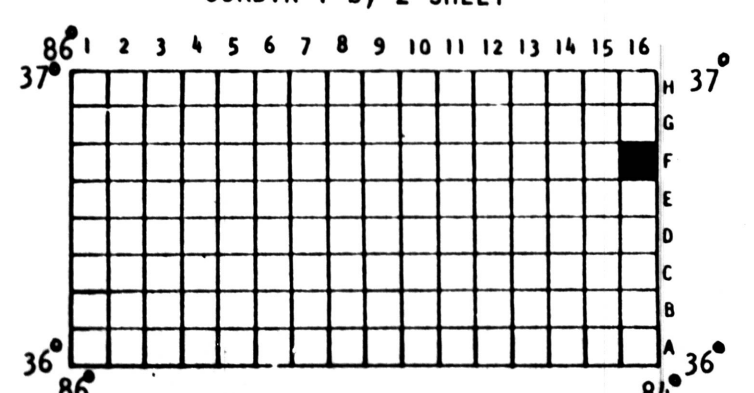
CORBIN 1 by 2 SHEET

The first five digits of the open file number designate the specific 1:250,000 scale map sheet of which this quadrangle is a part. The last two digits designate the position of the quadrangle in a subdivision of the 1:250,000 scale map based on rows and tiers shown in the diagram to the right. The location of this quadrangle is shown by the black square.
