Descriptions of the Animas River-Cement Creek Confluence and Mixing Zone near Silverton, Colorado, during the Late Summers of 1996 and 1997

U.S. Geological Survey Open File Report 2005-1064

by Laurence E. Schemel and Marisa H. Cox

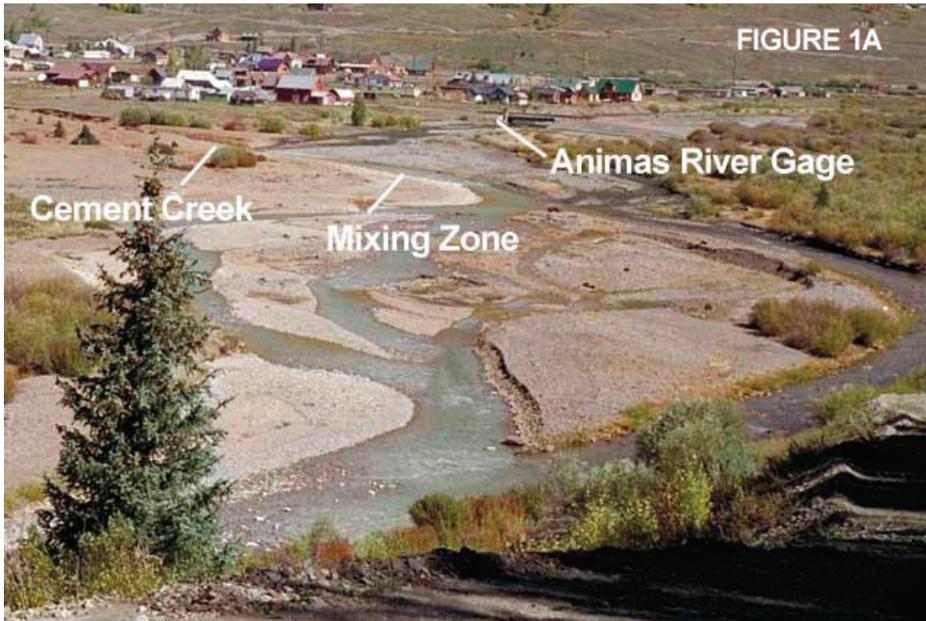
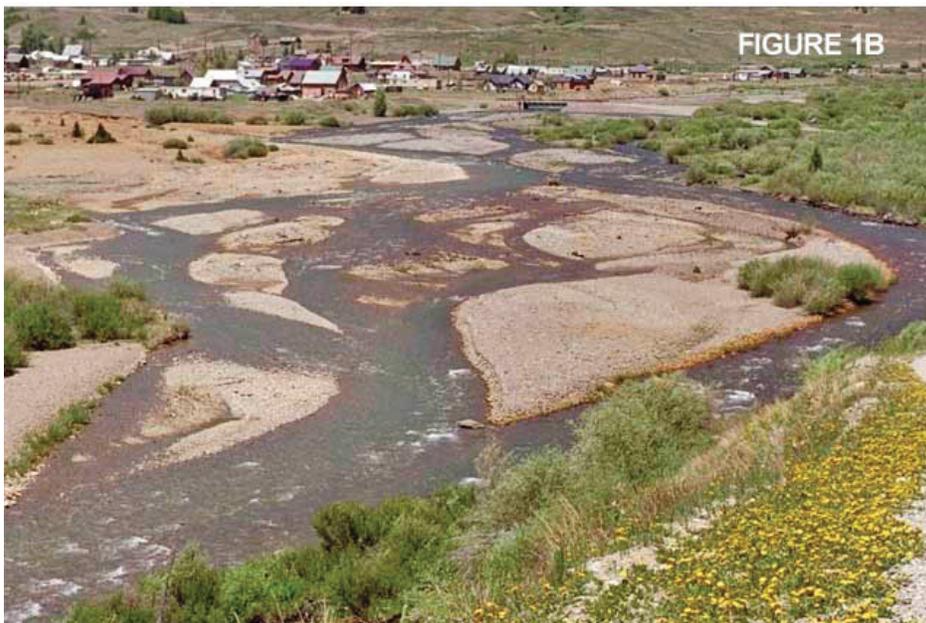
Figure 1 shows photographs of the Cement Creek-Animas River confluence and the network of channels downstream during late summer 1996 (A) and 1997 (B). Discharge from the upper Animas River flowed under the bridge at the location of the Animas River gage (shown in A). In both years, the river formed two main tributaries below the gage. The left-side (of the photograph) tributary discharged directly to the (primary) confluence with Cement Creek, and the right-side tributary flowed to locations downstream from the primary confluence. Most of the flow from the right-side tributary was carried by a channel (far right) around the area labeled “Mixing Zone” (Figure 1A) and the network of channels immediately downstream. Therefore, a secondary confluence of Animas River inflow with partially mixed waters from the Mixing Zone was located at bottom of the photographs shown in Figure 1. Consequently, complete mixing of Cement Creek with the Animas River occurred over several hundred meters in both years. In 1997, however, additional braiding of discharge from the Animas River was evident between the two main tributaries identified above. In addition to the left tributary, one braid discharged near the primary confluence with Cement Creek, and two additional braids discharged to the Mixing Zone downstream (Figure 1B). The distribution of inflow from the Animas River in 1997 neutralized inflow from Cement Creek in a more gradual fashion than had been the case in 1996, which preserved and intensified the across-channel gradients in the Mixing Zone that are described below.

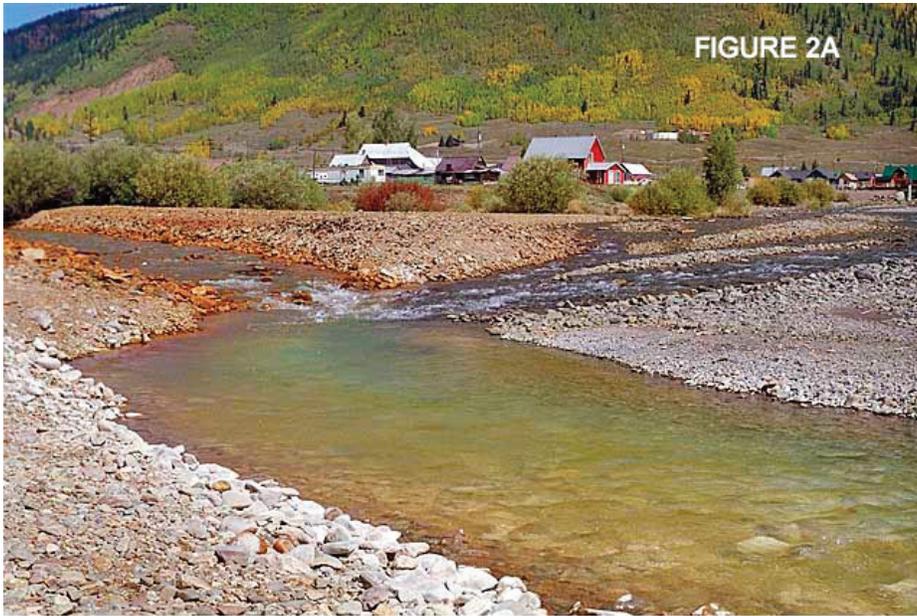
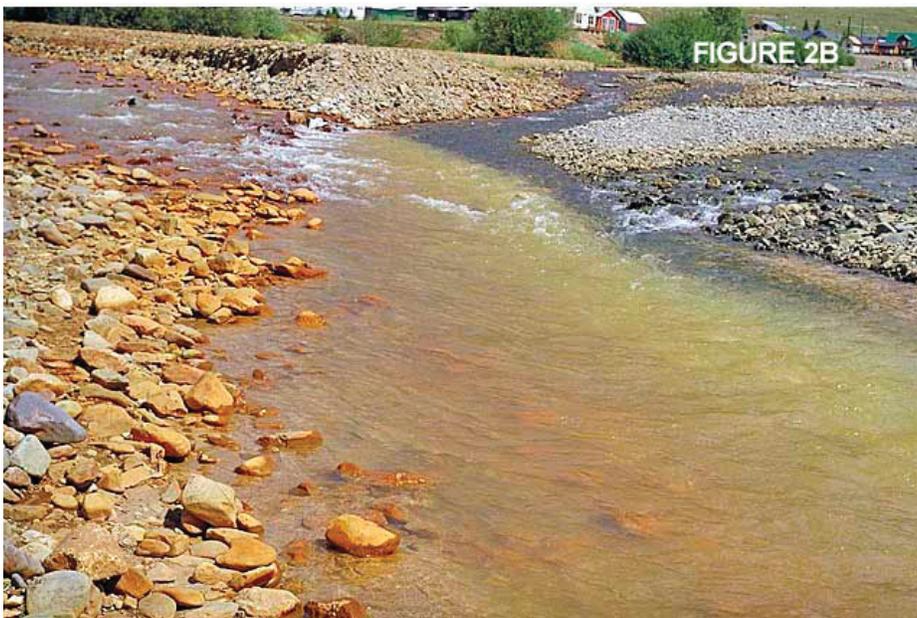
Figure 2 shows details of the confluence of Cement Creek (left inflow) and the Animas River (right inflow) in 1996 (A) and 1997 (B). Rocks that line the bank of Cement Creek were red because some (ferric) iron precipitated even at the low pH. The Animas River inflow was clear and the bank was not coated because concentrations of metals that would precipitate at its circum-neutral pH were relatively dilute. Mixing of the two streams resulted in the formation of colloidal particles of both iron and aluminum (oxy)hydroxides. The “opalescence” in the water column of the Mixing Zone was due to light refraction by the colloids. Precipitates coating the left-side bank of the Mixing Zone were iron- (red) and aluminum- (white) rich mixtures. In the Mixing Zone, red precipitates were found nearest the confluence (Figure 2B), but white precipitates generally dominated farther downstream (Figure 2A). As shown in both photographs, the water column was clear near the right-side bank and the rocks were not coated because the two source waters were not well mixed across the channel.

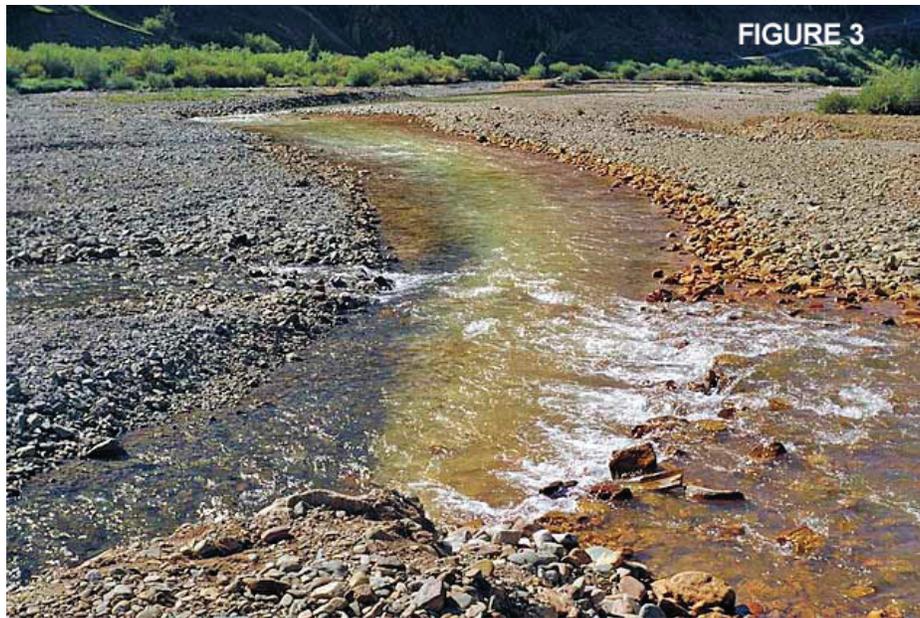
Figure 3 is a view of the Mixing Zone looking downstream from the confluence of Cement Creek with the first two inflows from the Animas River in 1997. It clearly shows the lack of coatings on bank rocks nearest the Animas River inflows and red coatings on the right-side bank, nearest inflow from Cement Creek. Although distinct banding was apparent in the Mixing Zone waters, this effect was primarily the result of coatings on the substrate. Red coatings near the right side indicated iron-rich precipitates, which can form at a pH lower than the pH range where aluminum precipitates. In mid-channel, white coatings indicated aluminum-rich precipitates formed as the pH was raised by mixing with the Animas River. The presence of additional inflows (braids) from the Animas River in 1997 preserved the banding pattern much farther downstream than was the case in 1996.
