HISTORICAL CHANGES IN THE MISSISSIPPI-ALABAMA BARRIER ISLANDS AND THE ROLES OF EXTREME STORMS, SEA LEVEL, AND HUMAN ACTIVITIES

Open-File Report 2007-1161

U.S. Geological Survey

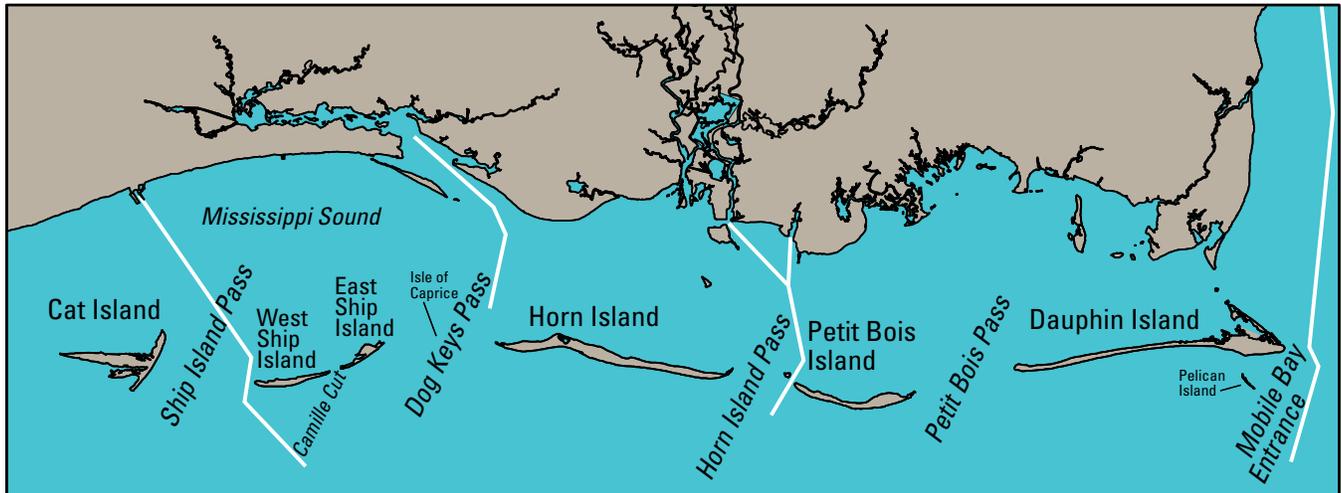
Figure 1. Locations of the Mississippi-Alabama barrier islands and associated tidal inlets. Deep draft shipping channels maintained by periodic dredging are shown as white lines.

Petit Bois Island in 1848 had an irregular shape with alternating narrow and wide segments, and sand spits and shoals on the extreme eastern and western ends. At that time the eastern end of Petit Bois was a remnant of Dauphin Island. Richmond (1962) presented a French exploration map of 1732 that showed a continuous barrier to the east that included what later became Petit Bois and Dauphin Islands. The same map also showed the recognizable shapes and orientations of Cat, Ship, and Horn Islands, so the general accuracy of the map is reliable. Otvos (1979) concluded that the elongated barrier spit of Dauphin Island was breached between 1740 and 1766, possibly as the result of the 1740 hurricane. The breach isolated Petit Bois Island from Dauphin Island and formed the intervening tidal inlet known as Petit Bois Pass (Fig. 1). The relatively wide eastern part

The most dramatic example of coastal change of a MS-AL offshore island was the rapid formation and destruction of the Isle of Caprice (Fig. 1). This relatively small sand island formed in Mississippi Sound as a result of barrier migration and changes in current patterns within Dog Key Pass. The Isle of Caprice, which was shown (but unnamed) only on the 1917 topographic map, emerged on the sand platform between Horn Island and Ship Island and became subaerial when sand deposited between two channels caused several small sand shoals to coalesce (Rucker and Snowden, 1988). In the mid 1920s, the Isle of Caprice was developed into a popular offshore entertainment center with cabanas, a gambling casino, restaurant, artesian potable water supply, electric power plant, and a ferry landing (Rucker and Snowden, 1988). By 1932, all of these physical assets had

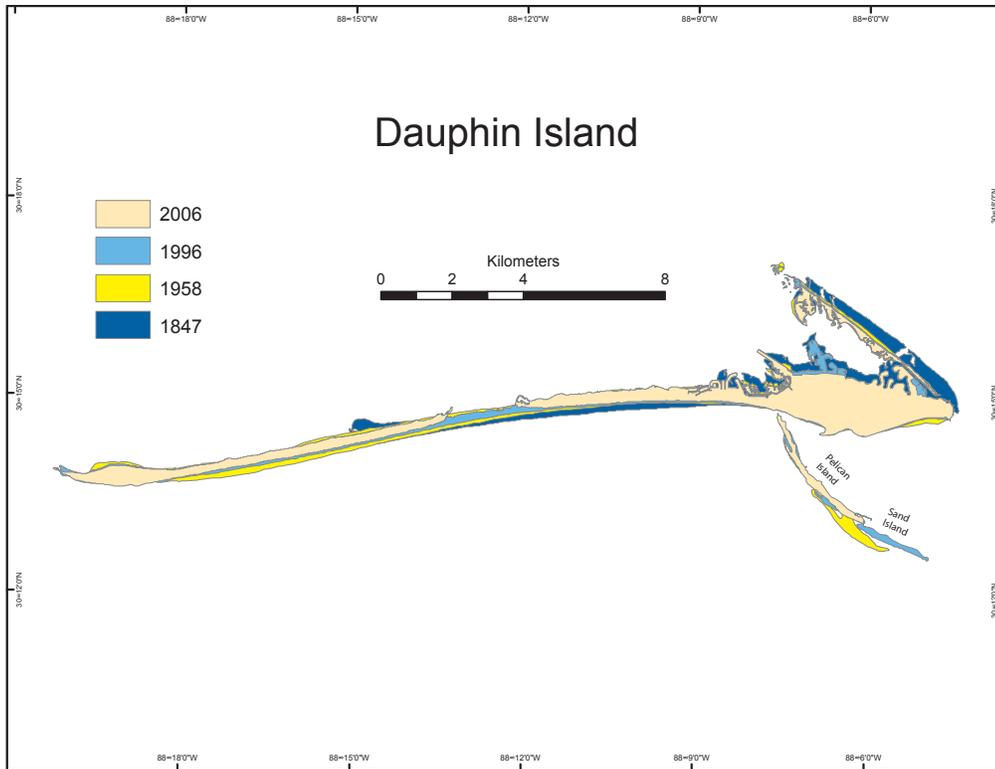
Figure 2. Morphological changes in Dauphin Island between 1847 and 2006.

The high and wide island core that anchors the eastern quarter of Dauphin Island maintained a stable position while this segment of the barrier gradually narrowed as a result of beach erosion along the Gulf and Sound shores. Changes for this eastern segment were minimized naturally by sand supplied to the Gulf shore by the ebb-tidal delta and its shoals, Pelican and Sand Islands. The shoals and emerged spits also protect the eastern end of the island from storm waves in the Gulf of Mexico. The island's eastern segment has been partly stabilized by groins and riprap around Fort Gaines and the construction of bulkheads along the Sound shores.

Before Petit Bois Island separated and migrated westward in the 18th century, Dauphin Island was the largest island of the MS-AL island chain. Those events significantly reduced the size of Dauphin Island and provided space for its subsequent growth. In contrast to the relatively stable eastern end, the narrow western three-fourths of the island has changed dramatically as a result of two independent processes. The island has grown westward at its western terminus as a result of lateral spit accretion and inlet migration (Fig. 2). In fact the downdrift end of the island has grown so far westward that it overlaps the former eastern end of Petit Bois Island in the mid 1800s (Fig. 3). Also the narrow island segment has migrated landward primarily as a result of Gulf beach erosion and storm overwash fan deposition. Waves and currents generated in the Sound subsequently rework the fans and much of the washover sand is incorporated into the sandy shoal platform and molded into large subaqueous bedforms. The topographic map of 1853/54 shows that Dauphin Island was breached in two places by wide inlets opened as a result of hurricanes in the northern Gulf in 1851 and 1852 that caused abnormally high tides at Mobile (U.S. Army Corps of Engineers, 1965a). The breaches were not open at the time of the 1847 topographic survey.

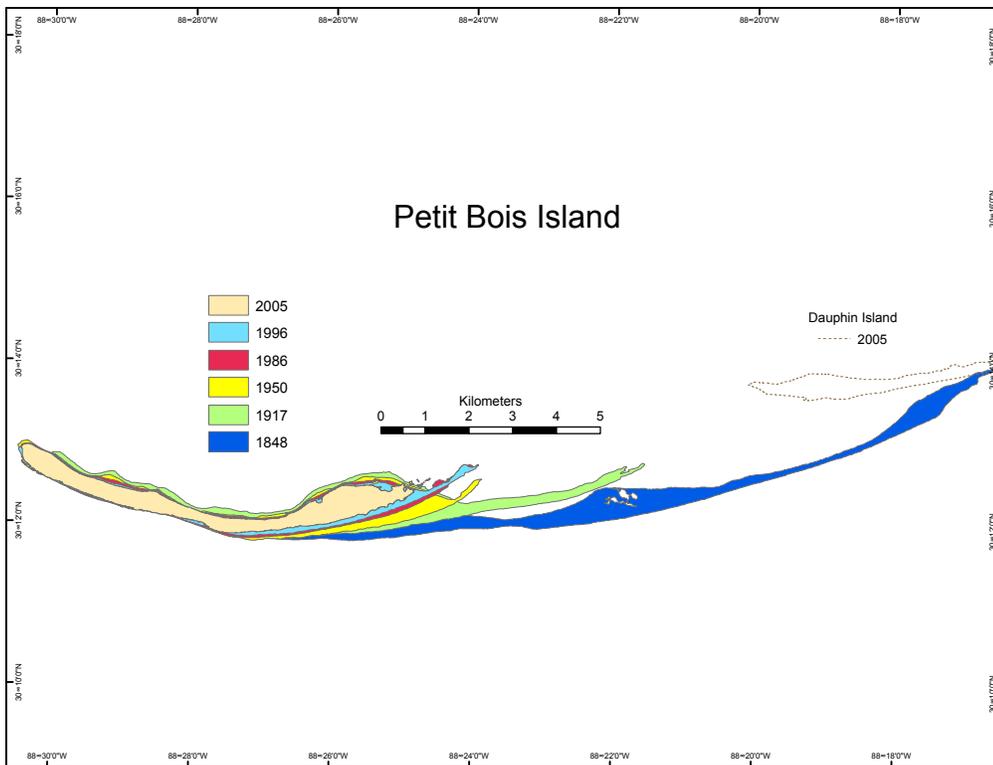
Figure 3. Morphological changes in Petit Bois Island between 1848 and 2005.

The barrier island that underwent the most rapid and radical historical changes was Petit Bois. This is illustrated by monitoring the wide triangular segment of the island, which was located on its extreme western end in 1848 (Fig. 3). By 1917 the eastern part of the island had eroded and retreated so much that the wide triangular segment was located in the center of the island. Subsequent erosion of the eastern spit and extension of the western spit caused the stable wide segment to form the eastern end of the island by 1950. Since then, Petit Bois has continued to narrow and the eastern shore has rotated counterclockwise as a result of wave refraction and associated differential erosion and overwash along the eastern Gulf beach.

Between 1848 and 2005 Petit Bois Island lost 54% of its land area (Table 2). Although they were the highest for any of the MS barriers, rates of land loss for the first period of record (1847 and 1917) were relatively low at about 1.5 ha/yr. Since then rates of land loss have progressively increased and between 1917 and 1960 they averaged 3.9 ha/yr. Land loss rates decreased slightly between 1950 and 1986 to 2.3 ha/yr, but they accelerated between 1986 and 2005 to 8.5 ha/yr. Within that period the most recent average rates of land loss (2000-2005) were highest at 16 ha/yr.

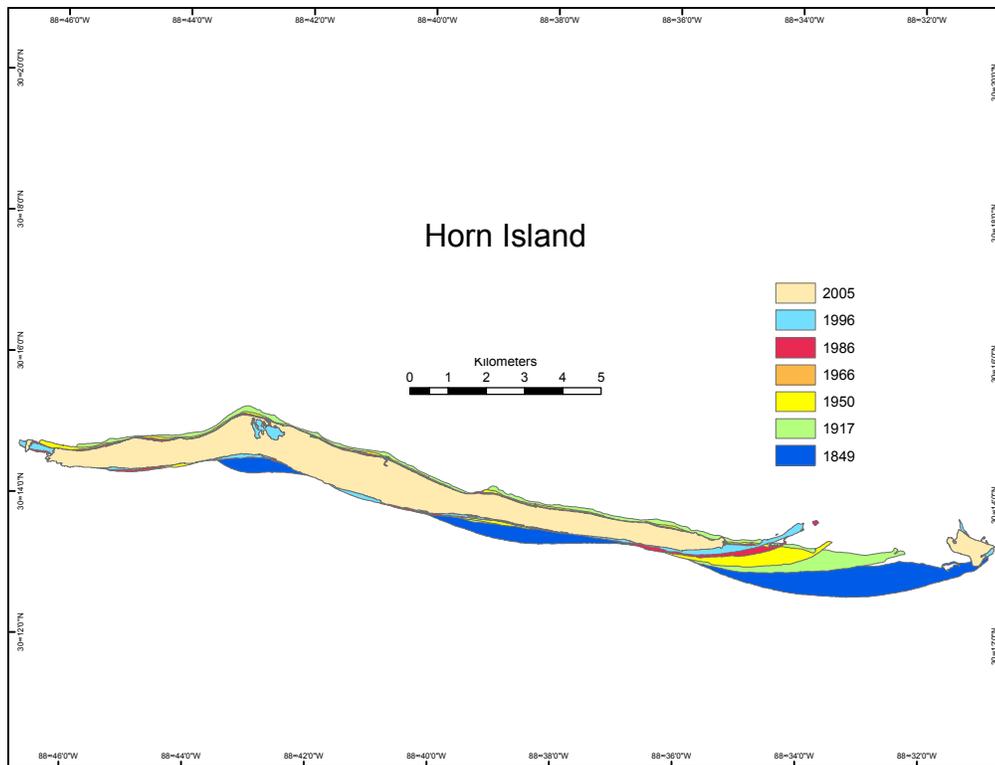
Figure 4. Morphological changes in Horn Island between 1849 and 2005.

The long-term morphological changes recorded for Horn Island (Fig. 4) were similar to those recorded for Petit Bois Island. The eastern part of Horn Island eroded substantially and some of that sediment was transferred to the western tip of the island that grew by lateral spit accretion. The island orientation changed where the spit attached to the former western end of the island. The island also narrowed as a result of beach erosion around the island perimeter. There was some accretion of the Gulf shore that caused the island to widen while it retained the quasi-sinusoidal alongshore pattern. Like Petit Bois, Horn Island lost substantially more land area on the eastern end than it gained on the western end, and the eastern end rotated counterclockwise as a result of wave refraction and associated differential erosion.

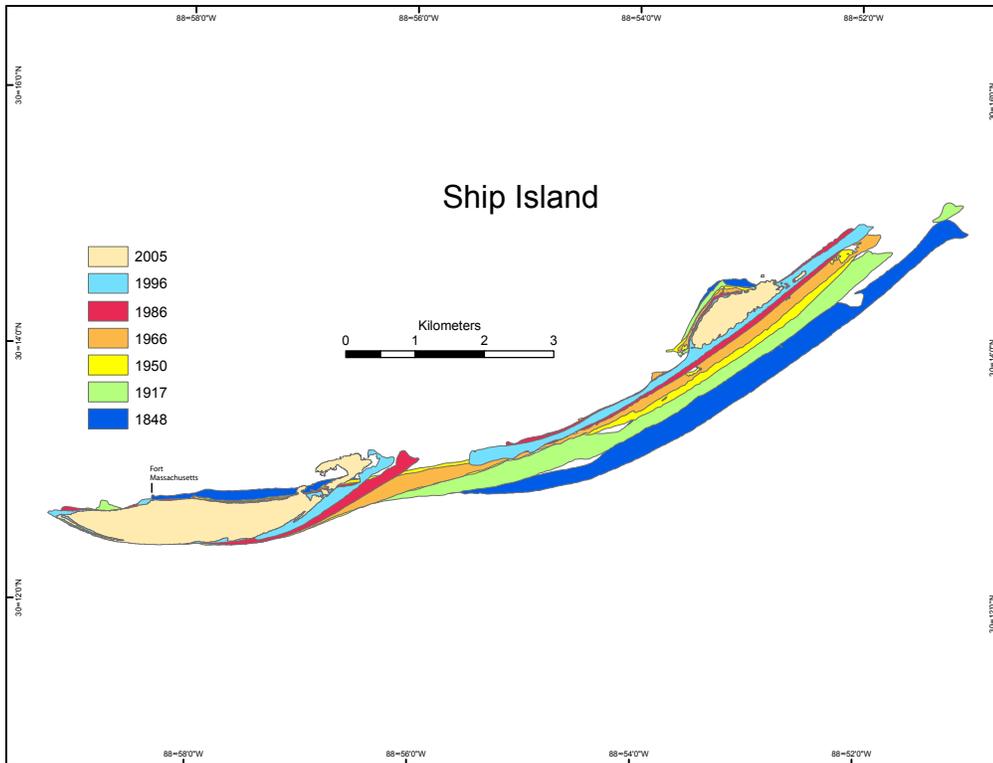
Figure 5. Morphological changes in Ship Island between 1848 and 2005.

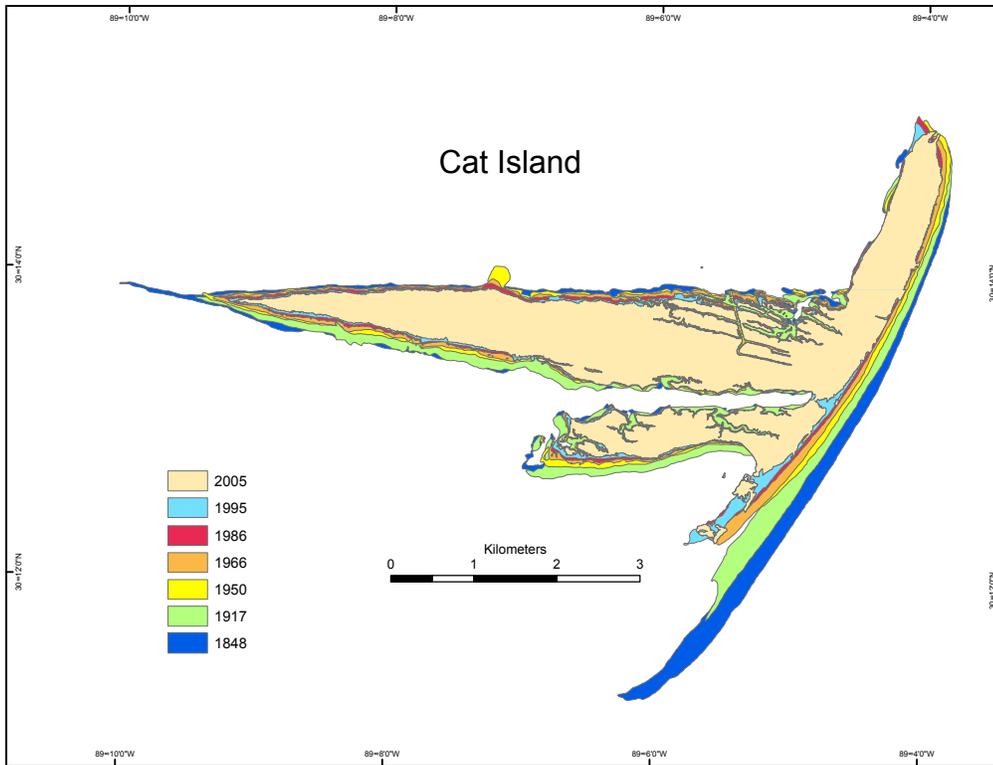
Figure 6. Morphological changes in Cat Island between 1848 and 2005.

The island that has shown the least morphological change is Cat Island (Fig. 6), which has remained a relatively stable landform throughout its recent history. This is because interior elevations and the orientation of Cat Island prevent breaching, and overwash by storm waves except along spits of the eastern shore. Although the core of the island has not moved, the island perimeters have shifted as a result of substantial unequal erosion along the east facing shore. Greater erosion along the southern spit compared to the northern spit caused a clockwise rotation of shoreline position, spit shortening, and retreat of the western spit. Erosion around the rest of the island has caused island narrowing.

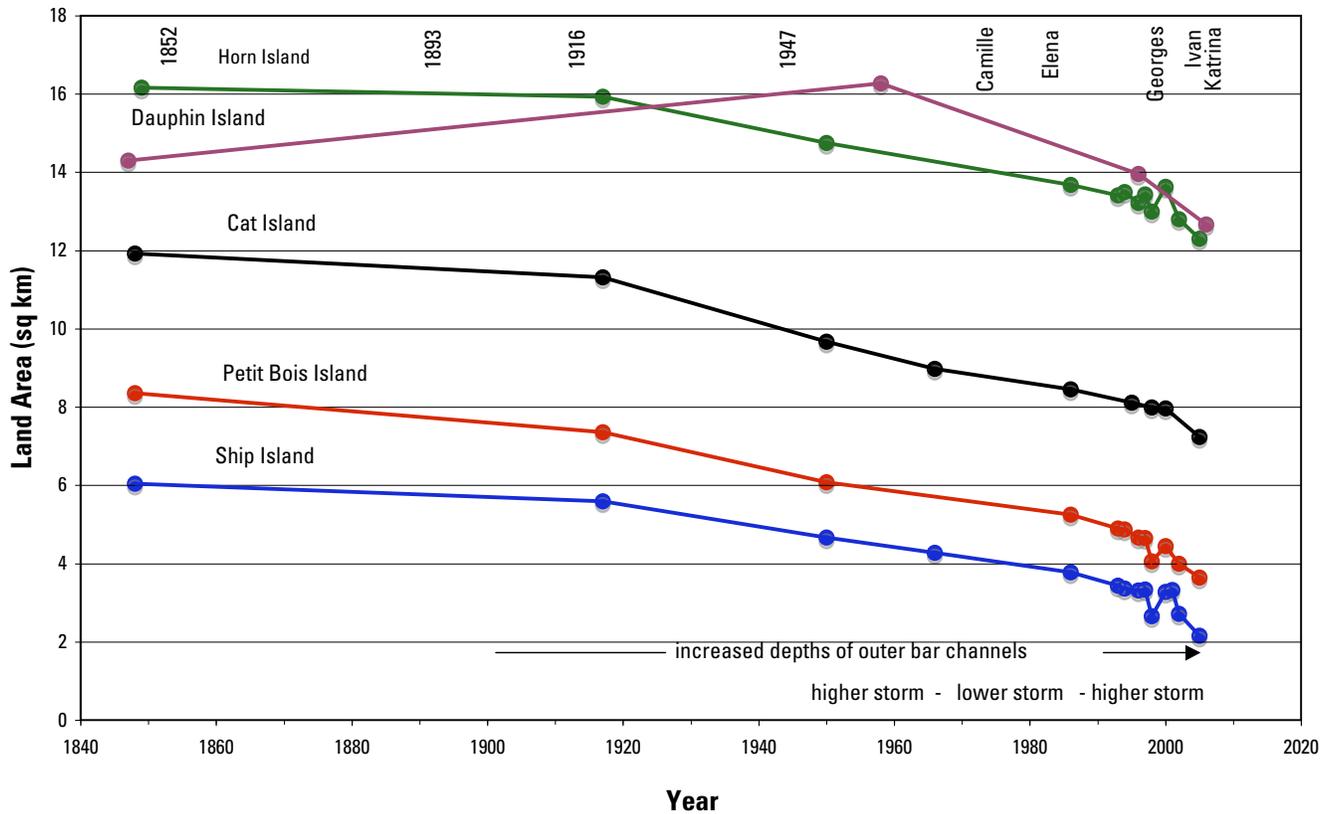
Figure 7. Historical land loss trends for the Mississippi-Alabama barrier islands relative to the timing of major hurricanes and human activities that impacted the islands.

The remarkable temporal similarity of generally accelerated rates of land loss for each of the MS-AL barrier islands (Fig. 7) suggests that one or more of the primary regional factors causing land loss has changed dramatically since the mid 1800s. The three most likely causes of land loss in the Gulf coast region are frequent intense storms, a relative rise in sea level, and a reduction in sediment supply (Morton, 2003).

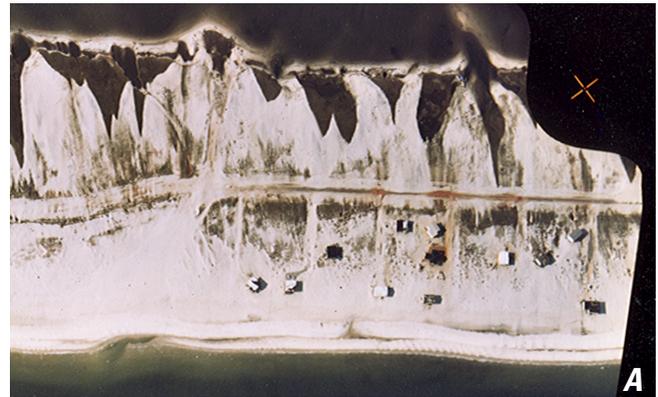
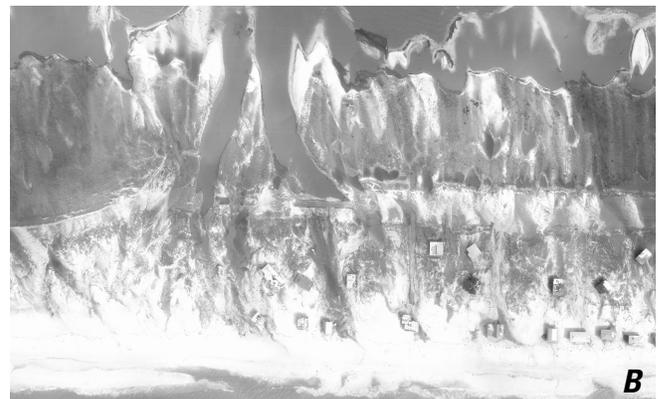
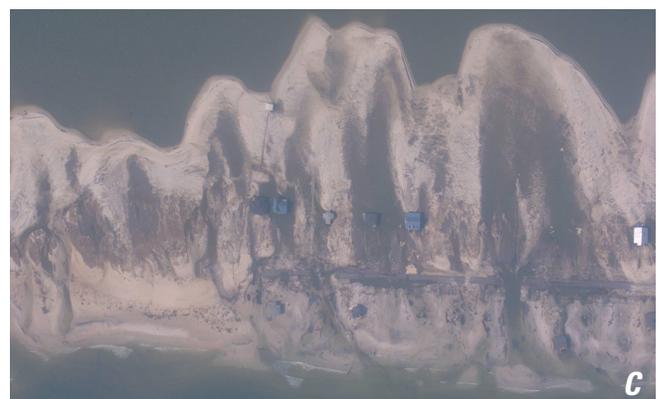
Figure 8. Impacts of A. Hurricanes Camille (1969), B. Frederic (1979), and C. Katrina (2005) on Dauphin Island. Photographs taken after landfall by the National Oceanic and Atmospheric Administration and the Florida Department of Transportation.

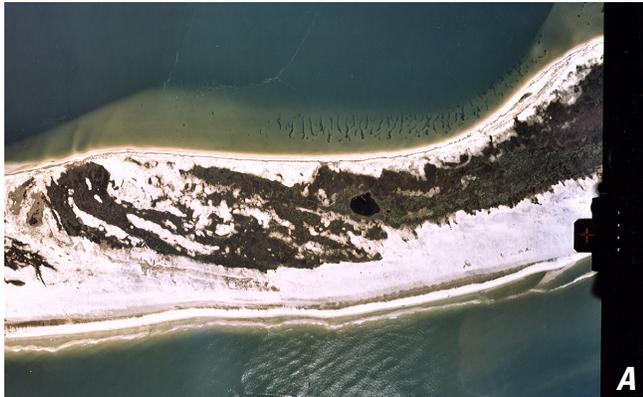
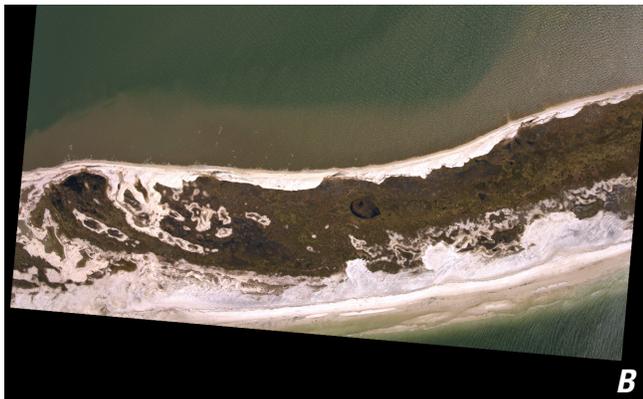
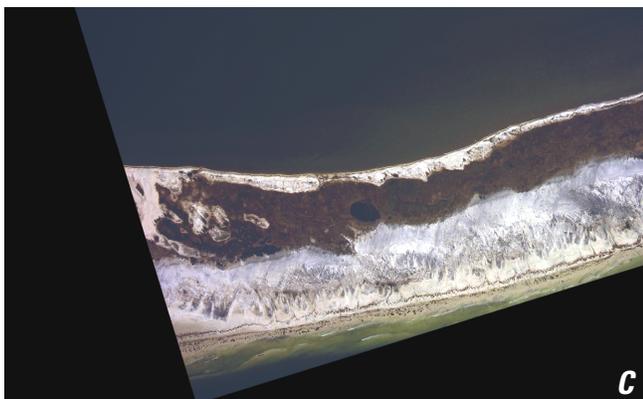
Figure 9. Impacts of A. Hurricanes Camille (1969), B. Ivan (2004), and C. Katrina (2005) on Petit Bois Island. Photographs taken after landfall by the National Oceanic and Atmospheric Administration.

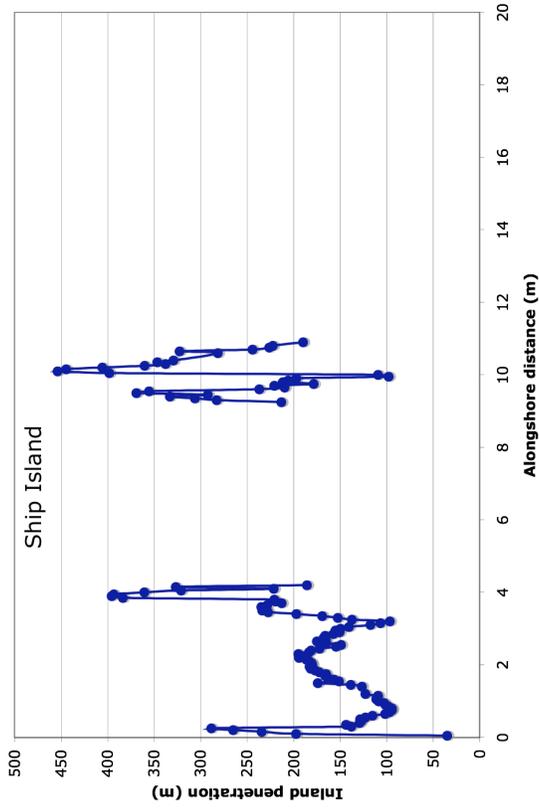
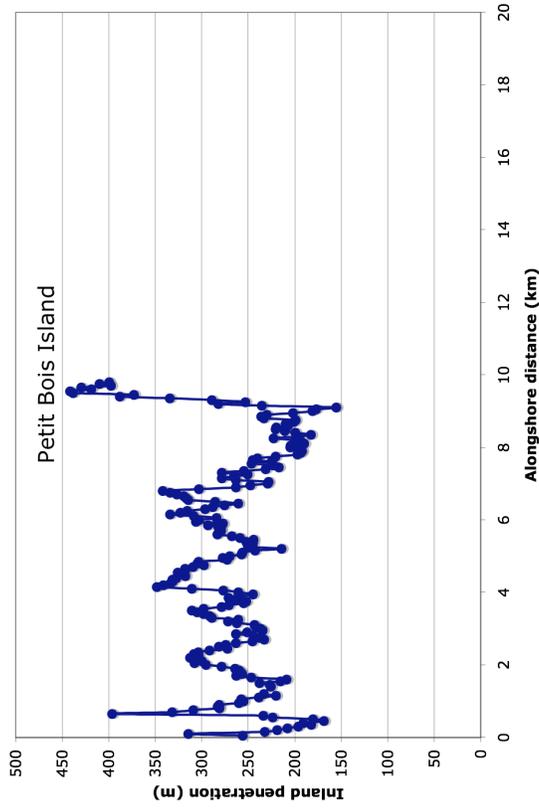
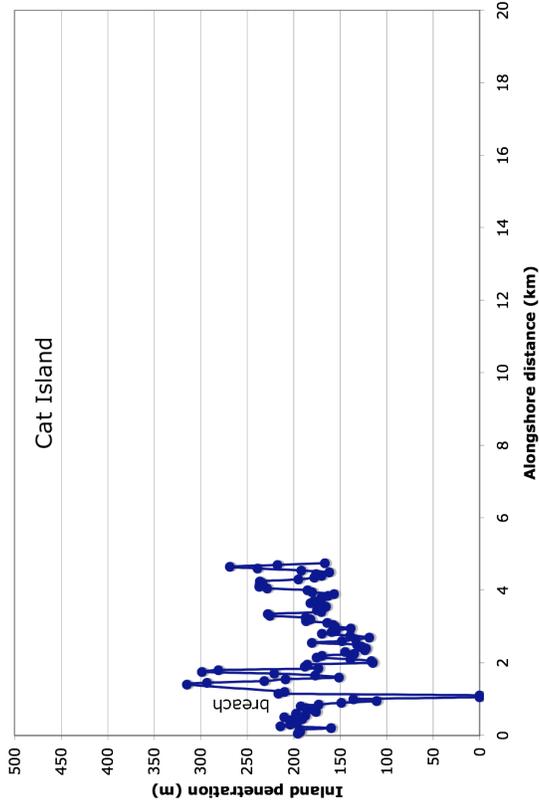
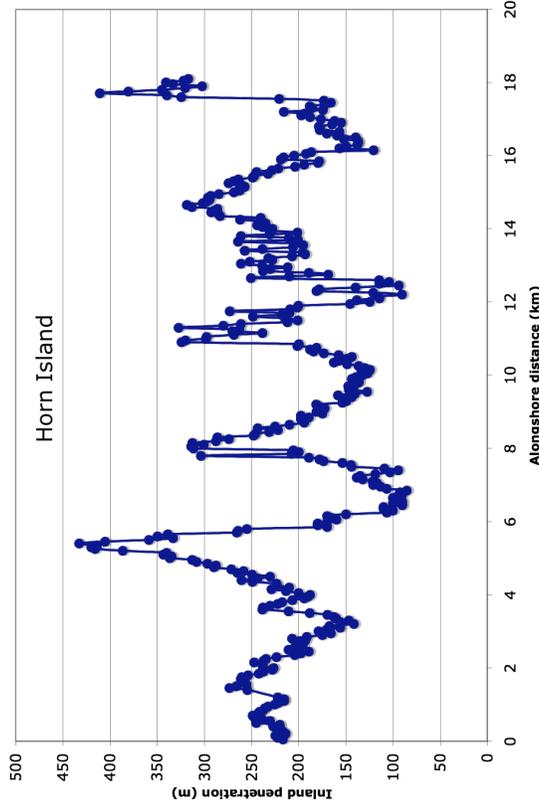
Figure 10. Inland penetration of washover sand deposited by Hurricane Katrina on the Mississippi barrier islands. Measurements were made on post-storm aerial photographs taken by the National Oceanic and Atmospheric Administration. Baseline for measurements was the pre-Katrina shoreline.
