ABSTRACT

Bathymetry of Totten Reservoir, Montezuma County, Colorado, 2011

By
Michael S. Kohn
2012

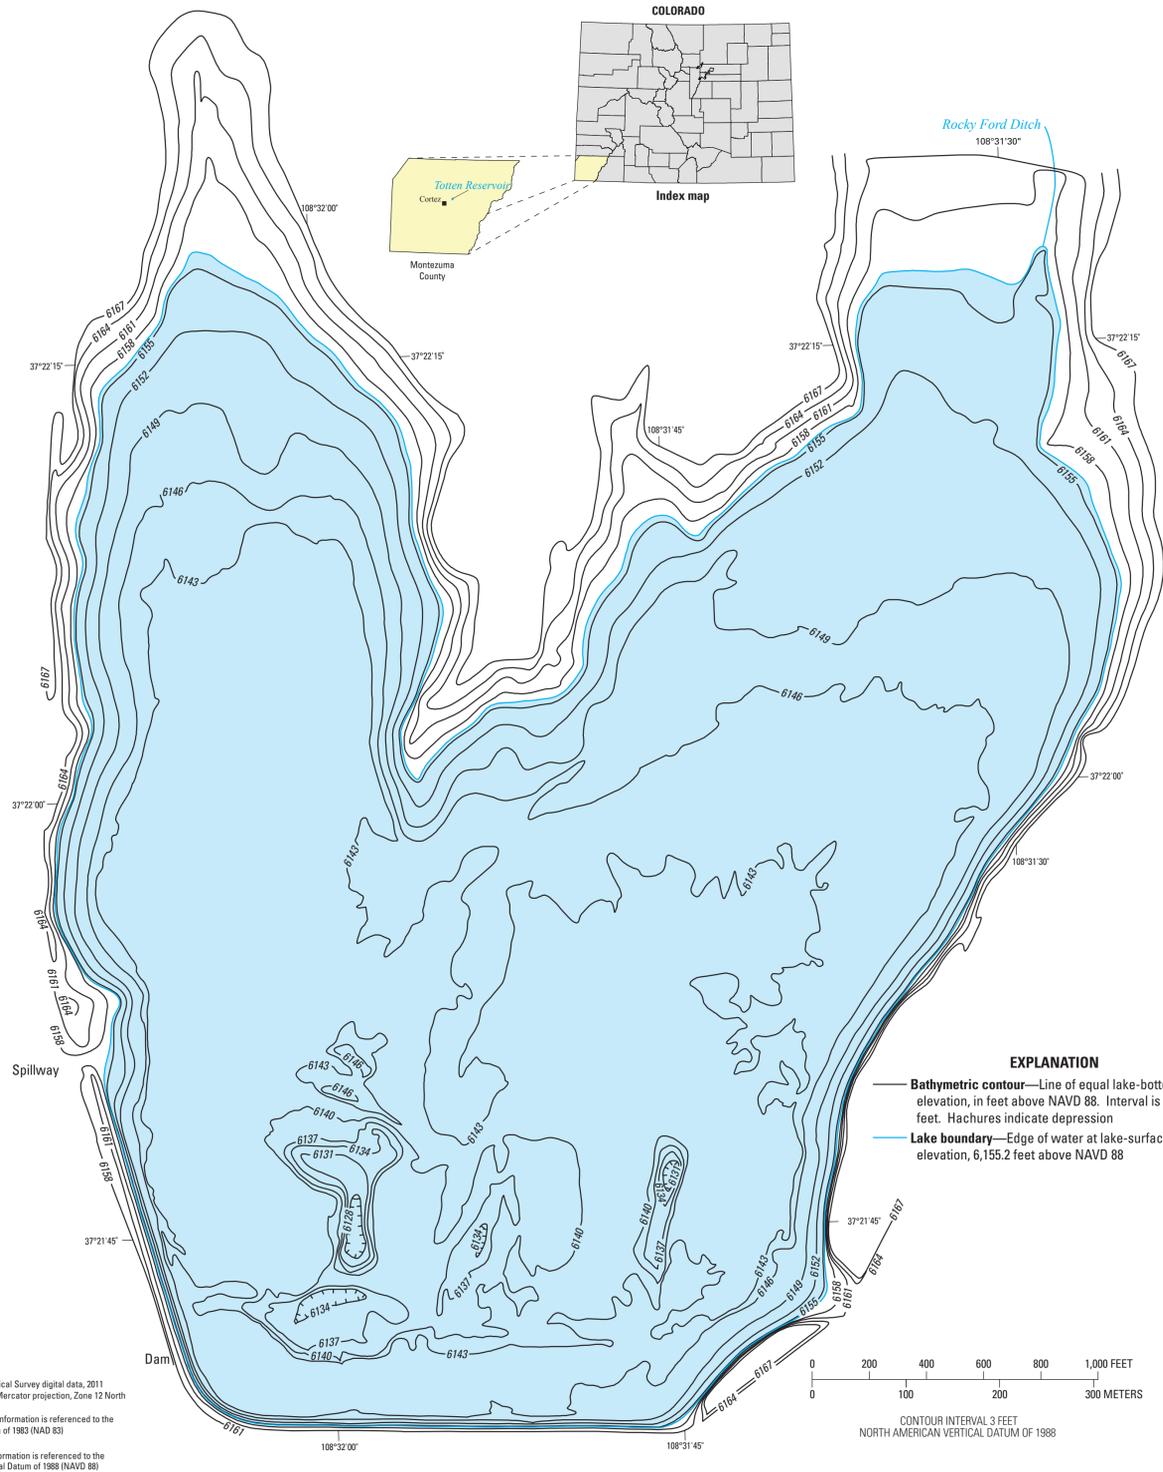
Figure 1. Bathymetric contours of Totten Reservoir, Montezuma County, Colorado, 2011 (not for navigational use).

The bathymetric dataset was imported into Environmental Systems Research Institute (ESRI) ArcMap 9.3.1 (Environmental Systems Research Institute, Inc., 2010) so the elevation contours and reservoir area and volume could be determined from the lake bottom to approximately 2–3 ft above the top of dam. Once the 6.56-ft grid was created using HYPACK 2011, it was merged with the RTK GPS dataset in ArcMap by generating a triangulated irregular network (TIN) from both datasets. The TIN was then converted to a 6.56-ft horizontal grid, and using the contour tool in ArcMap, contours at intervals of 3 ft were produced. The areas and volumes at various elevations were computed using the surface volume tool in ArcMap (figs. 1–3, and table 1).

In figure 1, some of the upper contours are not continuous; this is mainly due to the spillway not allowing for the continuation of the contours as the spillway invert is below the elevation of the top of the dam. However, at the northeast end of the reservoir, near the inlet, sufficient data were not collected to resolve the contours causing the breaks. Where breaks in contours occurred, it was assumed the areas and volumes above that point were computed as if a vertical wall existed at that point. That assumption provided better results than using a high resolution digital elevation model. When comparing the 10-meter digital elevation model (DEM) (Gesch and others, 2002) at the reservoir with the data collected, it appeared that the DEM did not provide sufficient accuracy to improve the dataset collected for this report. Therefore, no DEM was used to supplement the dataset and the results of this report were generated only from field data.
