Geomorphic Segmentation, Hydraulic Geometry, and Hydraulic Microhabitats of the Niobrara River, Nebraska— Methods and Initial Results

Scientific Investigations Report 2009–5008

By Jason S. Alexander, Ronald B. Zelt, and Nathaniel J. Schaepe

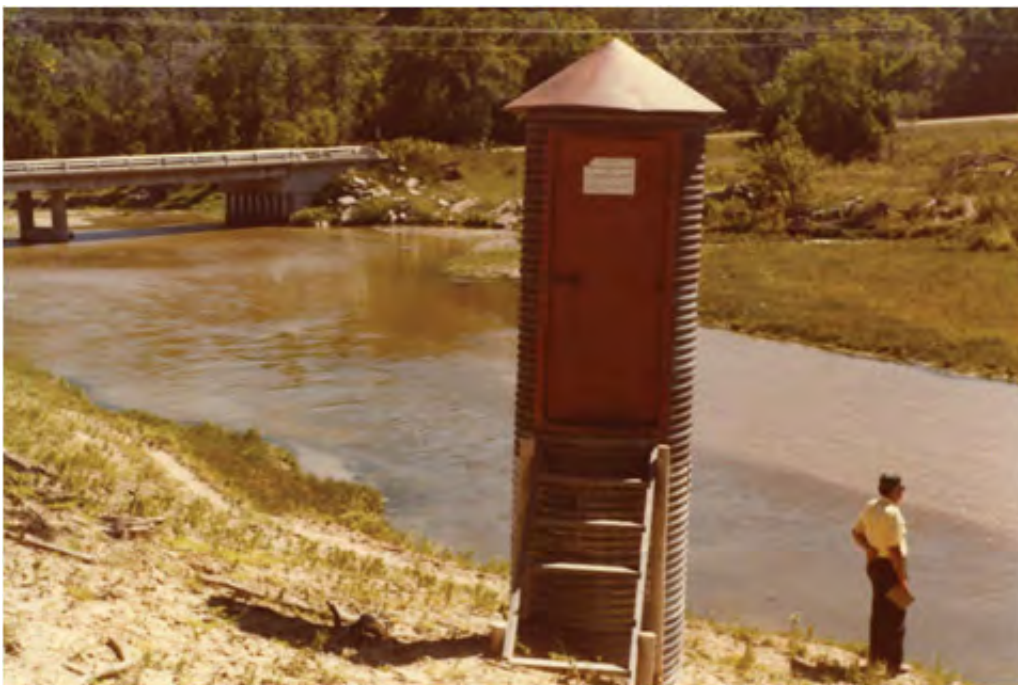
Figure 1-1. Photograph of the Niobrara River near Gordon streamflow-gaging station reach. Photograph was taken looking downstream. The gage house is in the foreground. Many of the measurements were made near the upstream face of the bridge. (USGS file photograph)

At a bridge crossing, located 11 mi south of Gordon, Nebr., and approximately 16 mi downstream from the Pine Creek confluence, the USGS and NDNR operated a streamflow-gaging station from 1946 to 1993. The original streamflow gage was located 4 mi downstream from this location and operated intermittently between August 1928 and September 1932. Channel width varied considerably upstream and downstream from the bridge, but the channel itself was fairly straight and shallow. The streambed consisted of sand and silt and shifted considerably. The left bank was high and did not have a significant amount of vegetation. The right bank was low, covered in woody vegetation, and subject to overflow at higher magnitude discharges. Most measurements were made while wading. Only a few high-magnitude discharge measurements were made; these measurements were made from the bridge.

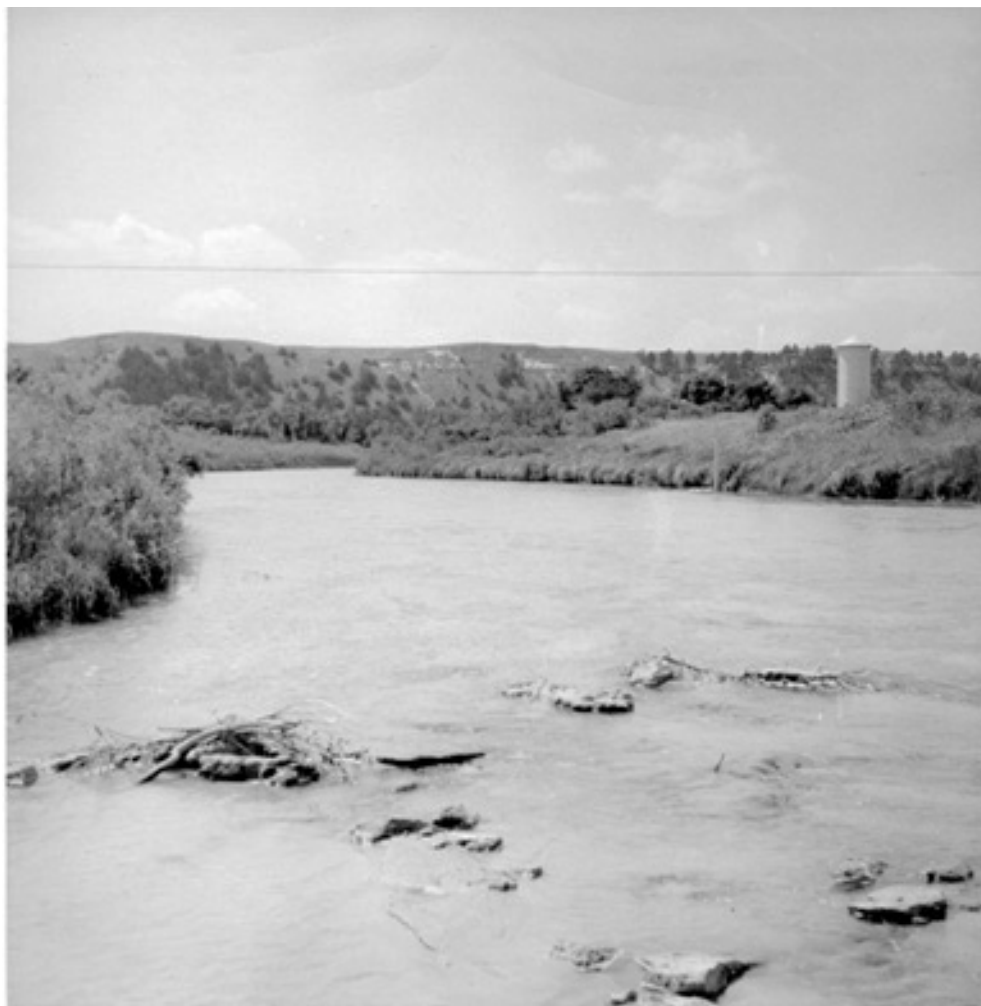
Figure 1-2. Photograph of the Niobrara River near Cody streamflow-gaging station reach. Photo was taken looking upstream. The gage house can be seen on the left river bank (right side of photo). The cableway can be seen one-third distance down from the top of the photo. Most measurements were made by wading underneath the cableway. High-flow measurements were made using the cable car. (USGS file photograph)

The USGS operated a streamflow gage 10 mi south of Cody, Nebr., from 1948 to 1957, located 5 mi downstream from the Bear Creek confluence, and a quarter mile upstream from an unnamed county road bridge. The channel was straight and uniform 500 ft upstream and downstream from the gage. The right bank was low and was overtopped during high-magnitude discharges, whereas the left bank was higher in elevation and rarely overtopped. The bed of the channel was gravel and the slope was steep enough to produce increased velocities during average flow conditions. A bedrock and gravel riffle extended from 50 ft below the gage on the left bank to about 200 ft below the gage on the right bank. The riffle was fairly persistent but subject to some shifting. During low flows the stream was waded, but during high-magnitude flows a cableway located 40 ft downstream from the gage was used for measurements.

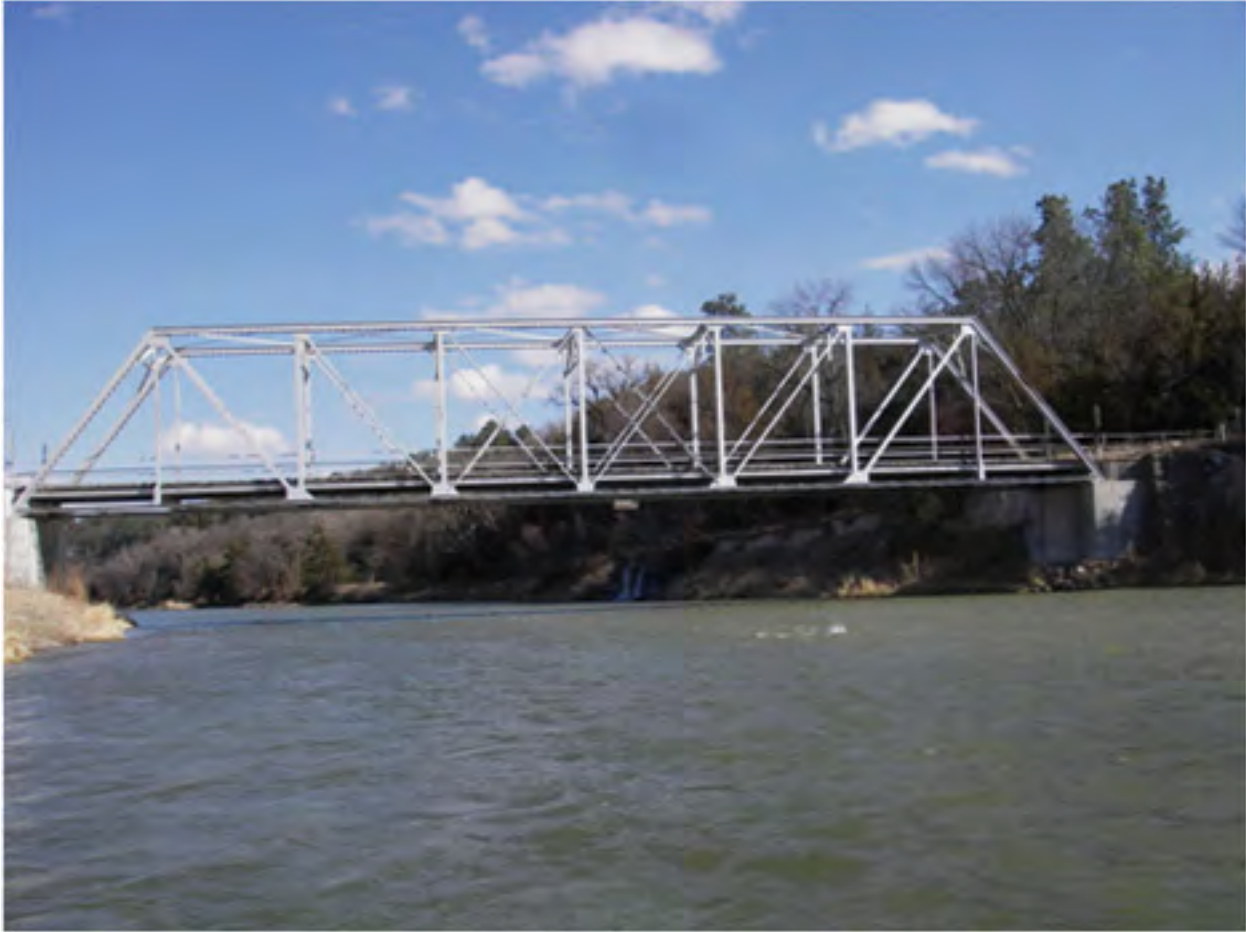
Figure 1-3. Photograph of the Niobrara River near Sparks streamflow-gaging station reach. Photo was taken looking downstream. The gage house is on the left bank, immediately downstream from the bridge. Most discharge measurements were made by wading downstream from the bridge. High-flow measurements are made from the bridge. (Photograph taken by Ronald Zelt, USGS).

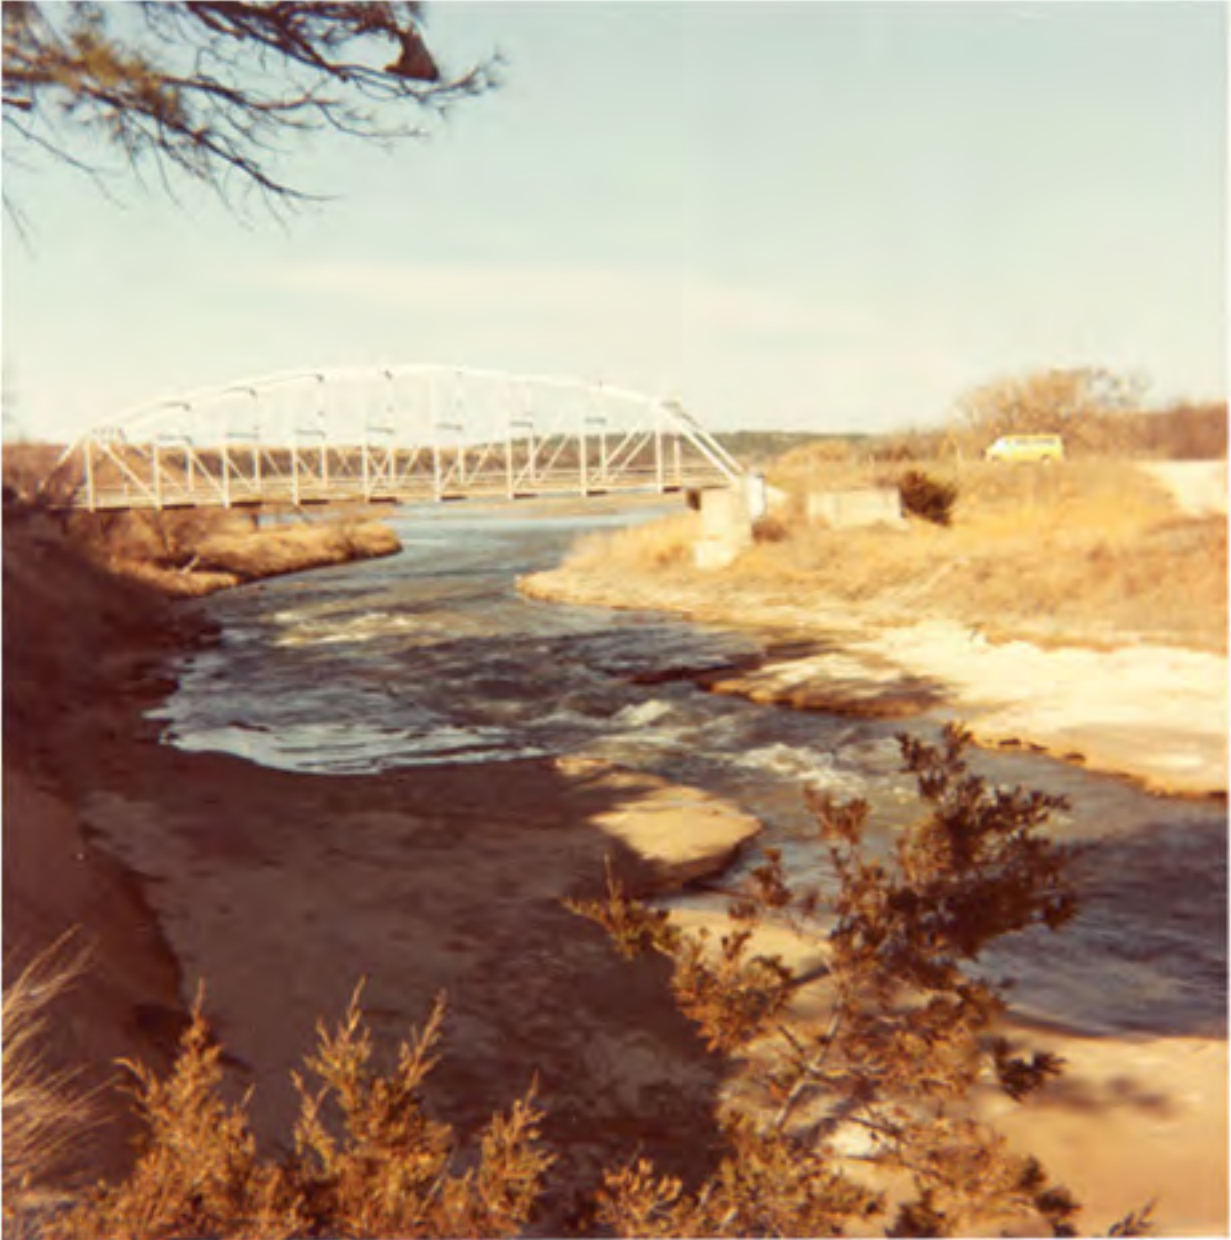
Figure 1-4. Photograph of the Niobrara River near Norden streamflow-gaging station reach. Photo was taken looking upstream from the right river bank. The gage house can be seen on the left river bank (right side of photo), just downstream from the bridge. Discharge measurements were made by both wading and using the bridge. However, only bridge measurements were used for the hydraulic geometry relation. The bedrock notch is now located several meters upstream from the bridge. (USGS file photograph)

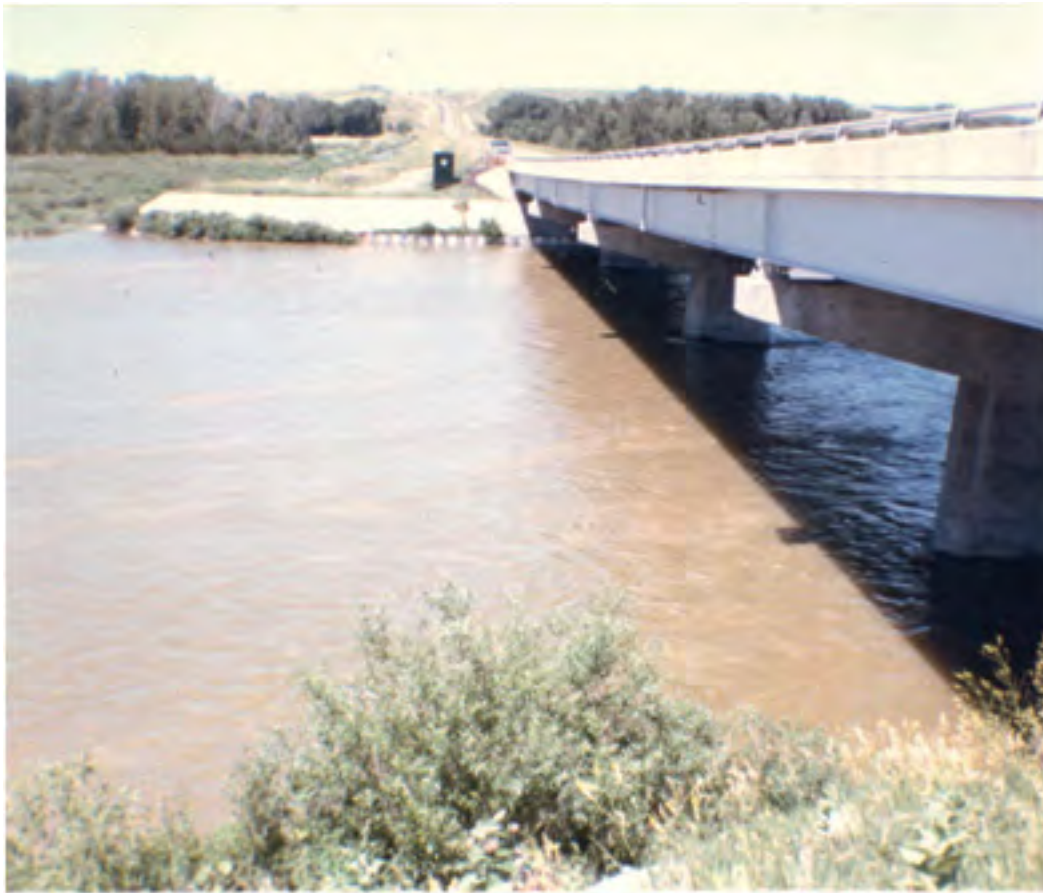
Figure 1-5. Photograph of the Niobrara River near Mariaville streamflow-gaging station reach. Photo was taken from the left river bank looking toward the right river bank. Gage house can be seen on opposite side of river. Flow is from right to left. Discharge measurements were made by both wading and using the bridge. However, only bridge measurements were used for the hydraulic geometry relation. (Photograph taken by Mark Nelson, Nebraska Department of Natural Resources)

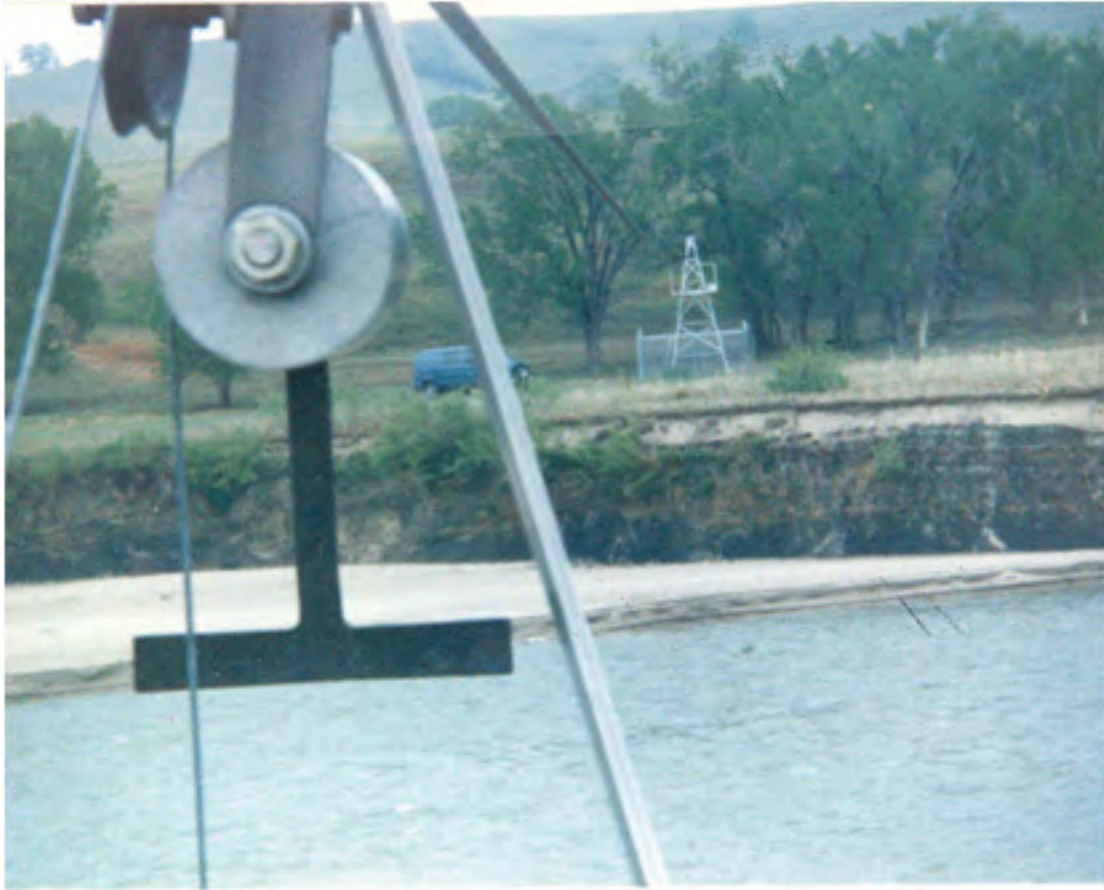
Figure 1-6. Photograph of the Niobrara River near Spencer streamflow-gaging station reach. Photo was taken from the right river bank looking toward the left river bank. Flow is from left to right. Only cable-car measurements were used for the hydraulic geometry relation. (USGS file photograph)

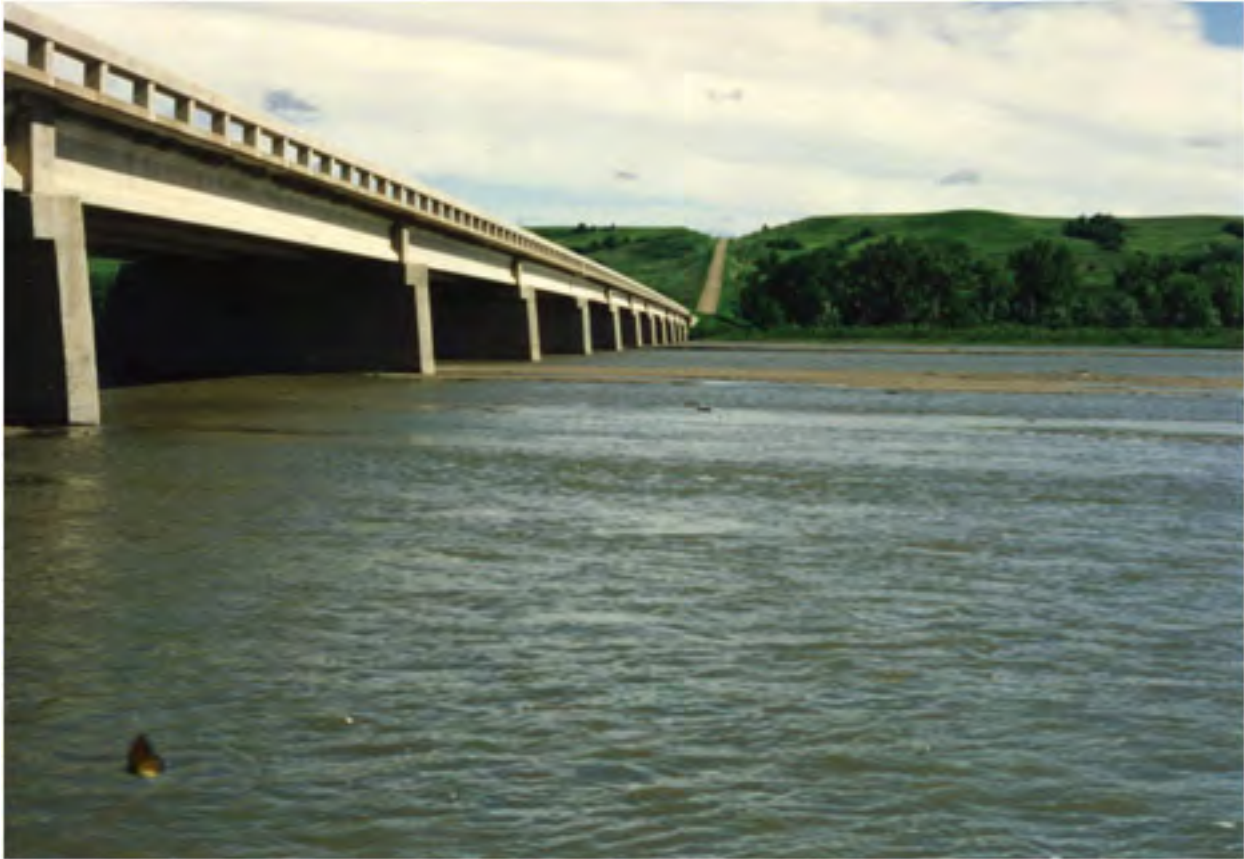
Figure 1-7. Photograph of the Niobrara River near Verdel streamflow-gaging station reach. Photo was taken from the right river bank looking toward the left river bank. Flow is from left to right. Only bridge measurements were used for the hydraulic geometry relation. The gage was moved to this location in 1986. Prior to 1986, the gage was located approximately one-half mile downstream at a narrower channel section. (USGS file photograph)

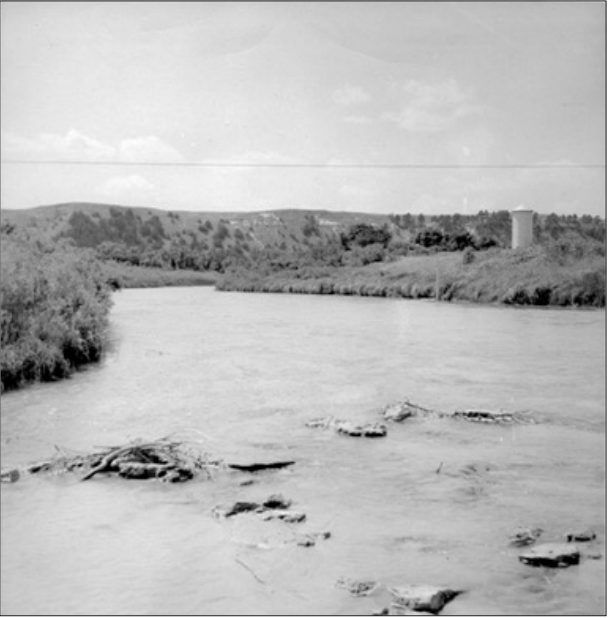
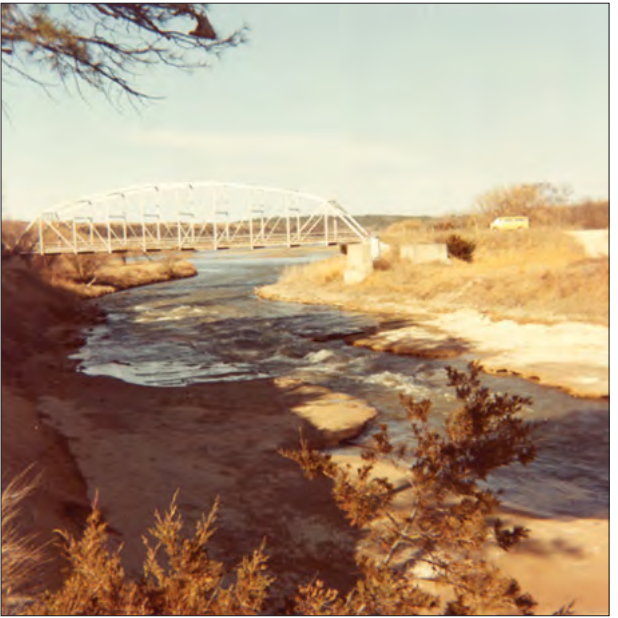
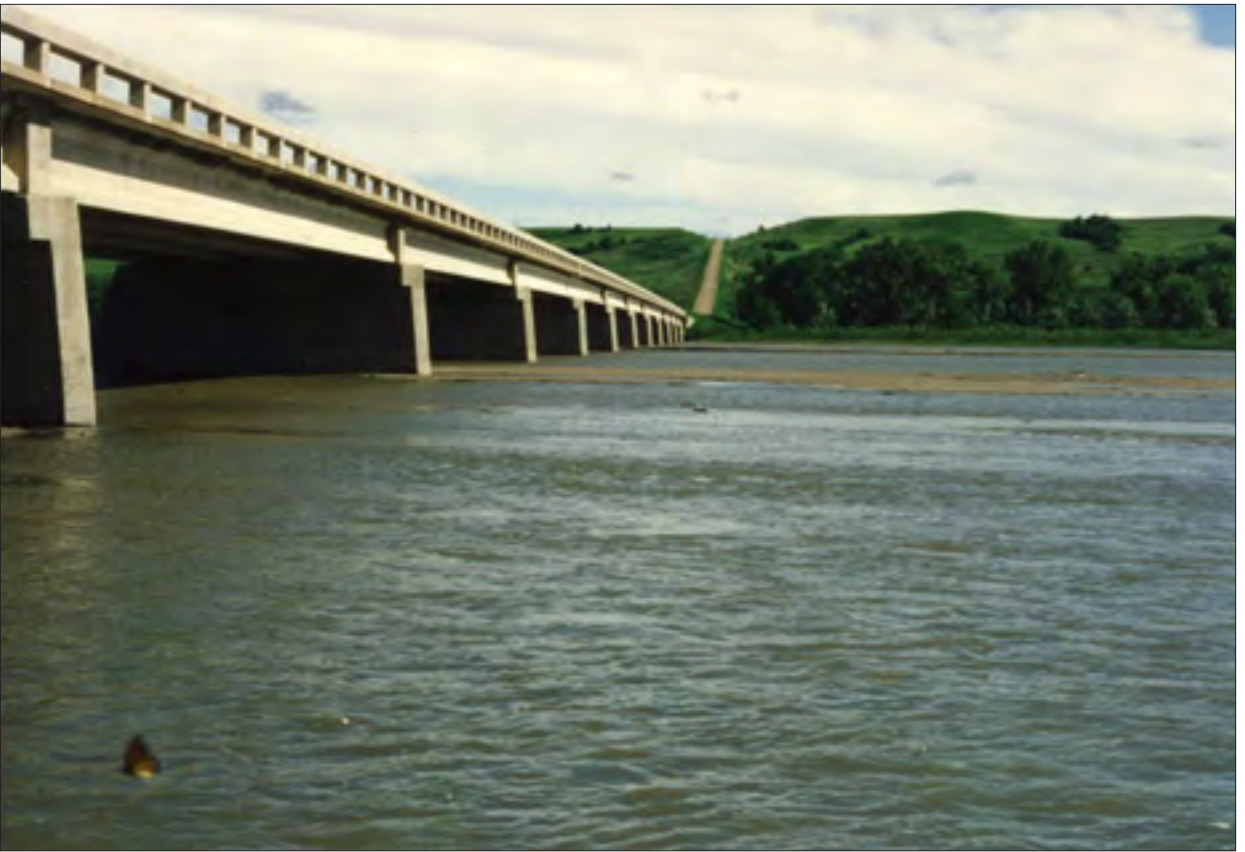
Back cover. Upper left photograph is the Niobrara River near Cody streamflow-gaging station reach and was taken looking upstream. Upper right photograph is the Niobrara River near Norden streamflow-gaging station reach and was taken looking upstream from the right river bank. Bottom photograph is the Niobrara River near Verdel streamflow-gaging station reach and was taken from the right river bank looking toward the left river bank. (USGS file photographs)
