# Evaluation of Ground-Water/Surface-Water Relations, Chapman Creek, West-Central Ohio, by Means of Multiple Methods

Water-Resources Investigations Report 01-4202

**By Denise H. Dumouchelle**

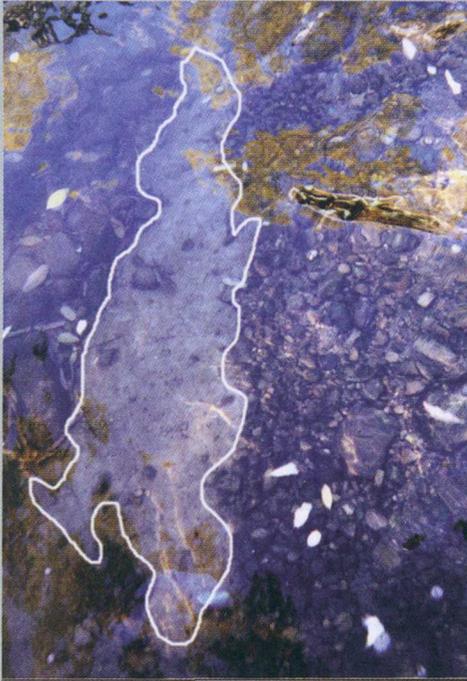
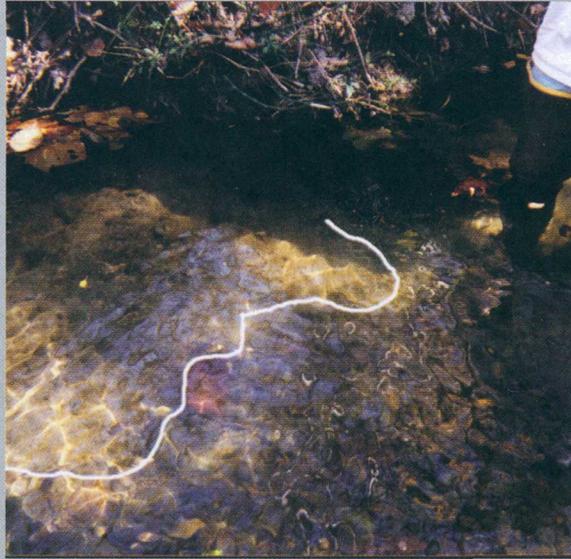
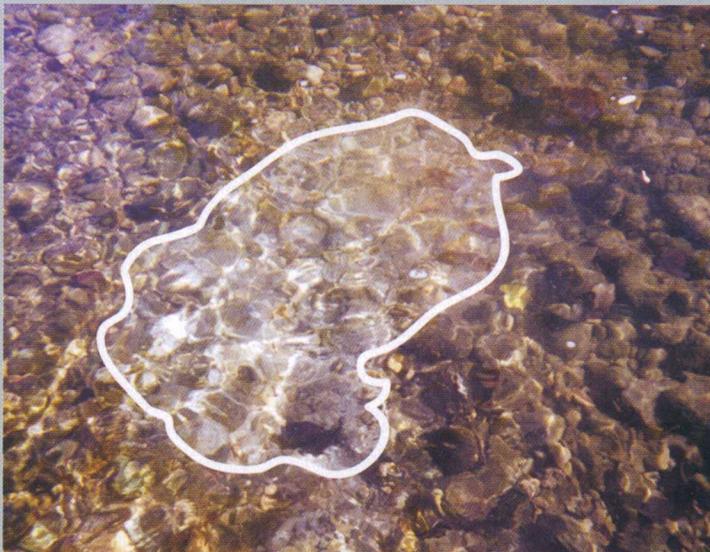
Near Willow Dale Road Bridge, hole is about 5 feet in length.

Near TS5.

Scour hole downstream from P4 (upstream from TS4), about 5.5 feet wide.

**Figure 4.** Scour holes in Chapman Creek, west-central Ohio. (White lines indicate approximate edges of the holes.)

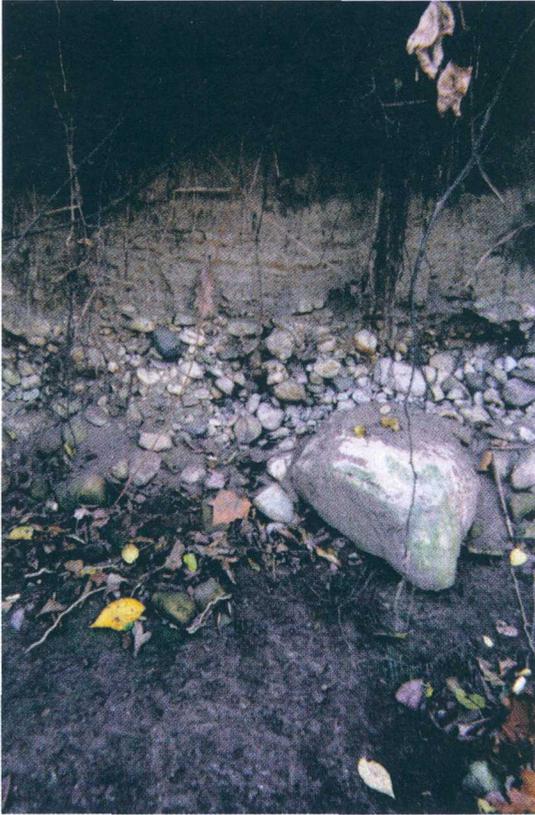
**Figure 5.** Till and gravel layer (near TS5) along bank of Chapman Creek, west-central Ohio. The large boulder on the right of the photo is approximately 2 feet across.

Various lines of evidence indicate that beneath 2–4 ft of coarse streambed materials is a layer of fine-grained till. While trying to install a piezometer just downstream from Willow Dale Road (downstream from P1, fig. 1), USGS personnel hit a very hard layer about 2 ft below the streambed.
