MAP SHOWING GEOLOGIC STRUCTURE OF T. 25 N., RS. 11 AND 12 E., OKLAHOMA

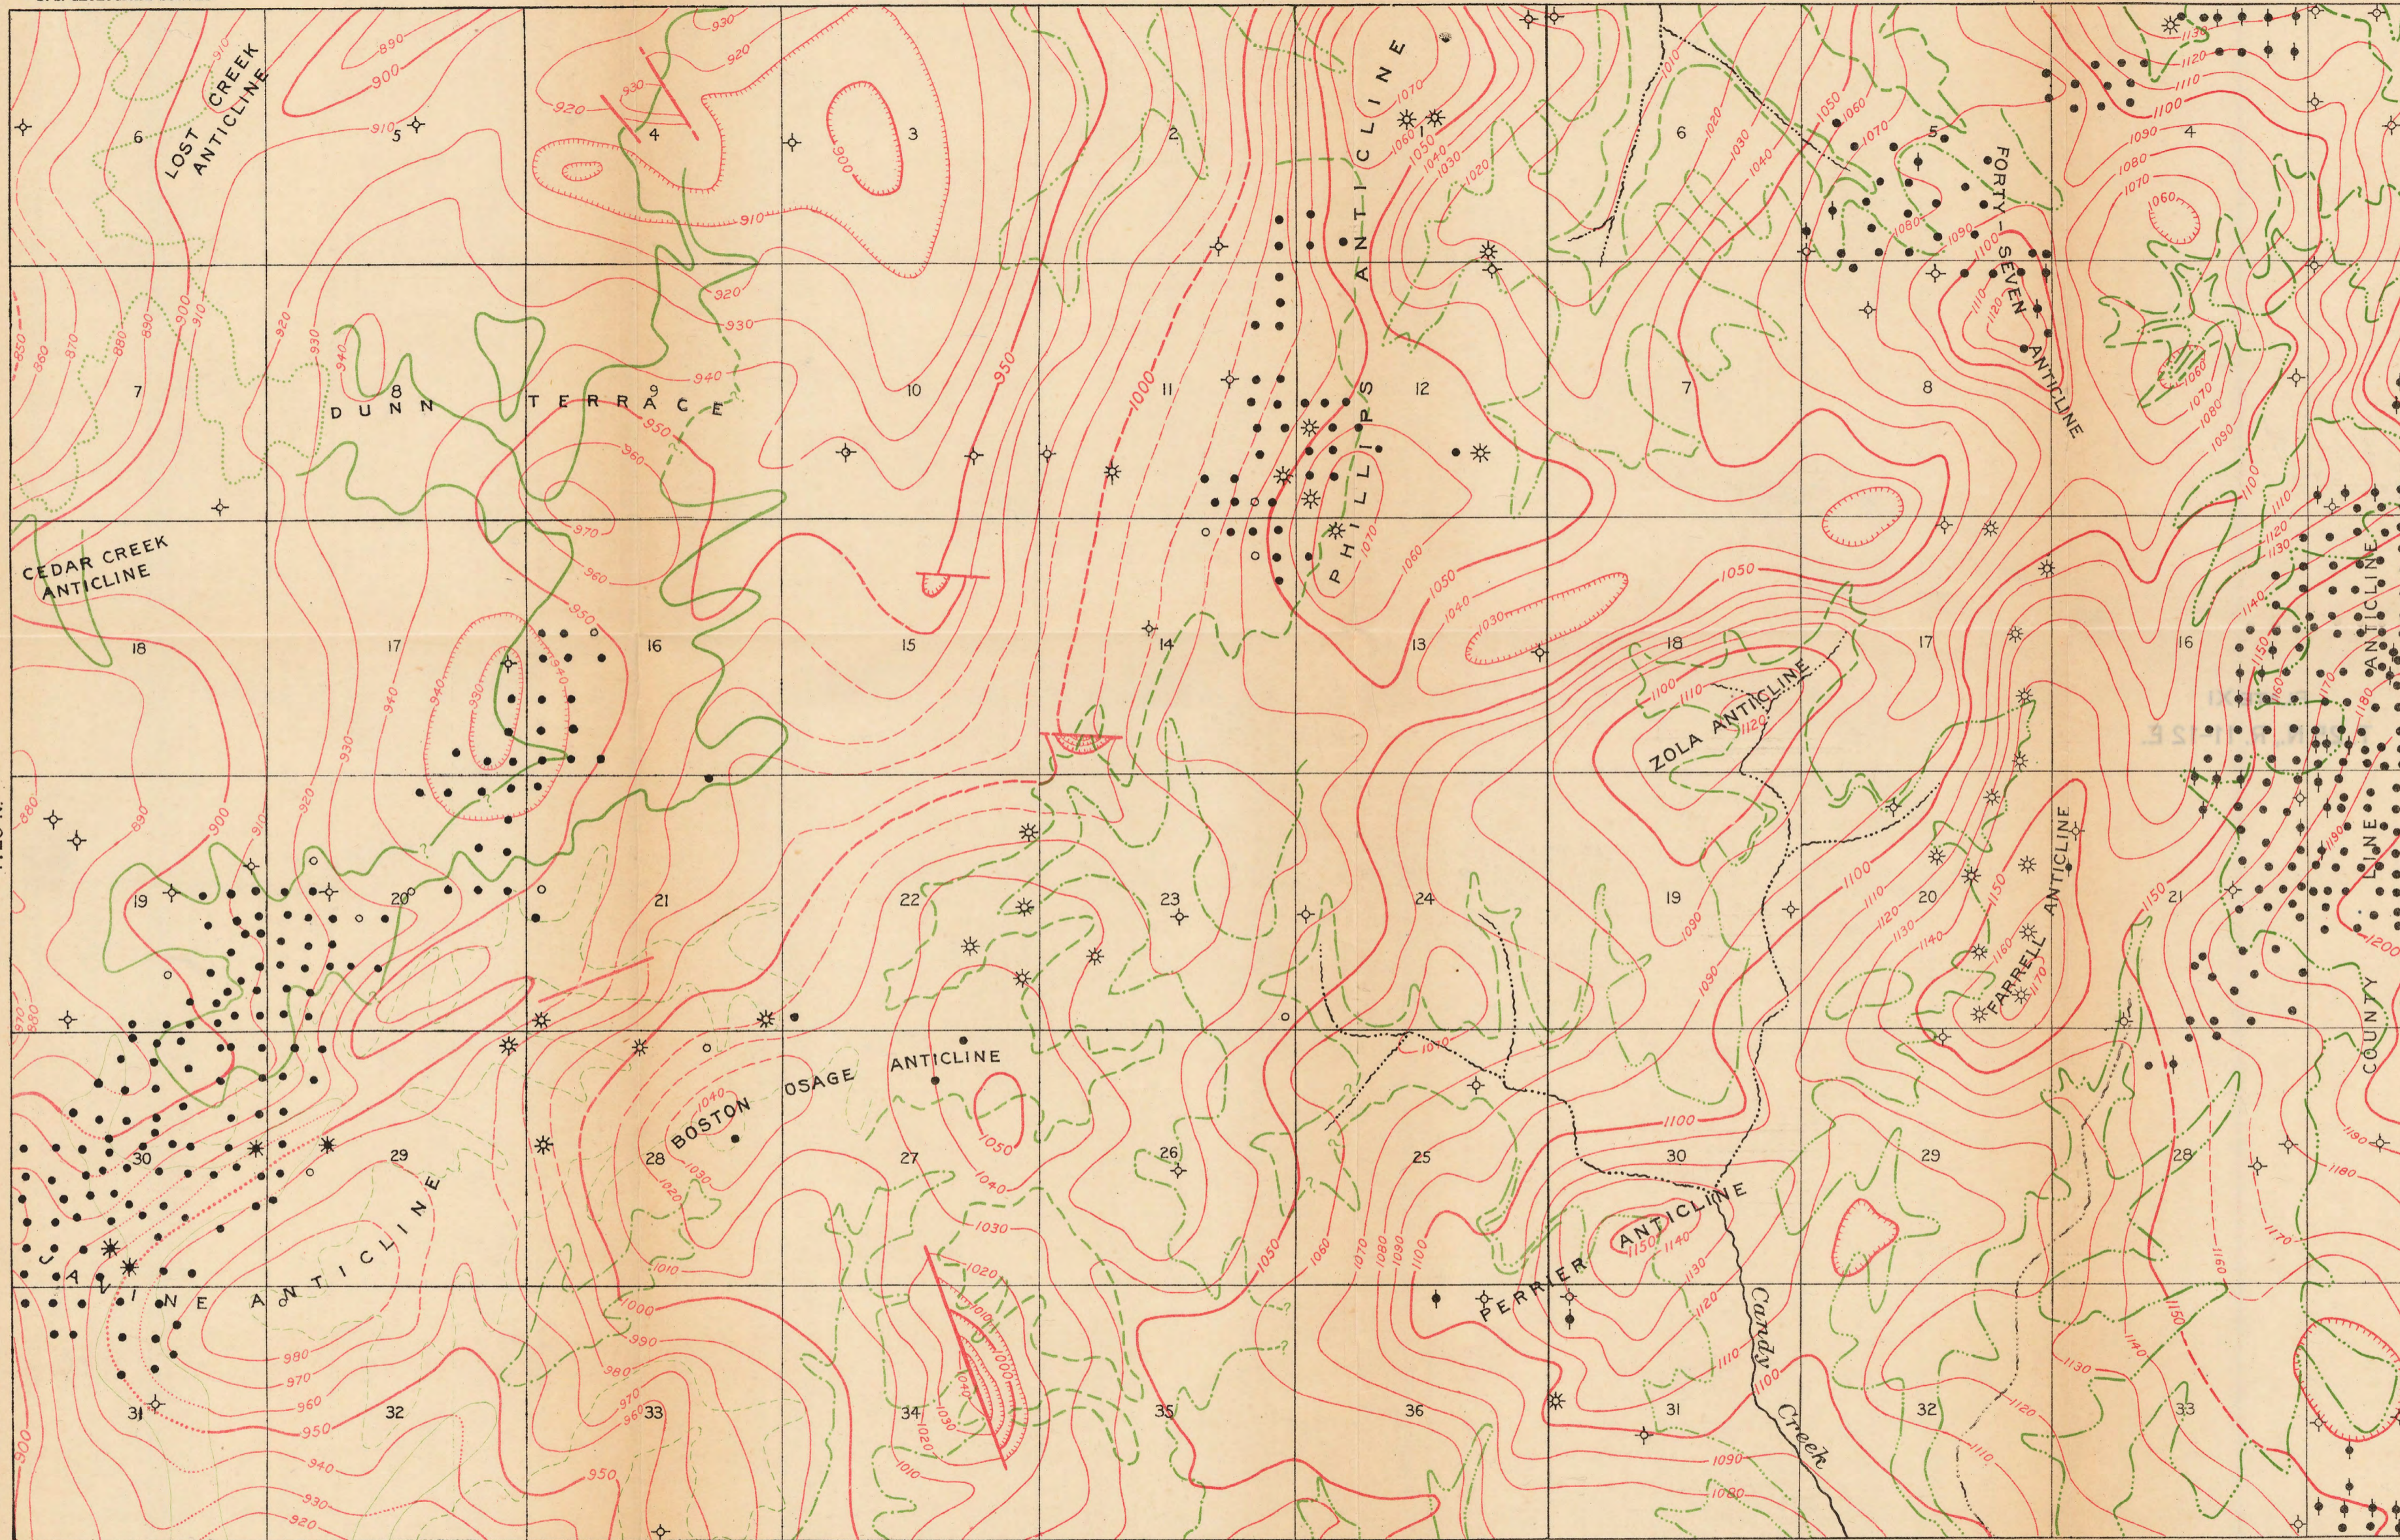
Sandstone 43 feet above Bigheart sandstone
-

Top of Bigheart sandstone
-

Base of Bigheart sandstone
-

Top of Okesa sandstone
-

Faults
-

Structure contours
Contour interval 10 feet
-
