Uncontrolled photomosaic base prepared by U.S. Geological Survey. Photographs taken July 1973, by U.S. National Aeronautics and Space Administration.

**EROSIONAL AND DEPOSITIONAL PROVINCES AND FEATURES, MOLALLA RIVER BASIN, OREGON**

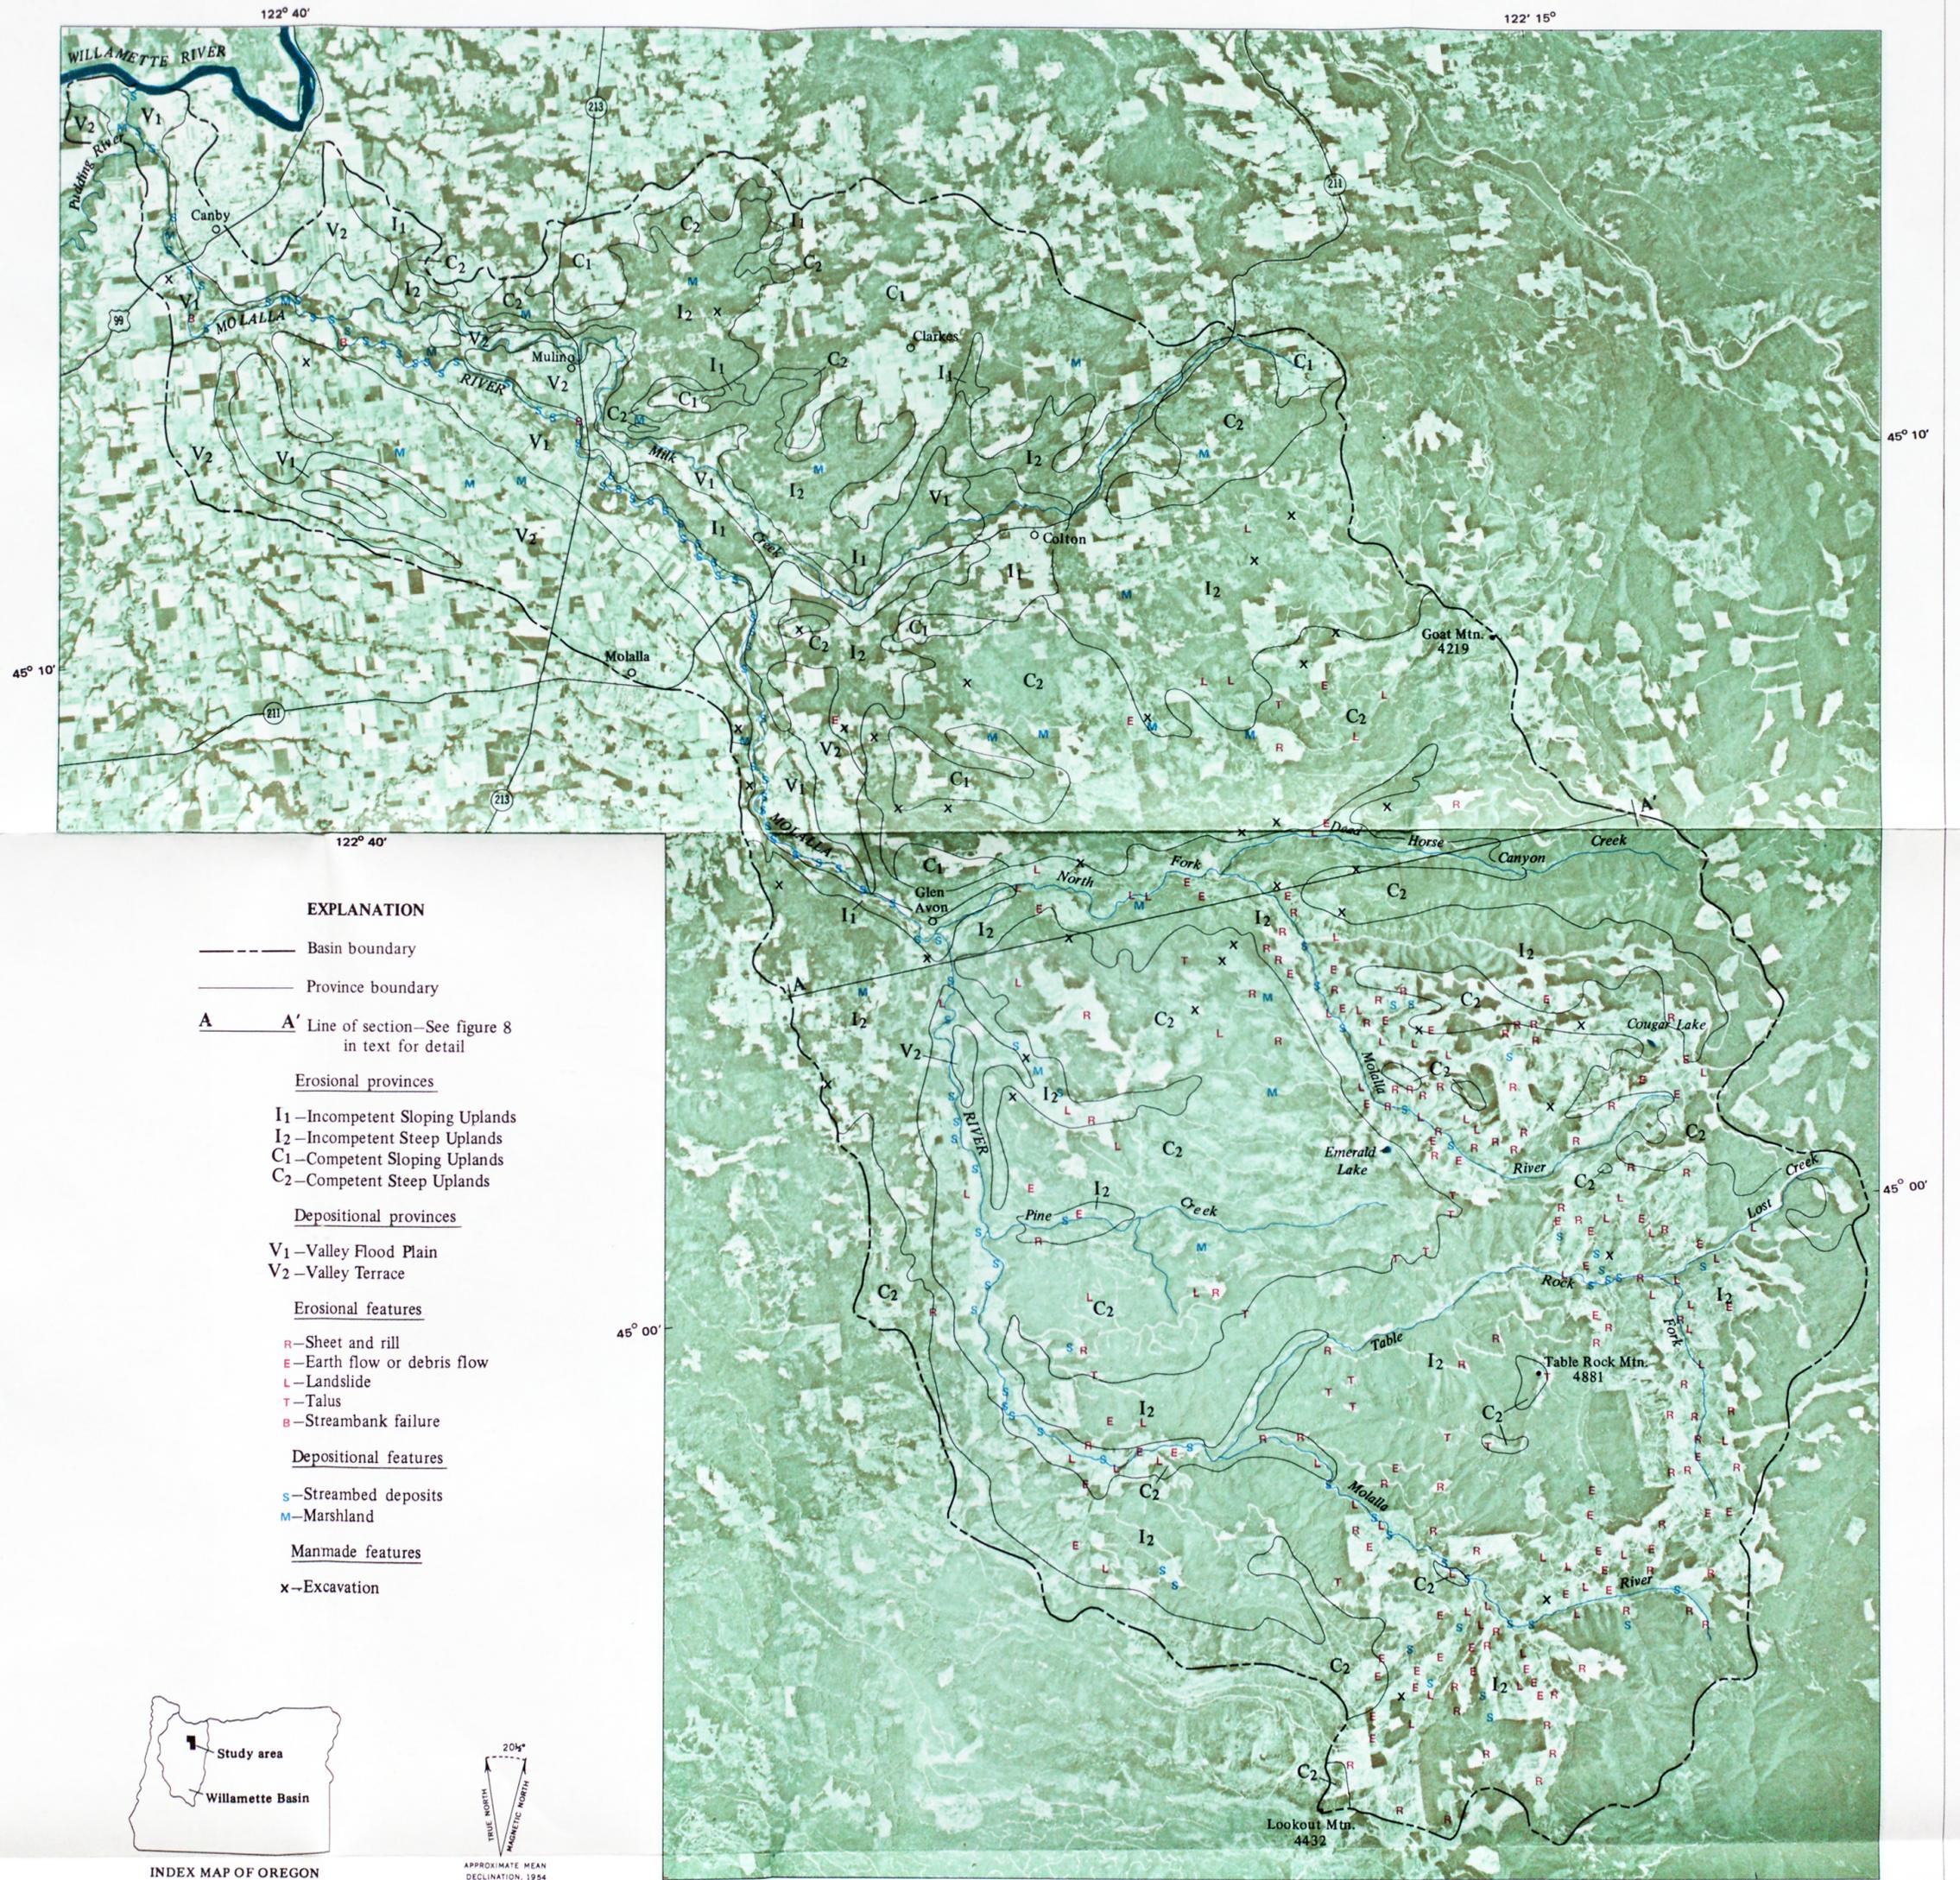
- Basin boundary
- Province boundary
- A** A' Line of section—See figure 8 in text for detail
- Erosional provinces
- I<sub>1</sub>—Incompetent Sloping Uplands
- I<sub>2</sub>—Incompetent Steep Uplands
- C<sub>1</sub>—Competent Sloping Uplands
- C<sub>2</sub>—Competent Steep Uplands
- Depositional provinces
- V<sub>1</sub>—Valley Flood Plain
- V<sub>2</sub>—Valley Terrace
- Erosional features
- R—Sheet and rill
- E—Earth flow or debris flow
- L—Landslide
- T—Talus
- B—Streambank failure
- Depositional features
- S—Streambed deposits
- M—Marshland
- Manmade features
- x—Excavation
