Surficial geologic maps along the riparian zone of the Animas River and its headwater tributaries, Silverton to Durango, Colorado, with upper Animas River watershed gradient profiles

By Robert W. Blair, Jr., Douglas B. Yager, and Stanley E. Church

Digital Data Series DDS-71

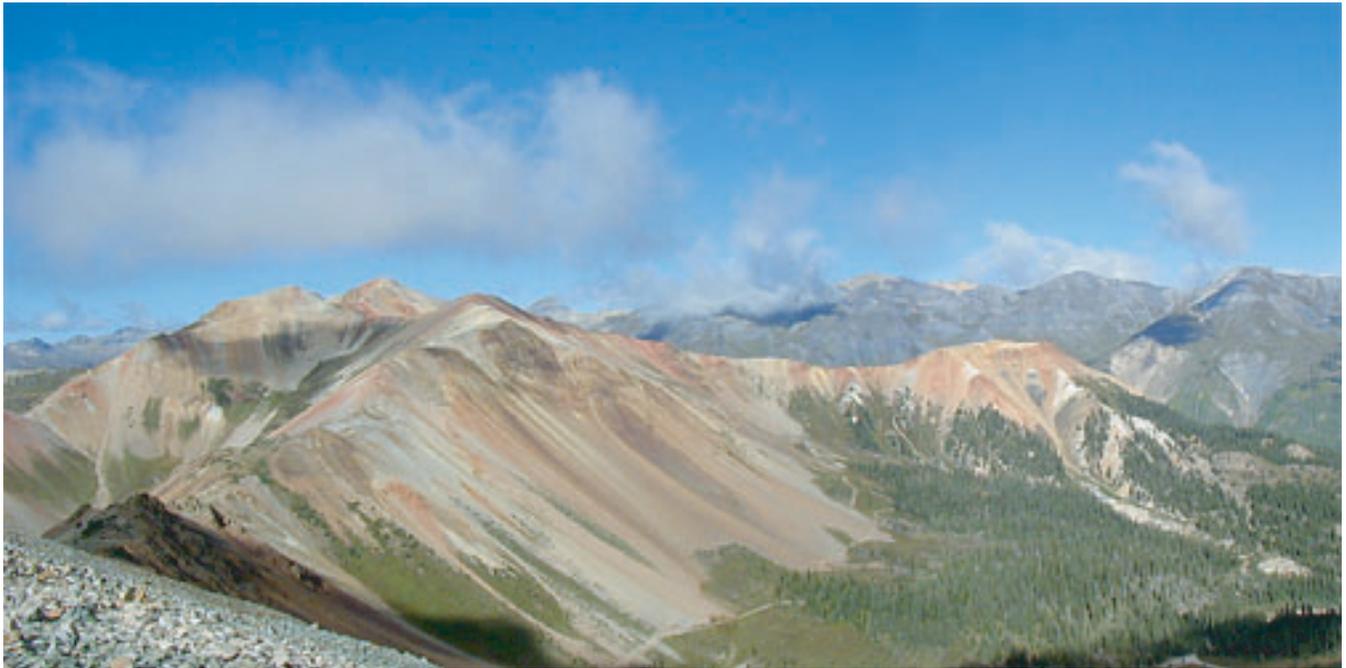
View looking north of talus and debris cone material weathered from the steep slopes of Red Mountain No. 2 near the headwaters of the upper Animas River watershed. Rocks of Silverton Volcanics in foreground are bleached white by intense hydrothermal alteration. Purple-hued rocks in distance are mostly older volcanics of San Juan Formation.
