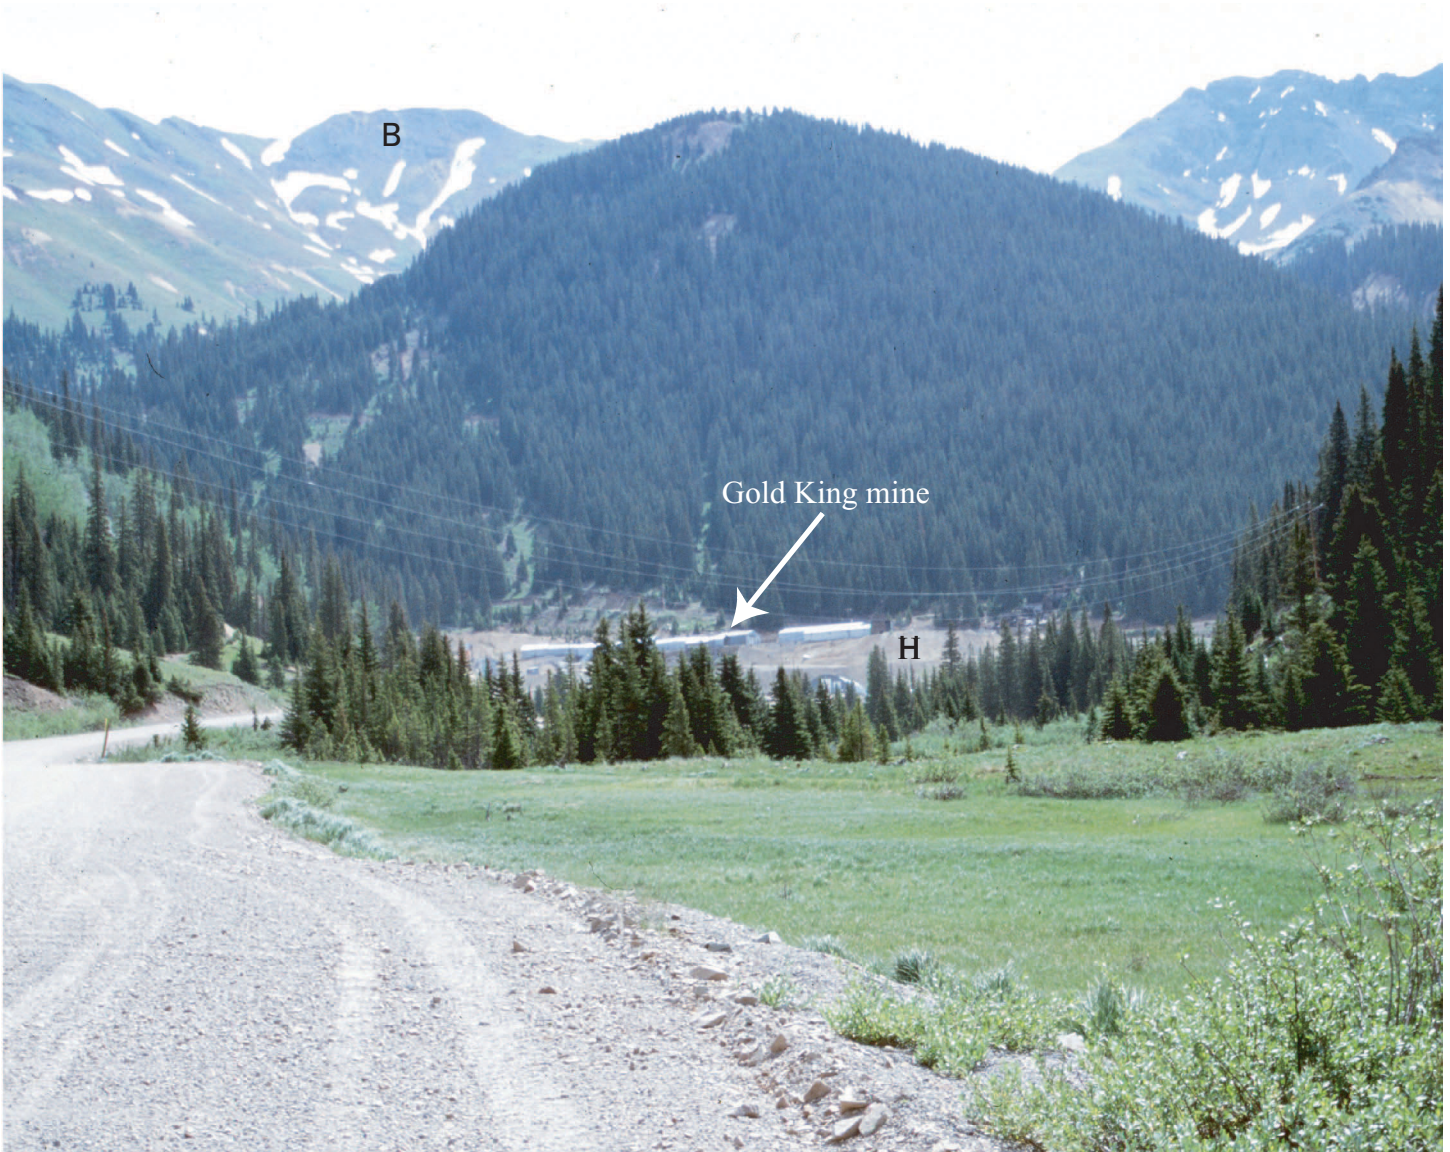
2. Human works (H). Looking north and northeast along Cement Creek toward Gold King mine at Gladstone. Arrow also is near the recent American Tunnel adit access to the Sunnyside mine. Mines are inactive since 1992 but reclamation activities are presently taking place. Slopes are mostly forest-covered colluvium (c), not visible at this scale, and bedrock (B).
