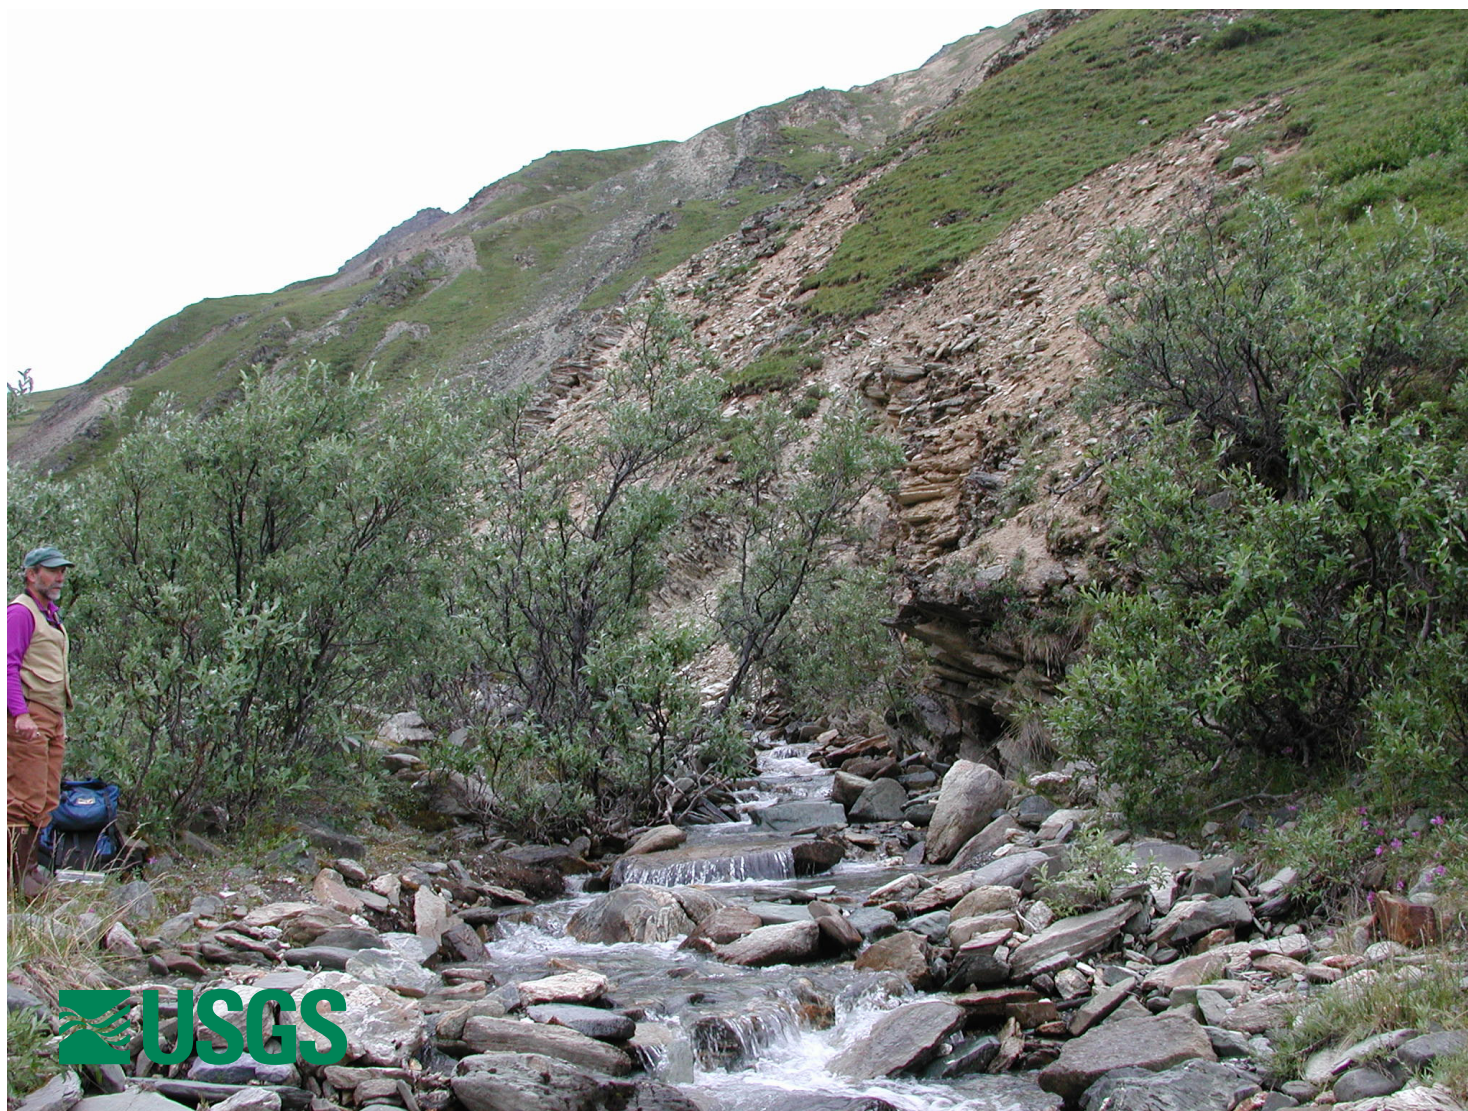
Photo 03BF005-1. View to SW of sample site on Red Mountain Creek, just above alteration zone; pH 7.1, conductivity 830 $\mu\text{S}/\text{cm}$.
