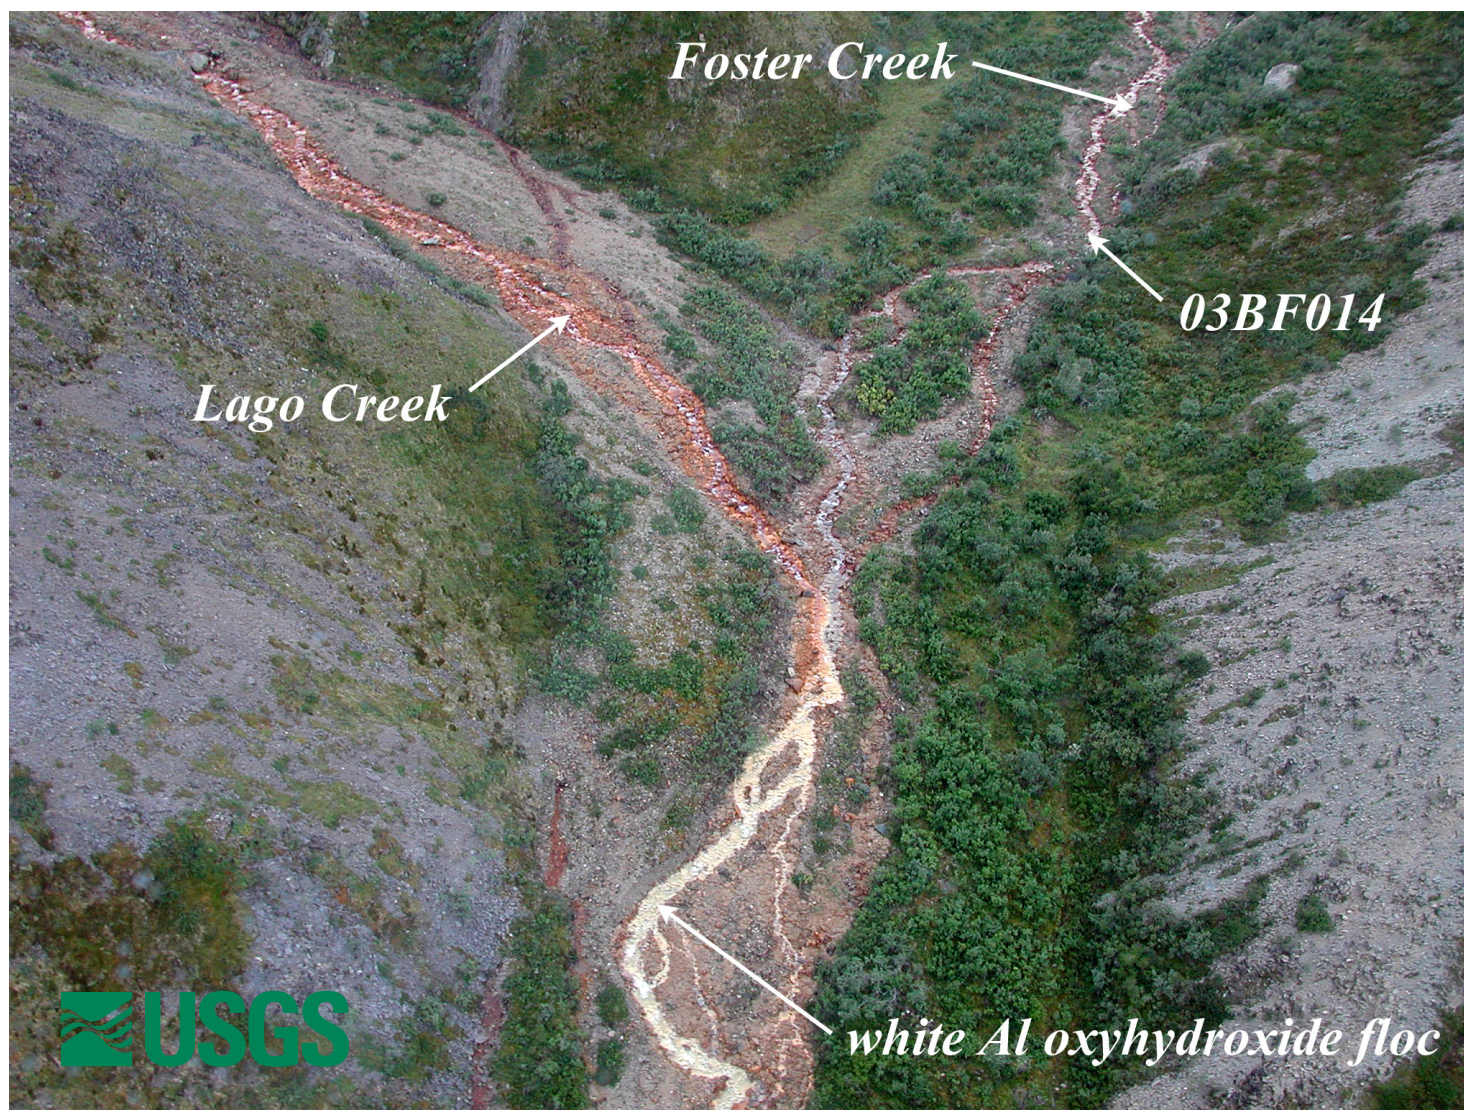
Photo 03BF014-4. View from air looking SW onto Foster Creek (R) and Lago Creek (L). Note heavy white Al oxyhydroxide precipitation on Foster Creek downstream of the confluence.
