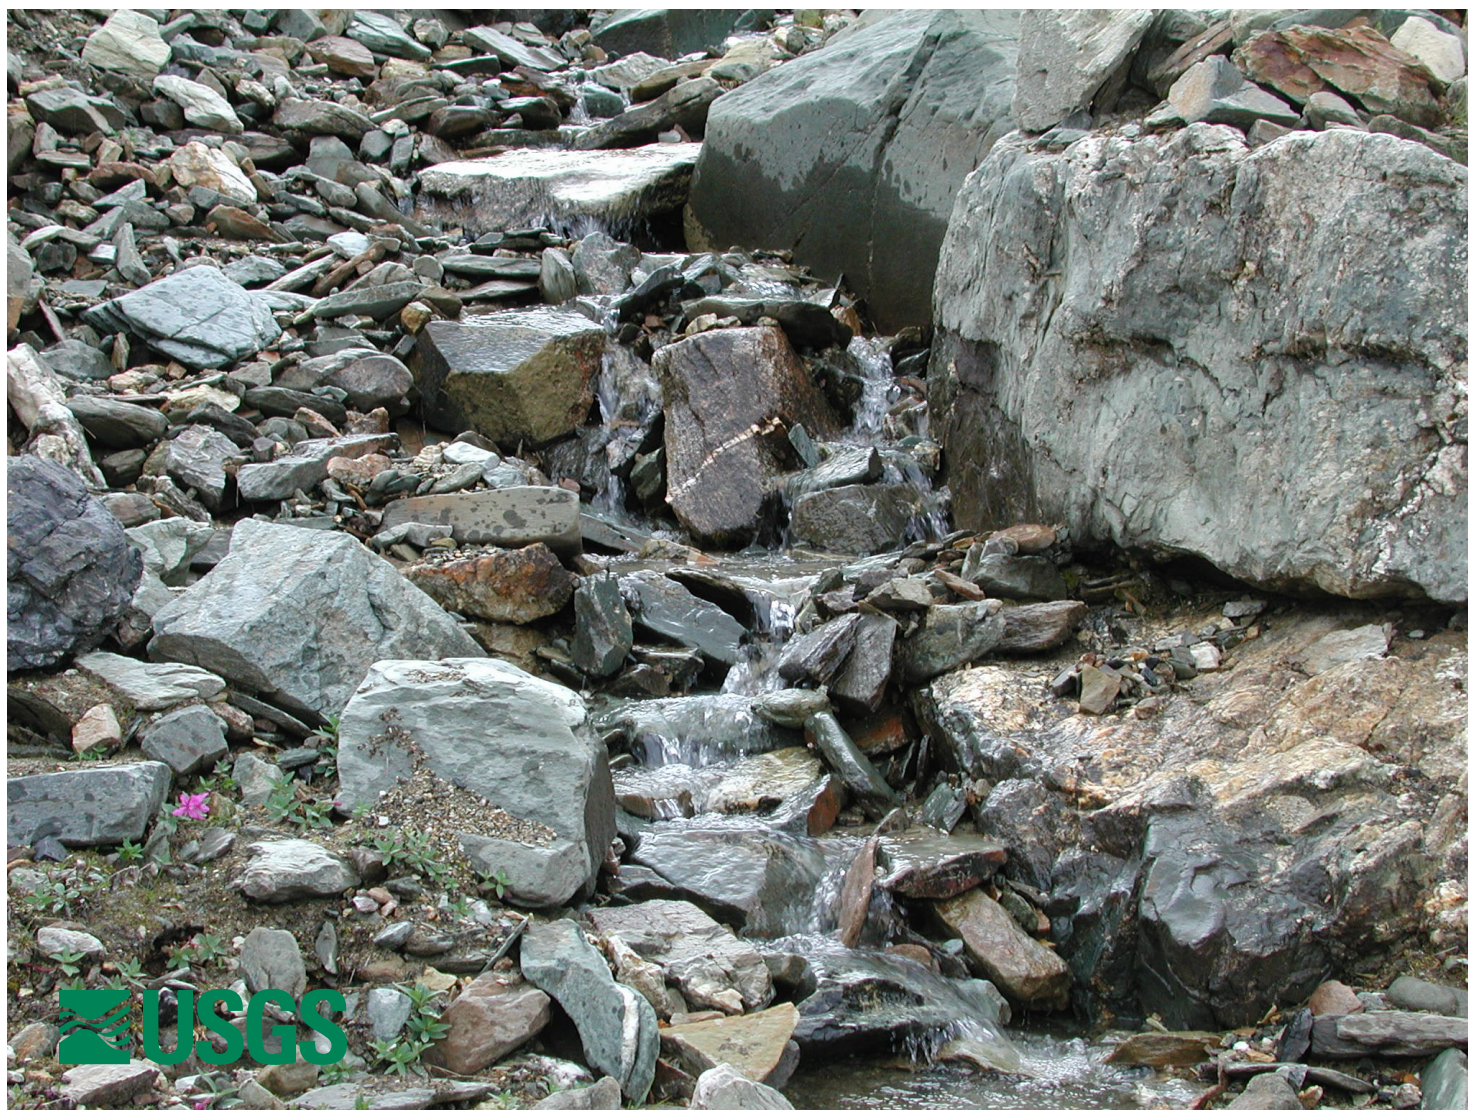
Photo 03BF020-1. Sample site, upper Lago Creek, above alteration zone; pH 7.6, conductivity 740 $\mu\text{S}/\text{cm}$.
