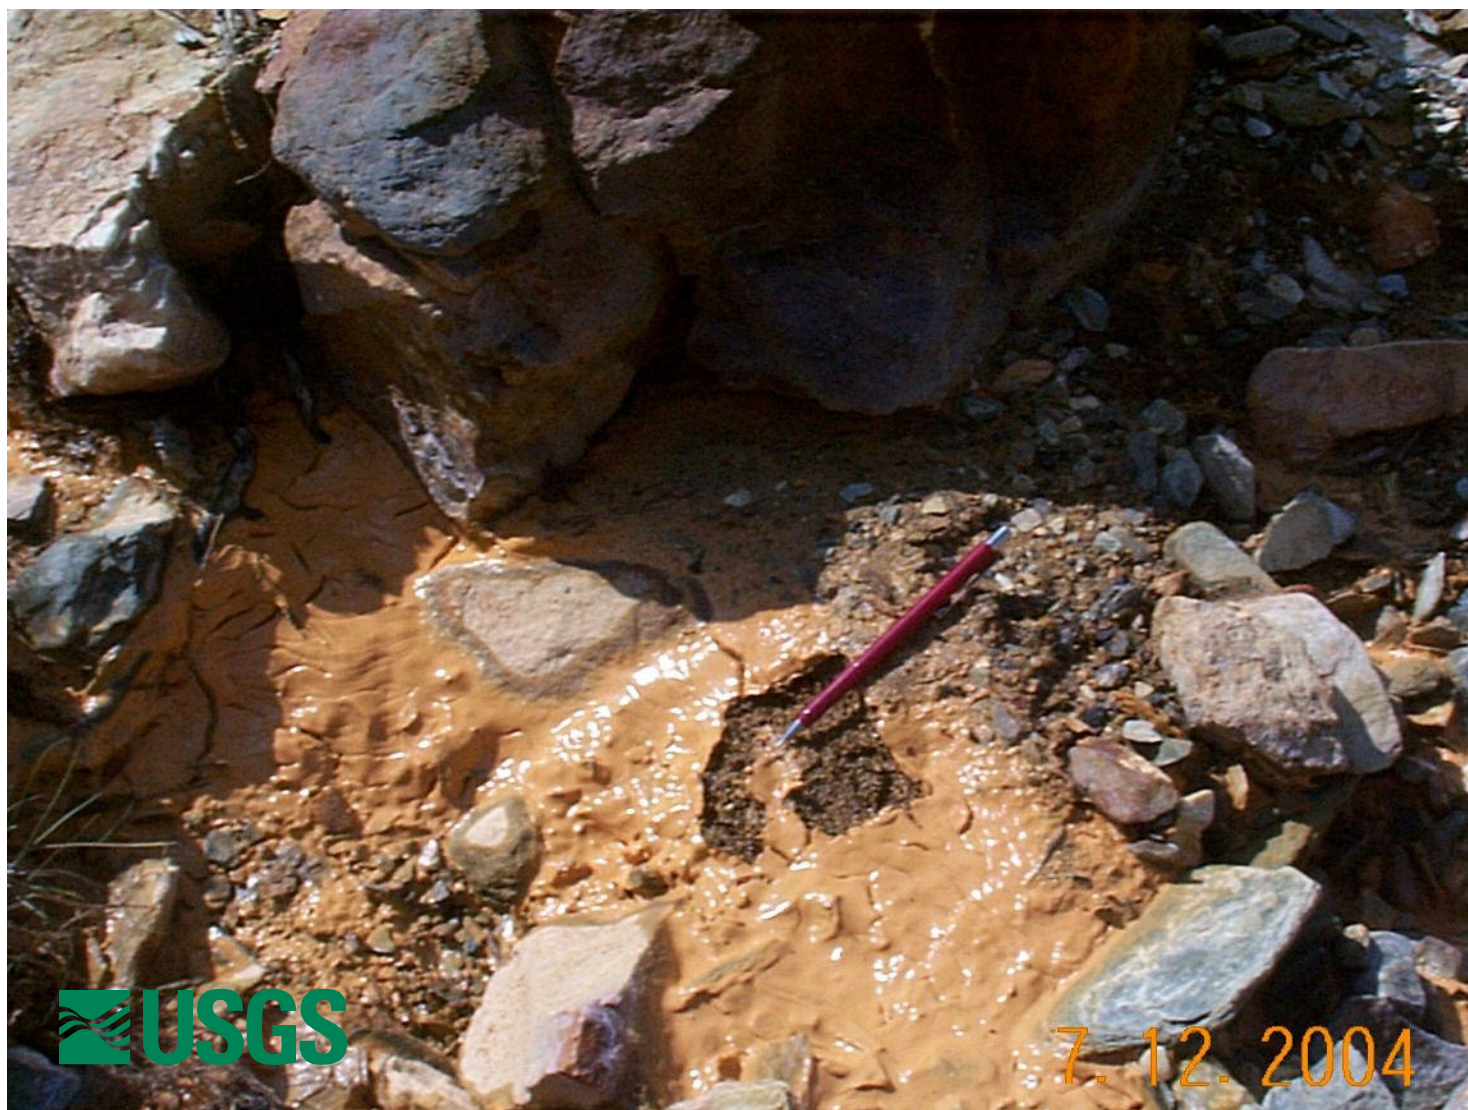
**Photo 04JHBF12.** Gelatinous Al- and Fe-rich precipitate in evaporating side pool along Lago Creek.
