Sediment Samples and Channel-Geometry Data, Lower Platte River Watershed, Nebraska, 2010

Data Series 572

U.S. Department of the Interior
U.S. Geological Survey

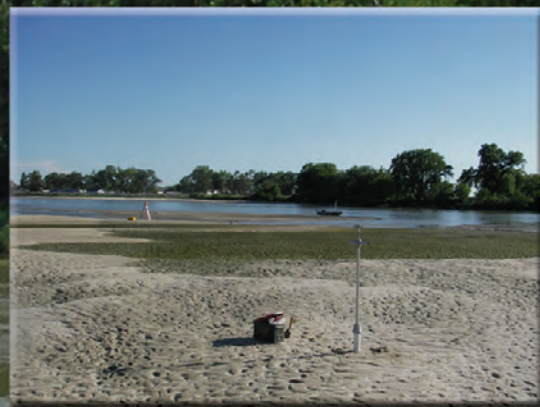
Upper right photograph: Typical bank of Platte River after bank was prepared for sampling.
