Coastal Change During Hurricane Dennis 2005

Hurricane Dennis made landfall as a Category 3 storm on Santa Rosa Island in the Florida Panhandle on July 10, 2005. Exposed to some of the strongest winds, Santa Rosa Island suffered erosion, as well as severe overwash. A storm surge of 2 m was recorded near Navarre Beach.

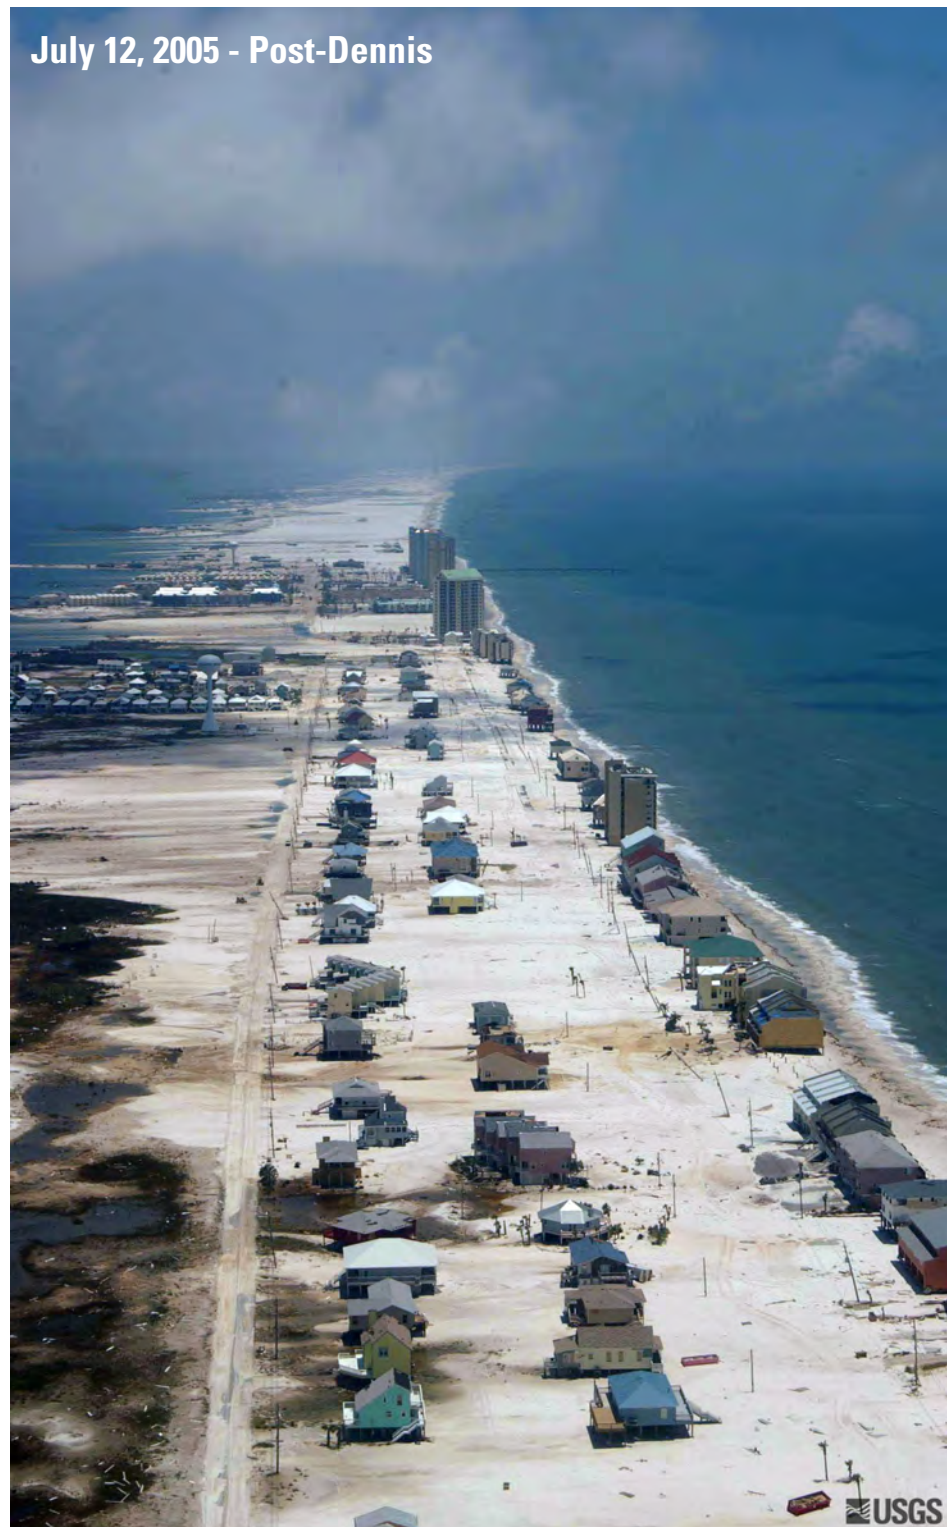
Figure 2. Santa Rosa Island, Florida, suffered severe erosion and overwash during Hurricane Dennis. Looking east, the magnitude of the overwash is evident. Overwash fans extend northward across the island, covering roads with sand eroded from the beach and dunes. In some cases, the overwash extends into the back bay.

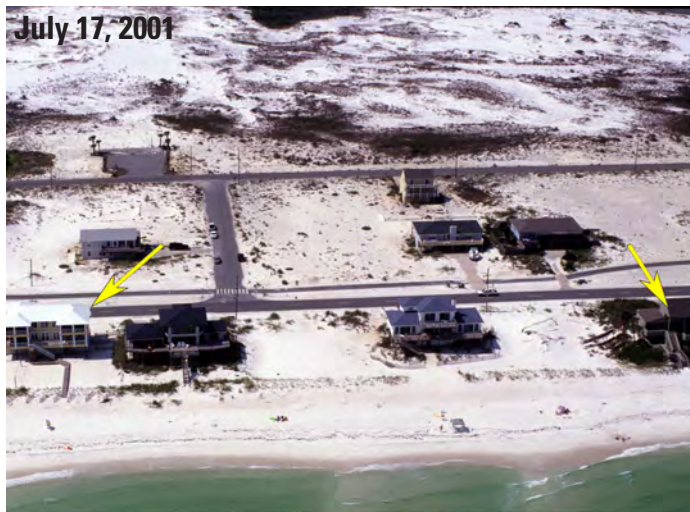
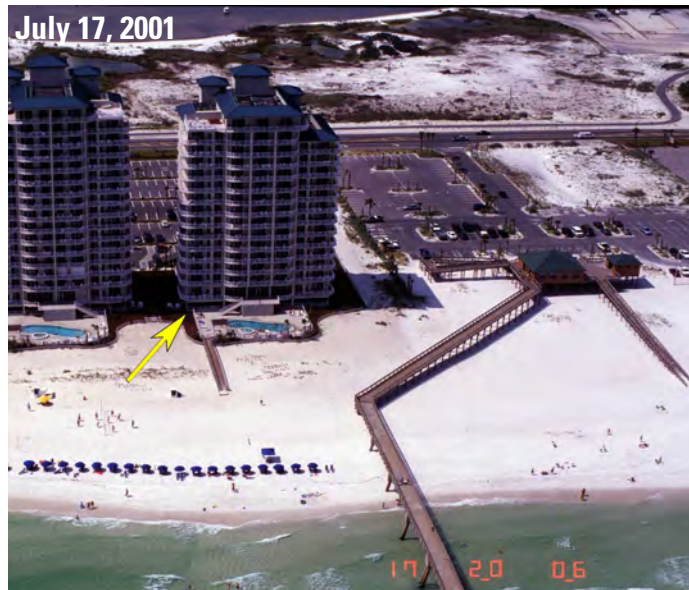
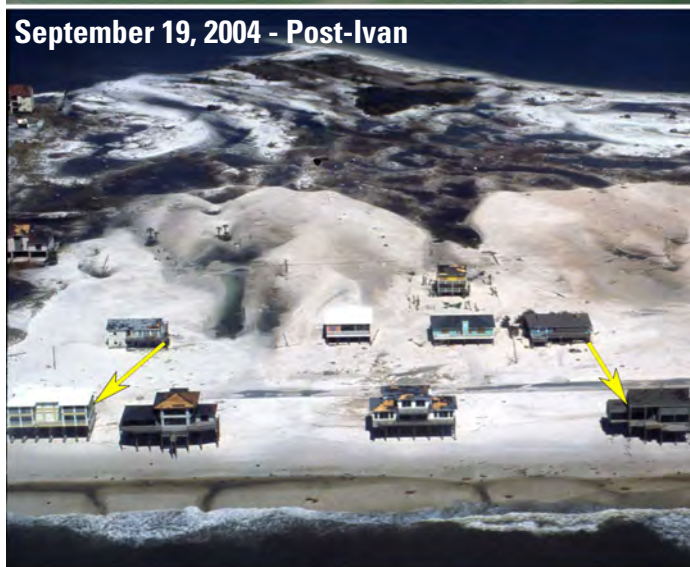
Figure 3. Navarre Beach, Florida. On this part of Navarre Beach, overwash deposits from Hurricane Dennis extend farther landward than overwash deposits from Hurricane Ivan. Deposits from both storms covered the two coast-parallel roads. (Arrows in all images point to the same features.)
