# Real-Time Seismic Monitoring of Instrumented Hospital Buildings

The Veterans Affairs Medical Center in Memphis has been recently instrumented for real-time seismic monitoring

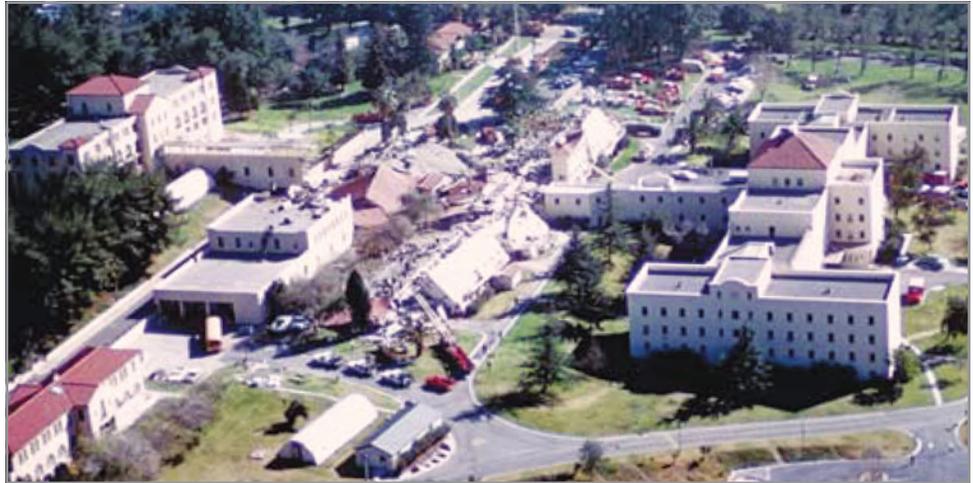
The 1971 San Fernando, California, earthquake (magnitude 6.7) collapsed four buildings at the San Fernando VA Hospital, killing 49 people. The buildings had been built in 1925, before building codes were in effect. Real-time seismic monitoring of such buildings can provide critical information about their structural integrity and help save lives in future earthquakes.

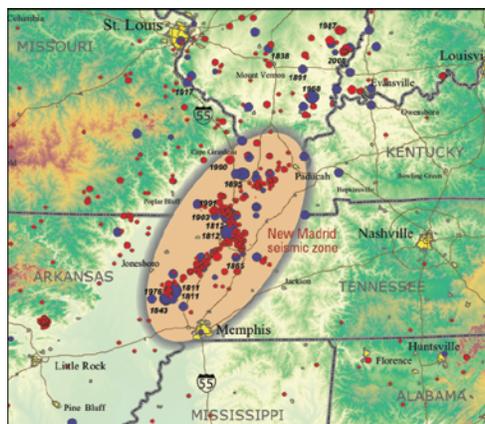
Map showing earthquakes greater than magnitude 2.5 in the New Madrid Seismic Zone and its surroundings. Red dots are earthquakes that occurred after 1972, blue dots are earthquakes before 1972. Magnitudes of earthquakes are proportional to size of dots—largest dots are magnitude 7–8.

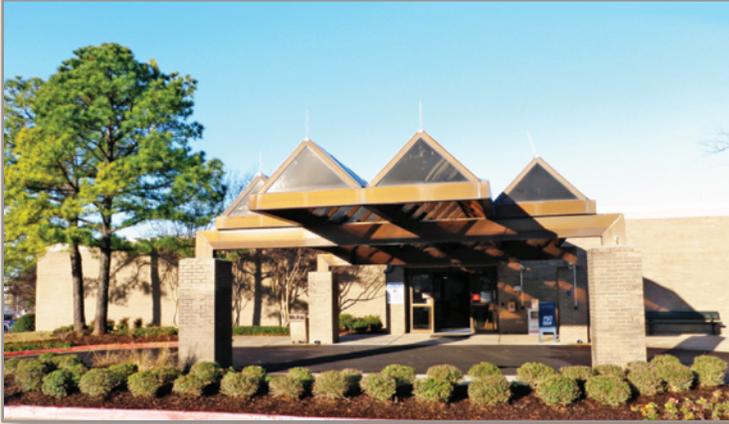
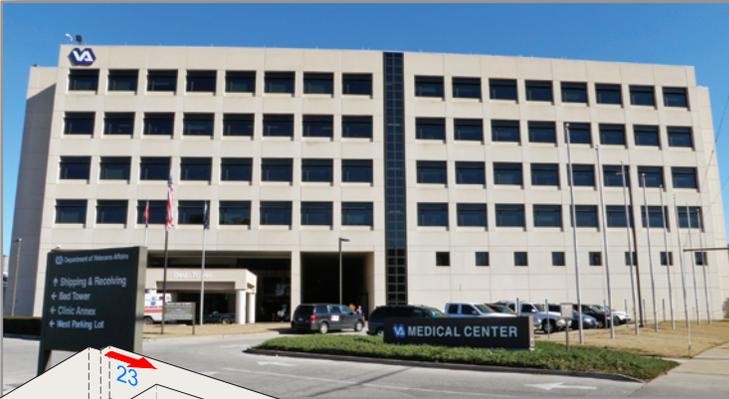
In the Memphis, Tennessee, VA Medical Center, the Spinal Cord Injury (top) and Bed Tower (above) buildings now have the most sophisticated structural-health monitoring systems in the country.

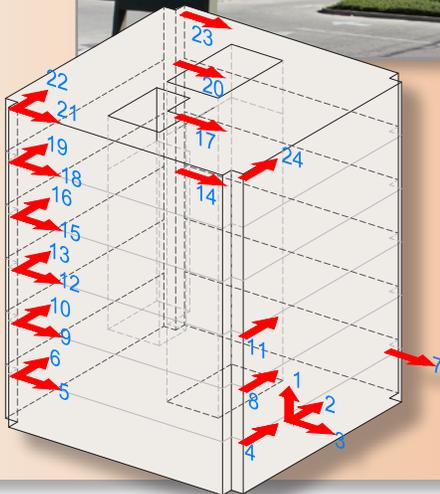
As shown in the schematic (left), motion sensors have been deployed permanently on each floor of the Bed Tower building. Red arrows indicate the locations of sensors from ground level to roof. These sensors are connected to the central data-acquisition and transmission system.

For these purposes, the USGS's NSMP has recently instrumented two buildings in the Memphis VA Medical Center. The monitoring system installed in the 5-story Bed Tower consists of a seismic array of 24 sensors. The 3-story Spinal Cord Injury building has 12 sensors. These sensors are deployed permanently in critical locations at each level of the buildings to detect building motion along the reference east-west and north-south directions;

vertical motion is monitored at the ground level. Specifically, the instrumentation within these buildings is designed to record lateral swaying, twisting (torsion), traveltime of transmitted seismic waves from foundation to roof, and drift (relative displacement) between pairs of adjacent floors, as well as overall building offset. The extent of swaying, twisting, and drift can be compared to what the building was designed to withstand.
