In cooperation with the Texas Natural Resource Conservation Commission

Occurrence of Polychlorinated Biphenyls (PCBs) on Suspended Sediment in the Donna Canal, Hidalgo County, Texas, 1999–2001

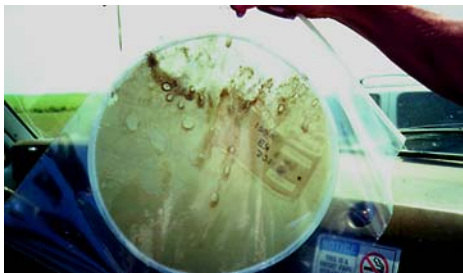
Suspended sediment from Donna Canal collected on a filter.

Suspended sediment was collected for analysis by filtering. At each sampling site, tubing was suspended in the canal about 2.5 meters from the bank at a depth of about 1 meter, and water was pumped from the canal with a peristaltic pump; at bridges and at the mouth of a siphon in the canal, the tubing was suspended in the center of the canal. For all but the final round

of sampling, water was pumped through a 298-millimeter-diameter glass fiber filter with a nominal pore size of 0.5 micrometer. For the final round of sampling, water was pumped through similarly sized PTFE (Teflon) filters. Water was pumped through the filter until the filter clogged; three filters were used at each site, and a total of 25 to 140 liters of water was filtered. The filters were put inside a baked glass jar and chilled until sent to the laboratory for analysis. Unfiltered water samples also were submitted for analysis of total suspended sediment concentration. PCBs were analyzed by gas chromatography/mass spectrometry (GC/MS) following the method of Foreman and others (1995).

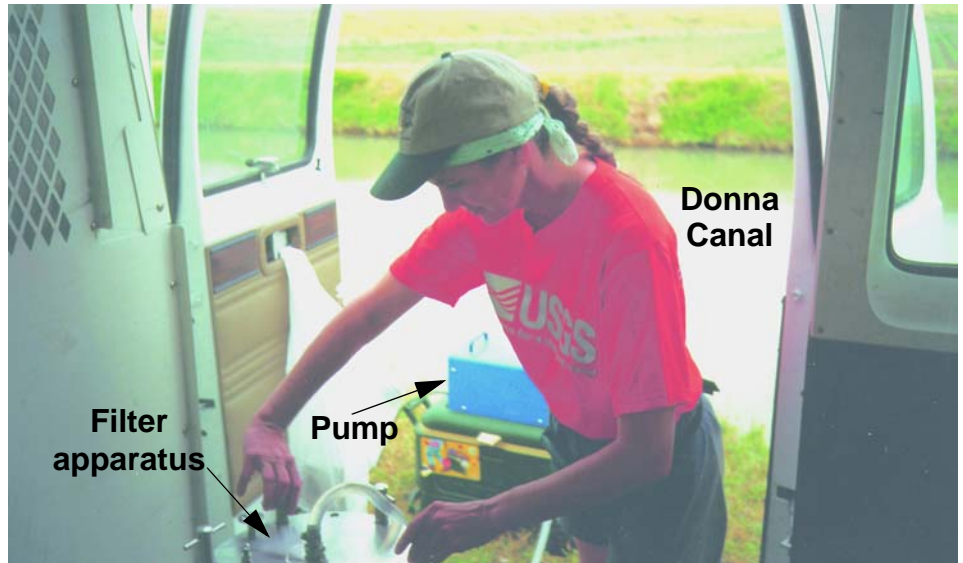
Collecting a suspended sediment sample from the Donna Canal.

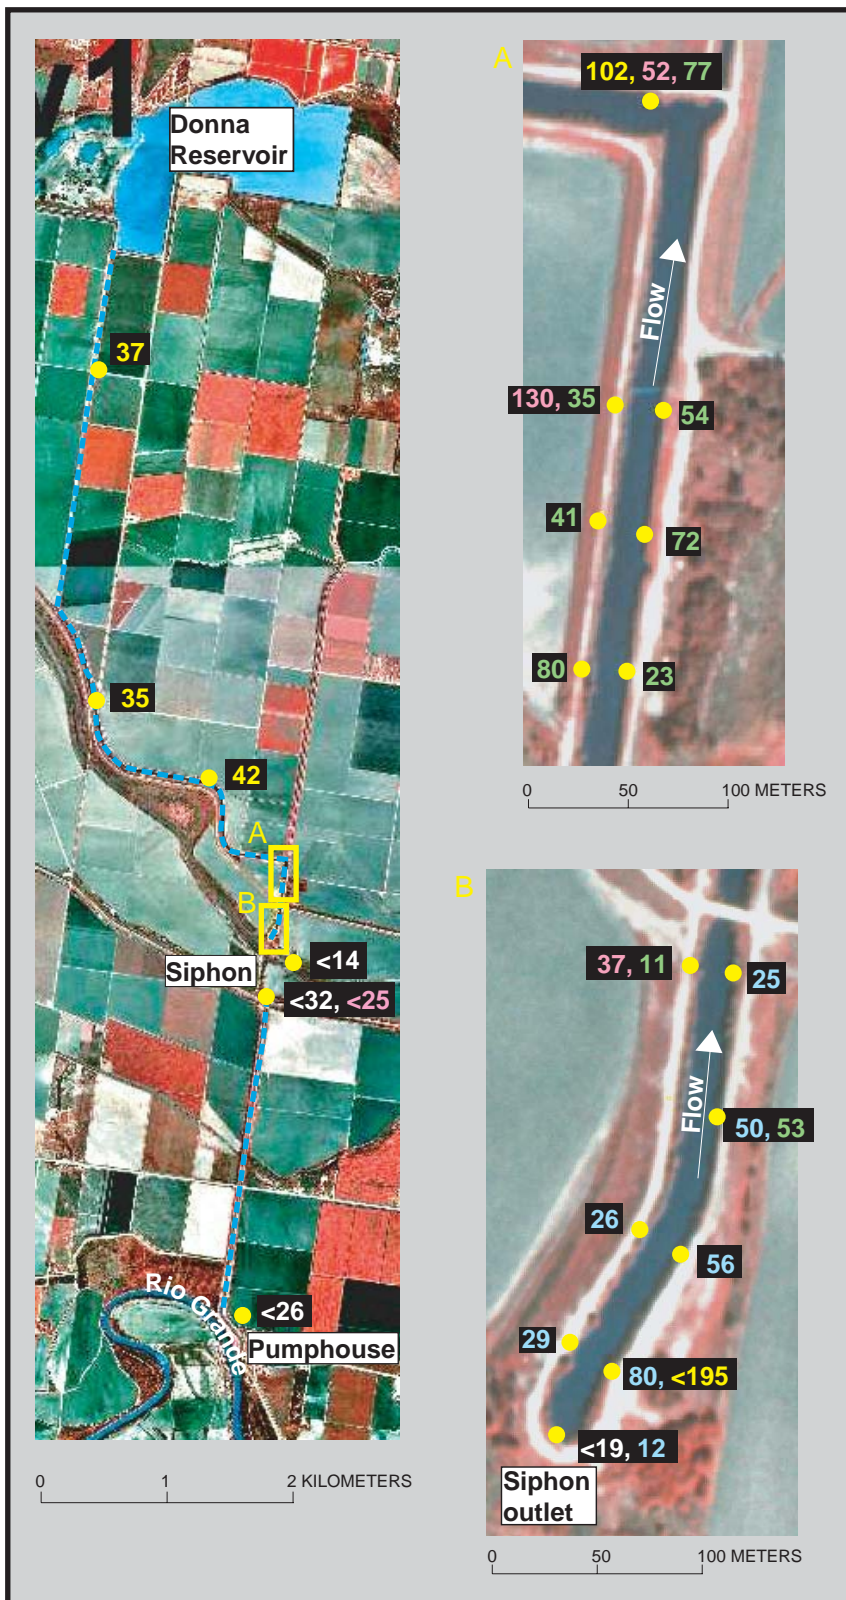
Figure 2. Aerial photographs of the Donna Canal (indicated by the dashed blue line), sampling sites, and concentrations detected. Flow is to the north from the pumphouse toward the reservoir. To the right are enlarged images of two areas of the canal chosen for more closely spaced sampling. Sampling sites are indicated with yellow dots, and results of samples collected during the same sampling trip are shown in the same color: white (February 1999), yellow (July 1999), pink (January 2000), blue (July 2000), and green (April 2001). All concentrations are in micrograms per kilogram of sediment collected.

Five separate sampling trips to the Donna Canal were made to collect suspended sediment. The overall strategy was to narrow the search for the PCB source area(s) from the entire 11-kilometer length to a much shorter distance by collecting samples at more closely spaced intervals. The sampling sites and spacing were chosen on the basis of the results from the previous event (fig. 2).

○ No PCBs were detected during the first round of sampling when samples were collected from sites near the pumphouse, at the siphon inlet, at the siphon outlet, and in the Arroyo Colorado (results shown in white, fig. 2). These results suggested that the source of the PCBs must be downstream (north) of the siphon outlet.

● The results of the second sampling round (shown in yellow, fig. 2) confirmed that the source was in or downstream of the siphon outlet, and that it was probably upstream (south) of the 90-degree bend. On the basis of these detections, samples were collected at more closely spaced intervals in the reach downstream of the siphon to try to pinpoint the PCB source.

● The results of the third sampling round (shown in pink, fig. 2) indicated a possible PCB source in the 200-meter reach downstream of the siphon outlet and a possible second source at least 150 meters upstream of the 90-degree bend.

● On the basis of previous results, the fourth sampling round samples were collected at about 50-meter intervals on both banks of the canal downstream of the siphon outlet. The results (shown in blue, fig. 2) indicated a potential PCB source on the right bank of the canal, just downstream of the siphon outlet.

at about 50-meter intervals in the reach upstream of the 90-degree bend. The results (shown in green, fig. 2) confirmed the presence of PCBs in suspended sediment along this section of the canal but do not identify any one location as a probable PCB source. One or several sources of PCBs might be present along this stretch of the canal.

In conclusion, the source or sources of the PCBs must be located between the siphon outlet and the 90-degree bend in the Donna Canal.

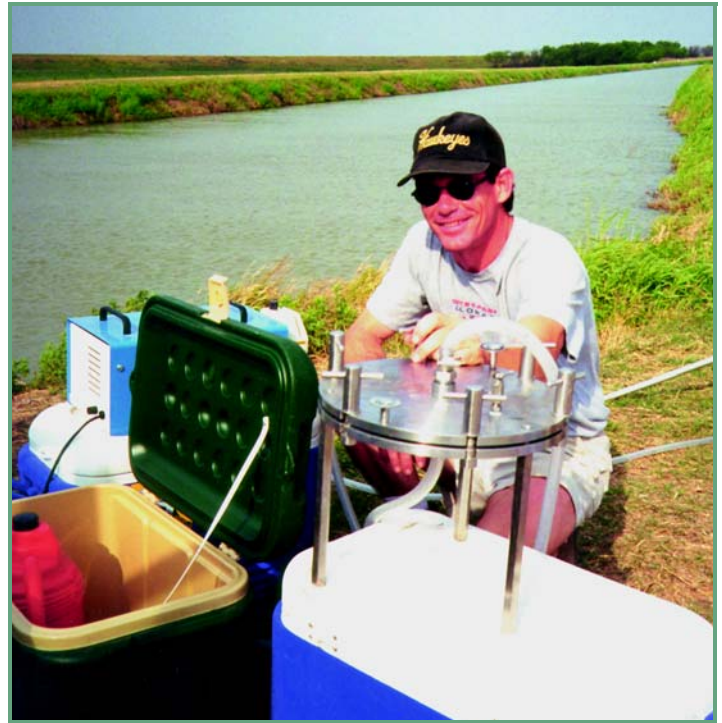
Sampling suspended sediment at Donna Canal.
