TETON DAM FLOOD, SOUTHEASTERN IDAHO, JUNE 1976

TETON DAM FLOOD OF JUNE 1976, RIGBY QUADRANGLE, IDAHO
By Herman A. Ray and Bruce B. Bigelow

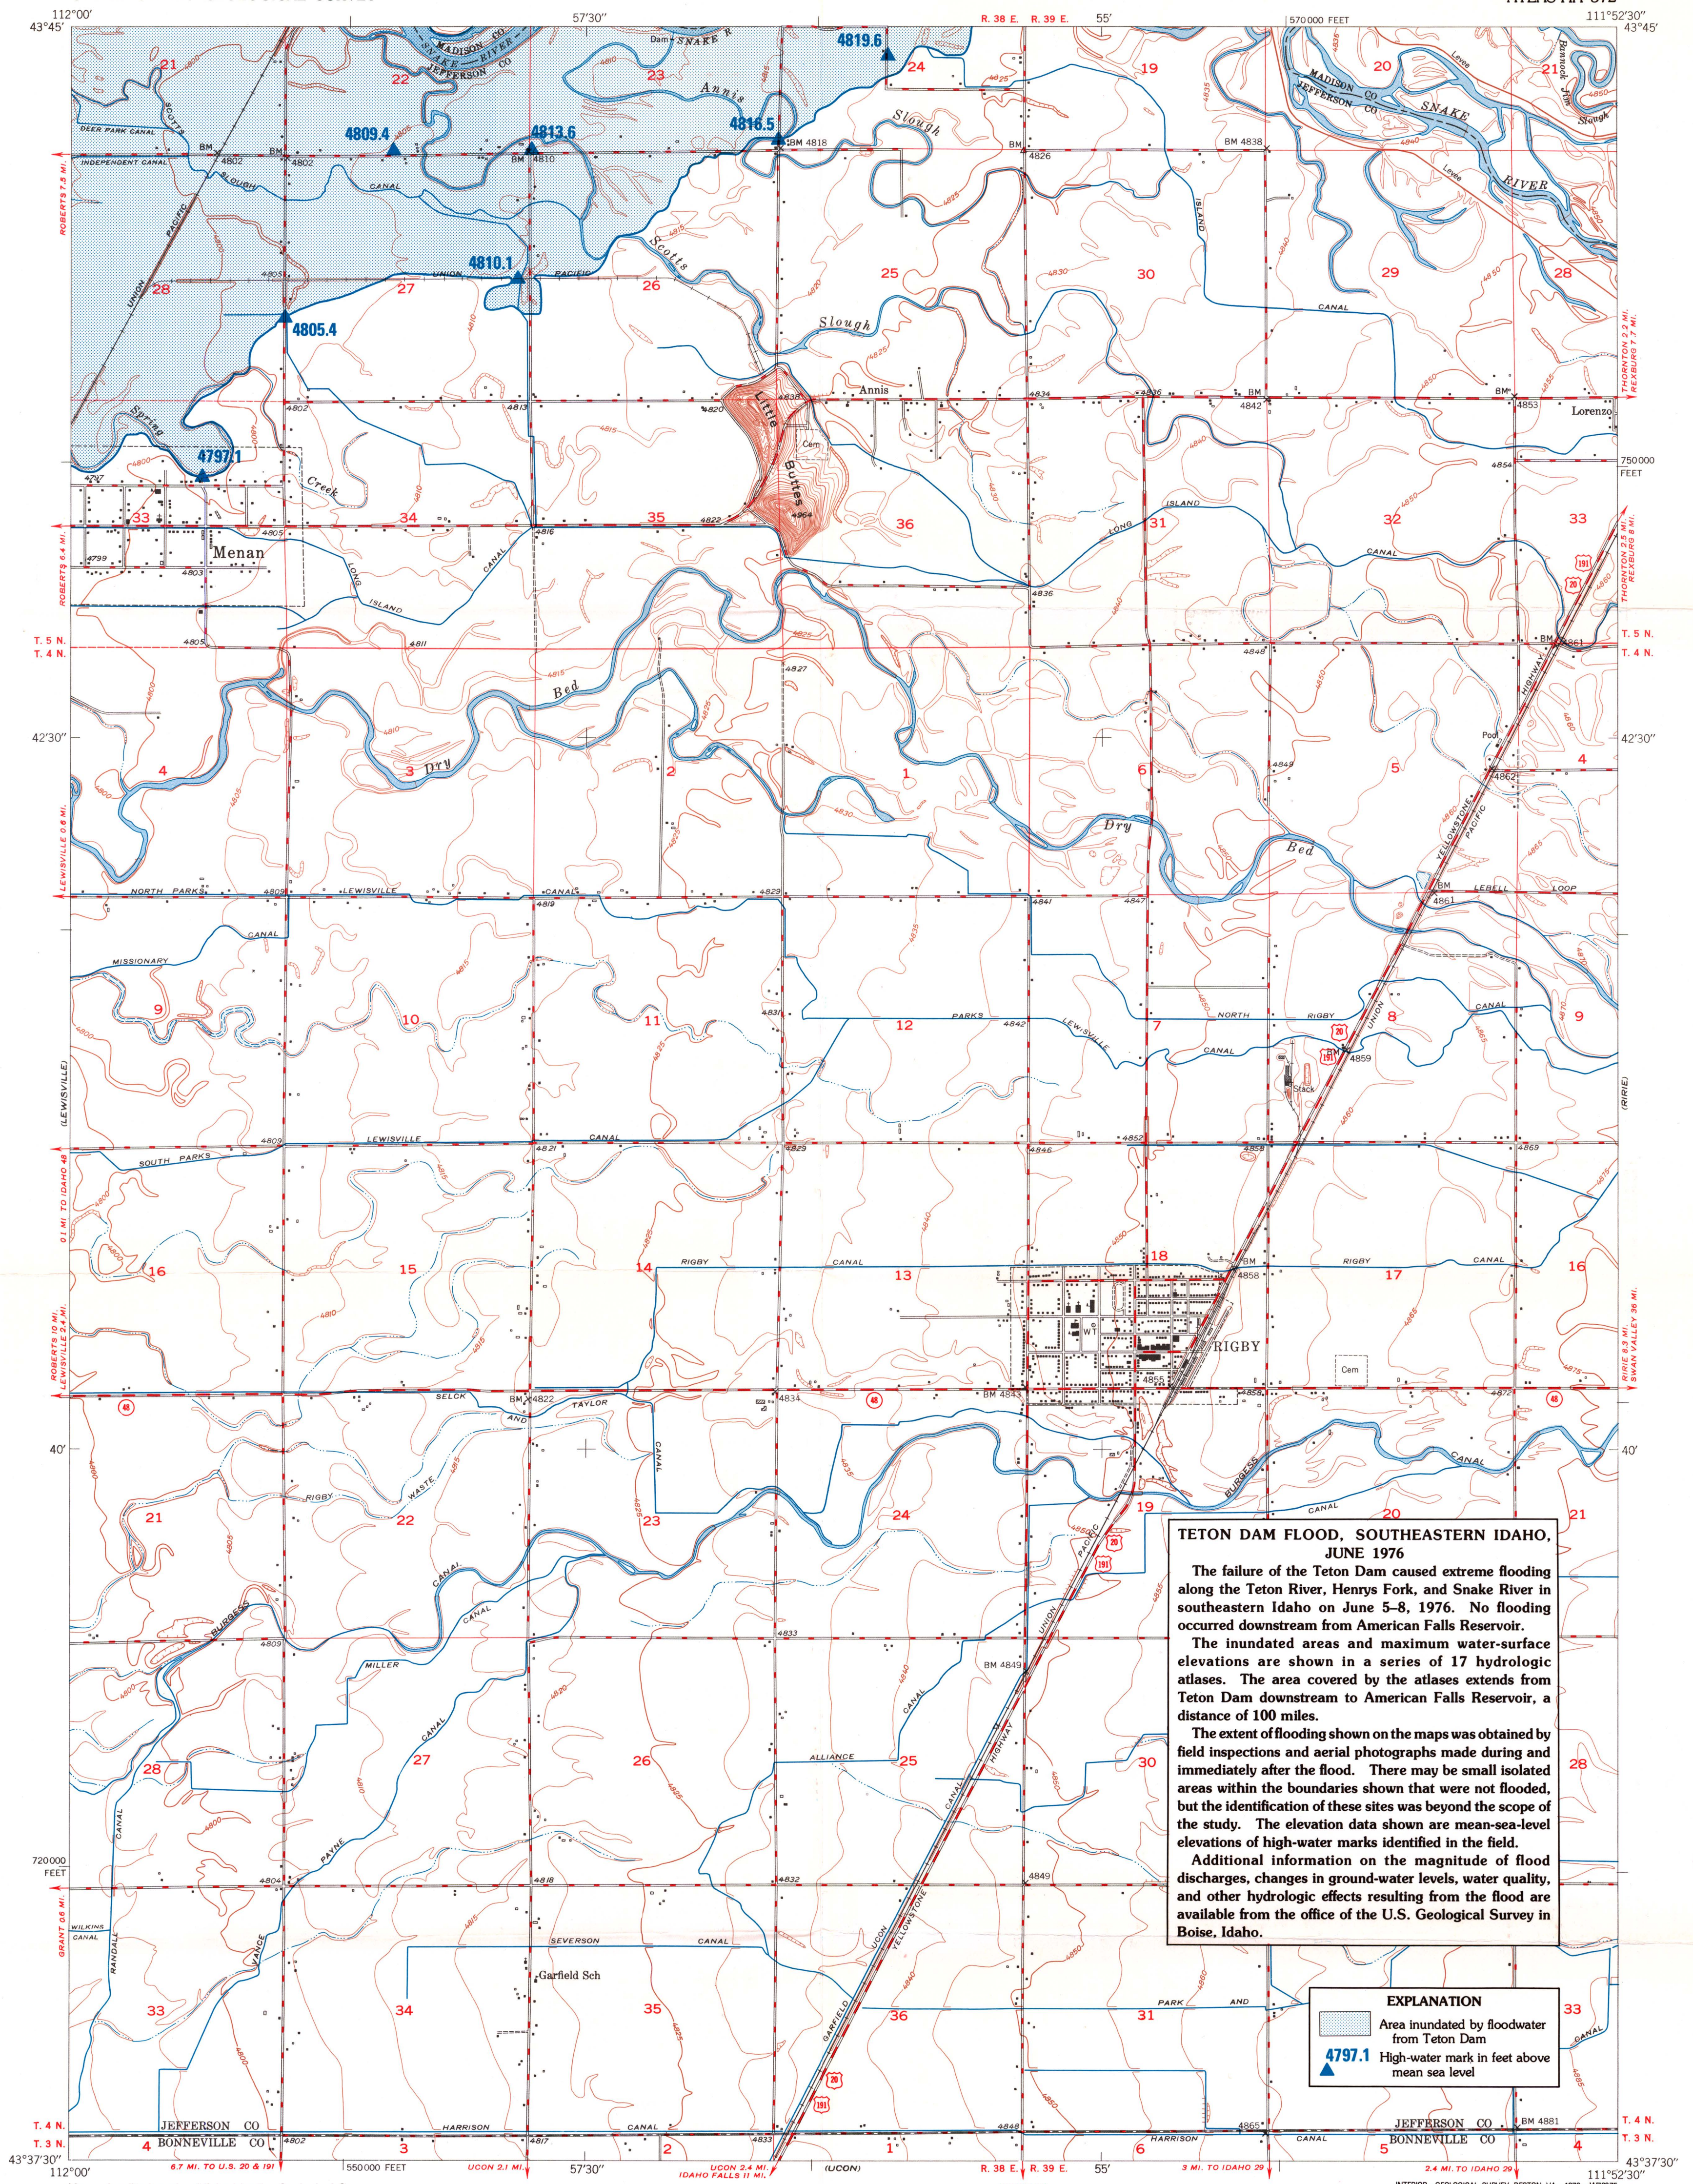
The failure of the Teton Dam caused extreme flooding along the Teton River, Henrys Fork, and Snake River in southeastern Idaho on June 5-8, 1976. No flooding occurred downstream from American Falls Reservoir.

The inundated areas and maximum water-surface elevations are shown in a series of 17 hydrologic atlases. The area covered by the atlases extends from Teton Dam downstream to American Falls Reservoir, a distance of 100 miles.

The extent of flooding shown on the maps was obtained by field inspections and aerial photographs made during and immediately after the flood. There may be small isolated areas within the boundaries shown that were not flooded, but the identification of these sites was beyond the scope of the study. The elevation data shown are mean-sea-level elevations of high-water marks identified in the field.

Area inundated by floodwater from Teton Dam

4797.1 High-water mark in feet above mean sea level
