DESCRIPTION OF SCENE

THE VIKING MISSION

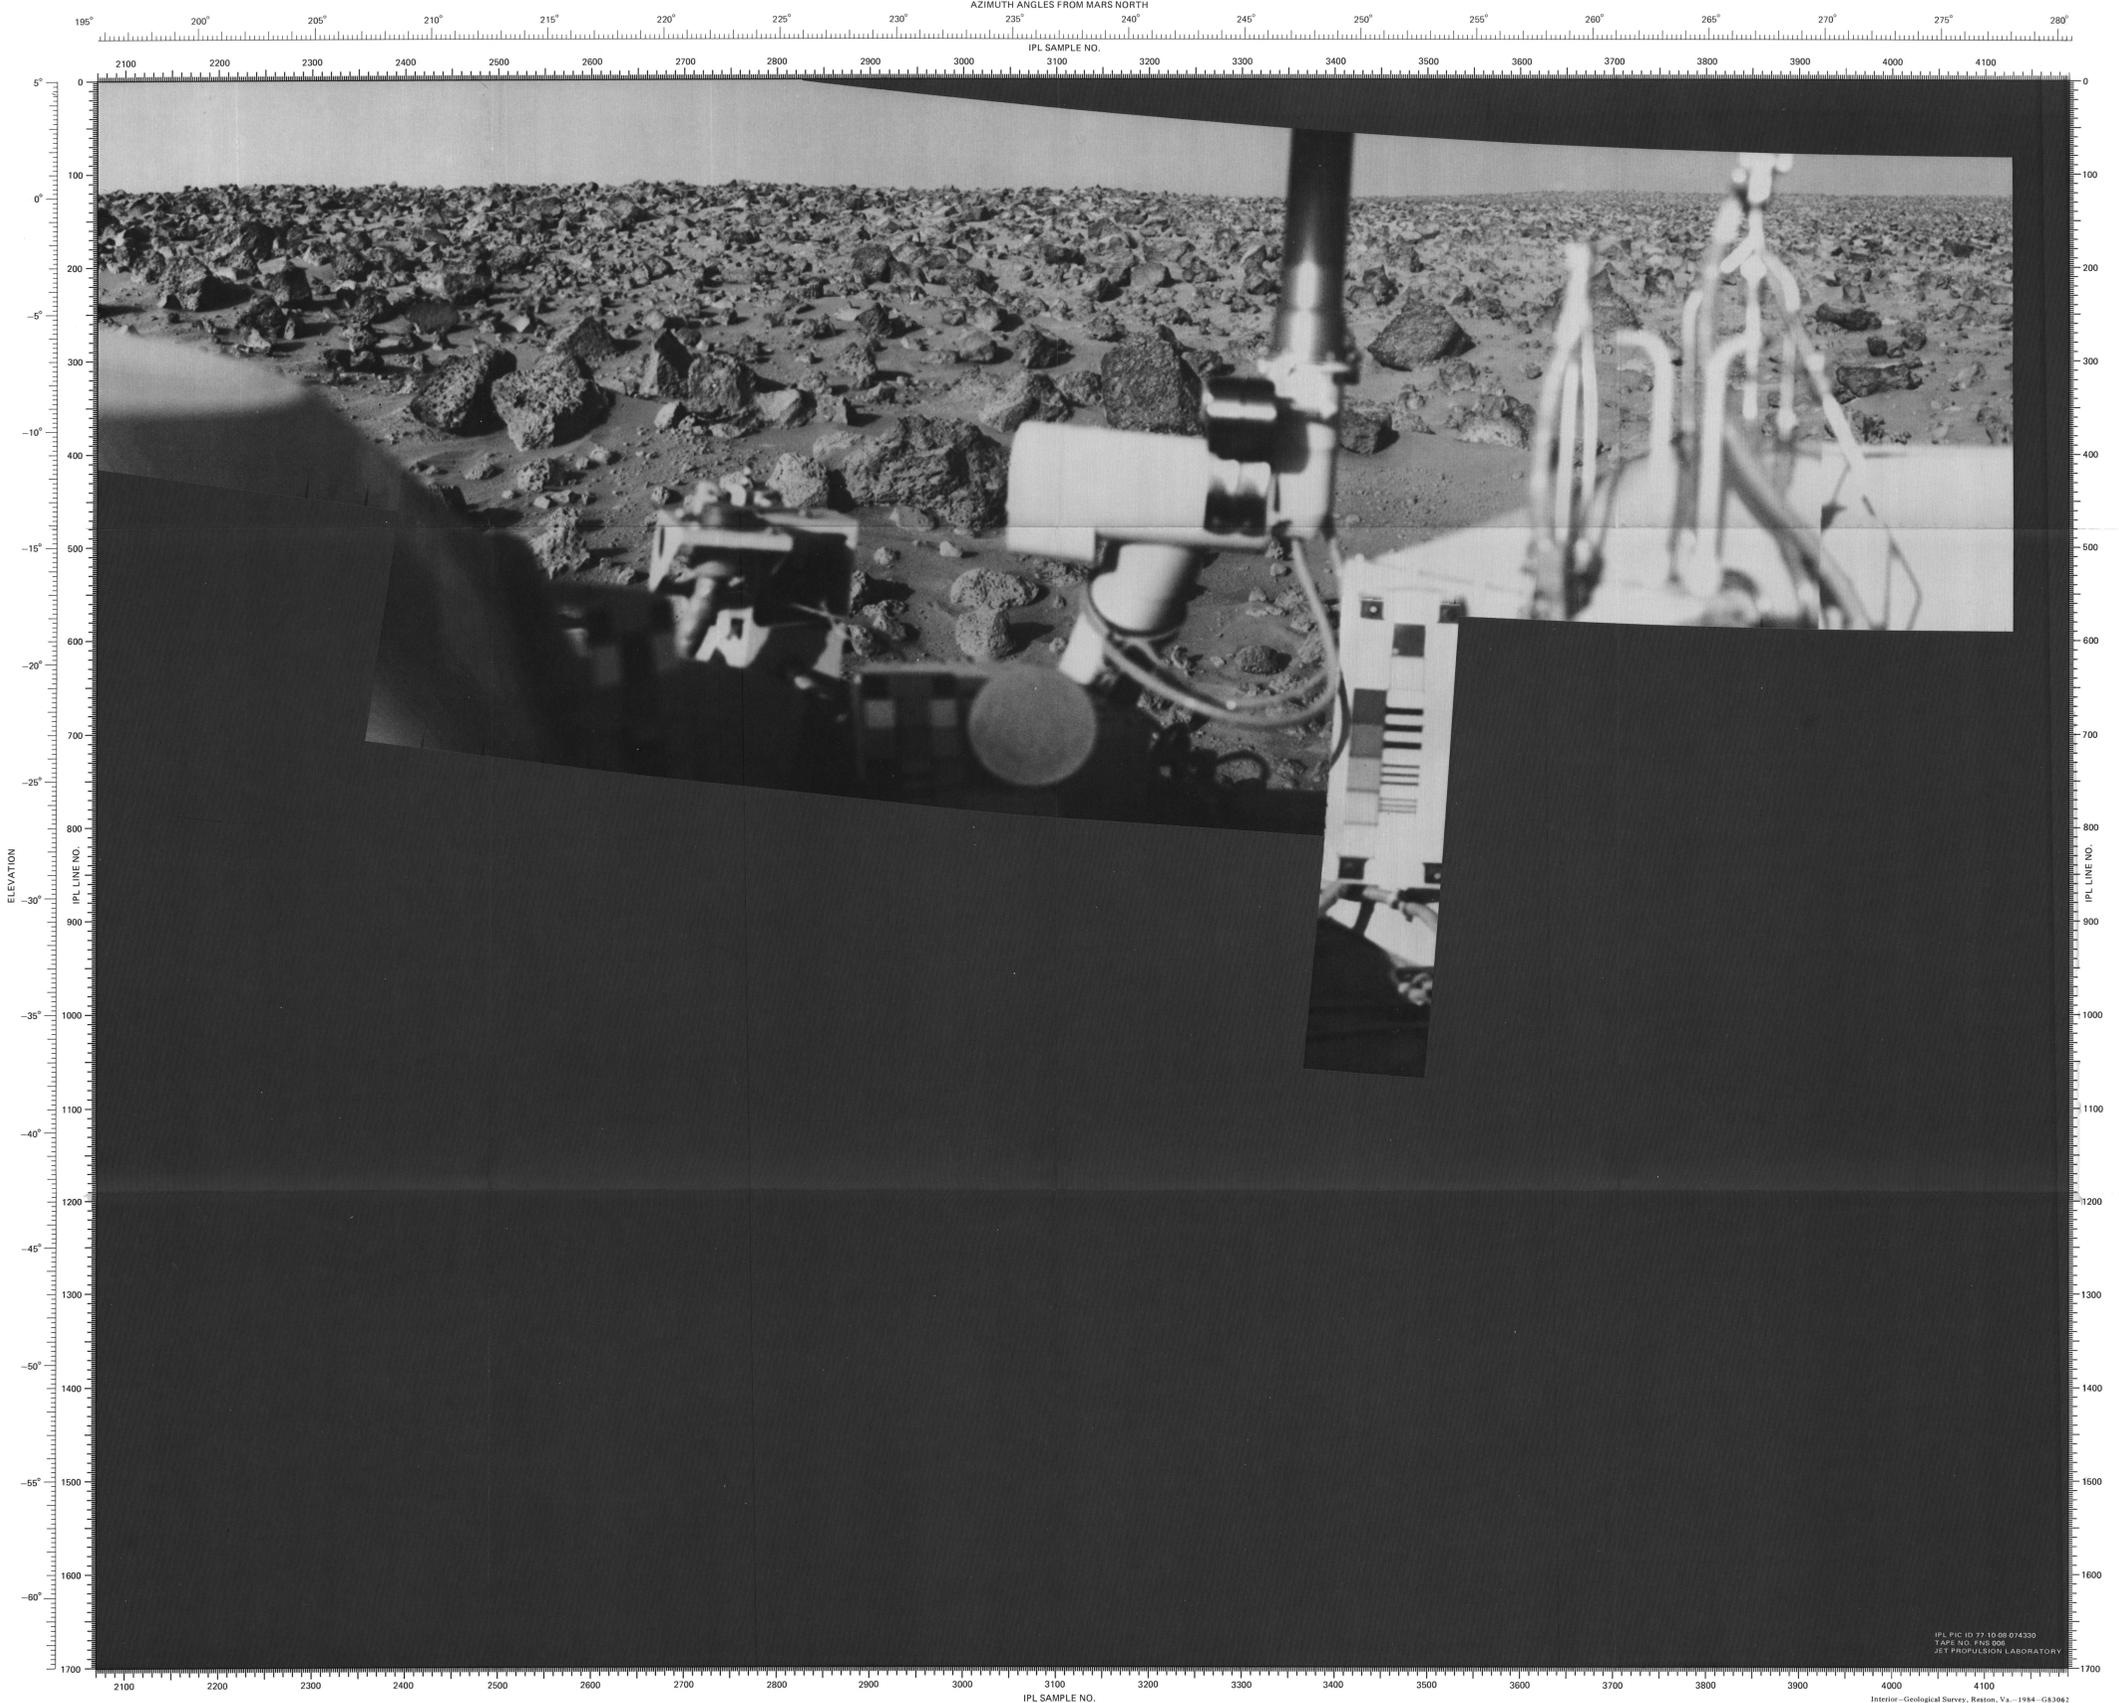
This view southwest over the top of the lander shows the same flat-level surface of Utopia Planitia as is viewed in all directions from the lander. The distribution of the large, subangular pitted or vesicular blocks is nearly uniform in all directions out to the horizon. The large blocks appear to be mostly on the surface of fine-grained material. Distributed among the blocks are a few small drifts of the fine-grained material from between the blocks and atop the drifts. Parts of the lander that are seen in the view are from the left - cover cover, a Radioisotope Thermoelectric Generator (RTG) (line 350, sample 2380); mounting structure for Leg 1 (line 500, sample 2800); three calibration test charts for the camera (line 600, sample 2600); a parabolic mirror for viewing the magnets on the surface-sampler backhoe (line 690, sample 3080); the mast that supports the high gain S-band antenna, (line 530, sample 3380); the cover over the other RTG (line 450, sample 4050); tubes and cables that connected the lander to the orbiter during transit to Mars (line 200, sample 3850). Upon command from Earth, the lander separated from the orbiter and performed all of its pre-programmed landing maneuvers under its own power.
