LANDSLIDES AND RELATED FEATURES OF THE PITTSFIELD, PA. QUADRANGLE

by John S. Pomeroy 1981
 U.S. Geological Survey
 OPEN FILE MAP 81-238 (6-5)

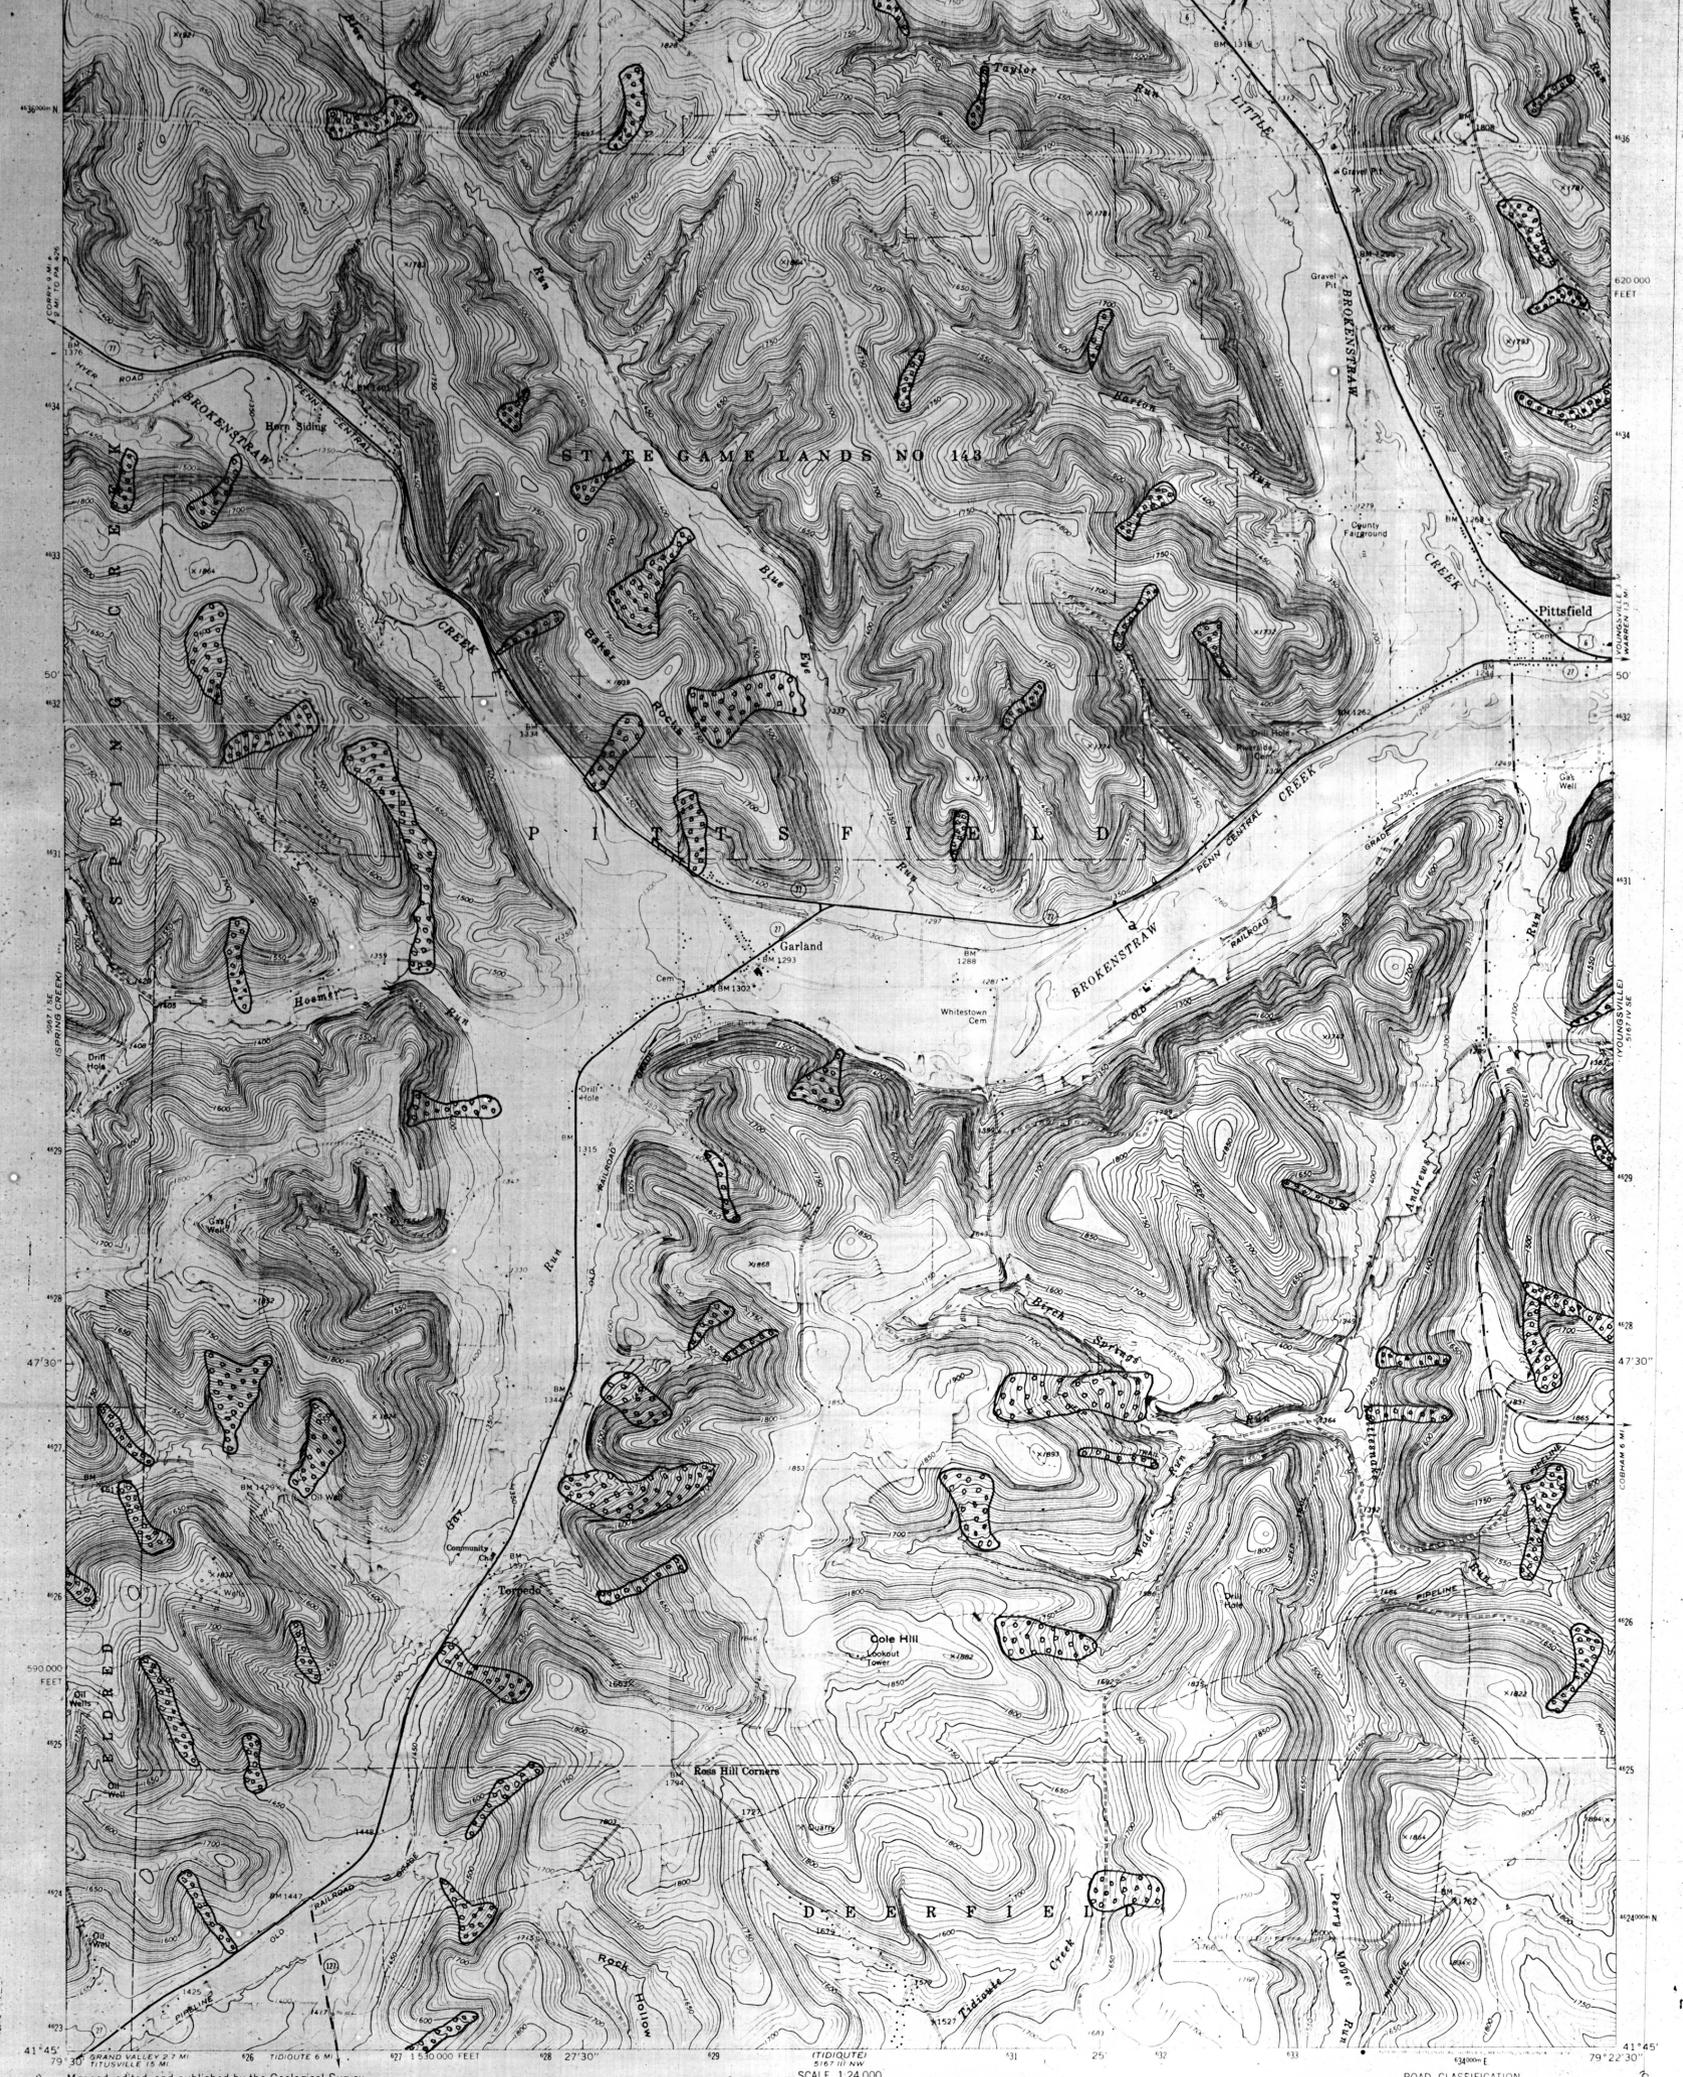
Landslides and related features interpreted from aerial photographs:
 1:78,000 (black and white) 1977
 Photointerpretation and field check 1978-1979
 This map has not been edited or reviewed for conformity with Geological Survey standards and nomenclature.

NOTE
 Information shown is intended as a general guide to ground conditions as of the date of field check. Additional landslides and rockfalls should be anticipated in all map units. The map unit depicts the dominant condition in the area delineated and variations in slope stability may occur at any point in the unit. This map is suitable for general planning purposes and as a supplement to more detailed studies for site selection. The map cannot be used as a substitute for detailed geologic and engineering investigations to establish design and construction criteria of specific sites. Some symbols may not appear on this map because the description is applicable to a series of maps.
