### LANDSLIDES AND RELATED FEATURES

OF THE CORSICA, PA. QUADRANGLE

by  
John S. Pomeroy  
1981

U.S. Geological Survey  
OPEN FILE MAP 81-238 (B-7)

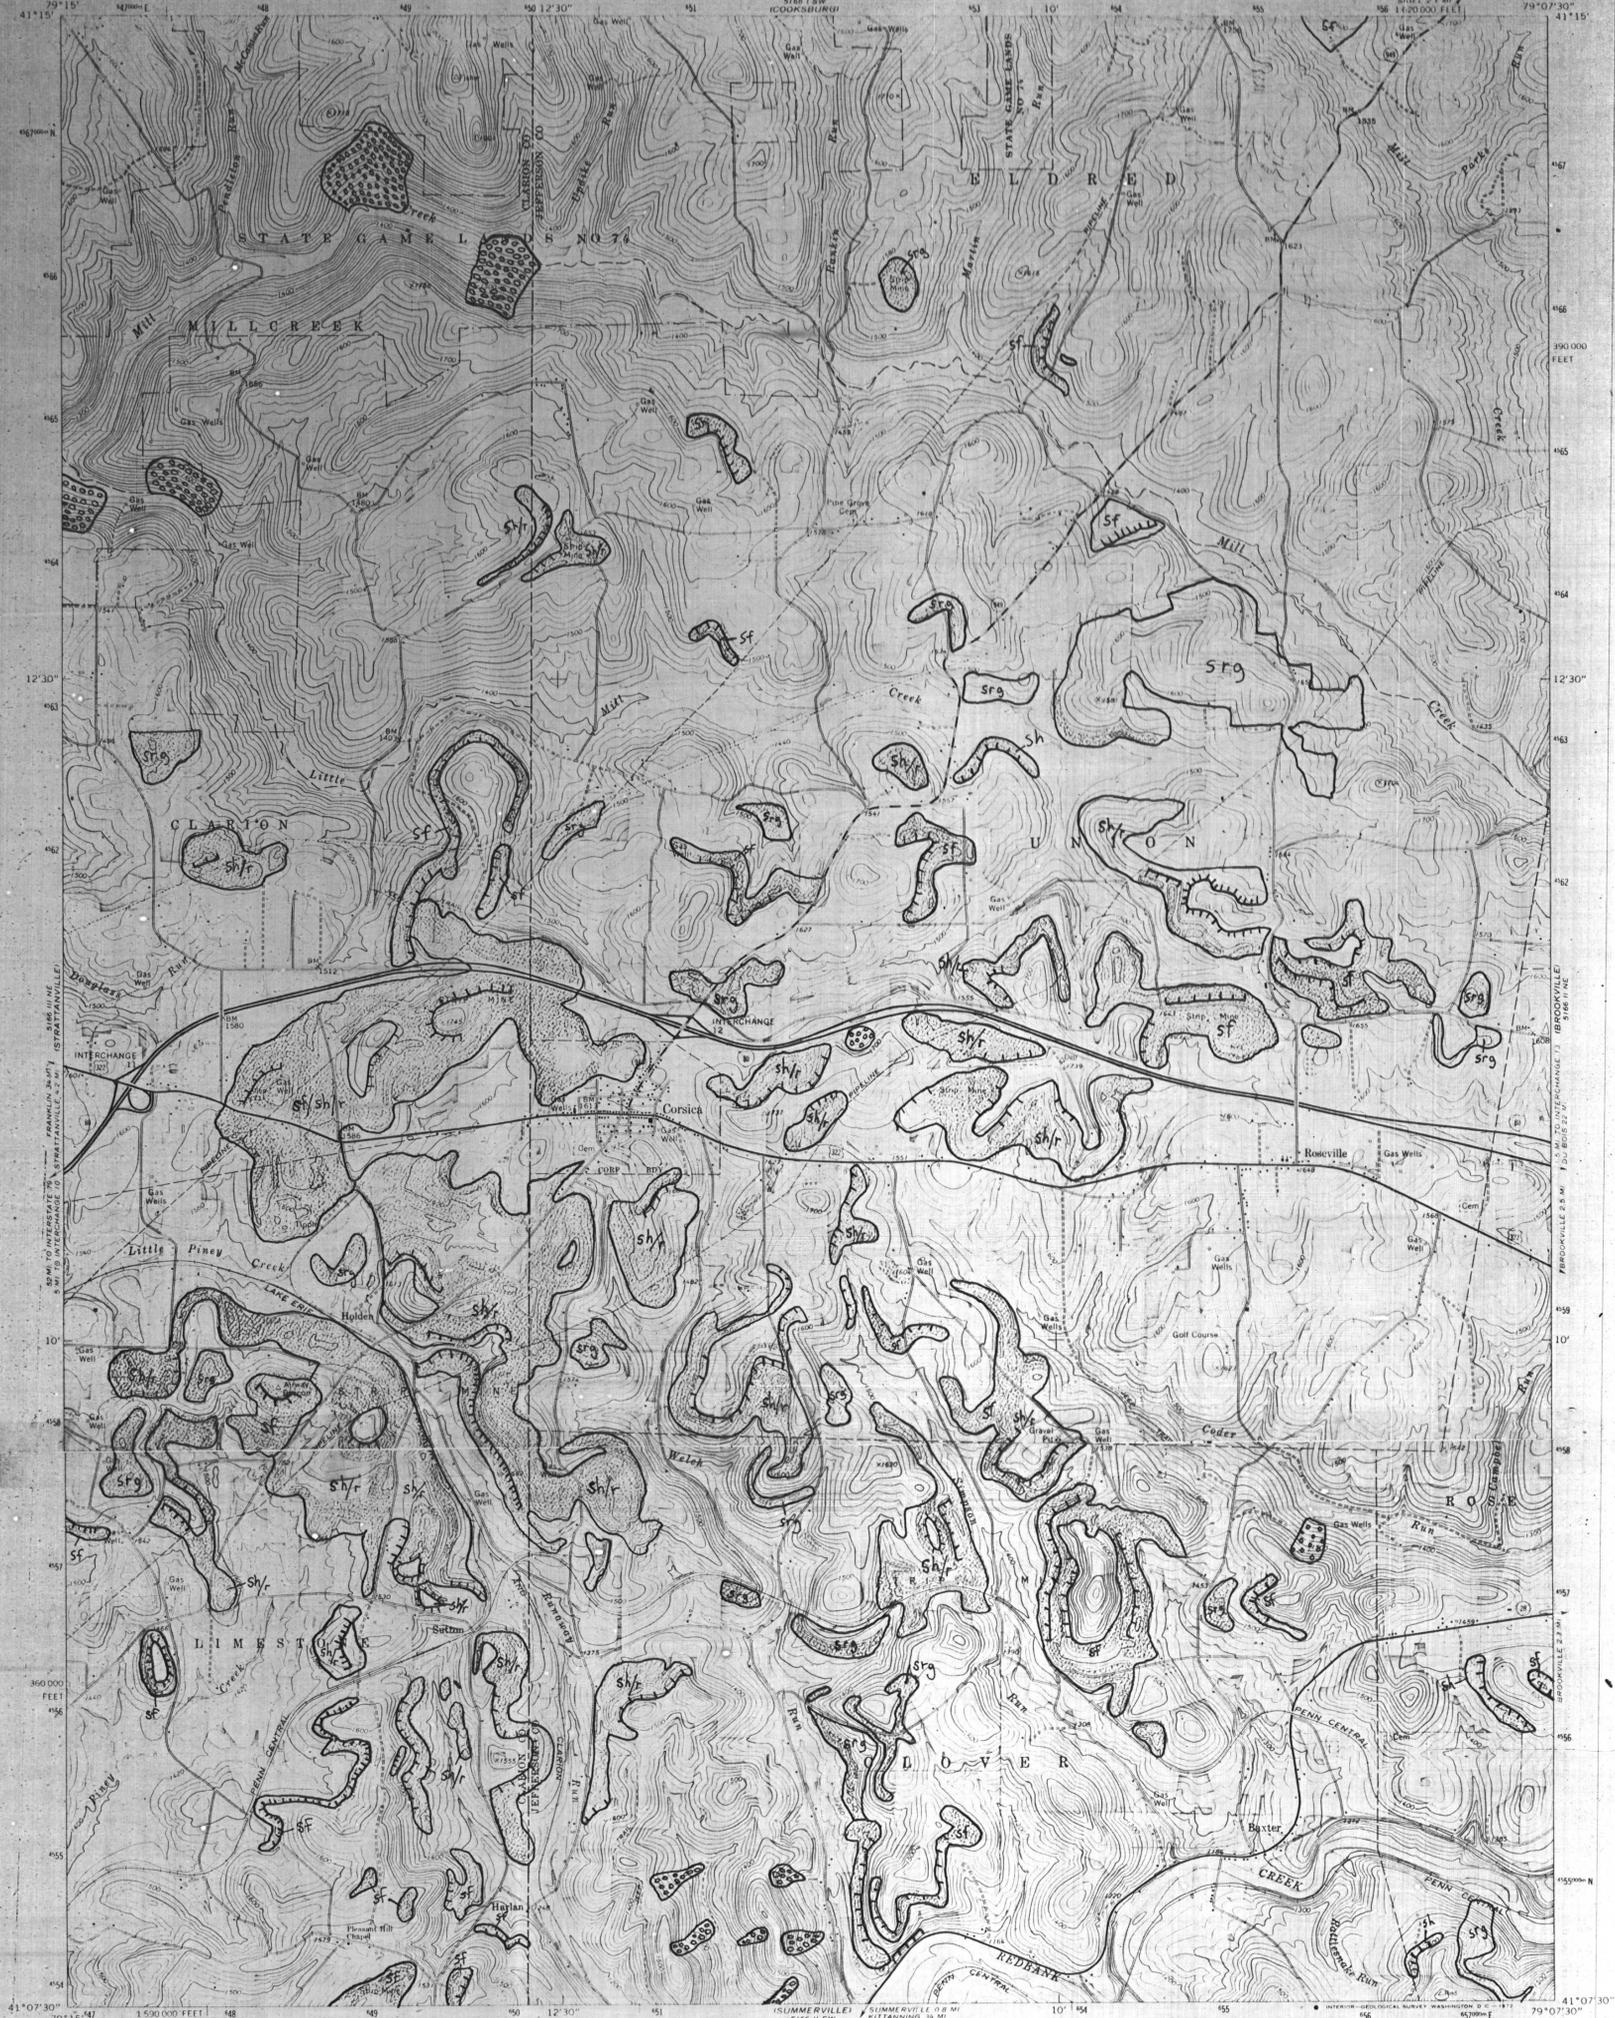
**A** **ACTIVE OR RECENTLY ACTIVE LANDSLIDE**  
Complex landslide composed of earthflow, debris slide, earth and rock slump. Identified from historical records, and from scars, debris and other field evidence. Ground extremely unstable; sliding accelerated by excavation, loading and changes in drainage conditions. May include areas with several active slides too small to be shown separately. Questioned where doubtful. May be shown with symbol (A) where difficult to discern.

**C** **OLD LANDSLIDE**  
Area of extensive hummocky ground caused by earthflow and earth and rock slump. Lacks clear evidence of active sliding. Relatively stable in natural, undisturbed state, generally not affected by small structures properly sited in areas away from the edge of the toe; can be reactivated by extensive, rapid excavation, loading, and changes in ground water and surface water conditions. Area of old landslide probably includes recent ones not identified from field evidence or otherwise documented. Upslope boundary of landslide generally defined by modified scarp, but downslope (toe) may be gradational and not well defined. Questioned where doubtful.

**V** **COLLUVIAL SLOPE**  
Valley wall along major streams with slope as steep as 40° (85%); stony, clayey silt soil up to 50 ft. (15 m) thick; commonly buttressed by a terrace or bench at the toe of the slope; very susceptible to sliding by cutting of toe area, removal of terrace or bench, and overloading; slide commonly activated without apparent cause.

**Y** **AREAS SUSCEPTIBLE TO DEBRIS FLOWS AND DEBRIS AVALANCHES**  
Primarily shallow, narrow ravines and chutes with accumulation of stony colluvium generally 10 ft. (3 m) or less in thickness; susceptible to rapid movement during intense rainfall. Most ravines and chutes designated show evidence of former debris flows and avalanches. Symbol (Y) designates historical debris flow or debris avalanche.

**M** **AREAS SUSCEPTIBLE TO ROCKFALL**  
Steep, locally vertical, natural and man-made slopes and cliffs, 15 ft. (4.5 m) or more high; formed dominantly of sandstone, limestone, sandy shale, mudstone and claystone. Interbedded mudstone, claystone and shale weather rapidly leaving sandstone and limestone rock faces unsupported.

**S** **SOIL AND ROCK SUSCEPTIBLE TO LANDSLIDING**  
Soil and rock similar to that involved in landslides elsewhere in map area; primarily areas underlain by claystone, mudstone and shale associated with other rock types. Rock weathers rapidly on exposure forming clayey soil highly susceptible to sliding. Includes coves (U-shaped, shallow valleys) containing thick layers of clayey soil that are very susceptible to sliding where excavation breaks continuity of slope and where overloaded by artificial fill.

**AREAS LEAST PRONE TO LANDSLIDES**  
Map areas in which no patterns or symbols are shown; primarily valley floors, ridge tops and broad benches; modification by excavation and fill may lead to local landslides. Includes slopes where landslides are sparse.
