LANDSLIDES AND RELATED FEATURES

OF THE CROSBY, PA. QUADRANGLE

by  
John S. Pomeroy  
1981

U.S. Geological Survey  
OPEN FILE MAP 81-238 (F-13)

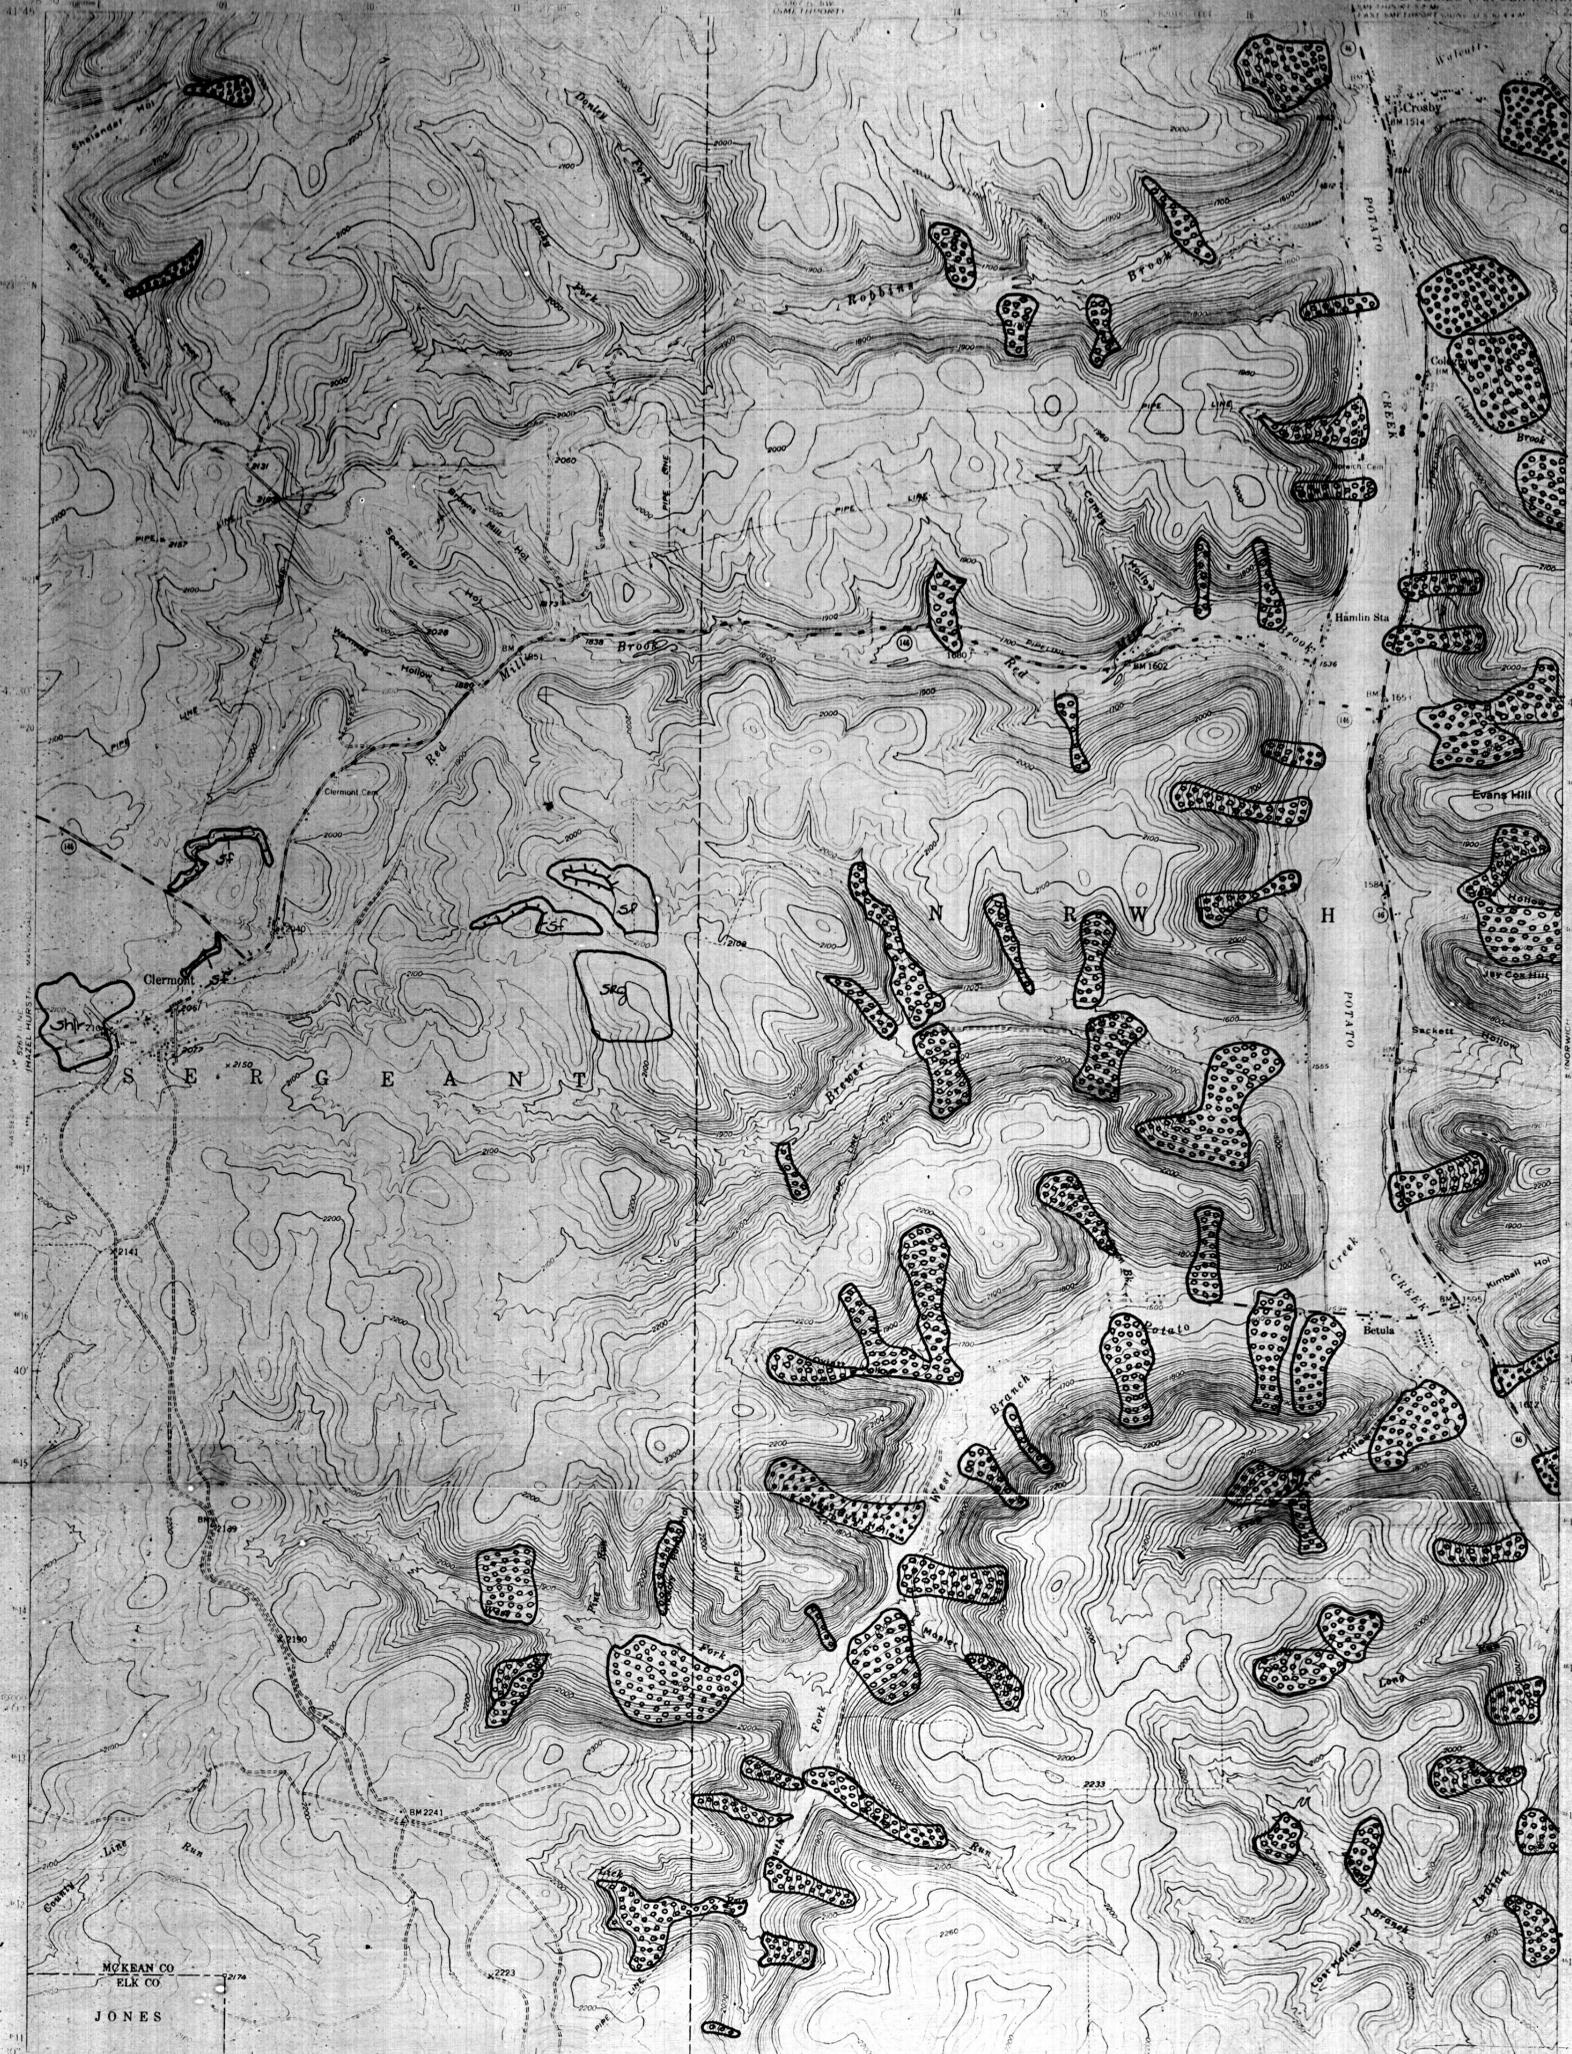
Landslides and related features interpreted  
from aerial photographs:  
1:78,000 (black and white) 1977

Photointerpretation and field check 1978-1979  
This map has not been edited or reviewed  
for conformity with Geological Survey  
standards and nomenclature.

NOTE  
Information shown is intended as a  
general guide to ground conditions as of  
the date of field check. Additional  
landslides and rockfalls should be anticipated  
in all map units. The map unit depicts  
the dominant condition in the area delineated  
and variations in slope stability may occur  
at any point in the unit. This map is suitable  
for general planning purposes and as a  
supplement to more detailed studies for site  
selection. The map cannot be used as a  
substitute for detailed geologic and engineering  
investigations to establish design and  
construction criteria of specific sites.  
Some symbols may not appear on this map  
because the description is applicable to a  
series of maps.

Quadrangle does not contain landslides or related features.
